# Victoria Baths

Friday, 06 October 2023

Prepared For Performance Electrical

**18 Issues Identified**

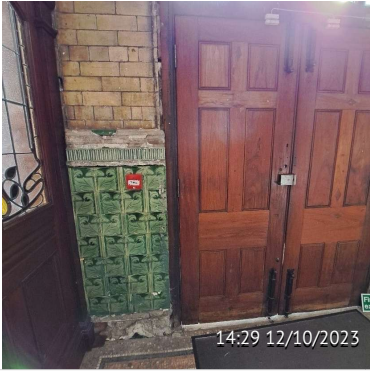
## Main Entrance

Call point

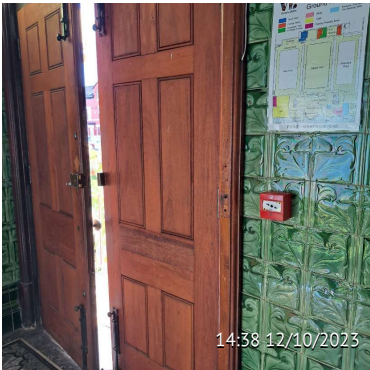
## Front Entrance Door

Call point

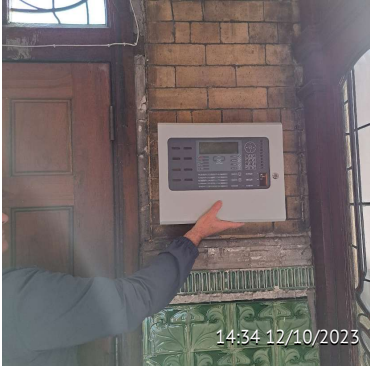
## Front Entrance

Typical panel

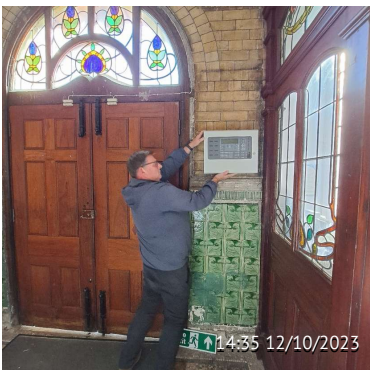
## Front Entrance

Typical positioning of panel

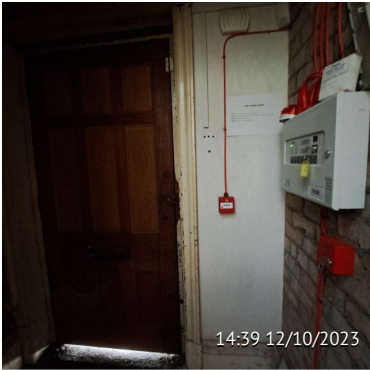
**Existing Equipment**  
Existing call point and fire alarm panel

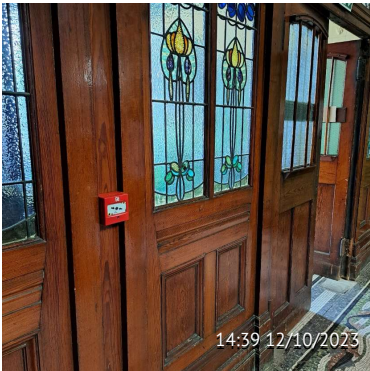
**Internal Wooden Panel**  
Call point on wooden entrance doors

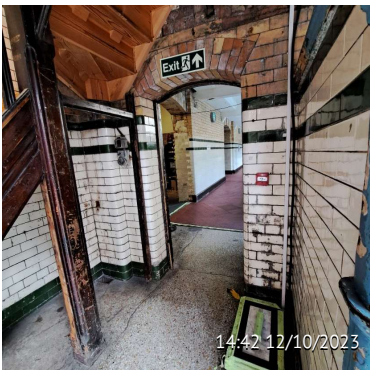
**Tiled Area**  
Call point at rear building

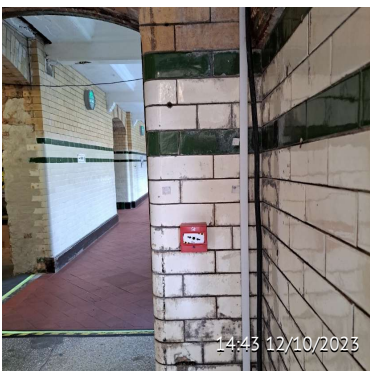
**Tiled Area**  
Close up image of call point

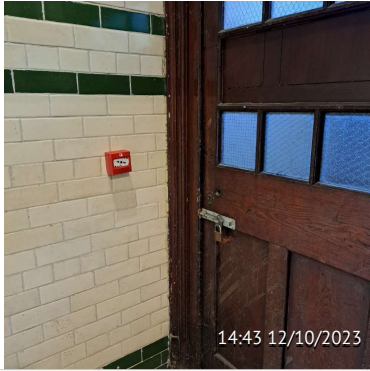
### Rear of Building

Call point near exit on tiled surface

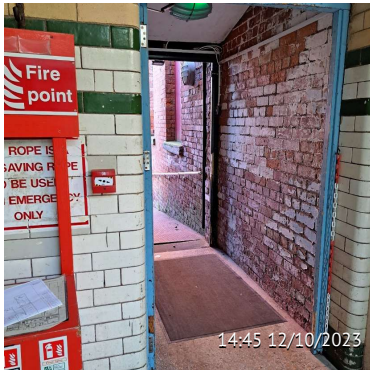
### Exit To Rear

Call point adjacent to rear exit

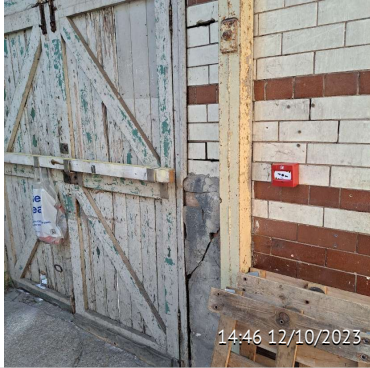
### Outbuilding

Call point in outbuilding

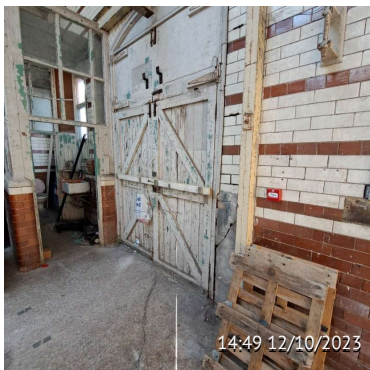
### Outbuilding Image 2

Call point I outbuilding image 2

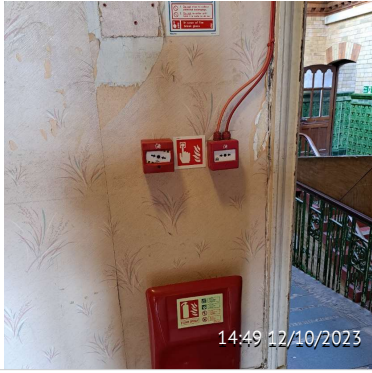
## First Floor

Call in living area entrance

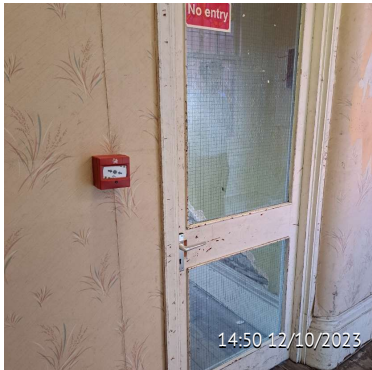
## First Floor

Call point in corridor

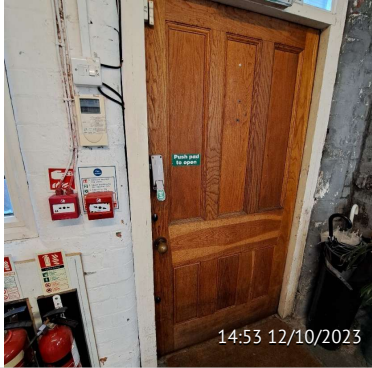
## Left Hand Side Front Door

Call point at side of door in office area
