| <b>20820-DWC-EX-ZZ-RP-S-00001-P03</b> | <b>26<sup>th</sup> March 2024</b> |
| <b>117-119 Portland Street<br/>Manchester</b><br><br><b>Structural Report for Planning</b> | |
| <b>Bruntwood AV Limited</b> | |

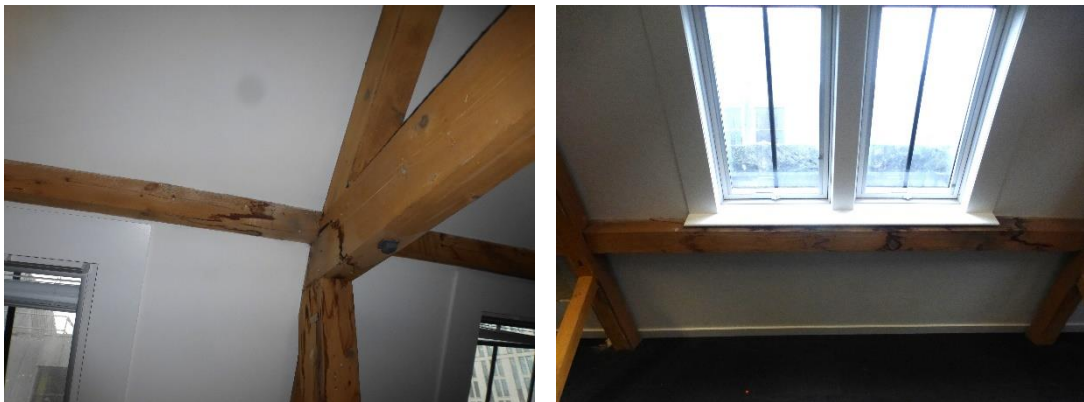
- 3.7 There is evidence of water penetration to the trusses and side purlins at almost every window. However, the windows were replaced and the flashings fully refurbished in 2019 and the water ingress and staining is historic. A record photo from 2019 is below with the staining already showing.

Water staining to timber trusses and purlins at 4<sup>th</sup> floor level.

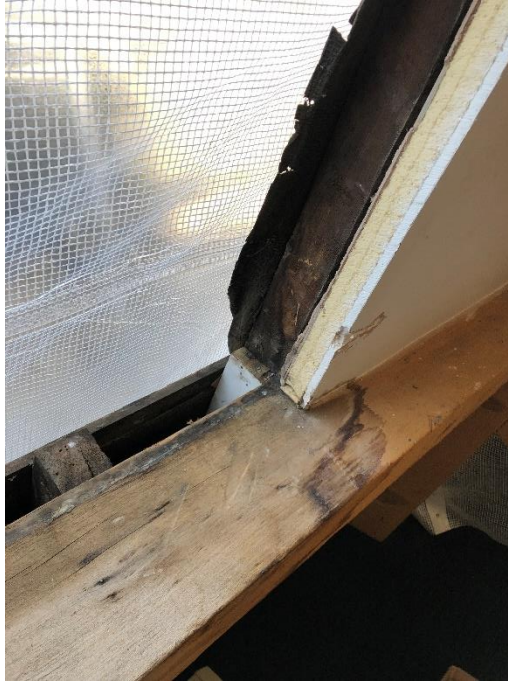
Record photo from 2019 showing the water staining to the purlins.

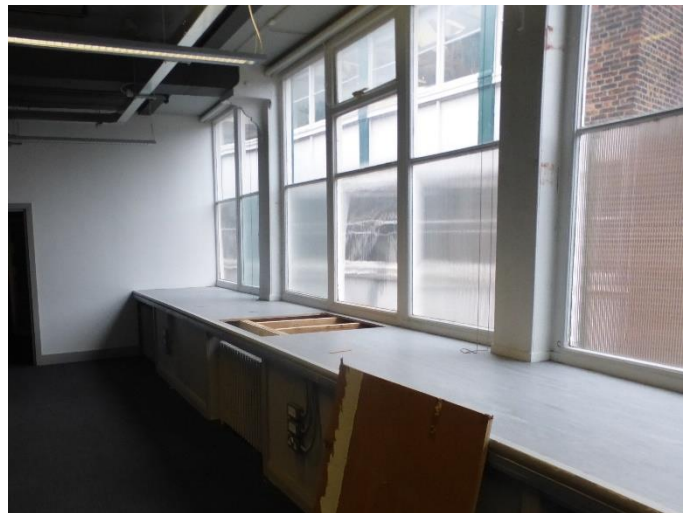
- 3.13 The glazed elevation is formed with cast iron stanchions supporting the timber floor beams on large brackets. Internally the cast iron framing and windows appear to be in good condition.

Glazed rear elevation.  
Note large cast iron bracket supporting timber floor beam

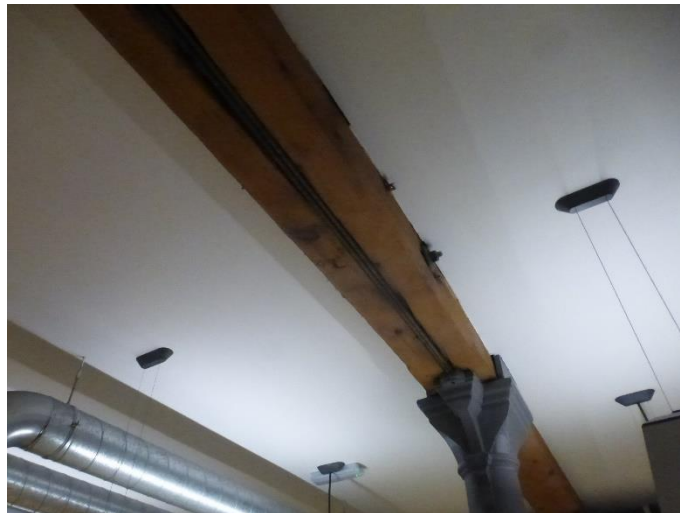
- 3.30 We noted one main beam at u/s ground floor is a 'fitch' beam, with steel plates sandwiched between timber beams. We assume that when originally constructed there was a heavier use in this area.

### One fitch beam noted at underside ground floor.

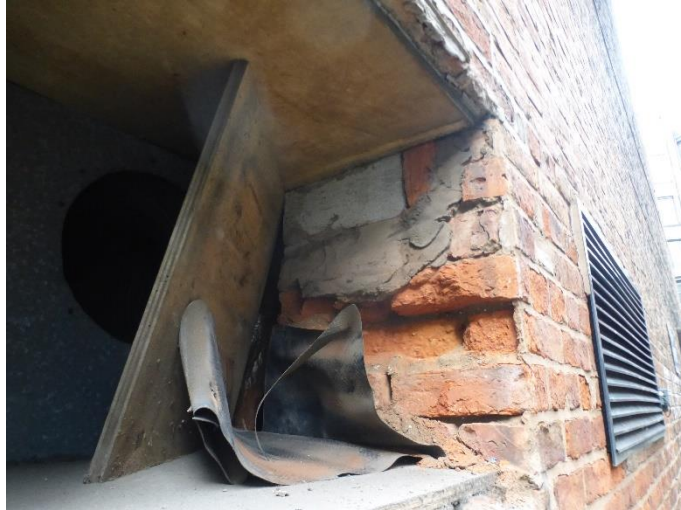
Opening in gable wall with louvre cover removed.

4.5 New louvre openings to the gable wall can be formed by locally propping the wall to allow the openings to be cut out. Concrete lintels can be used to the internal faces with a proprietary hidden lintel to the outer face to ensure that the existing brick face is visible directly above the new openings.

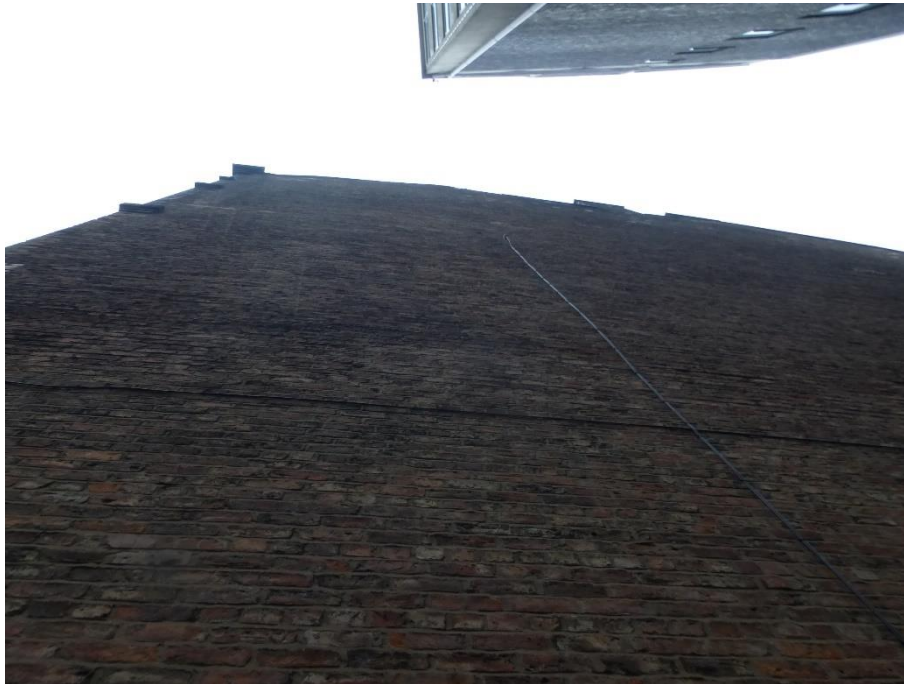
- 3.39 The gable (to the East) elevation contains no windows but does have 2 vent openings. We noted that the brickwork face is not 100% vertical, but we did not consider any of the areas that appears to bulge outwards or inwards to be excessive and certainly as would be expected for a building of this type and age. The wall thickness was measured as 490mm at ground floor level.

Small areas of misalignment can be seen on the gable wall, but not excessive

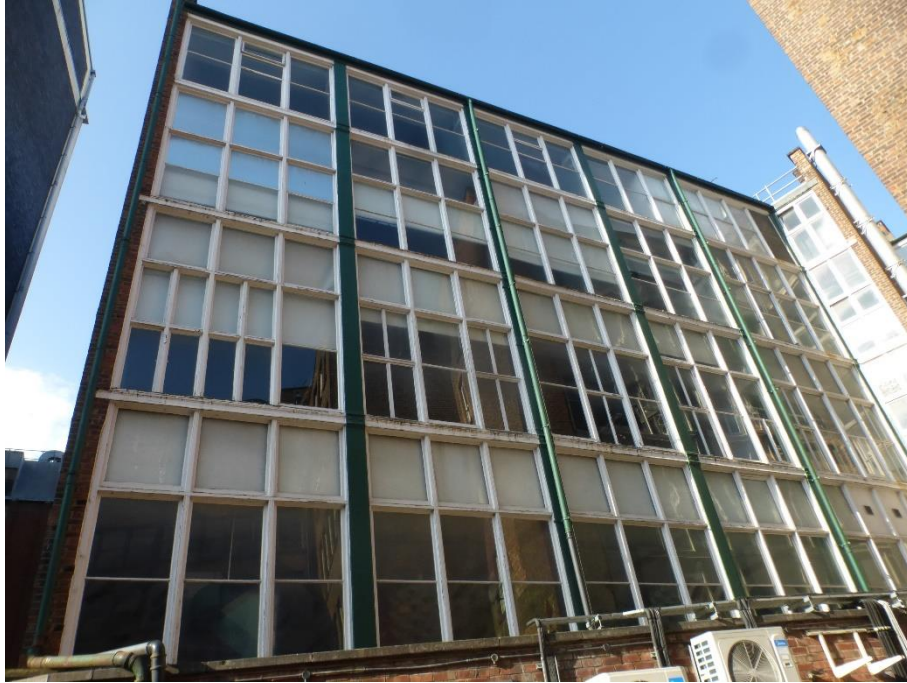
- 3.40 The main rear (North) elevation is formed with a cast iron frame of stanchions and beams. The stanchions support the building floor beams at each level. From street level, the cast iron framing appears to be in good condition, albeit in need of refurbishment; cleaning and repainting etc. The timber framed windows are showing signs of deterioration.

Main rear elevation viewed from car park
