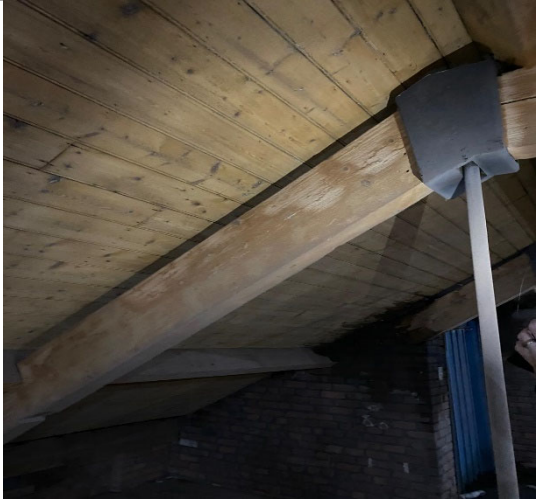
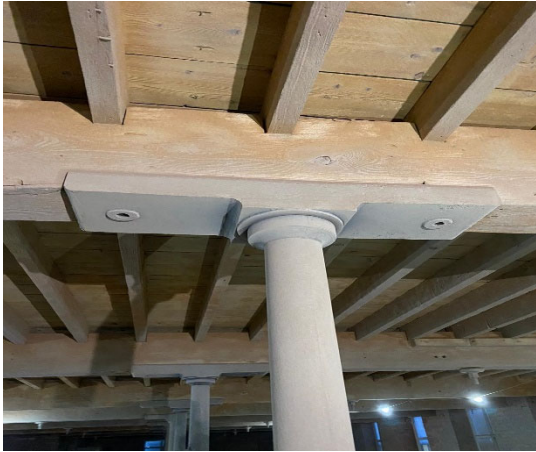
| Ref | Feature | Description | Removed / Retained | Methodology | Sample Date | Photograph |
|---|---|---|---|---|---|---|
| <b>G1</b> | Columns & beam shoes | Painted cast iron columns and varying types of primary beam support shoes | Retained | Existing paint to be lightly removed and new intumescent paint finish to be applied | Approved 05/12/2023 | |

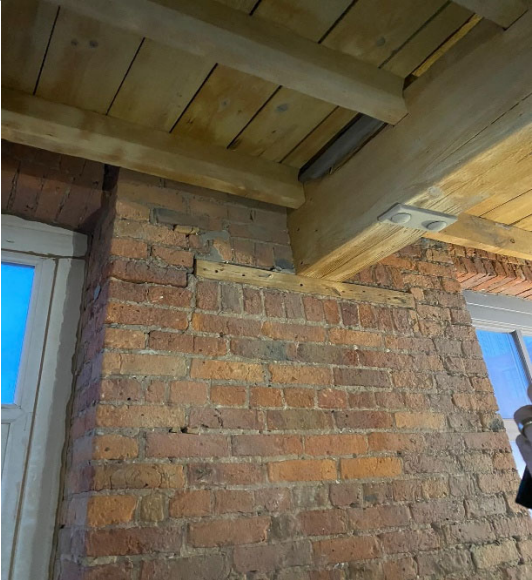
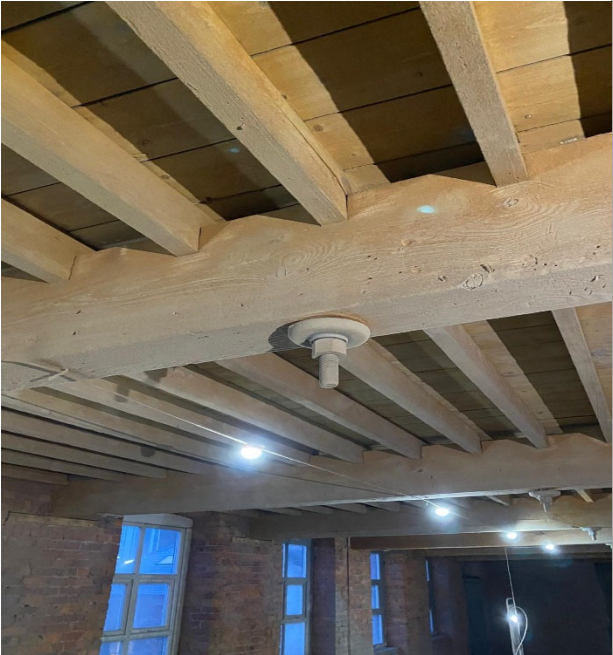
| G2 | Primary beams | Painted 400 x 200mm timber beams spanning full width | Retained & fully revealed | Existing paint to be lightly removed and new clear intumescent coating to be applied. Beam ends to be replaced where rotten to be confirmed following strip out works | Approved 05/12/2023 | |

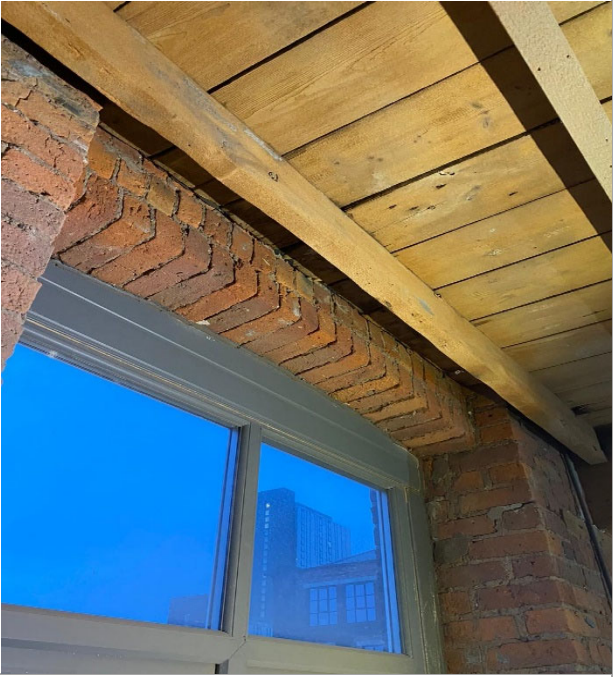
| <b>G3</b> | Joists | 175 x 65mm<br>timber joists at<br>400mm<br>centres<br>spanning<br>between<br>primary<br>beams | Retained<br>&<br>exposed | Joists to be<br>lightly sanded<br>and new<br>clear<br>intumescent<br>coating to be<br>applied | Approved<br>05/12/2023 | |

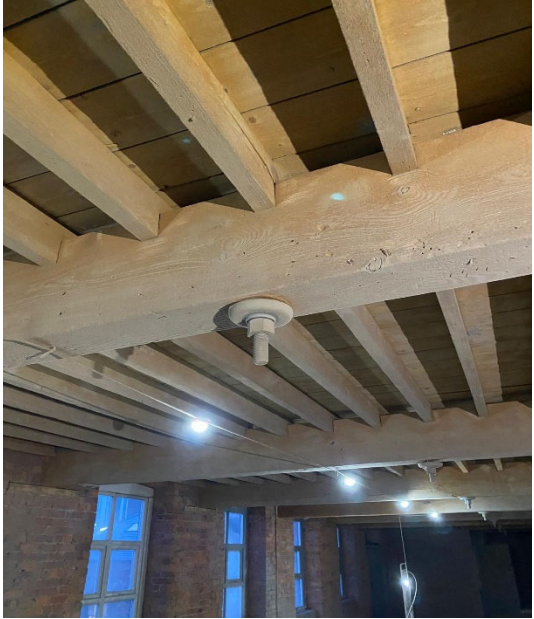
| <b>G4</b> | Timber board soffits | Two layers of timber planks spanning across joists forming floor deck above | Retained & exposed | Boards to be lightly sanded and new clear intumescent coating to be applied | Approved<br>05/12/2023 | |

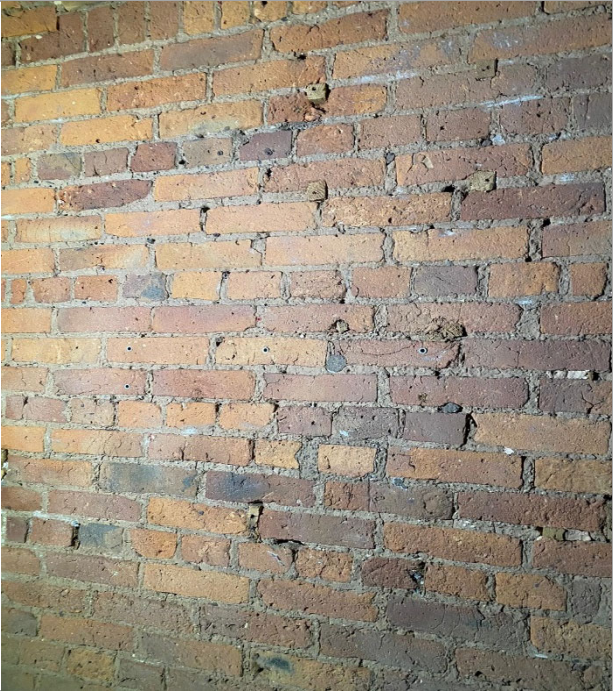
| <b>G6</b> | Internal face of external walls | Exposed brickwork with paint finish with small areas of plasterboard dry lining | Retained & cleaned of paint | Existing paint finish to be lightly removed and brickwork left uncoated and exposed. Internal face of east gable to be dry lined. | Approved<br>05/12/2023 | |

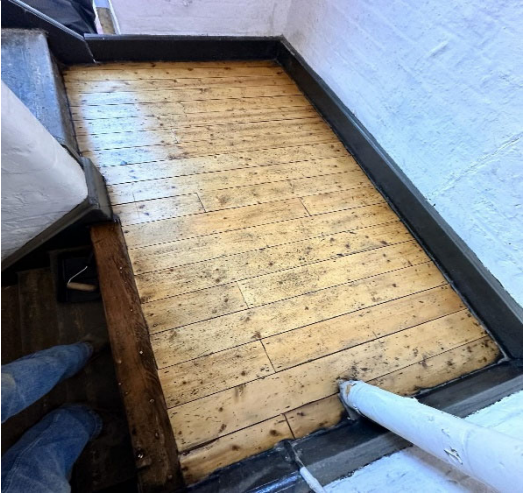
| G11 | North east stair | Painted brickwork walls to stair enclosure with stair construction of timber joists overlaid with timber board flooring and vinyl covering. Underside of boards form soffit. | Retained & cleaned of paint | Existing paint finish to be lightly removed and brickwork left uncoated and exposed. Vinyl floor covering to be removed and replaced. Boards and joists to be lightly cleaned of paint and fully exposed. | Approved 05/12/2023 | |

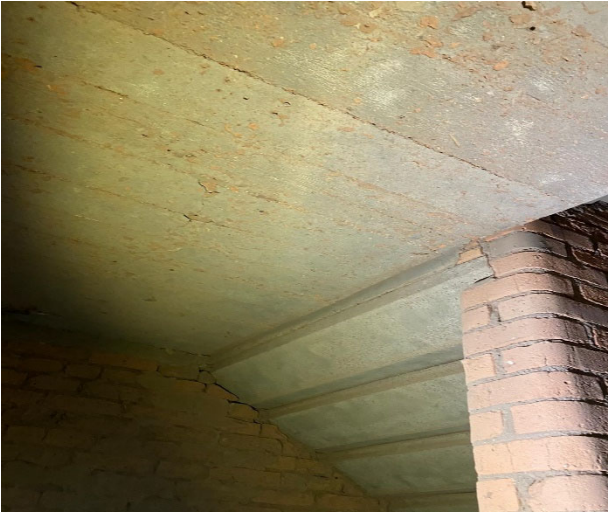
| G12 | North west stair | Painted brickwork walls to stair enclosure with stair construction of concrete flights with paint finish to exposed concrete soffits. | Retained & cleaned of paint | Existing paint finish to be lightly removed and brickwork left uncoated and exposed. Concrete elements to be cleaned of paint and coated with clear dust sealer. | Approved 05/12/2023 | |

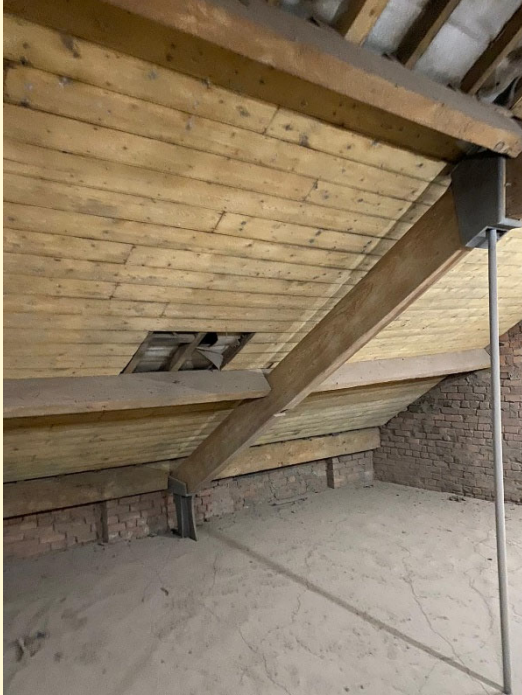
| 41 | Roof trusses | Primary timber trusses with hanging rods | Retained & cleaned | Existing paint to be lightly removed and new clear intumescent coating to be applied. | 29/01/2024 | |

| | | | | | | Works now out of scope – timber to be over boarded so not left exposed. | |

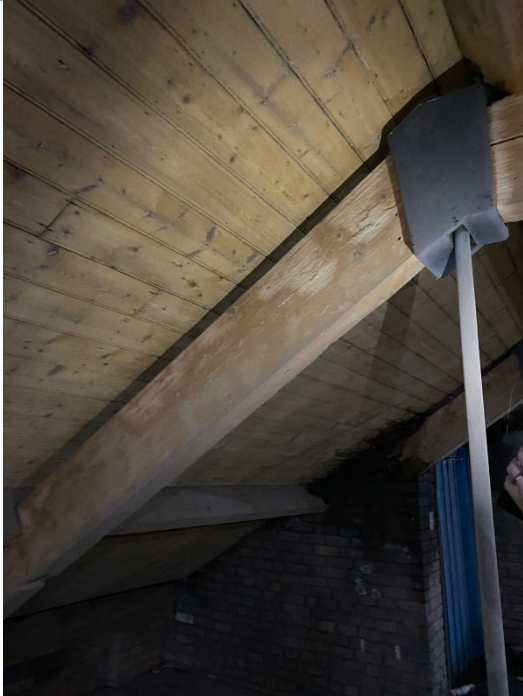
| 42 | Purlins | 100 x 225mm timber purlins | Generally retained. Upper purlin to south roof slope to be removed | Purlins to be lightly cleaned of paint | Approved 05/12/2023 | | |

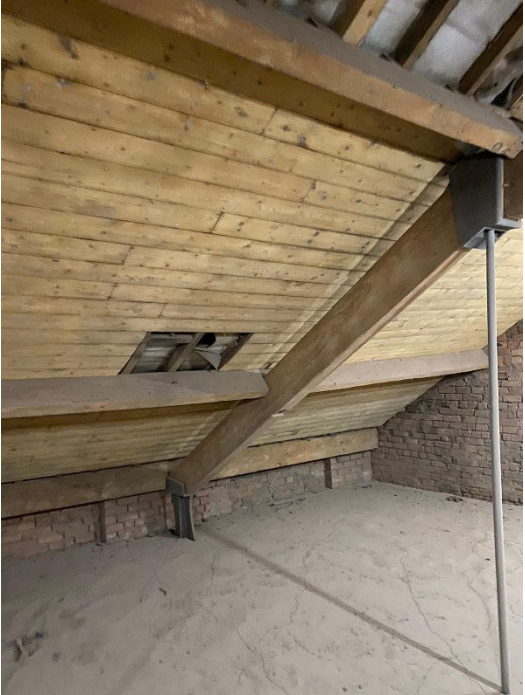
| 44 | Ceiling lining | Painted timber strip ceiling fixed to underside of rafters | Retained | Boards to be cleaned in situ, removed & then reinstated over new insulation fixed to underside of rafters | Approved<br>05/12/2023 | |
