## SCHEDULE OF WORKS

| PROJECT | MIDLAND HOTEL WEST ENTRANCE |
| PROJECT REF. | 2045 |

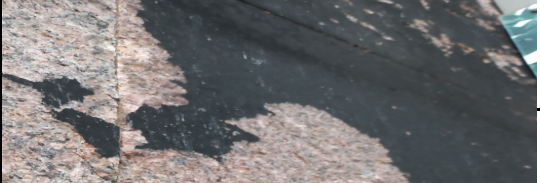
| Item Ref | Item of Work | Image of Condition (if available) | Like for Like Repair? |
|---|---|---|---|
| 3.01 | Smoke soiling to surface of both Peterhead and Shap granite. TORC heated steam system. Refer to drawings (210) and (100) for extent. Refer to NBS CI C40. | | Yes |

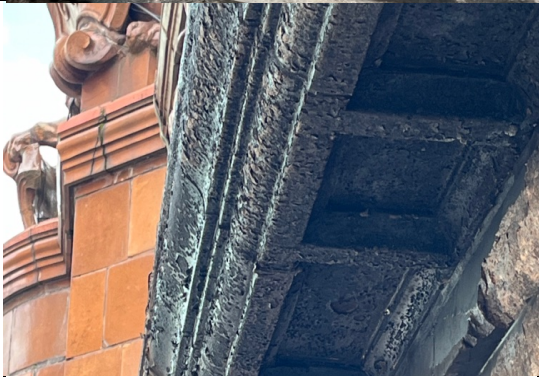
| Item Ref | Item of Work | Image of Condition (if available) | Like for Like Repair? |
|---|---|---|---|
| 3.04 | Smoke soiling to surface of faience terracotta balcony. TORC heated steam system. Refer to drawings (210) and (100) for extent. Refer to NBS Cl C40. | | Yes |

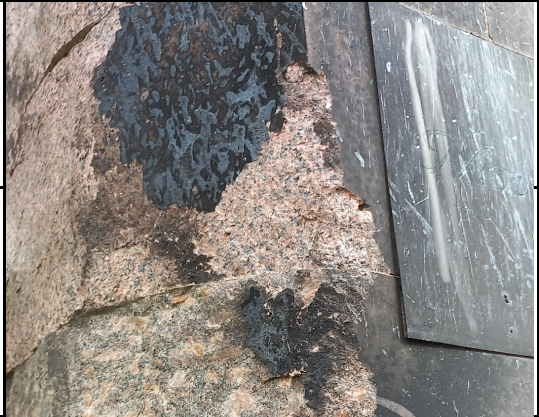
| Item Ref | Item of Work | Image of Condition (if available) | Like for Like Repair? |
|---|---|---|---|
| 4.01 | Produce a set of full working details for the masonry replacement. Proposals must be agreed with structural engineer. Include programme for removal to ensure stability of structure and full protection. Allow for a full temporary arch former to be supplied, installed and taken away to support underside of arch. | | n/a |

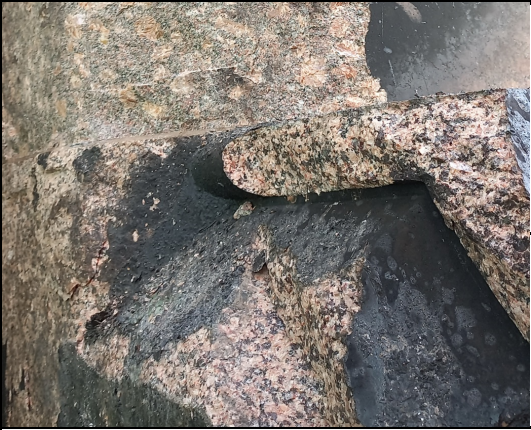
| Item Ref | Item of Work | Image of Condition (if available) | Like for Like Repair? |
|---|---|---|---|
| 4.03 | Approx. 100mm deep full stone indent repairs to Dalbeattie granite. Allow for careful cutting out, supply and preparation of stone, and insertion with mortar and pointing as per NBS CI C41. Refer to M&E methodology, and drawings (210) and (100) for extent. Carry out stainless steel dowelling or similar restraint proposals as per S.E. details. Fixings should not be visible on the surface of the stone. | | No - See Heritage Statement |

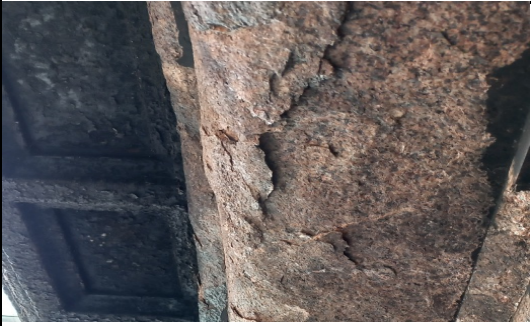
| Item Ref | Item of Work | Image of Condition (if available) | Like for Like Repair? |
|---|---|---|---|
| 5.01 | Redress the curved cantilevered stone above the centre of the arch. Profile to be agreed with the Conservation Officer on site. Allow for chamfer detail shown on drawing (400) | | No - See Heritage Statement |

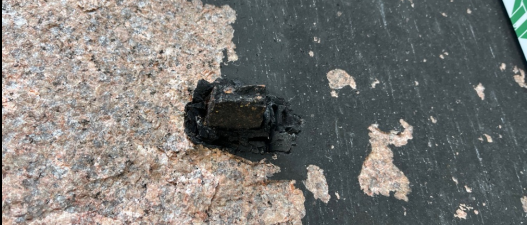
| Item Ref | Item of Work | Image of Condition (if available) | Like for Like Repair? |
|---|---|---|---|
| 6.01 | Following DOFF cleaning, carefully remove 2 no. existing metal hinge pieces embedded in stones 17 and 57. Allow for removal of soiling and rust with hand tools and abrasion as required. Reinstall into new stone surface. Allow for molten lead fixings. | | No - See Heritage Statement |

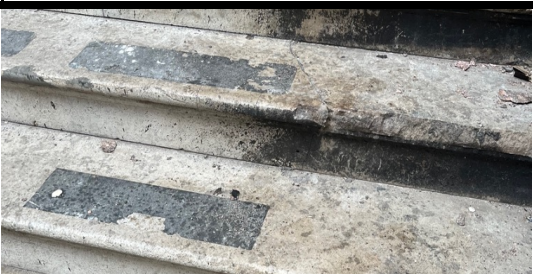
| Item Ref | Item of Work | Image of Condition (if available) | Like for Like Repair? |
|---|---|---|---|
| 6.02 | Replacement anti-slip carborundum inserts to steps. Carefully remove existing adhesive pads using TORC as per CI C40 (see above). Cut out stone and insert proprietary inserts. Refer to NBS CI L30. | | No - See Heritage Statement |
