Phase II Geoenvironmental Site Assessment  
Vine Street, Gorton

Reference: 14-944-R1-3  
Date: October 2023

## **PHASE II GEOENVIRONMENTAL SITE ASSESSMENT**

Land off Vine Street  
Gorton  
Manchester  
M18 8SR

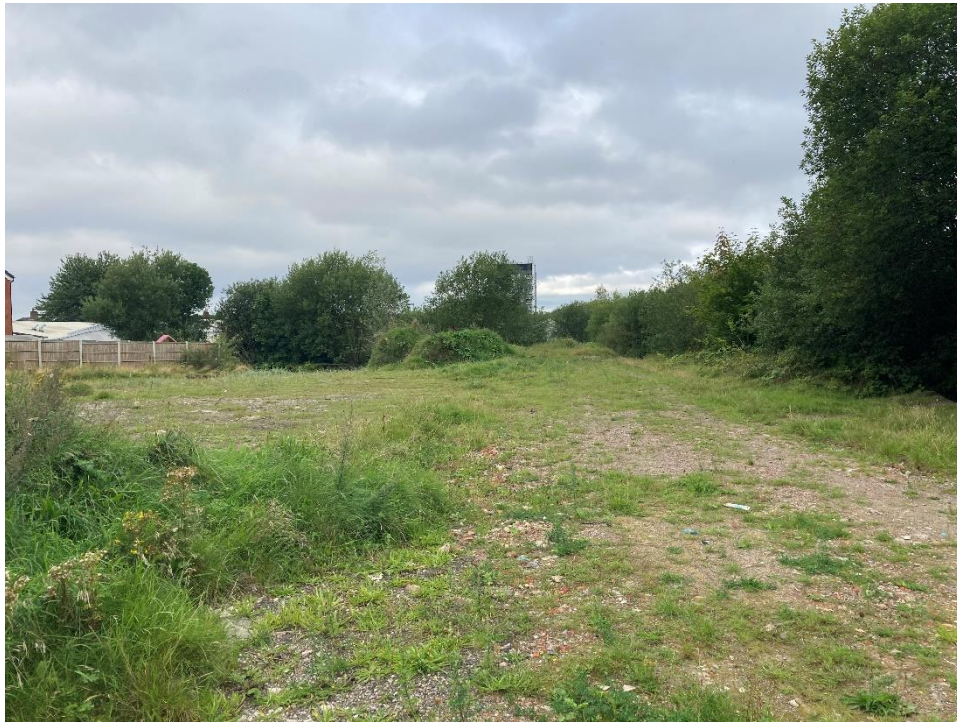
PLATE 1 SITE VIEWED LOOKING WEST

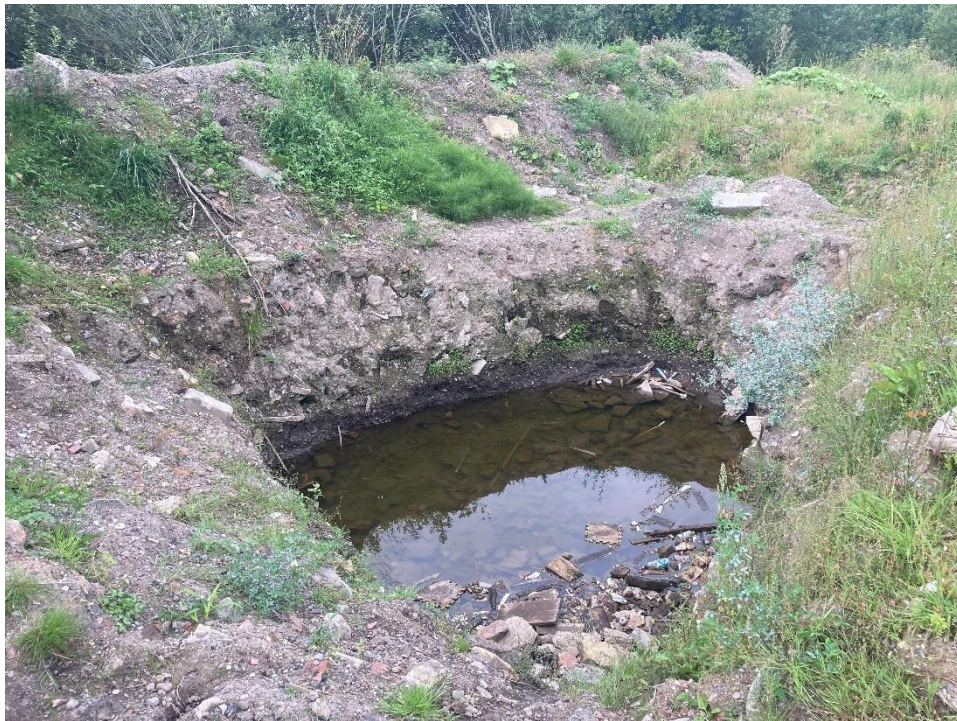
PLATE 2 VIEW OF EXCAVATION WITHIN THE WESTERN SECTOR

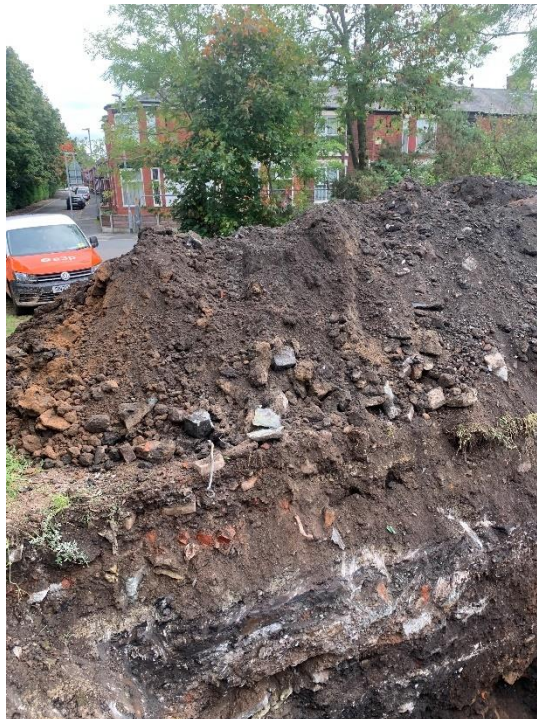
PLATE 4 EXCAVATION FOR CULVERT TRENCH (EASTERN SECTOR)

However, during the enabling works, it is recommended that a watching brief is completed in this area to confirm the presence or absence of the feature.

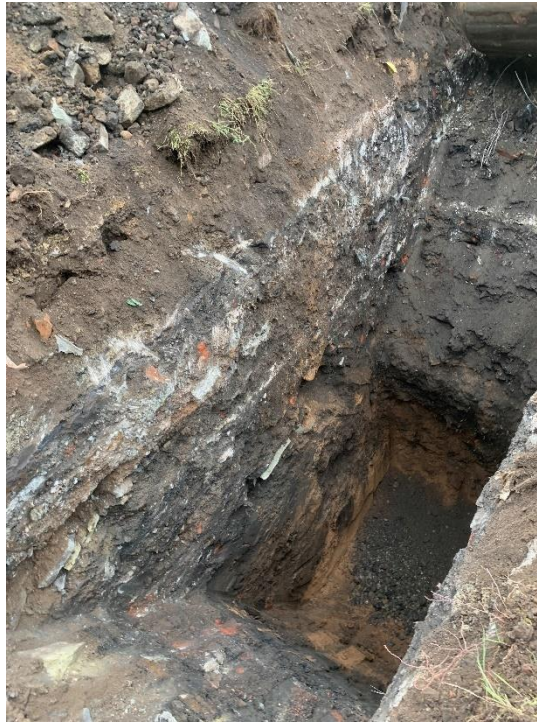
PLATE 5      EXCAVATION FOR CULVERT TRENCH (EASTERN SECTOR)
