# CCTV Report

1133 Rochdale Road,  
Manchester, M9 8DS

43437CCTV-01

Project name:  
**Rochdale Road**

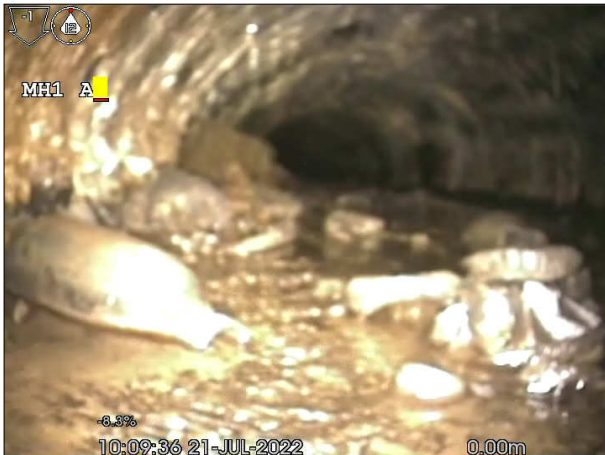
| 1:150 | position | code | observation | counter | photo | grade |
|---|---|---|---|---|---|---|
| | 0.20 | S1 DES | Debris silt, 25 % cross-sectional area loss, Start | 00:00:00 | 4_4a | (Serv) 1 |

Photo: 4\_4a, 00:00:00  
0.2m, Debris silt, 25 % cross-sectional area loss, Start

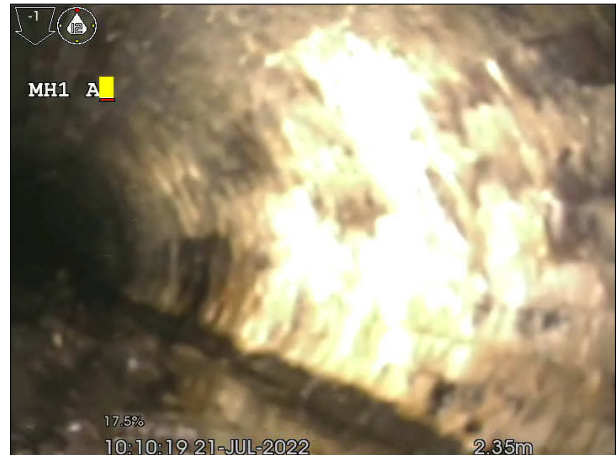
Photo: 1\_5a, 00:00:00  
2.35m, General Condition photograph

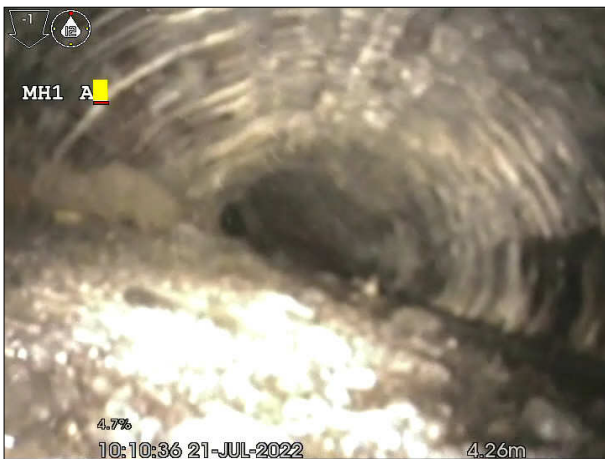
| 1:150 | position | code | observation | counter | photo | grade |
|---|---|---|---|---|---|---|
| | 4.26 | C1 DES | Debris silt, 35 % cross-sectional area loss, Changed | 00:00:00 | 1_6a | (Serv) 1 |

Photo: 1\_6a, 00:00:00  
4.26m, Debris silt, 35 % cross-sectional area loss, Changed

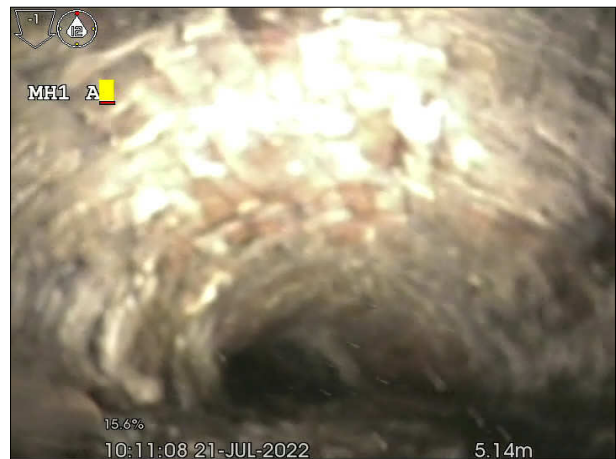
| 1:150 | position | code | observation | counter | photo | grade |
|---|---|---|---|---|---|---|
| | 5.00 | C1 DES | Debris silt, 40 % cross-sectional area loss, Changed | 00:00:00 | 1_7a | (Serv) 1 |

Photo: 1\_7a, 00:00:00  
5m, Debris silt, 40 % cross-sectional area loss, Changed

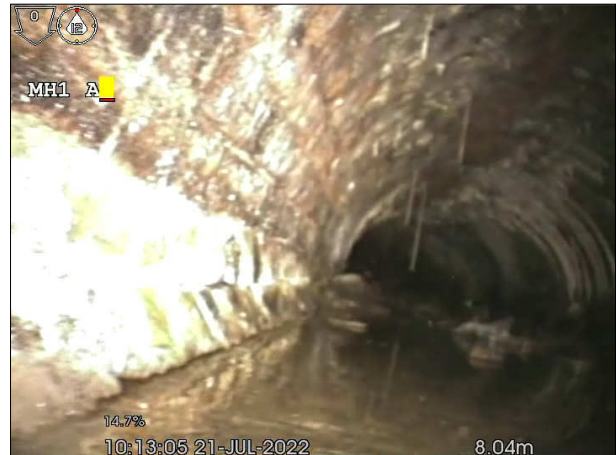
Photo: 1\_10a, 00:00:00  
8.3m, General Condition photograph

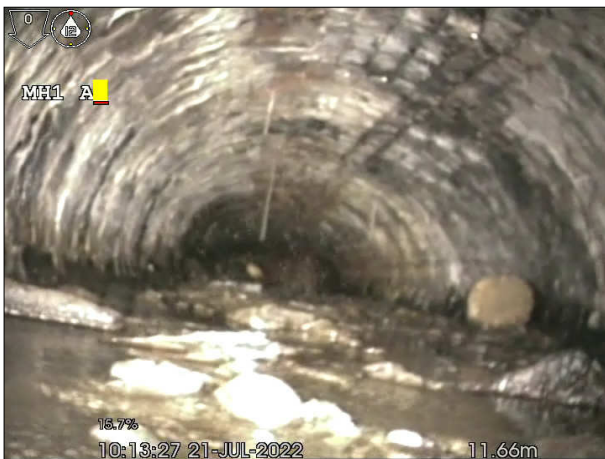
Photo: 11\_11a, 00:00:00  
11.66m, General Condition photograph

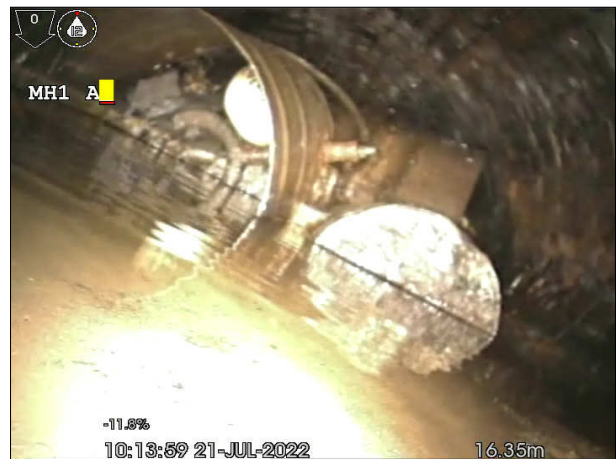
| 1:150 | position | code | observation | counter | photo | grade |
|---|---|---|---|---|---|---|
| | 18.00 | GO | General Observation, Remark: Obstruction. | 00:00:00 | 13_13a | (Misc) 0 |

Photo: 13\_13a, 00:00:00  
18m, General Observation, Remark: Obstruction.

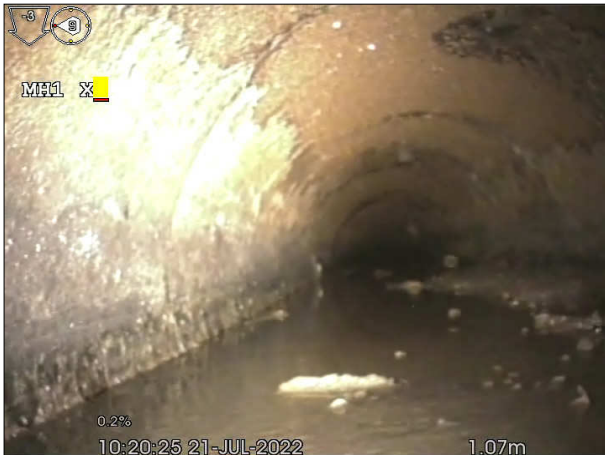
Photo: 2\_4a, 00:00:00  
1.07m, General Condition photograph

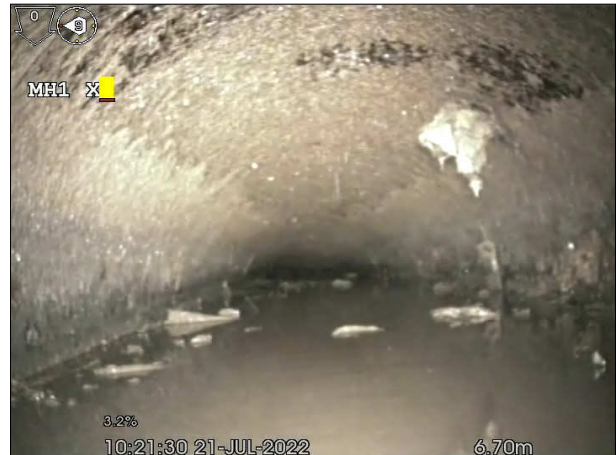
Photo: 2\_6a, 00:00:00  
6.7m, General Condition photograph

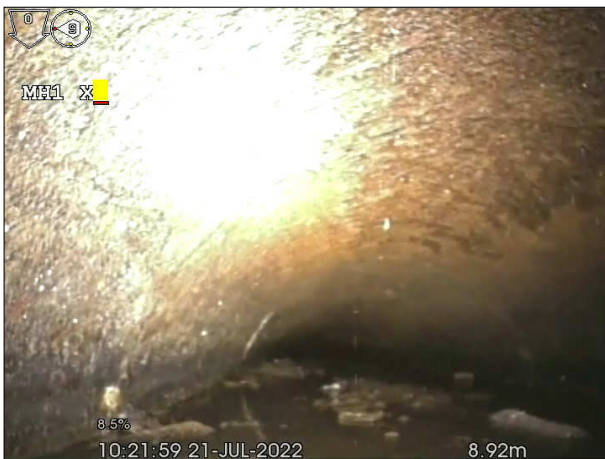
Photo: 24\_8a, 00:00:00  
8.92m, General Condition photograph
