| Project Name:<br>Studio Tashkeel Architecture | Project number: | Date:<br>24/03/2021 | Contact: | |

Project name :  
Studio Tashkeel Architecture

| Nr. | US MH | DS MH | Date | Road | Tape No. | Material | m | (m) |
|---|---|---|---|---|---|---|---|---|
| 1 | SD83009420 | SD83009403 | 24/03/2021 | Herbert Street | | Brick | 54.32 | 54.32 |

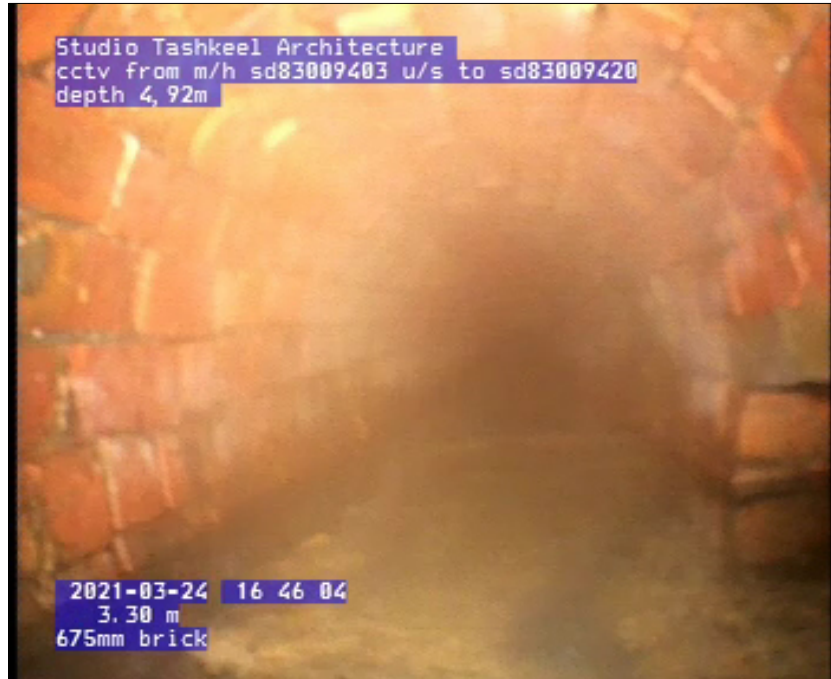
| | 3.30 | MB | Missing bricks, from 3 to 4 o'clock | 4 |

Photo: 1\_1\_8\_A.jpg  
3.3m, Missing bricks, from 3 to 4 o'clock

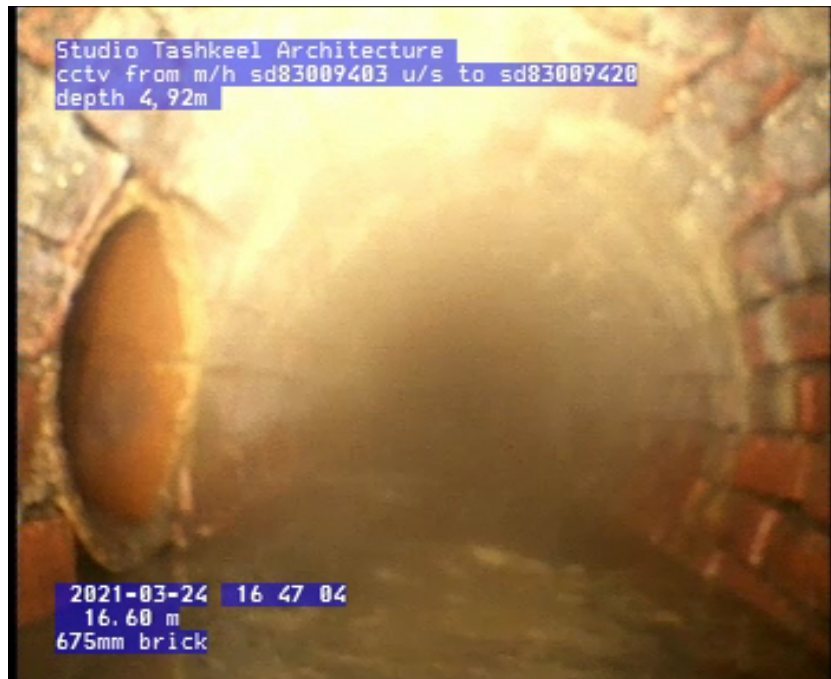
Photo: 1\_1\_14\_A.jpg  
16.6m, Connection other than junction, at 9 o'clock, diameter 225mm

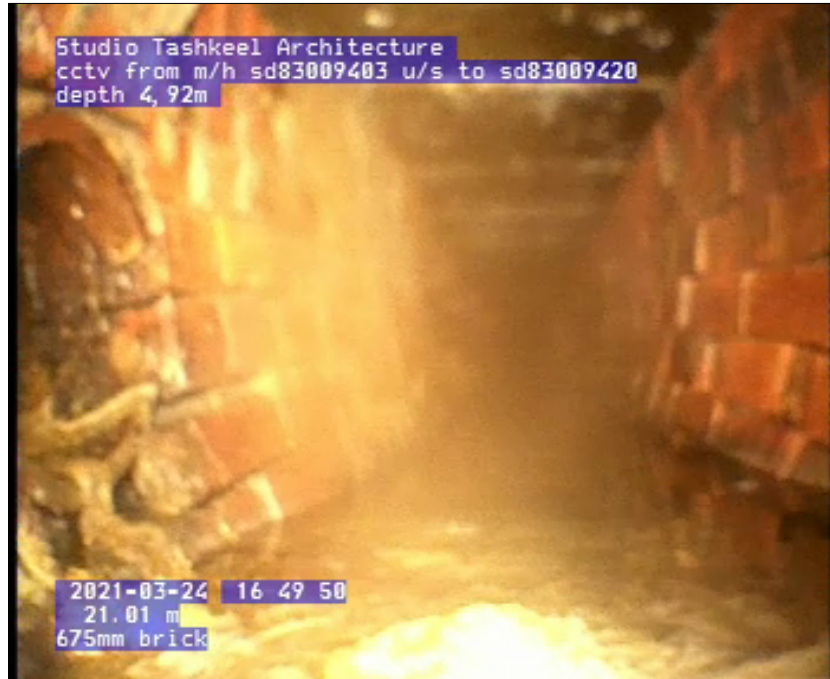
Photo: 1\_1\_16\_A.jpg

21.01m, Connection other than junction, at 9 o'clock, diameter 225mm

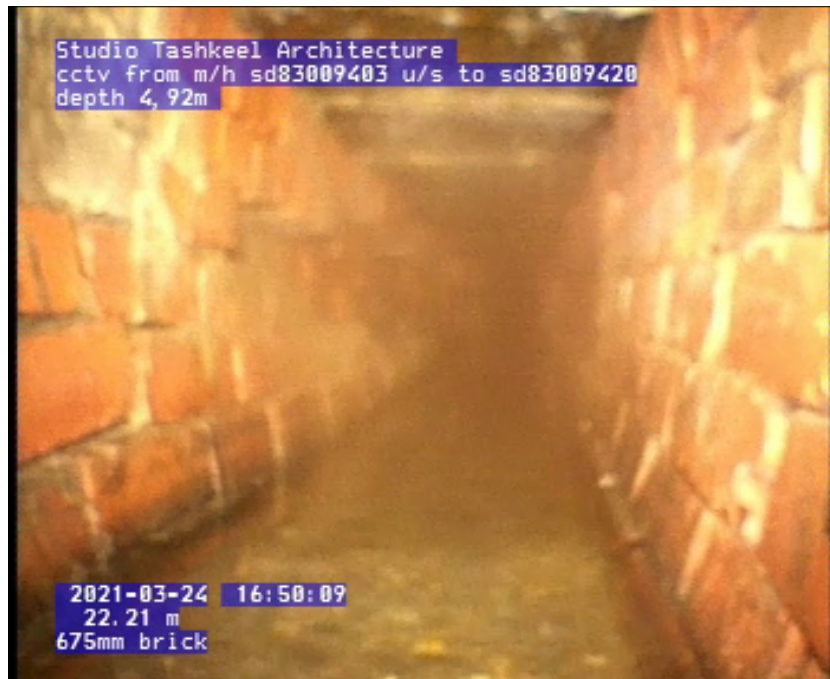
Photo: 1\_1\_18\_A.jpg

22.03m, Dimension changes, 750mm high, 675mm wide

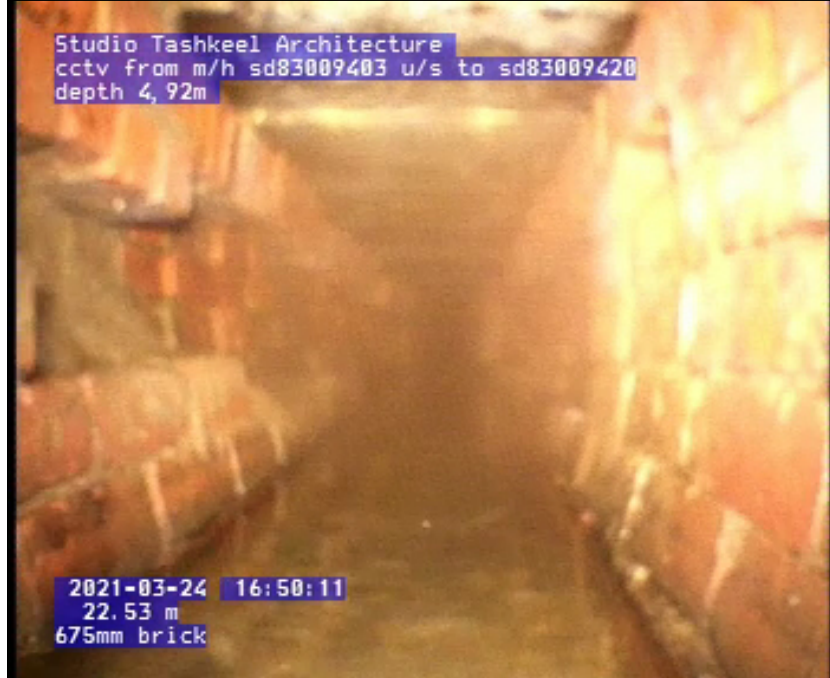
| | 22.53 | MB | Missing bricks, from 7 to 5 o'clock, Start | 5 |

Photo: 1\_1\_20\_A.jpg  
22.53m, Missing bricks, from 7 to 5 o'clock, Start

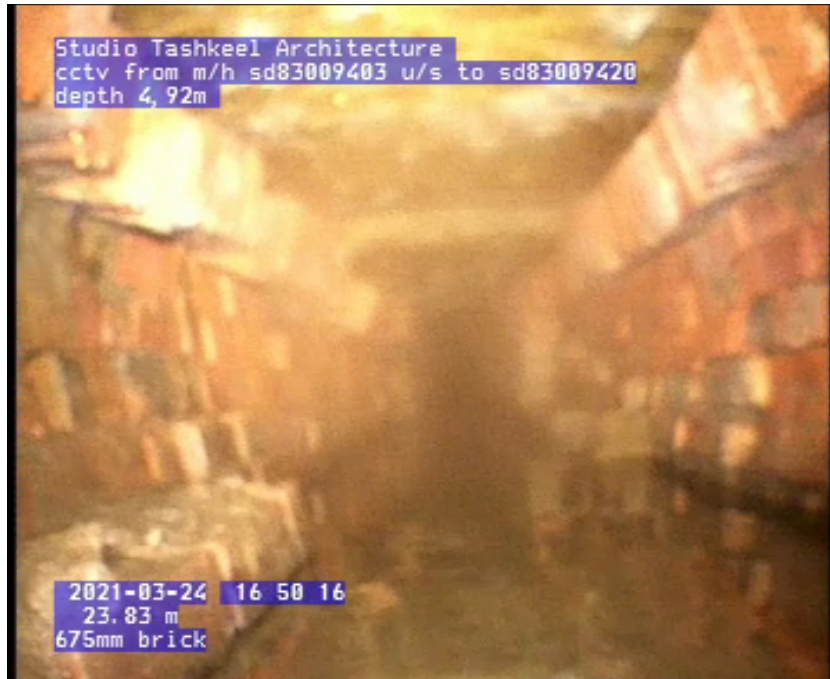
Photo: 1\_1\_21\_A.jpg  
23.83m, General photograph taken at this point

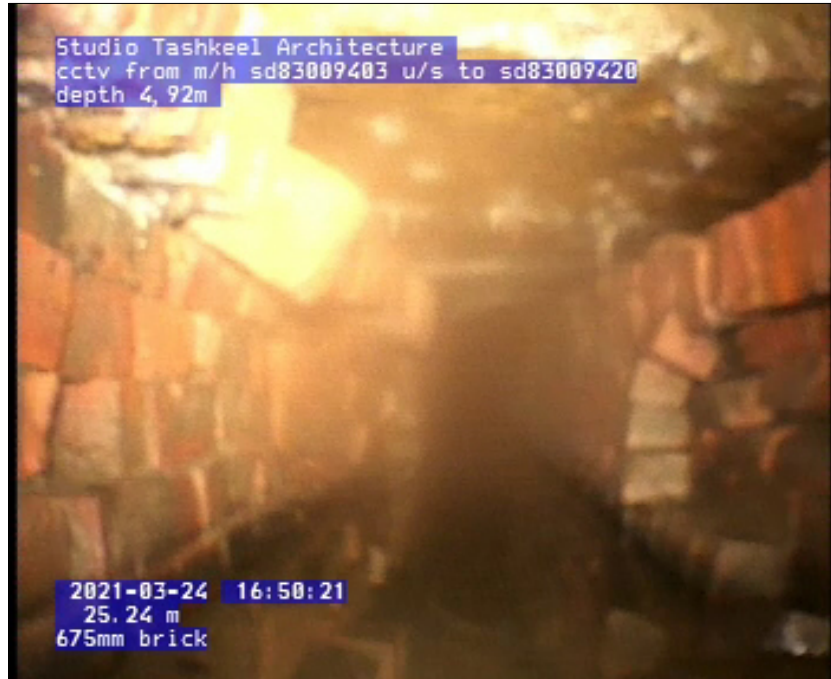
| | 25.21 | DB | Displaced bricks, at 11 o'clock | 3 |

Photo: 1\_1\_22\_A.jpg  
25.21m, Displaced bricks, at 11 o'clock

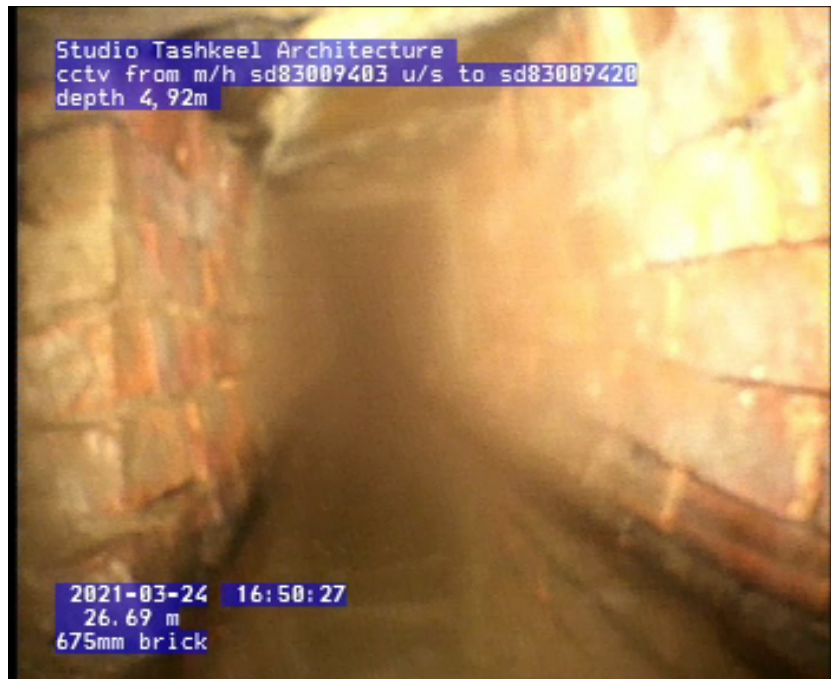
Photo: 1\_1\_23\_A.jpg  
26.69m, General remark

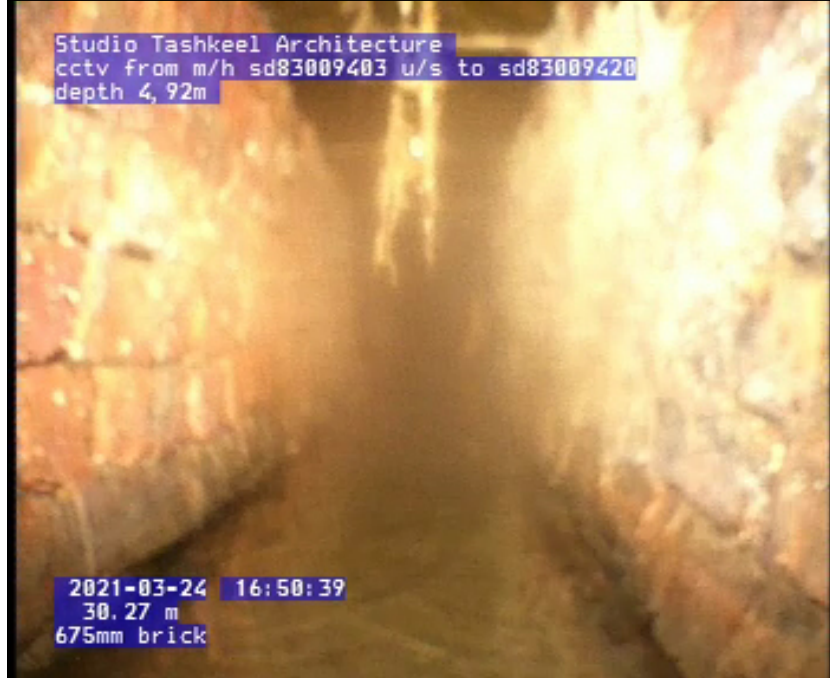
| | 30.27 | RF | Roots, fine | 2 |

Photo: 1\_1\_24\_A.jpg  
30.27m, Roots, fine

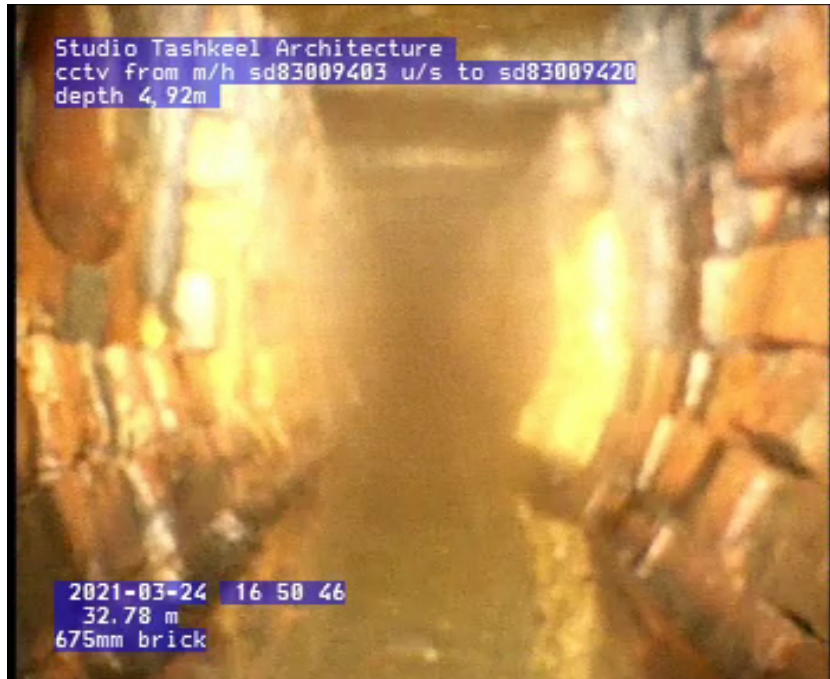
Photo: 1\_1\_25\_A.jpg  
32.73m, Connection other than junction, at 10 o'clock, diameter 150mm

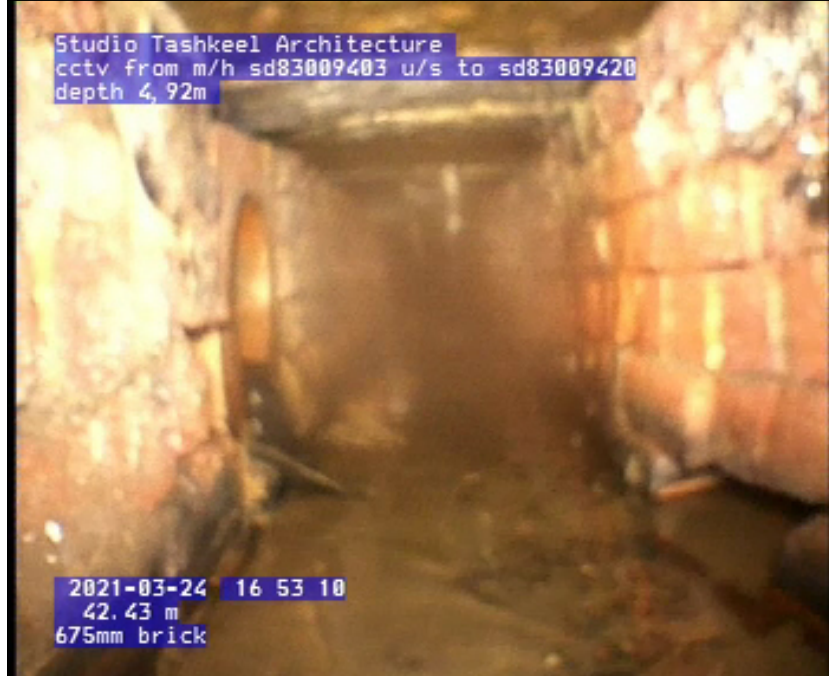
| 42.43 | MB | Missing bricks, at 5 o'clock | 4 |

Photo: 1\_1\_34\_A.jpg  
42.43m, Missing bricks, at 5 o'clock

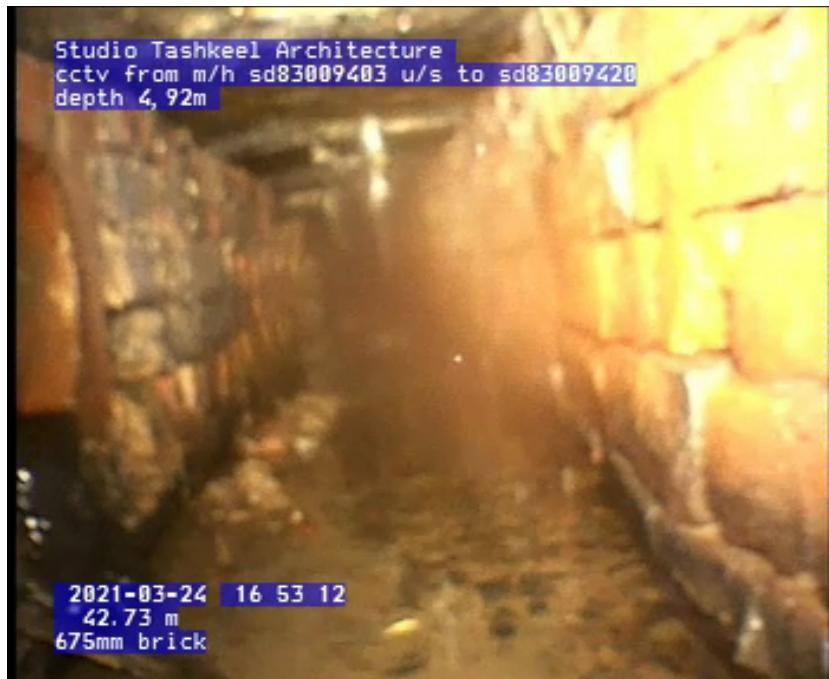
Photo: 1\_1\_35\_A.jpg  
42.73m, Connection other than junction, at 9 o'clock, diameter 225mm

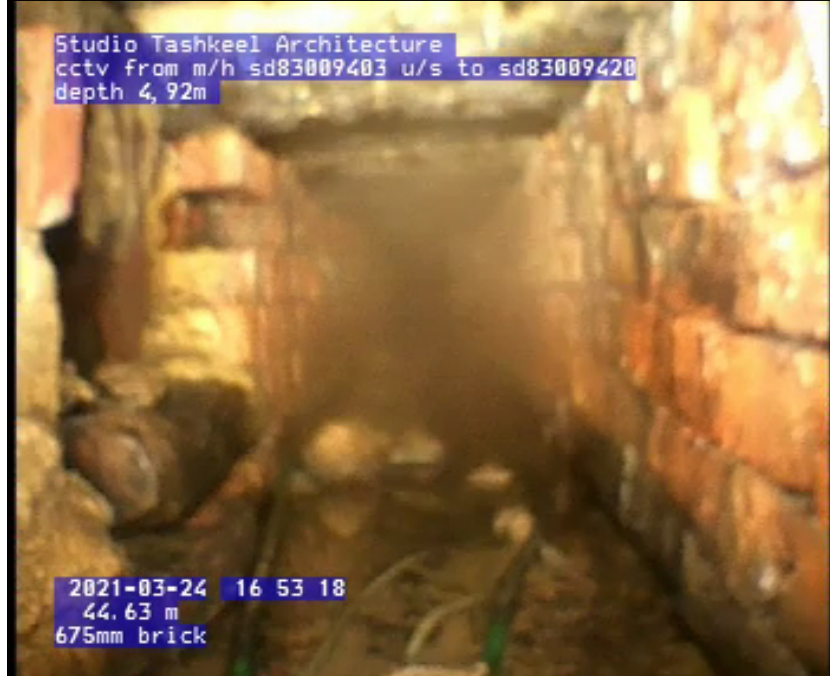
| 44.63 | MB | Missing bricks, from 7 to 11 o'clock | 5 |

Photo: 1\_1\_36\_A.jpg  
44.63m, Missing bricks, from 7 to 11 o'clock

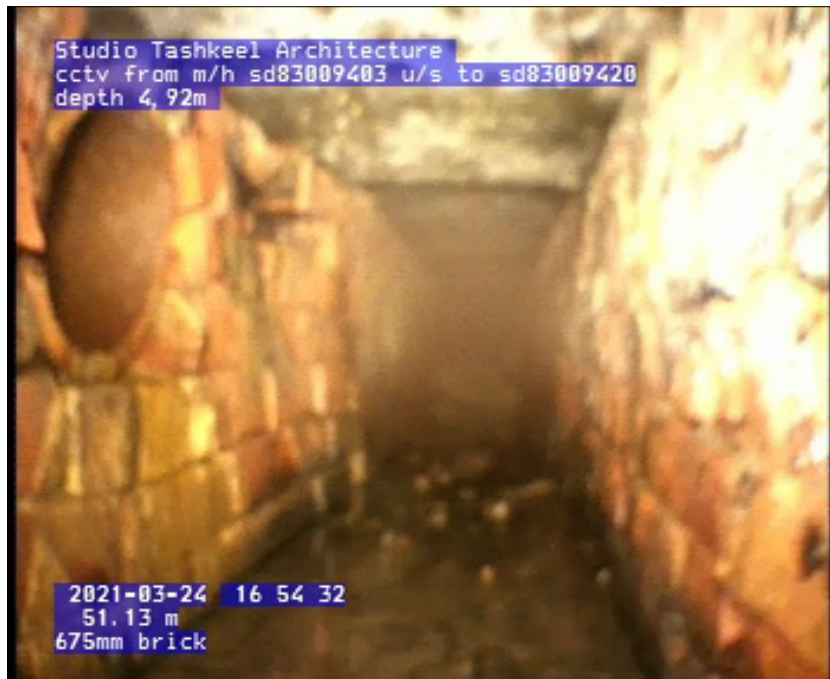
Photo: 1\_1\_40\_A.jpg  
51.13m, Connection other than junction, at 10 o'clock, diameter 150mm

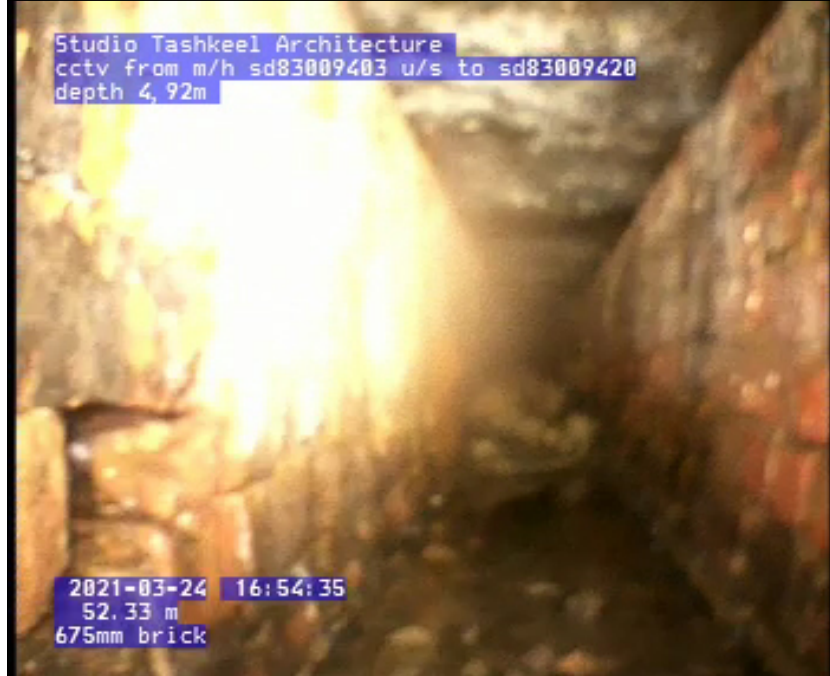
| 52.33 | MB | Missing bricks, at 9 o'clock | 4 |

Photo: 1\_1\_41\_A.jpg  
52.33m, Missing bricks, at 9 o'clock

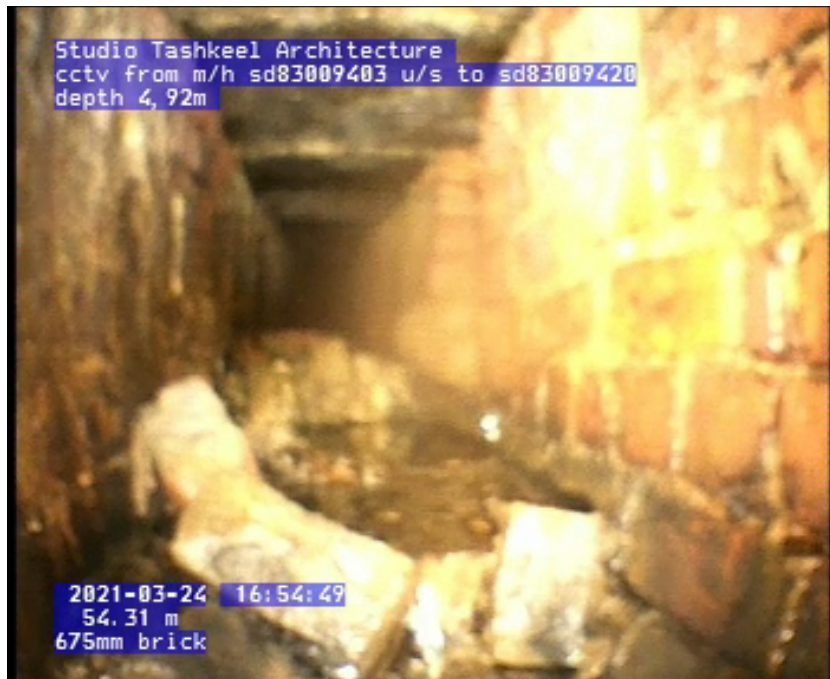
| 54.31 | DER | Settled deposits, coarse, 30% cross-sectional area loss | 4 |

Photo: 1\_1\_47\_A.jpg  
54.31m, Settled deposits, coarse, 30% cross-sectional area loss
