# One Medlock Street Development

## Highway Pre-condition Survey

Sweco UK Limited 2888385  
 Project Name One Medlock Street Development  
 Planning Application Reference 135419/FO/2022N/A  
 Client RG Group  
 Author Jordan Bamber Sweco  
 Date 11/10/2023  
 Document reference One Medlock Pre-condition Survey

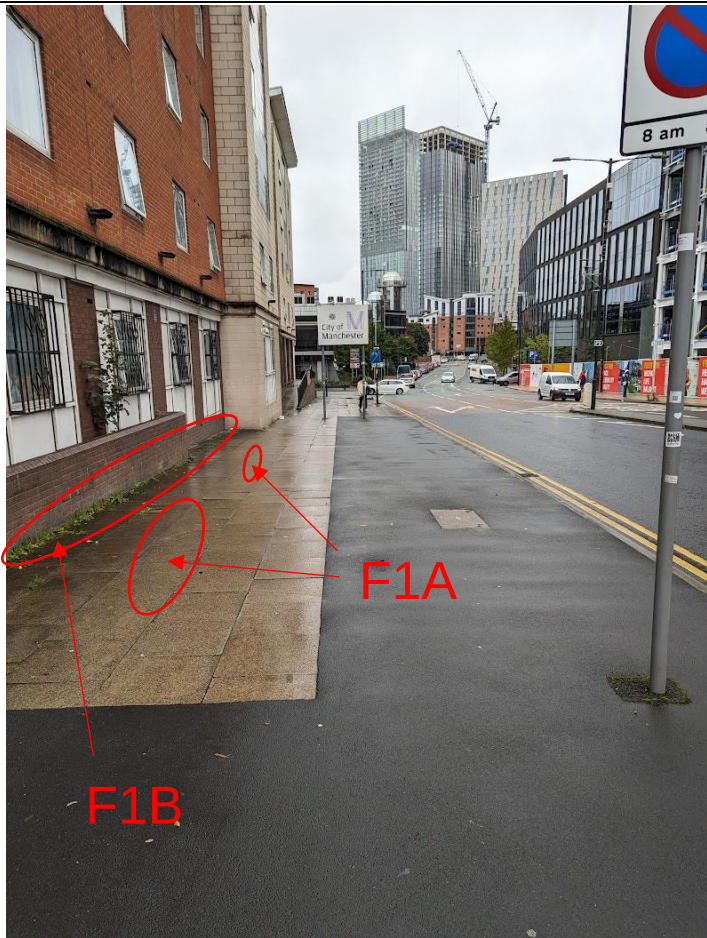
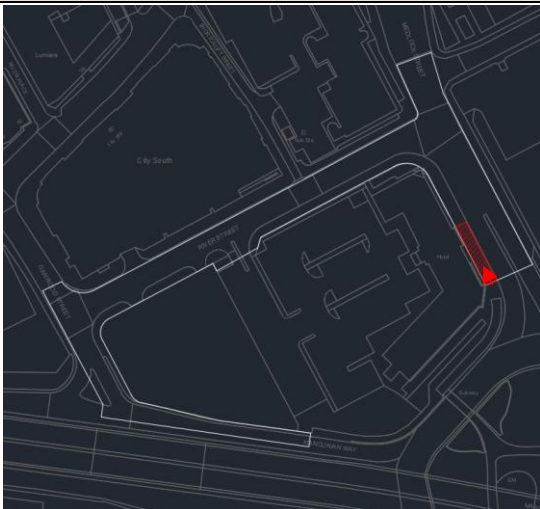
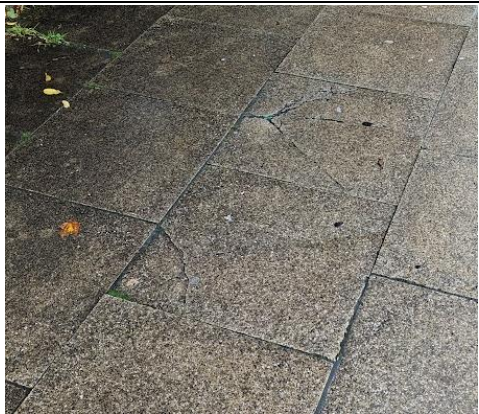
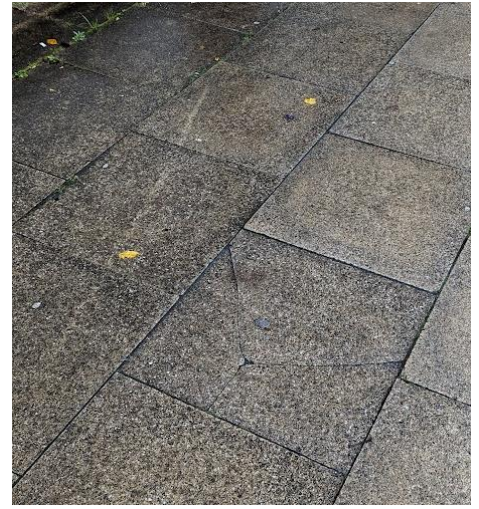
| | <p>Location F1: Grid Reference X=383680 Y=397207</p> <p>Notes:</p> <p>F1A. Cracked paving slabs.</p> <p>F1B. Overgrown vegetation at paving boundary with building line.</p> | |

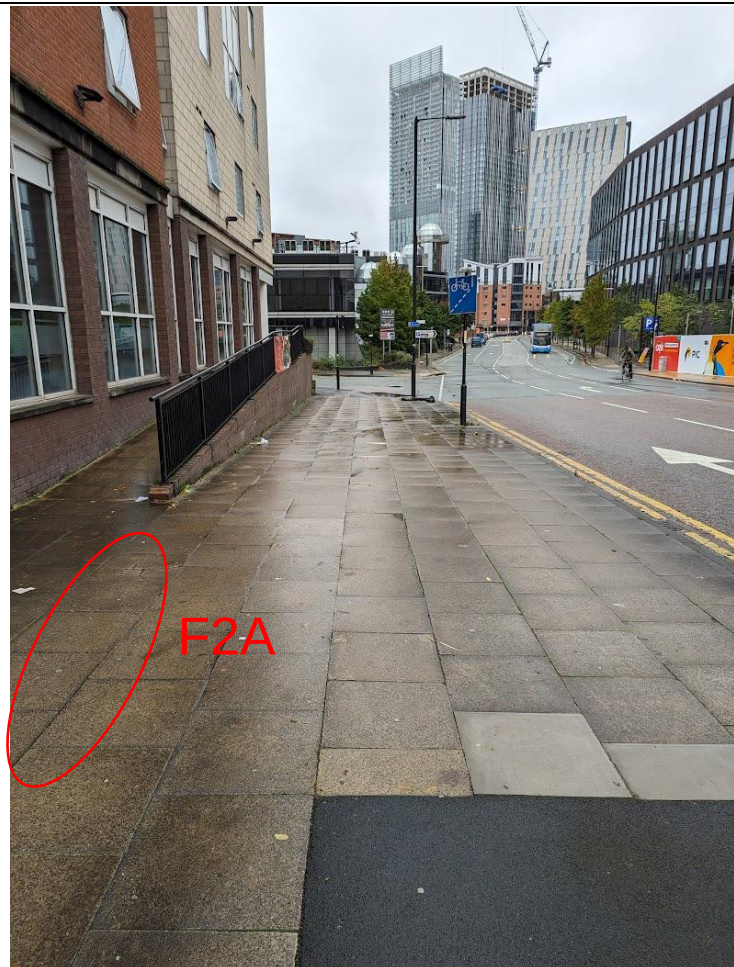
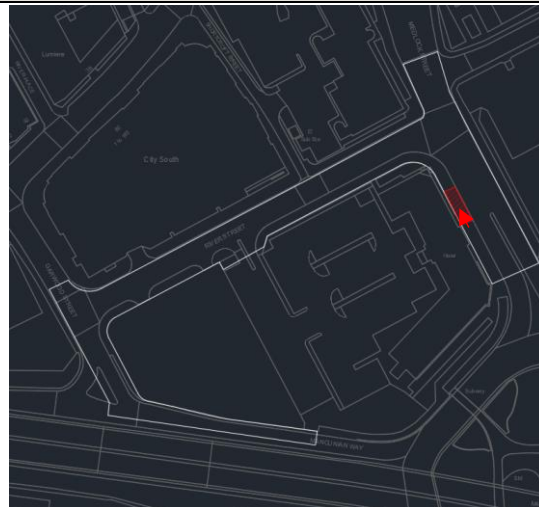
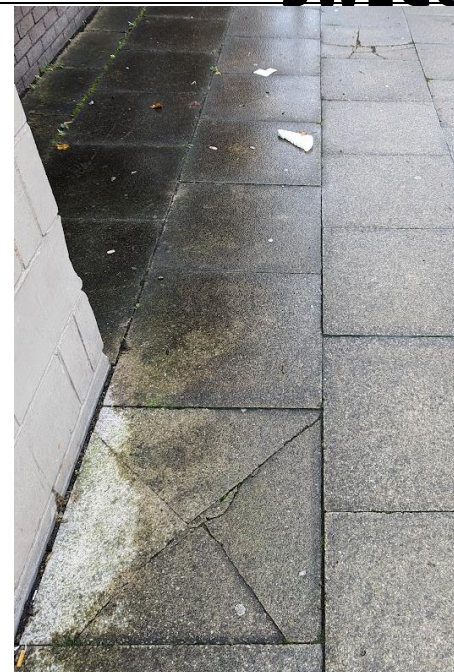
Location F2: Grid Reference X=383671 Y=397225

F2A. Cracked paving slabs

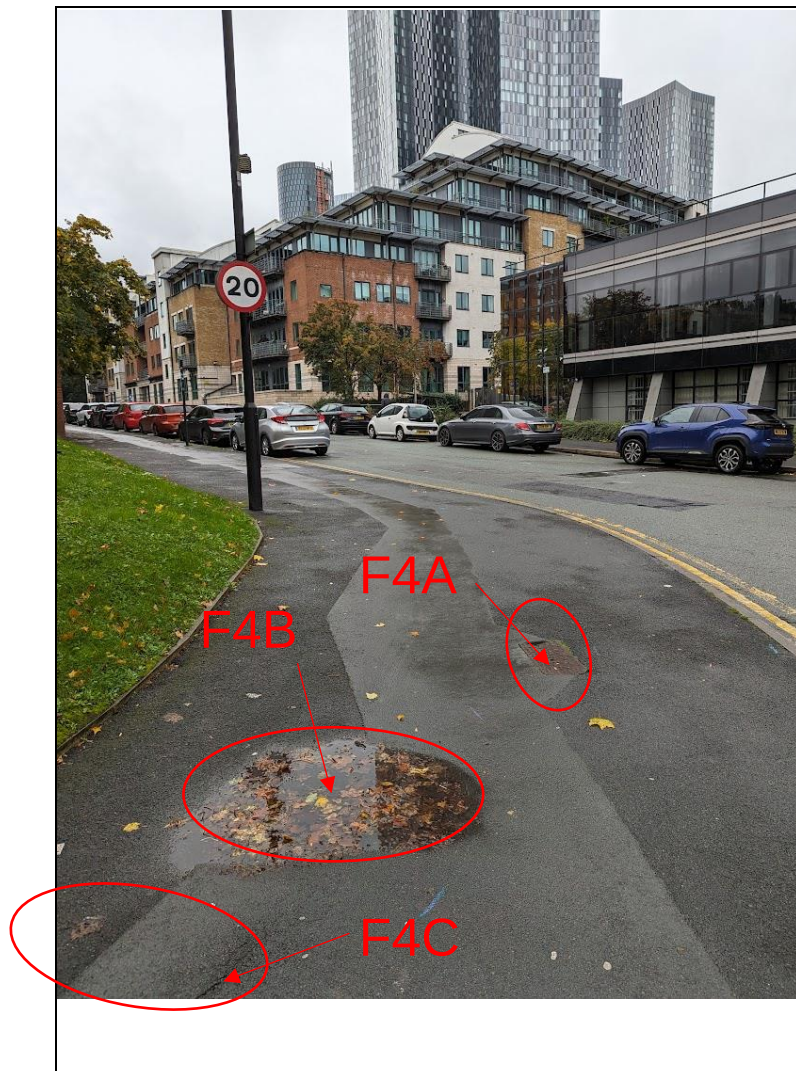
Location F4: Grid Reference X= 383655 Y= 397245

F4A. Shattered utility chamber.

F4B. Footway low spot resulting in ponding of water.

F4C. Asphalt cracking.

F4D. Potholes and cracking of kerb unit.

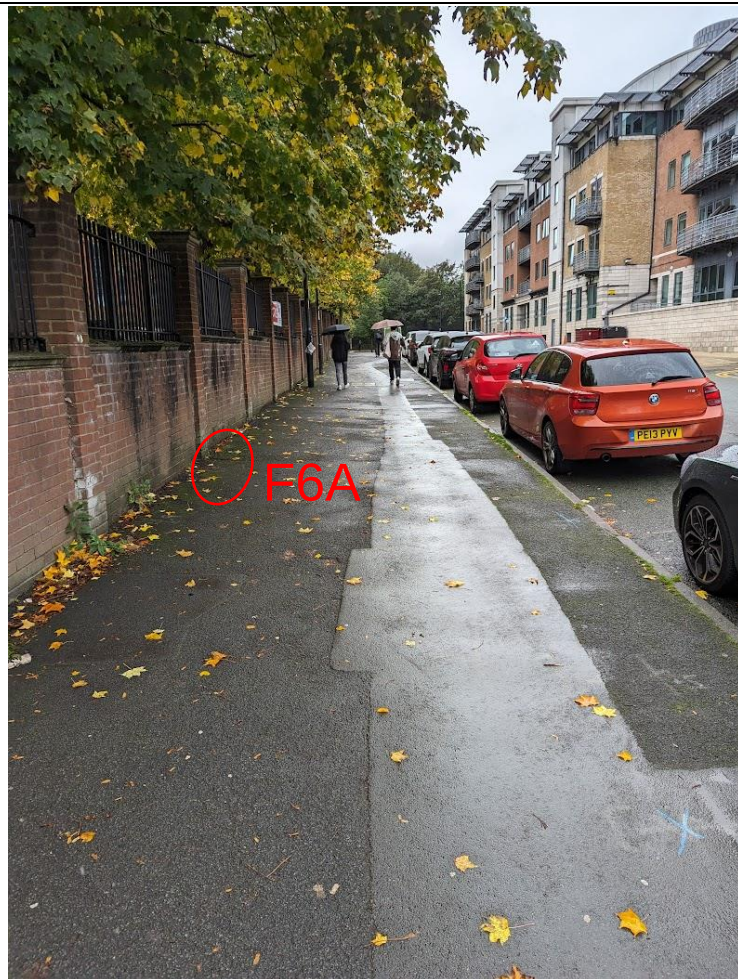
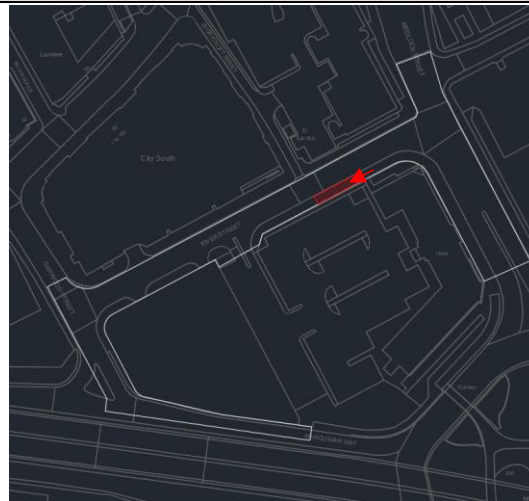
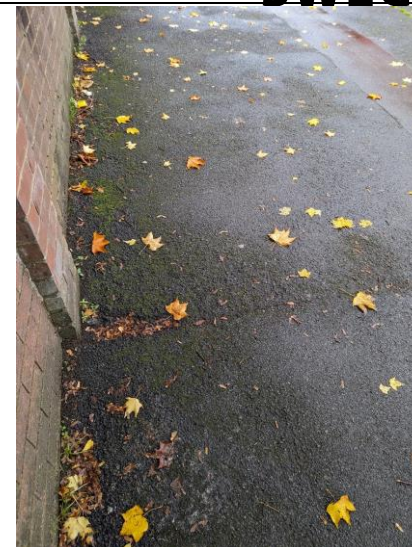
Location F6: Grid Reference X= 383628 Y= 397233

F6A. Asphalt joint failure

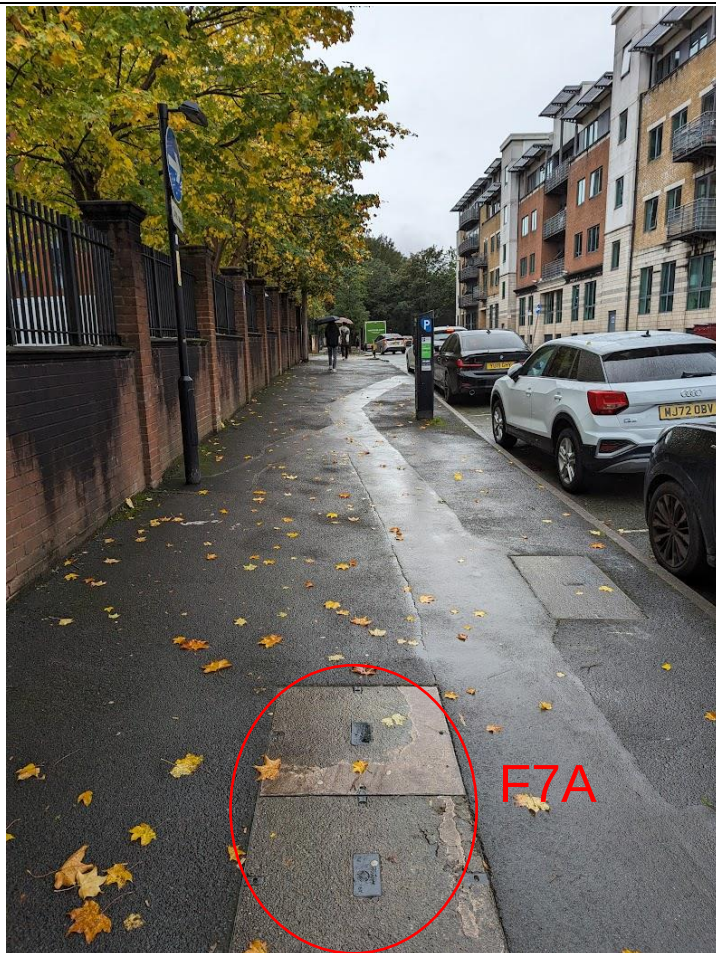
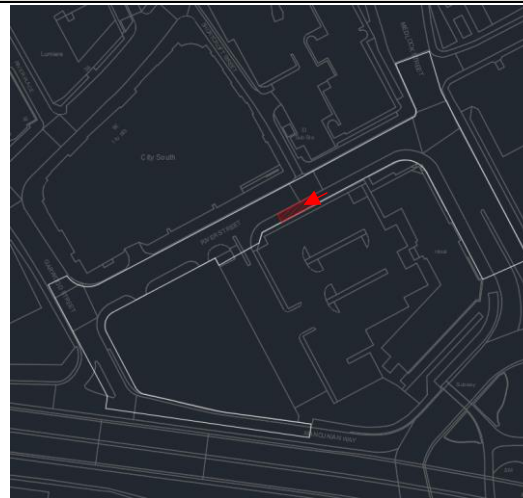
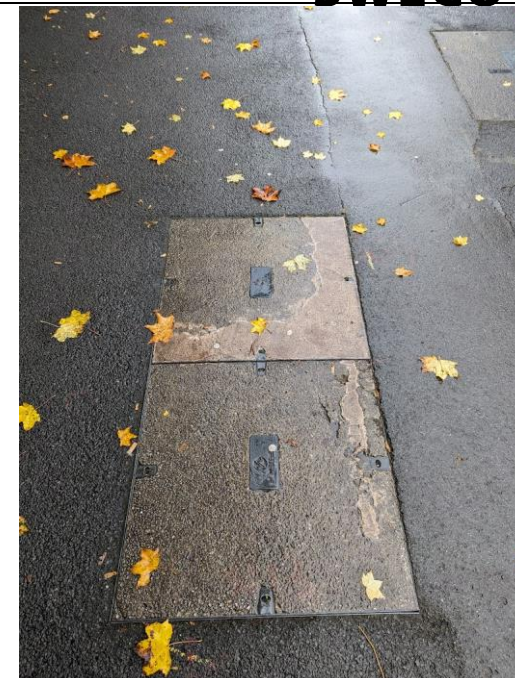
Location F7: Grid Reference X= 383609 Y= 397224

F7A. Degraded inspection chamber lid.

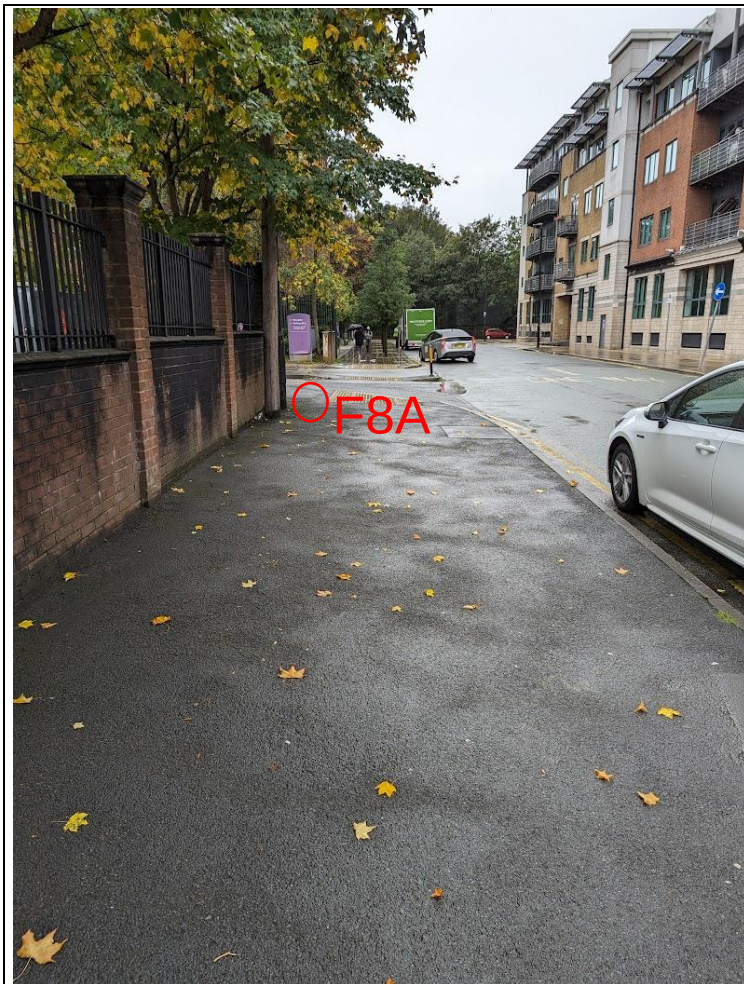
Location F8: Grid Reference X= 383598 Y= 397217

F8A. Scarring in footway from removed bollard.

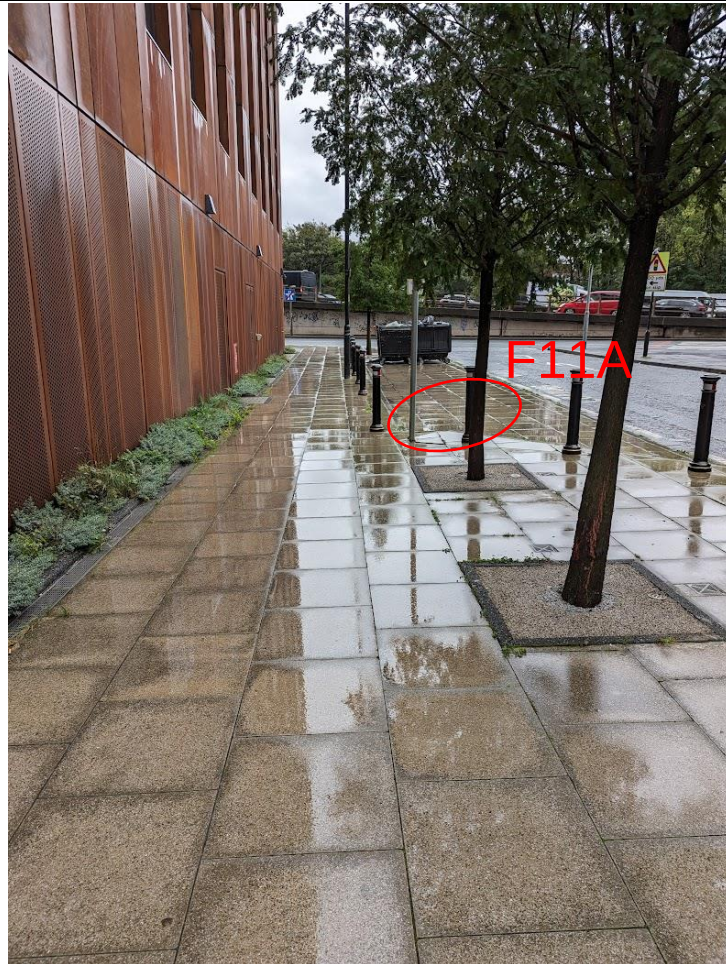
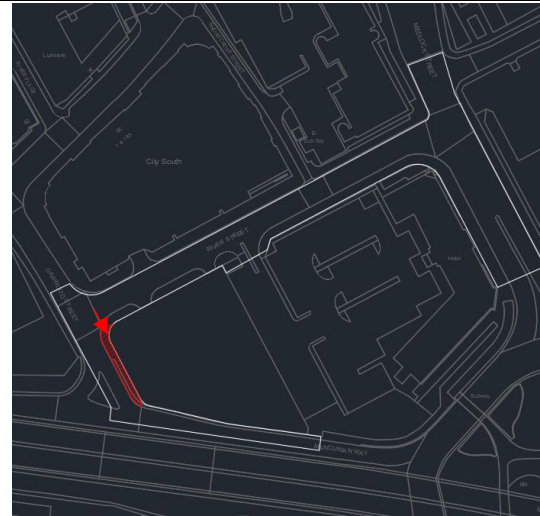
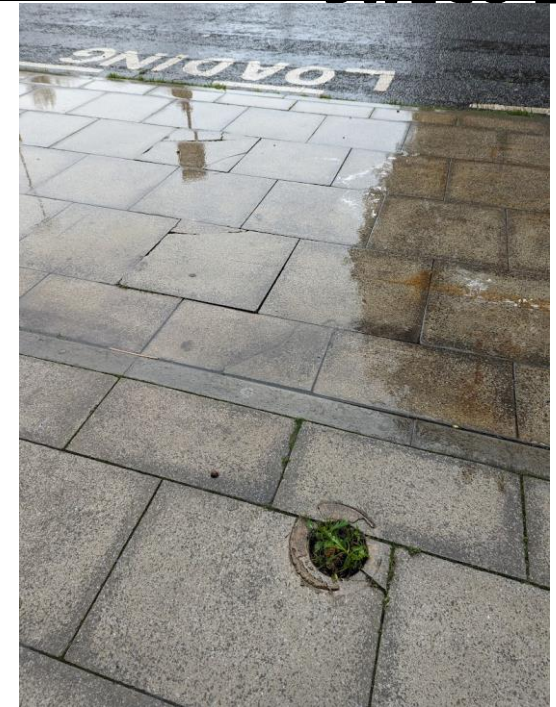
Location F11: Grid Reference X= 383538 Y= 397165

F11A. Cracked paving slabs in vehicle layby

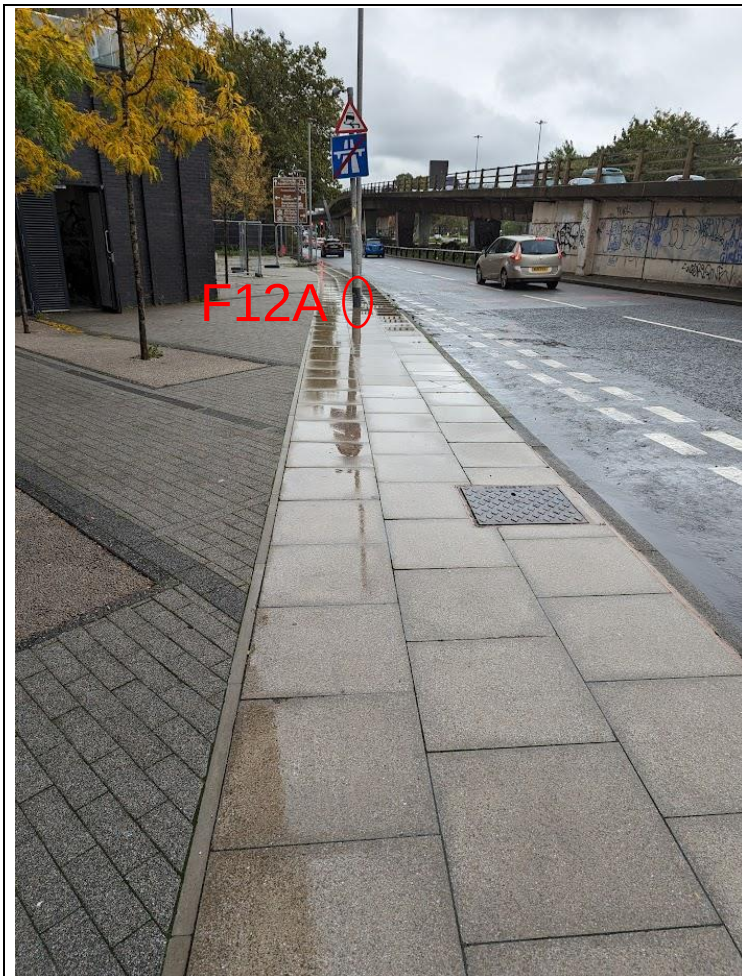
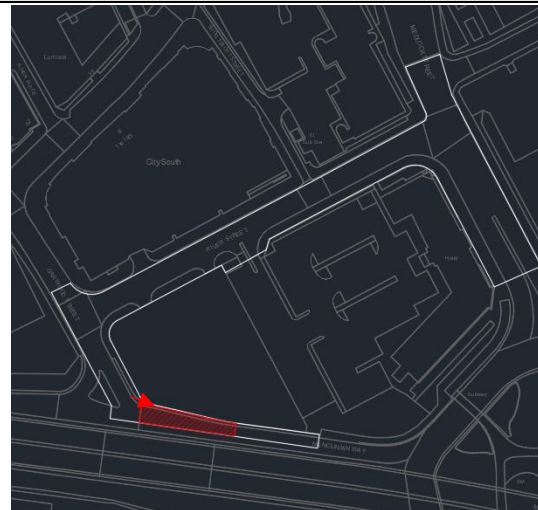
Location F12: Grid Reference X= 383565 Y= 397143

F12A. Damaged sign-post base

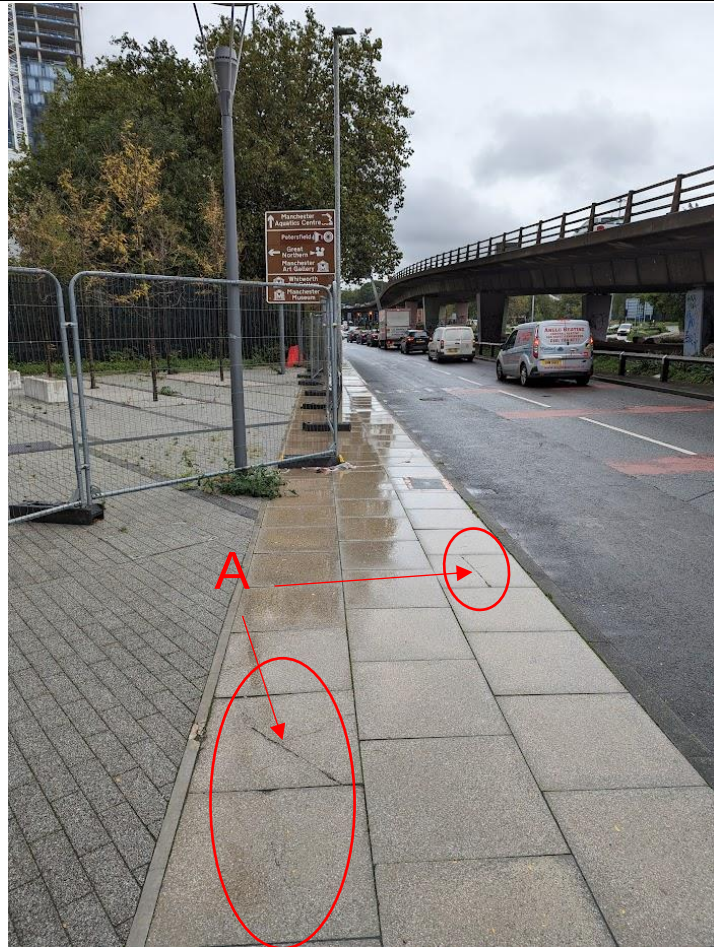
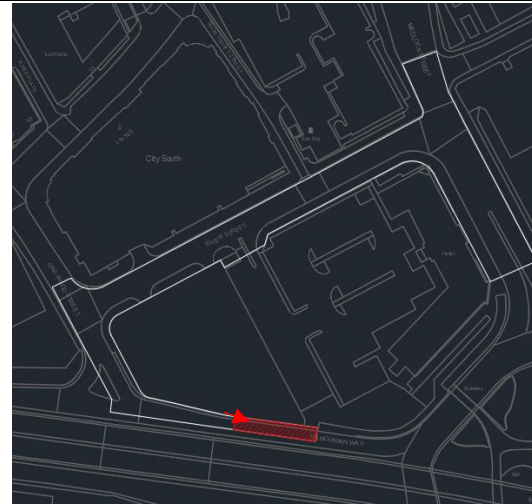
Location F13: Grid Reference X= 383601 Y= 397137

F13A. Cracked paving slabs

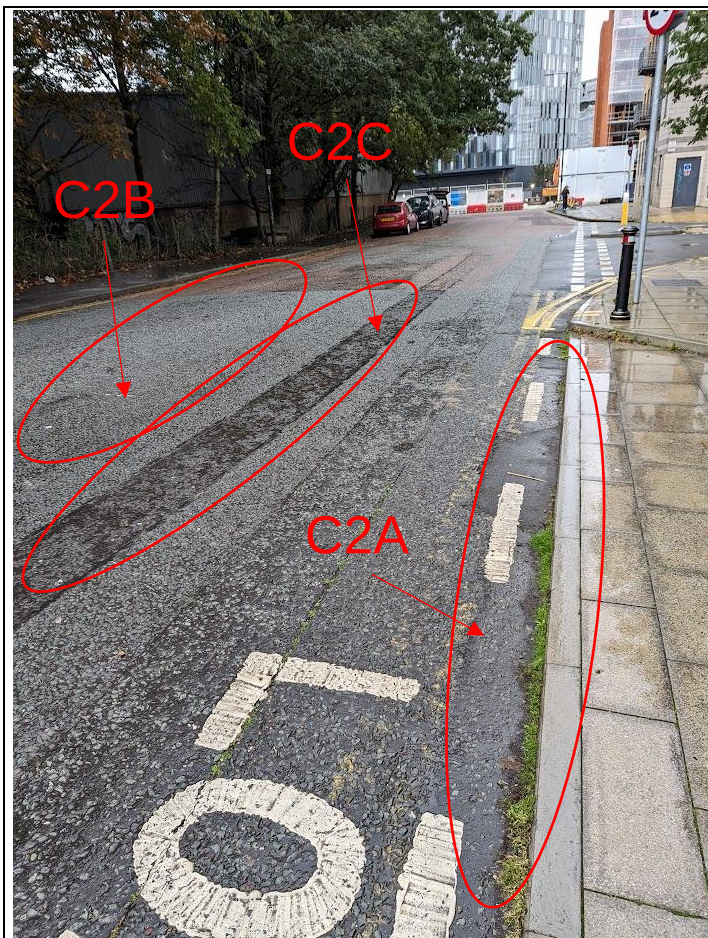
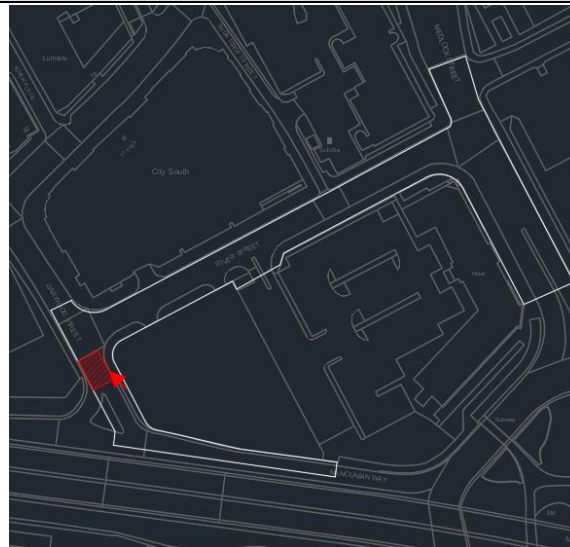
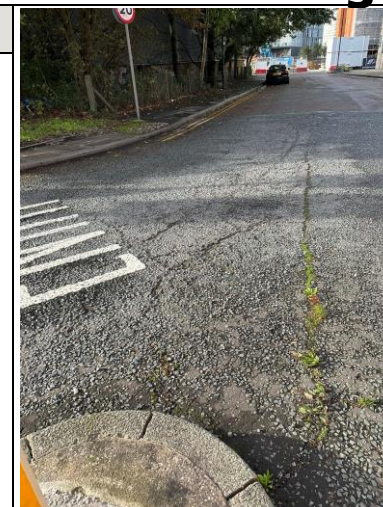
Location C2: Grid Reference X= 383529 Y= 397171

C2A. General surface wear at carriageway edge with evidence of previous patch repairs.

C2B. Longitudinal and transverse cracking.

C2C. Visible carriageway trenches.

Additional photo taken 13/10/2023 indicating clearer evidence of longitudinal and transverse cracking in this location in dry conditions.

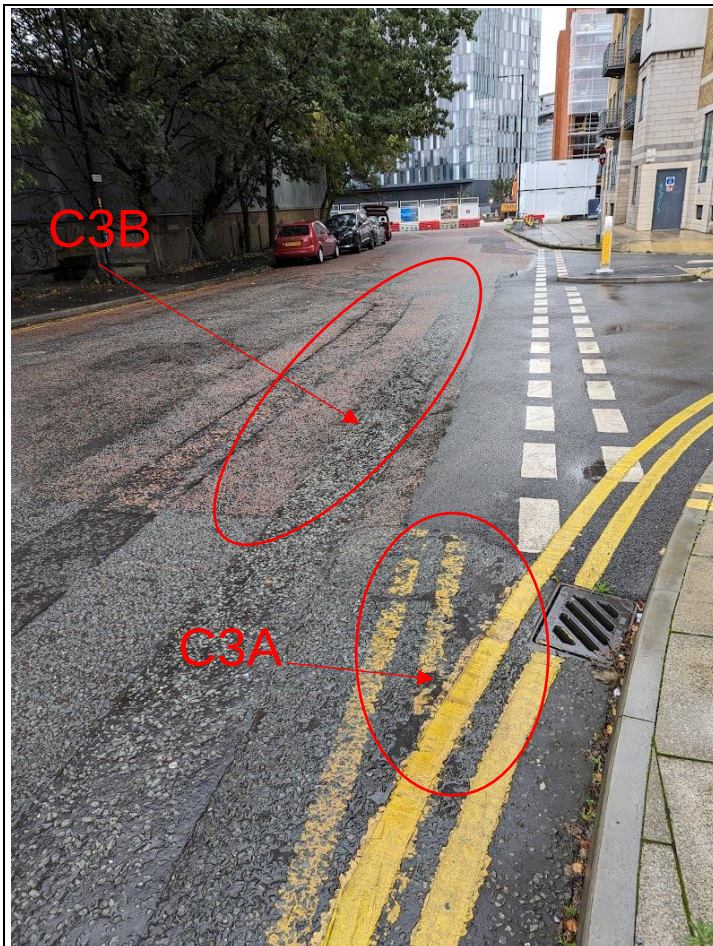
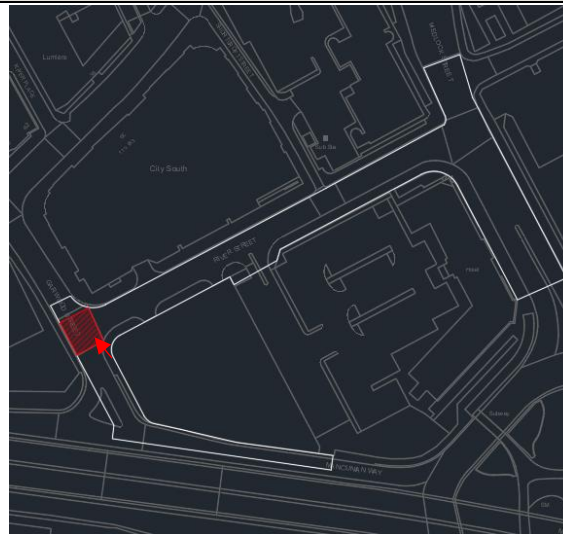
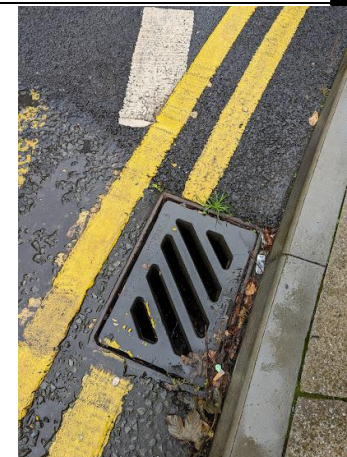
Location C3: Grid Reference X= 383523 Y= 397184

C3A. General surface wear.

C3B. Visible carriageway trenches of contrasting colour surface course.

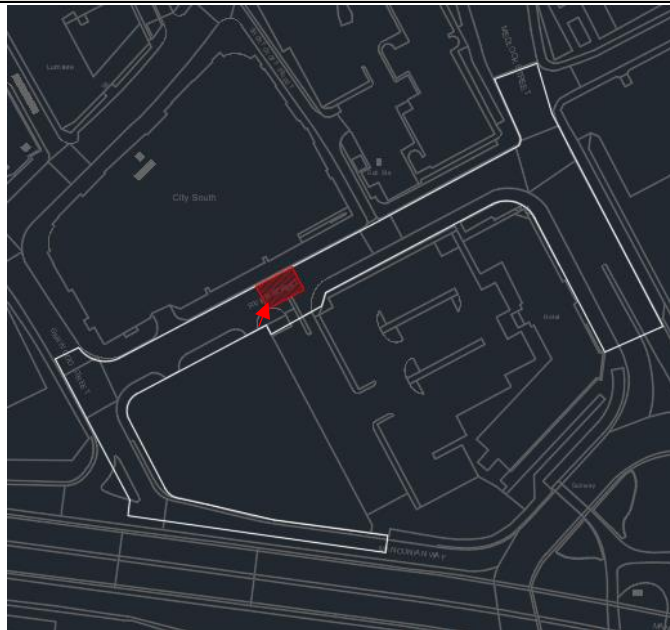
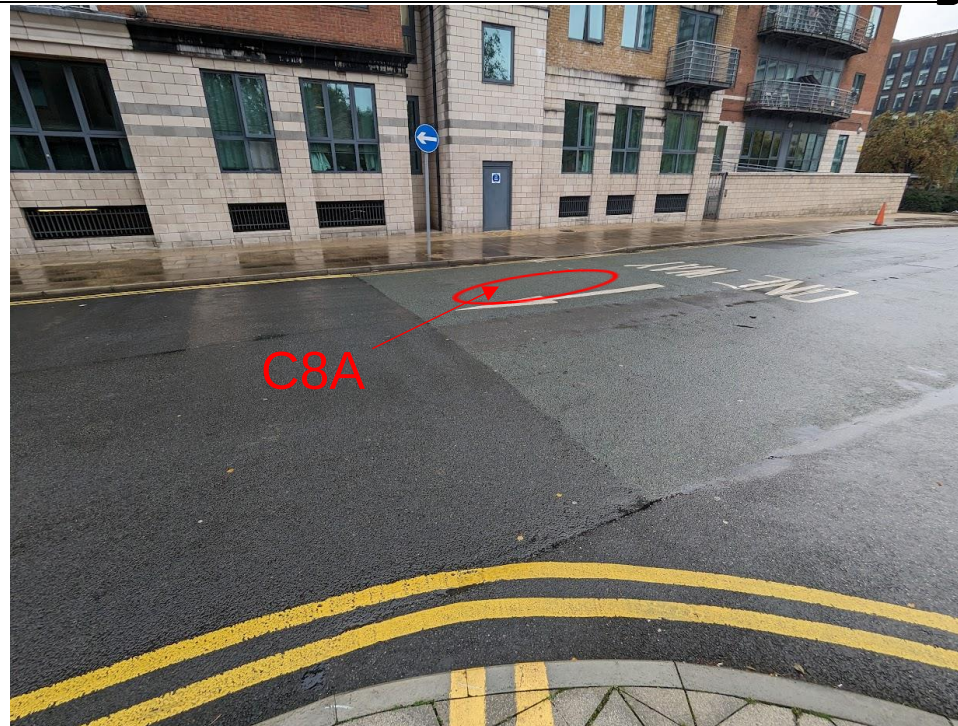
Location C8: Grid Reference X= 383582 Y= 397216

C8A. Longitudinal cracking

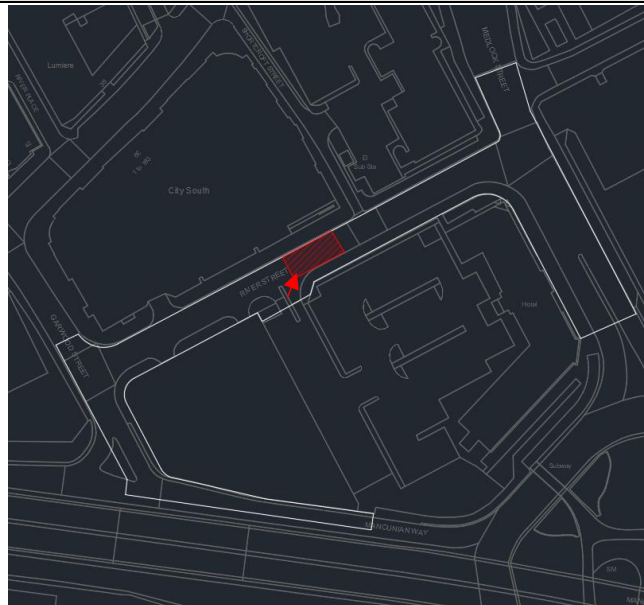
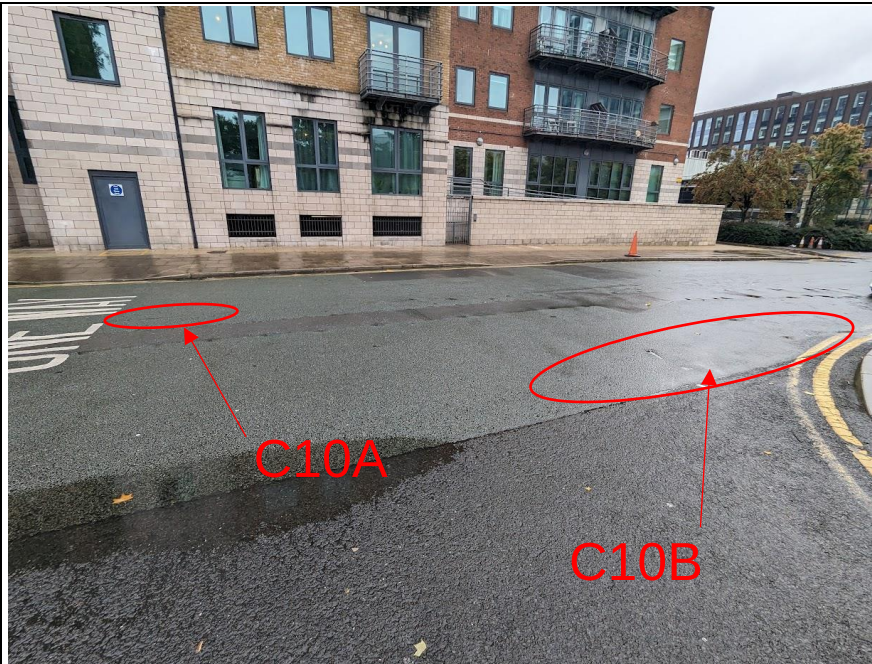
Location C10: Grid Reference X=383597 Y=397223

C10A. Longitudinal Cracking

C10B. General surface wear

C10C. Worn down kerb units

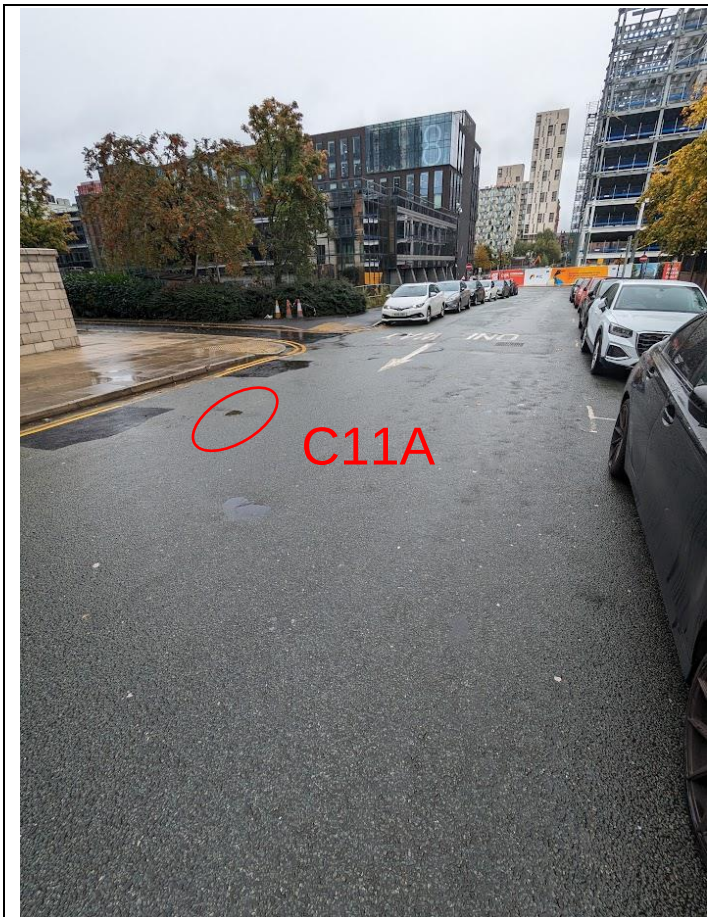
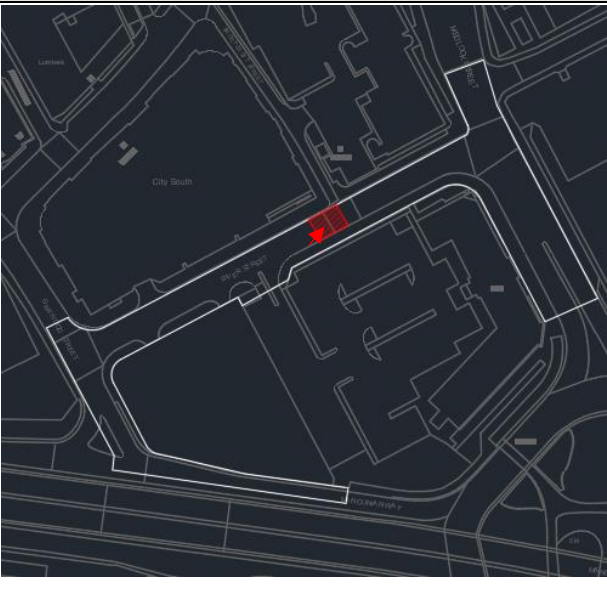
| | <div data-bbox="952 156 1556 199"> <p>Location C11: Grid Reference X= 383609 Y= 397230</p> </div> <div data-bbox="952 199 1556 790"> </div> <div data-bbox="952 798 1556 1211"> <p>Notes:</p> <p>C11A. General surface wear</p> </div> |

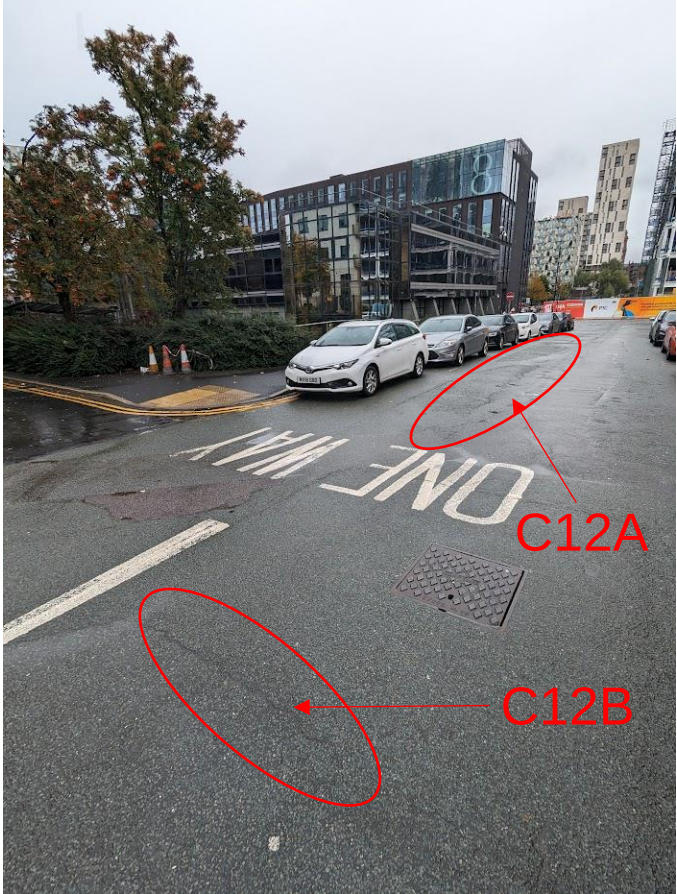
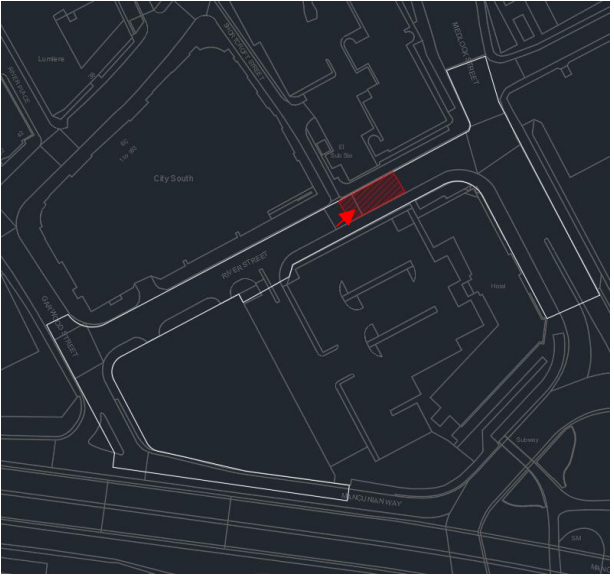
| | <div data-bbox="952 159 1563 199"> <p>Location C12: Grid Reference X= 383623 Y= 397237</p> </div> <div data-bbox="952 204 1563 783"> </div> <div data-bbox="952 804 1563 922"> <p>Notes:</p> <p>C12A. Longitudinal Cracking with significant surface failure</p> <p>C12B. Transverse Cracking</p> </div> <div data-bbox="1570 156 1908 603"> </div> |

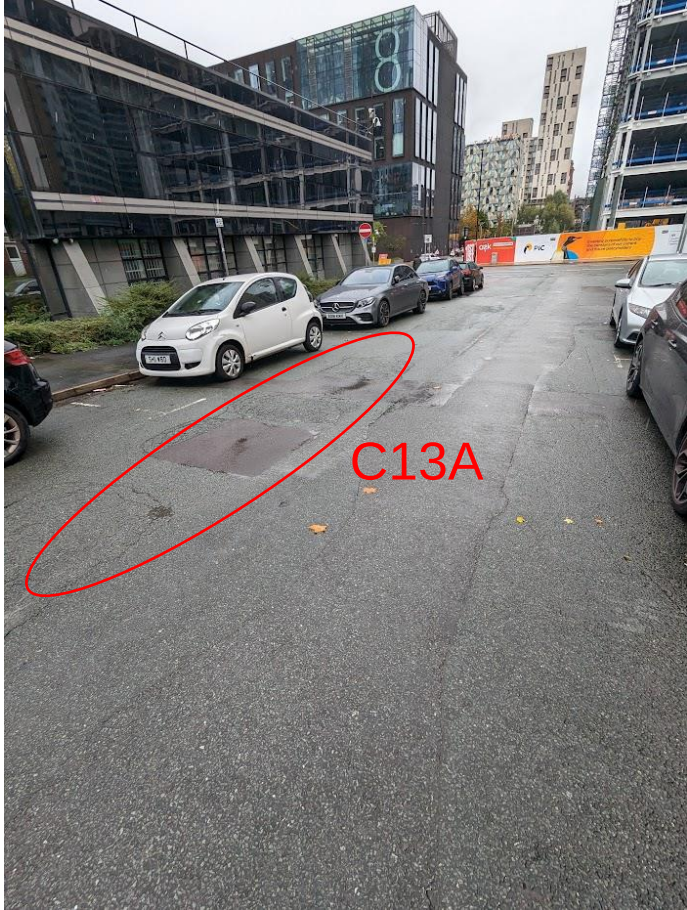
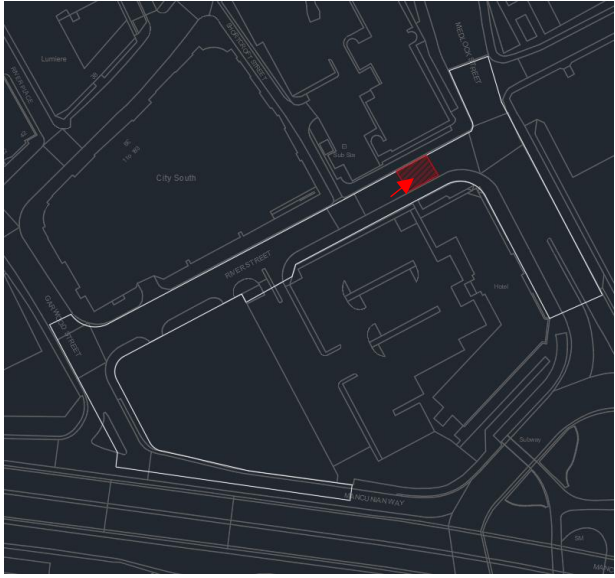
| | <p>Location C13: Grid Reference X= 383638 Y= 397245</p> <p>Notes:</p> <p>C13A. Longitudinal cracking with significant surface failure</p> <p>C13B. Kerb units deteriorated</p> <p>C13C. Debris build up at gully pot</p> | |

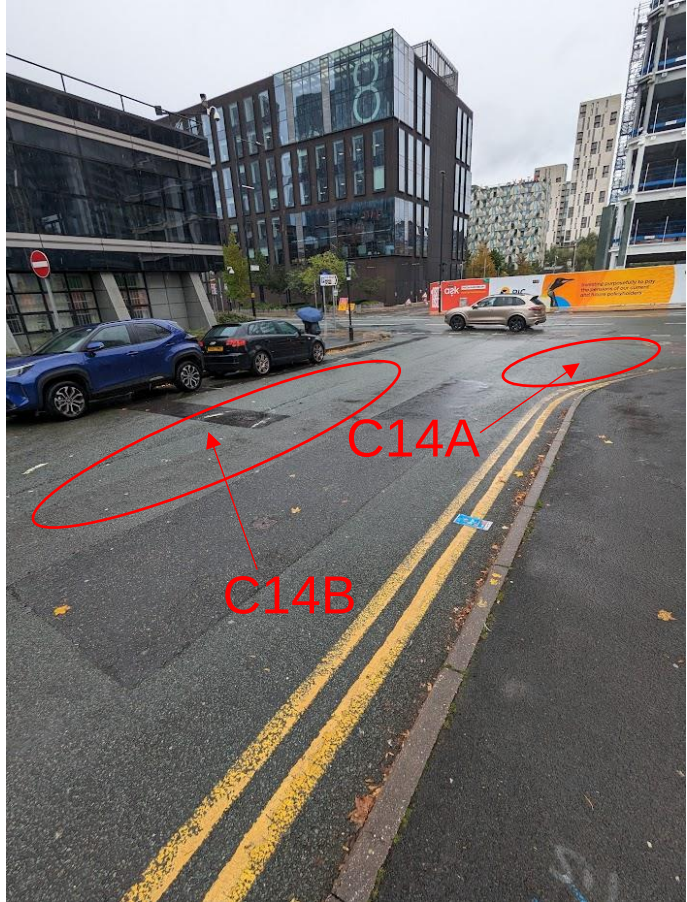
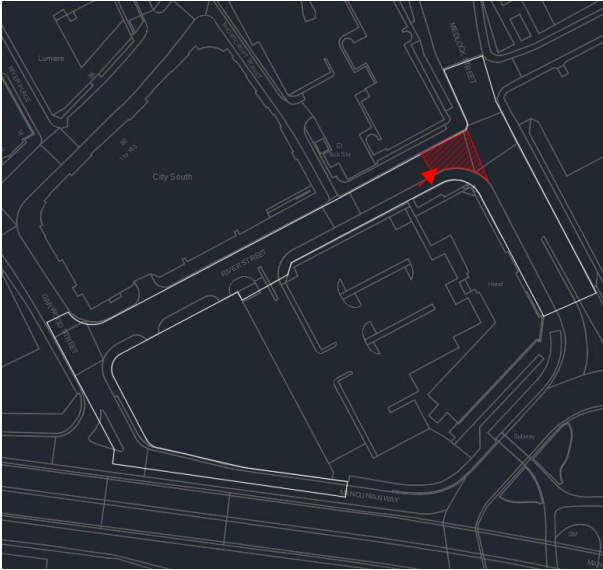
| | <p>Location C14: Grid Reference X= 383651 Y= 397252</p> <p>Notes:</p> <p>C14A. Longitudinal and transverse cracking</p> <p>C14B. Longitudinal cracking with minor surface failure</p> | |

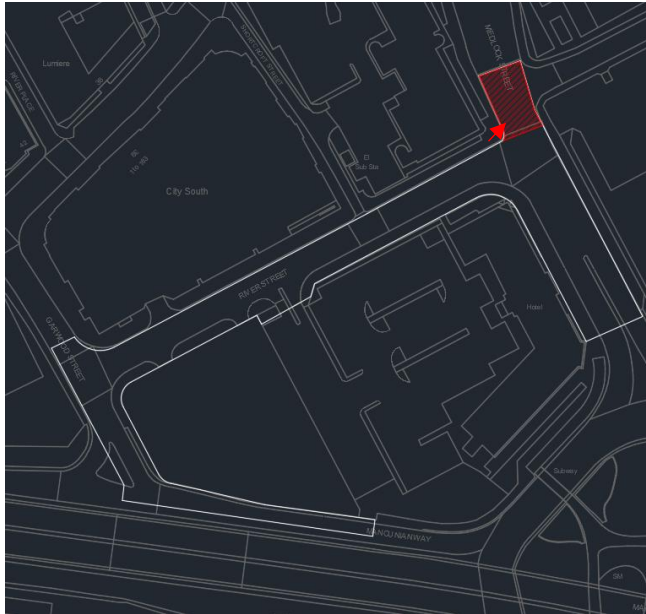
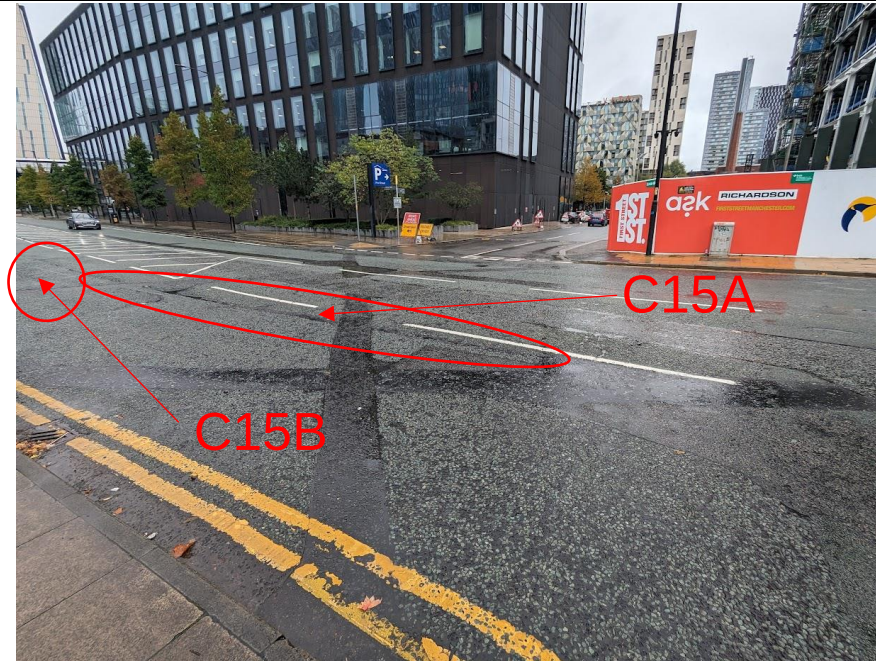
C15A. Longitudinal cracking in right wheel track of lane 1 northbound

C15B. General surface wear

C15C. Debris build up at gully pot

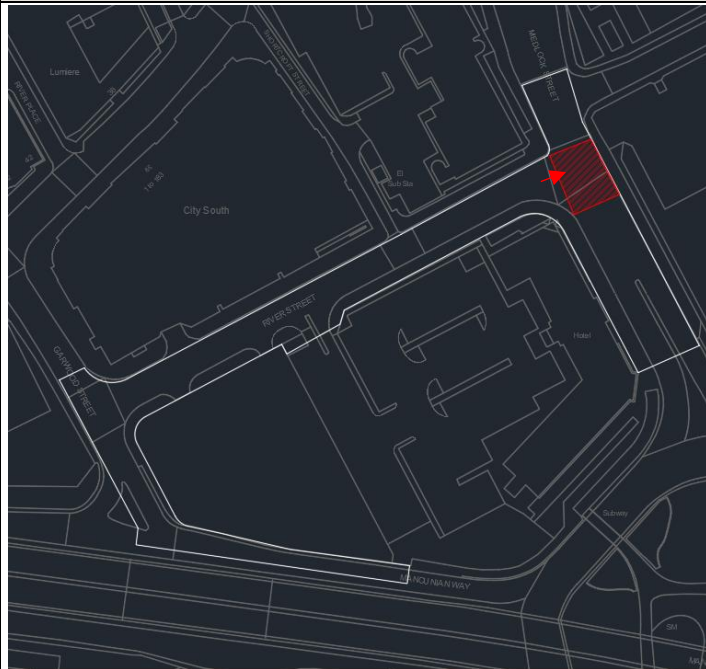
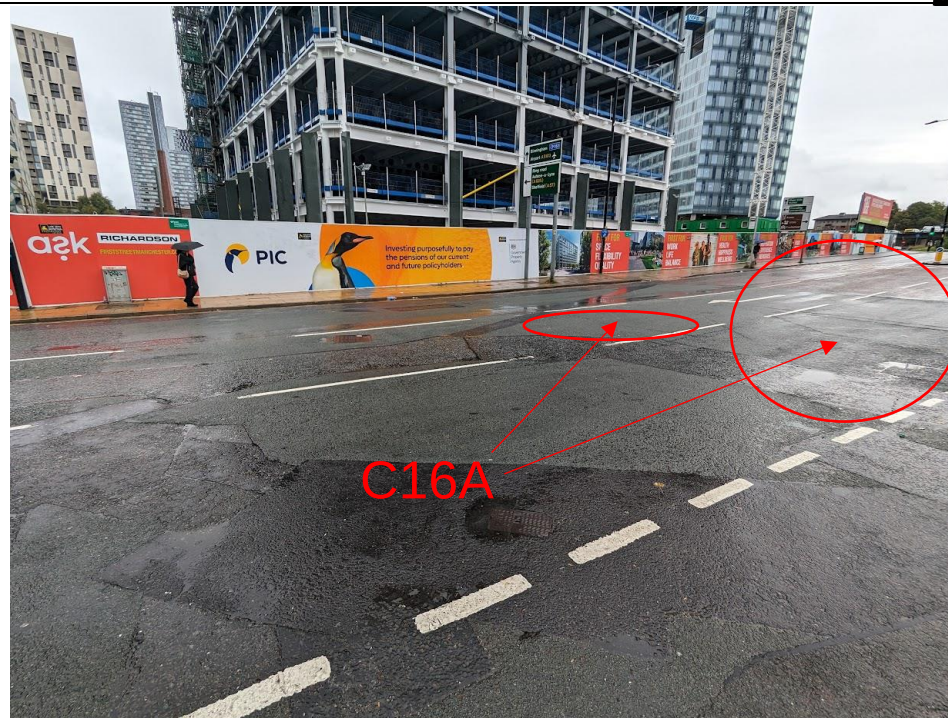
Location C16: Grid Reference X= 383669 Y= 397251

C16A. Transverse cracking across lanes 1 and 2 northbound

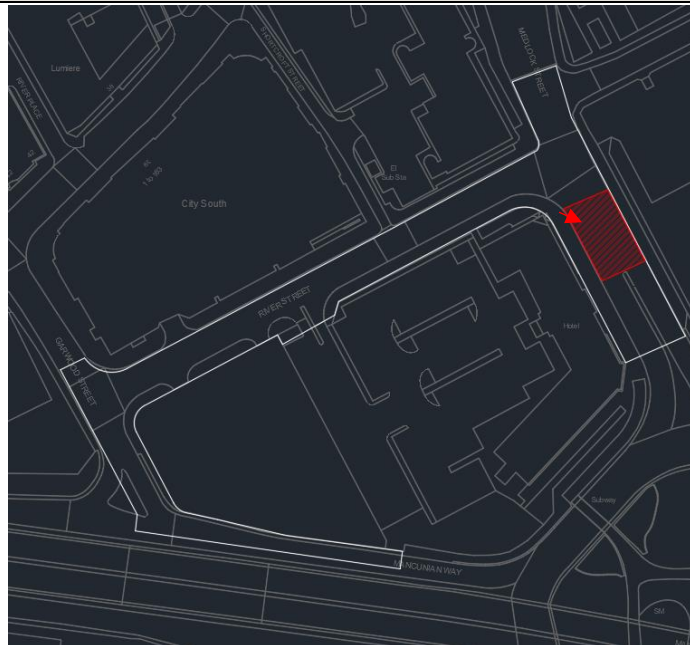
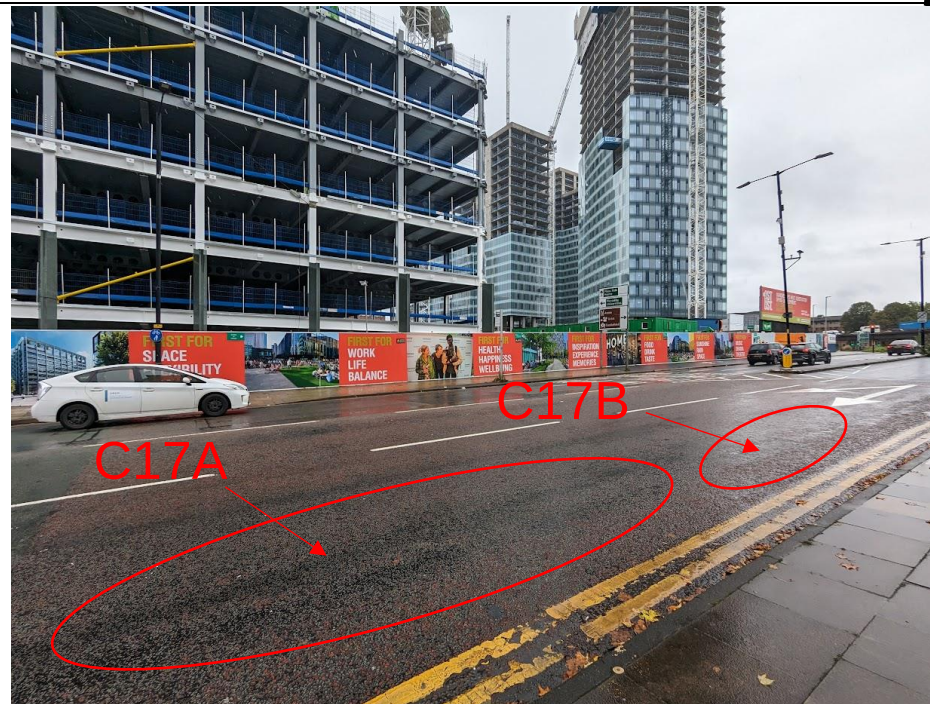
Location C17: Grid Reference X= 383677 Y= 397235

C17A. General surface wear

C17B. Longitudinal Cracking
