Hotspur Press, Cambridge Street,  
Manchester

Construction Methodology and  
Façade Retention

Sept 2023

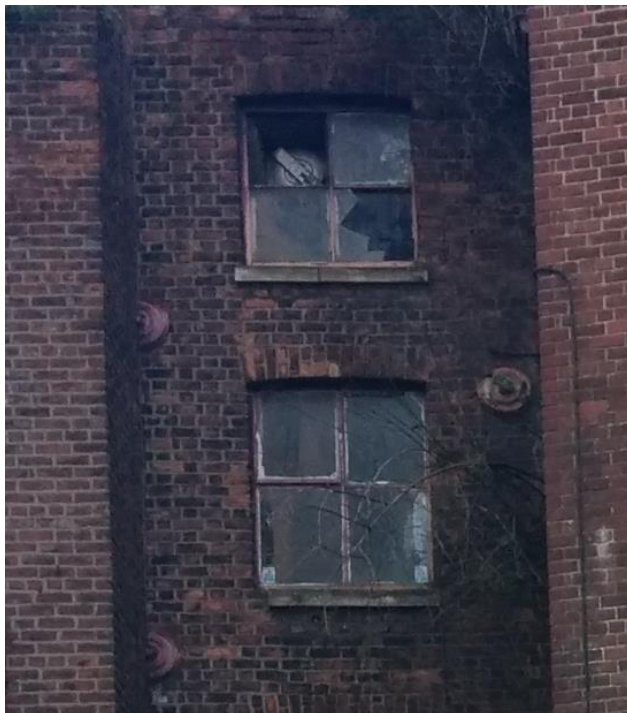
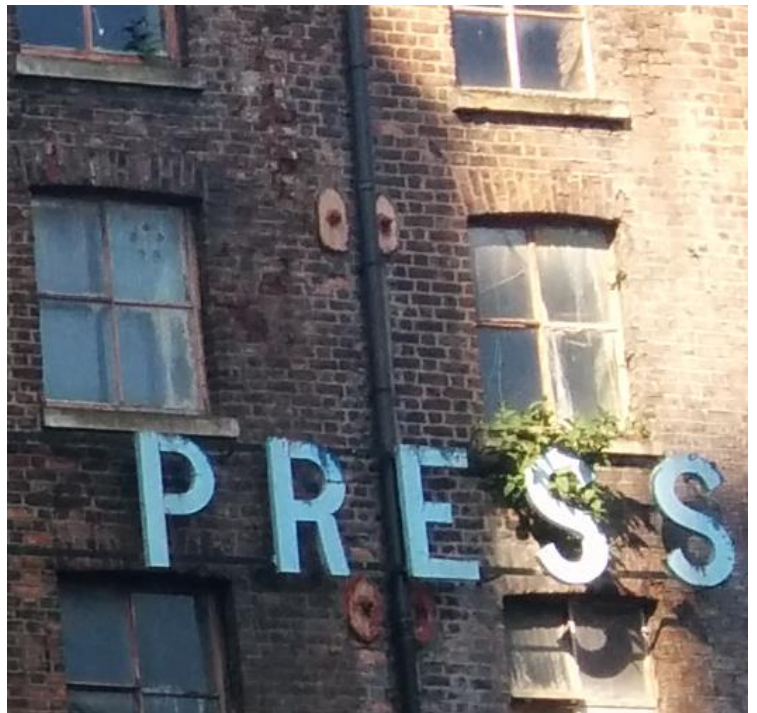
As viewed from Cambridge Street level it appears that there are several pattress plates visible along the eastern elevation, as illustrated in Figure 2. The pattress plates in Figure 2 (A) might be connected through steel tie rods to the pattress plates in the lift shaft connecting the Warehouse building to the Mill structure- this is noted in the Structural Appraisal Report.

Traditionally, pattress plates are added as a remediation measure to restrain lateral movement of the facades that may have occurred during the life of the structure. Pattress plates have been installed to the head of the first-floor and second-floor windows, as is shown in Figure 2 (B). The plates in Figure 2 (B) are not visible on the opposite elevation, thus indicating that they do not pass through the entire structure, although ties could be hidden from view within the floor build up. Since there are no visible corresponding pattress plates on the western elevation, the pattress plates indicated in Figure 2 are likely to be restraining only the eastern elevation from bowing laterally.

*Figure 2 - Pattress plates on eastern elevation (taken 2018)*

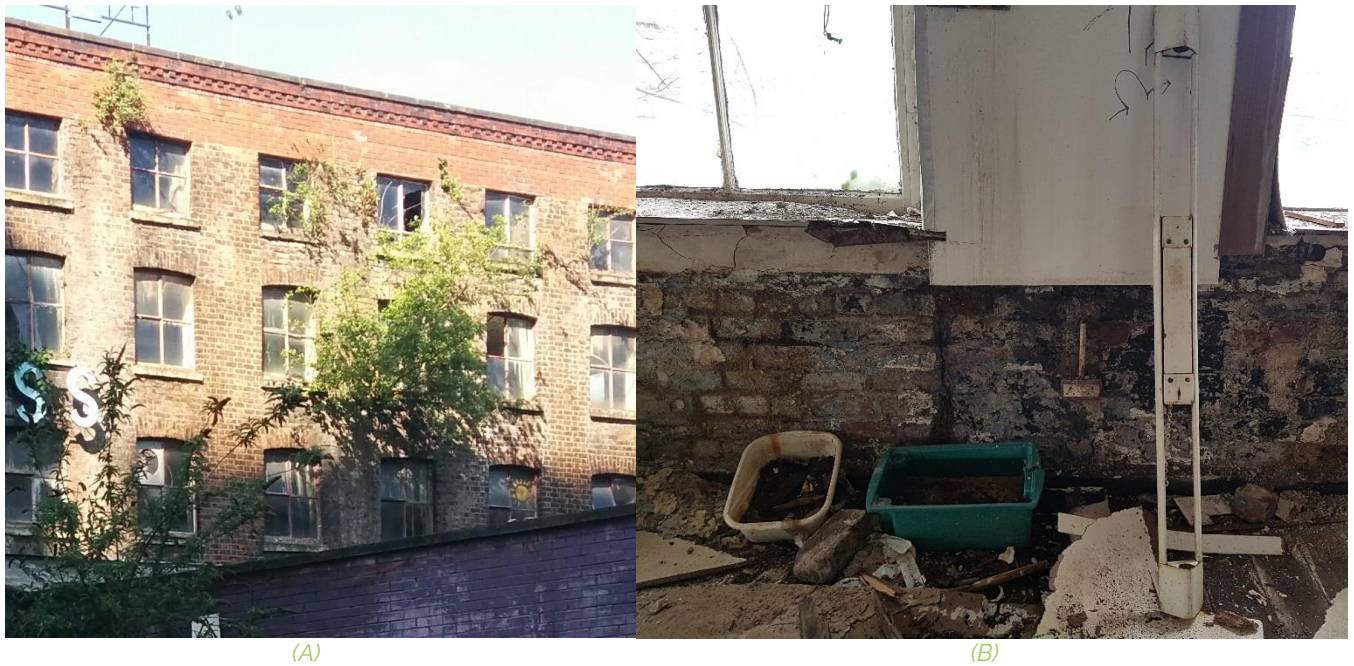
In some instances, at the head of the second-floor windows, as per Figure 3 (A), the surrounding brickwork has become dislodged as the vegetation root system expands and forces the brickwork out of alignment. Cracking has also been induced due to the expansion of the root system. Internally, severe water penetration has led to the crumbling and spalling of the masonry, as illustrated in Figure 3 (B).

The cause of this growth is most likely due to open mortar joints in the stonework, allowing spores within the air to take root.

Figure 3 - Severe vegetation growth on eastern elevation (taken 2018)

There are signs of vegetation growth at the top of the third-floor window located at the corner with the staircase structure, as per Figure 3 (A)

Widespread vegetation growth which has been identified. This growth would need to be removed, treated and then local masonry repairs and repointing carried out prior to implementation of a façade retention strategy and removal of internal floors.

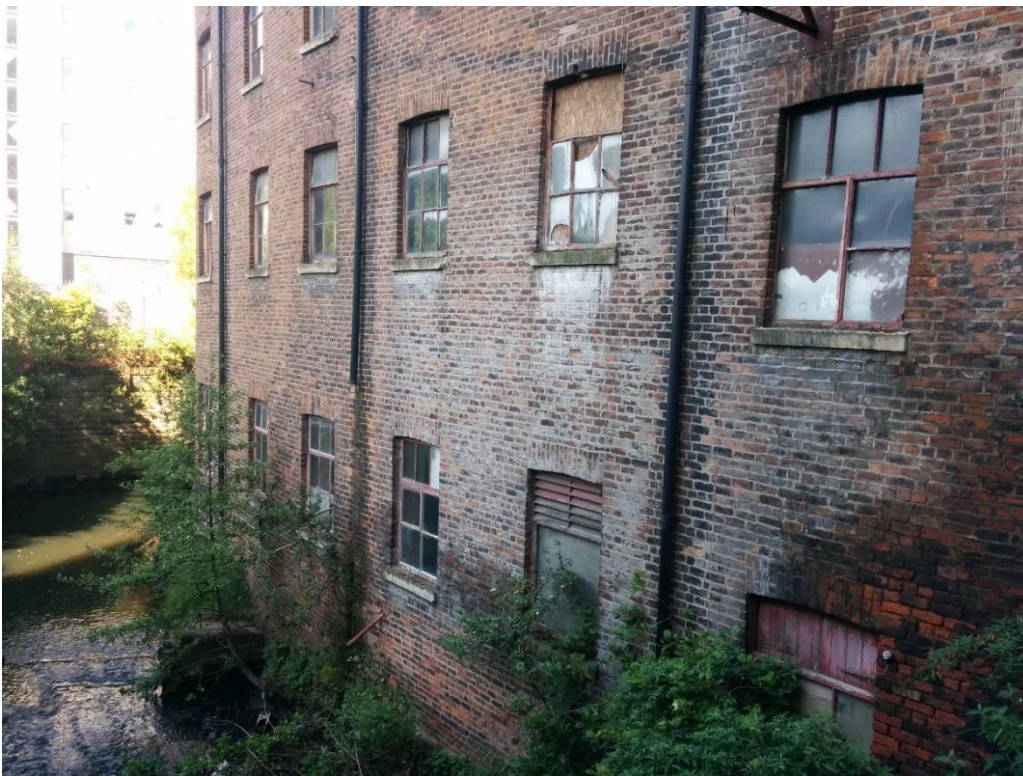
The façade is made up of loadbearing masonry with timber joists and beams that bear into the wall. The southern elevation façade is typically in poor condition. There are signs of prolonged water ingress from poor weatherproofing at parapet level and well established vegetation growth, and the build-up of mosses and lichens is evident, particularly in the areas surrounding rainwater goods and the areas adjacent the River Medlock, as illustrated in Figure 4.

*Figure 4 - Heavy vegetation growth on south elevation (taken 2018)*

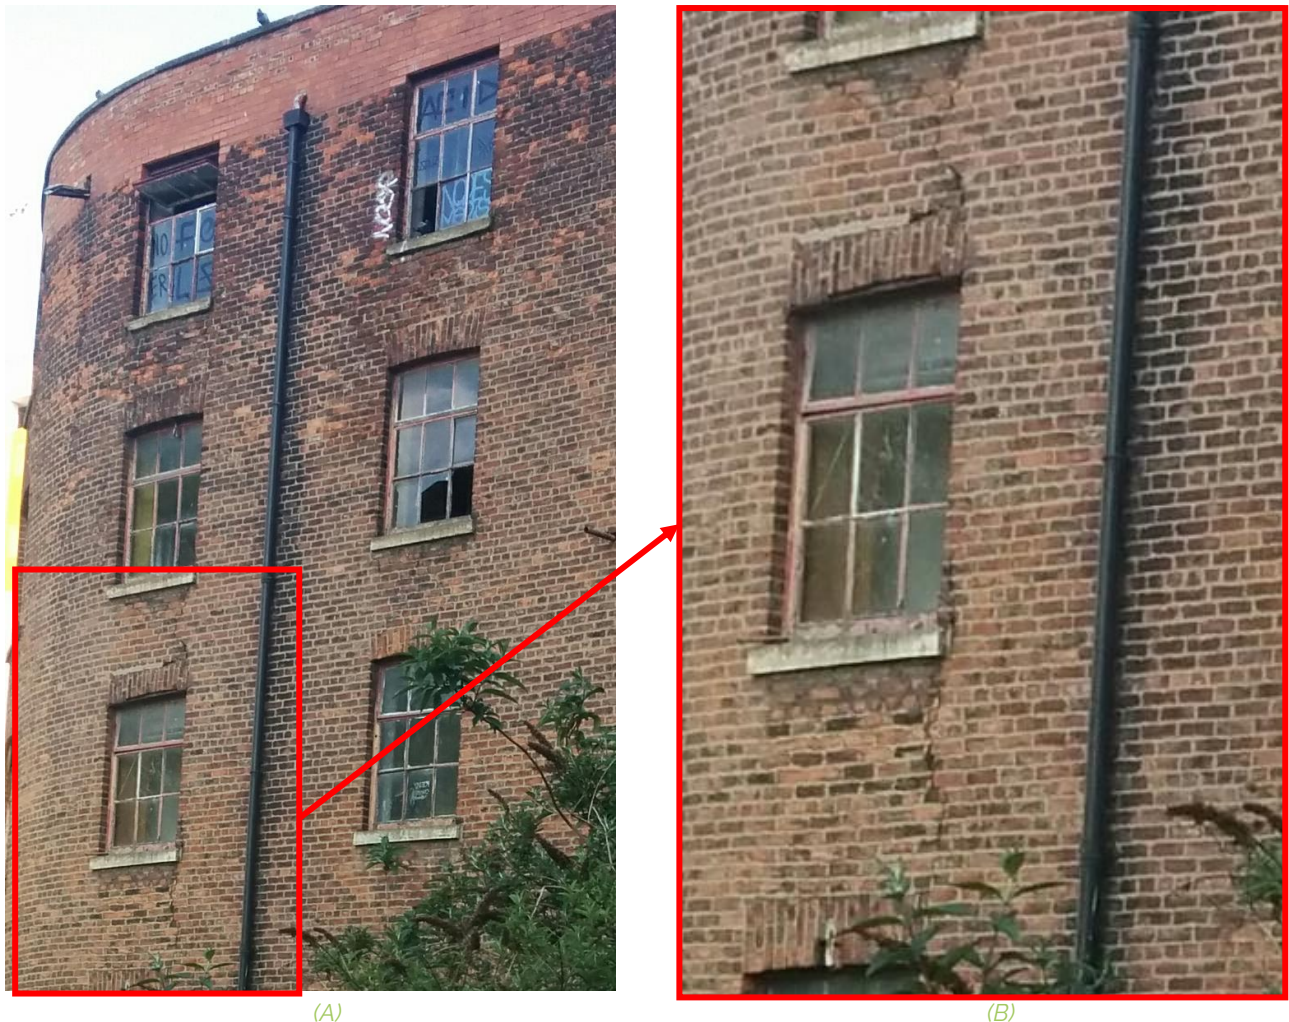
There appears to be a significant change in the visual appearance to the brickwork at the head of the third-floor windows. The band of brickwork from the window head of the third-floor appears to be consistent up to the top of the parapet, as illustrated in Figure 5, (A). It appears the original brickwork arch lintels above third-floor windows had been previously replaced with steel lintels, most probably during works of the parapet

*Figure 5 - Significant cracking on southern elevation (taken 2018)*

Cracking is evident to the head of the ground-floor window, with a vertical stepped crack leading up to the window sill at the first-floor level, continuing through the lintel at first-floor window up until the sill at third-floor level, as illustrated in Figure 5. Several of the brickwork units to the window opening appear to be loose, due to the cracking in the elevation wall. The cracks in the elevation may be due to movement of the building, which would indicate settlement of the river wall and foundations. Cracking in the brickwork walls could be due also to thermal expansion, although further investigations into the brickwork is required to determine the cause of this cracking.

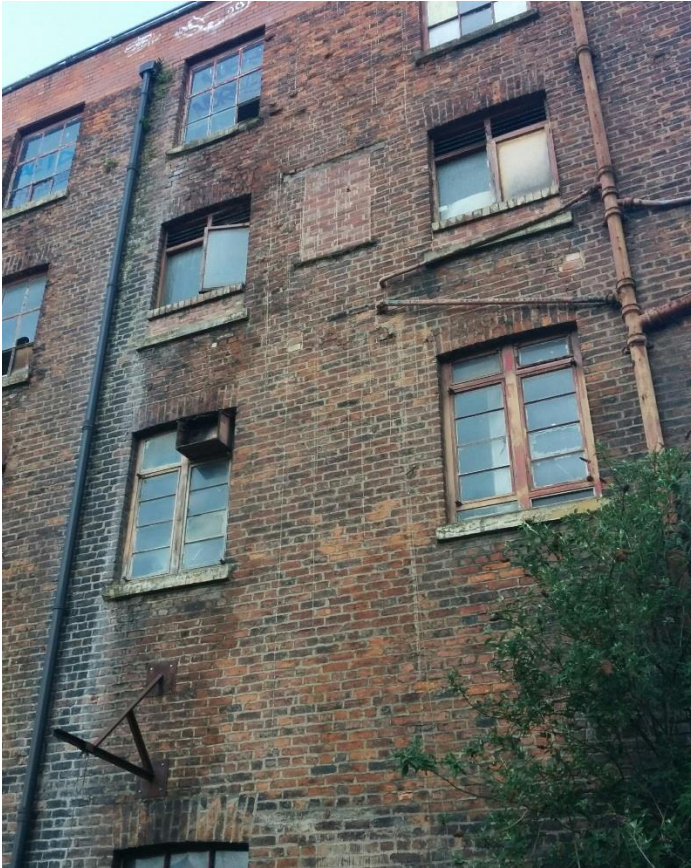
At second floor level it appears a former window opening was previously infilled with modern brickwork. The adjacent window openings have been reduced and the space between the previous sill and the new window sills has been previously infilled with modern brickwork as depicted in

Figure 6. A protruding hoist structure is protruding over River Medlock between ground and first floor level, refer also to Figure 6.

*Figure 6 - Modern brickwork infill at second floor (taken 2018)*

Modified windows. As per Civic Engineers Structural Appraisal Report it has been observed that 1No of the original windows has been modified using a different type of brickwork (visually, unknown from a structural perspective) We understand the architectural intent is to return to the original window position.

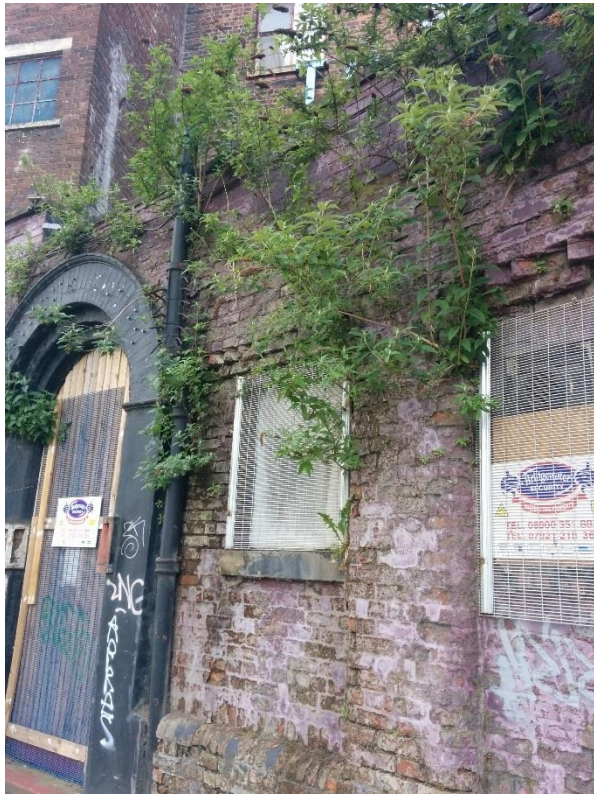
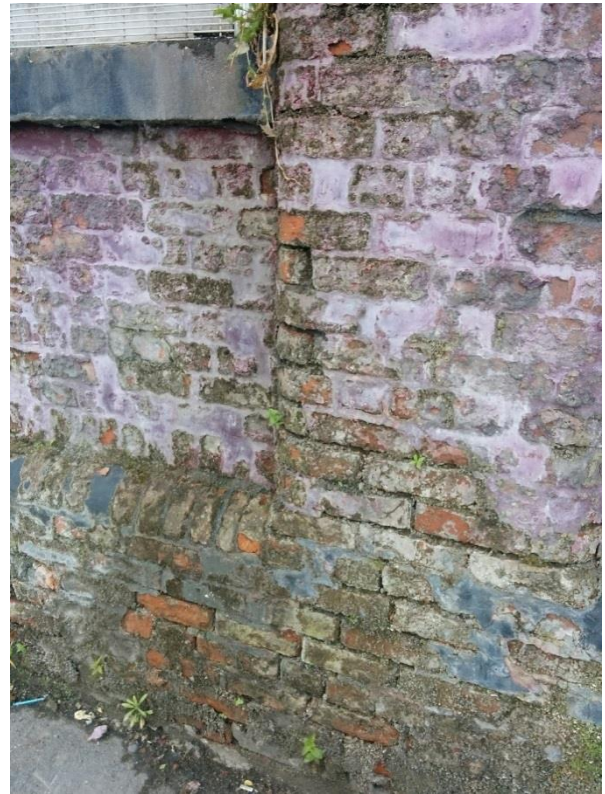
Generally the single storey building elevation along Gloucester Street is in poor condition with significant vegetation growth evident in several places along the wall, as shown in Figure 16 (A). There is a loss of mortar within the brickwork joints and some discoloration of the brickwork, as per Figure 16 (B). There are several brickwork units that appear to be crumbling, with significant build-up of moss and lichens on the brickwork wall. The wall has been previously painted, with paint chipping off due to weathering of brickwork.

Visual inspection suggests the wall appears to exhibit a lean towards Gloucester Street at the head.. The inclination was not measured but was visible to the eye.

Figure 16 - Wall following the curve comprising both of Gloucester Street and Cambridge Street

The advantage of opting for a dismantle and rebuild approach with this wall is that the above structural concerns can be addressed as part of the rebuild process to restore plumbness and stability to the wall.

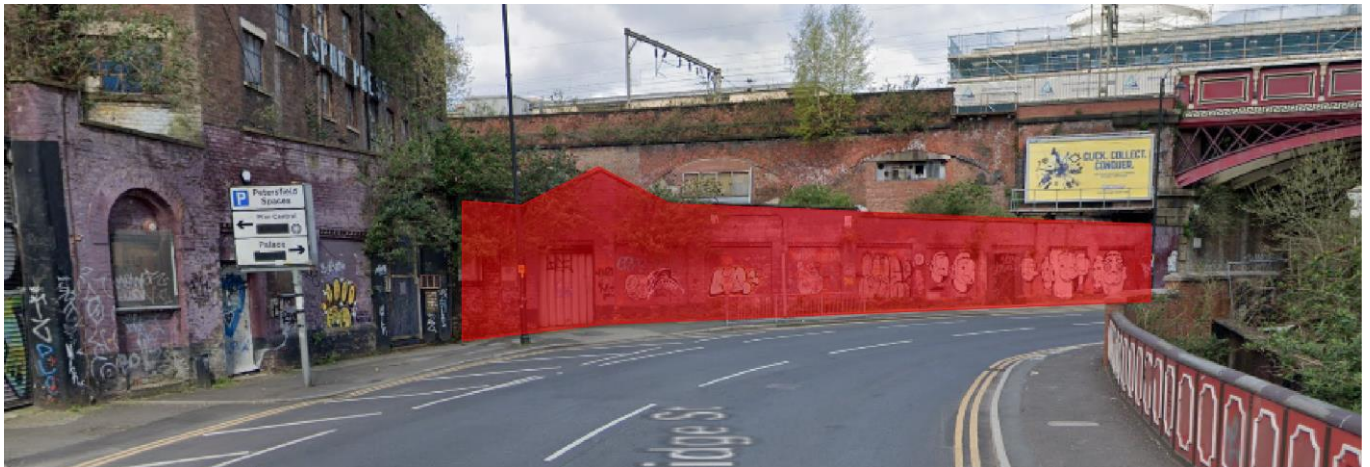
Temporary road closures may be required for on street access. Road closures will need to be agreed with Manchester City Council's Highways Department. The section that would suit site access is shown in Figure 17 below, which corresponds to the leaning section of wall.

Figure 17 - Leaning wall + site access provision
