**Project****Project Name:** 63-65 Upper Chorlton Road**Project Description:** 63-65 Upper Chorlton Road**Project Number:** DCCTMT26369**Project Date:** 06/07/2023**Inspection Standard:** MSCC5 Sewers & Drainage GB (SRM5 Scoring)

| <b>Project Name</b><br>63-65 Upper Chorlton Road | <b>Project Number</b><br>DCCTMT26369 | <b>Project Date</b><br>06/07/2023 |

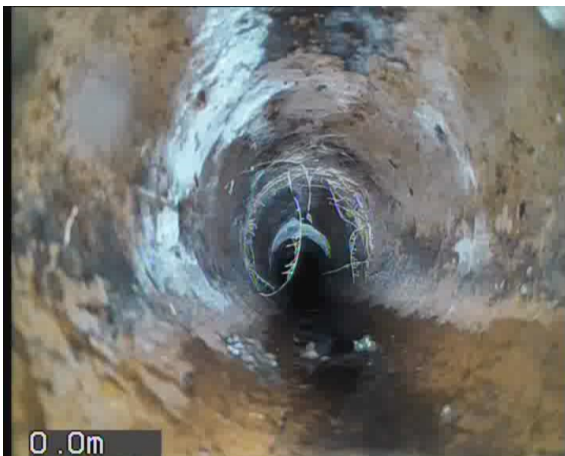
| Scale: | 1:93 | Position [m] | Code | Observation | MPEG | Photo | Grade |
|---|---|---|---|---|---|---|---|
| | | 0.50 | RFJ | Roots, fine at joint | 00:00:28 | HOLX_296<br>dc49c-b43<br>3-46e6-b8 | 2 |

HOLX\_296dc49c-b433-46e6-b823-476ff07f555d\_20230706\_141149\_423.jpg, 00:00:28, 0.50 m  
Roots, fine at joint

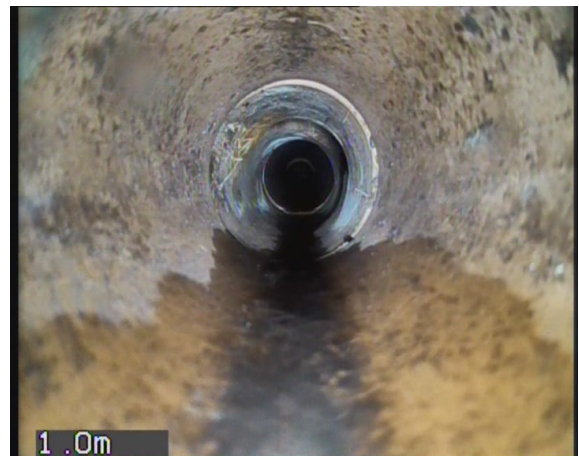
| Scale: | 1:93 | Position [m] | Code | Observation | MPEG | Photo | Grade |
|---|---|---|---|---|---|---|---|
| | | 1.20 | RFJ | Roots, fine at joint | 00:00:38 | HOLX_fd0<br>25202-e33<br>a-4a99-86 | 2 |

HOLX\_fd025202-e33a-4a99-8644-b8ab0bc96fb6\_20230706\_141219\_816.jpg, 00:00:38, 1.20 m  
Roots, fine at joint

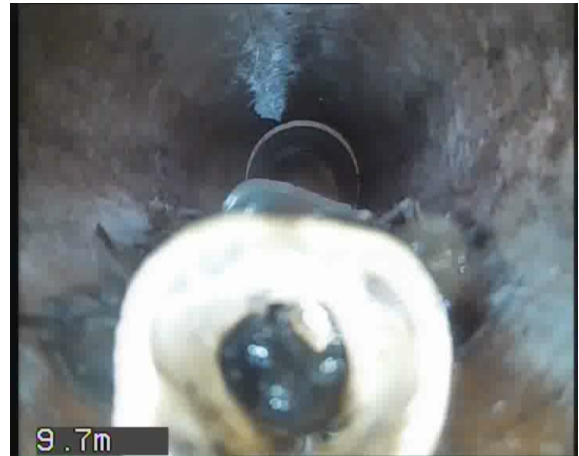
| Scale: | 1:93 | Position [m] | Code | Observation | MPEG | Photo | Grade |
|---|---|---|---|---|---|---|---|
| | | 9.70 | OBZ | Other obstacles from 5 o'clock to 7 o'clock, 20% cross-sectional area loss: Obstruction | 00:01:45 | HOLX_bbd<br>fef19-5a48<br>-4709-937 | 5 |

HOLX\_bbddef19-5a48-4709-9377-e3b40a3892d7\_20230706\_141628\_416.jpg, 00:01:45, 9.70 m  
Other obstacles from 5 o'clock to 7 o'clock, 20% cross-sectional area loss, Obstruction

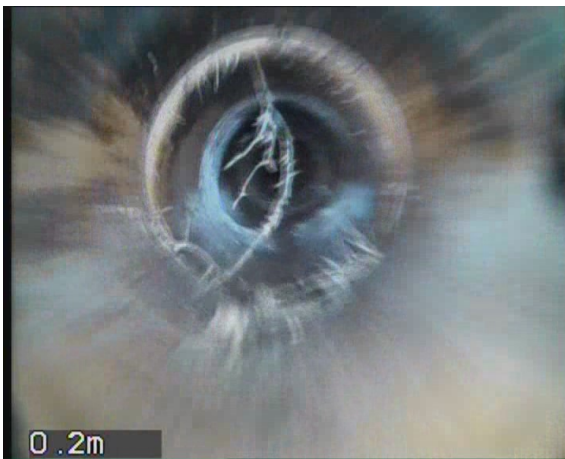
| Scale: | 1:50 | Position [m] | Code | Observation | MPEG | Photo | Grade |
|---|---|---|---|---|---|---|---|
| | | 0.30 | RFJ | Roots, fine at joint | 00:00:36 | HOLX_f19<br>a829c-729<br>a-4d22-b1 | 2 |

HOLX\_f19a829c-729a-4d22-b119-50254150705c\_20230706\_144741\_205.jpg, 00:00:36, 0.30 m  
Roots, fine at joint

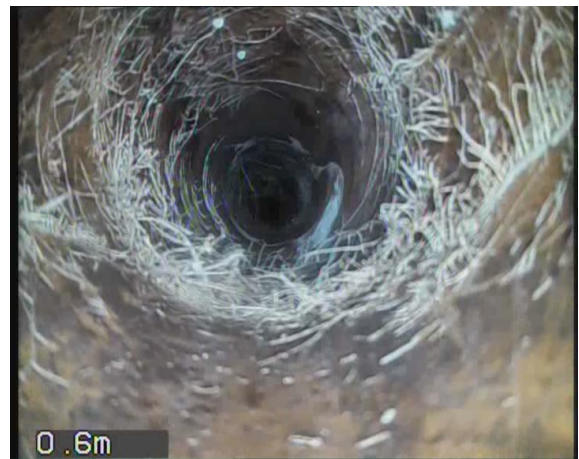
| Scale: | 1:50 | Position [m] | Code | Observation | MPEG | Photo | Grade |
|---|---|---|---|---|---|---|---|
| | | 0.70 | RFJ | Roots, fine at joint: to 1.8m | 00:00:39 | HOLX_b70<br>94c9e-f71<br>a-4390-8a | 2 |

HOLX\_b7094c9e-f71a-4390-8a2c-82a8b89ce3f7\_20230706\_144752\_637.jpg, 00:00:39, 0.70 m  
Roots, fine at joint, to 1.8m

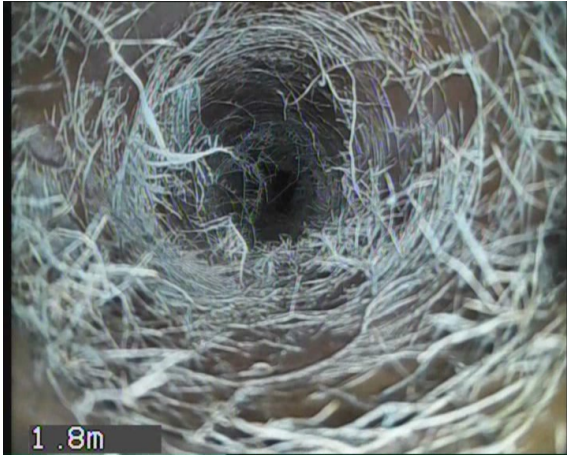
| Scale: | 1:50 | Position [m] | Code | Observation | MPEG | Photo | Grade |
|---|---|---|---|---|---|---|---|
| | | 1.80 | RM | Roots, mass, 20% cross-sectional area loss | 00:00:47 | HOLX_c49<br>5cdf7-afae<br>-413b-8d7 | 5 |

HOLX\_c495cdf7-afae-413b-8d70-2309c91349b9\_20230706\_1  
44823\_017.jpg, 00:00:47, 1.80 m  
Roots, mass, 20% cross-sectional area loss

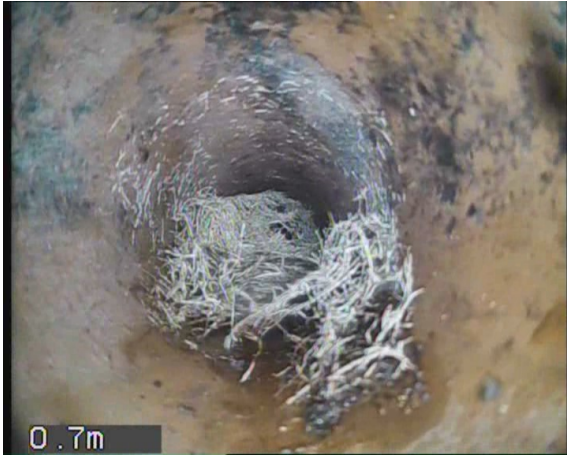
| Scale: | 1:50 | Position [m] | Code | Observation | MPEG | Photo | Grade |
|---|---|---|---|---|---|---|---|
| | | 0.80 | RM | Roots, mass, 100% cross-sectional area loss | 00:00:11 | HOLX_8b7d95bc-b8ef-4f2a-9f80 | 5 |

HOLX\_8b7d95bc-b8ef-4f2a-9f80-63491000b28e\_20230706\_1  
45747\_645.jpg, 00:00:11, 0.80 m  
Roots, mass, 100% cross-sectional area loss

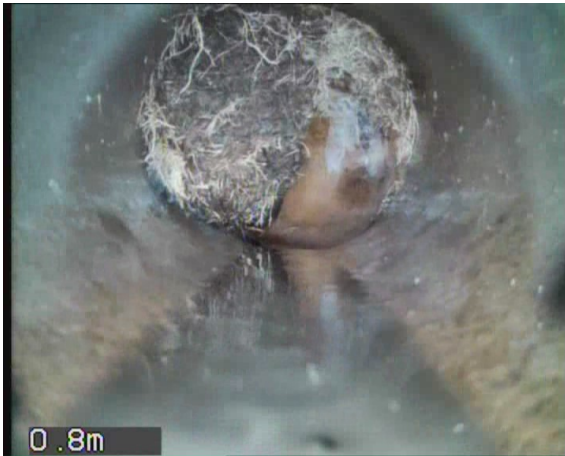
| Scale: | 1:50 | Position [m] | Code | Observation | MPEG | Photo | Grade |
|---|---|---|---|---|---|---|---|
| | | 1.00 | RMJ | Roots, mass at joint, 80% cross-sectional area loss | 00:00:18 | MH1X_aa<br>273359-72<br>9b-4f23-94 | 5 |

MH1X\_aa273359-729b-4f23-940b-d8675b318ea2\_20230706\_150200\_004.jpg, 00:00:18, 1.00 m  
Roots, mass at joint, 80% cross-sectional area loss

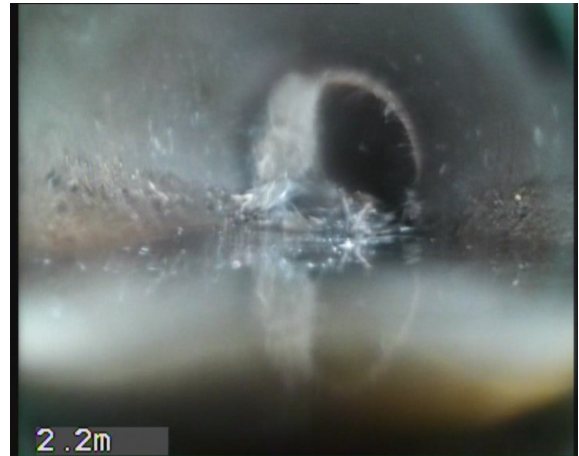
| Scale: | 1:50 | Position [m] | Code | Observation | MPEG | Photo | Grade |
|---|---|---|---|---|---|---|---|
| | | 2.30 | WL | Water level, 40% of the vertical dimension | 00:00:26 | MH1X_49<br>43f859-0f9<br>7-45a6-b8f | |

MH1X\_4943f859-0f97-45a6-b8f1-ce69cc39453f\_20230706\_150613\_957.jpg, 00:00:26, 2.30 m  
Water level, 40% of the vertical dimension

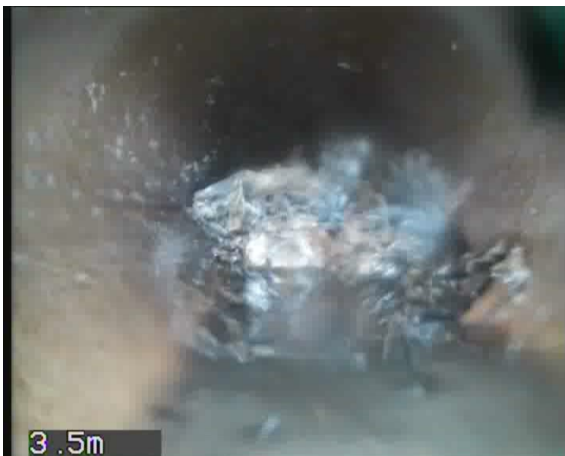
| Scale: | 1:50 | Position [m] | Code | Observation | MPEG | Photo | Grade |
|---|---|---|---|---|---|---|---|
| | | 3.60 | RM | Roots, mass, 75% cross-sectional area loss | 00:00:46 | MH1X_d3<br>511976-11<br>b8-4d56-b | 5 |

MH1X\_d3511976-11b8-4d56-b062-5a1e811e0b99\_20230706\_150645\_188.jpg, 00:00:46, 3.60 m  
Roots, mass, 75% cross-sectional area loss

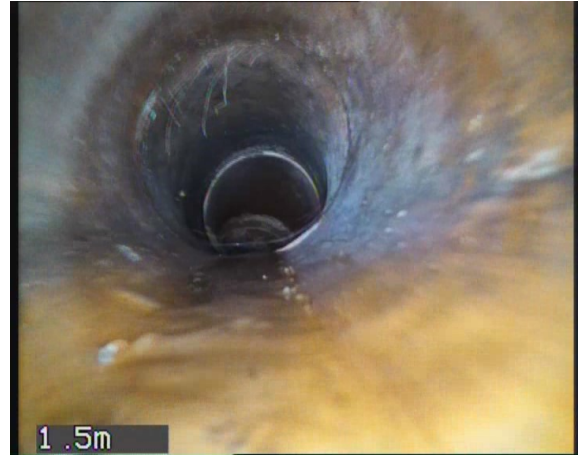
MH2X\_e63b2c25-b512-474a-b5dc-6a9fbf5f667d\_20230706\_151040\_723.jpg, 00:00:50, 1.60 m  
Roots, fine

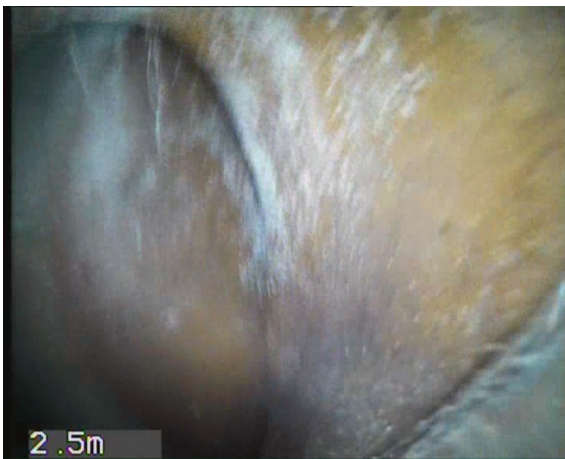
MH2X\_077422f4-e6f4-4b0f-8667-8d31a5d6da3b\_20230706\_151144\_037.jpg, 00:01:00, 2.50 m  
Line deviates down, Transporting drain

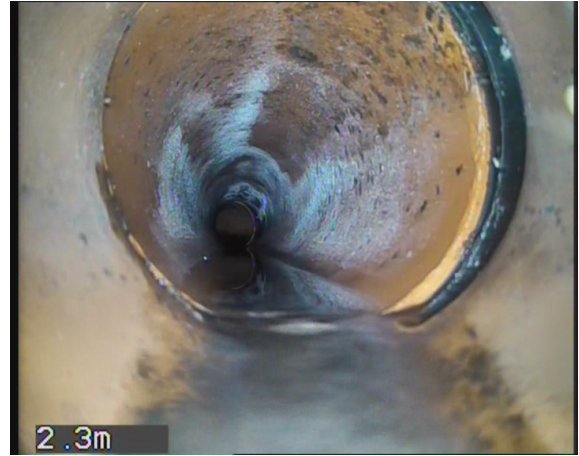
HOLX\_ed093011-e2f5-4a5d-bb0a-c82d1728c269\_20230706\_152249\_767.jpg, 00:00:29, 2.40 m  
Joint displaced, medium

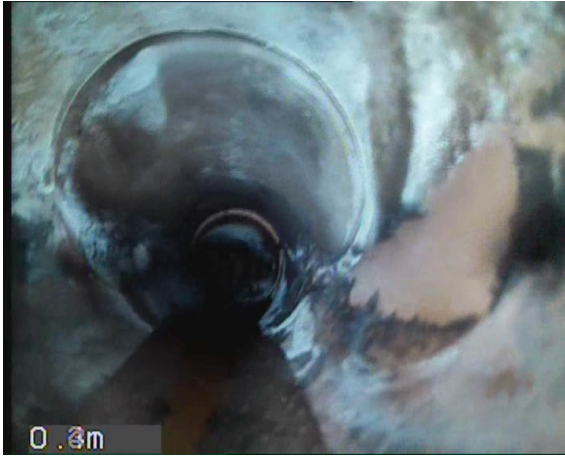
<table><tr><th>Position [m]</th><th>Code</th><th>Observation</th><th>MPEG</th><th>Photo</th><th>Grade</th></tr><tr><td>0.40</td><td>CC</td><td>Crack, circumferential from 8 o'clock to 4 o'clock</td><td>00:00:16</td><td>HOLX_3aa<br/>05ce1-21f<br/>2-4054-9a</td><td>2 / 2</td></tr></table>

HOLX\_3aa05ce1-21f2-4054-9a49-fd8b3a24f0d7\_20230706\_1  
55614\_563.jpg, 00:00:16, 0.40 m  
Crack, circumferential from 8 o'clock to 4 o'clock

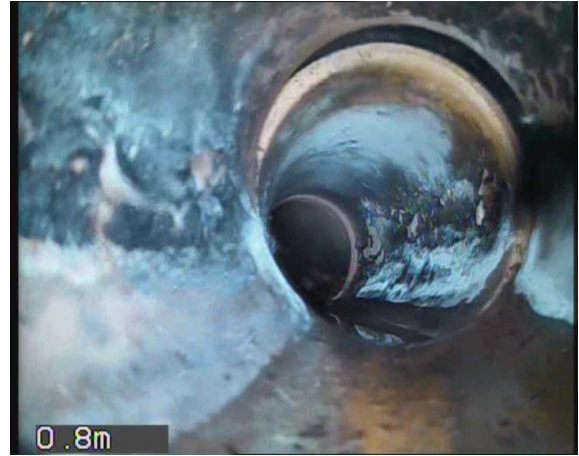
HOLX\_24c842d0-7291-42a2-9a2d-4fe320ef24cf\_20230706\_1  
55624\_515.jpg, 00:00:19, 0.90 m  
Joint displaced, large

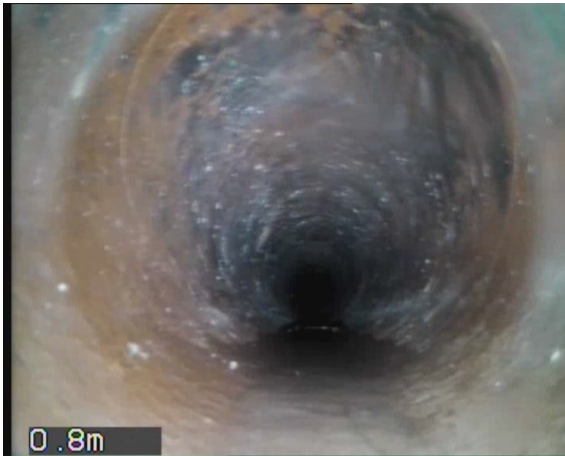
| Scale: 1:115 | Position [m] | Code | Observation | MPEG | Photo | Grade |
|---|---|---|---|---|---|---|
| | 0.10 | CC | Crack, circumferential from 8 o'clock to 4 o'clock | 00:00:24 | MH4X_cc0<br>20988-001<br>1-4340-9d | 2 / 2 |

MH4X\_cc020988-0011-4340-9d52-a30c5b3e12e1\_20230706\_161752\_145.jpg, 00:00:24, 0.10 m  
Crack, circumferential from 8 o'clock to 4 o'clock

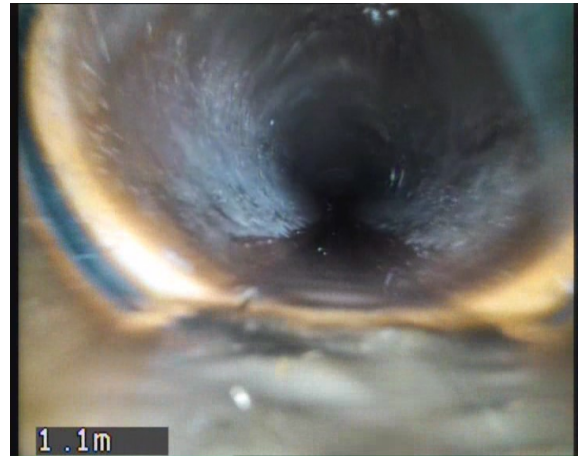
MH4X\_f61c2840-9846-4037-b65c-955f31a6e4c6\_20230706\_161824\_721.jpg, 00:00:32, 1.20 m  
Joint displaced, large

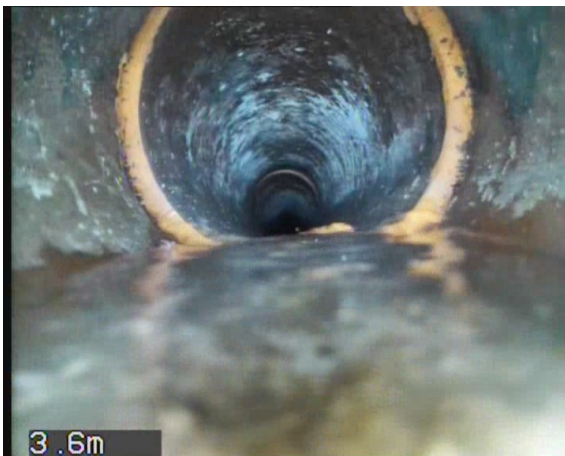
MH4X\_18eae1b9-5507-4cfd-9d9e-79c916e211a7\_20230706\_162134\_655.jpg, 00:00:49, 3.80 m  
Joint displaced, large

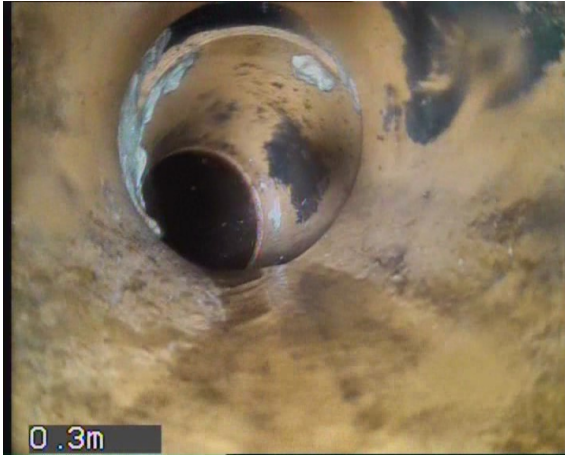
MH5X\_fdccdda9-5e7a-4bf9-ad5b-b03a58808f1c\_20230706\_162759\_472.jpg, 00:00:07, 0.50 m  
Joint displaced, large

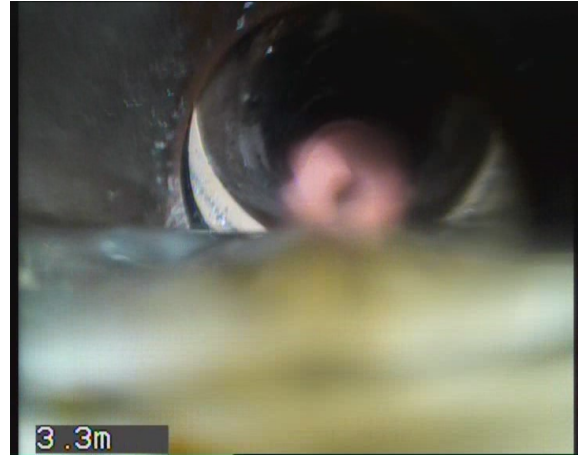
MH5X\_487dd600-ffd7-4a9d-97c7-d70b5083bec7\_20230706\_162926\_946.jpg, 00:00:27, 3.40 m  
Joint displaced, large

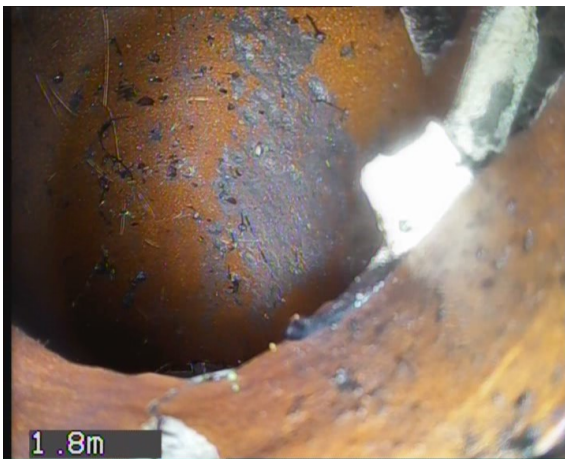
HOLX\_9afadac9-e2fa-45be-98cb-f03a69889fb9\_20230706\_1  
64450\_725.jpg, 00:00:26, 0.00 m  
Joint displaced, large

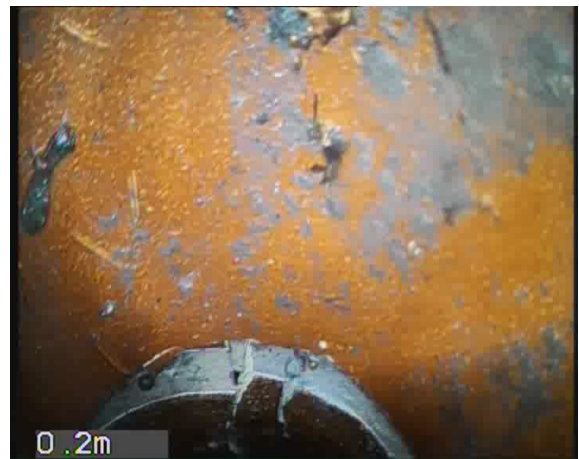
HOLX\_76cc9b2a-b665-447d-95d1-72fa29e6e91d\_20230706\_1  
64459\_040.jpg, 00:00:38, 0.20 m  
Joint displaced, large

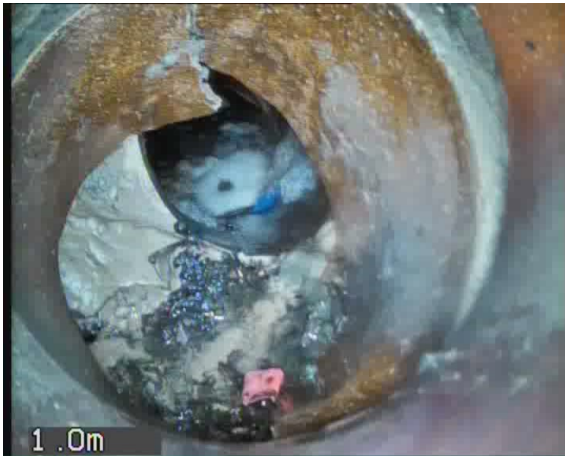
HOLX\_40921092-5114-432d-b558-0fec6fb603fd\_20230706\_1  
64509\_567.jpg, 00:00:52, 1.20 m  
Collapsed drain or sewer, 75% cross-sectional area loss

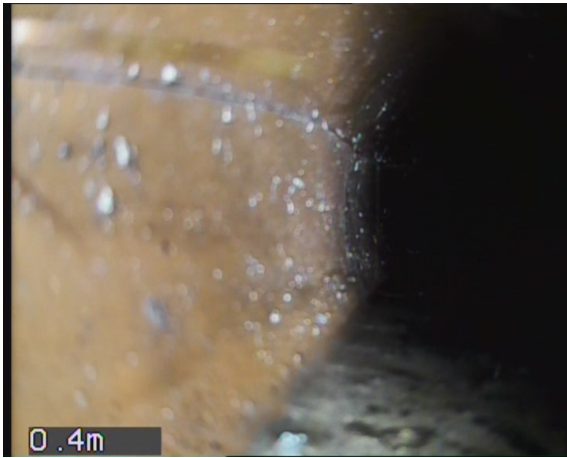
| Scale: | 1:50 | Position [m] | Code | Observation | MPEG | Photo | Grade |
|---|---|---|---|---|---|---|---|
| | | 0.40 | CL | Crack, longitudinal at 9 o'clock | 00:00:18 | HOLX_4e1<br>bb815-3bc<br>9-4277-90f | 2 / 2 |

HOLX\_4e1bb815-3bc9-4277-90fa-31b5bc985996\_20230707\_081603\_804.jpg, 00:00:18, 0.40 m  
Crack, longitudinal at 9 o'clock

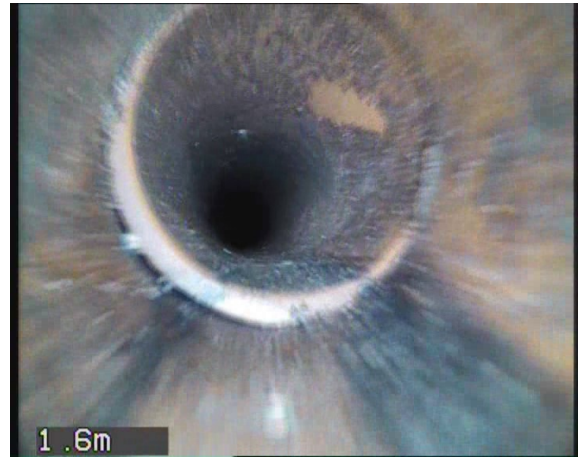
HOLX\_cb5b205e-9967-4c27-9535-0bbcbd1f7b20\_20230707\_081624\_701.jpg, 00:00:23, 1.70 m  
Joint displaced, large

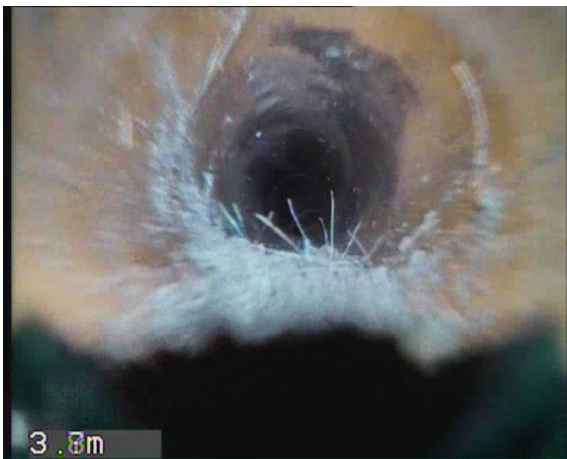
HOLX\_e67ee152-1c09-4ec4-b448-c6d1fba0b59b\_20230707\_082517\_066.jpg, 00:00:32, 3.90 m  
Settled deposits, fine, 10% cross-sectional area loss, Silt

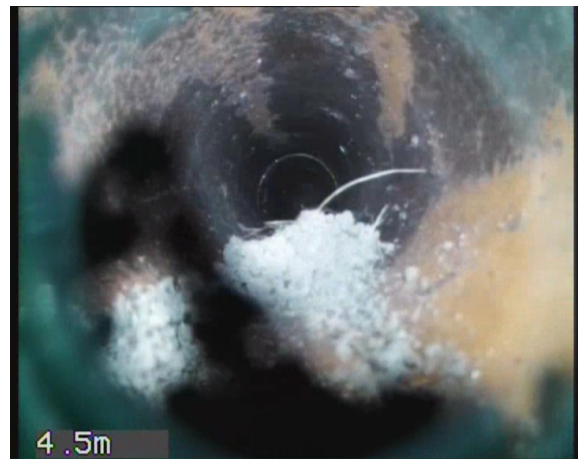
HOLX\_89ff2a4d-168b-4738-b25e-0c54171b5712\_20230707\_082541\_259.jpg, 00:00:40, 4.50 m  
Survey abandoned, Unable to pass silt
