## Moss Side Millennium Powerhouse Condition Survey

**Issue 1**

15 March 2022

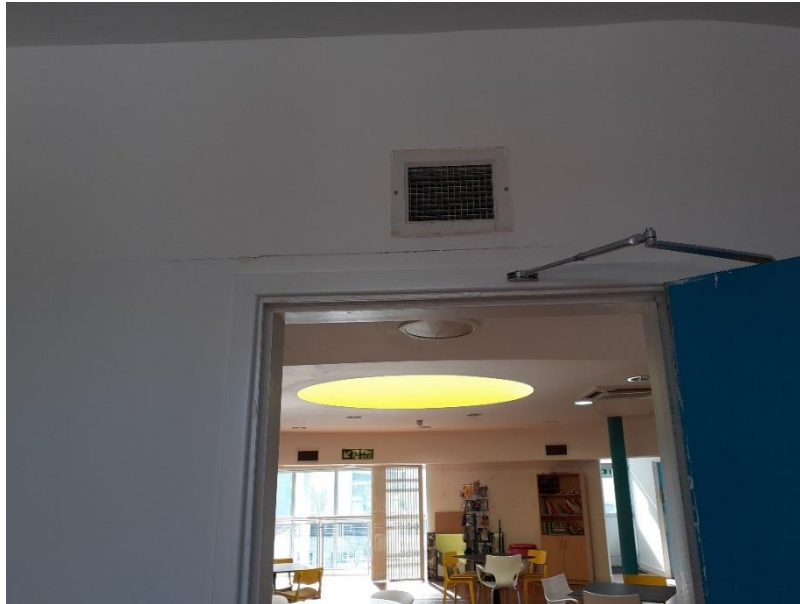
Cracks in  
stud wall  
over doorway

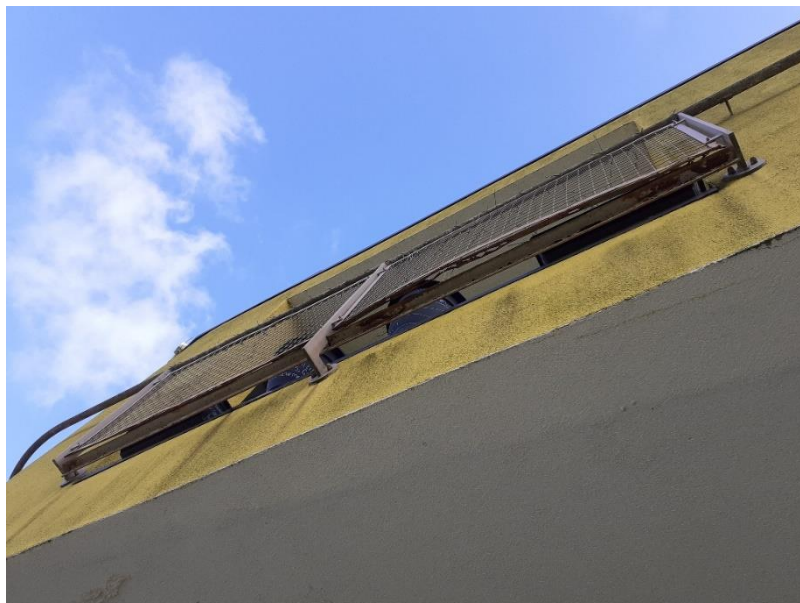
Balustrade  
corroded and  
deformed

The infill panels of the internal balustrades are not adequately fixed to the balusters. The fixings are simple bolts and many of these are easily turned by hand. In some instances the bolts are missing and the panel is attached with a plastic cable tie. It is recommended that all balustrades be checked and the bolts replaced with fixings that are not accessible to the public.

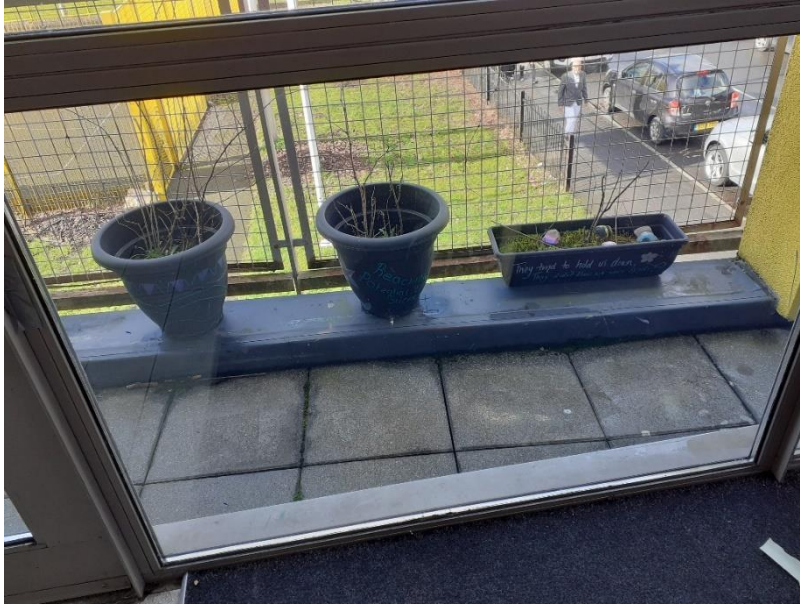
Decaying  
seals on  
curtain wall.

The seals on the aluminium doors, windows and curtain walling are beginning to fail. These should be repaired where necessary. Consideration should be given to replacement of low level glazed panels in the curtain walling.

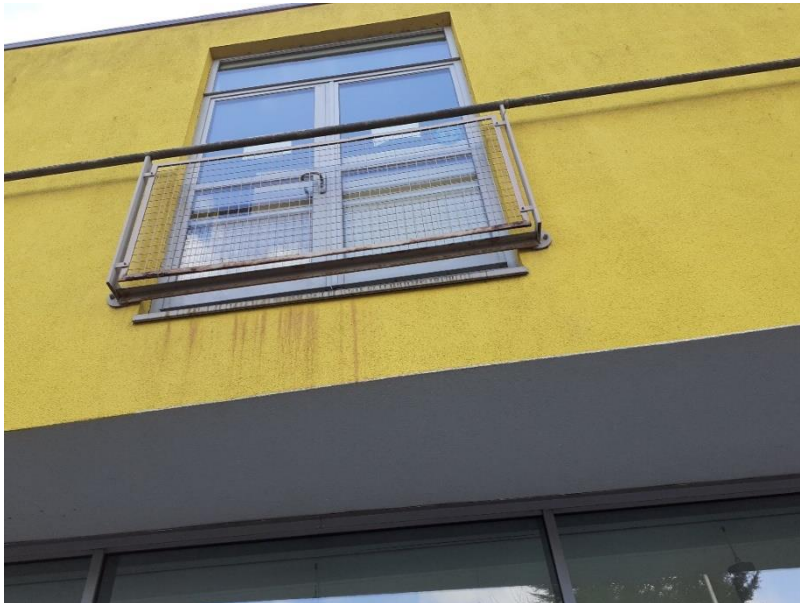
Corrosion of  
Juliet balcony

Corrosion of exposed external steelwork should be treated with appropriate anti corrosion products.

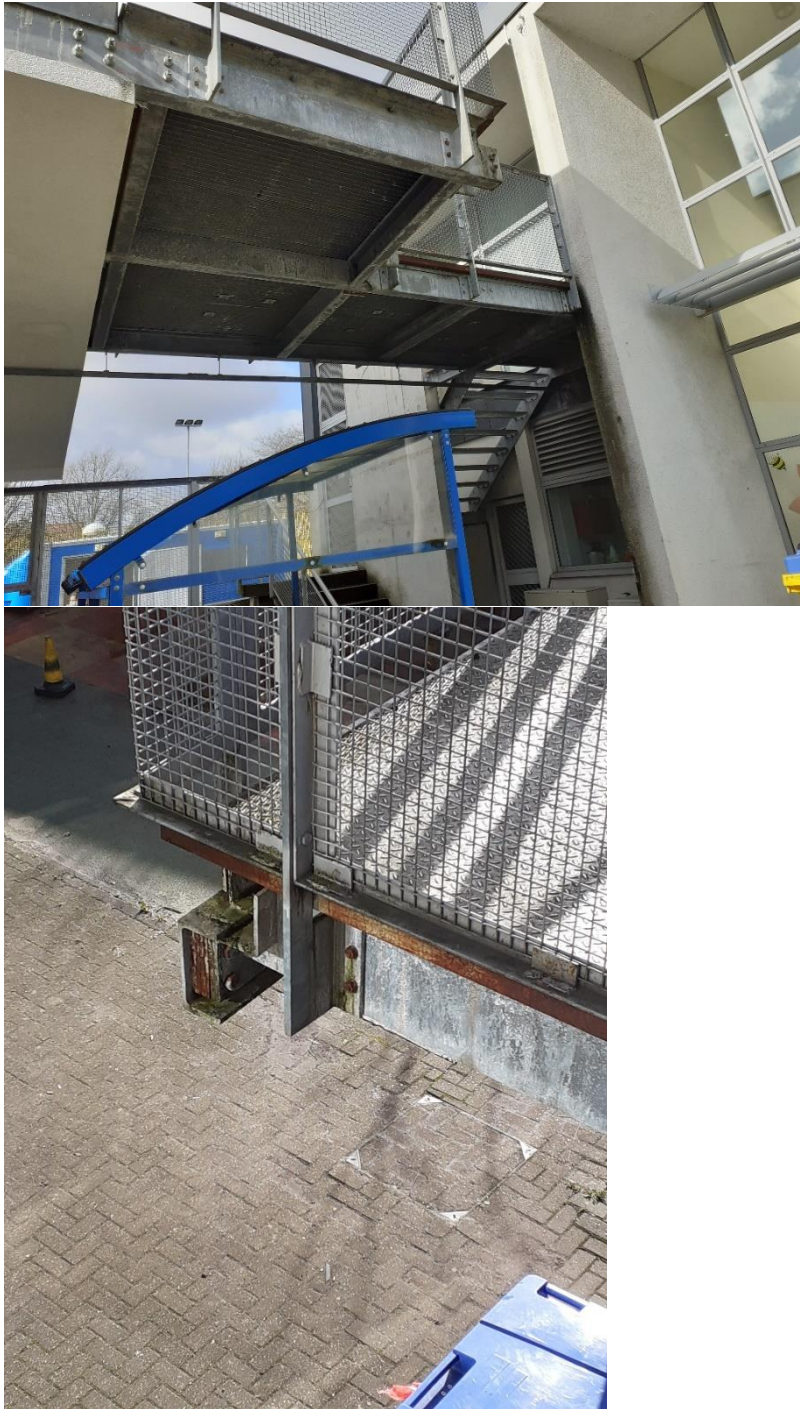
Some uneven durbar plates and corrosion of support steelwork. Note water staining on support masonry.

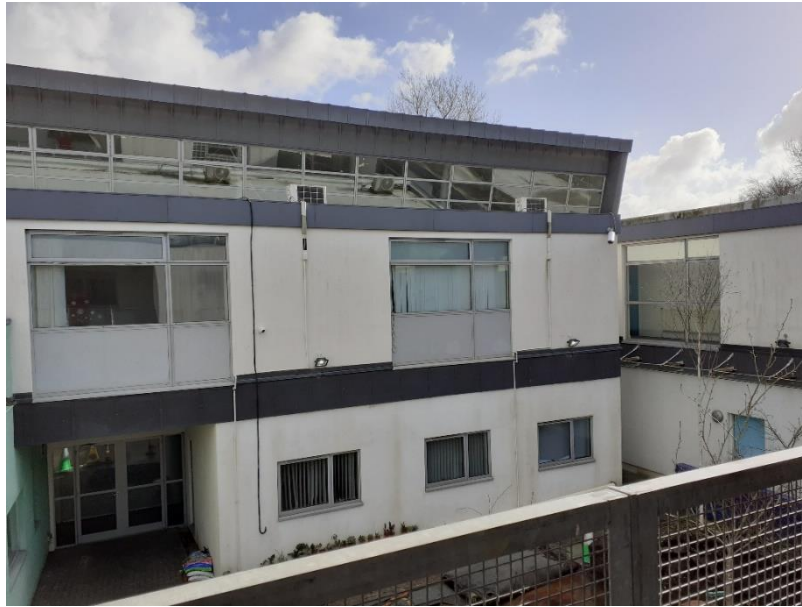
Seals around windows decaying and/or loose.

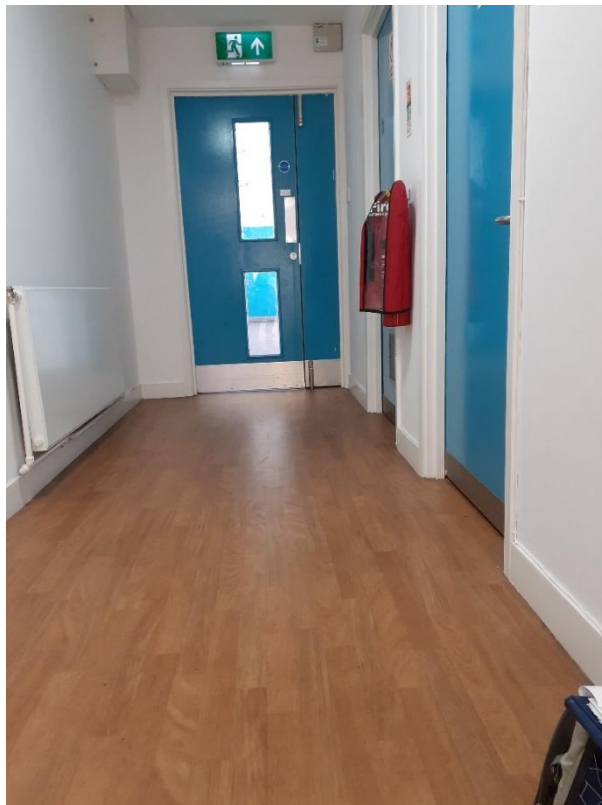
Slight gap below fire door

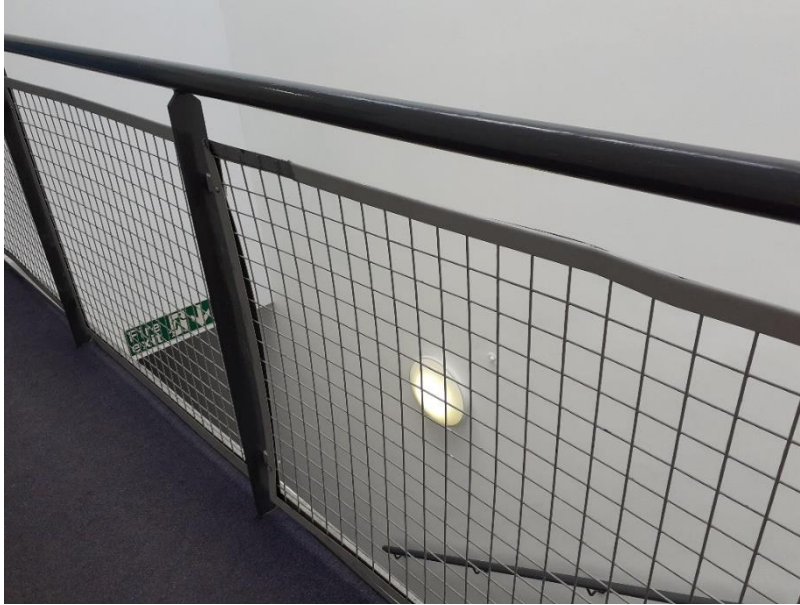
Damaged panels to balustrade.

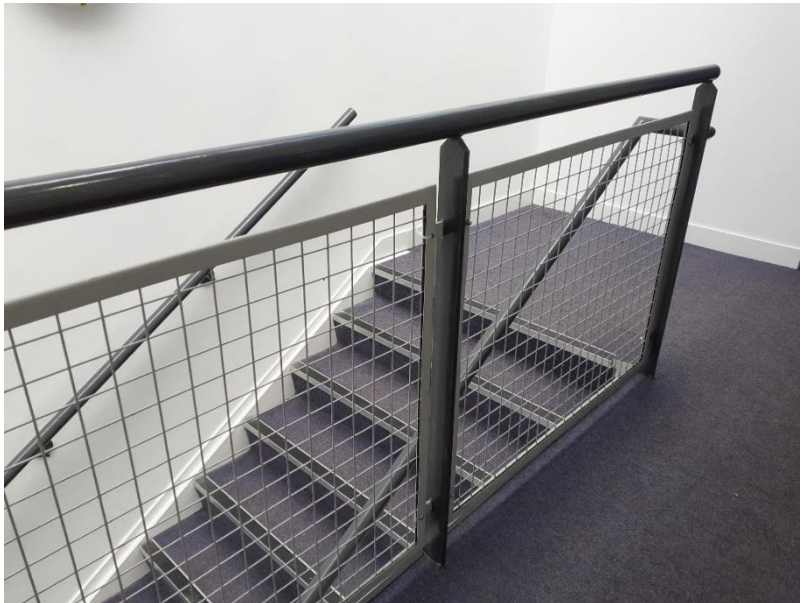
Panel infill fixed with plastic cable tie.

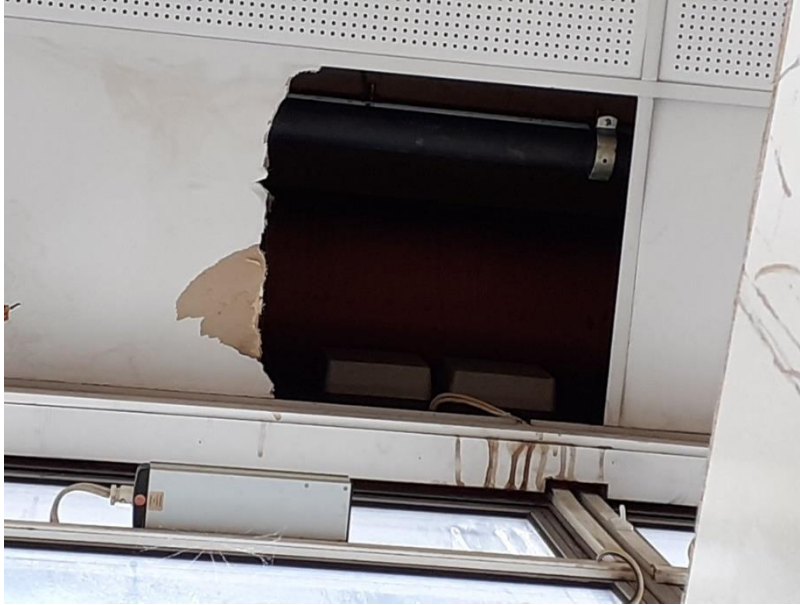
Water damage at high level.

The internal rainwater goods should be checked on a regular basis and repairs effected immediately as observed. Damage to internal finishes should be repaired.

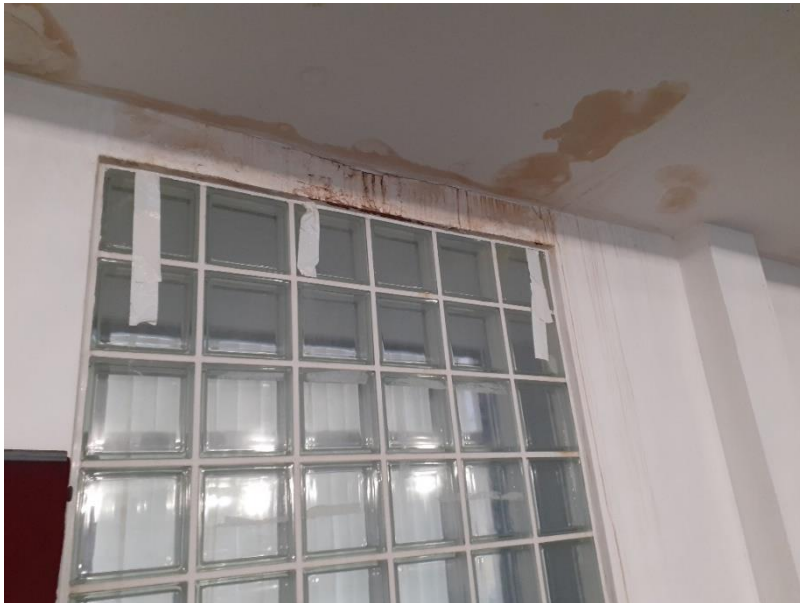
Rusting of lintel over opening.

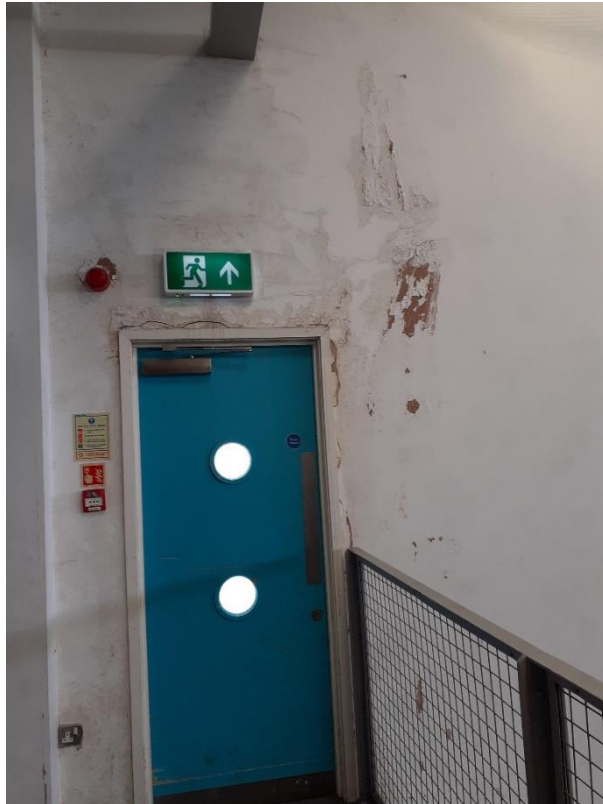
water  
damage to  
wall  
surrounding  
fire exit

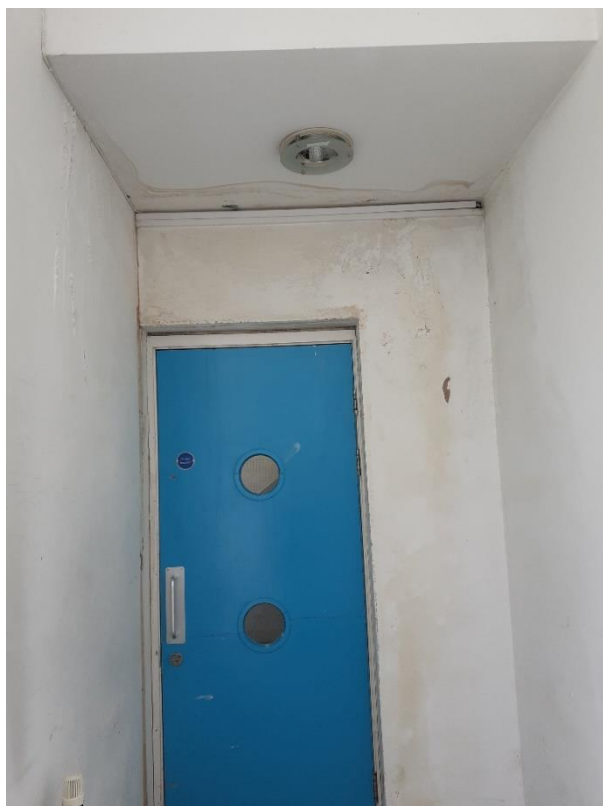
water  
damage to  
wall  
surrounding  
fire exit

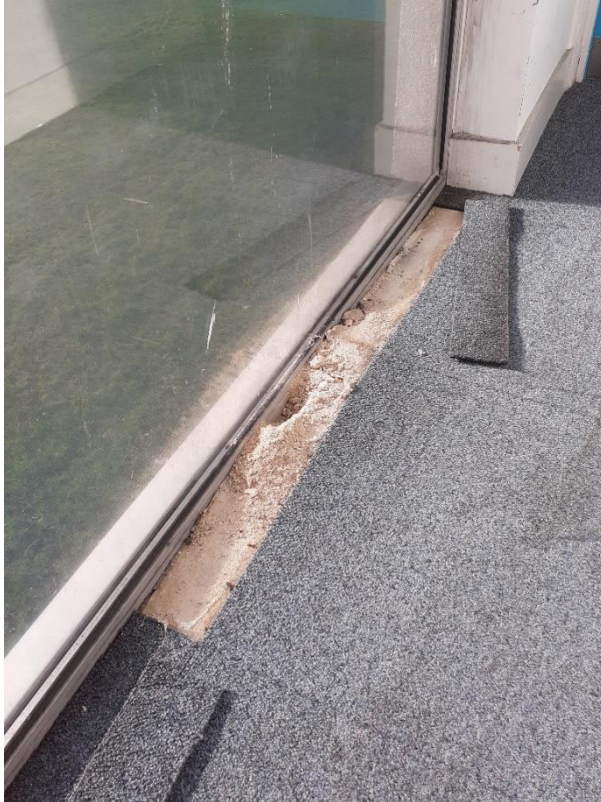
Spalled  
screed to  
floor adjacent  
glazed  
curtain wall

Spalled screed in the south corridor of zone 6 should be cut out and replaced when the curtain walling has been repaired.

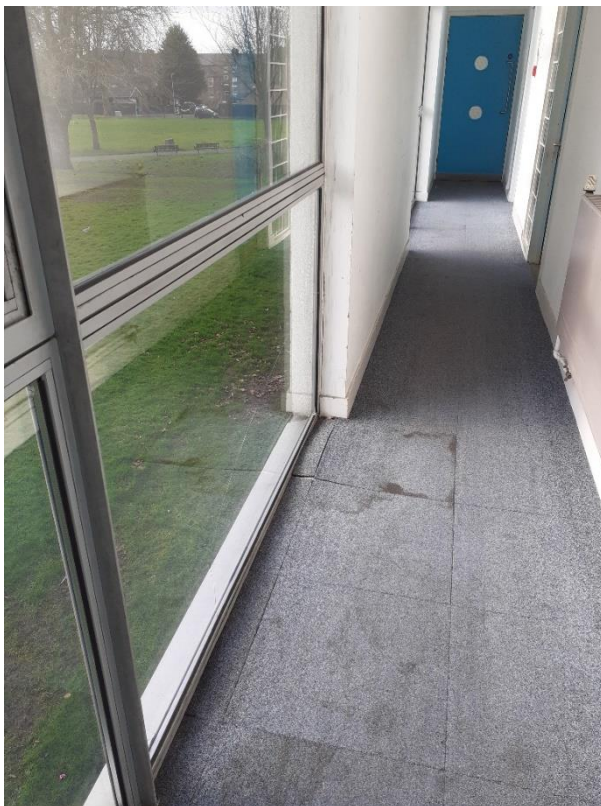
Evidence of  
water ingress  
at base of  
glazed  
curtain wall.

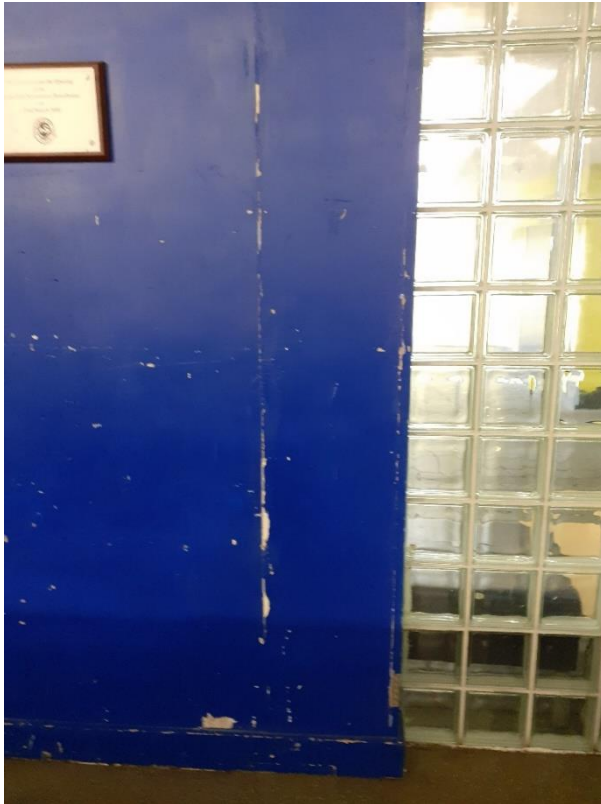
Vertical cracks in plaster column surround

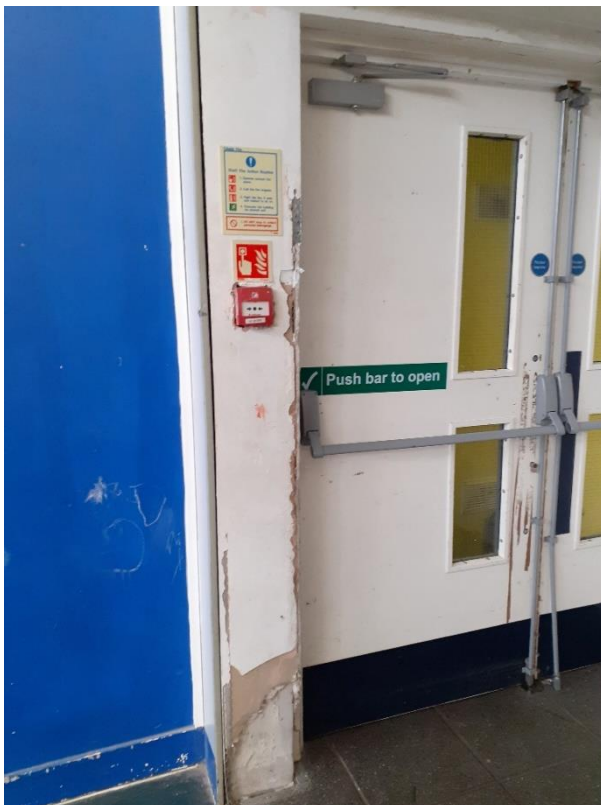
Damaged plaster to corners

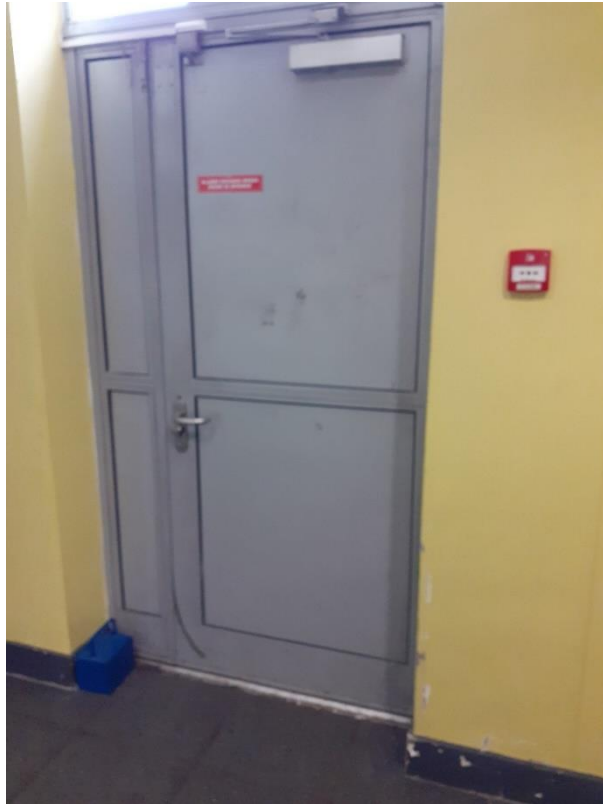
Seal loose on exterior fire exit door.

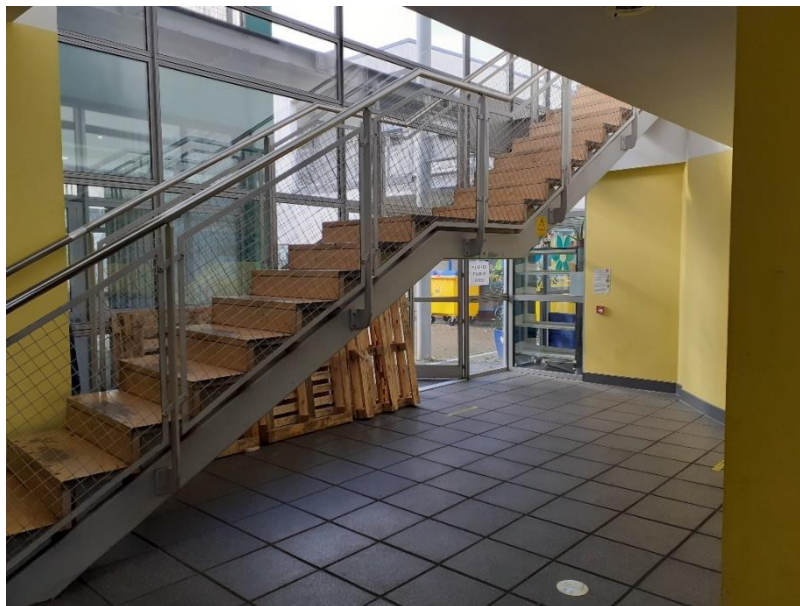
Headroom compromised below stair.

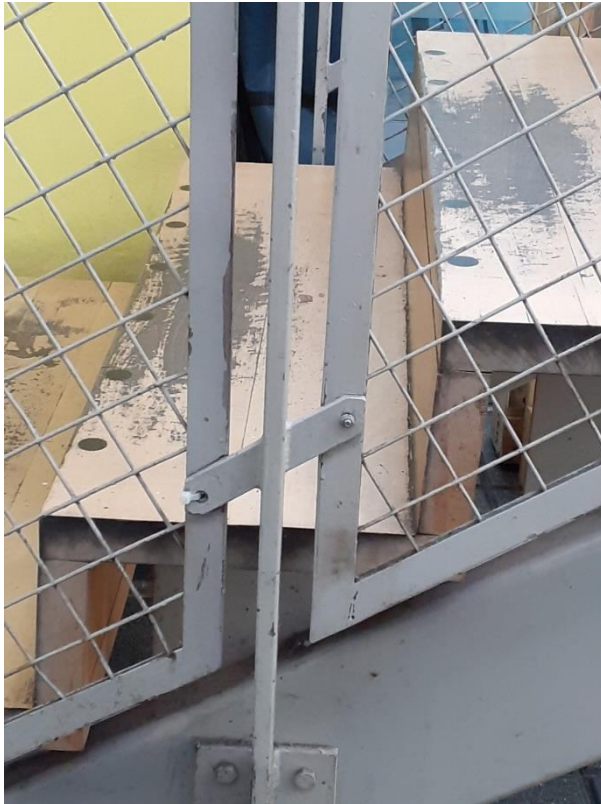
Balustrade  
infill panel  
fixed with  
plastic cable  
ties.

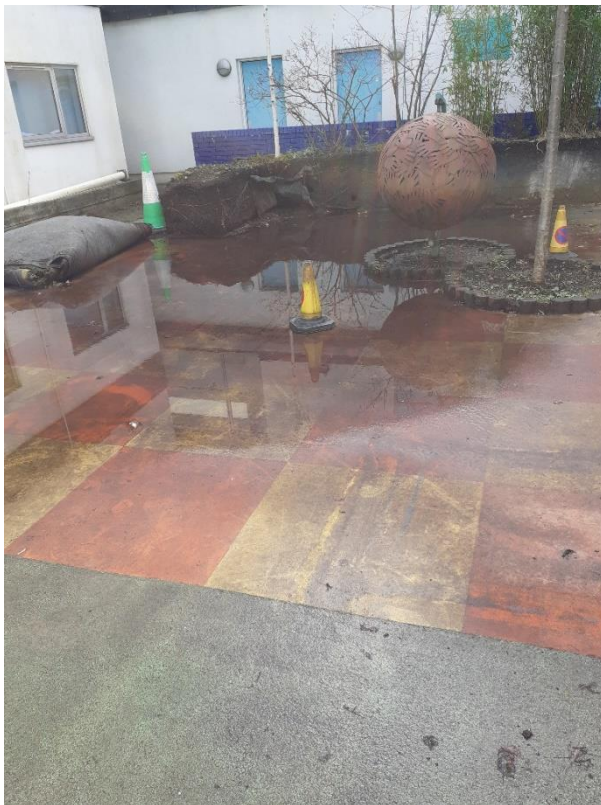
Water  
pooling in  
courtyard

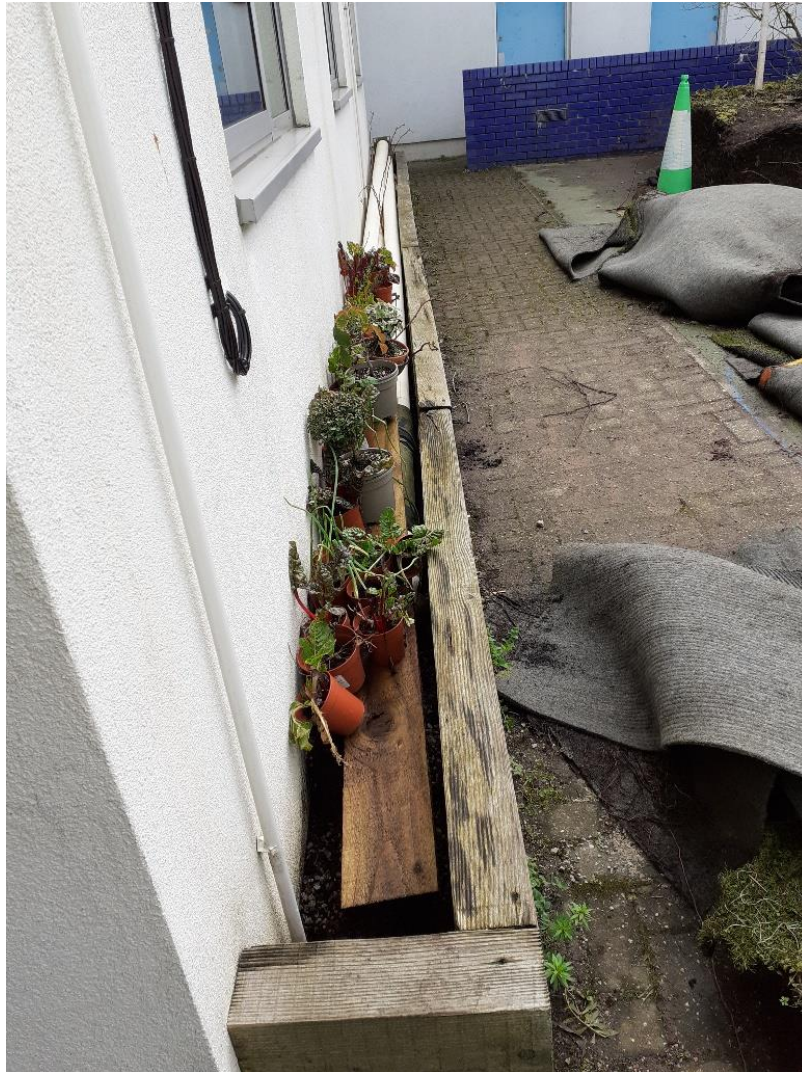
Soil in planter  
above DPC  
level

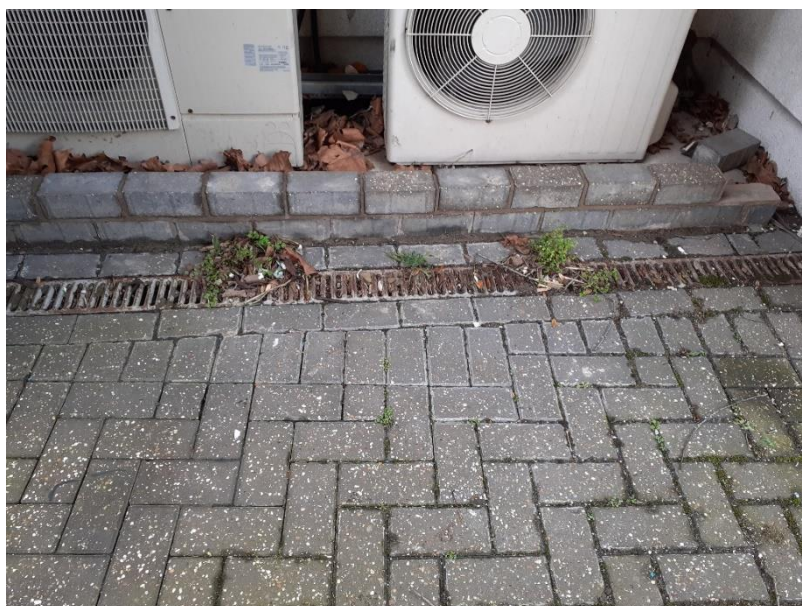
Blocked  
channel drain

The blocked channel drains should be cleared and checked on a regular basis.

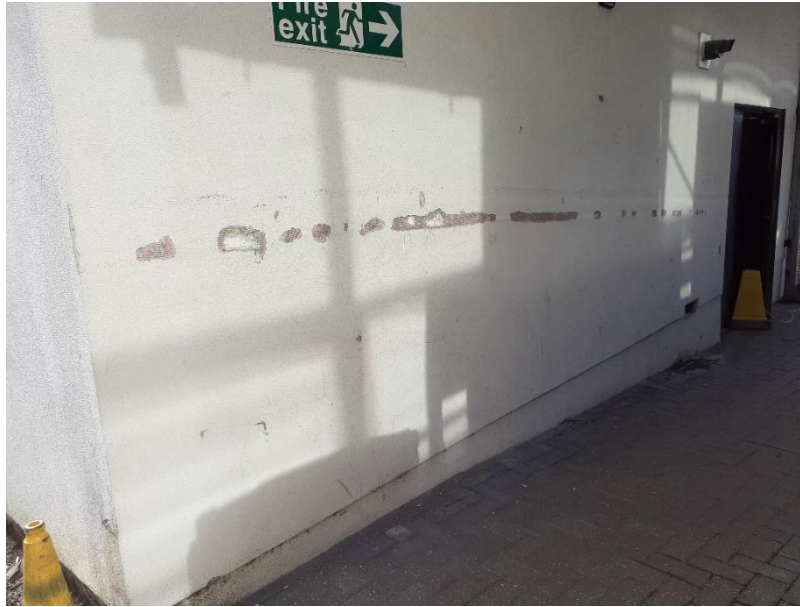
Typical  
damage to  
cladding  
panel

The external cladding panels comprise a thin coat of rough surface render over an expanded polystyrene core and are easily damaged either by accident or through vandalism. Holes in the panels will allow ingress of rainwater and patch repairs should be carried out.

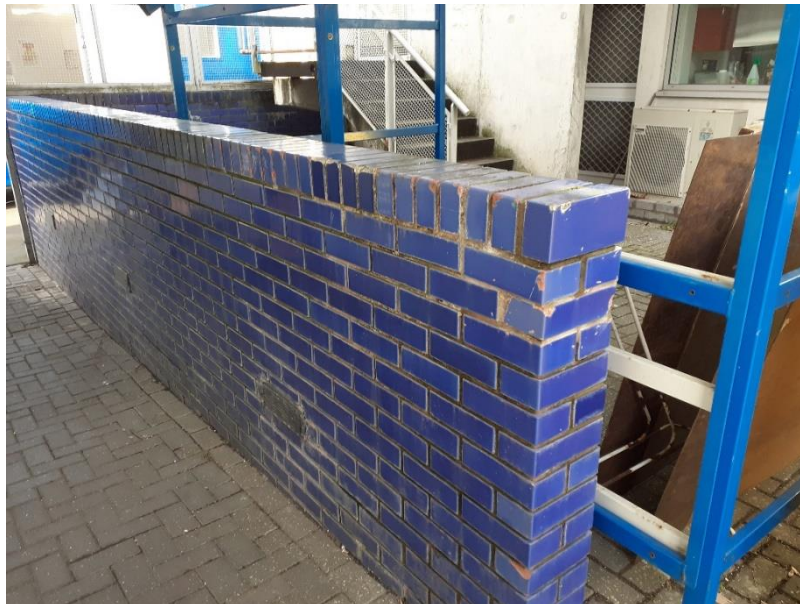
Damaged  
glazed bricks

The face of the glazed bricks are easily chipped and the edges become sharp which could pose a potential hazard to staff and visitors to the site. Damaged brick units should be replaced.

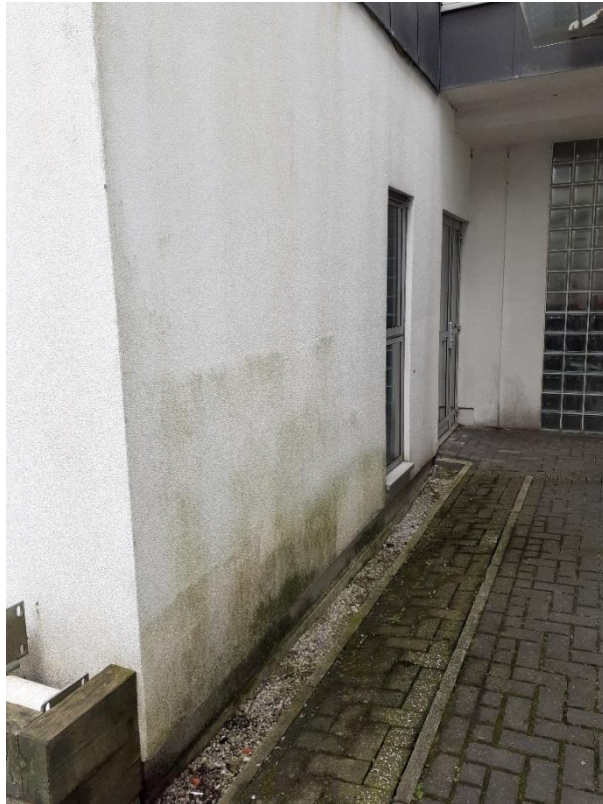
Stained  
cladding

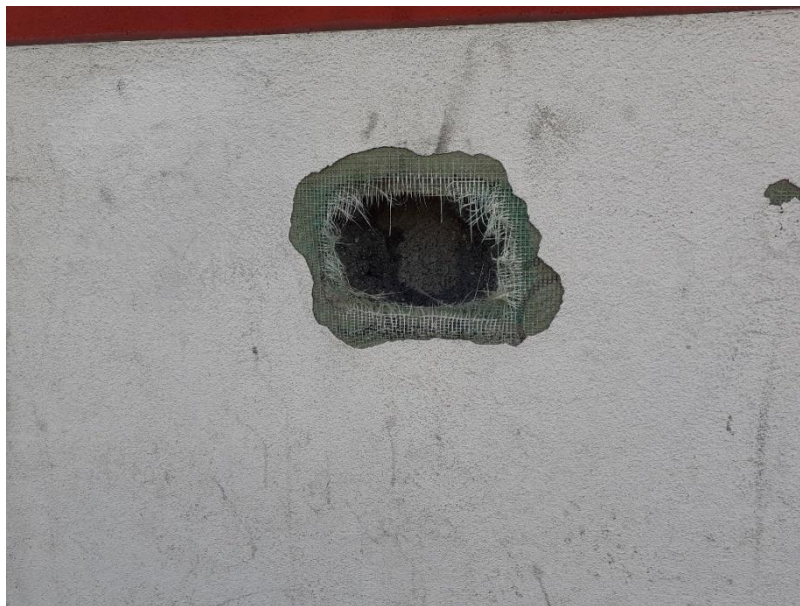
Typical hole  
in cladding

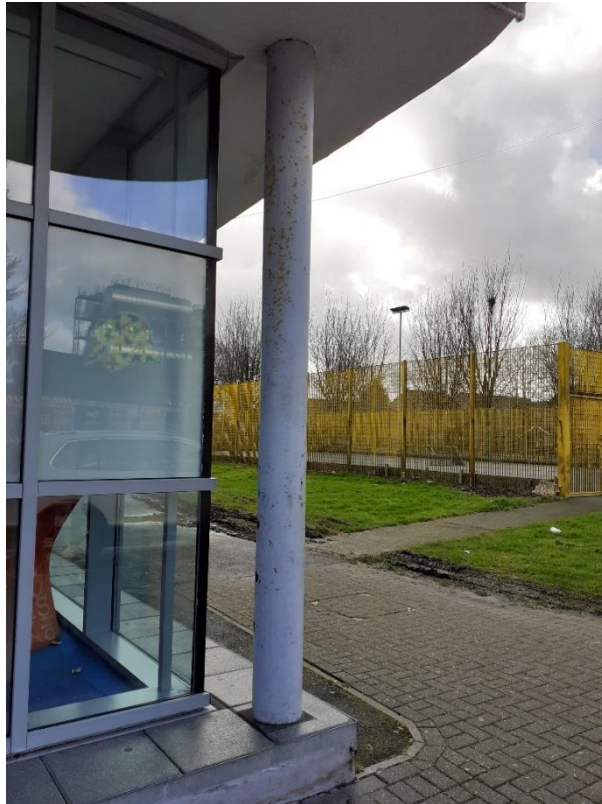
Steel  
columns  
have chipped  
paint and  
corrosion.

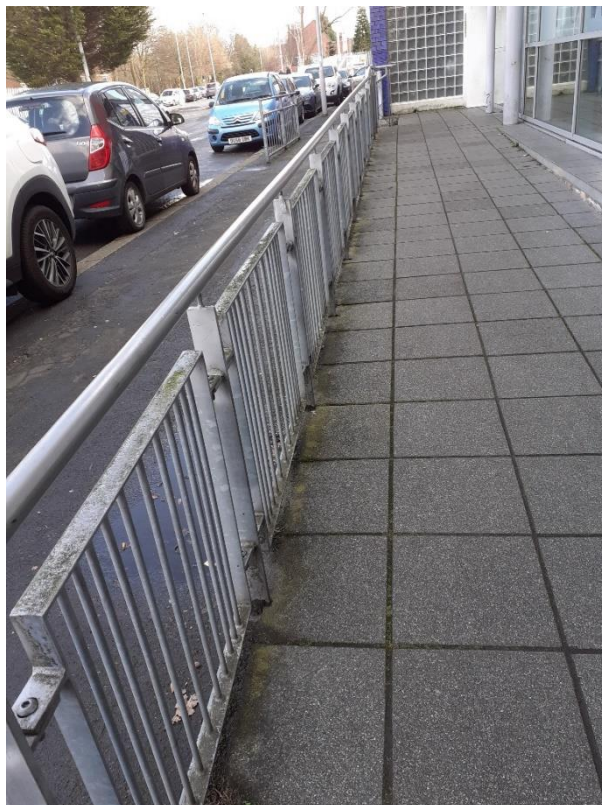
Ramp edge  
protection  
railing is  
loose and  
wobbly.

The loose ramp edge protection should be replaced or repaired.

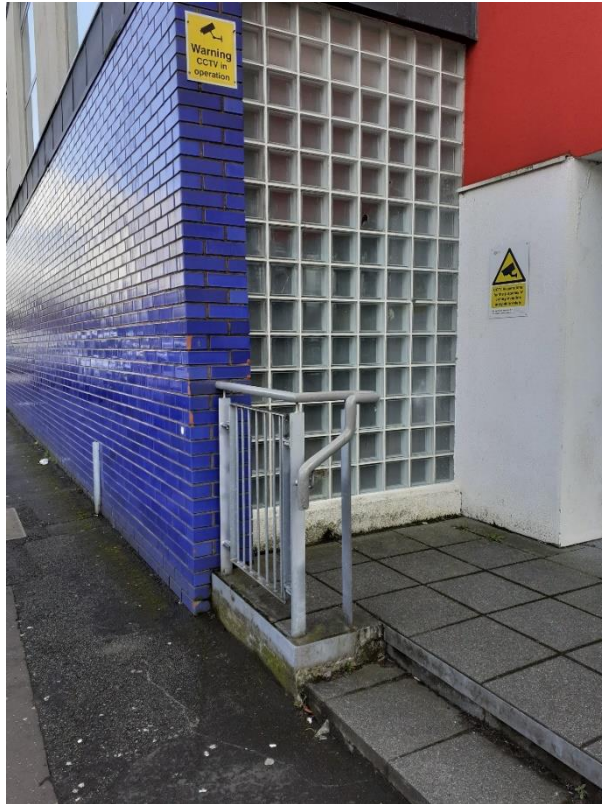
Chipped  
glass blocks  
and glazed  
bricks  
adjacent  
main  
entrance

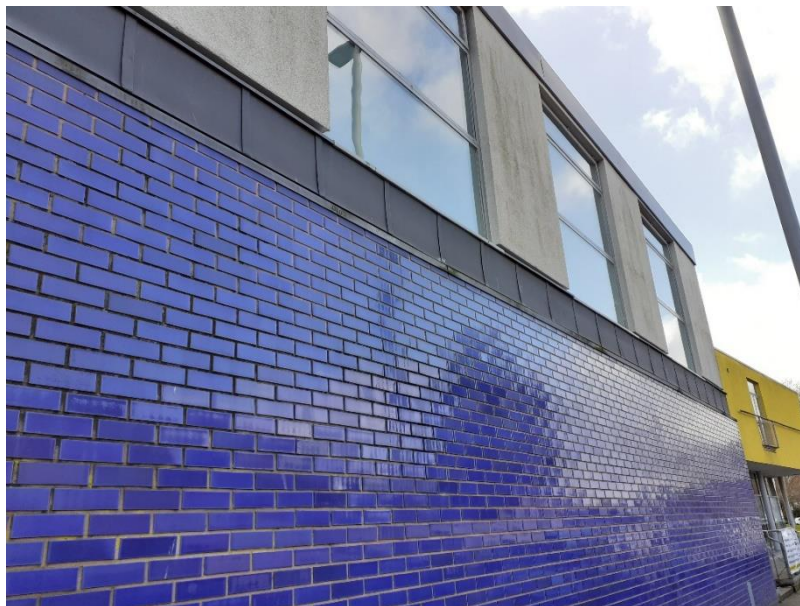
Stained  
cladding and  
algae growth  
on sill.

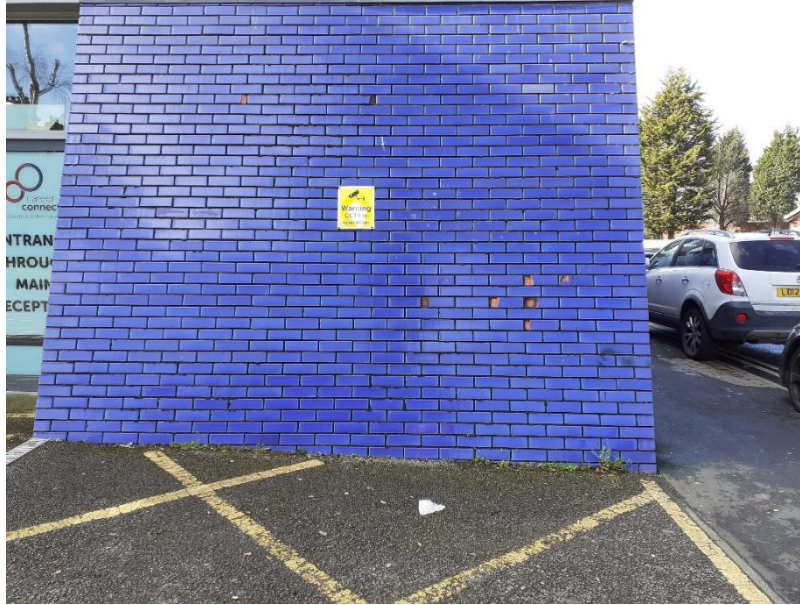
Chipped  
glazed bricks  
and mossy  
growth

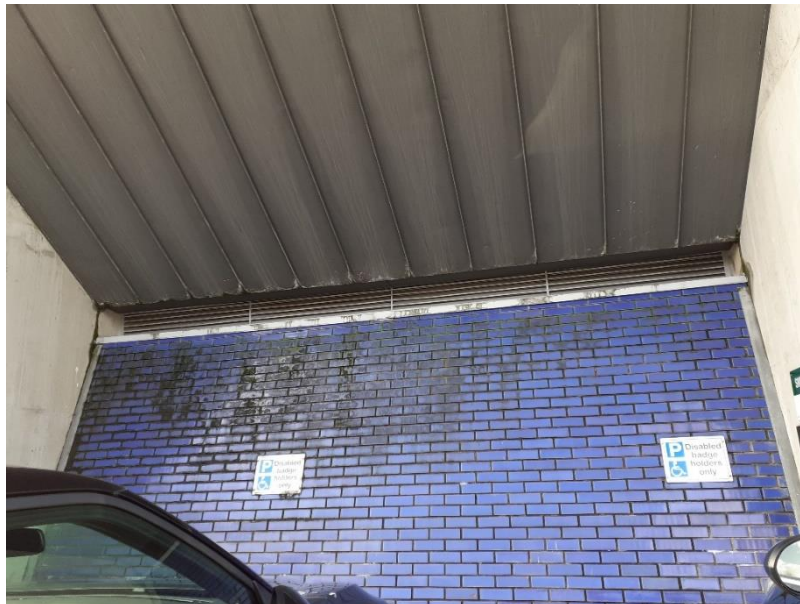
Algae on  
glazed  
bricks, water  
tracks on  
underside of  
curved roof,  
corrosion on  
ends of roof  
panels.

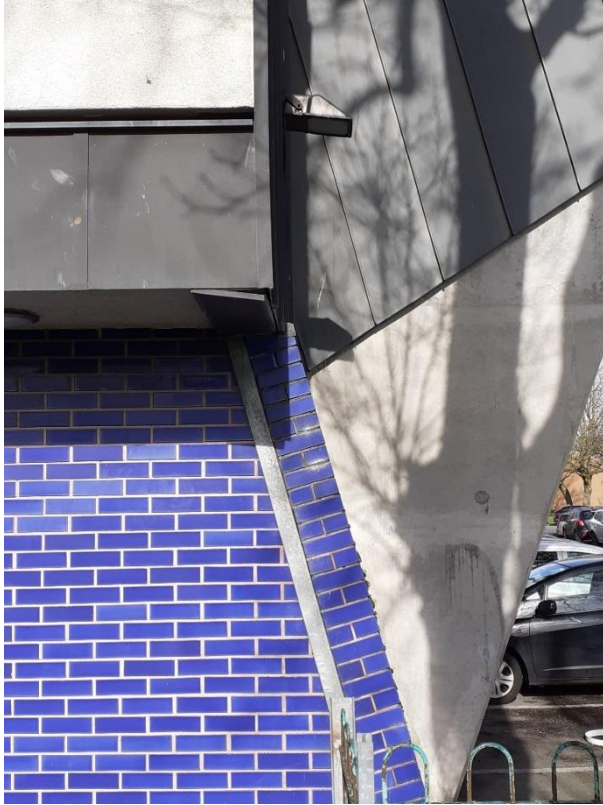
Loose soffit  
panel

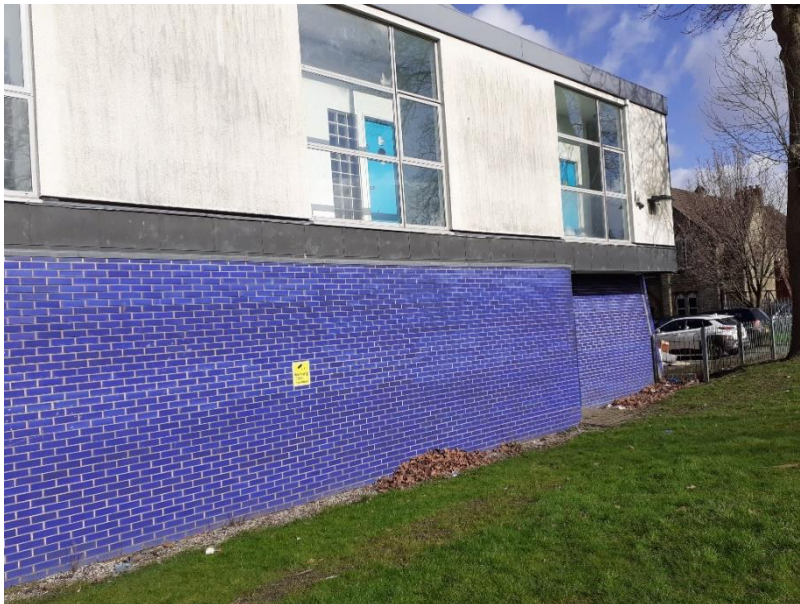
Stained  
cladding  
panels

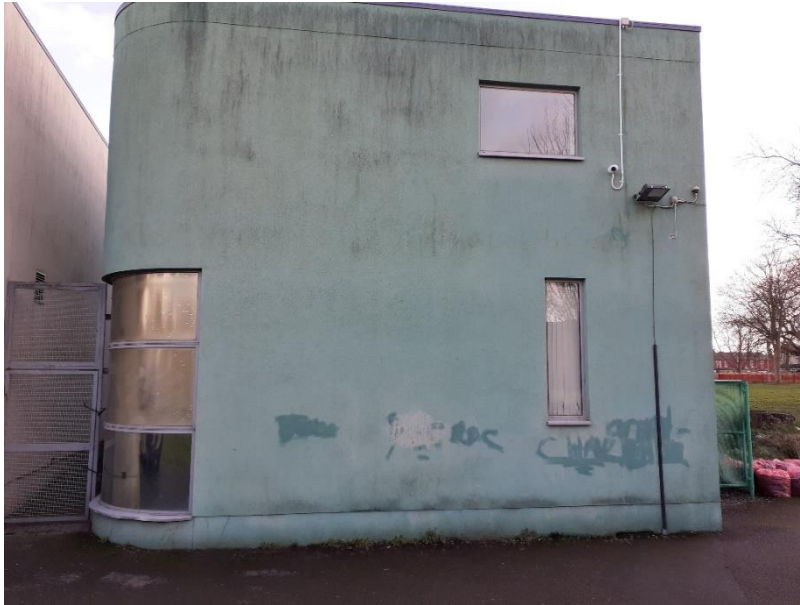
Stained  
cladding,  
vandal  
damage at  
low level

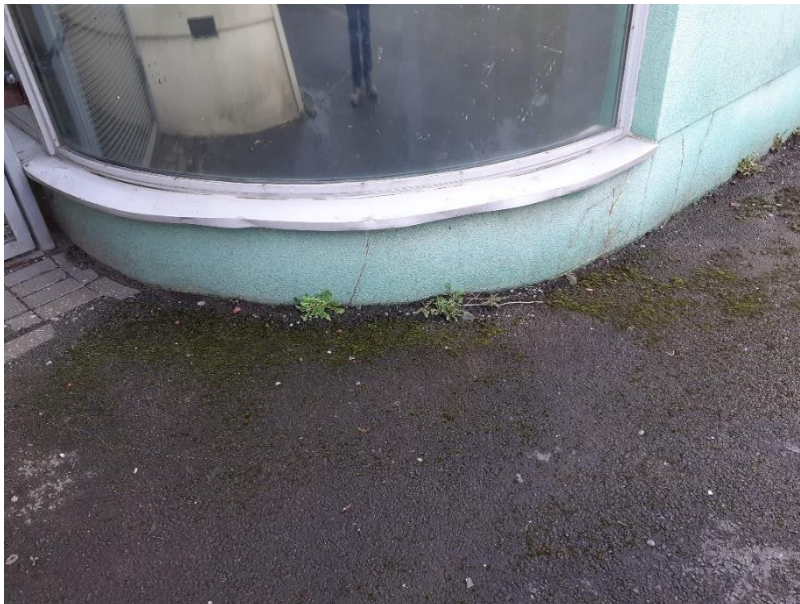
Vandal  
damage to  
sill

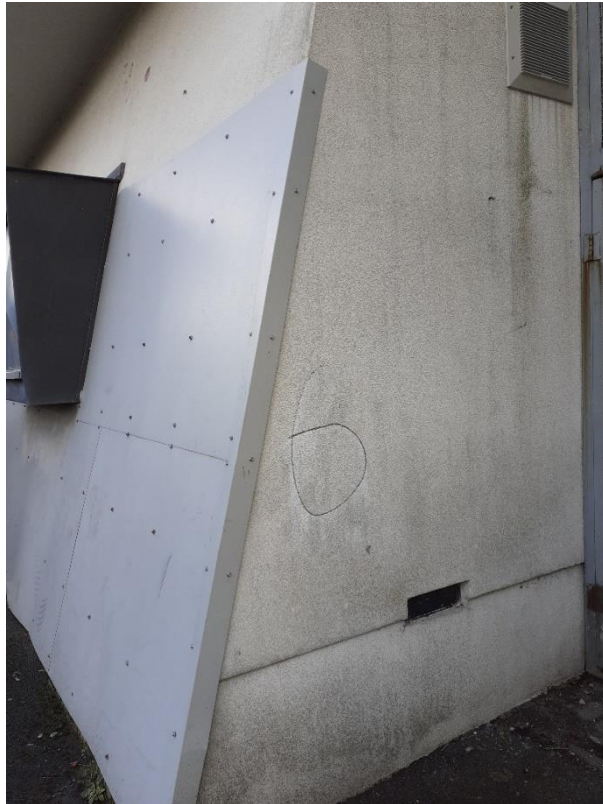
Steel sheet over cladding is loose at the corner and buckled at the bottom.
