# ARBORICULTURAL REPORT (BS 5837:2012)

13 PARKFILED ROAD SOUTH  
DIDSBURY  
MANCHESTER  
M20 6DB

December 2019

PM/FULL/20/12/19

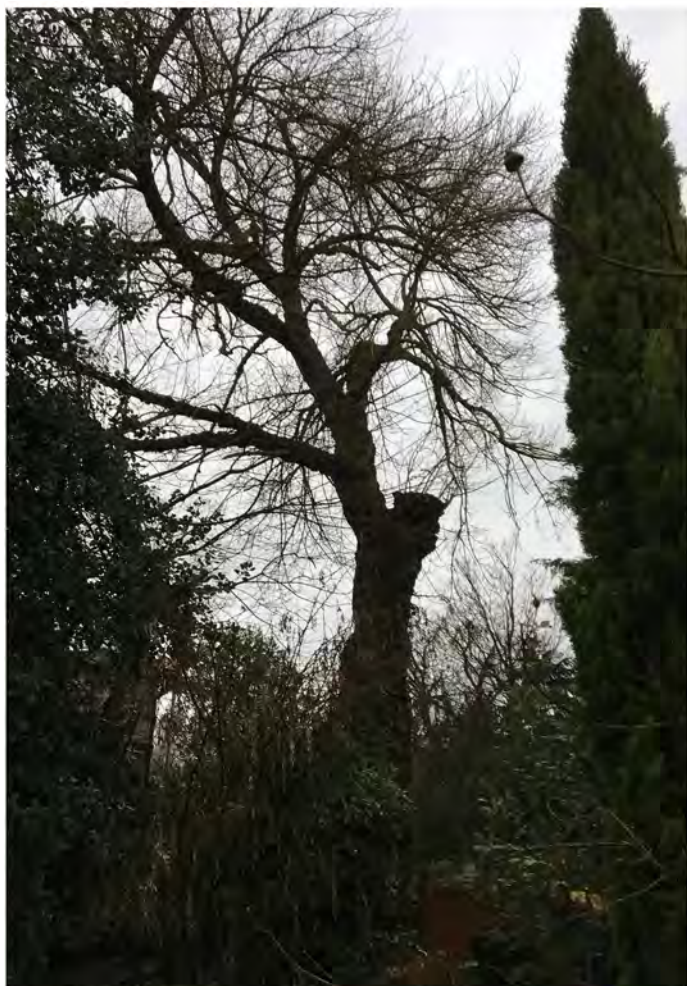
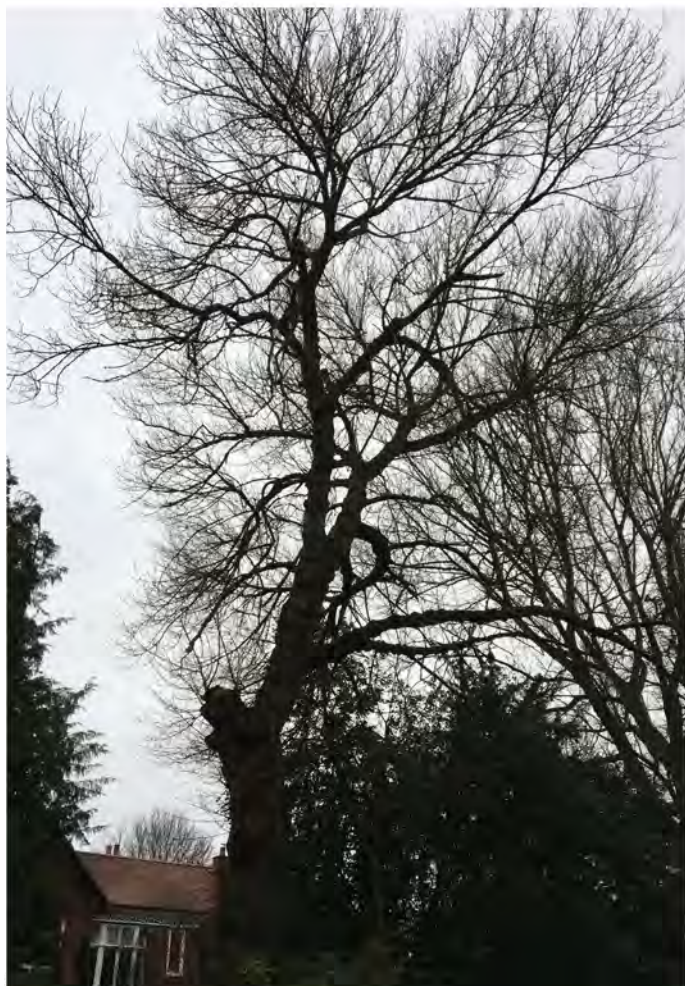
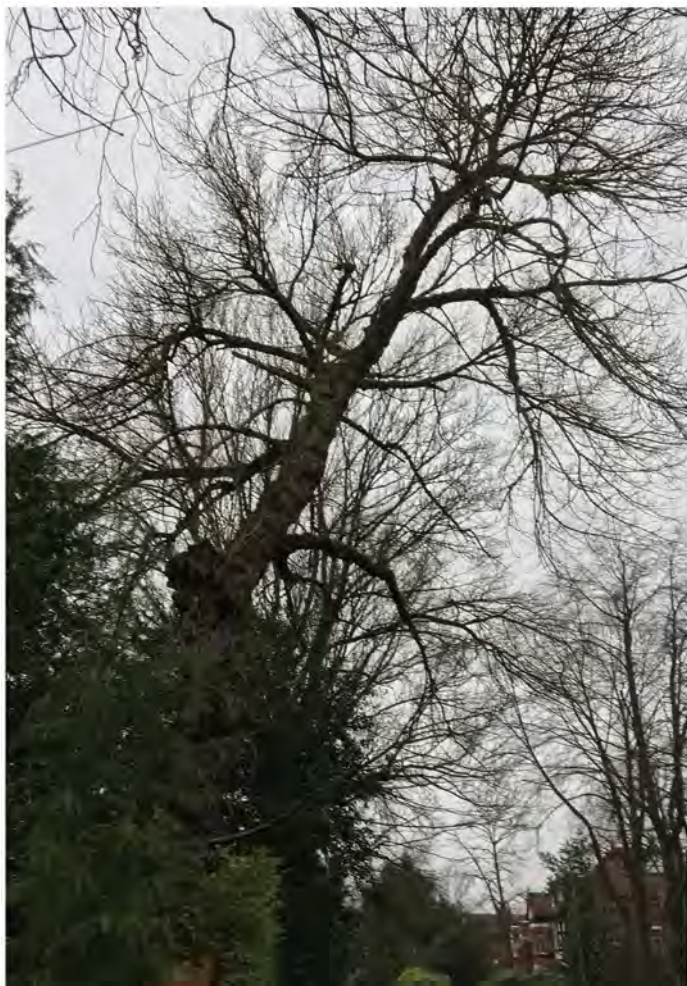
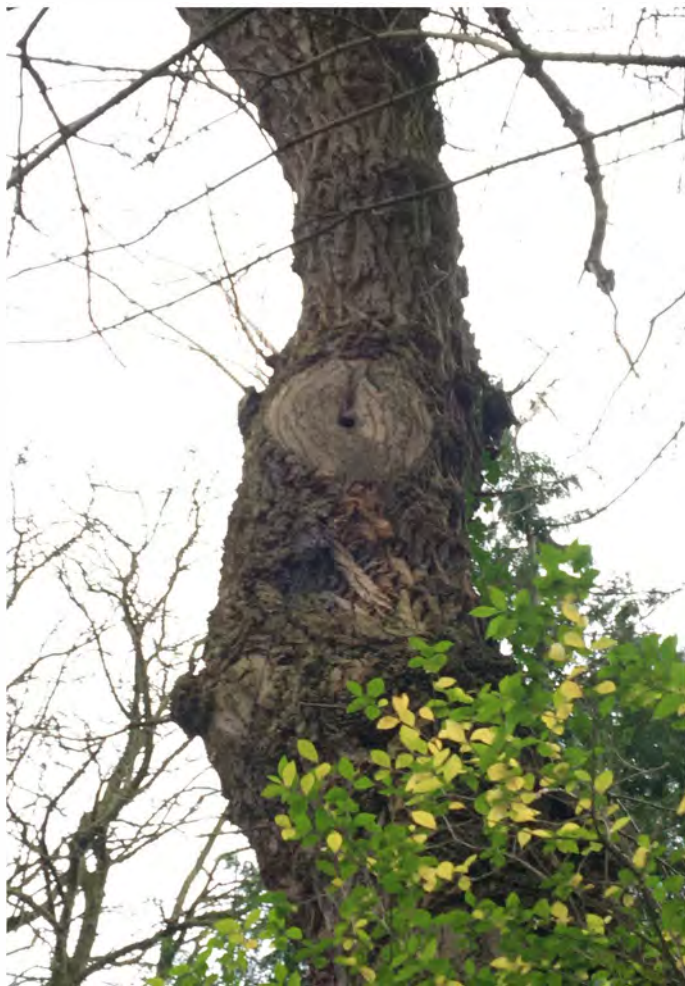
T1 Poplar

5.1.2 T1 (Poplar) should be considered for removal or drastic reduction regardless of development before it starts to shed large limbs, which is typical of the species anyway despite poor previous management. The tree is severely unbalanced due to previous major limb removal and has a suspected large area of decay at this point. Several minor failures are evident within the crown. The branch structure is such that there is a lot of end weight on the limbs with some stress marks evident.

| Arboricultural Data Sheet: 13 Parkfield Road South, Didsbury, Manchester, M20 6DB | | | | | | | | | | | Date of Survey: 10/12/19 | | Surveyor: PM | | | |
|---|---|---|---|---|---|---|---|---|---|---|---|---|---|---|---|---|
| T1 | Hybrid Poplar (Manchester Poplar) | 1190 | 19 | FM | 9 | 5 | 10 | 10 | 6 | B/C | A very large specimen located within raised planting area adjacent o retaining wall. The wall is buckled and cracked in a number of places presumably due to the expansion of the boottrees area and roots. The tree is very unbalanced mainly due to the historic removal of limbs on the eastern side. There will be more than likely significant decay within this pruning area. There is major deadwood in the crown and previous minor rip outs. There are several other large wounds form previous pruning present. Ivy on lower stem. | Remove crown to form pollard or fell and replace. | 10+ | C1 | 640.63 | 14.28 |

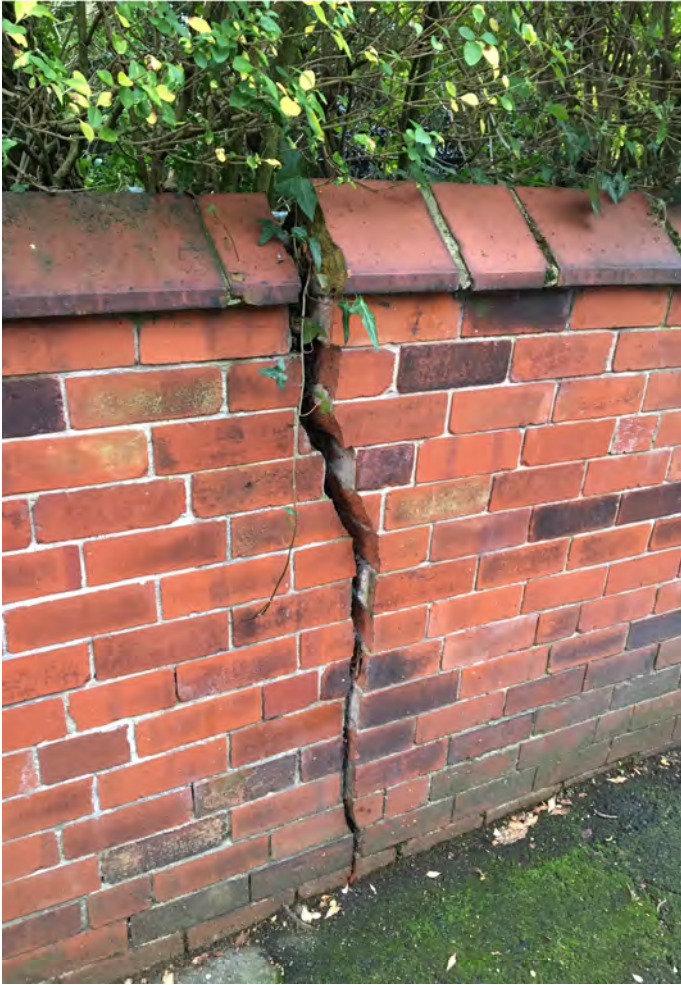
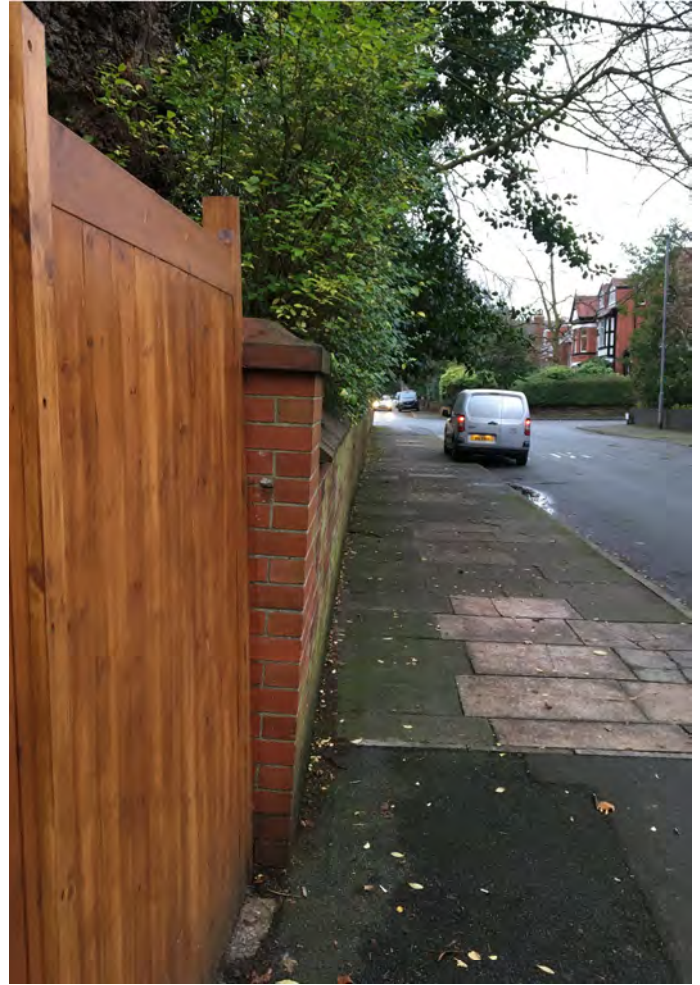
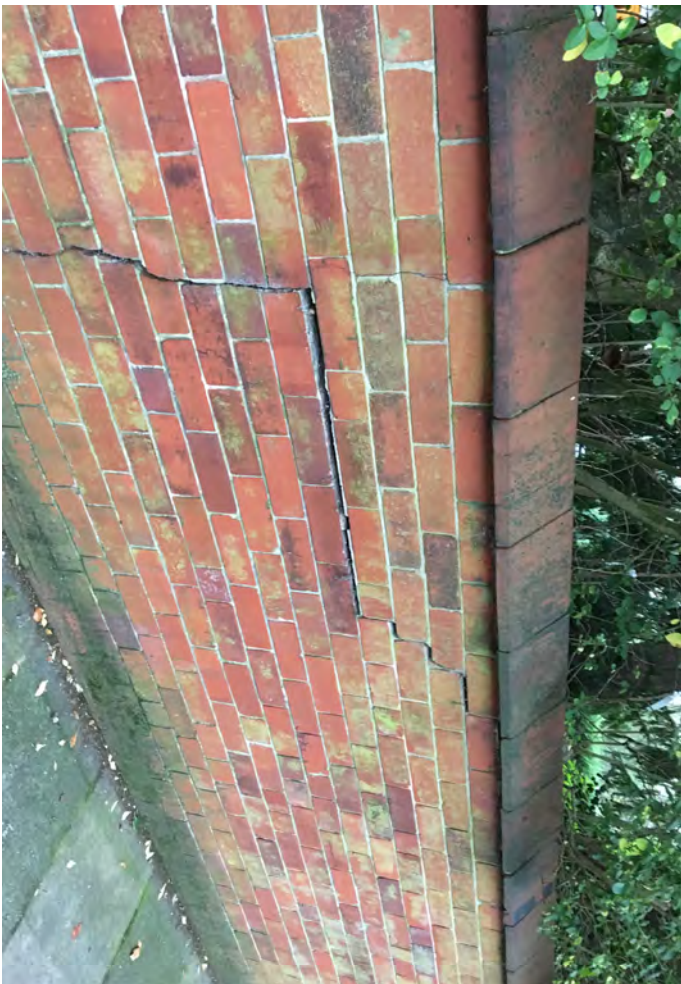
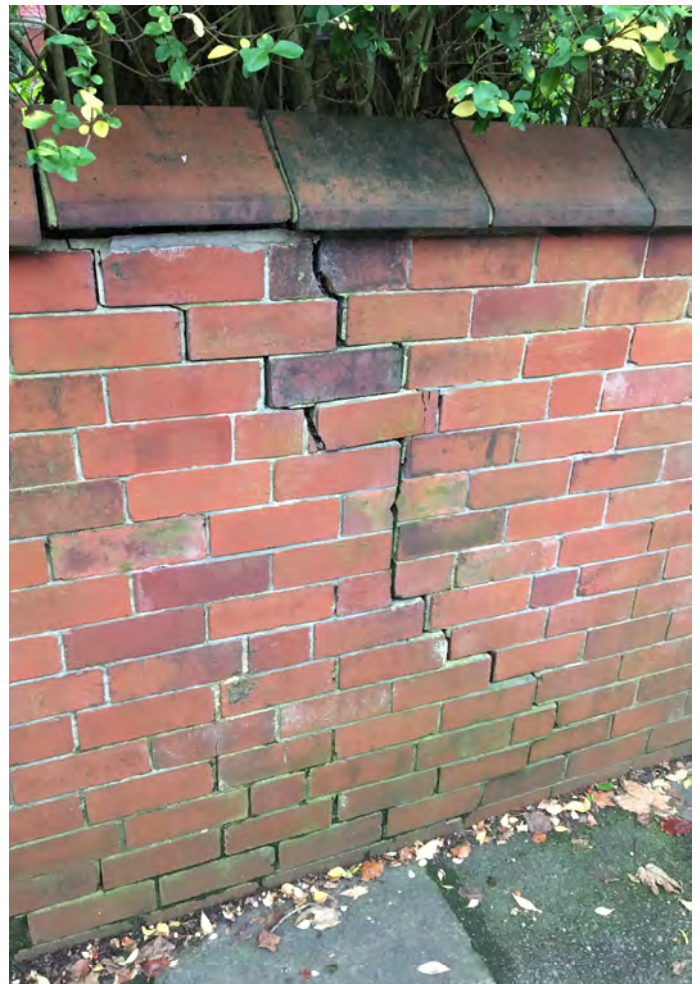
- 5.1.3 All these Poplars are causing major issues with the boundary wall, which may not be repairable with the trees in place. Further investigation on this will be required if it becomes an issue.
- 5.1.4 It is considered that these losses can be replaced along the same boundary post development with a large species tree such as Lime, Oak or Hornbeam to replace T1 and several more understory trees to replace the other dotted along the shrub area. The shrub area will also require some re-stocking to maintain the screen and border.

Damage to wall due to T1, T5 & T7

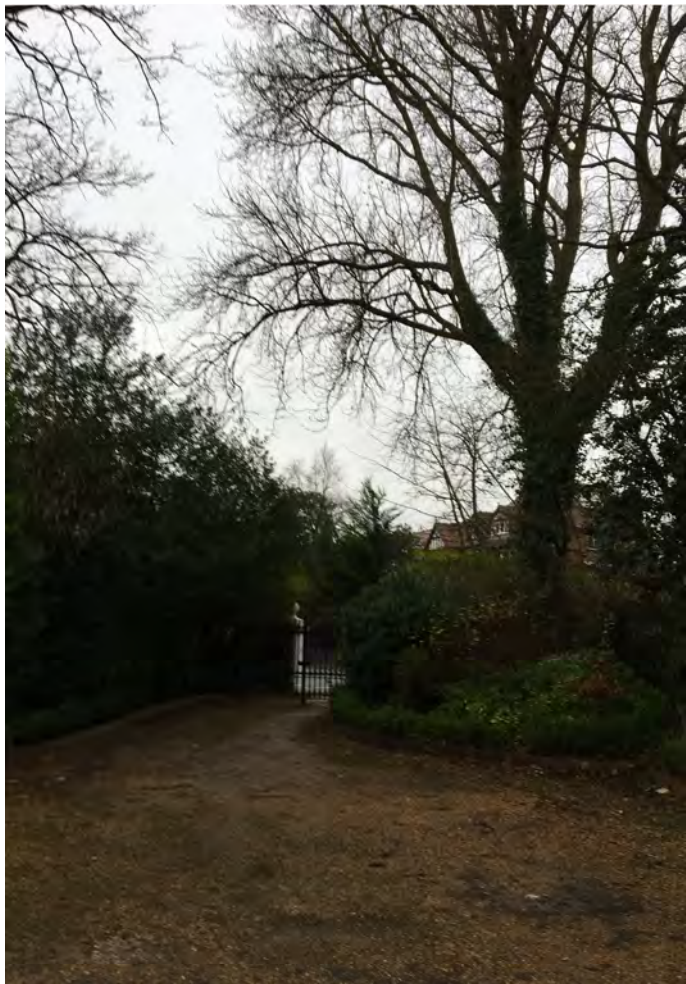
| Tree No. | Species | Dbh (mm) | Height (m) | Age | Crown Spread | | | | Crown C | Cond R | Observations and Comments | Preliminary Recommendations | ERC (Yrs) | TQC R | RPA (m <sup>2</sup> ) | RPA Circle Radius (m) |
|---|---|---|---|---|---|---|---|---|---|---|---|---|---|---|---|---|
| T7 | Hybrid Poplar | 1050 | 19 | FM | 10 | 10 | 12 | 10 | 5 | B | A very large well-formed tree within raised planting area. The adjacent retaining wall is damaged in several places presumably due to the expansion of the buttress area and roots. Major deadwood and broken branches present. Several branch stubs present. Previous minor branch removal. Stem shoots present. Ivy on lower stem. | <b>Remove significant deadwood and broken branches. Remove stem shoots.</b> | 20+ | B1 | 498.76 | 12.60 |

| Tree No. | Proposed Works |
|---|---|
| T5 & T7 | Remove significant deadwood and broken branches. Remove stem shoots. |

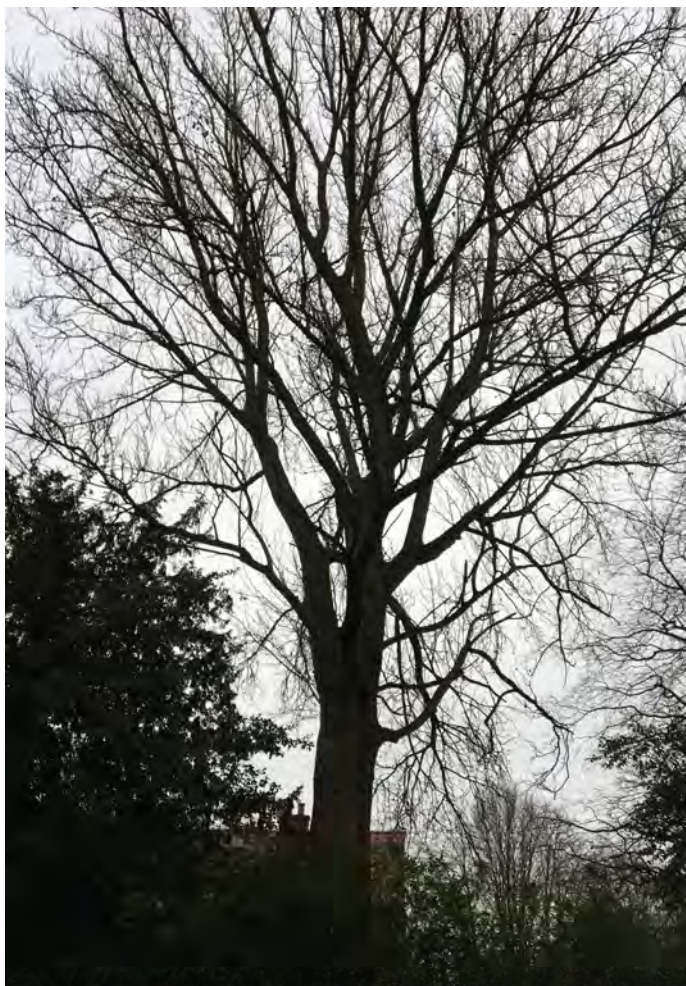
| Tree No. | Species | Dbh (mm) | Height (m) | Age | Crown Spread | | | | Crown C | Cond R | Observations and Comments | Preliminary Recommendations | ERC (Yrs) | TQC R | RPA (m <sup>2</sup> ) | RPA Circle Radius (m) |
|---|---|---|---|---|---|---|---|---|---|---|---|---|---|---|---|---|
| T5 | Hybrid Poplar | 960 | 19 | FM | 10 | 10 | 12 | 10 | 5 | B | A very large well-formed tree within raised planting area. The adjacent retaining wall is damaged in several places presumably due to the expansion of the buttress area and roots. Major deadwood and broken branches present. Several branch stubs present. Previous minor branch removal. Stem shoots present. | <b>Remove significant deadwood and broken branches. Remove stem shoots.</b> | 20+ | B1 | 416.92 | 11.52 |

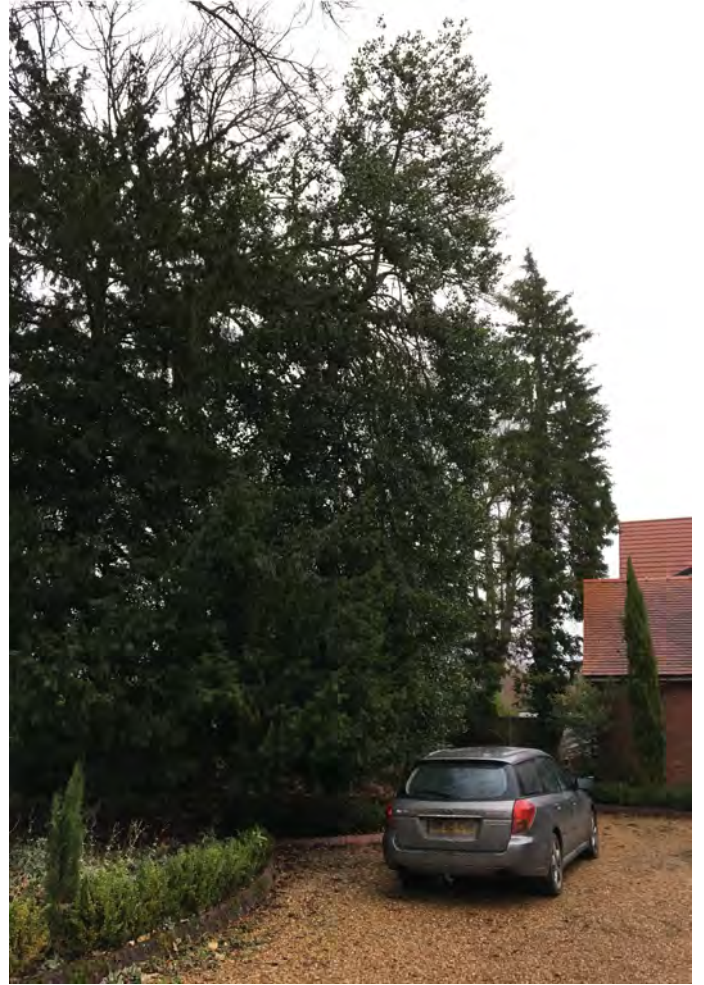
- 5.2.3 The extension is within 2m of T4 (Yew), which is approximately halfway into its RPA radius on one side. The crown of this tree will also require pruning back to accommodate the building. This is quite an impact on the tree but again the tree is considered young and hardy enough to cope with it or at least it is definitely worth trying to retain it in order maintain the screen. The area to be excavated for the foundations will need to be carried by hand under supervision for the top 600mm in order to avoid root wrenching by machine and to prune any roots encountered cleanly. The same will apply for the area adjacent to T2.
