| snookarchitects | project: | bridgewater house |
| 89 Wood Street | dwg no: | 301 |
| Liverpool | dwg title: | GF ceilings & cornice |

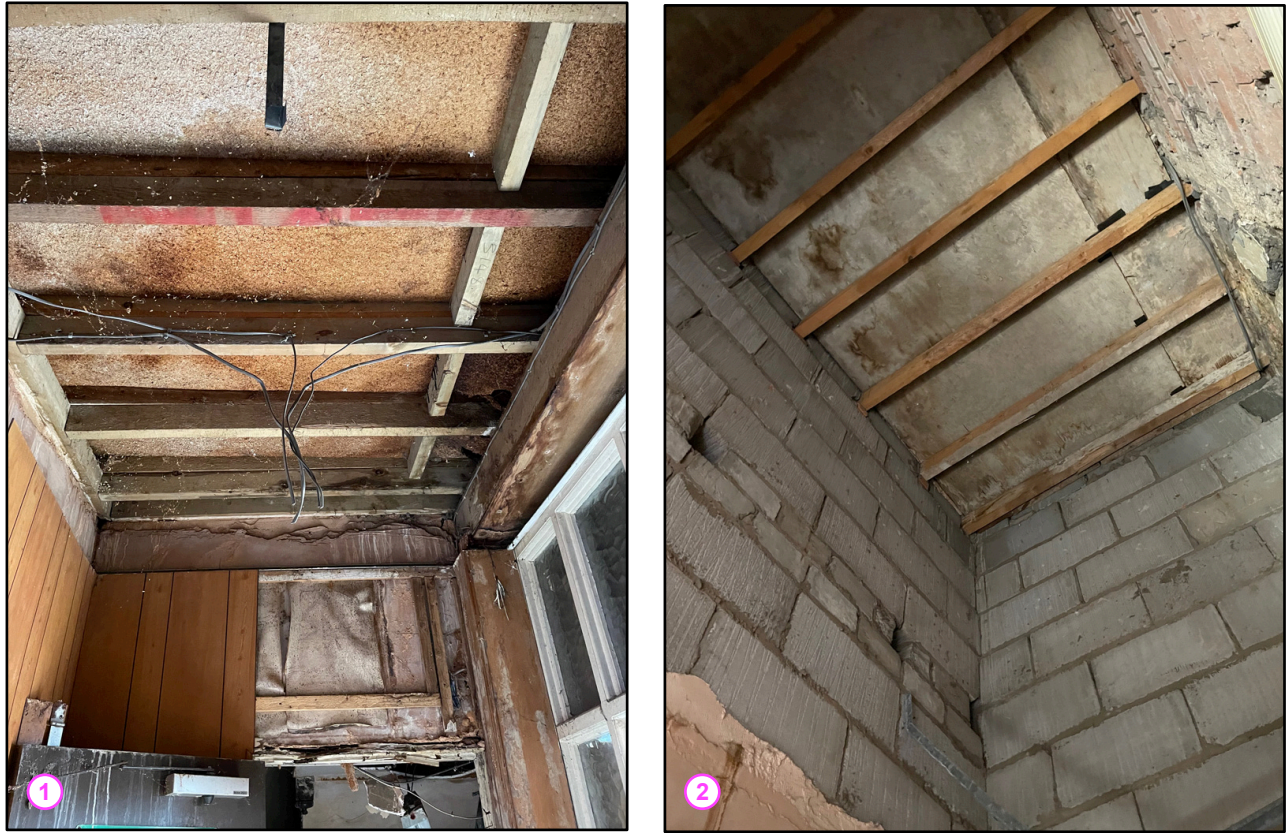
ROOM G.01

- No cornice
- Ceiling is gone completely
- Exposed timber joists

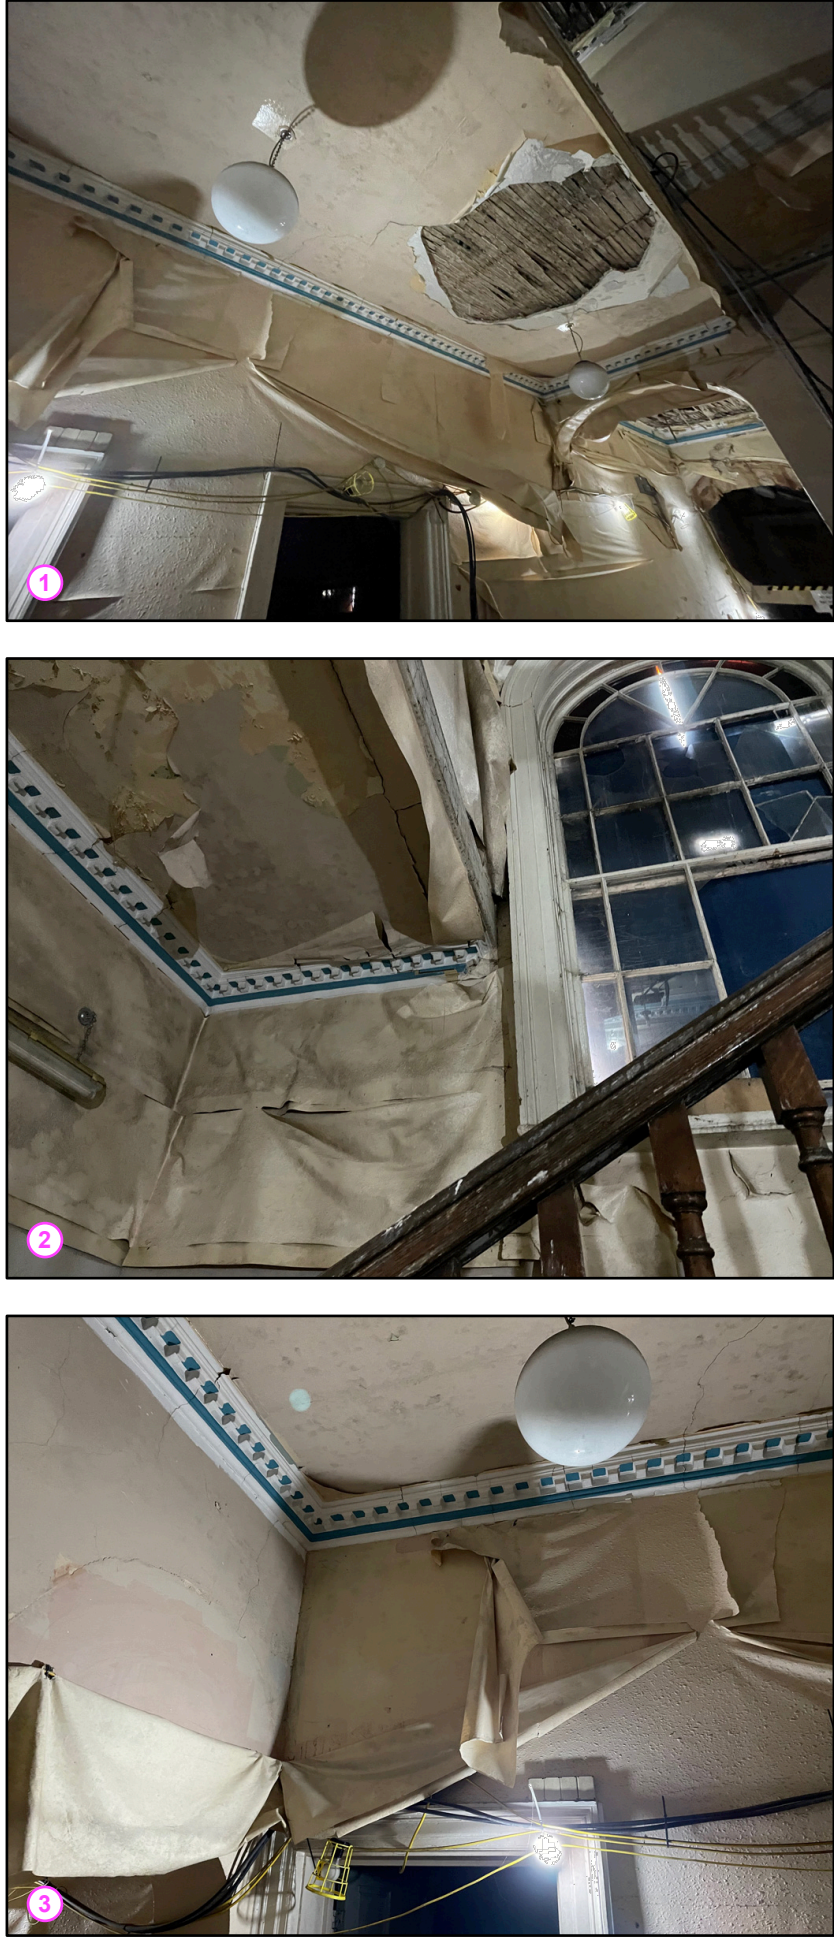
ROOM G.02

- Cornice as noted on the plan
- Plasterboard ceiling
- Partially collapsed ceiling as noted on the plan
- Water damage restricted to plasterboard ceiling

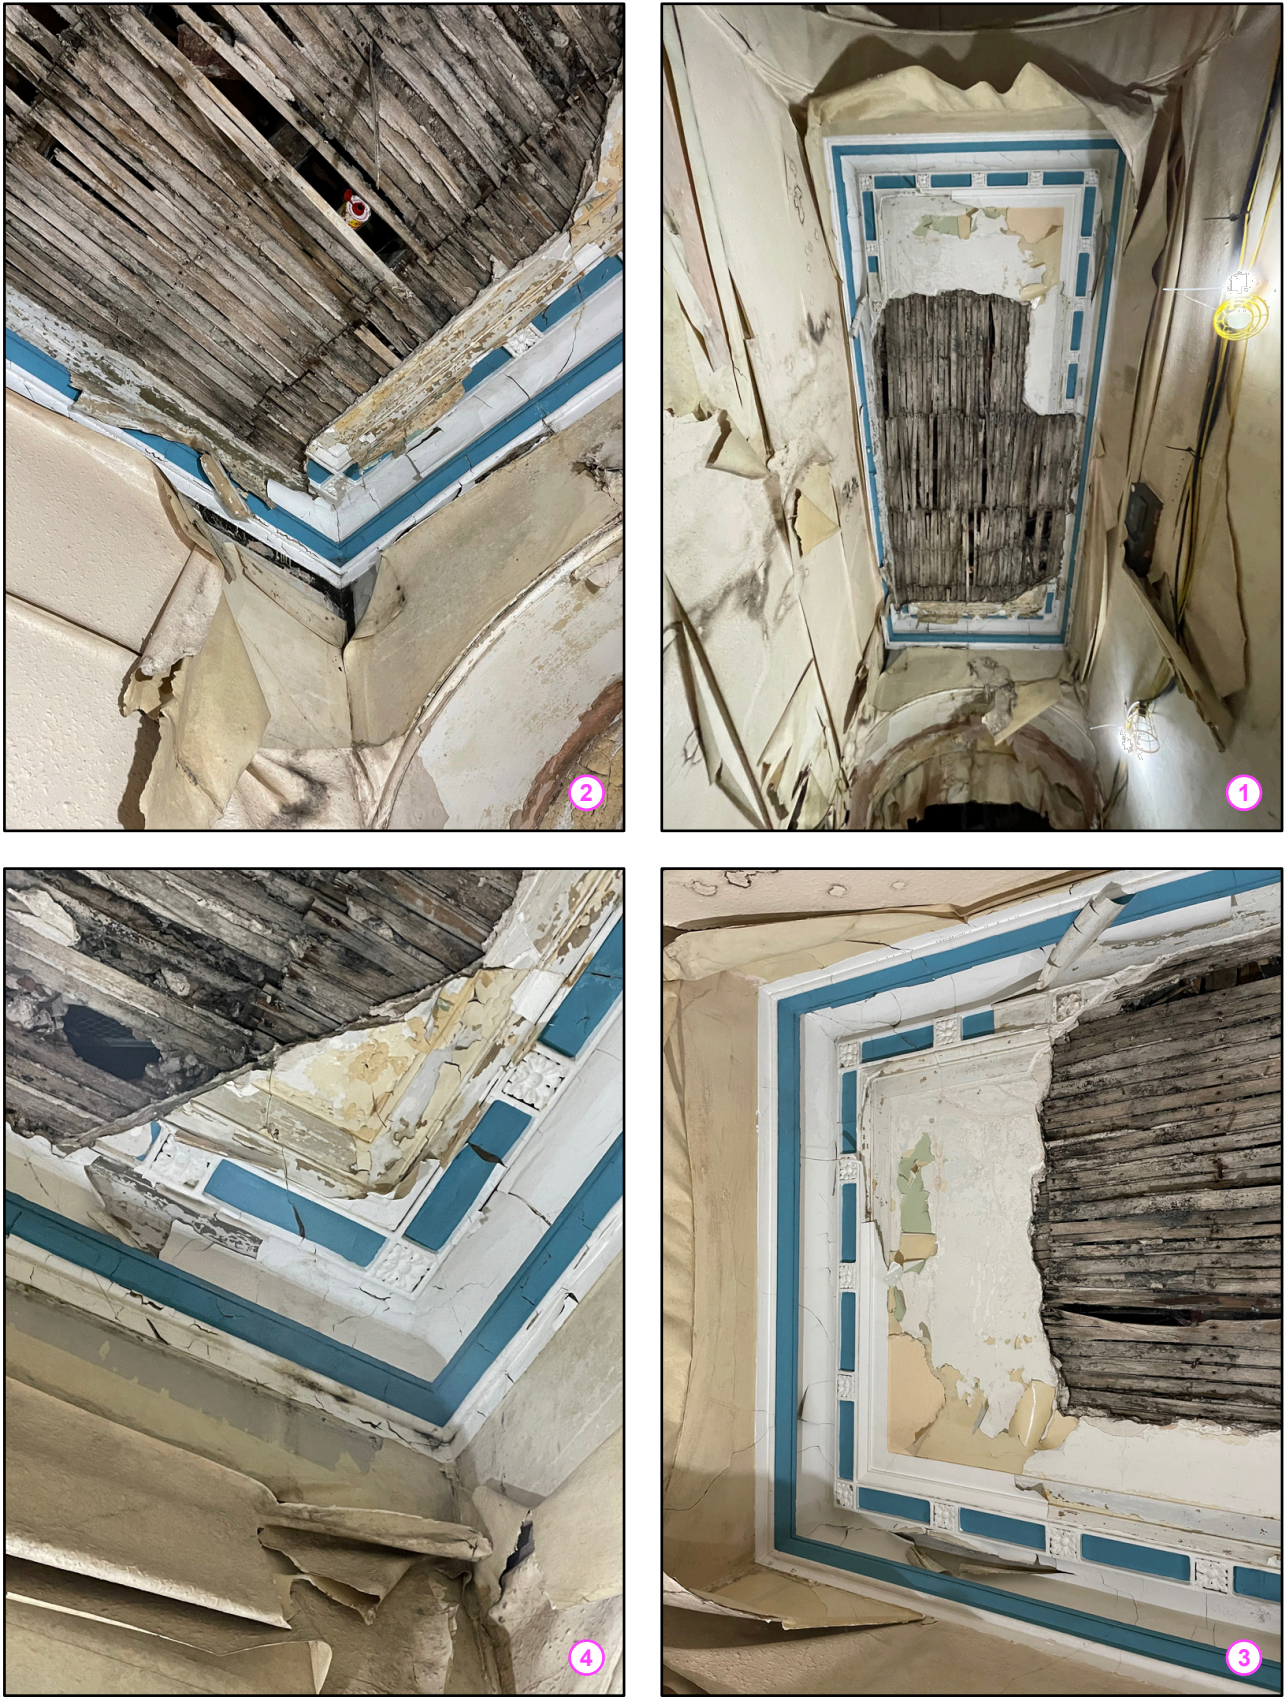
ROOM G.03

- Cornice as noted on the plan
- Most of the cornice is water damaged
- Partially collapsed ceiling as noted on the plan
- Ceiling is damaged

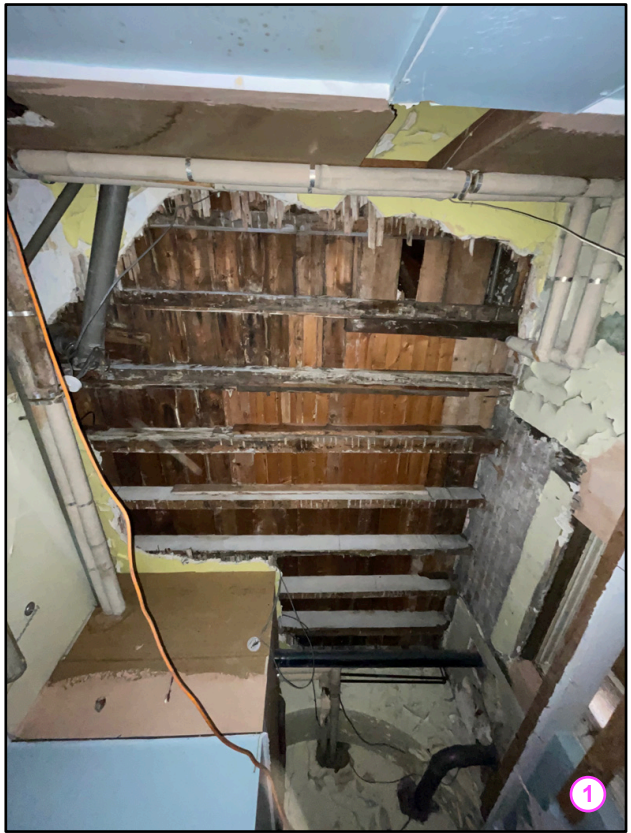
ROOM G.04

- No cornice
- Ceiling is gone completely
- Exposed timber joists
