# Water Safety Risk Assessment

## Public Realm improvements

Site: 70 Great Bridgewater Street  
Address: Manchester, M1 5ES  
Date produced: 14/03/2024

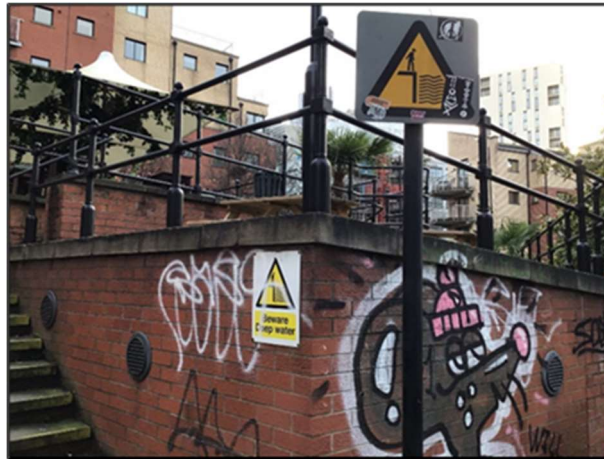
| <b>Observed Condition</b> | There was considerable graffiti on the hoarding around the site, and some graffiti on water safety signs on the adjoining site. |
| <b>Risk Rating</b> | Severity 4 x Likelihood 1 = Risk Rating 4 <b>Priority</b> 2 |

| Question | | Yes / No / N/A | Comments |
|---|---|---|---|
| 2. | Is the site maintained in a clean and tidy condition? | No | There was considerable graffiti on the hoarding around the site, and some graffiti on water safety signs on the adjoining site by the public house. Anti-graffiti coating to be applied to the building following completion of the refurbishment and also hoarding to be removed. |

Q2 - Safety signage on the adjacent site was covered in graffiti.

| <b>Recommended Action</b> | Once the building hoarding is removed and the building is occupied ensure that arrangements are in place to quickly remove any graffiti etc particularly from safety signs. |

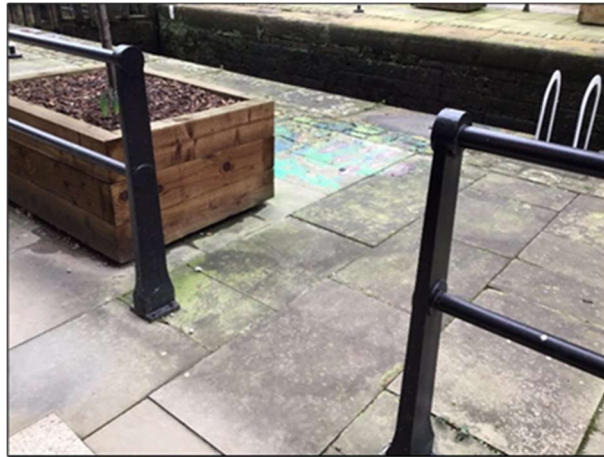
| <b>Observed Condition</b> | The access point in the railings to the lock access area is not gated. There is also a gap between to the lock access point railings and the railings to the adjoining footbridge. |
| <b>Risk Rating</b> | Severity 4 x Likelihood 2 = Risk Rating 8 <b>Priority</b> 1 |

Q11 - Open access point to the lock area.

| <b>Recommended Action</b> | Liaise with Canal and River Trust regarding closing the gaps in the railings to the lock access area as follows: <ol style="list-style-type: none"> <li>1. The lock access point should ideally be provided with an outward hinged gate to deter people from wandering into the lock access area.</li> <li>2. The gap between to the lock access point railings and the railings to the adjoining footbridge should be closed off by extending the barrier.</li> </ol> The railings are to be extend under the public realm improvement works. |

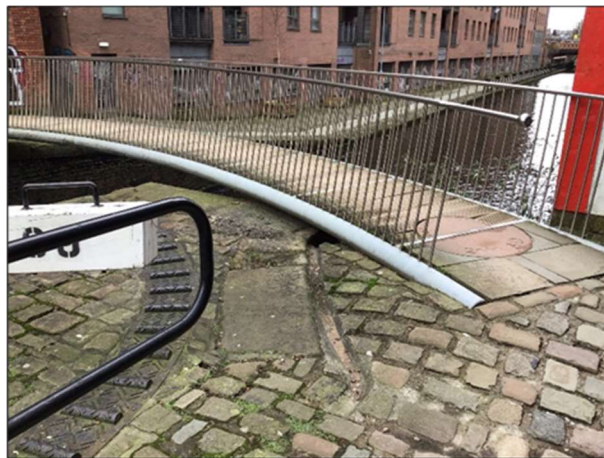
Q 11 - Gap between the lock access area railing and the footbridge railings.

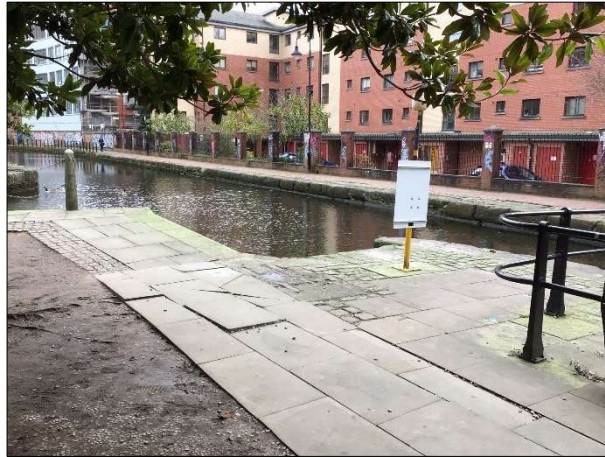
| <b>Observed Condition</b> | There is a large gap between the lock access railing and the post and chain water's edge protection to the open space to the east elevation of the building. It was reported that the post and chain edge protection was to be replaced with railings to match those around the lock. |
| <b>Risk Rating</b> | Severity 4 x Likelihood 2 = Risk Rating 8 <b>Priority</b> 1 |

| 14. | Is adequate edge protection provided to the water's edge areas? | No | There is a large gap between the railings to lock access area and the post and chain edge protection to the edge of the landscaped area. However, it was reported that the post and chain edge protection to the edge of the landscaped area is to be replaced with railings to match those around the lock access area. |

Q14 - Gap between the lock access area railing and post and chain water's edge protection.

| <b>Recommended Action</b> | Ensure that the railings that are to be installed to replace the post and chain water's edge protection extend fully to meet with the existing railings around the lock. |

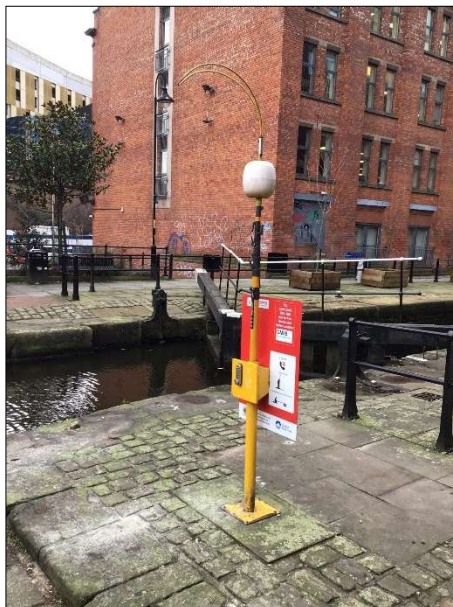
| <b>Observed Condition</b> | A "Reach and Rescue" telescopic lifesaving reach pole was in place by the lock. This had been provided in partnership between Greater Manchester Fire and Rescue Service and Canal and River Trust. The reach pole is secured by a coded lock and the release code can be obtained by dialling 999. |
| <b>Risk Rating</b> | Severity 4 x Likelihood 1 = Risk Rating 4 <b>Priority</b> 2 |

| 16. | Is adequate lifesaving equipment provided on site? | Yes | "Reach and Rescue" telescopic reach pole provided in partnership between Greater Manchester Fire and Rescue Service and Canal and River Trust. Continued availability and condition of the reach pole is to be monitored daily by building security staff. Reach pole maintenance arrangements need to be confirmed with Greater Manchester Fire and Rescue Service and Canal and River Trust. |

Q16 - "Reach and Rescue" lifesaving equipment is already in place by the lock.

| <b>Recommended Action</b> | Ensure that daily property checks for 70 Bridgewater Street cover the canal-side area and specifically the continued availability and condition of the "Reach and Rescue" lifesaving equipment. Should the equipment go missing or become damaged this should immediately be reported to Manchester Fire and Rescue Service.<br>Also confirm with Manchester Fire and Rescue Service arrangements for routine maintenance checks of the lifesaving reach pole. |

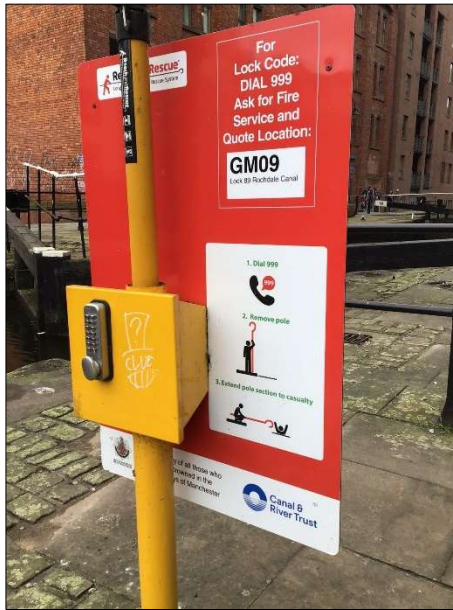
| <b>Observed Condition</b> | Emergency contact details are provided adjacent to the lock at the emergency reach-pole station. Clear signage is provided to advise that the code to access the equipment is obtained by dialling 999, asking for the Fire Service and quoting location reference GM09 (Lock 89 Rochdale Canal). Simple instructions on use of the reach pole are provided on the same sign.<br>The access code could also be held by the Building Manager / Security with the permission of Manchester Fire and Rescue Service. |
| <b>Risk Rating</b> | Severity 2 x Likelihood 1 = Risk Rating 2 <b>Priority</b> 4 |

Q26 - Emergency contact details and instructions provided at the emergency reach-pole station.

| <b>Recommended Action</b> | To facilitate legitimate access to the "Reach and Rescue" pole determine with Manchester Fire and Rescue Service whether the code to unlock the pole can be held securely by the building management / security team. This would enable access to the reach pole during water rescue drills - unwarranted calls to 999 should be avoided. |

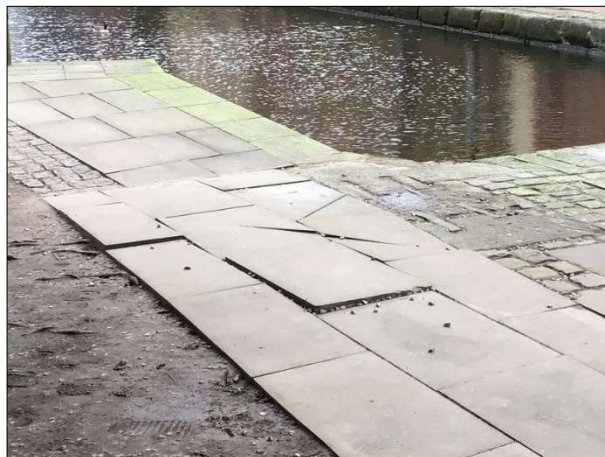
| <b>Observed Condition</b> | There were some uneven sections of paving near the reach pole station and the footbridge over the canal. These will be rectified through the area improvement works. |
| <b>Risk Rating</b> | Severity 3 x Likelihood 2 = Risk Rating 6 |
| <b>Priority</b> | 2 |

| 27. | Are surfaces maintained slip and trip free? | No | There were some uneven sections of paving near the reach pole station and the footbridge over the canal. These are to be rectified through the area improvement works. Any remaining slip or trip hazards spotted through the daily checks are to be routinely reported to the Manchester City Council which is responsible for the area. |

Q27 - Uneven paving near the reach pole station.

| <b>Recommended Action</b> | As far as possible within the scope of the area improvement works rectify all areas of uneven external paving. Any remaining or newly developed slip or trip hazards spotted through the process of daily checks should be routinely reported to the Manchester City Council for rectification as the land is under their ownership and thus responsibility for maintenance. |

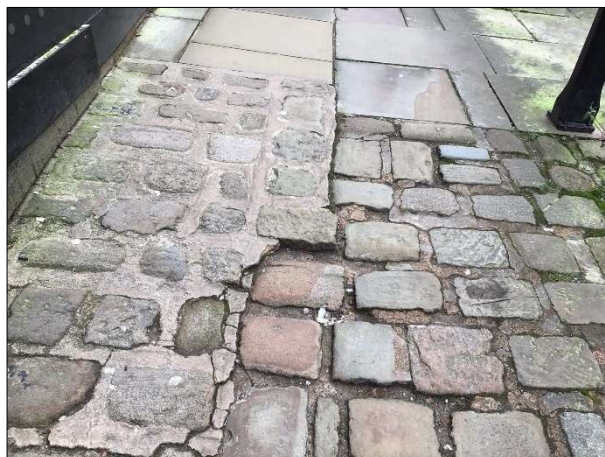
Q27 - Uneven section of cobbled paving near the footbridge over the canal.
