# GeoEnginSeer

## **Verification Completion Report for Ground Gas Protection Systems**

| Project Title | Nell Lane Apartments |

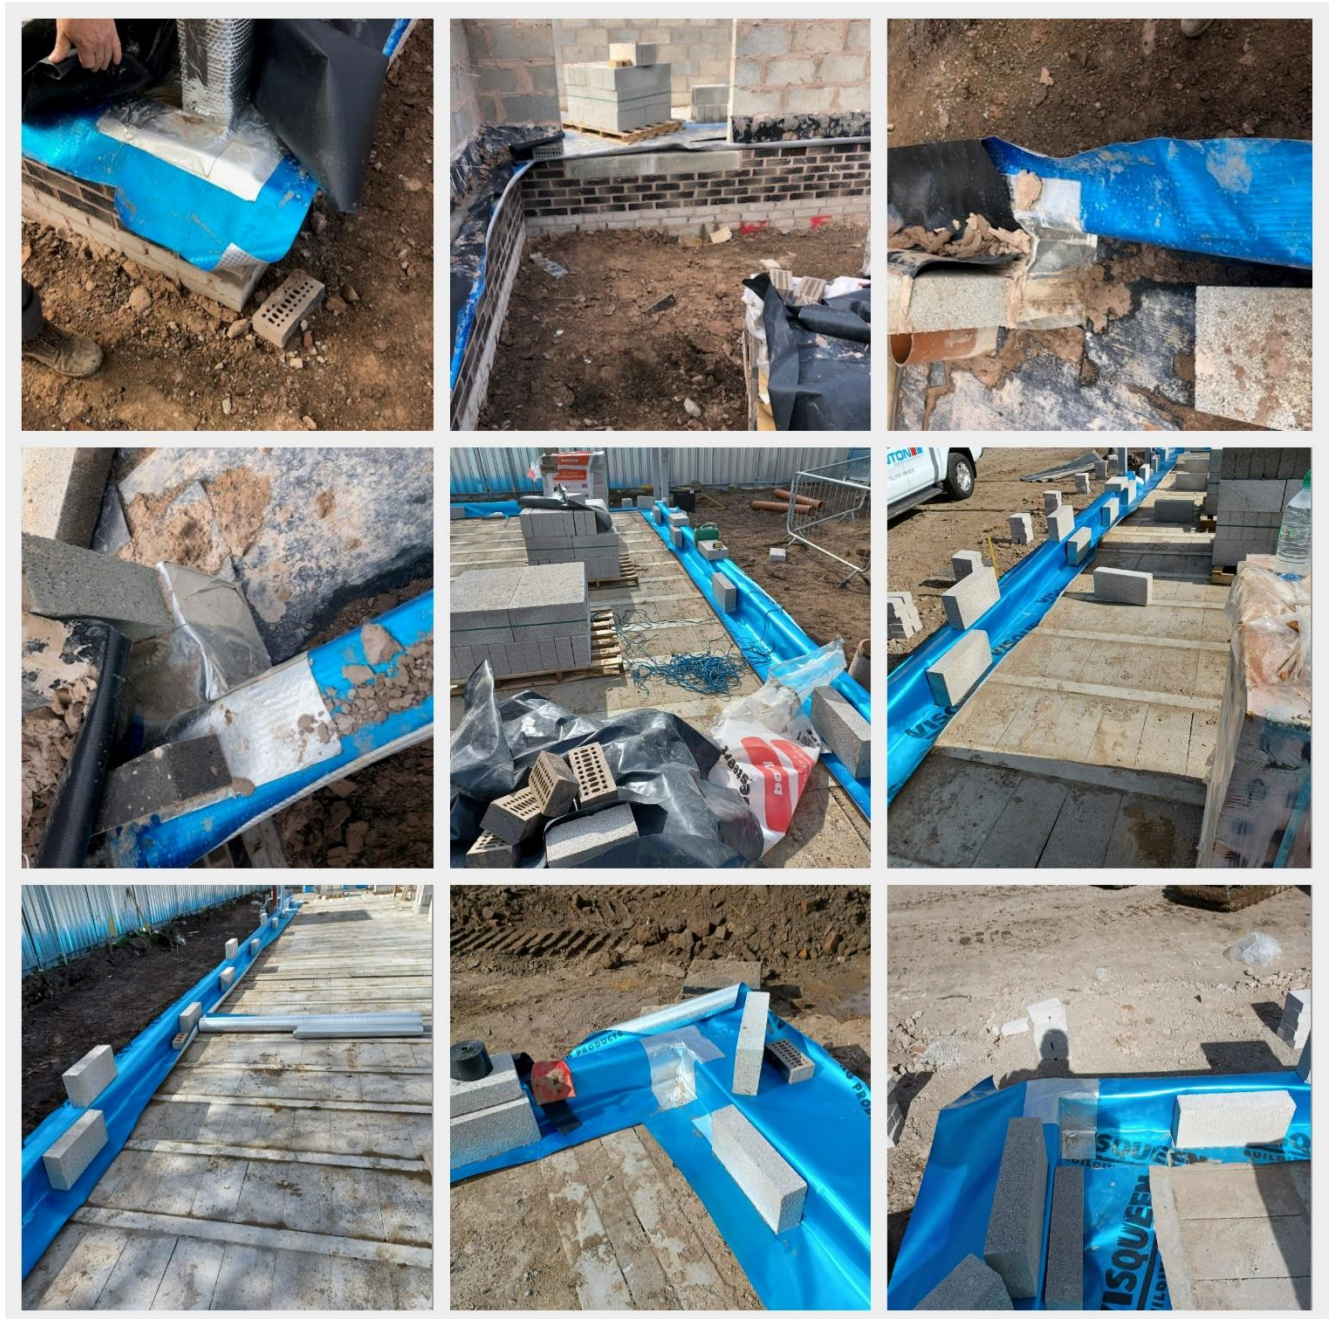
On the 15<sup>th</sup> April 2022 from 12:30-13:30hrs the edge detailing of the apartment block was inspected and found to have no errors.

Permimeter detail.

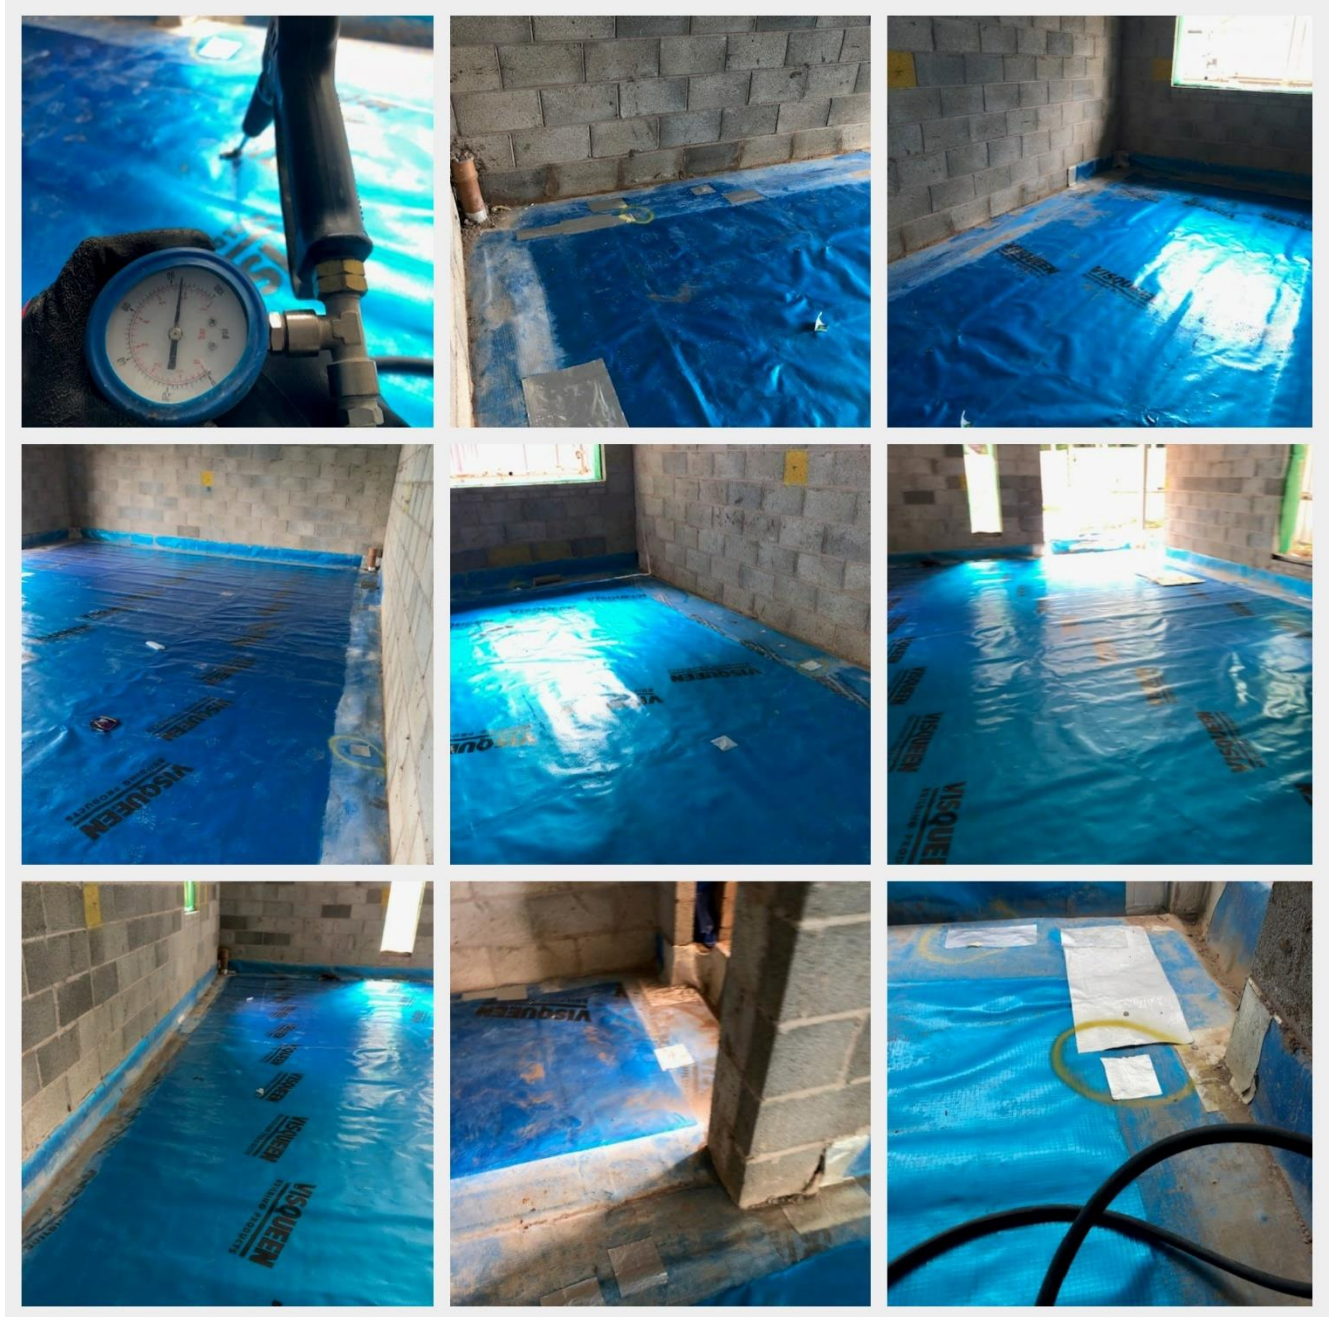
Infill Installations.

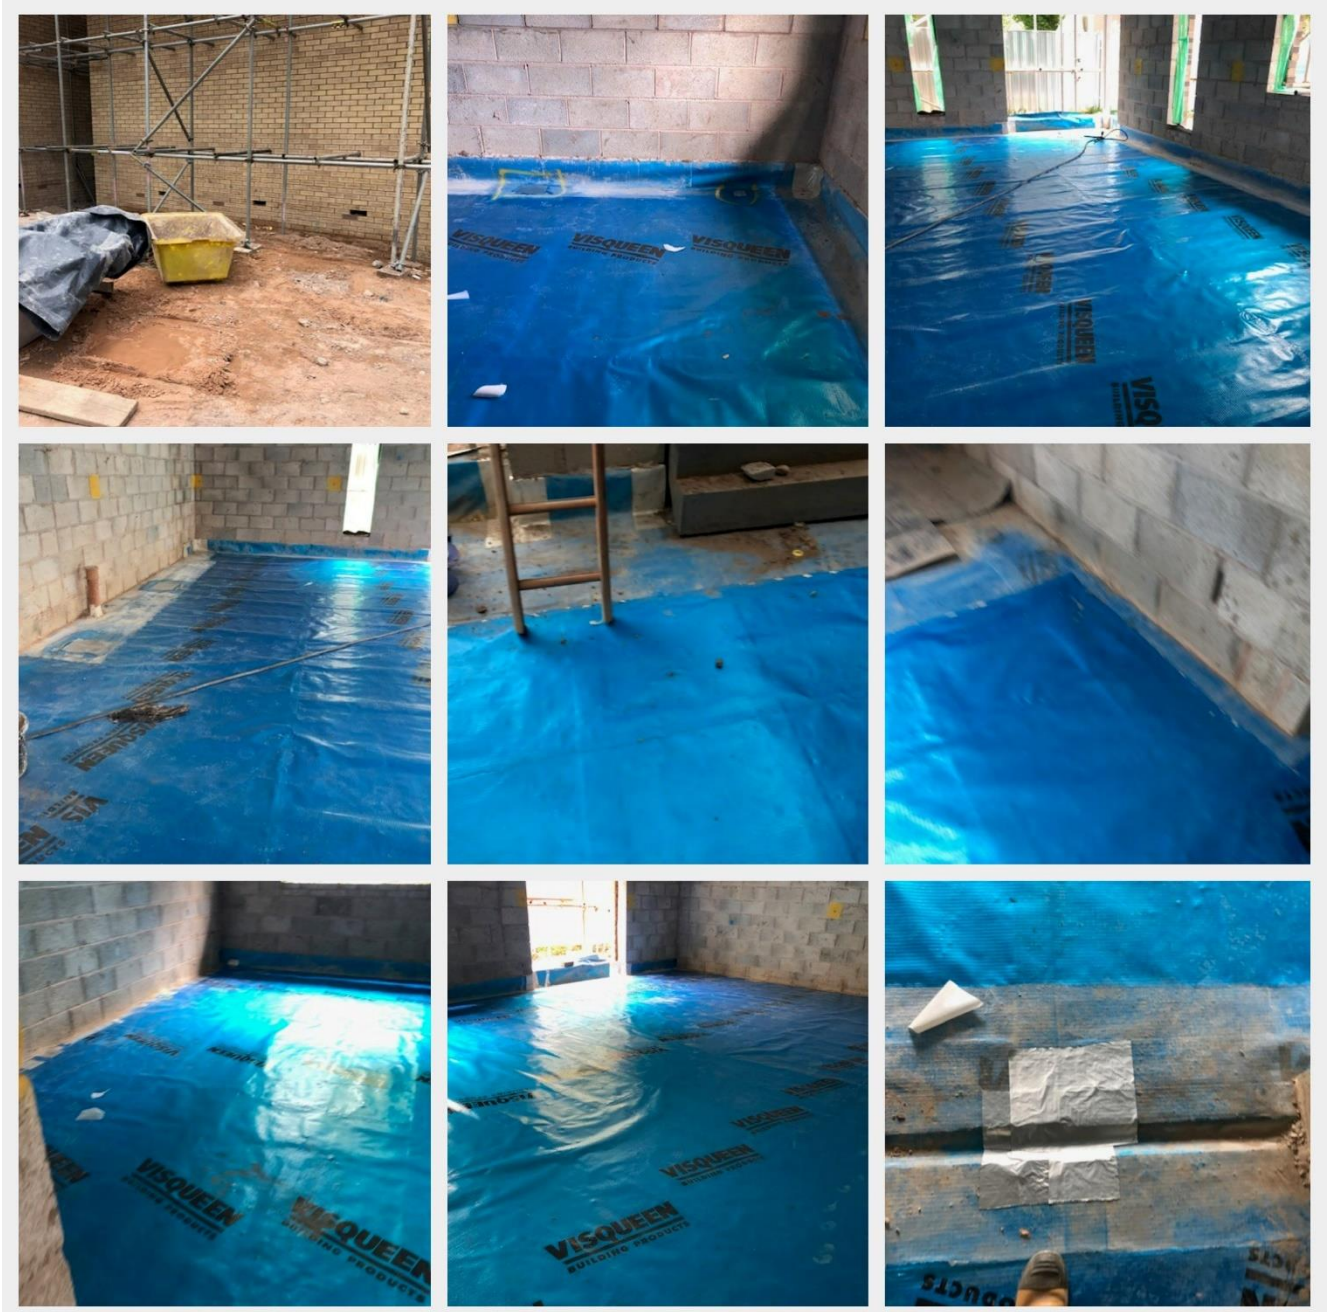
Infill Installations.
