## Jonathan Davidson Architects

Neptune Mill  
Chapelton St, Manchester

Historic & Industrial Features Audit  
353 PD 2001 (P2)

*October 2023*

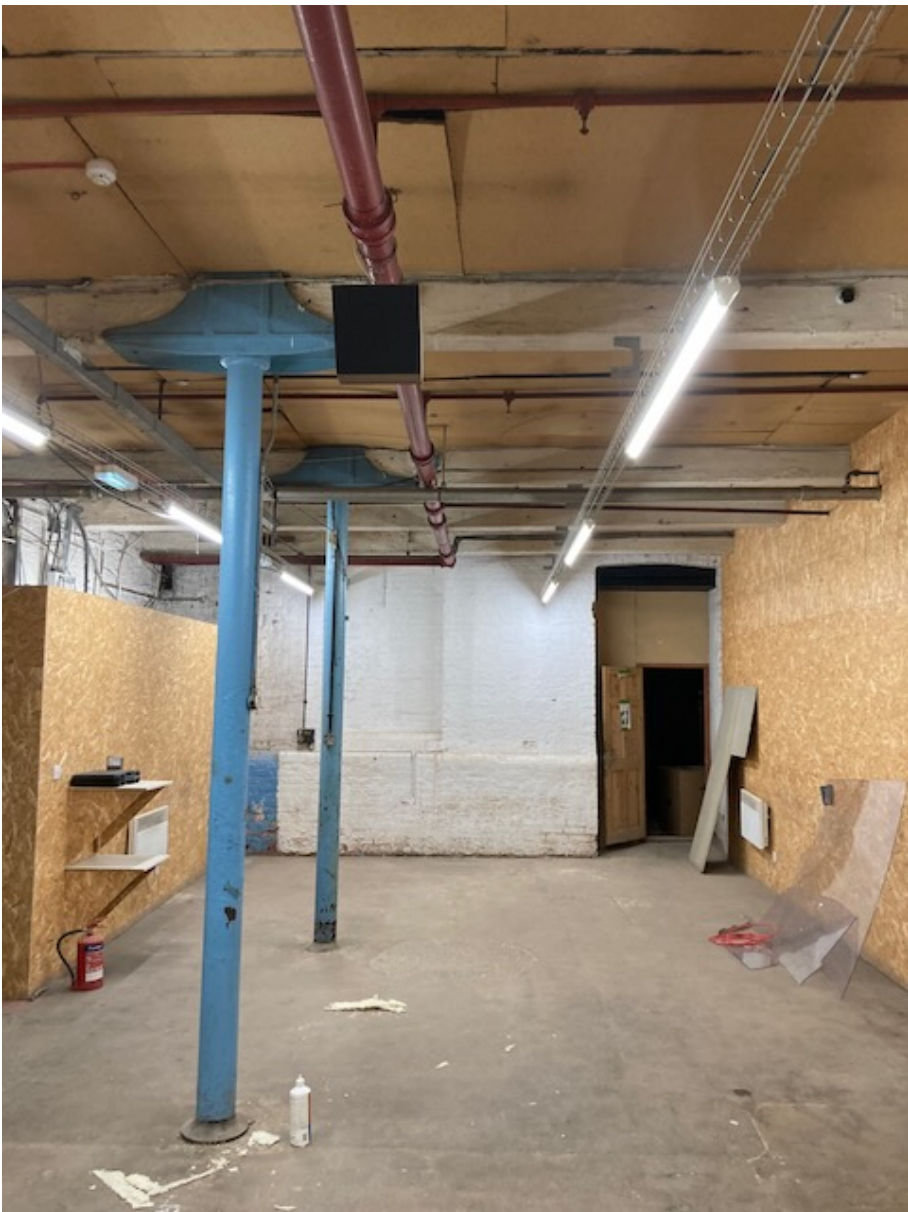
| Ref | Historic / Industrial Feature | Description | Removed / Retained | Works to be undertaken |
|---|---|---|---|---|
| G1 | Columns & beam shoes | Painted cast iron columns and varying types of primary beam support shoes | Retained | Existing paint to be lightly removed and new intumescent paint finish to be applied |

**ITEM G1**  
Typical column and beam shoe at ground floor

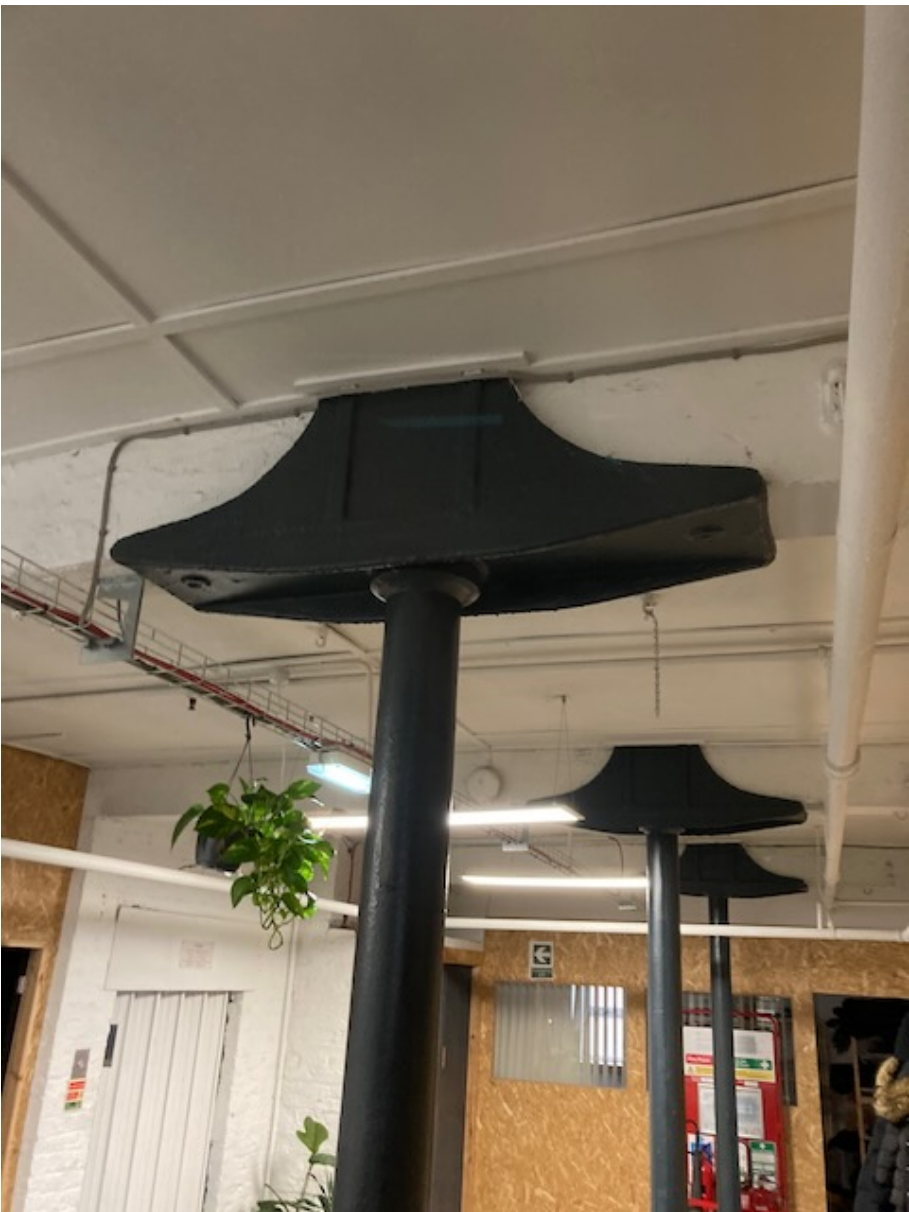
**ITEM G1**  
Typical column and beam shoe at 1st floor

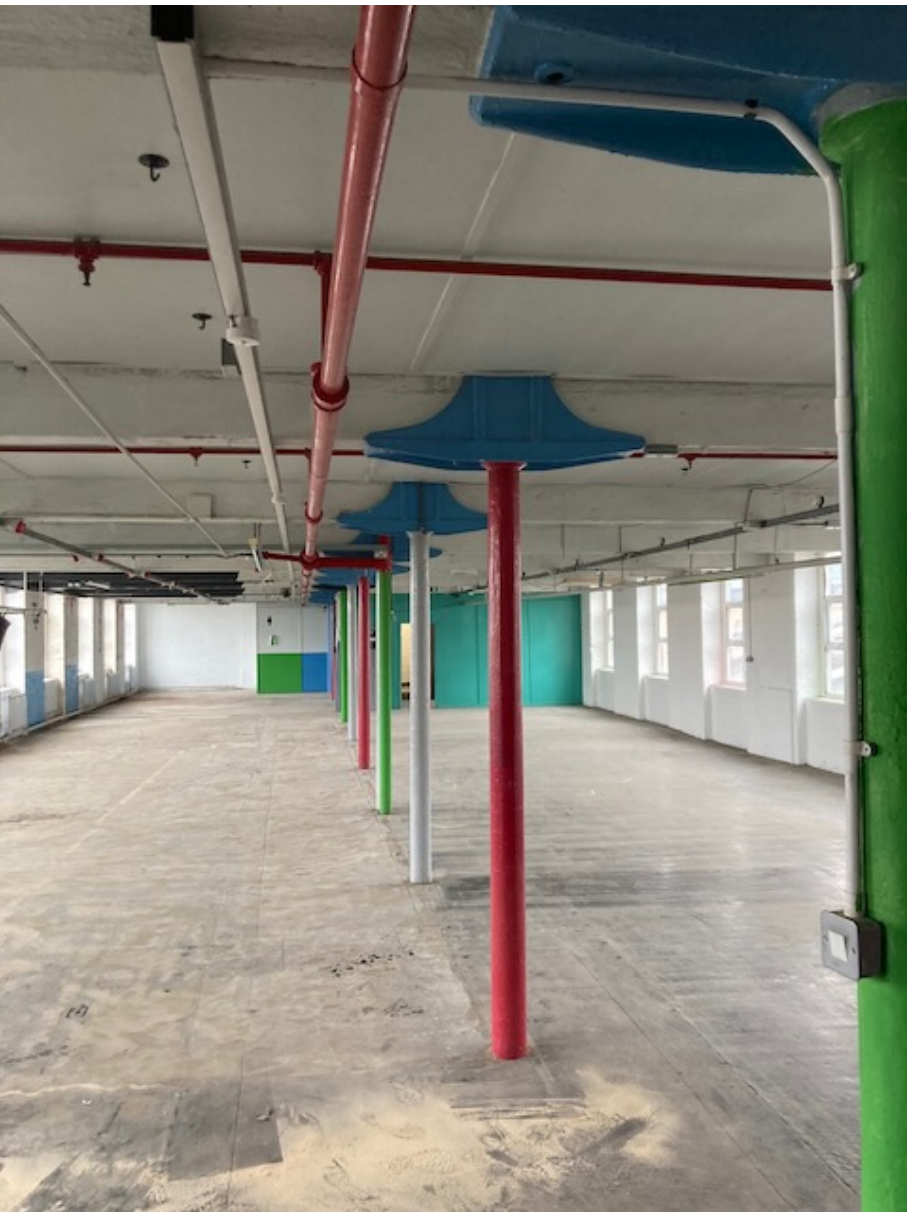
**ITEM G1**  
Typical column and beam shoe at 2nd floor

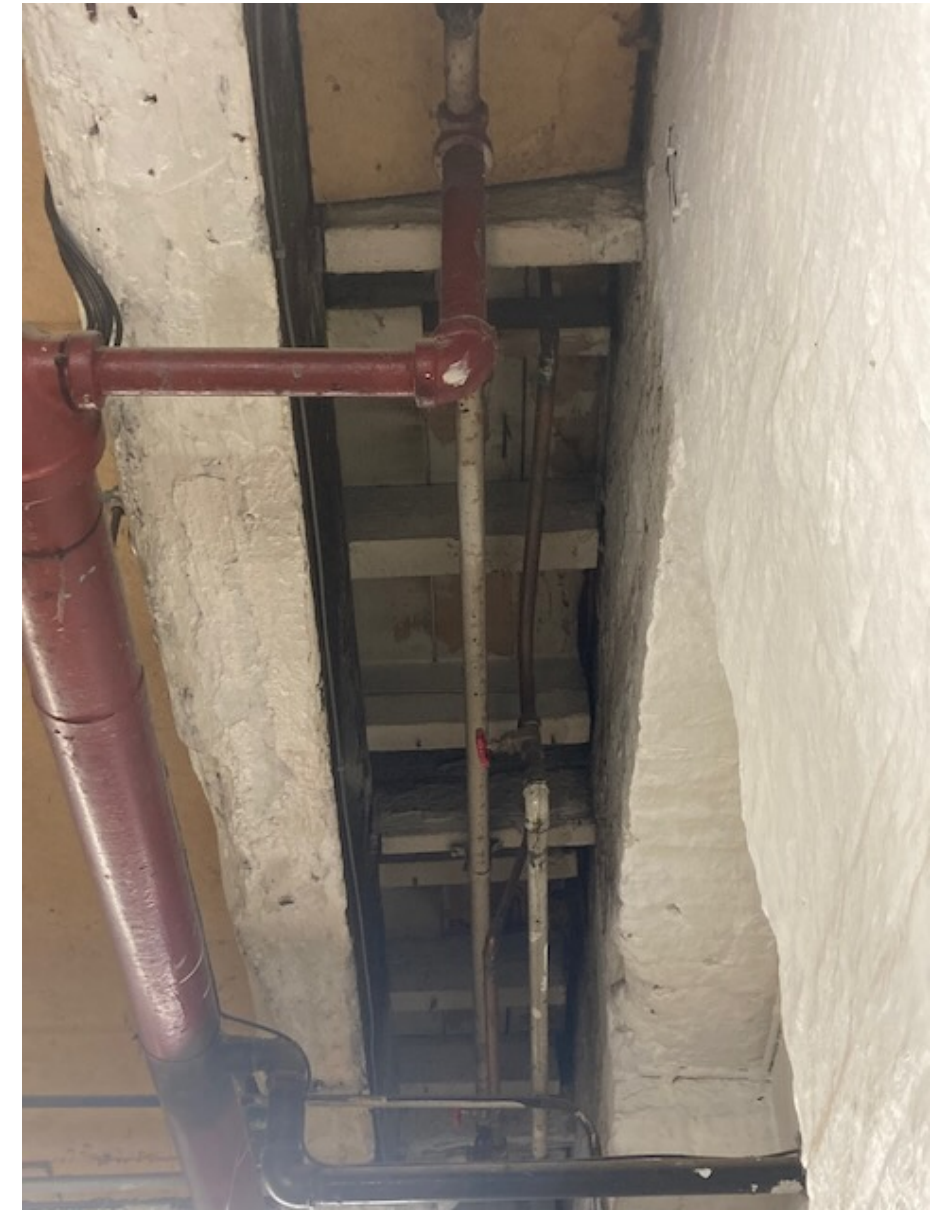
| Ref | Historic / Industrial Feature | Description | Removed / Retained | Works to be undertaken |
|---|---|---|---|---|
| G3 | Joists | 175 x 65mm timber joists at 400mm centres spanning between primary beams | Retained & exposed | Joists to be lightly sanded and new clear intumescent coating to be applied |
| G4 | Timber board soffits | Two layers of timber planks spanning across joists forming floor deck above | Retained & exposed | Boards to be lightly sanded and new clear intumescent coating to be applied |

**ITEM G3 / G4**  
Exposed joists at ground floor east gable

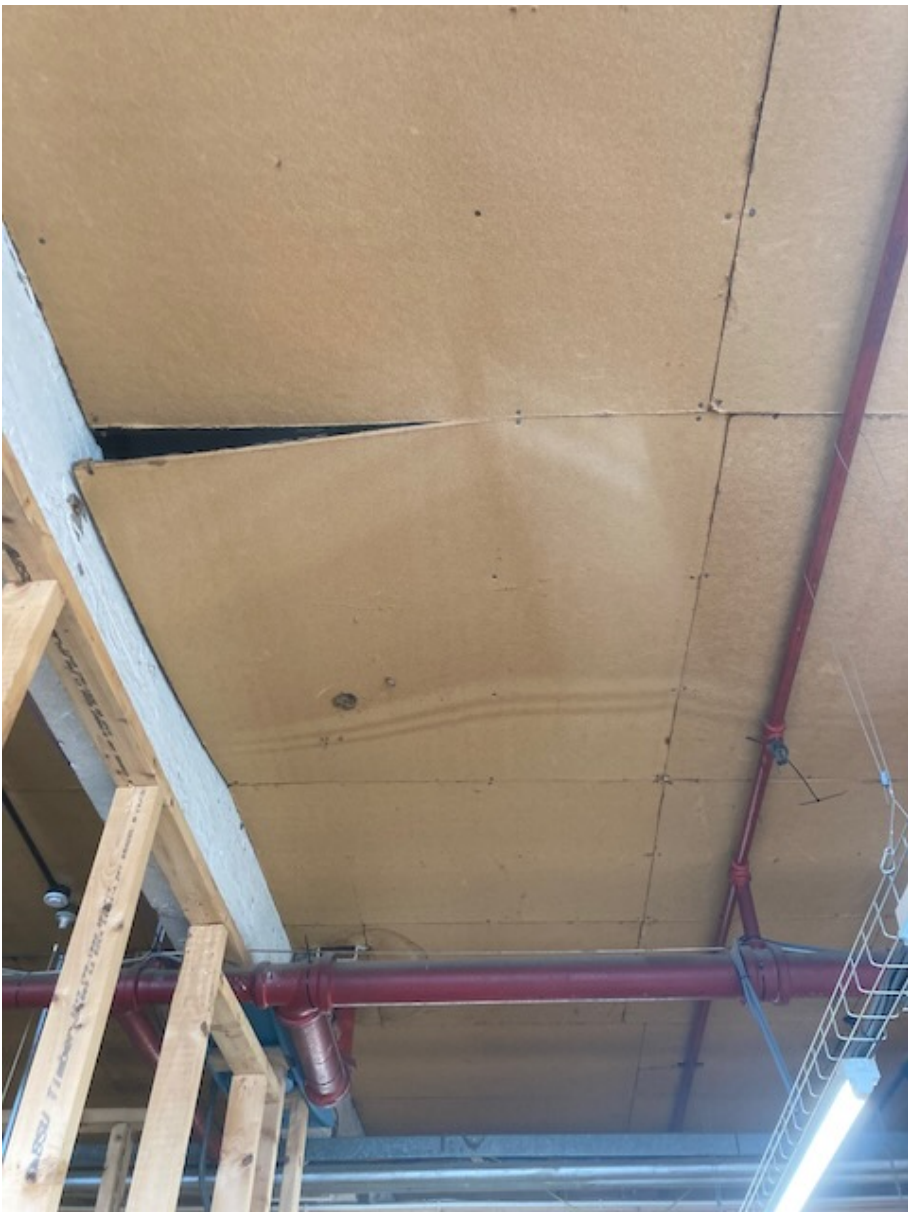
| Ref | Historic / Industrial Feature | Description | Removed / Retained | Works to be undertaken |
|---|---|---|---|---|
| G5 | Board ceilings | Various types of overlay board ceilings fixed to underside of joists with cover strips over board joints | Removed | All board ceilings to be removed to expose joists and timber board soffits above. Ceilings linings not considered to be original. |

**ITEM G5**  
Hardboard ceiling to ground floor

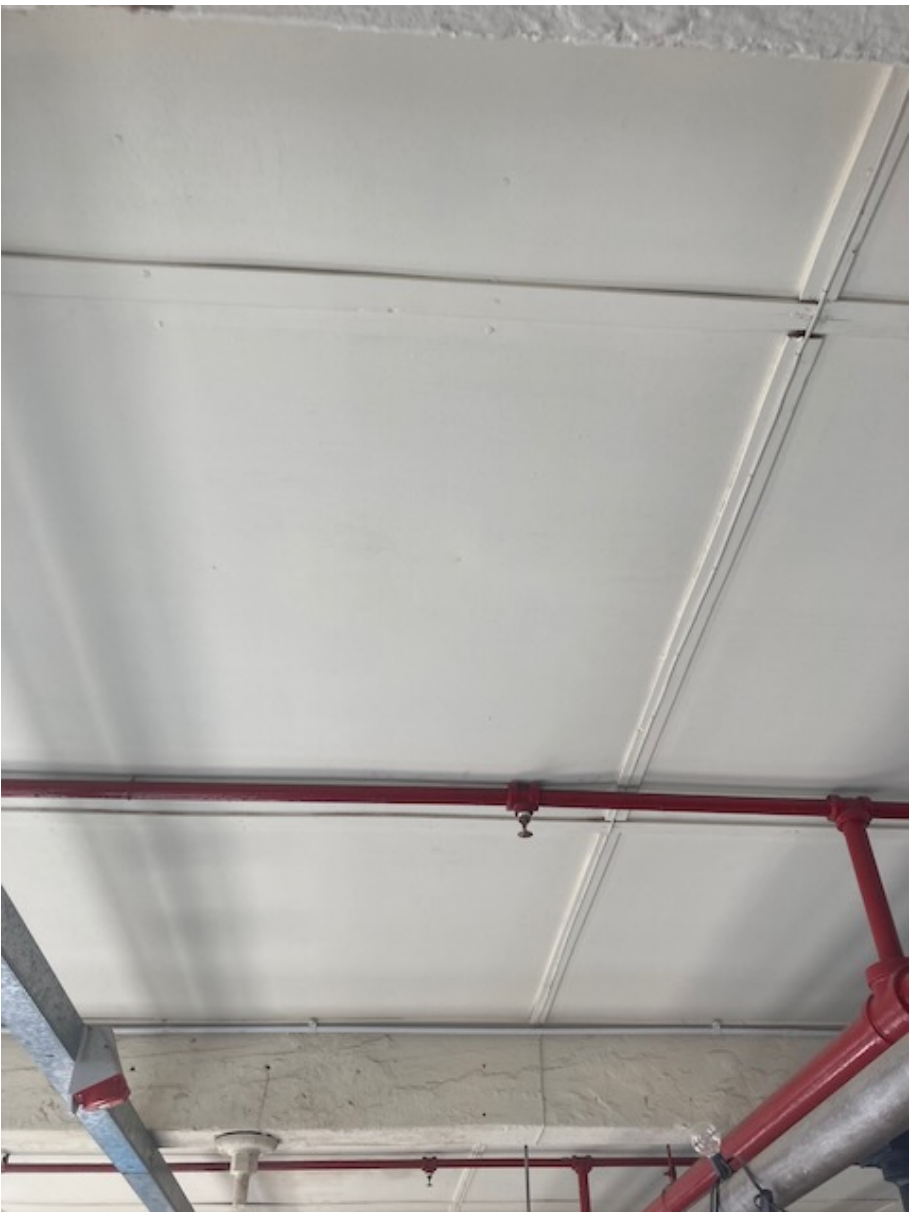
**ITEM G5**  
Typical board ceiling to upper floors (2nd floor shown)

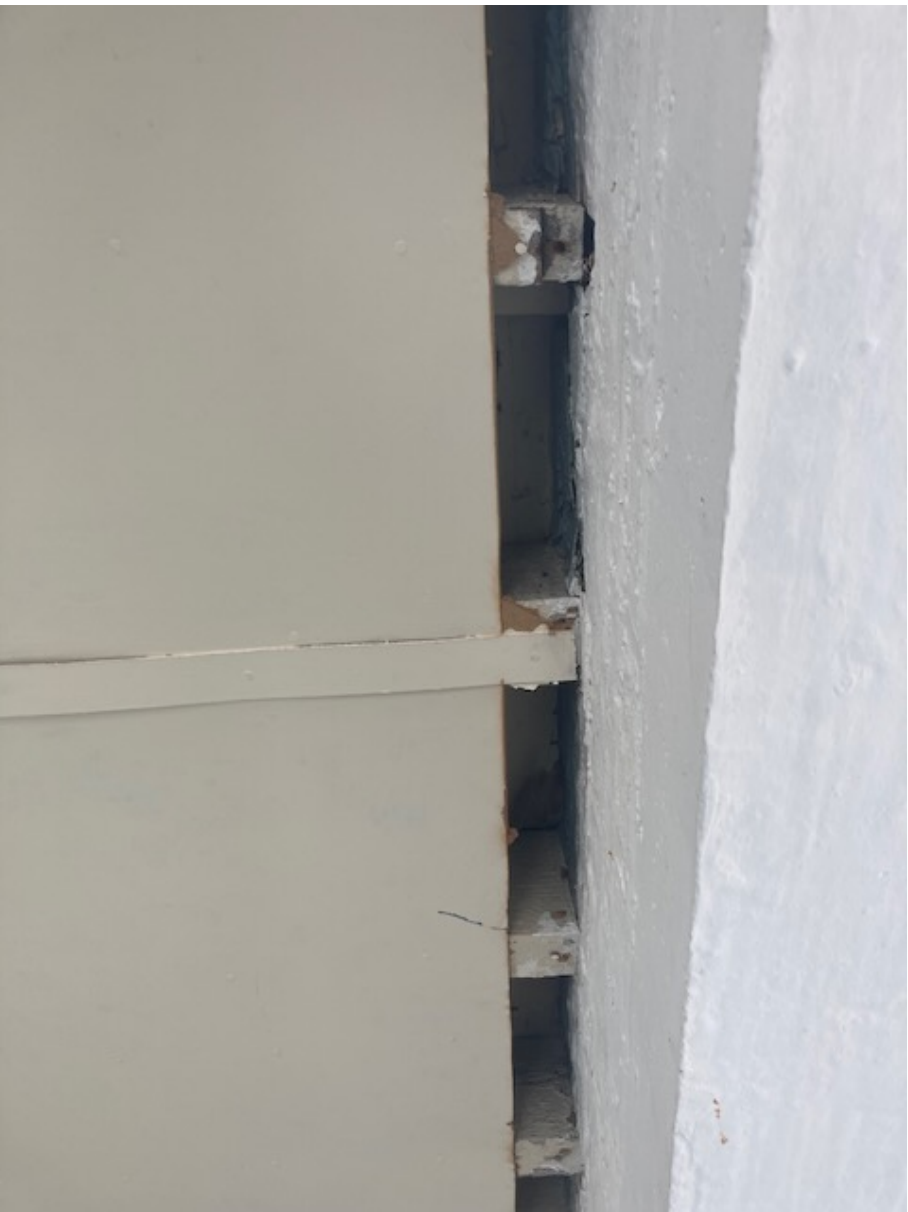
**ITEM G5**  
Typical board ceiling to upper floors with edge trim removed to show joists

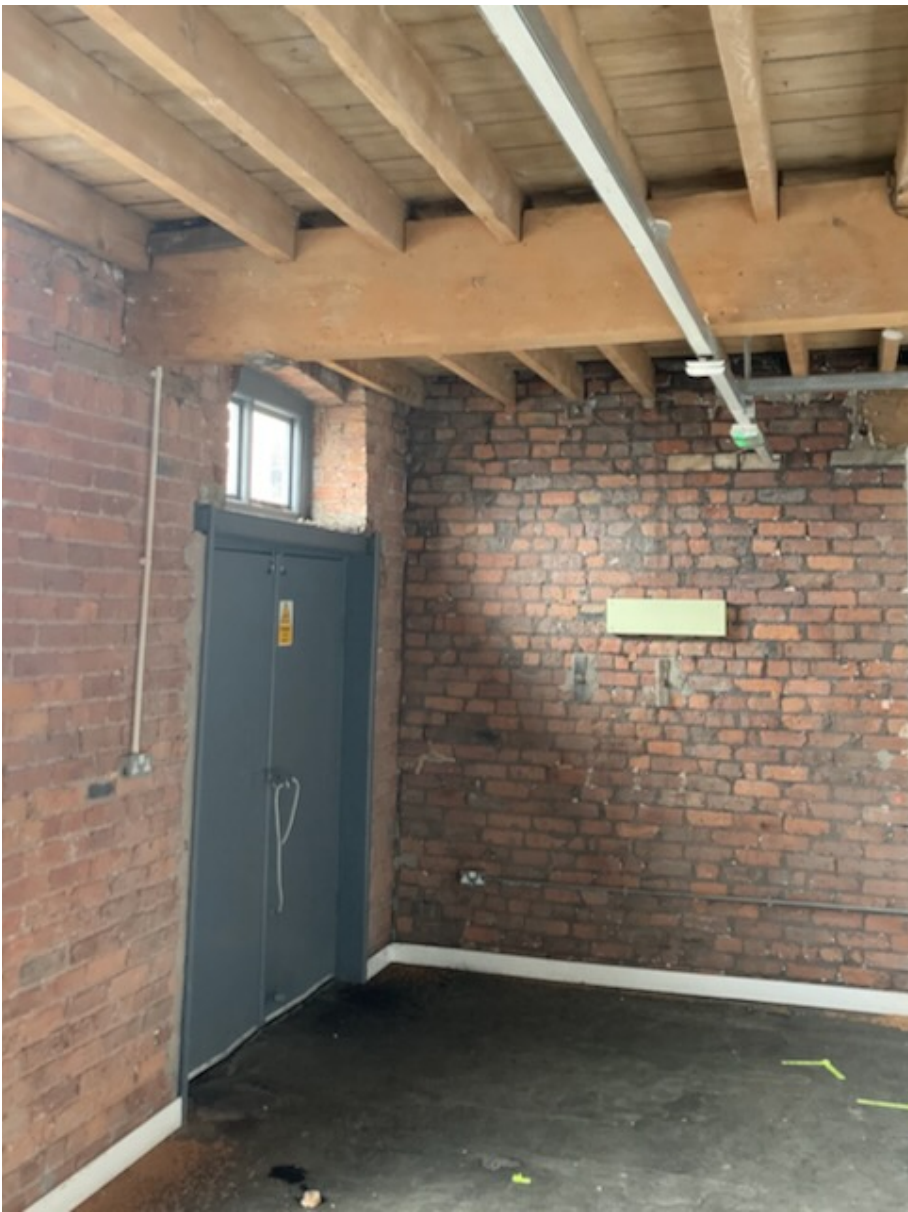
| Ref | Historic / Industrial Feature | Description | Removed / Retained | Works to be undertaken |
|---|---|---|---|---|
| G6 | Internal face of external walls | Exposed brickwork with paint finish with small areas of plasterboard dry lining | Retained & cleaned of paint | Existing paint finish to be lightly removed and brickwork left uncoated and exposed. Internal face of east gable to be dry lined. |

**ITEM G6**  
Sample of cleaned brickwork at 3rd floor

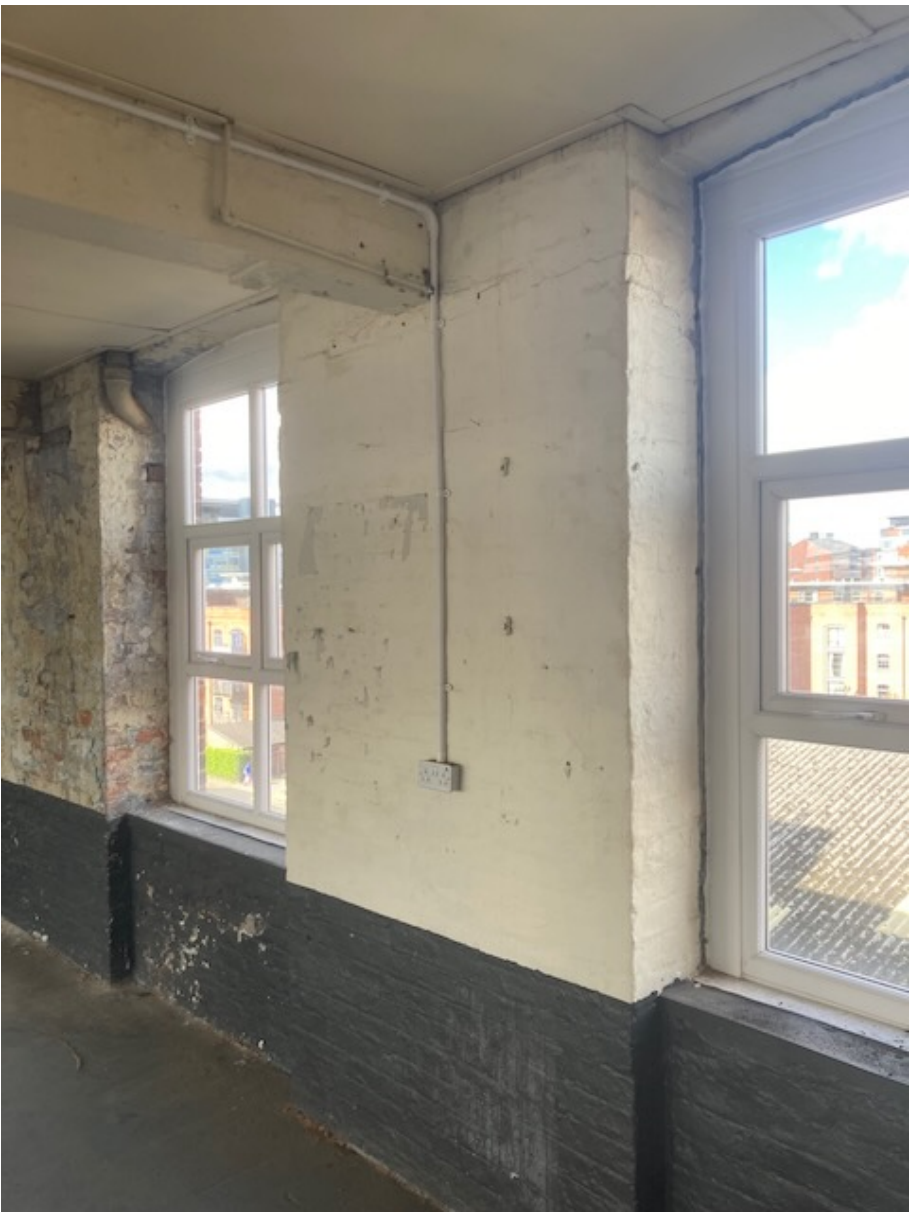
**ITEM G6**  
Typical painted brickwork walls (3rd floor)

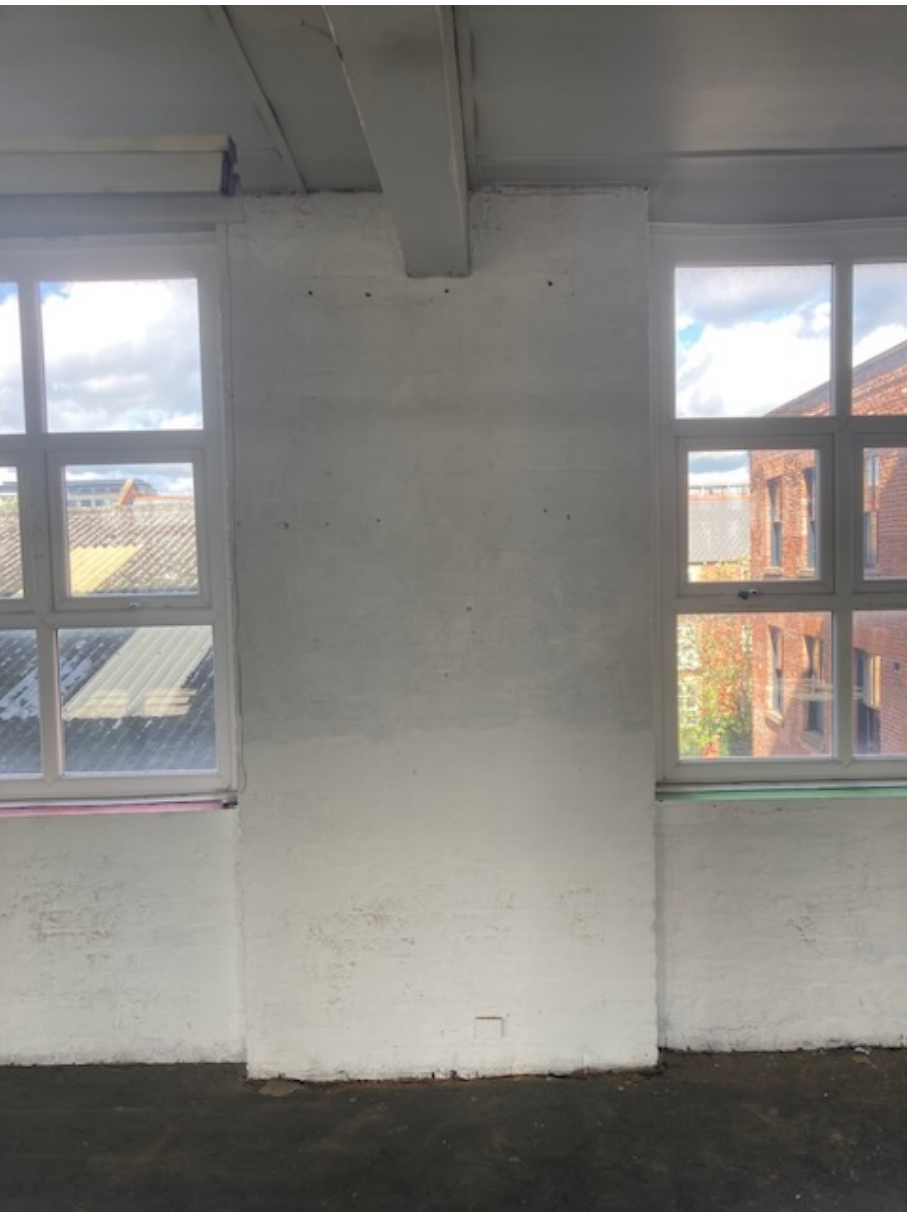
**ITEM G6**  
Typical painted brickwork walls (2nd floor)

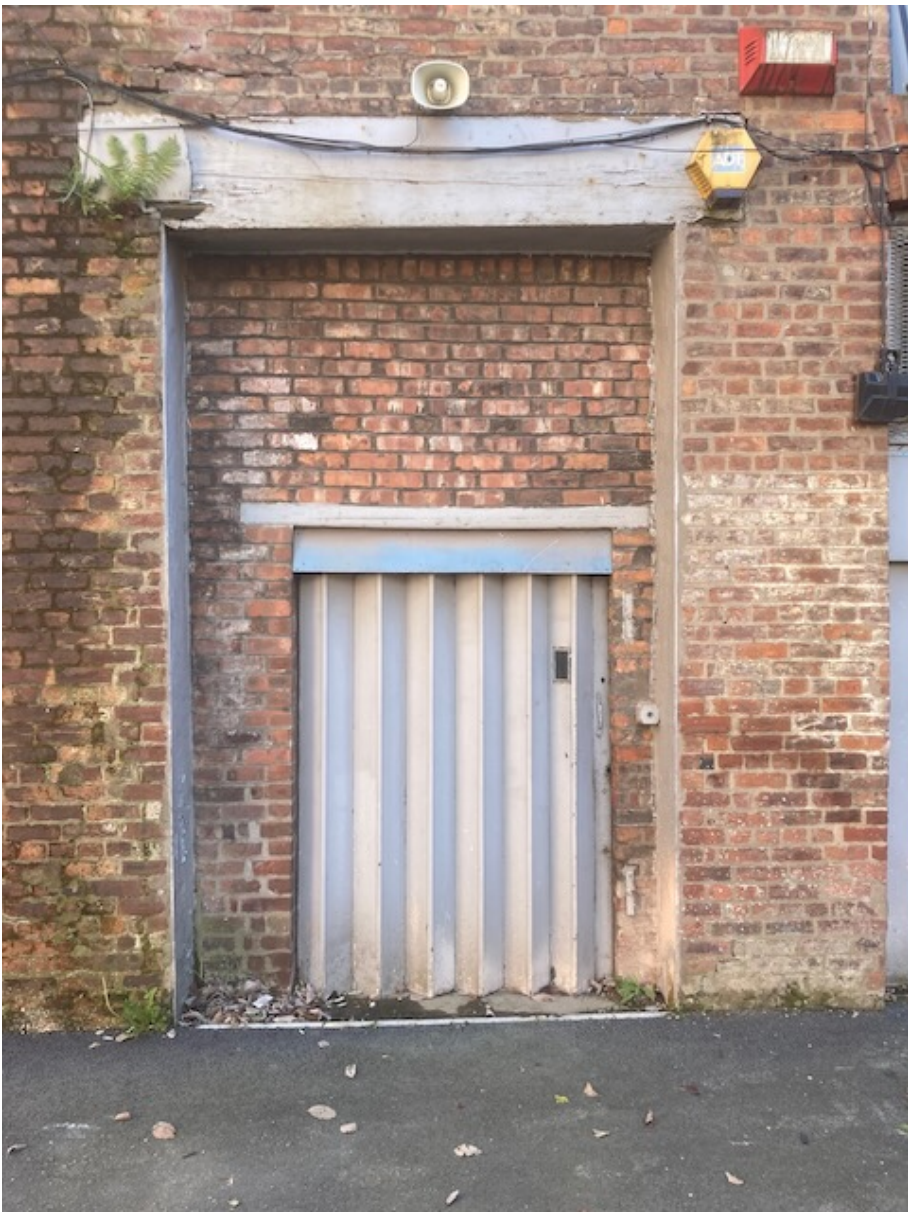
| Ref | Historic / Industrial Feature | Description | Removed / Retained | Works to be undertaken |
|---|---|---|---|---|
| G7 | Lift doors and equipment | Goods lift with steel concertina doors at each level and pulley wheel at head of shaft | Removed | All lift equipment to be removed and replaced with new, full lift installation. Lift car and doors not considered original. |

**ITEM G7**  
External lift doors at ground floor

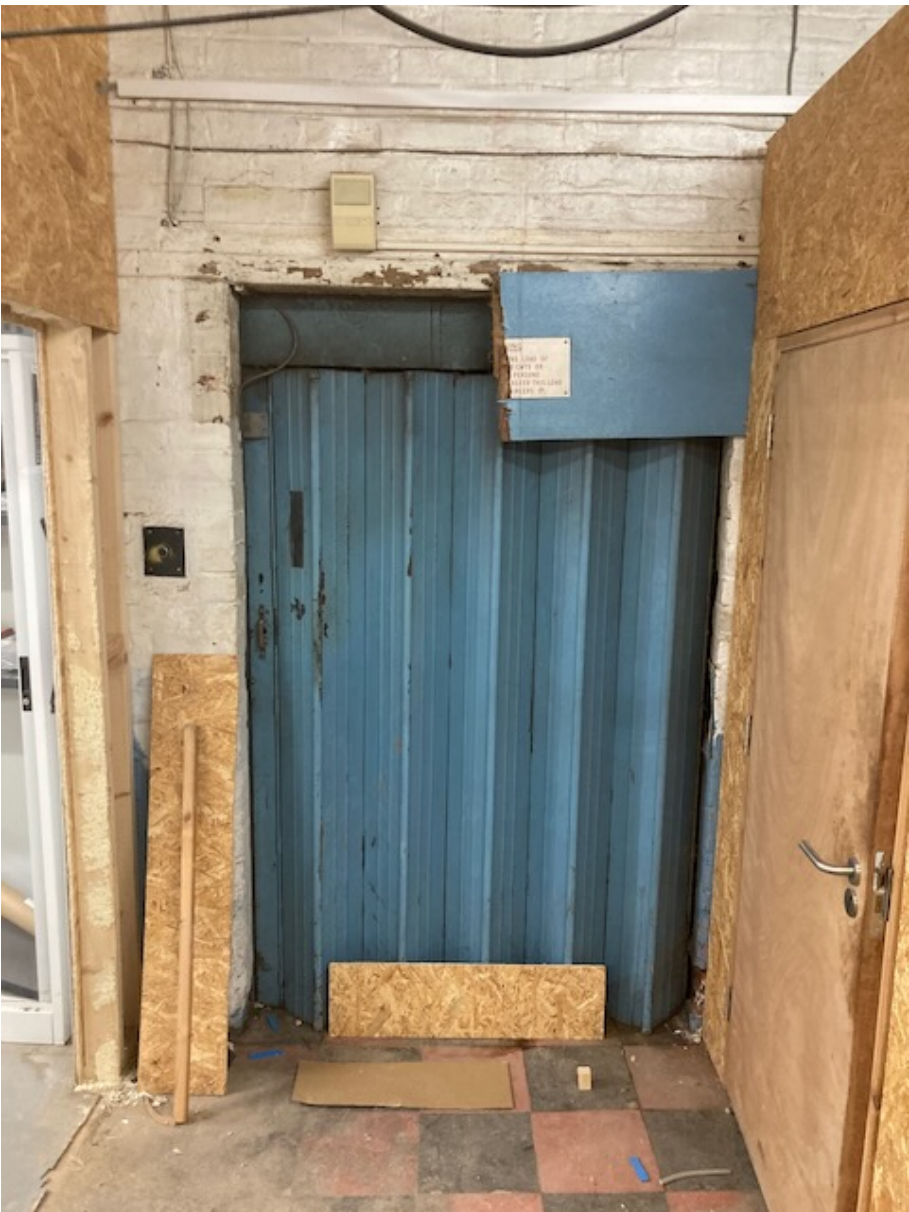
**ITEM G7**  
Internal lift doors at ground floor

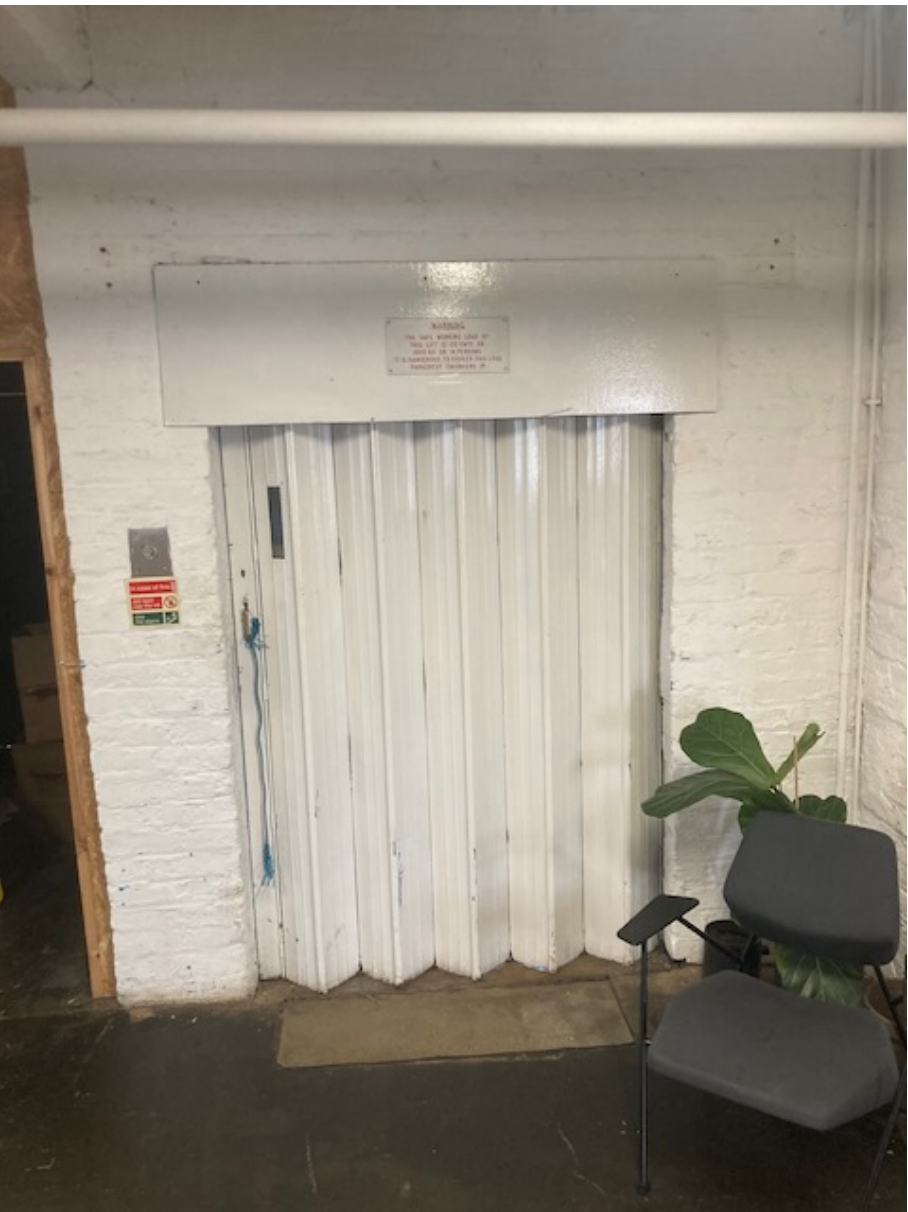
**ITEM G7**  
Internal lift doors at 1st floor

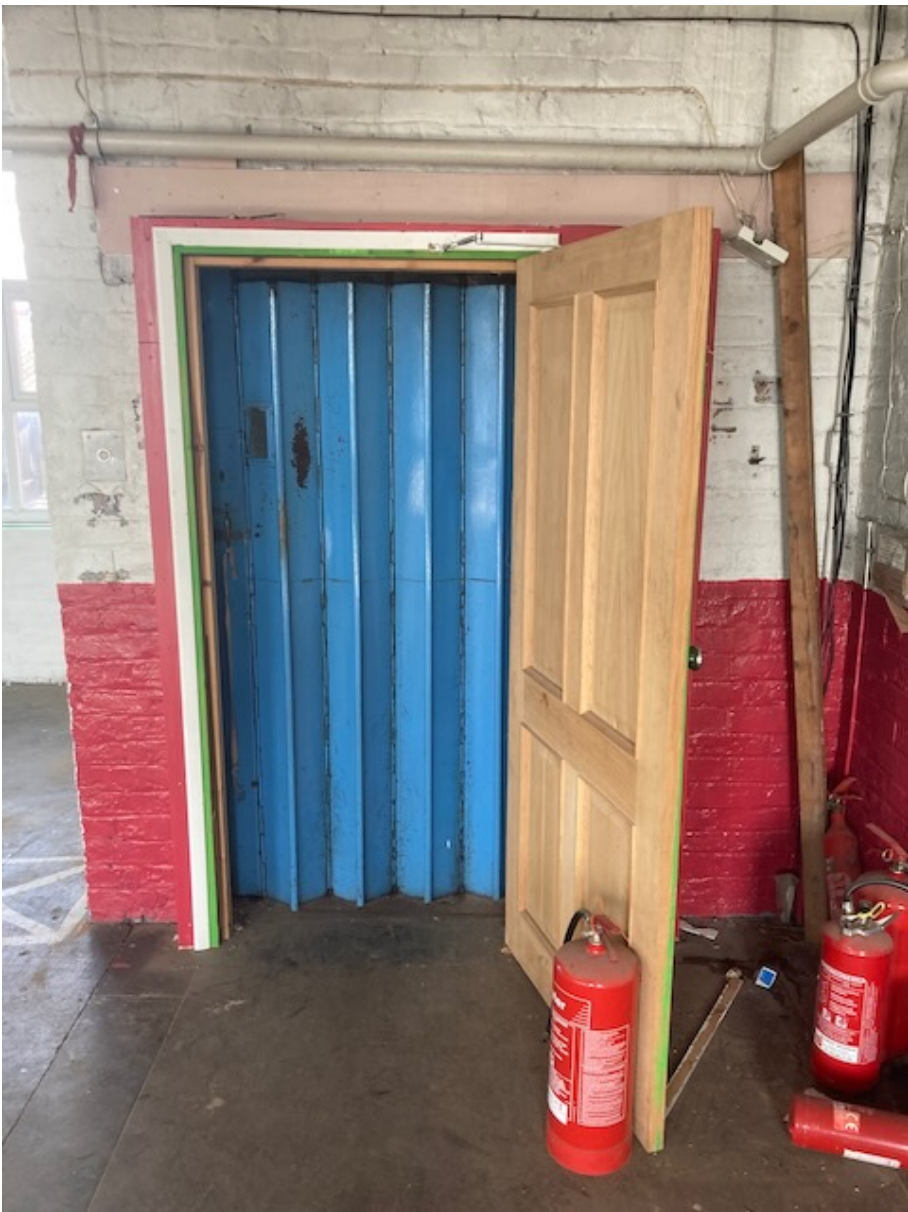
**ITEM G7**  
Internal lift doors at 2nd floor

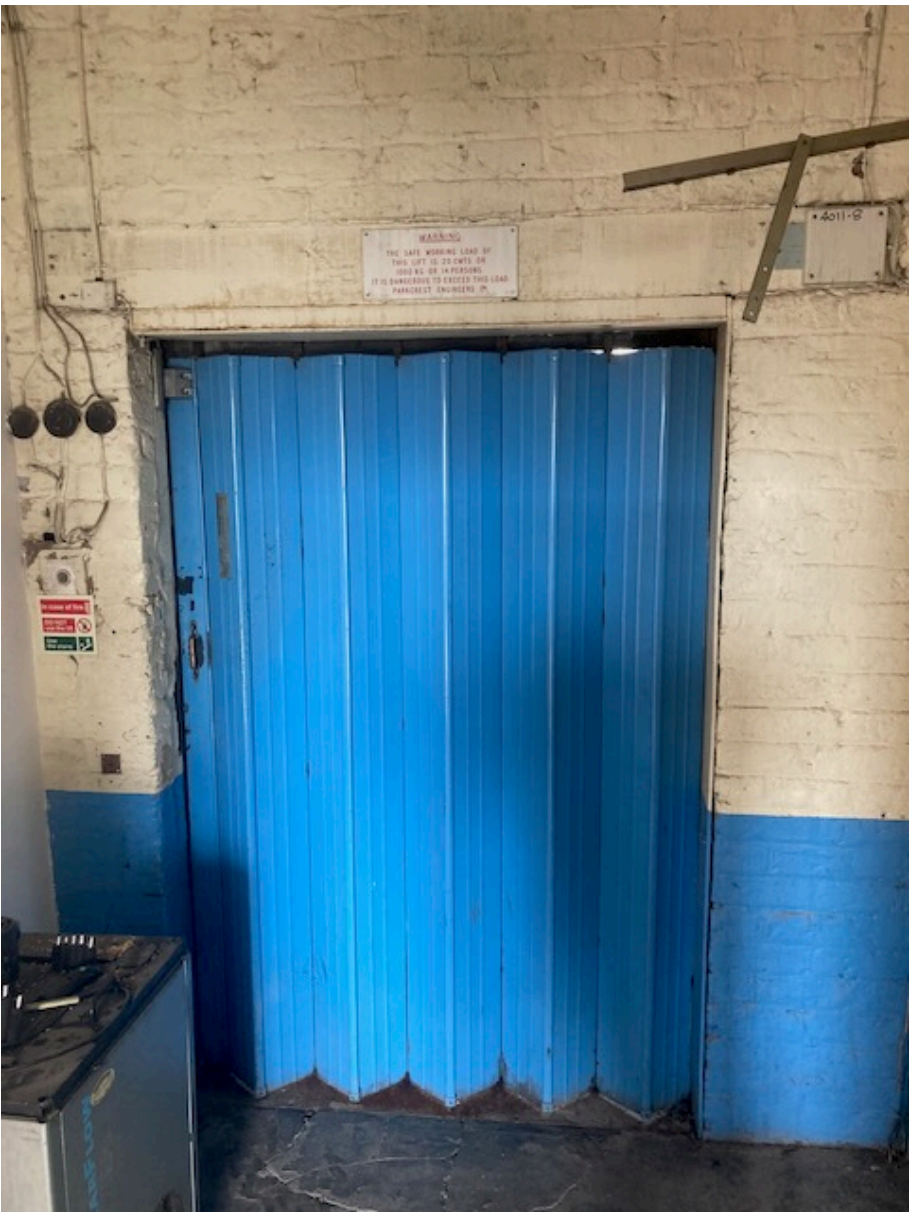
**ITEM G7**  
Internal lift doors at 3rd floor

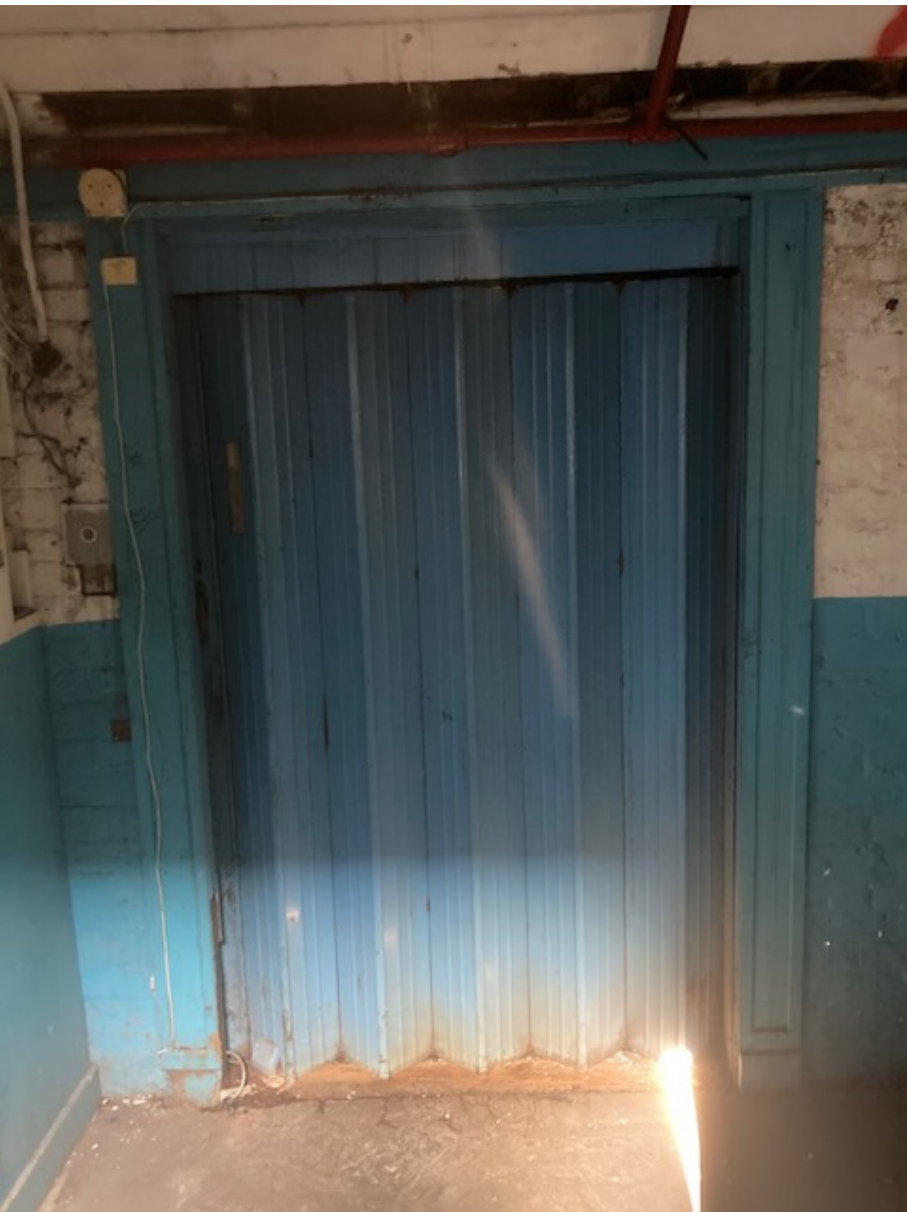
**ITEM G7**  
Internal lift doors at 3rd floor

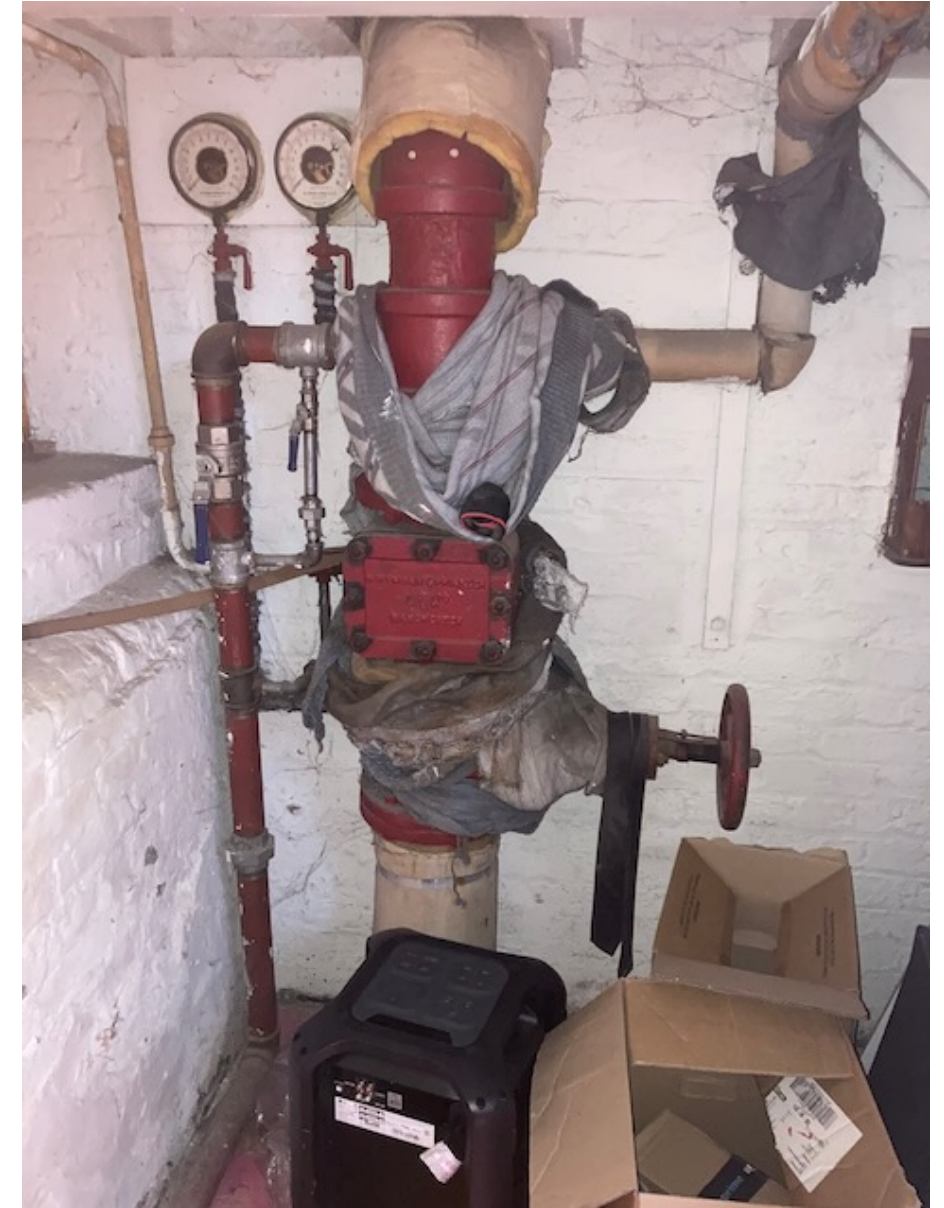
| Ref | Historic / Industrial Feature | Description | Removed / Retained | Works to be undertaken |
|---|---|---|---|---|
| G8 | Sprinkler pipework and equipment | Cast iron / steel sprinkler pipework to all floors with inlets / valves at ground floor level | Removed | All sprinkler pipework and equipment to be removed |

**ITEM G8**  
Sprinkler valves within North East Stair

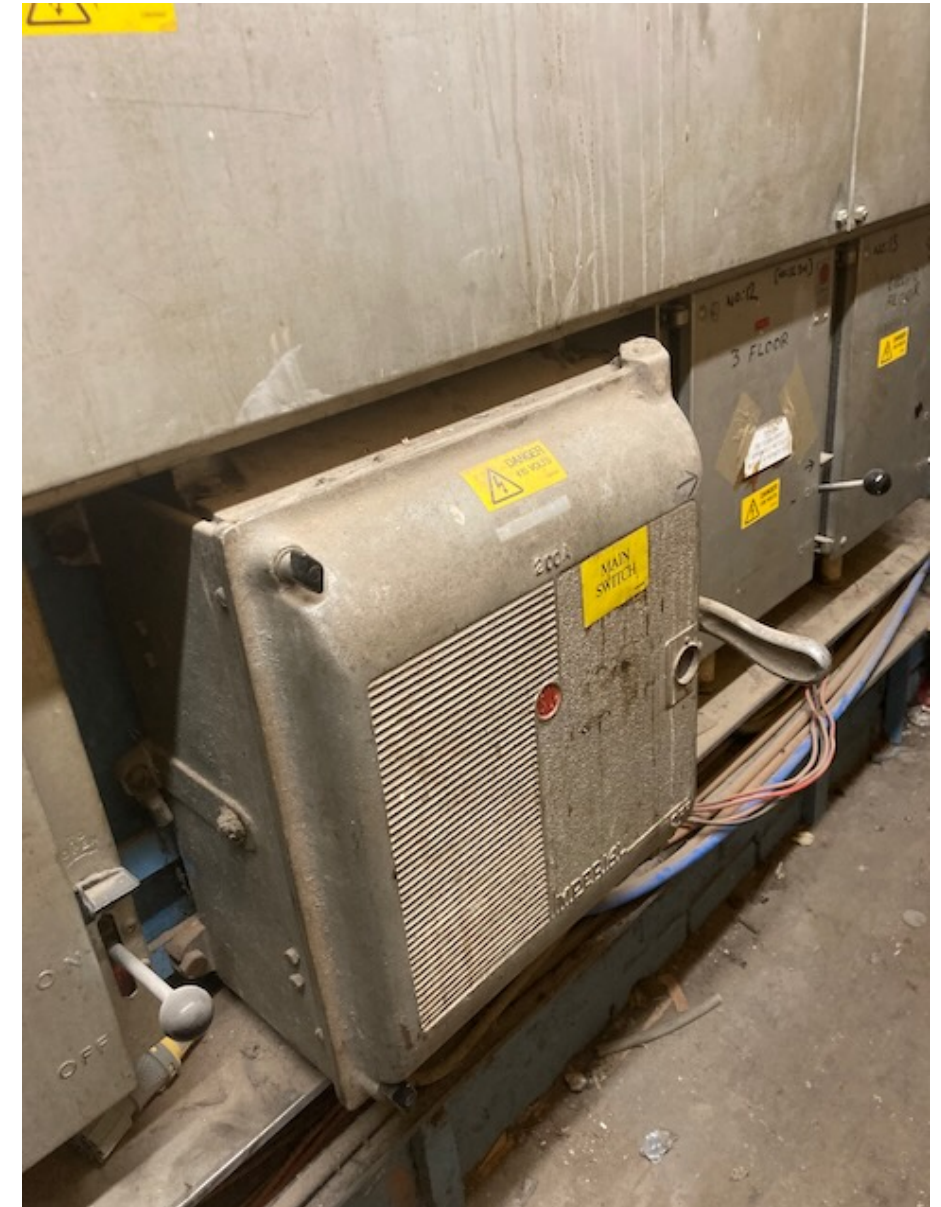
| Ref | Historic / Industrial Feature | Description | Removed / Retained | Works to be undertaken |
|---|---|---|---|---|
| G10 | Electric services & equipment | Electrical boxes and general equipment | Removed | All electrical equipment and installations to be removed |

**ITEM G10**  
Incoming electric supplies

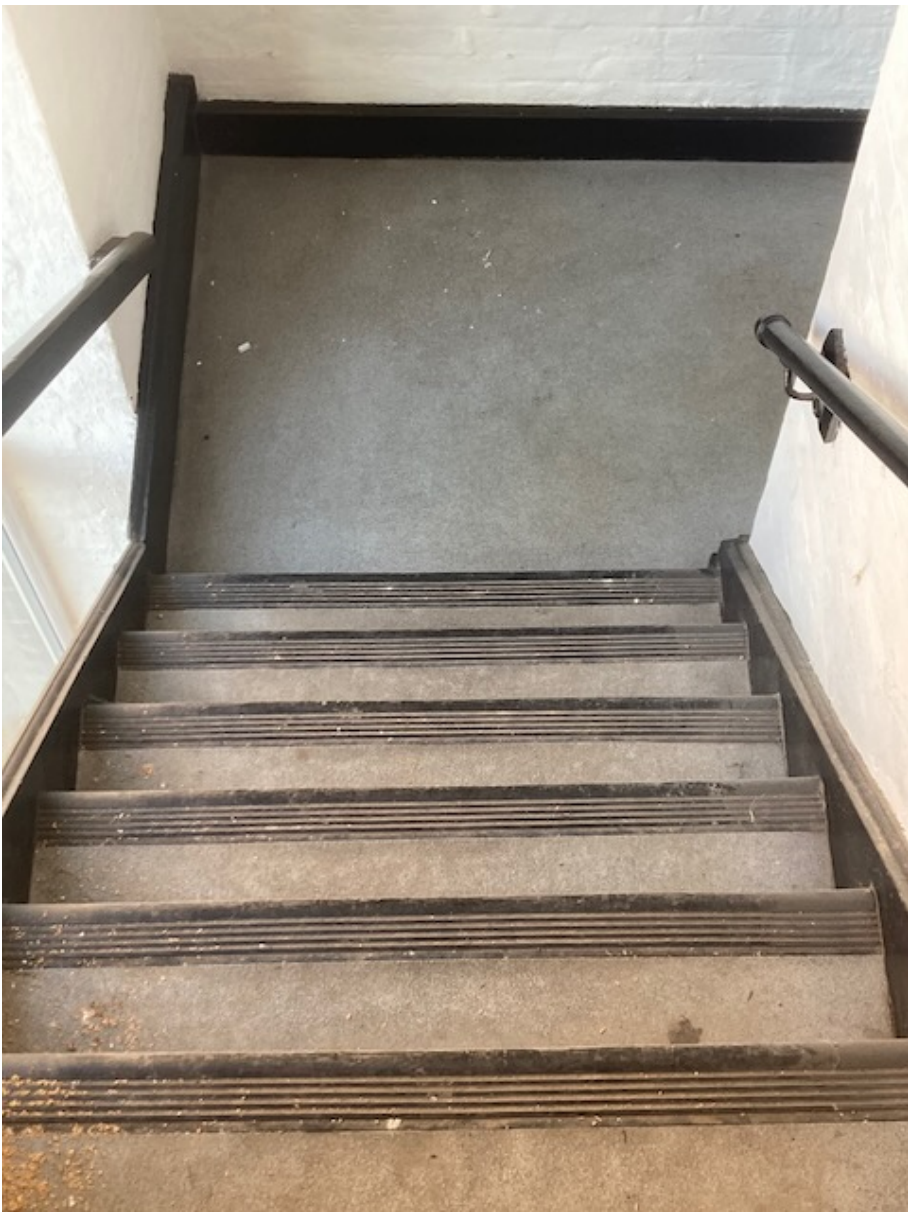
| Ref | Historic / Industrial Feature | Description | Removed / Retained | Works to be undertaken |
|---|---|---|---|---|
| G11 | North east stair | Painted brickwork walls to stair enclosure with stair construction of timber joists overlaid with timber board flooring and vinyl covering. Underside of boards form soffit. | Retained & cleaned of paint | Existing paint finish to be lightly removed and brickwork left uncoated and exposed. Vinyl floor covering to be removed and replaced. Boards and joists to be lightly cleaned of paint and fully exposed. |

**ITEM G11**  
Typical vinyl floor covering to north east stair
