## Jonathan Davidson Architects

Neptune Mill  
Chapelton St, Manchester

Historic & Industrial Features Audit  
353 PD 2001 (P2)

*October 2023*

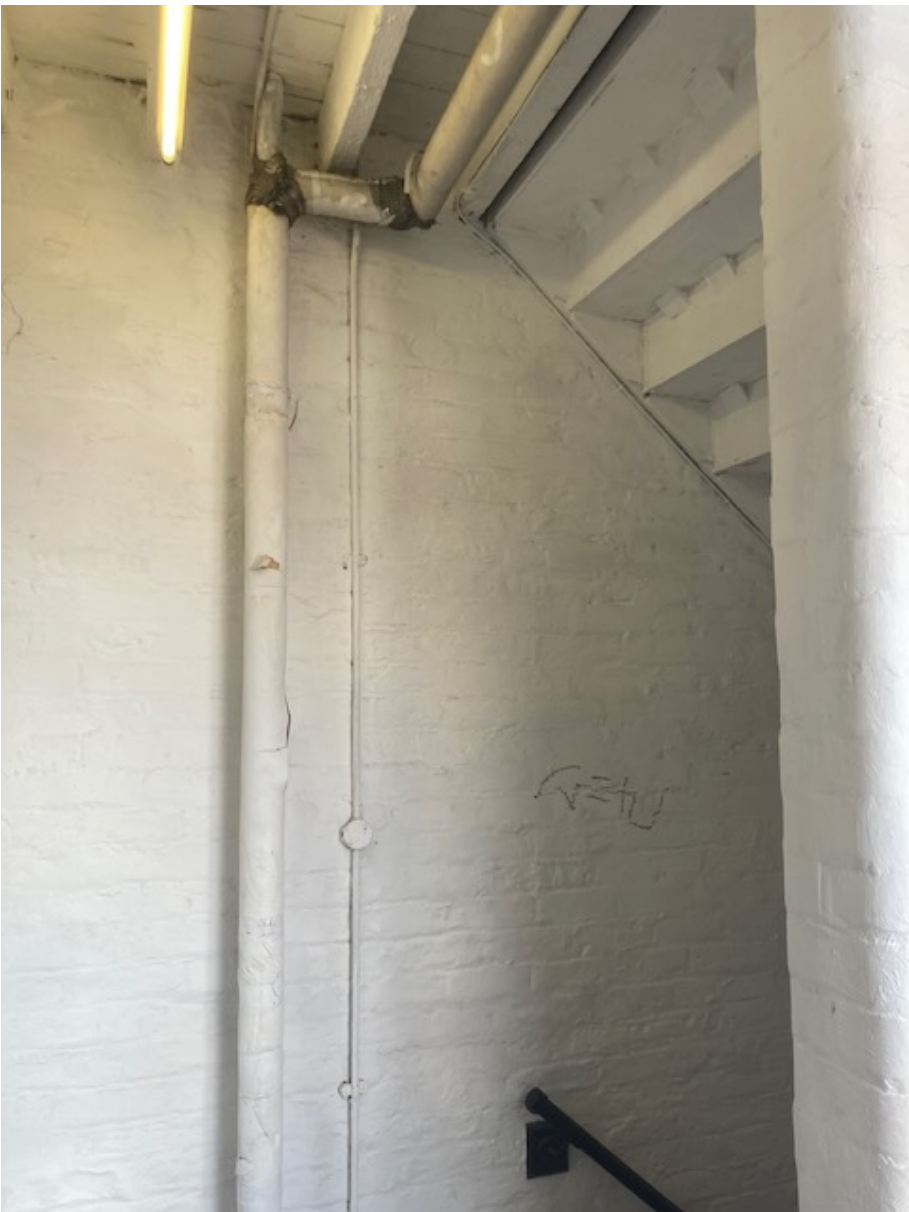
**ITEM G11**  
Typical painted walls to north east stair

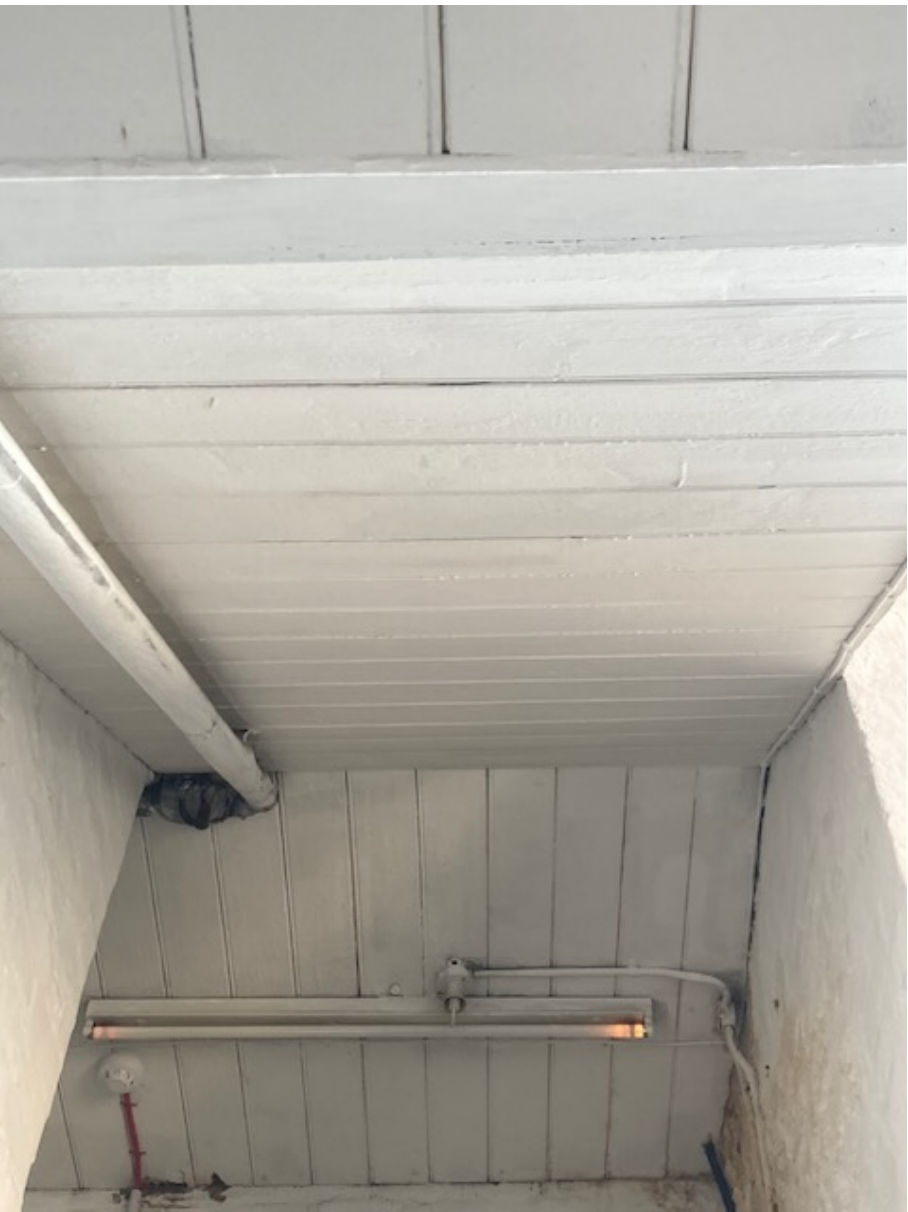
**ITEM G11**  
Typical timber soffit to north east stair

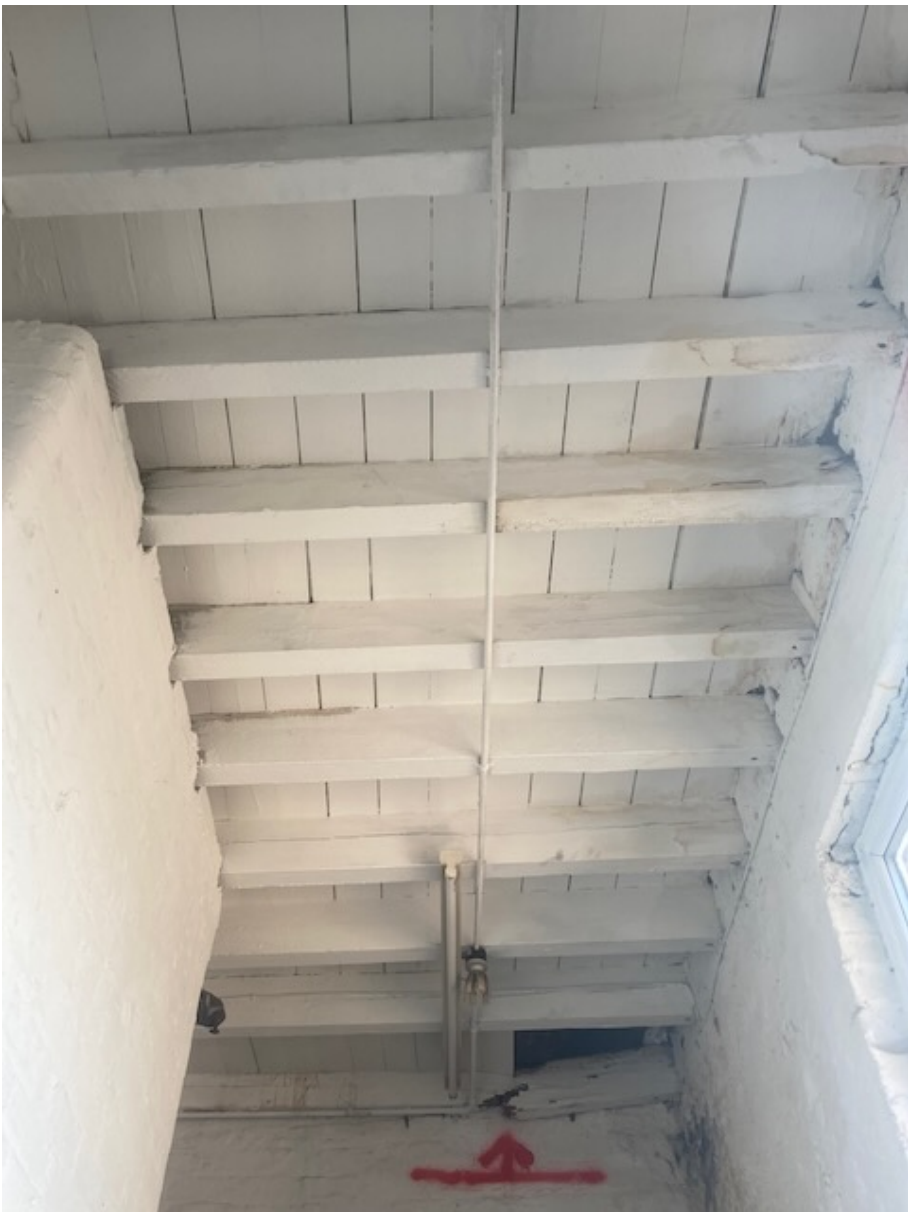
**ITEM G11**  
Timber joists and soffit to top floor of north east stair

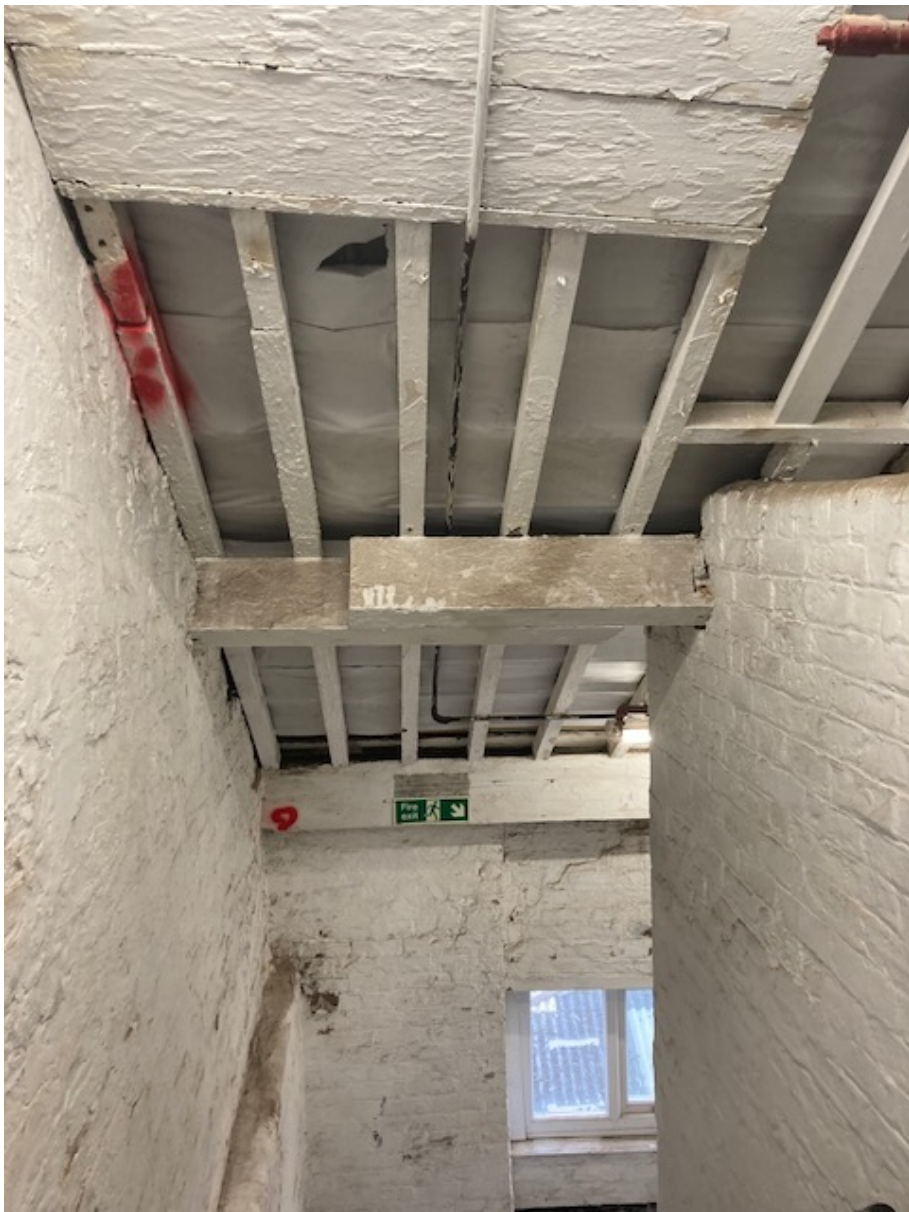
| Ref | Historic / Industrial Feature | Description | Removed / Retained | Works to be undertaken |
|---|---|---|---|---|
| G12 | North west stair | Painted brickwork walls to stair enclosure with stair construction of concrete flights with paint finish to exposed concrete soffits. | Retained & cleaned of paint | Existing paint finish to be lightly removed and brickwork left uncoated and exposed. Concrete elements to be cleaned of paint and coated with clear dust sealer. |

**ITEM G12**  
Timber joists to top floor of north west stair

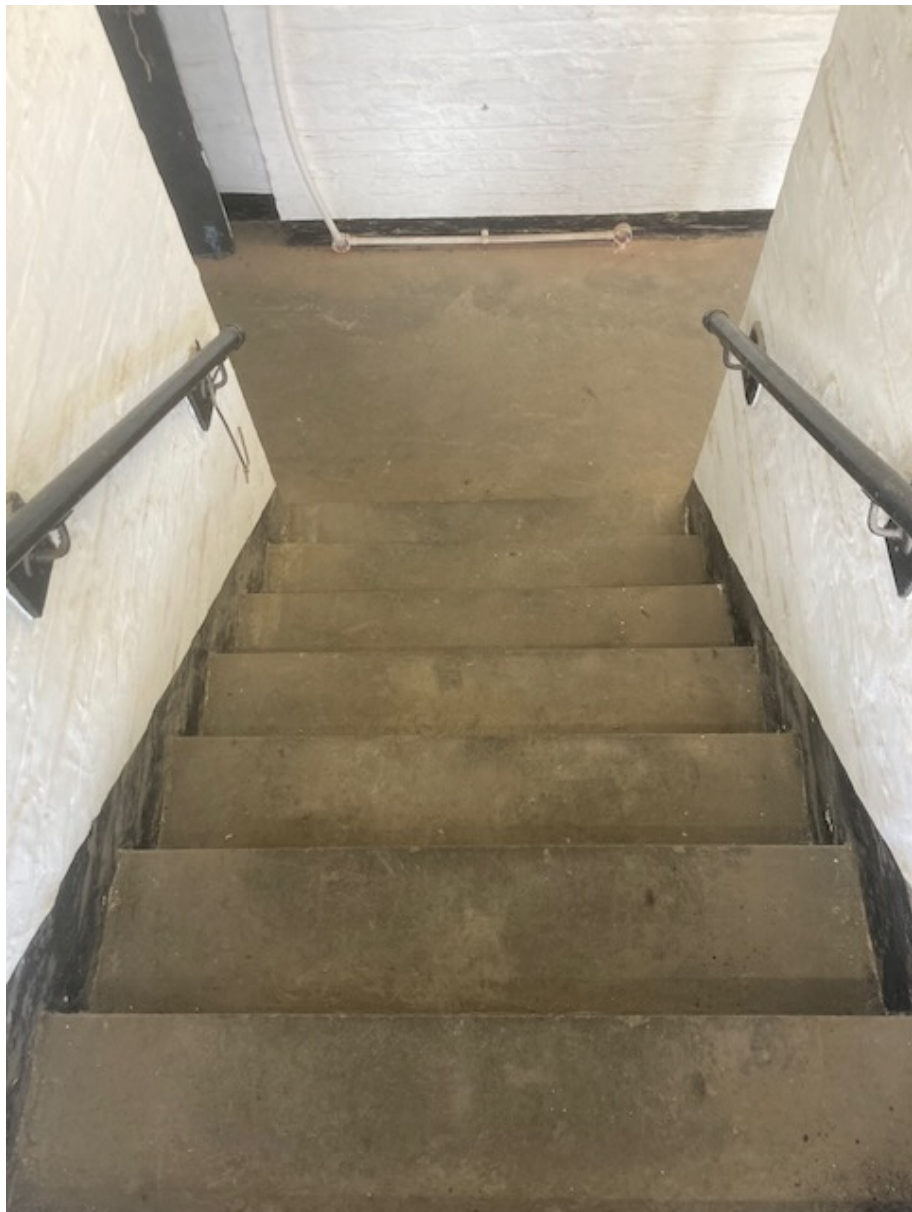
**ITEM G12**  
Typical concrete stairs to north west stair

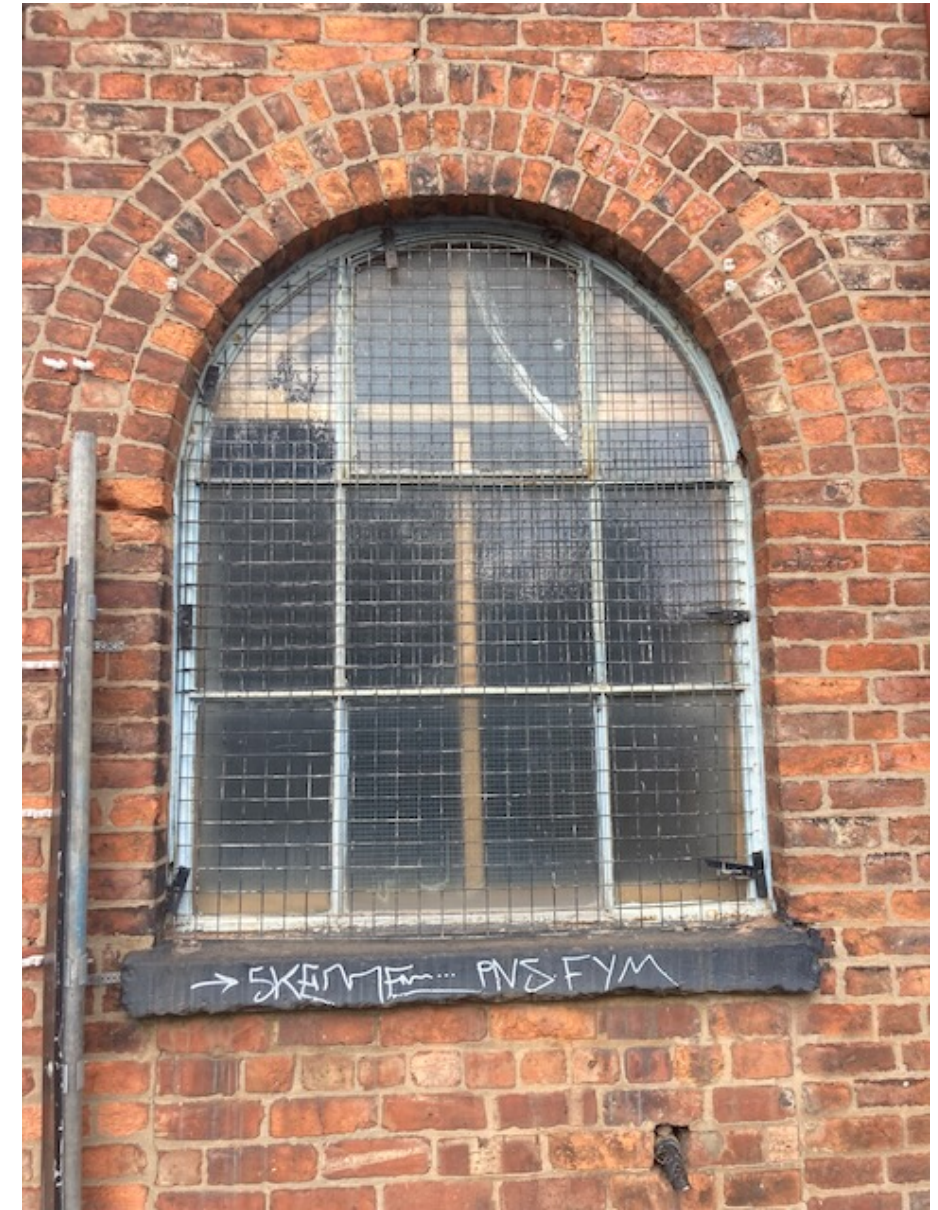
| Ref | Historic / Industrial Feature | Description | Removed / Retained | Works to be undertaken |
|---|---|---|---|---|
| G13 | Ground floor & lift shaft windows | W20 framed single glazed metal windows | Removed & replaced | Windows removed and replaced with new aluminium throughout. Note windows at upper levels are all uPVC and are being replaced. |

**ITEM G13**  
Metal arched window to Baird Street ground floor

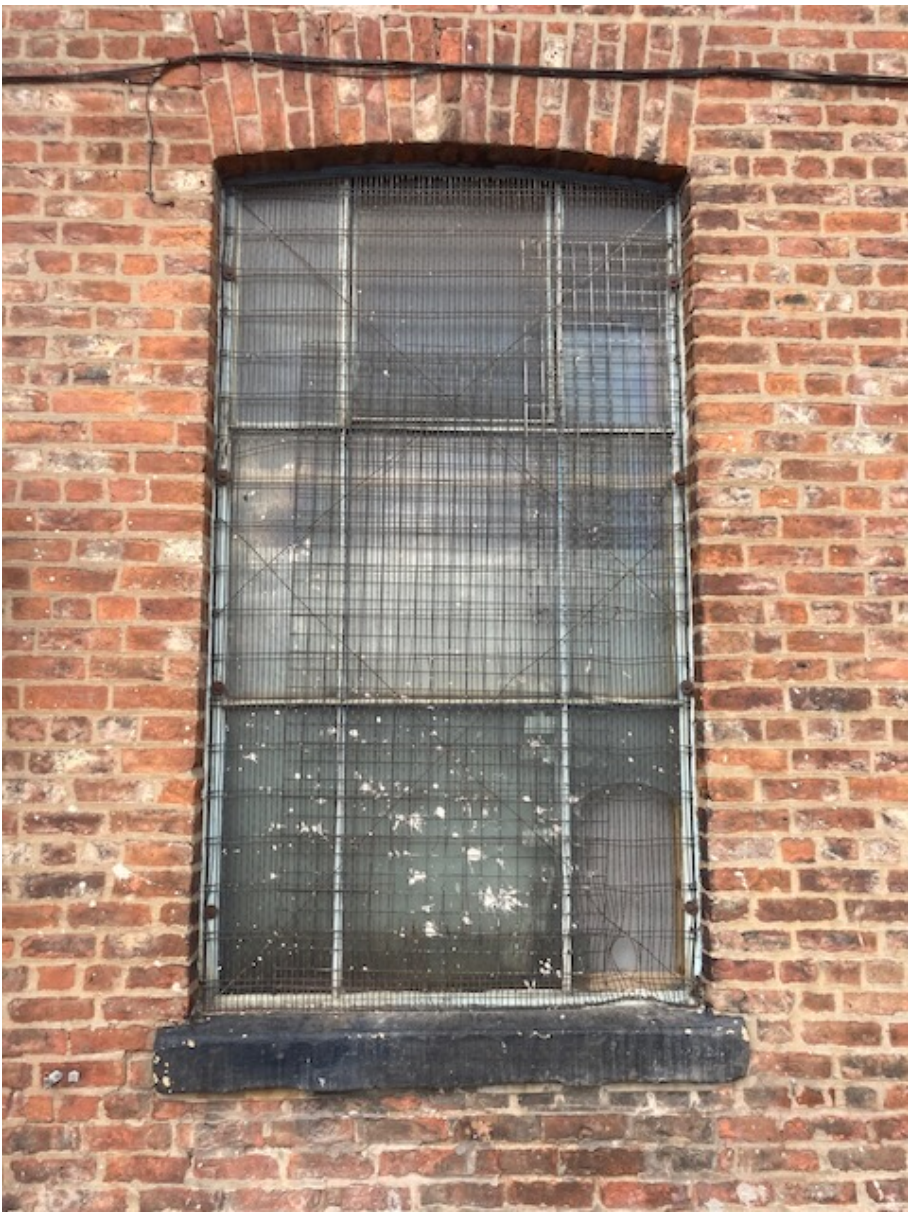
**ITEM G13**  
Typical metal window to Baird Street ground floor

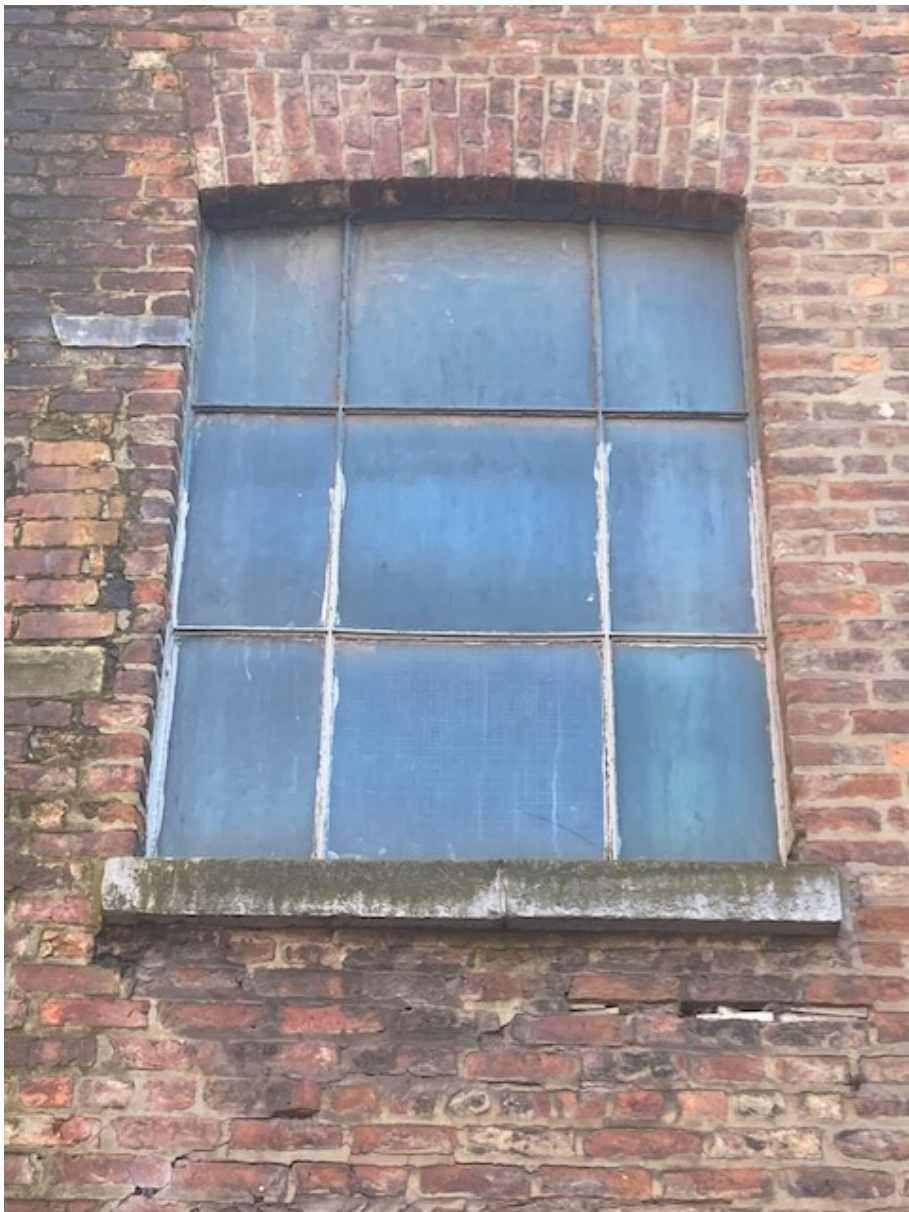
**ITEM G13**  
Typical metal window to lift shaft on north elevation

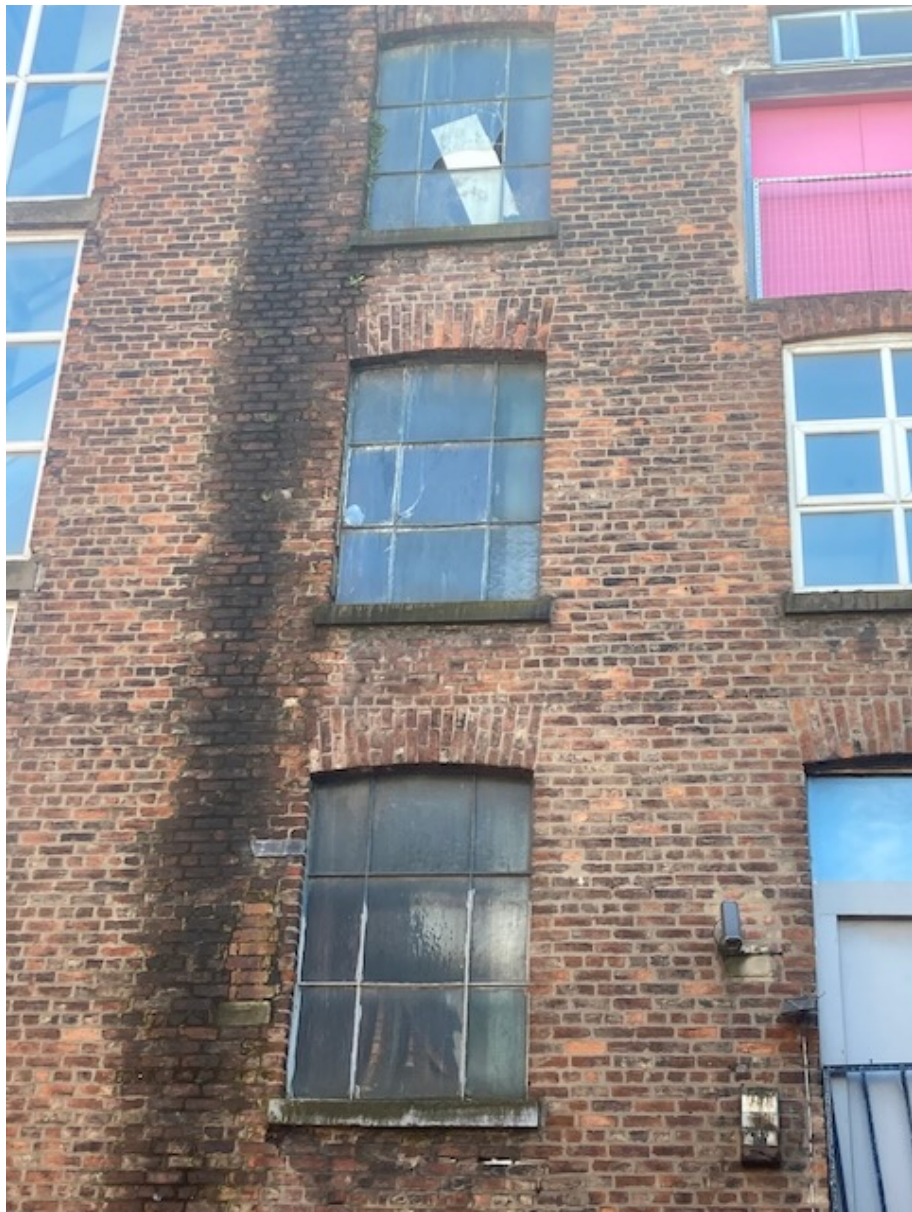
**ITEM G13**  
Group of three metal windows to lift shaft on north elevation

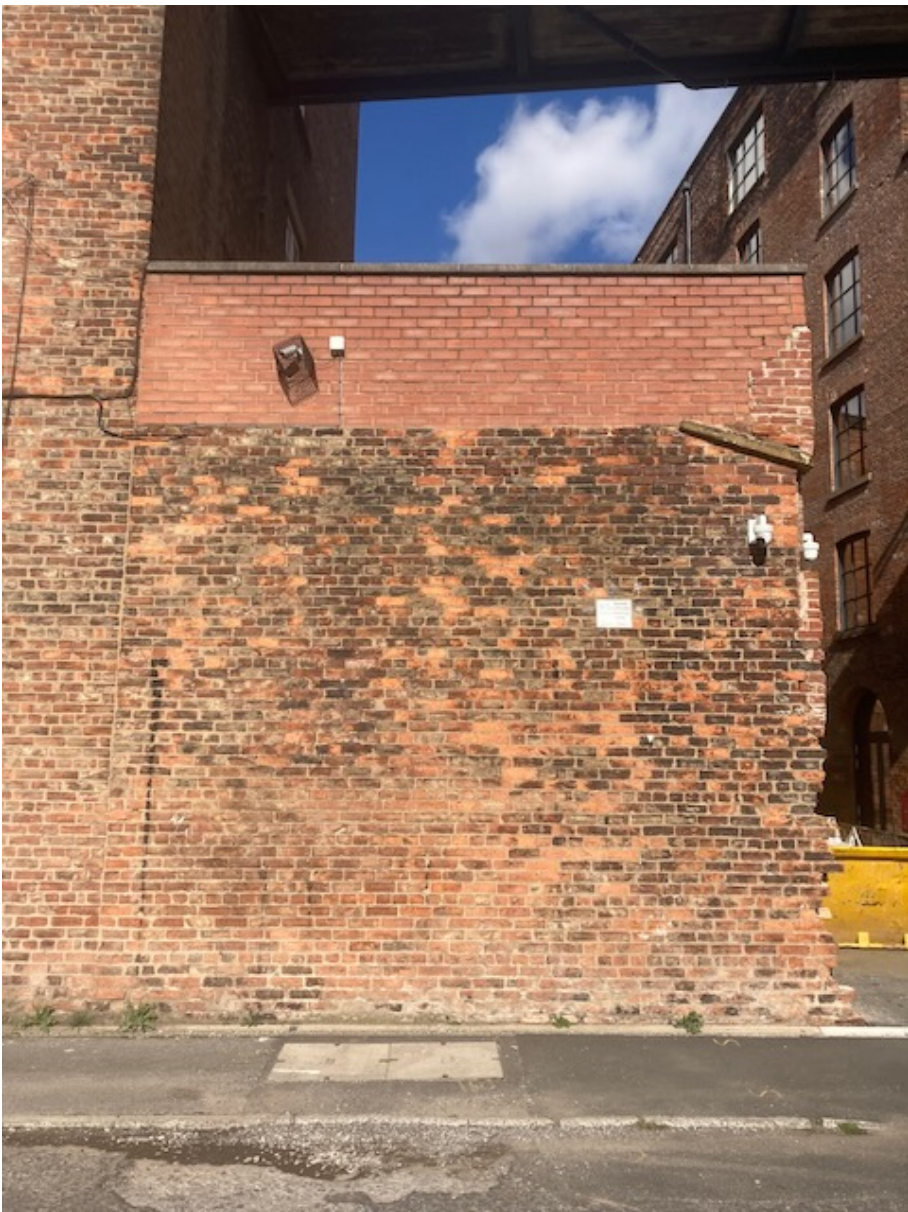
| Ref | Historic / Industrial Feature | Description | Removed / Retained | Works to be undertaken |
|---|---|---|---|---|
| 01 | Single storey offshoot to east gable end | Perimeter walls of brickwork of varying ages. Lower level of older brickwork with band of new brickwork above. Concrete floor slab laid to falls. Profiled metal roof covering laid on steel beams built in to gable wall. Steel roller shutter door to north elevation. | Removed | External walls to be removed down to underside of existing slab. Roof structure and covering to be removed. Concrete slab to be removed. |

**ITEM 01**  
Single storey offshoot viewed from Baird Street

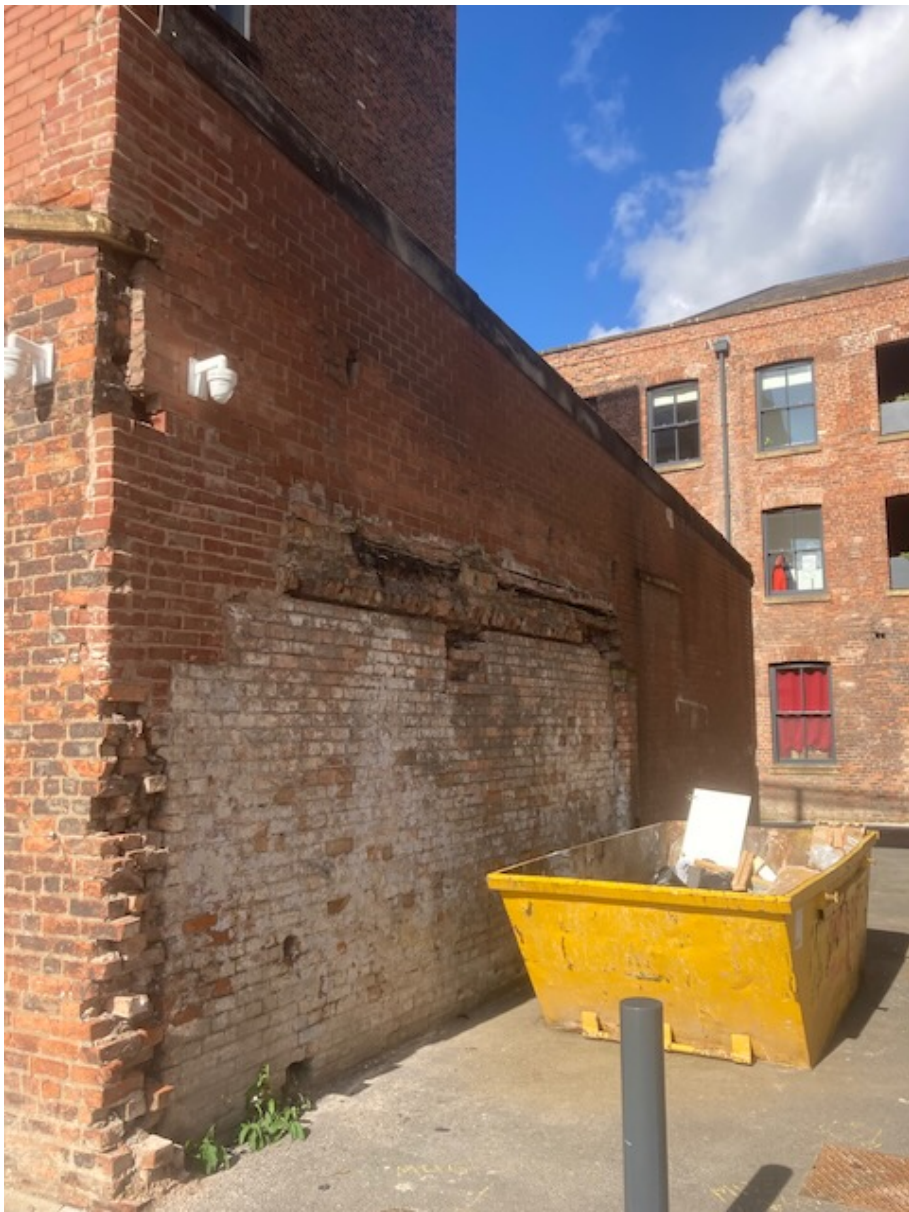
**ITEM 01**  
Single storey offshoot east elevation

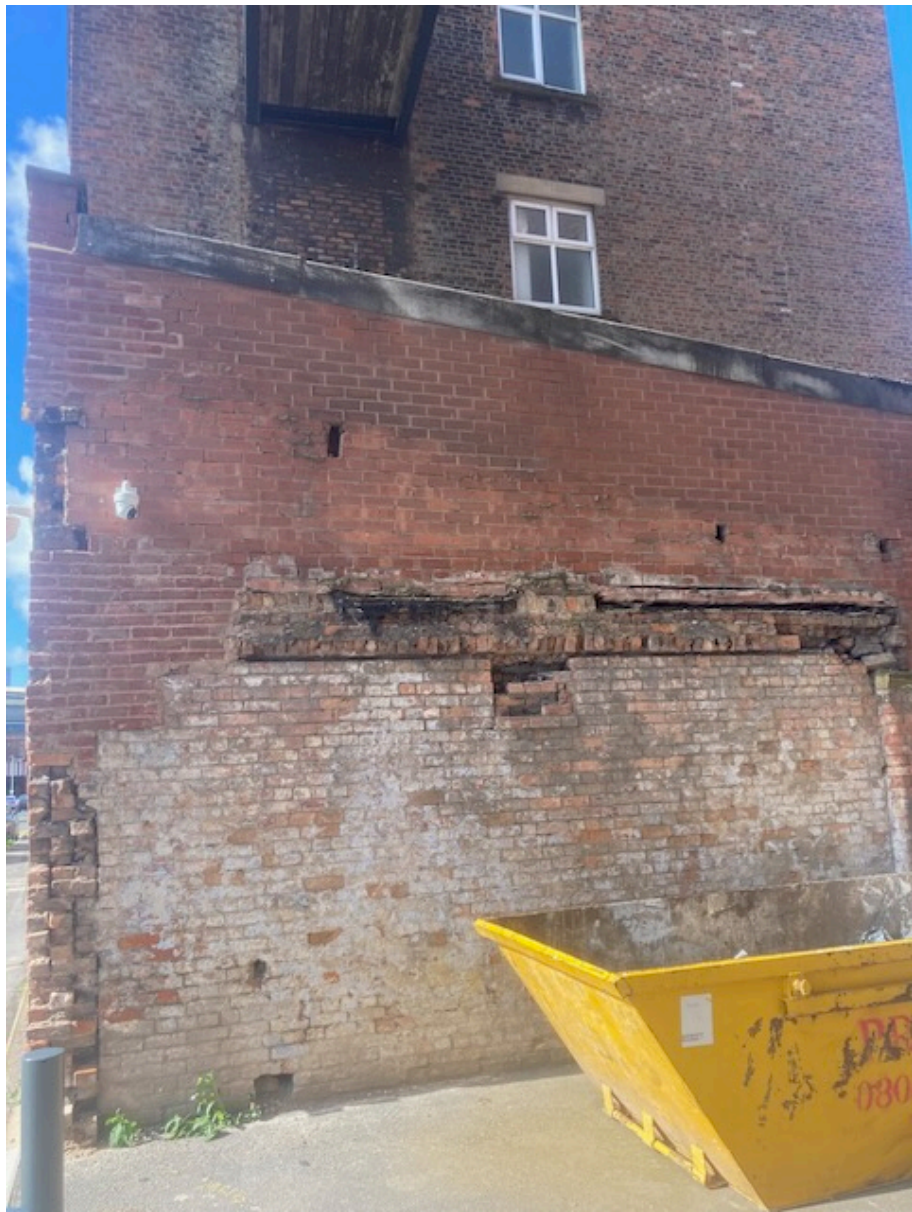
**ITEM 01**  
Single storey offshoot east elevation

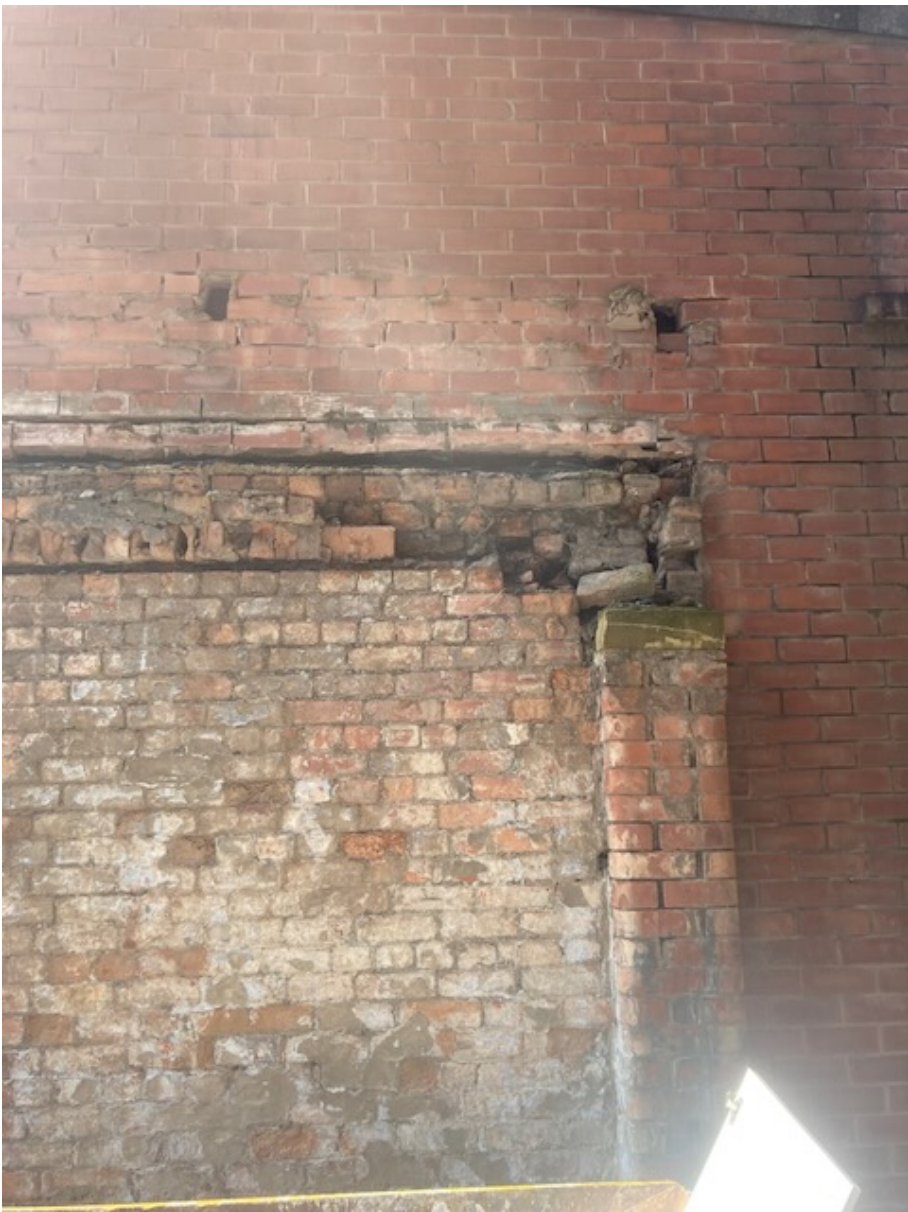
**ITEM 01**  
Detail of brickwork to east elevation of offshoot

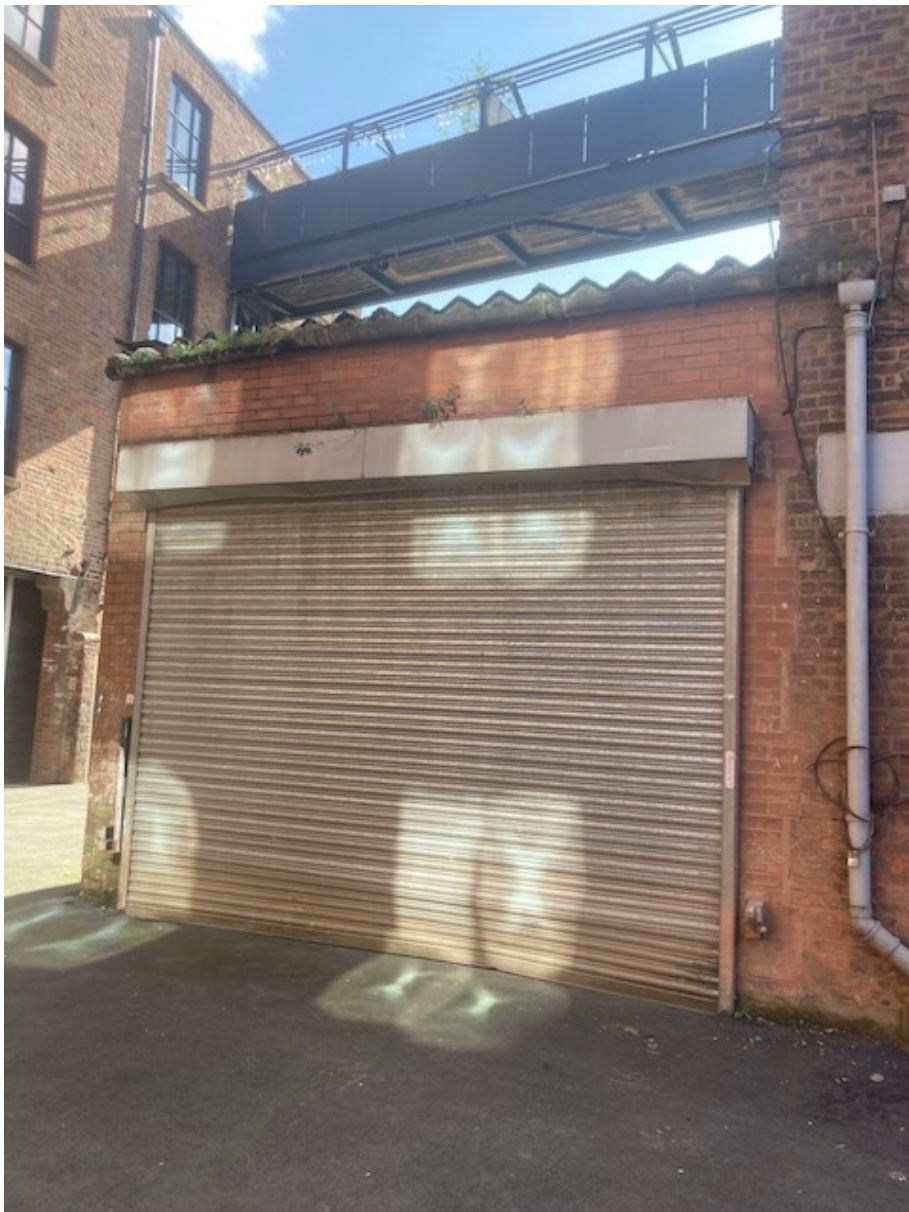
**ITEM 01**  
Single storey offshoot north elevation

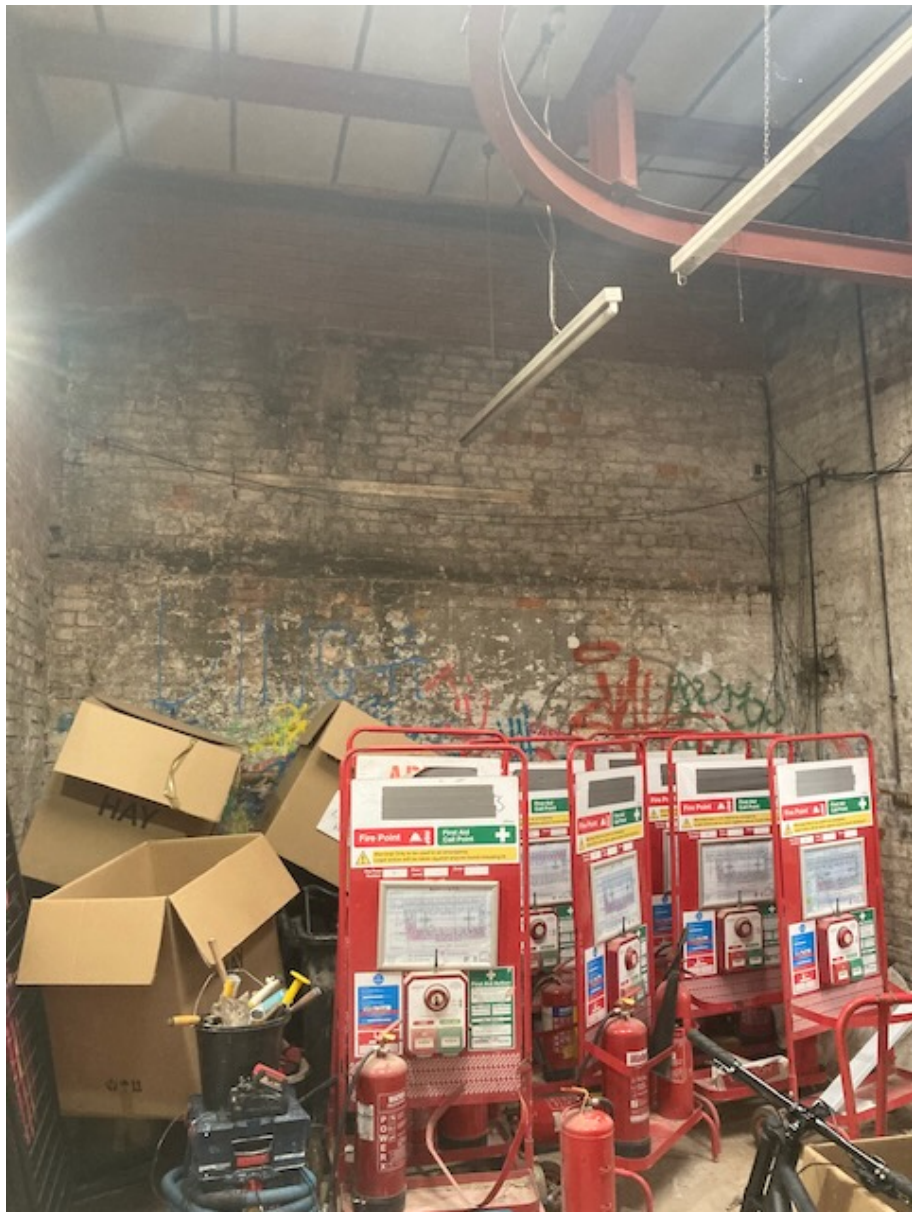
**ITEM 01**  
Internal view of single storey offshoot showing new roof steelwork

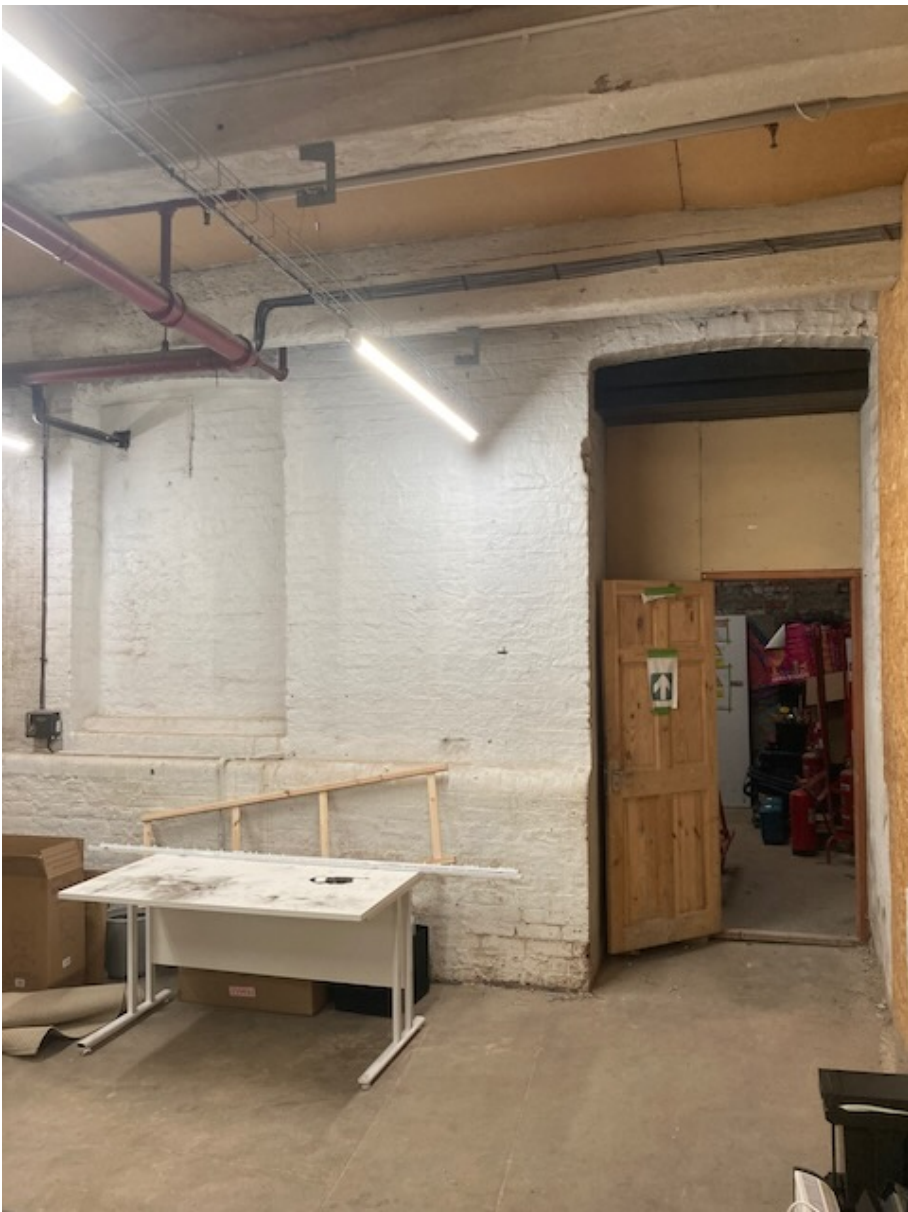
| Ref | Historic / Industrial Feature | Description | Removed / Retained | Works to be undertaken |
|---|---|---|---|---|
| 02 | Brickwork to east gable | External brick wall including recessed openings to internal face | Partially removed | Brickwork to be removed and new steel inserted to create new entrance opening |

**ITEM 02**  
Brickwork and features to internal face of east gable

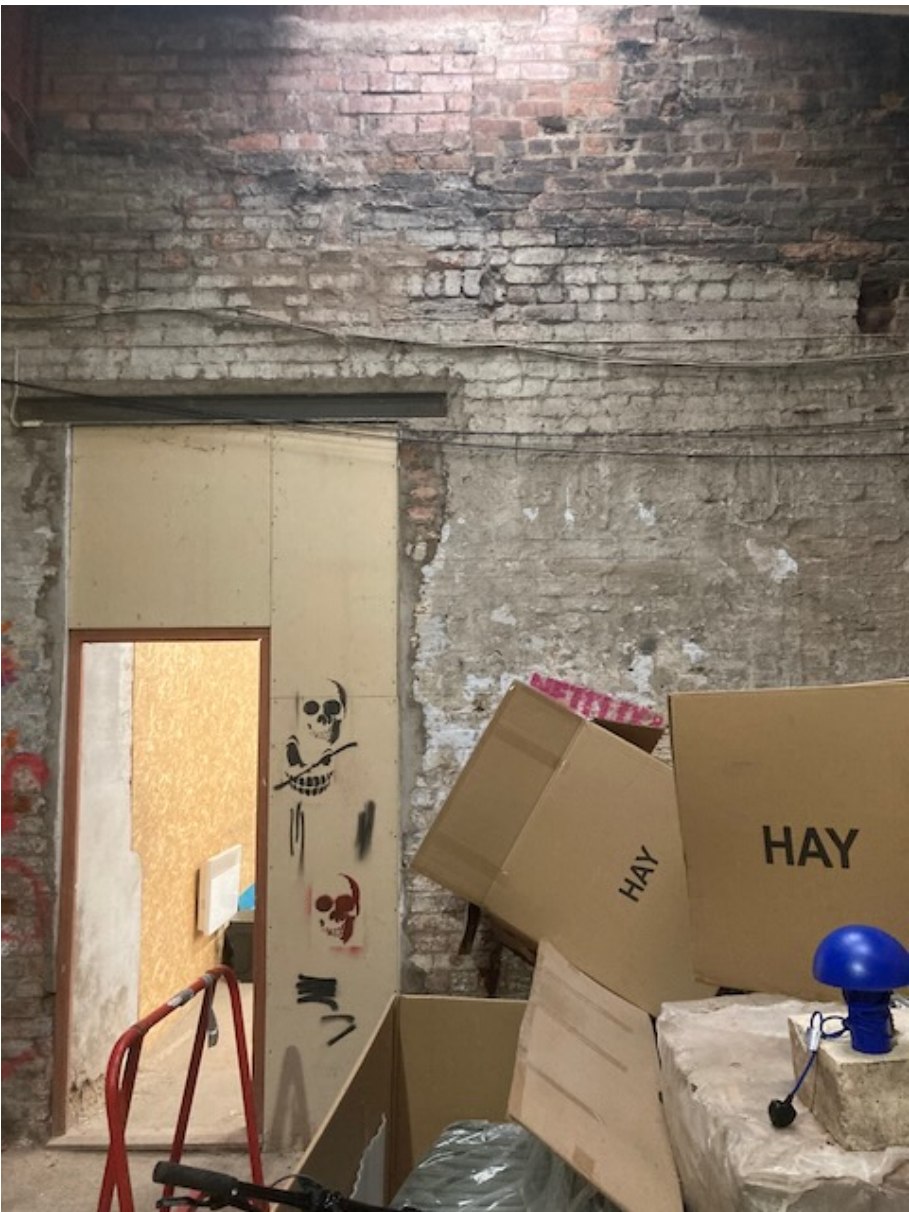
**ITEM 02**  
Brickwork and features to external face of east gable

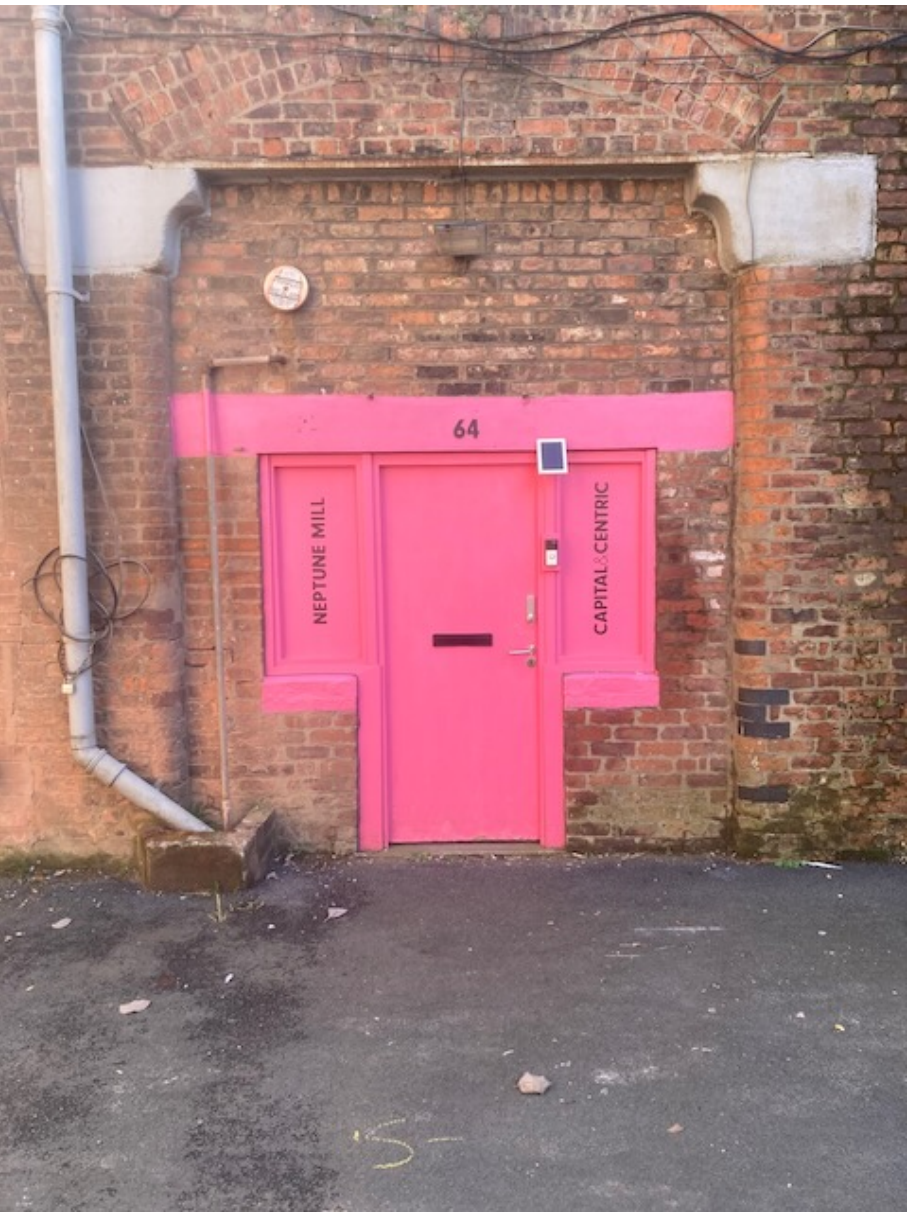
| Ref | Historic / Industrial Feature | Description | Removed / Retained | Works to be undertaken |
|---|---|---|---|---|
| 03 | Door and windows to NE stair | Timber door and window arrangement forming existing entrance from courtyard. Painted stone lintel above opening. | Removed & replaced | Stone lintel to be cleaned of paint and retained. Door and windows to be removed, window openings to be infilled with bricks reclaimed from alterations elsewhere and new aluminium door installed. |

**ITEM 03**  
Brickwork opening with stone lintel to north elevation

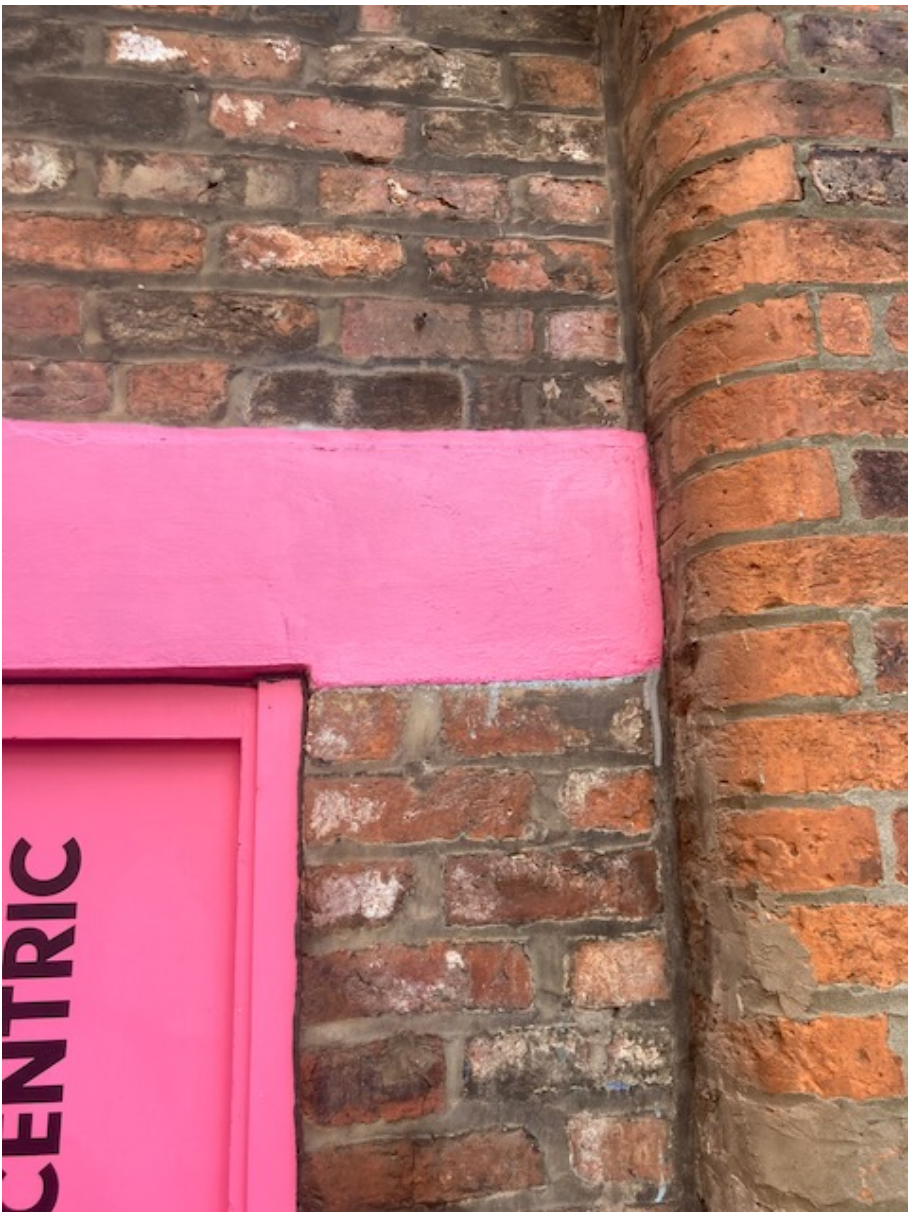
**ITEM 03**  
Painted stone lintel to head of entrance opening

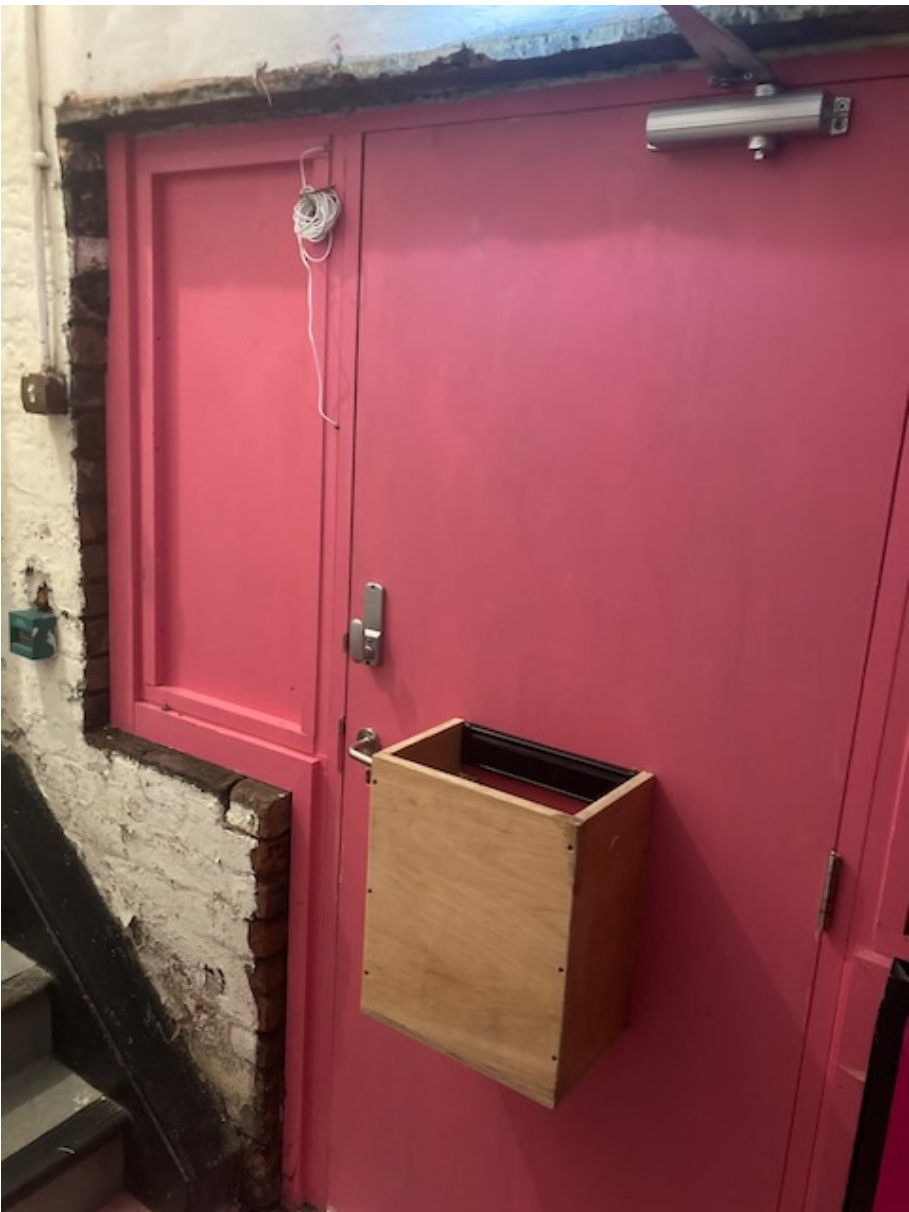
**ITEM 03**  
Entrance opening viewed from inside
