## Jonathan Davidson Architects

Neptune Mill  
Chapelton St, Manchester

Historic & Industrial Features Audit  
353 PD 2001 (P2)

*October 2023*

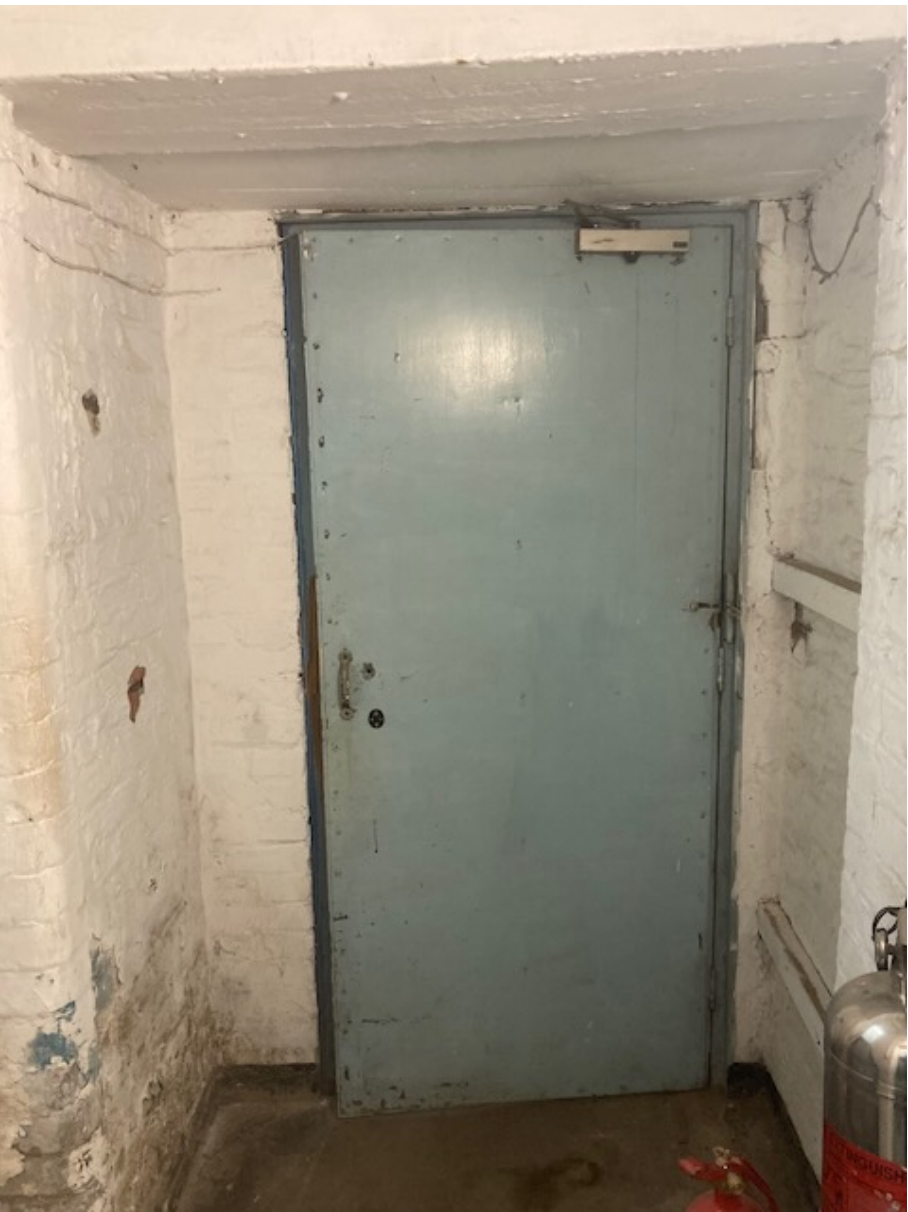
| Ref | Historic / Industrial Feature | Description | Removed / Retained | Works to be undertaken |
|---|---|---|---|---|
| 04 | Internal door to NW stair | Painted timber door with steel sheet overlay | Door and frame only to be removed. Brick surround and concrete lid retained | Door to be removed and replaced with new FD30 rated fire door |

**ITEM 04**  
Access door to north west stair (staircase side)

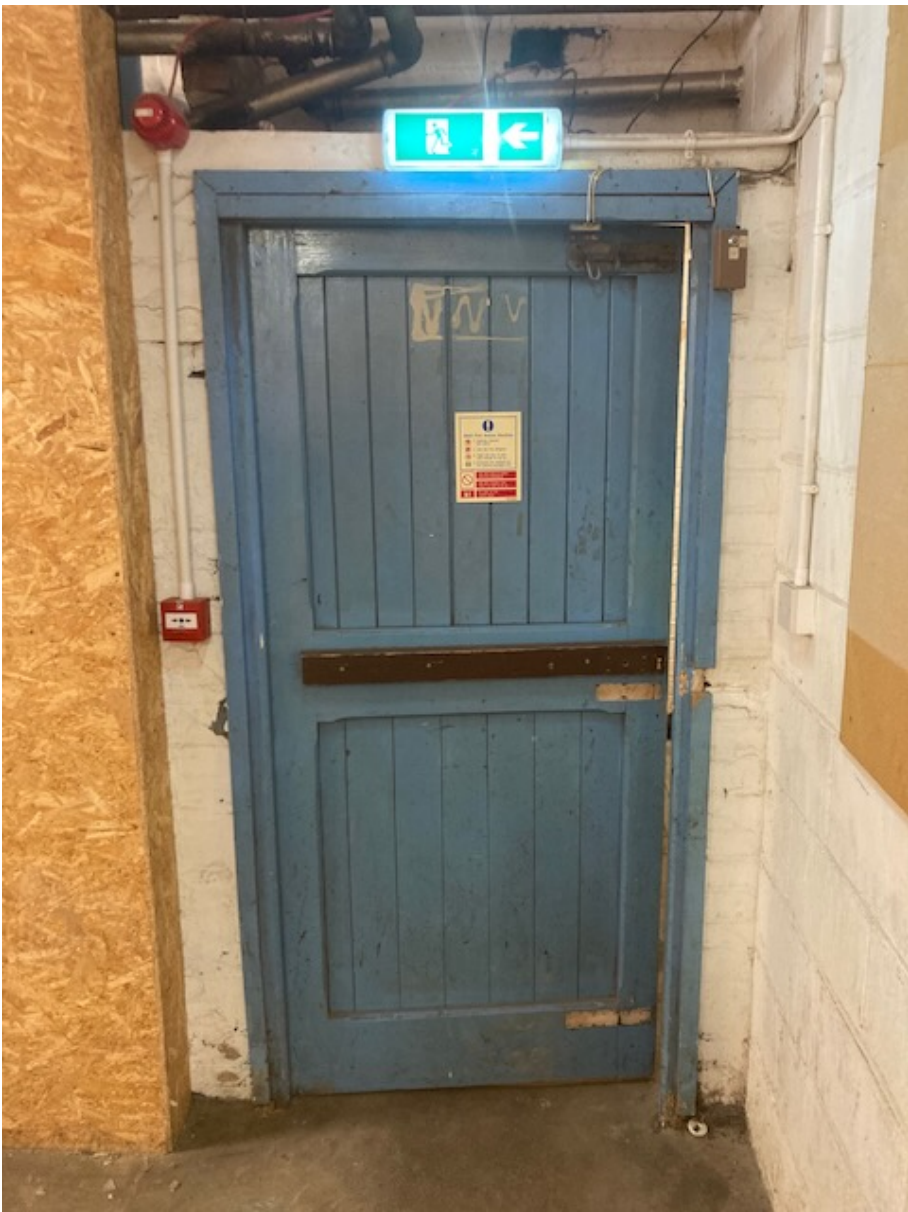
**ITEM 04**  
Access door to north west stair (office side)

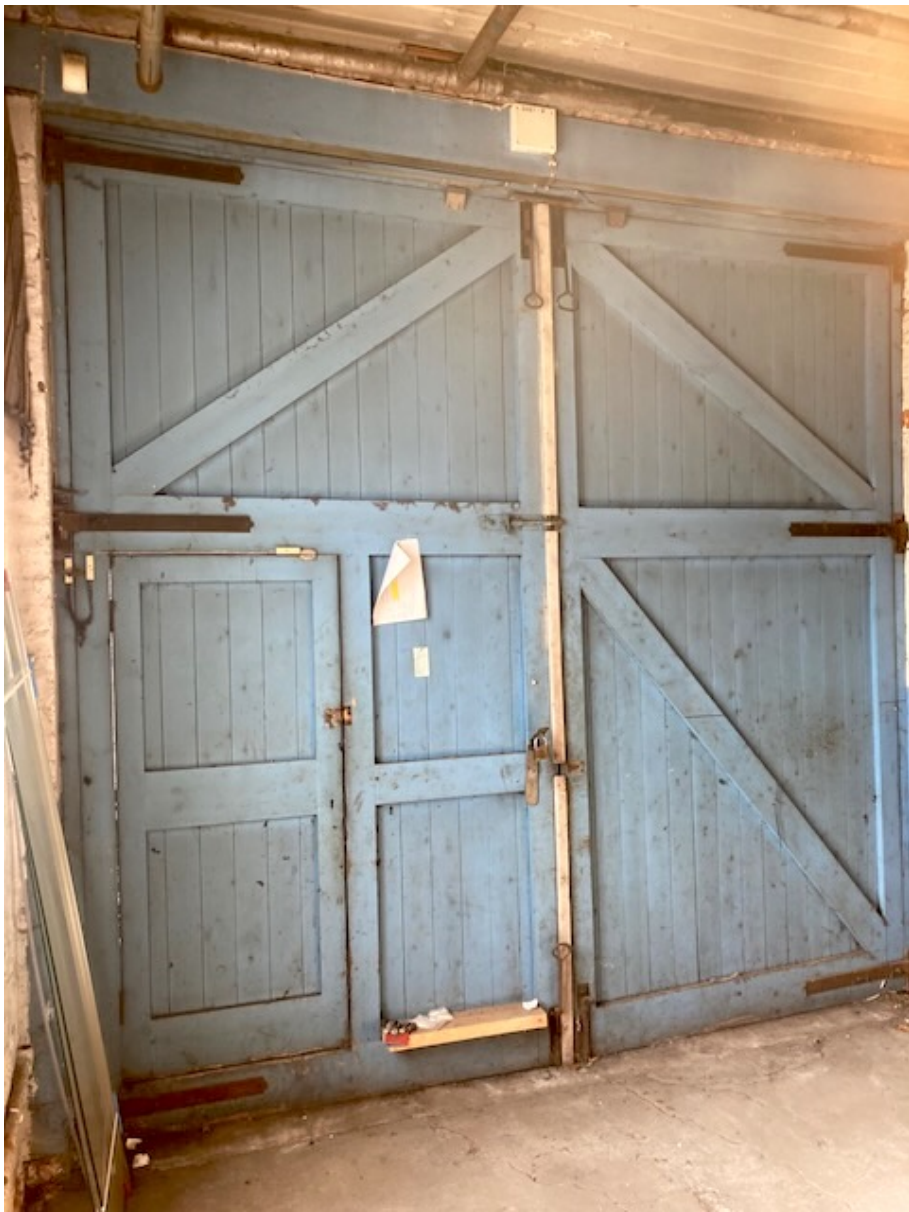
| Ref | Historic / Industrial Feature | Description | Removed / Retained | Works to be undertaken |
|---|---|---|---|---|
| 05 | External doors to west gable | Large, painted timber doors with inset personnel door and steel sheet overlay to external face | Retained, cleaned & exposed | Steel overlay sheeting to be removed externally. doors to be stripped of paint, sanded and coated with clear preservative treatment. ironmongery retained and repainted |

**ITEM 05**  
Internal view of doors to west gable

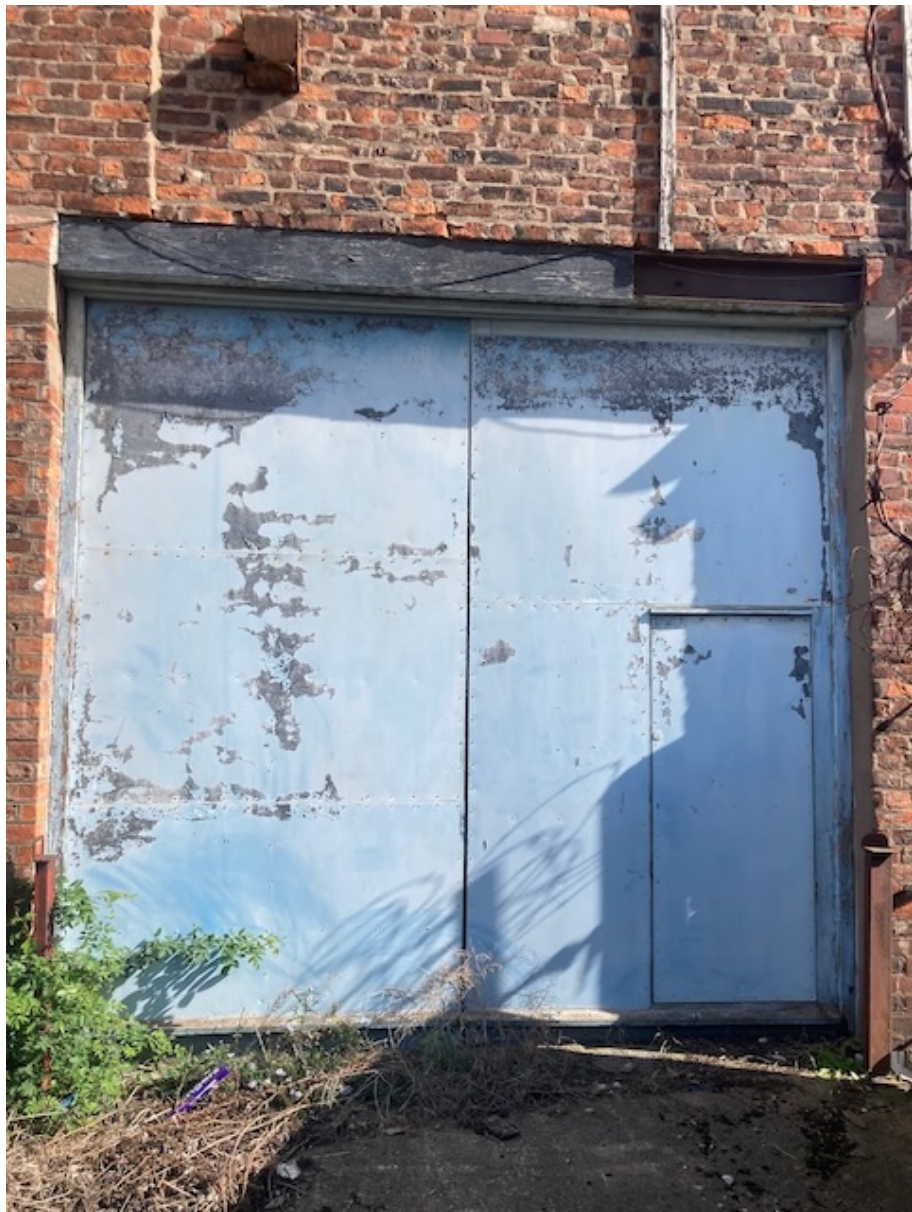
**ITEM 05**  
External view of doors to west gable

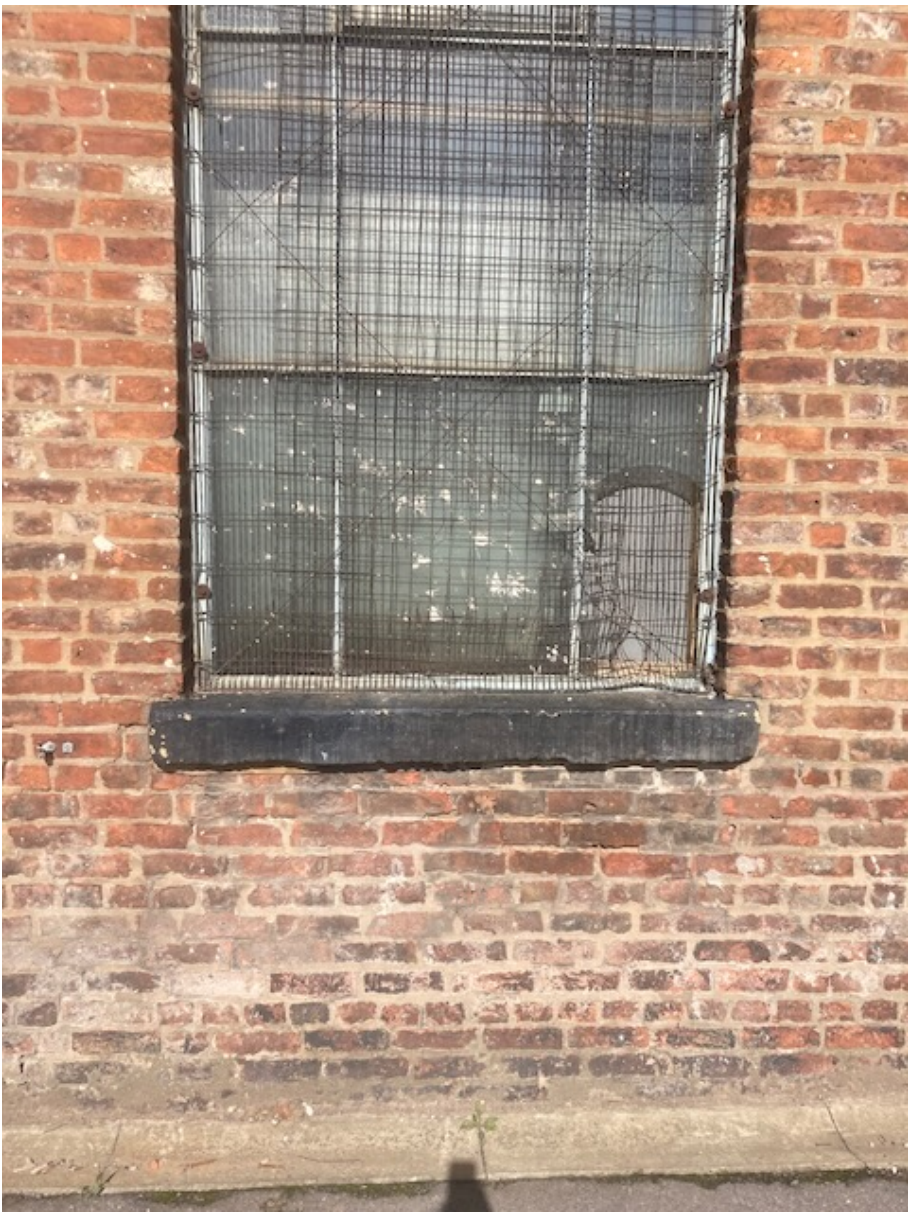
| Ref | Historic / Industrial Feature | Description | Removed / Retained | Works to be undertaken |
|---|---|---|---|---|
| 06 | Window cill and brickwork below to Baird Street elevation | Painted stone external window cill and brick external wall below. | Partially removed | Brickwork and cill removed to create new door opening. New jambs where brickwork removed to be formed to match existing profile above using bricks reclaimed from alteration. |

**ITEM 06**  
Cill and brickwork below to Baird Street ground floor

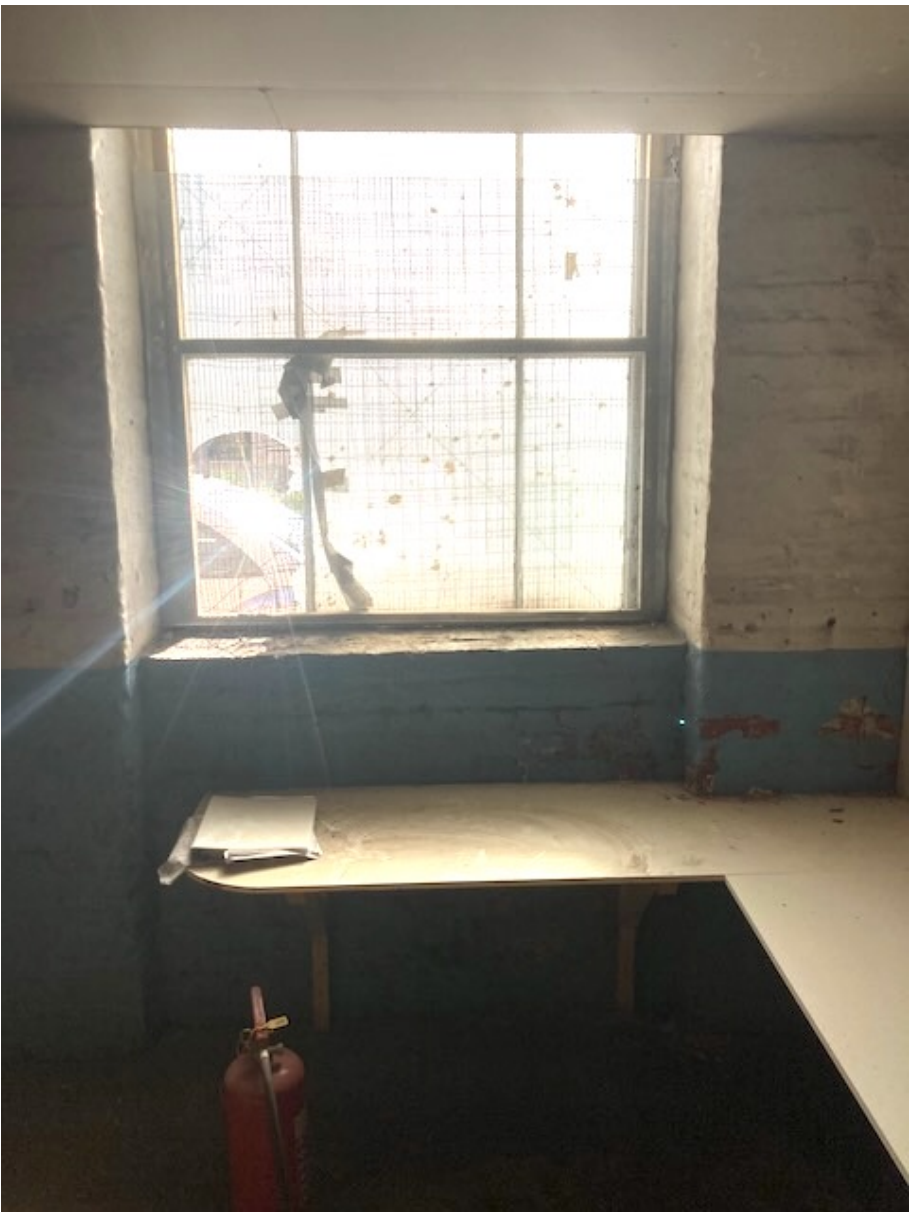
**ITEM 06**  
Internal view brickwork below window to Baird Street ground floor

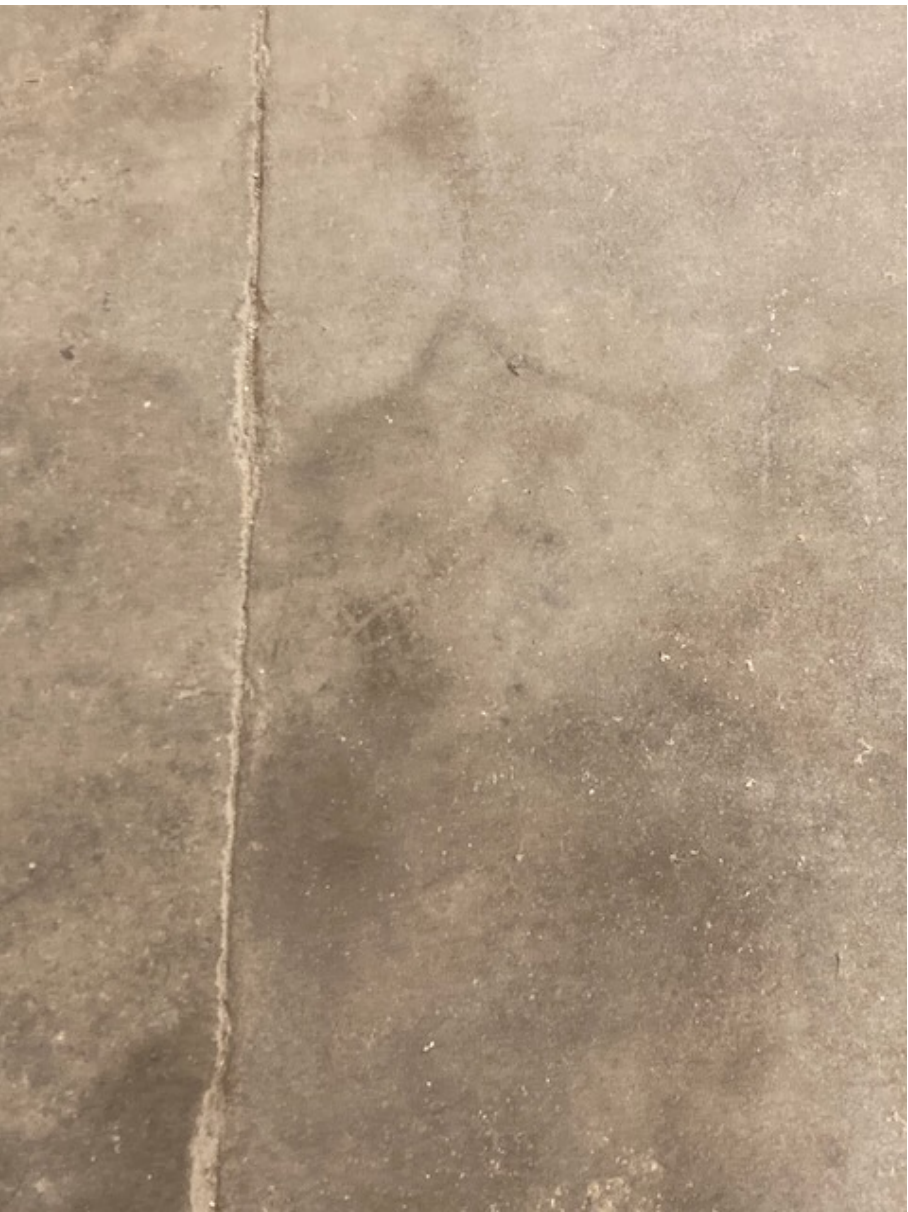
| Ref | Historic / Industrial Feature | Description | Removed / Retained | Works to be undertaken |
|---|---|---|---|---|
| 07 | Floor slab | Concrete ground floor slab | Retained and left exposed | Existing slab to be diamond polished in reception area and coated with clear dust dealer. Extent of works to remaining ground floor to be confirmed. |

**ITEM 07**  
Typical exposed concrete slab to ground floor

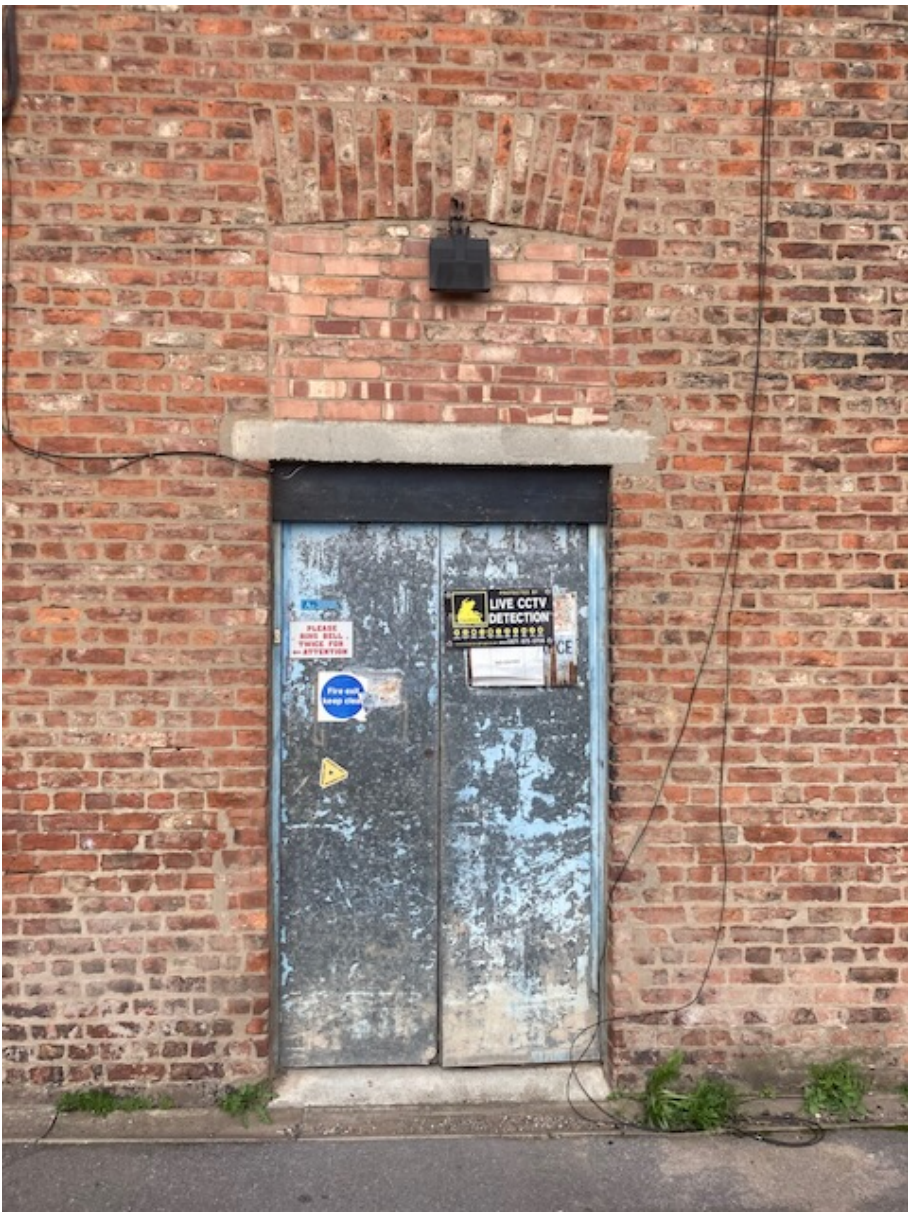
| Ref | Historic / Industrial Feature | Description | Removed / Retained | Works to be undertaken |
|---|---|---|---|---|
| 08 | Brickwork jambs to external doors on Baird Street | Poorly formed brickwork jambs to door openings following prior alterations. Original openings infilled with flush timber doors and timber/brick over panels. | Brickwork retained and made good. Infills removed | Brick jambs at low level to be reformed to match existing profile above using bricks reclaimed from alteration. Non original infills to overall openings to be removed. |

**ITEM 08**  
Infill brickwork, concrete lintel and timber doors to Baird Street opening

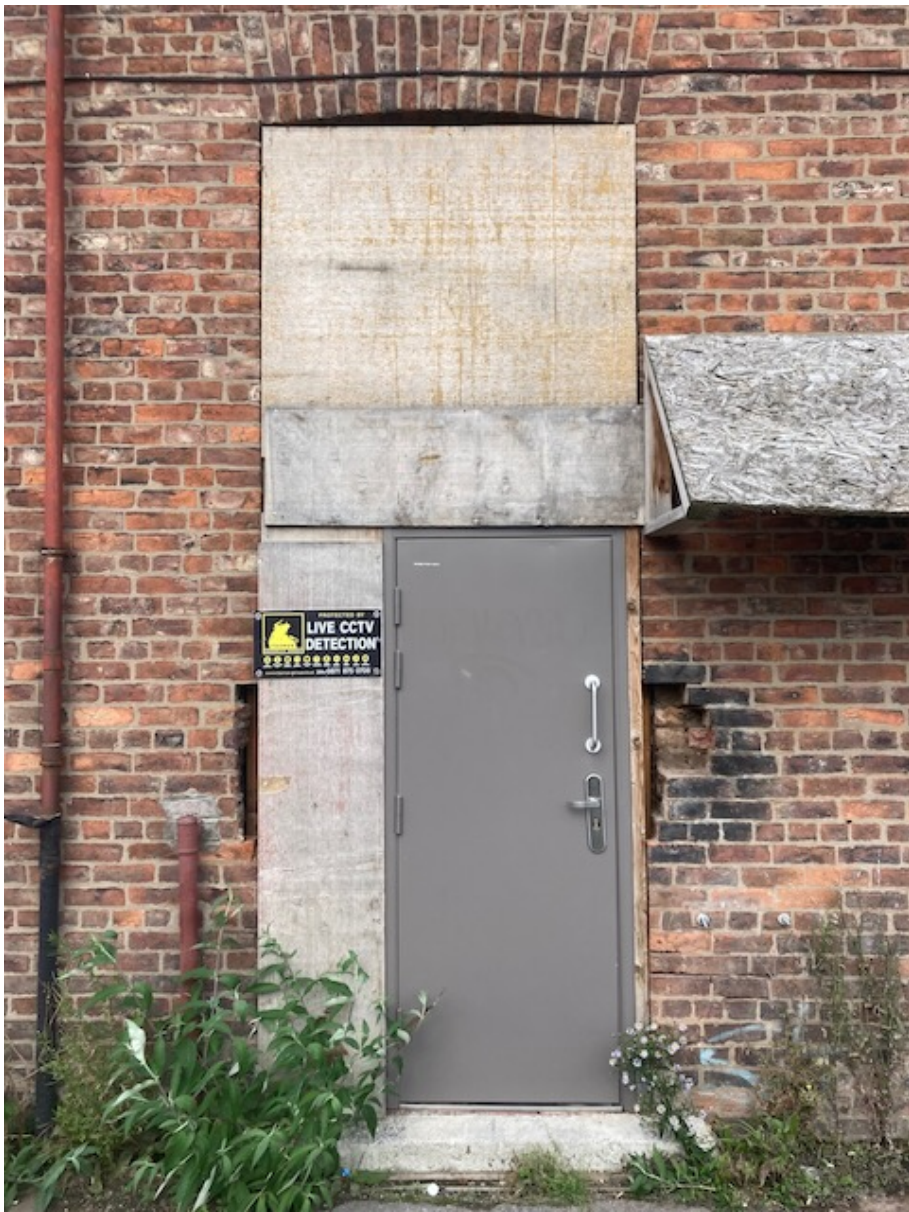
**ITEM 08**  
Timber doors and damaged brick reveals to Baird Street opening

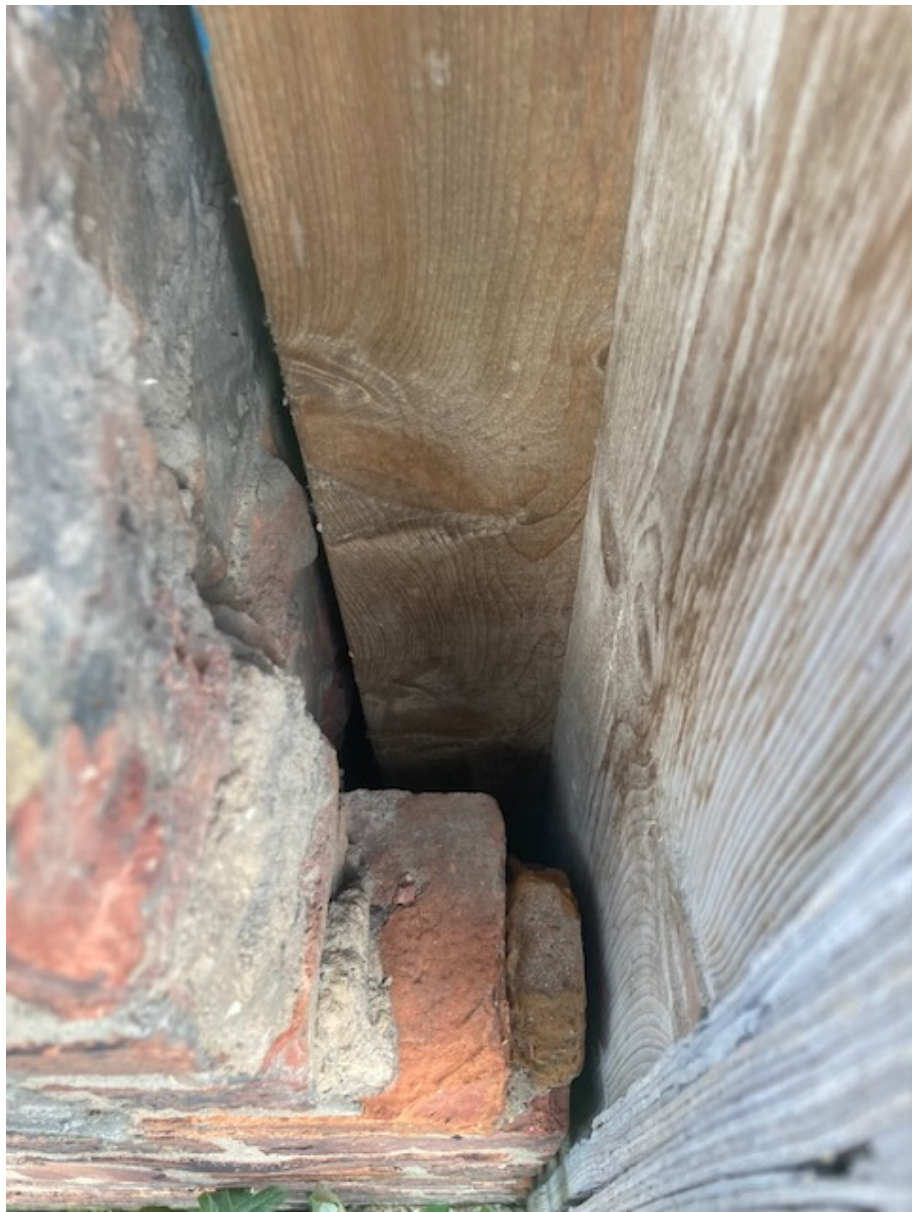
**ITEM 08**  
Damaged brick reveals to Baird Street opening

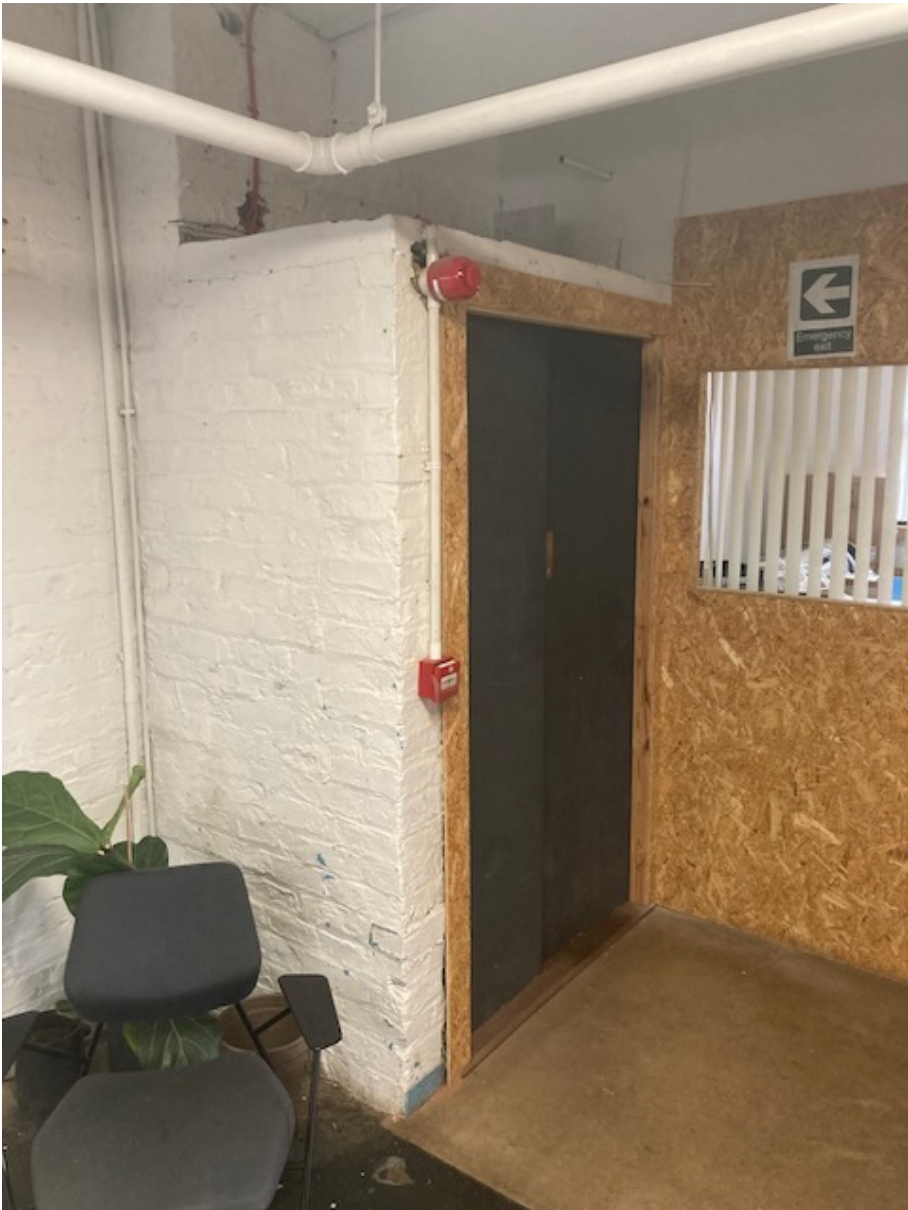
| Ref | Historic / Industrial Feature | Description | Removed / Retained | Works to be undertaken |
|---|---|---|---|---|
| 11 | Door surround to NE staircase | Painted brickwork flank walls with concrete lid over and timber doors. | Removed | Brickwork, lid and doors to be removed and new stud walls installed to form enlarged stair enclosure for disabled refuge. |

**ITEM 11**  
Brickwork lobby and timber doors to north east stair (office side)

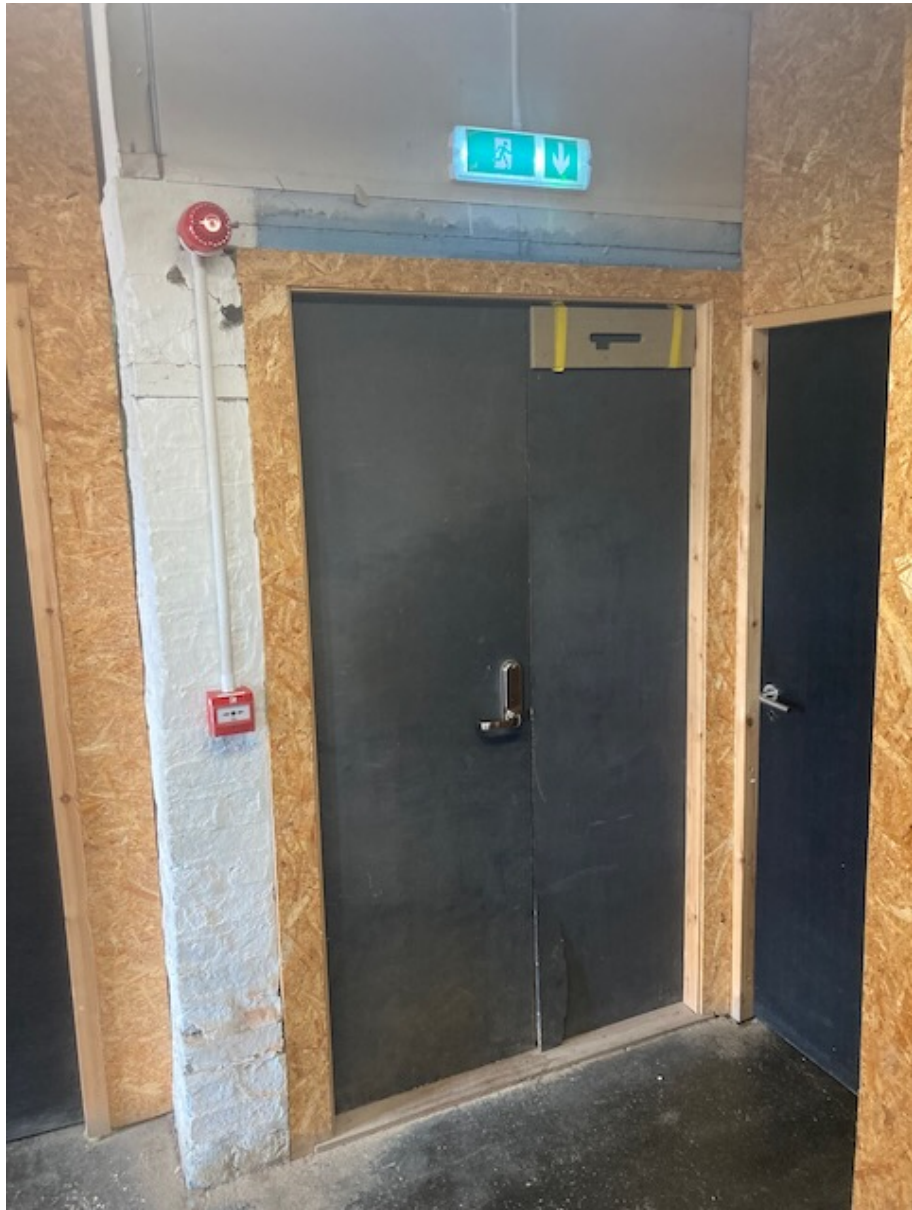
| Ref | Historic / Industrial Feature | Description | Removed / Retained | Works to be undertaken |
|---|---|---|---|---|
| 12 | Doors to NW staircase | Timber doors with boarded overlay | Door and frame only to be removed. Brick surround and concrete lid retained | Door to be removed and replaced with new FD30 rated fire door |

**ITEM 12**  
Brickwork lobby and timber doors to north west stair (office side)

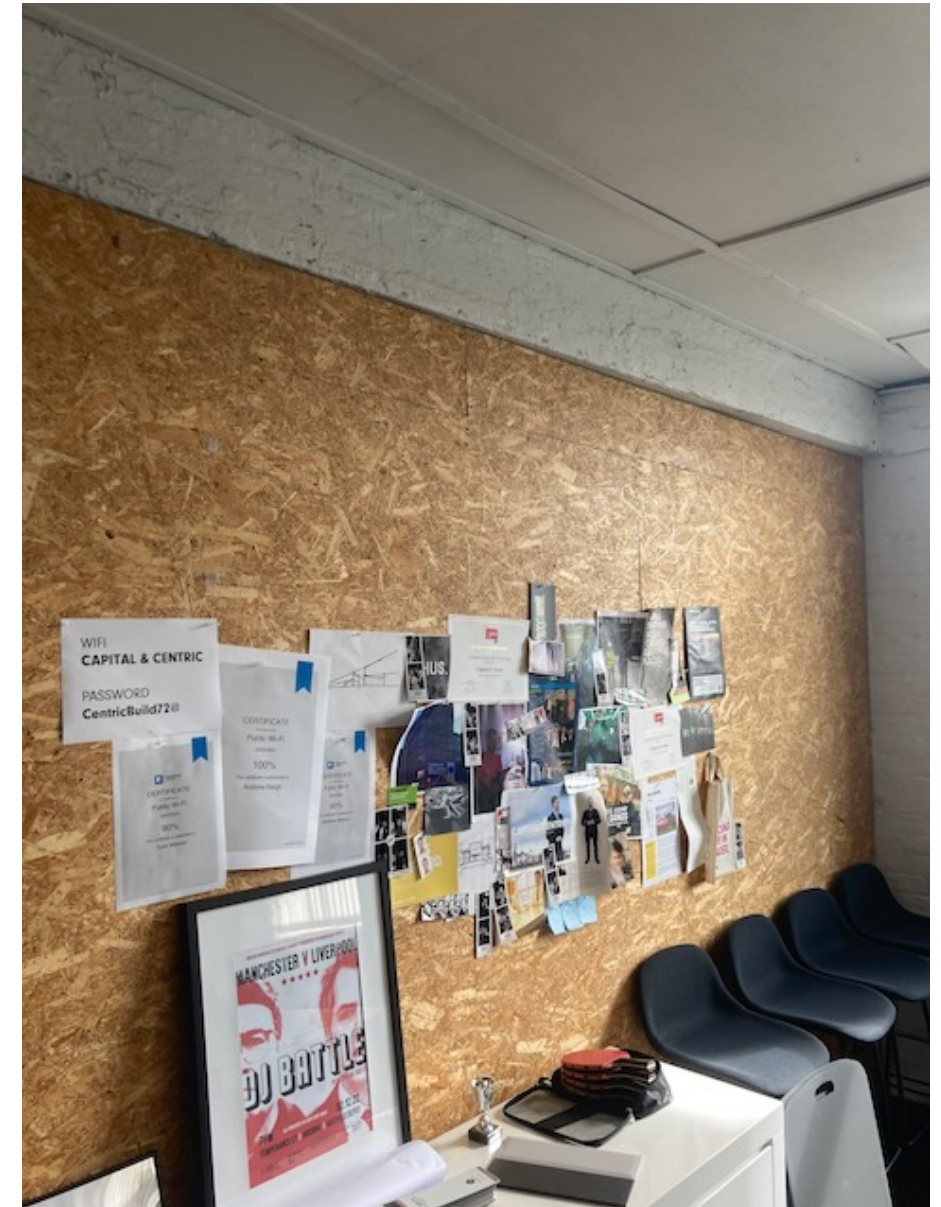
| Ref | Historic / Industrial Feature | Description | Removed / Retained | Works to be undertaken |
|---|---|---|---|---|
| 14 | Partitions | Timber stud partitions with OSB overlay | Removed | All stud partitions to be removed. All considered to be non original. |

**ITEM 14**  
Typical OSB faced stud wall beneath primary beam

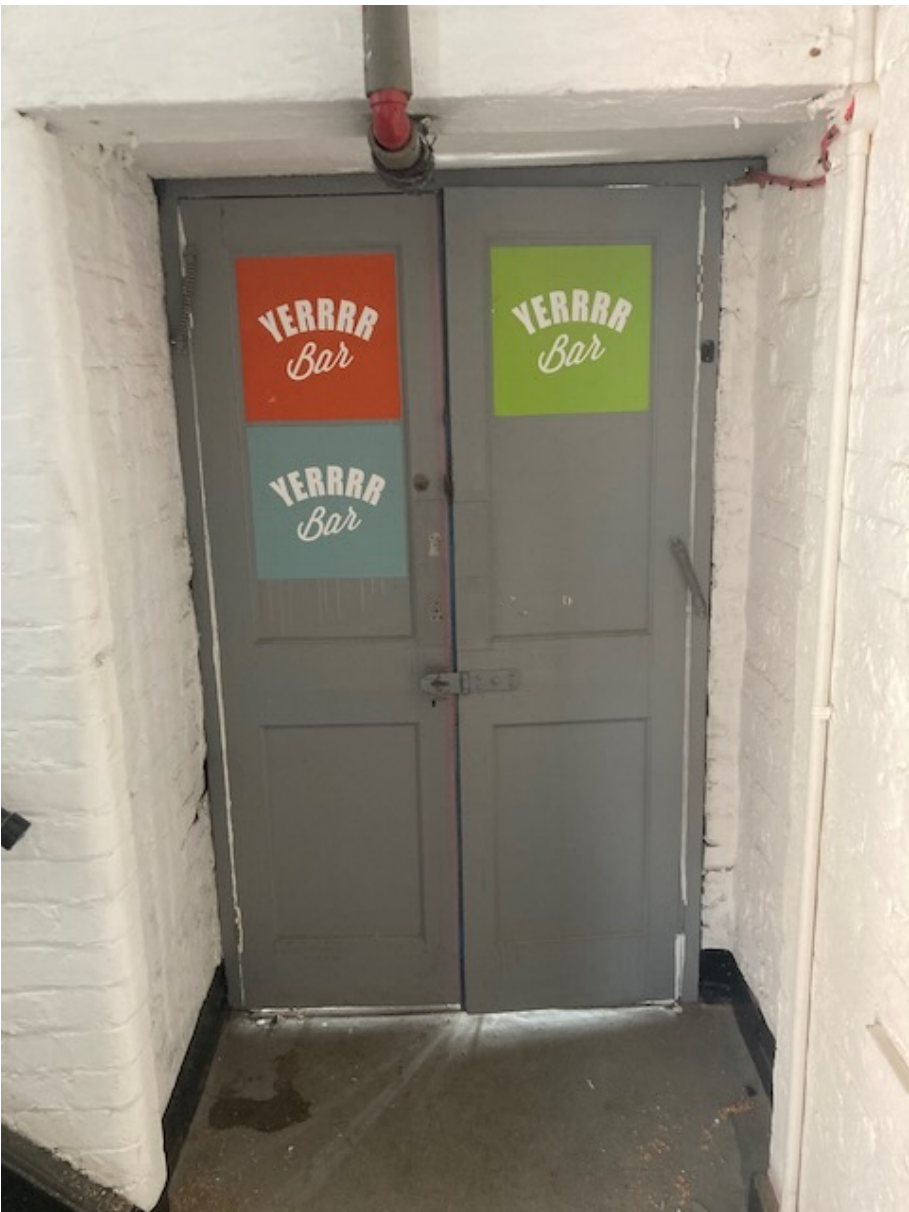
| Ref | Historic / Industrial Feature | Description | Removed / Retained | Works to be undertaken |
|---|---|---|---|---|
| 21 | Door surround to NE staircase | Painted brickwork flank walls with concrete lid over and timber doors. | Removed | Brickwork, lid and doors to be removed and new stud walls installed to form enlarged stair enclosure for disabled refuge. |

**ITEM 21**  
Brickwork lobby and timber doors to north east stair (stair side)

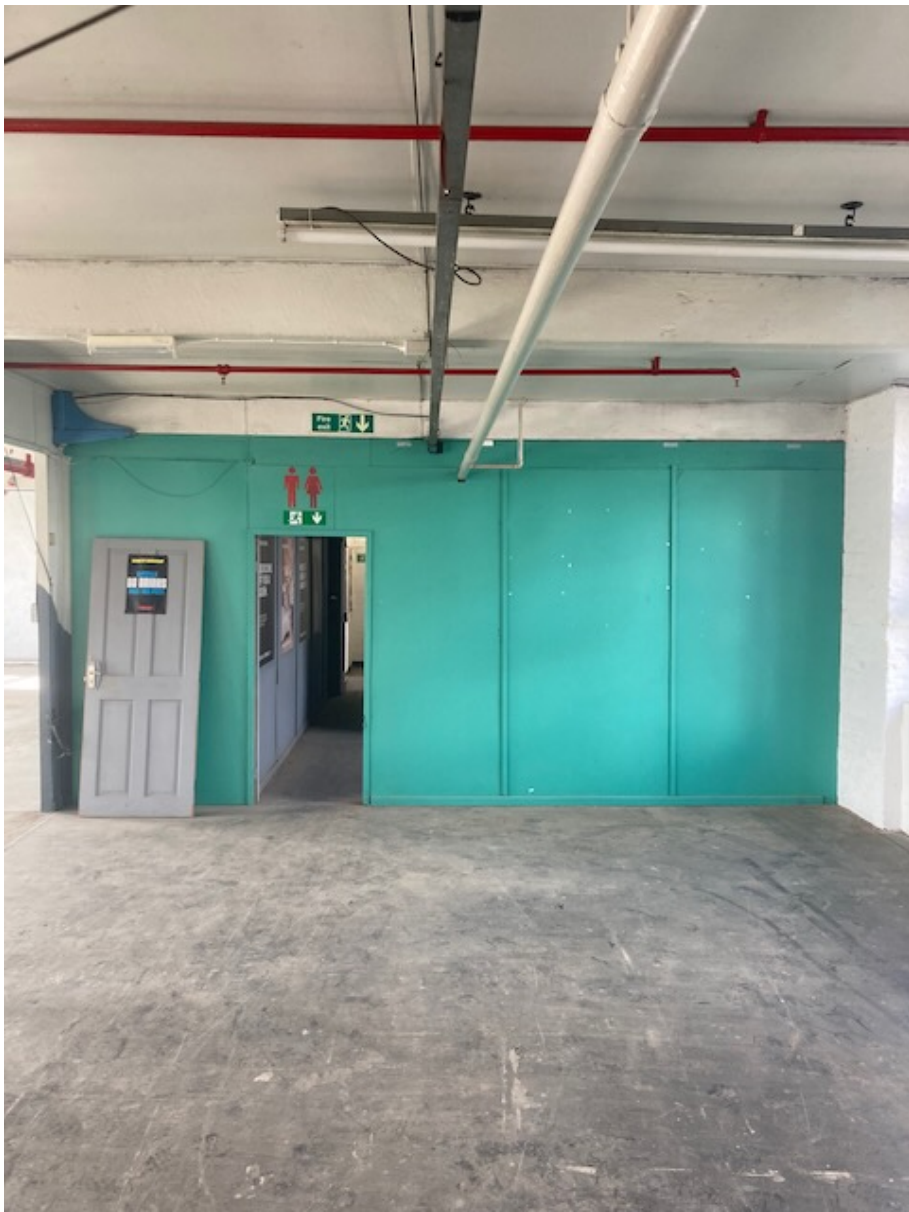
| Ref | Historic / Industrial Feature | Description | Removed / Retained | Works to be undertaken |
|---|---|---|---|---|
| 23 | Partitions | Timber stud partitions with board overlay and cover strips | Removed | All stud partitions to be removed. All considered to be non original. |

**ITEM 23**  
Boarded partitions forming WC enclosure

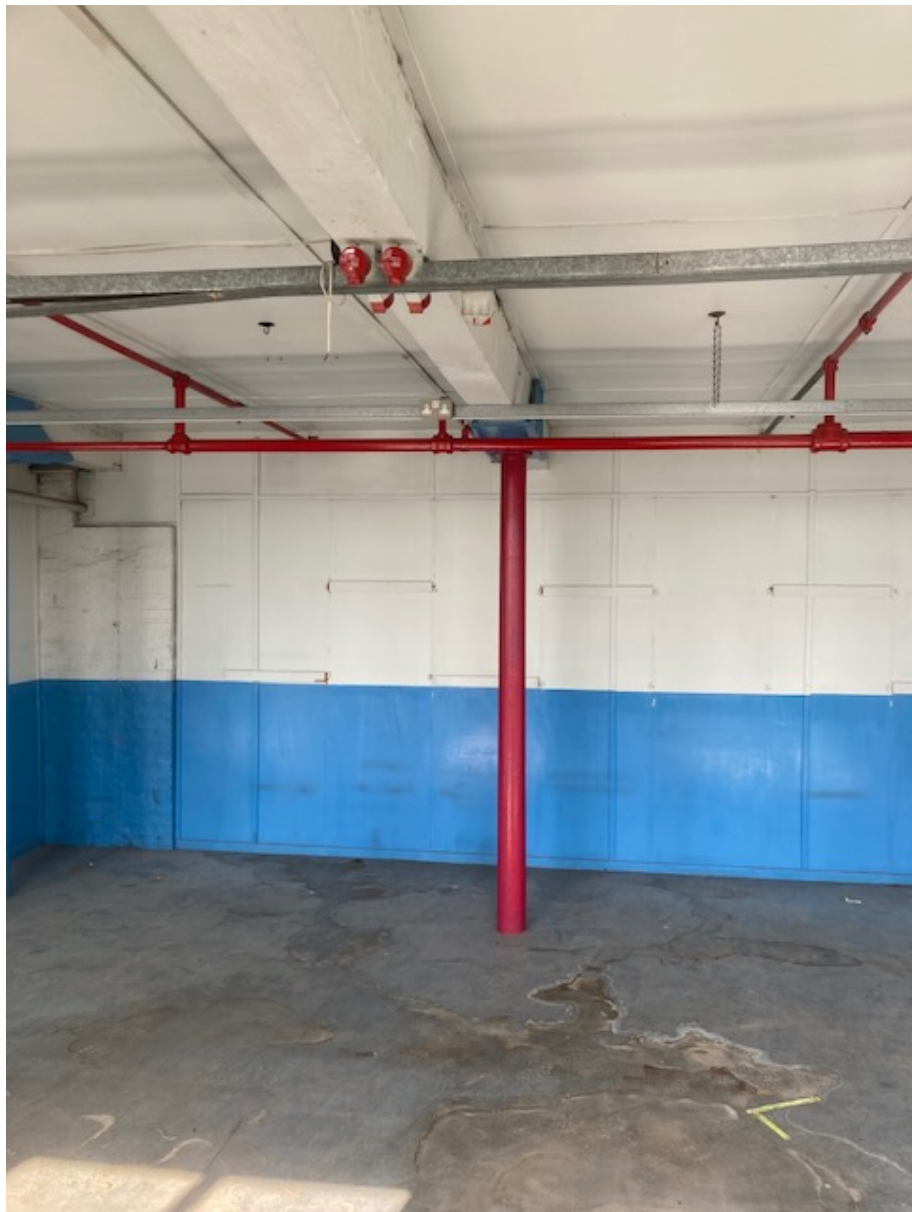
**ITEM 23**  
Boarded partitions forming WC enclosure

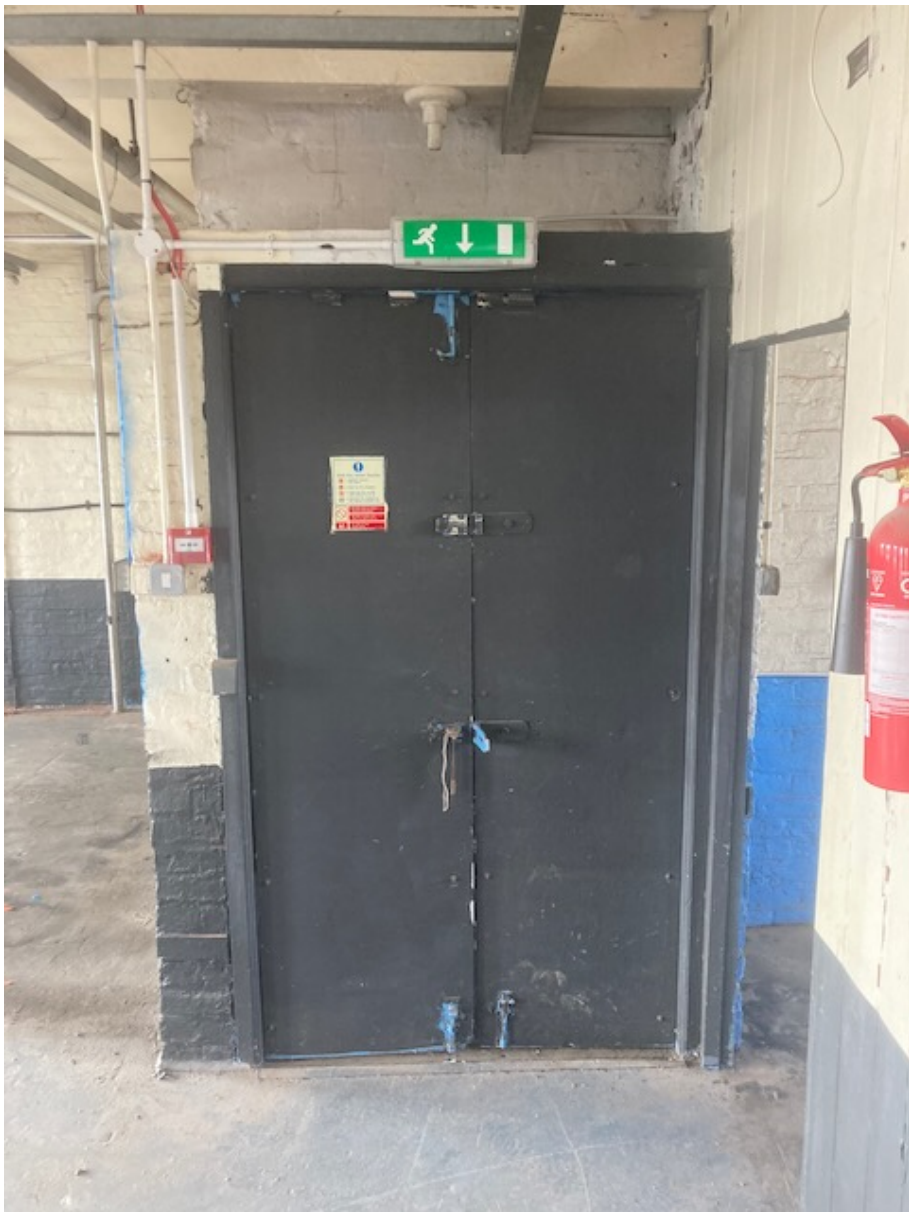
| Ref | Historic / Industrial Feature | Description | Removed / Retained | Works to be undertaken |
|---|---|---|---|---|
| 32 | Doors to NW staircase | Timber doors with boarded overlay | Door and frame only to be removed. Brick surround and concrete lid retained | Door to be removed and replaced with new FD30 rated fire door |

**ITEM 32**  
Brickwork lobby and timber doors to north west stair (office side)

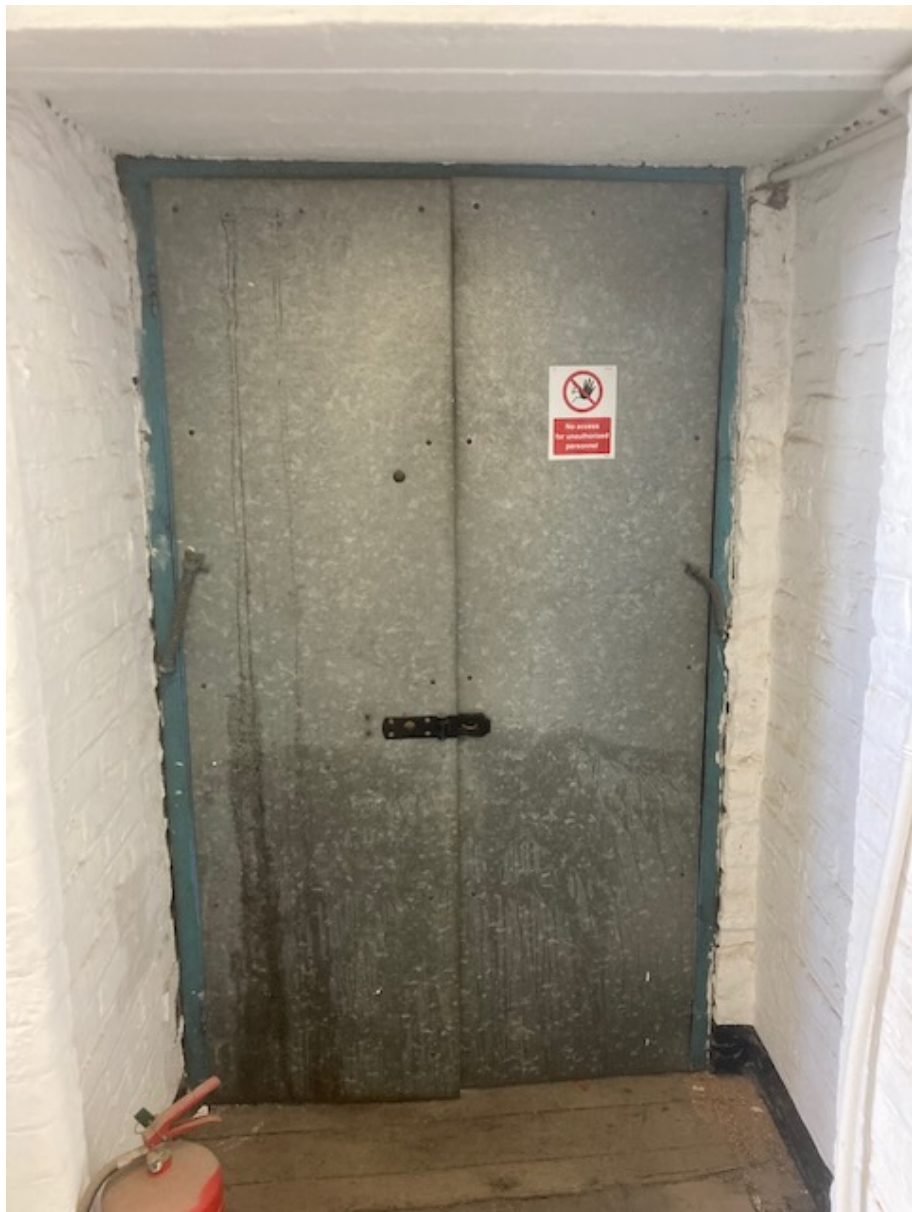
**ITEM 32**  
Brickwork lobby and timber doors to north west stair (stair side)

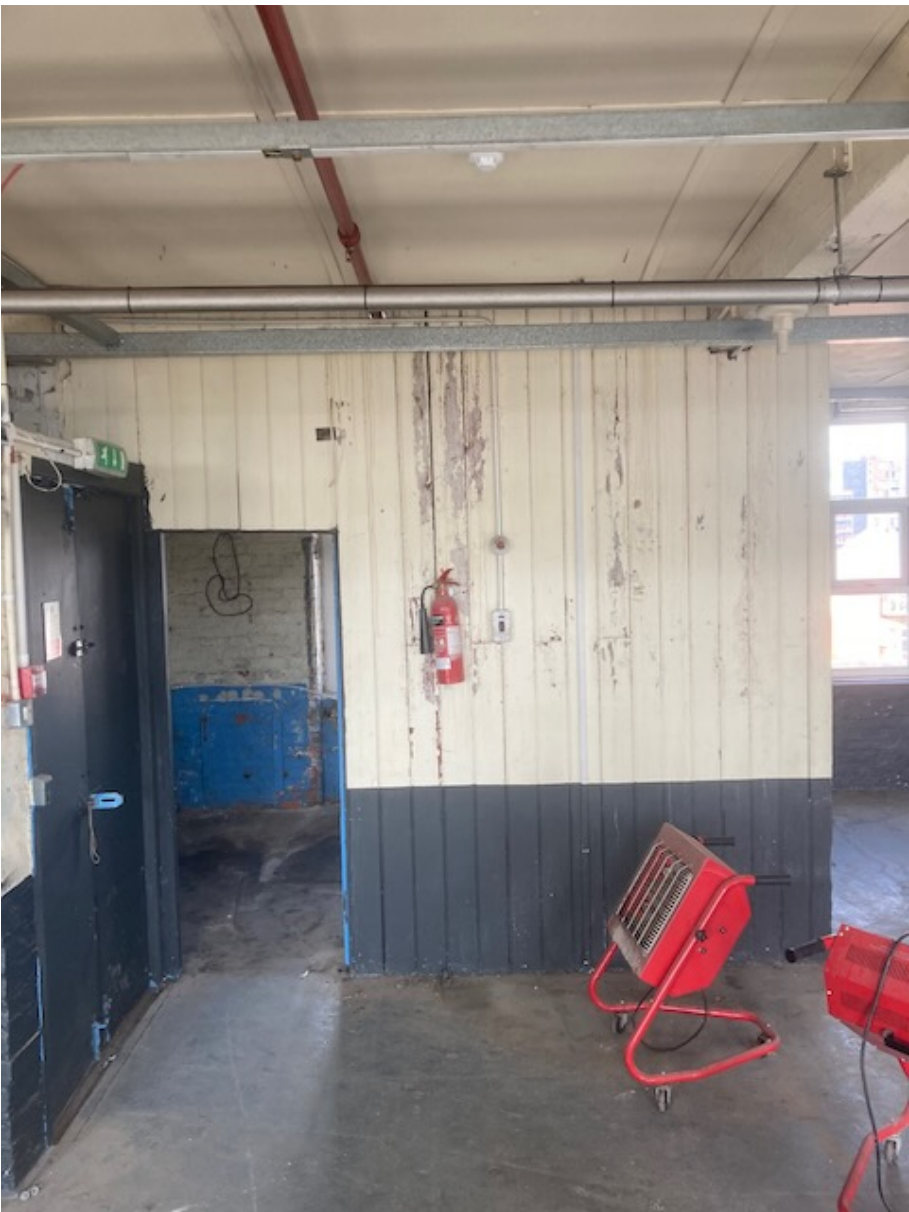
| Ref | Historic / Industrial Feature | Description | Removed / Retained | Works to be undertaken |
|---|---|---|---|---|
| 33 | Partitions | Timber stud partitions with vertical timber strip board overlay | Removed | All stud partitions to be removed. All considered to be non original. |

ITEM 33  
Timber board partition forming WC area
