## Jonathan Davidson Architects

Neptune Mill  
Chapelton St, Manchester

Historic & Industrial Features Audit  
353 PD 2001 (P2)

*October 2023*

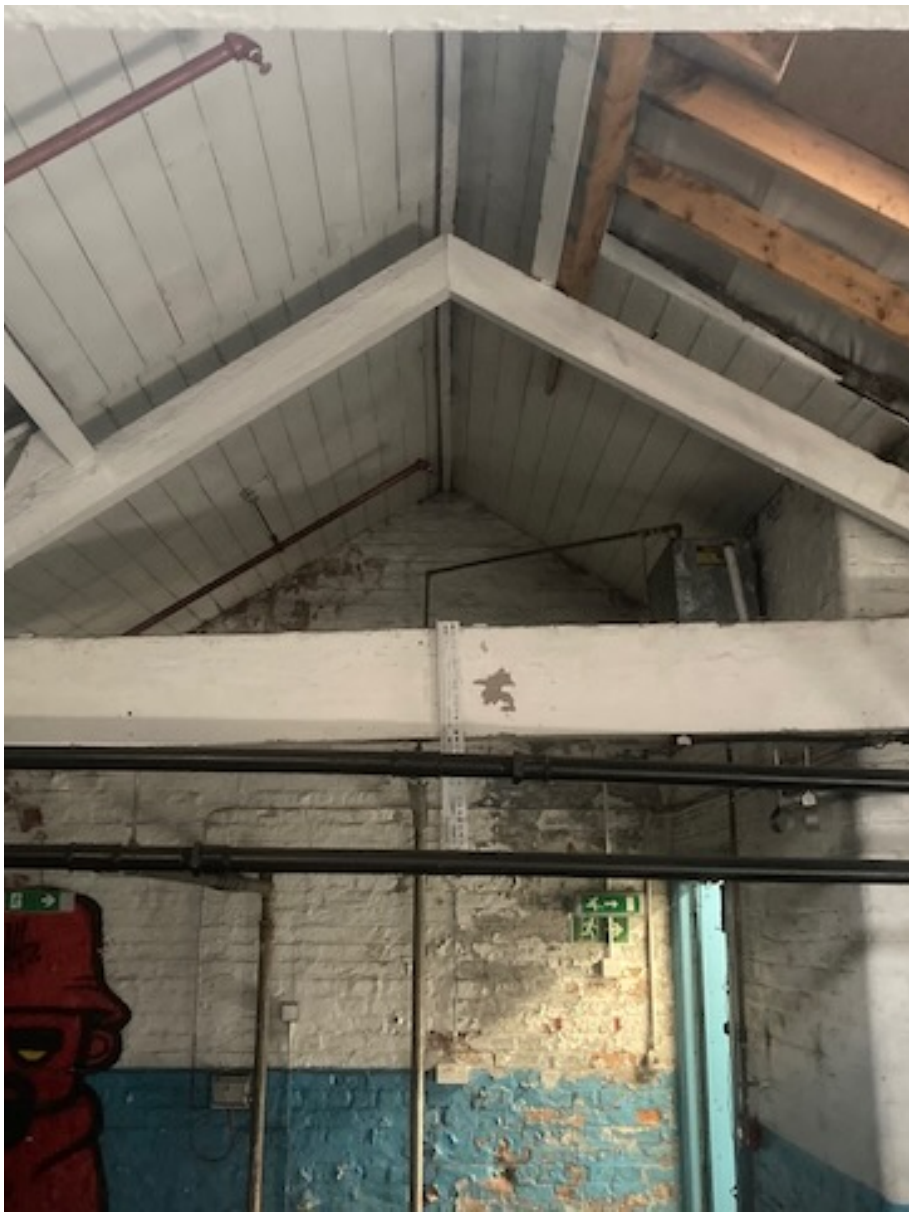
| Ref | Historic / Industrial Feature | Description | Removed / Retained | Works to be undertaken |
|---|---|---|---|---|
| 41 | Roof trusses | Primary timber trusses with hanging rods | Retained & cleaned | Existing paint to be lightly removed and new clear intumescent coating to be applied. |

**ITEM 41**  
Typical roof truss upper section with purlins and board ceiling

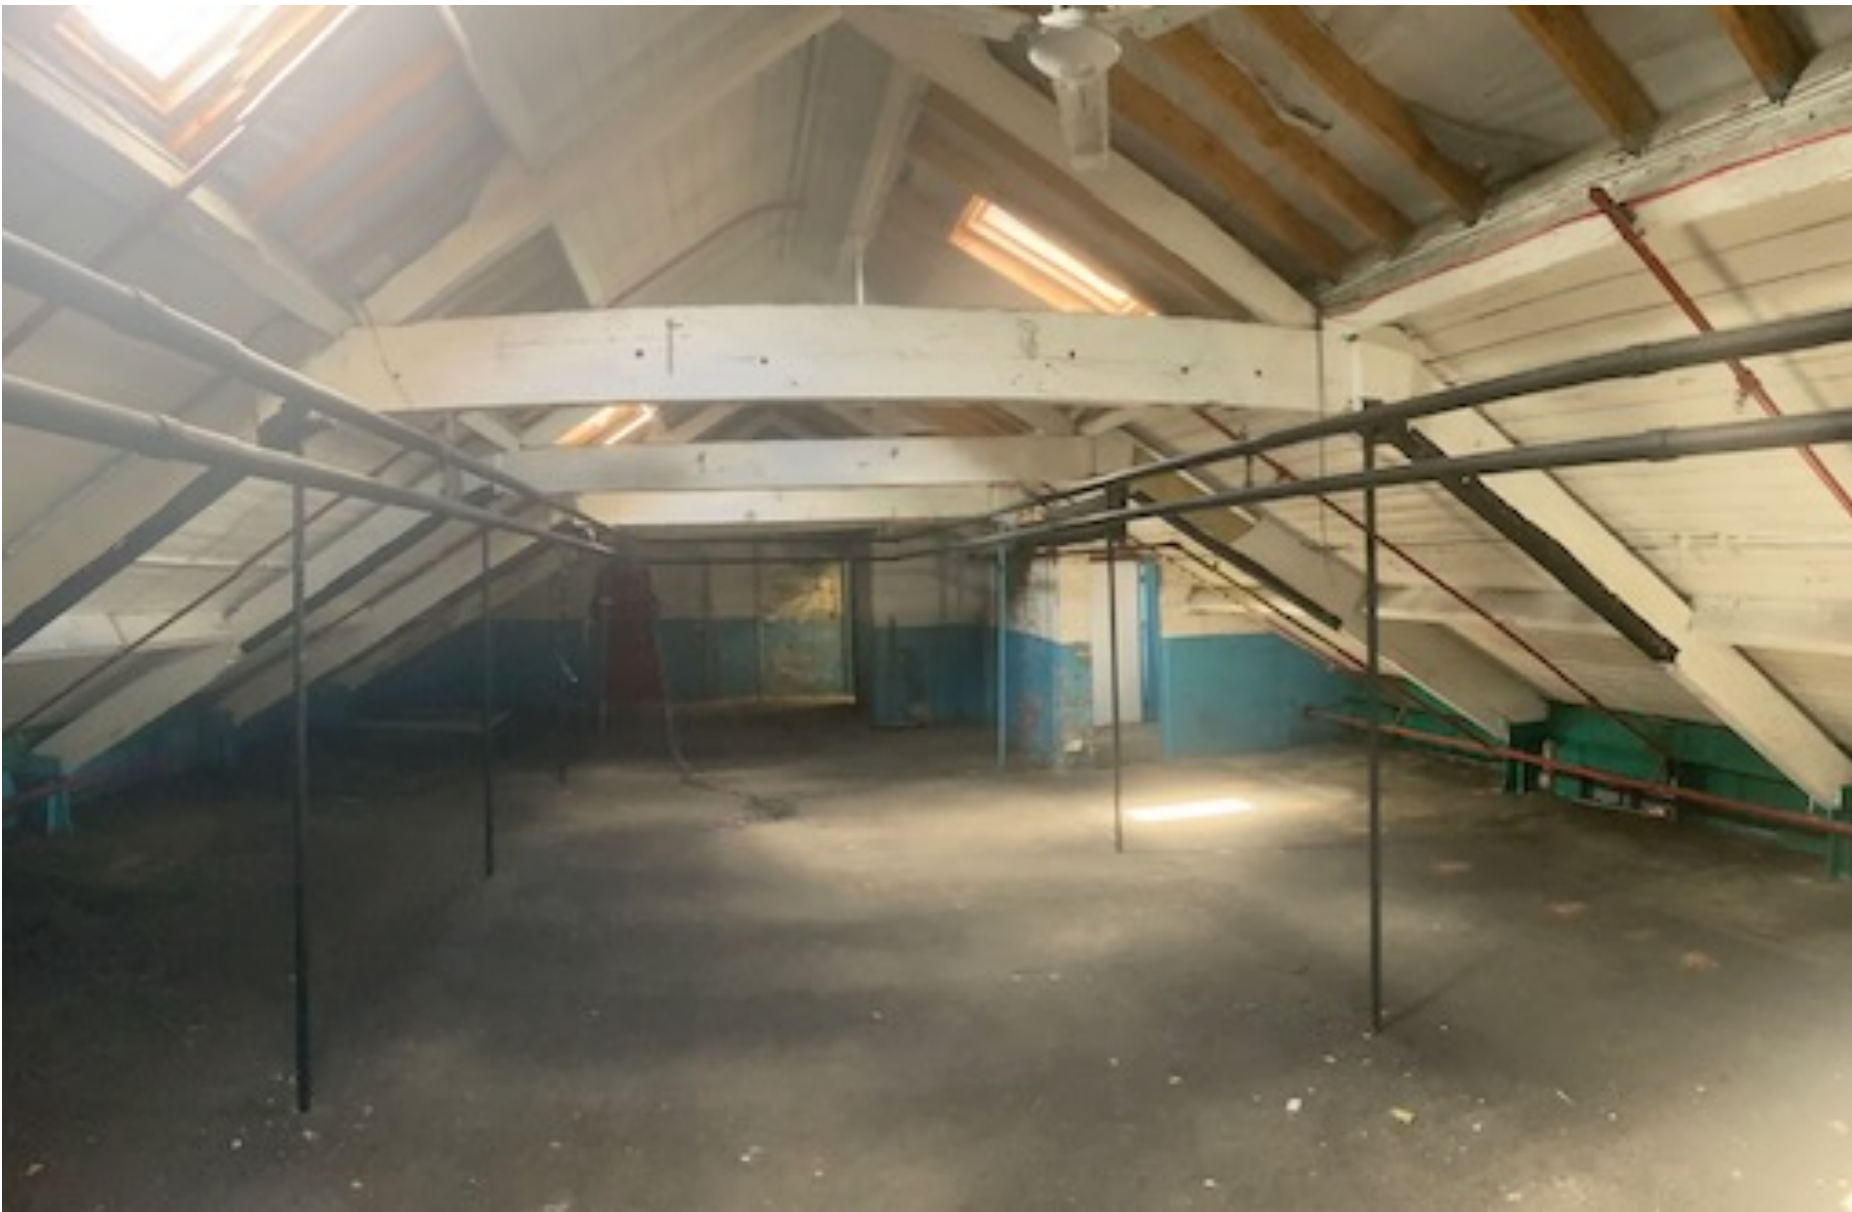
| Ref | Historic / Industrial Feature | Description | Removed / Retained | Works to be undertaken |
|---|---|---|---|---|
| 42 | Purlins | 100 x 225mm timber purlins | Generally retained. Upper purlin to south roof slope to be removed | Purlins to be lightly cleaned of paint |

**ITEM 41 / 42**  
Overall roof trusses and purlins with cast iron rods

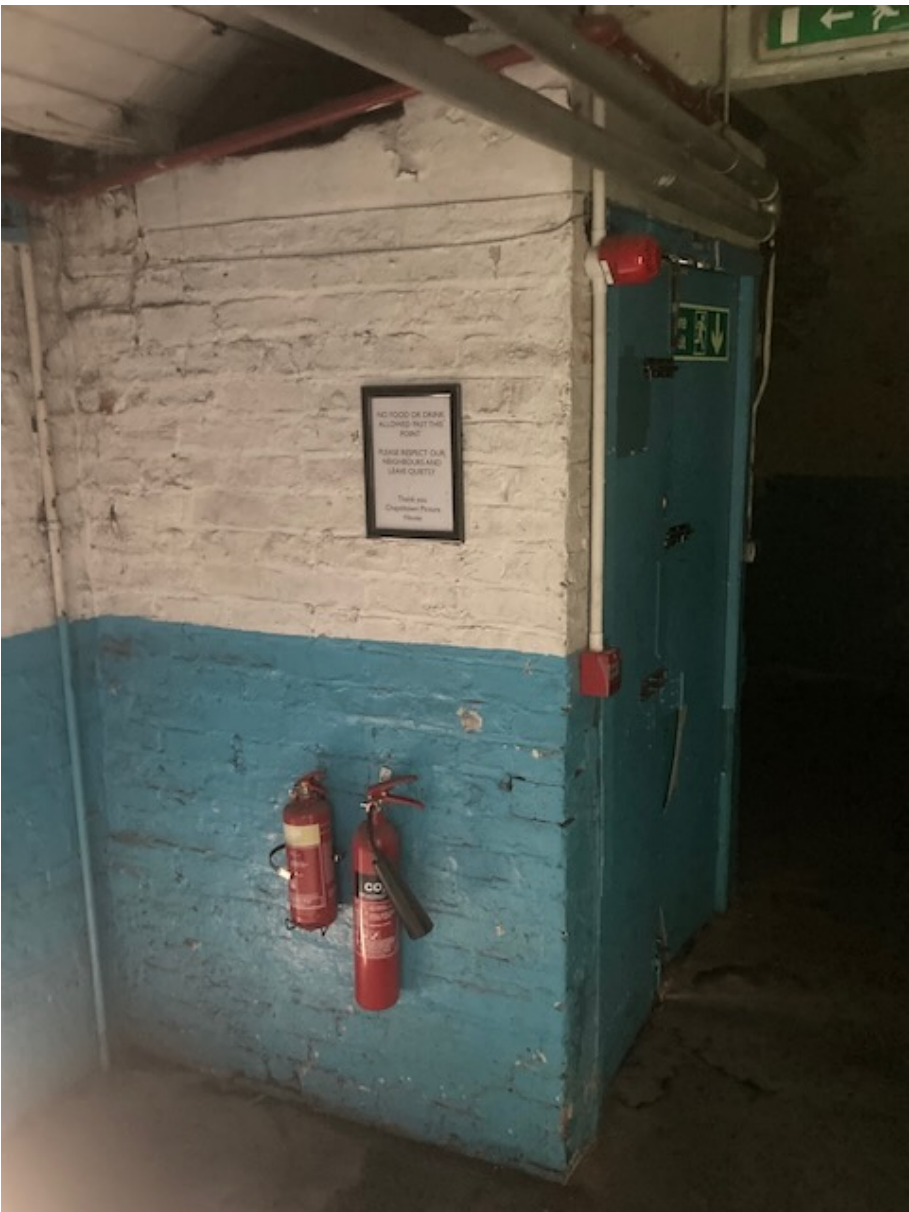
| Ref | Historic / Industrial Feature | Description | Removed / Retained | Works to be undertaken |
|---|---|---|---|---|
| 45 | Door surround to NE staircase | Painted brickwork flank walls with concrete lid over and timber doors. | Removed | Brickwork, lid and doors to be removed and new stud walls installed to form enlarged stair enclosure for disabled refuge. |

**ITEM 45**  
Brick lobby and timber doors to north east stair (office side)

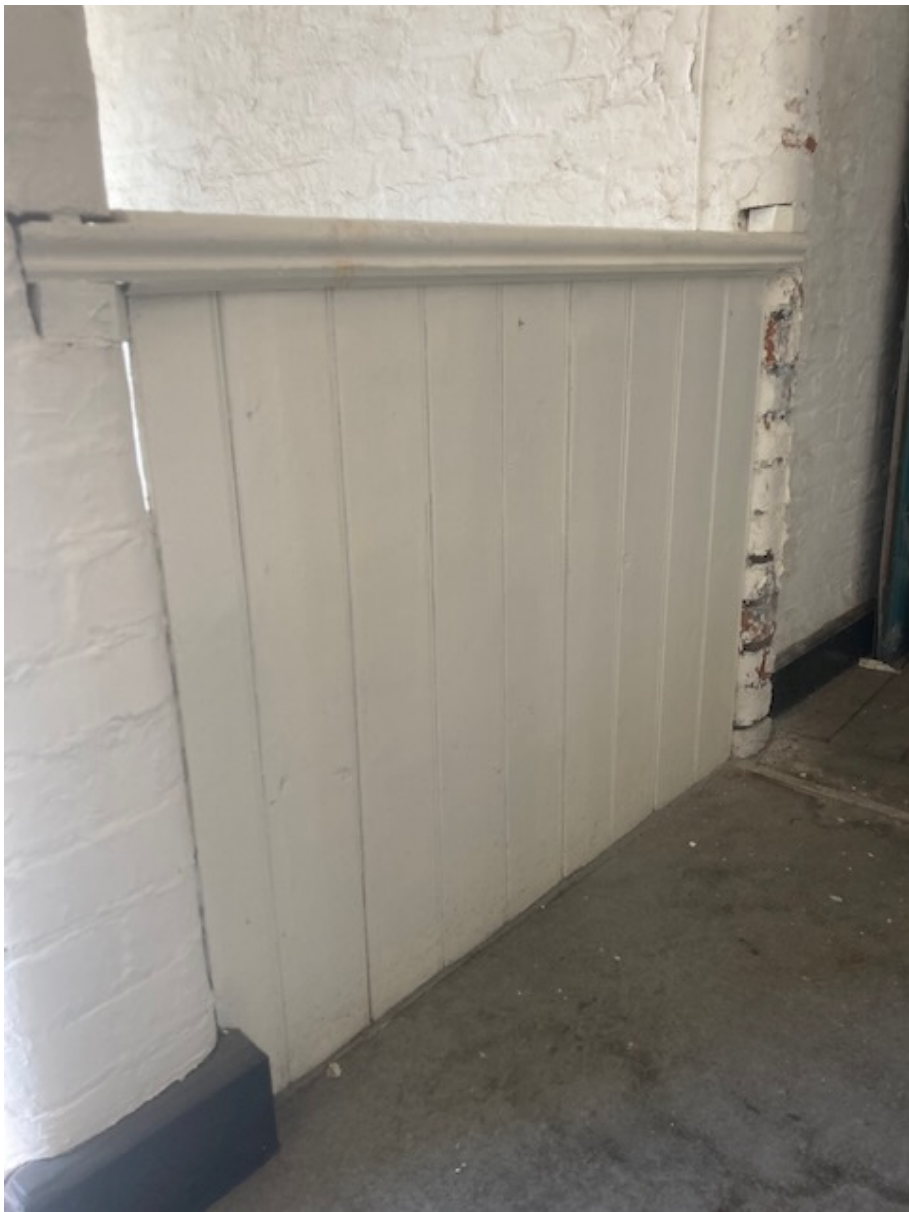
| Ref | Historic / Industrial Feature | Description | Removed / Retained | Works to be undertaken |
|---|---|---|---|---|
| 47 | Partitions | Timber stud partitions with board overlay and cover strips | Removed | All stud partitions to be removed. All considered to be non original. |

**ITEM 47**  
Timber balustrade panel at head of north east stair

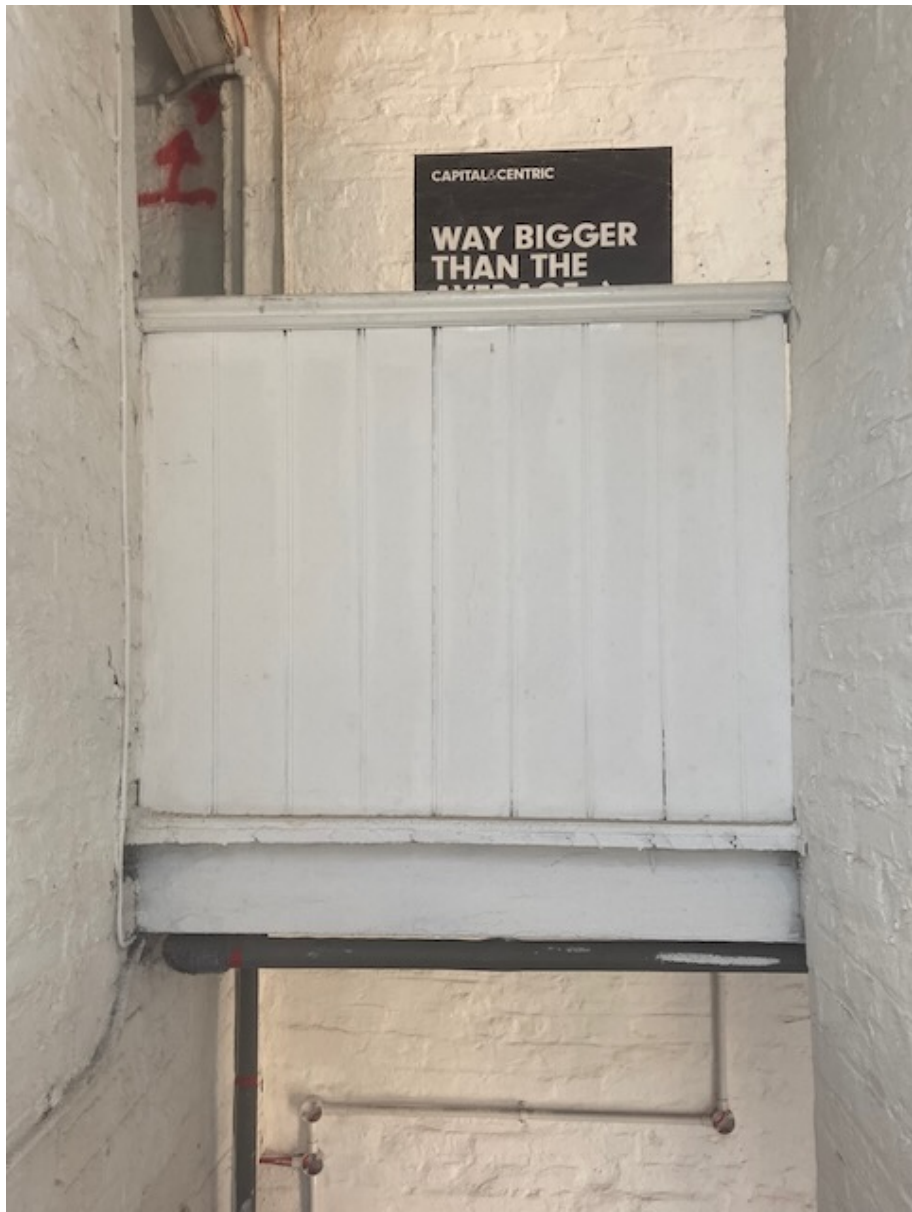
**ITEM 47**  
Timber balustrade panel at head of north east stair
