Detail: 117-119 Fabric Survey

Site: 117-119 Portland Street

Client: Bruntwood

Ref No: QRN.CR.3129

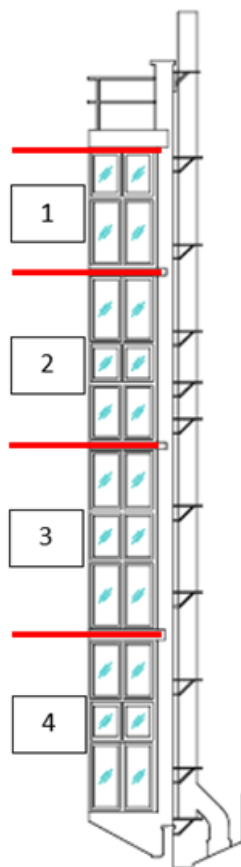
**Elevation EE**

| Area | Defect/Photo no. | Defect and Recommendation |
|---|---|---|
| 1 | 1 | The fascia board is completely rotten and requires replacement |
| 1 | 1 | Full window decorated finish has failed and requires a full scheme of refurbishment, all paint deteriorated. |
| 2 | 2 | Full window decorated finish has failed and requires a full scheme of refurbishment, all paint deteriorated. |
| 2 | 2 | The windowsill is rotten and require full replacement. Full window decorated finish has failed and requires a full scheme of refurbishment, all paint deteriorated. |
| 3 | 3 | Full window decorated finish has failed and requires a full scheme of refurbishment, all paint deteriorated. |

| 3 | 3 | Full window decorated finish has failed and requires a full scheme of refurbishment, all paint deteriorated. |
| 4 | 4 | Full window decorated finish has failed and requires a full scheme of refurbishment, all paint deteriorated. |
| Flat Roof | 1 | The roof is in good condition, with minor cleaning required to remove loose debris. |
| Flat Roof | 2 | There is vegetation growing out of the copingstones mortar joint and mortar has perished. |
| Flat Roof | 3 | There is vegetation growing out of the mortar joints and mortar has perished. |

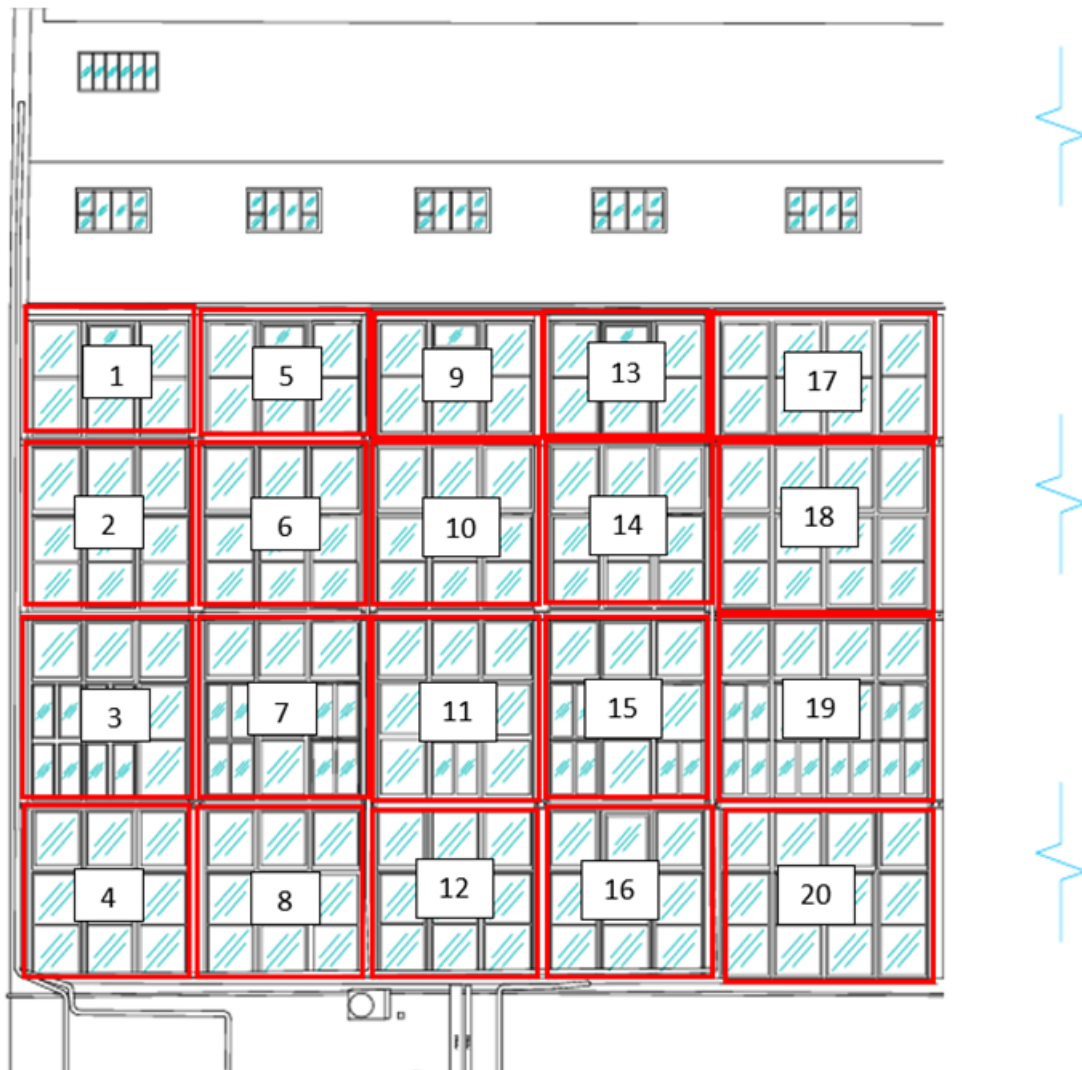
### Rear elevation glass curtain wall

| Area | Defect/Photo no. | Recommendation |
|---|---|---|
| 1 | 1 | Full window decorated finish has failed and requires a full scheme of refurbishment, all paint deteriorated. |
| 2 | 2 | Full window decorated finish has failed and requires a full scheme of refurbishment, all paint deteriorated.<br><br>1 x pane of glass has cracked and requires replacement – 960mm x 1230mm. |

| 2 | 2 | Full window decorated finish has failed and requires a full scheme of refurbishment, all paint deteriorated.<br><br>The windowsill is rotten and requires full replacement, approx. 2300mm |
| 3 | 3 | Full window decorated finish has failed and requires a full scheme of refurbishment, all paint deteriorated.<br><br>The windowsill is rotten and requires full replacement, approx. 3000mm |

| 9 | 9 | Full window decorated finish has failed and requires a full scheme of refurbishment, all paint deteriorated.<br><br>The windowsill is rotten and requires replacing, approx. 1,500mm |

| 11 | 11 | Full window decorated finish has failed and requires a full scheme of refurbishment, all paint deteriorated.<br><br>The windowsill has rotten and requires replacement – approx. 1,500mm section. |
| 14 | 14 | Full window decorated finish has failed and requires a full scheme of refurbishment, all paint deteriorated.<br><br>The windowsill is rotten and requires replacement – approx. 3,500mm section |

| 15 | 15 | Full window decorated finish has failed and requires a full scheme of refurbishment, all paint deteriorated.<br><br>The windowsill has rotten and requires replacement – approx. 3,500mm section. |
| 17 | 17 | Full window decorated finish has failed and requires a full scheme of refurbishment, all paint deteriorated.<br><br>The windowsill has rotten and requires replacement – approx. 2,000mm section |

| Cast Beam Structure | All green painted beams | Green painted cast iron beams decorated finish has failed and requires a full scheme of refurbishment, all paint deteriorated. |

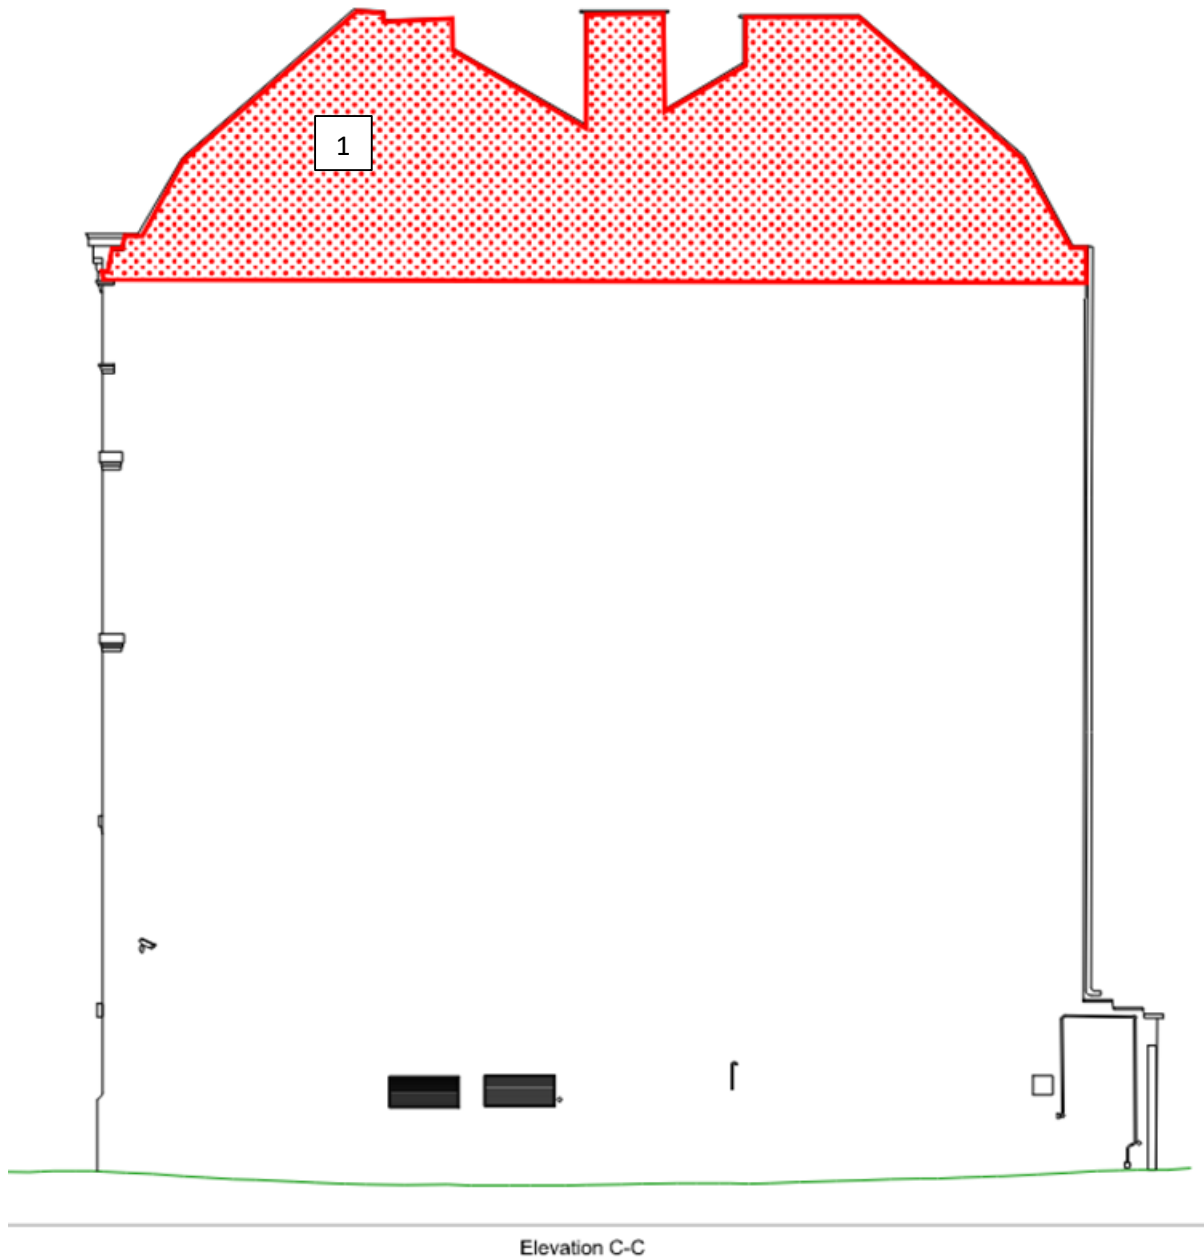
### Brick Gable

| Area | Defect drawing no. | Recommendation |
|---|---|---|
| Brick Gables | 1 | The two apices at high-level mortar joints has totally perished and there is vegetation growing through the joints. |
