## RENAISSANCE RESIDENTIAL TOWER – PLANNING CONDITION 4

| Subject: | Renaissance Project – Residential Tower – Planning Condition 4 Response | | |

Title: AA PROJECTS - RIVER IRWELL - ND9999  
RENAISSANCE HOTEL RIVER WALL INSPECTION

**Job Description  
Inspection to river wall**

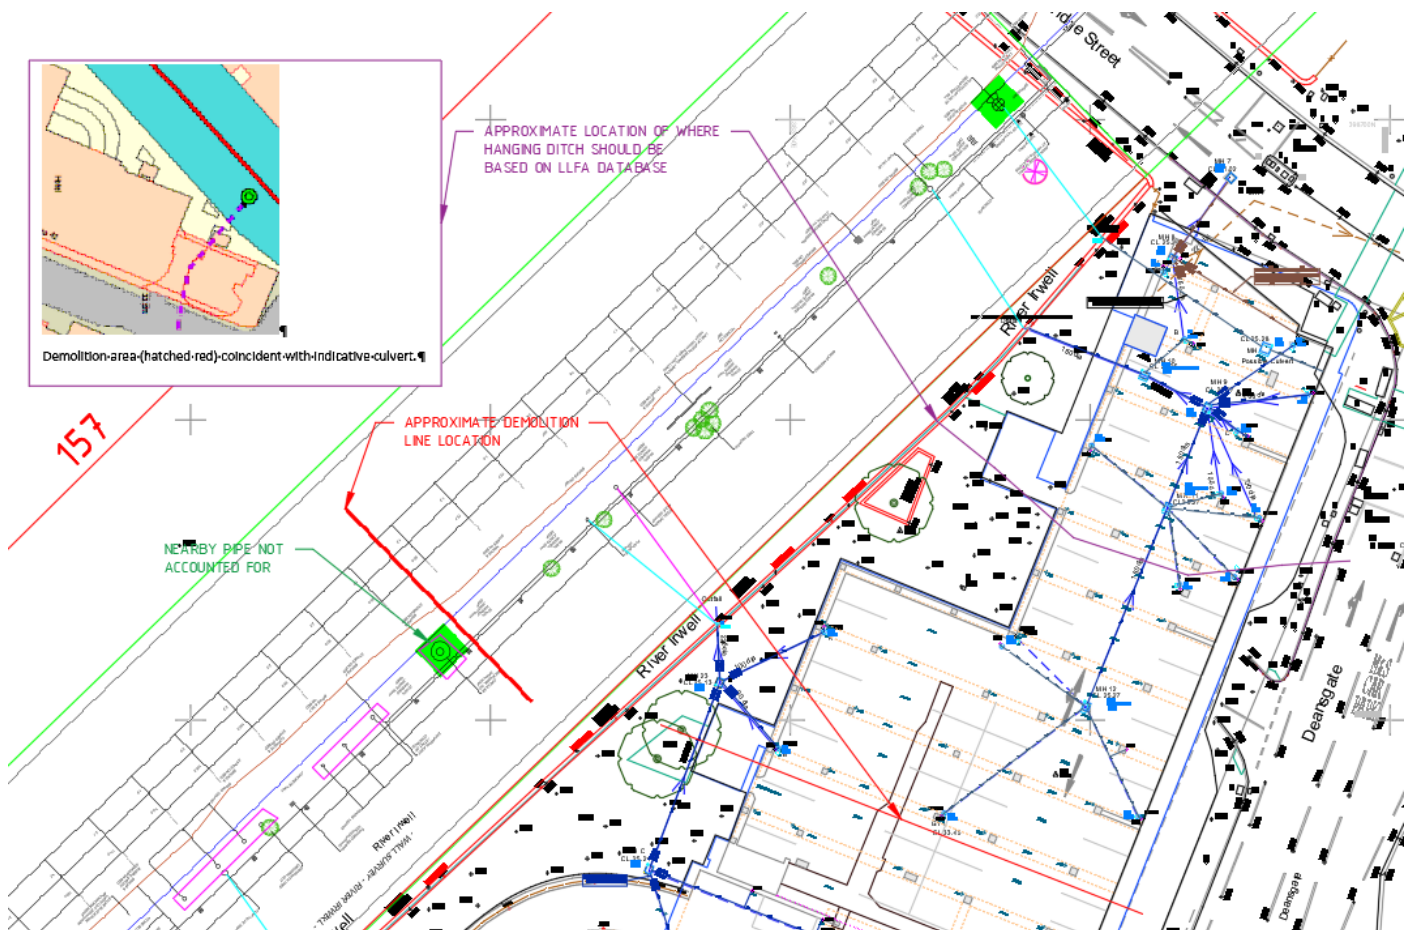
Figure 2: Overlay of CCTV and River Wall in Vicinity of Hanging Ditch

- All Manholes inside of the Existing LG3 Carpark level have been opened and CCTV surveyed with all connections either to the river, or the UU Sewer system confirmed.
  - No “Hanging Ditch” has been identified. There are Stormwater pipes to the river wall and the already identified northern UU Sewer overrun.
- A survey of the river wall has been undertaken by Northern Divers, refer to Appendix B. This identifies all the outlets along the river wall.
- The Northern Divers survey has been overlaid with the CCTV survey.
  - Within the vicinity of the “Hanging Ditch”, all outlets in the river have been accounted for by corresponding pipes identified in the CCTV manhole surveys.

Based on the above investigations, at this stage, it is not clear where the “Hanging Ditch” is or whether it exists.

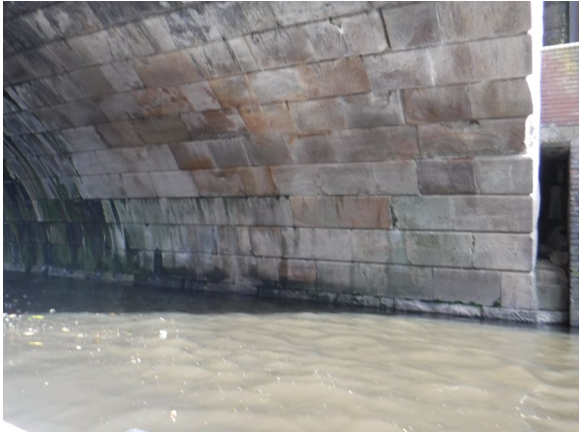
| DESCRIPTION | STRUCTURAL ASSESSMENT DESCRIPTION |
|---|---|
| <p><u>Section 1: Ch 0m to 15m</u></p> <p>Starting at the North elevation of Victoria Bridge upstream of the Renaissance Hotel.</p> <p>Construction :- Vertical stone blockwork from bed level to springing point forming</p> | <p>Abutment wall in this section was in good general condition with no missalignment of courses and being vertical in form.</p> <p>There is minor weathering throughout to the face of the structure above water level.</p> |

| <p>stone arch and stone ring voussoirs.</p> | <p>Joints below the waterline were found to be in good order with minor washing to a localised area at chainage +5.0m.</p> <p>Rock armour on river bed abutting the base of the wall.</p> <p>There is no evidence of undermining or potential scour development.</p> |

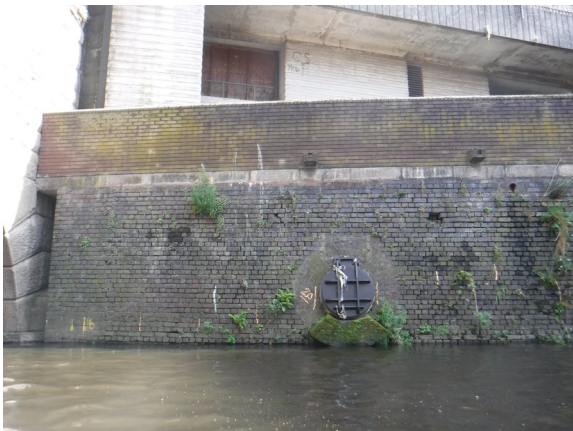
| <p><u>Section 2: Ch 15m to 91m</u></p> <p>Construction :- Brick with concrete capping stone to bed level. Brick fronting the perestrian area retaining wall.</p> | <p>Joints above water displaying extensive mortar loss to aproximately 80% of the structure with a maximum depth of up to 50mm. Below water mortar loss was noted to be 80% with a maximum depth of 50mm.</p> <p>Random areas of missing and loose brickwork notably at chainage 51m – 57m over six courses in hieght. (3.6m2)</p> <p>Areas of vegetaion growth was viewed along wall elevation were the root growth has caused minor lateral displacement and structural degregation.</p> <p>Drain outlet with flap valve visable at chainge 20.5m.</p> <p>Brick and general river debris on river bed abutting the base of the wall.</p> <p>There is no evidence of undermining or potential scour development.</p> |

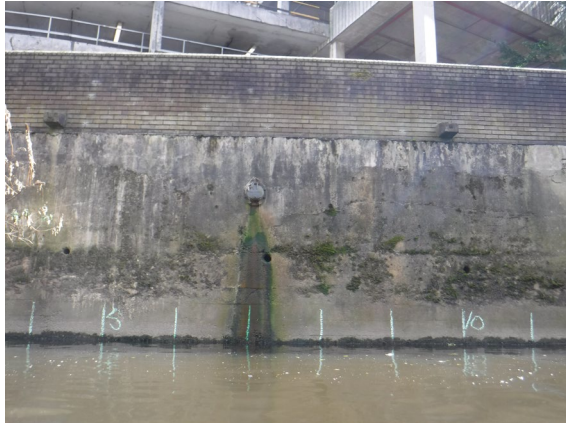
| <p><u>Section 3: Ch 91m to 116m</u></p> <p>Construction :- Vertical concrete wall to bed level. Brick fronting the perestrian area retaining wall.</p> | <p>Concrete wall in this section is in a fair general condition with no misalignment and vertical in form.</p> <p>There is a number of drain outlets noted along this section.</p> <p>Isolated area of vegetation growth at chainage 105m.</p> <p>Soft marine growth at waterline.</p> |

Brick and general river debris on river bed abutting the base of the wall.

There is no evidence of undermining or potential scour development.

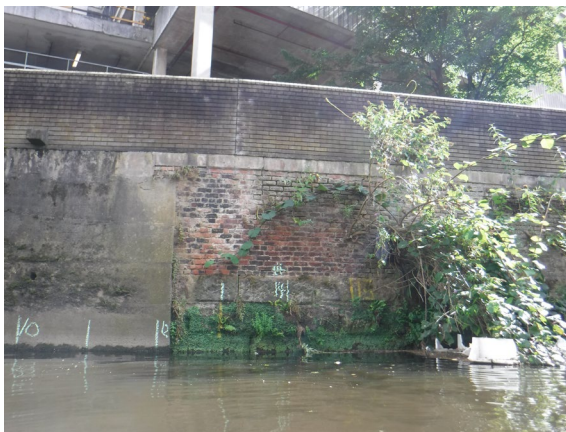
## Section 4: Ch 116m to 170m

Joints above water displaying extensive mortar loss to approximately 20% of the structure with a maximum depth of up to 15mm.

Below water to bed the blockwork was noted to be in fair general condition with no areas of missing material.

There are areas of re-pointing visible above water which cover around 40% of the total area in this section.

Areas of vegetation growth were viewed along the wall elevation where the root growth has caused lateral displacement and structural degradation. Brick and general river debris on river bed abutting the base of the wall.

There is no evidence of undermining or potential scour development.

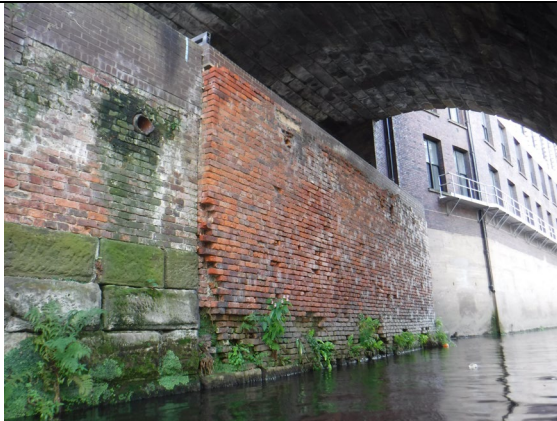
## Section 5: Ch 170m to 182m

Mortar loss displayed to 90% of this section with max depths of 100mm.

Random areas of missing and loose brickwork. Minor vegetation growth at water level.

Below water to bed the blockwork was noted to be in general fair condition with no areas of missing material.

Brick and general river debris on river bed abutting the base of the wall.

There is no evidence of undermining or potential scour development.

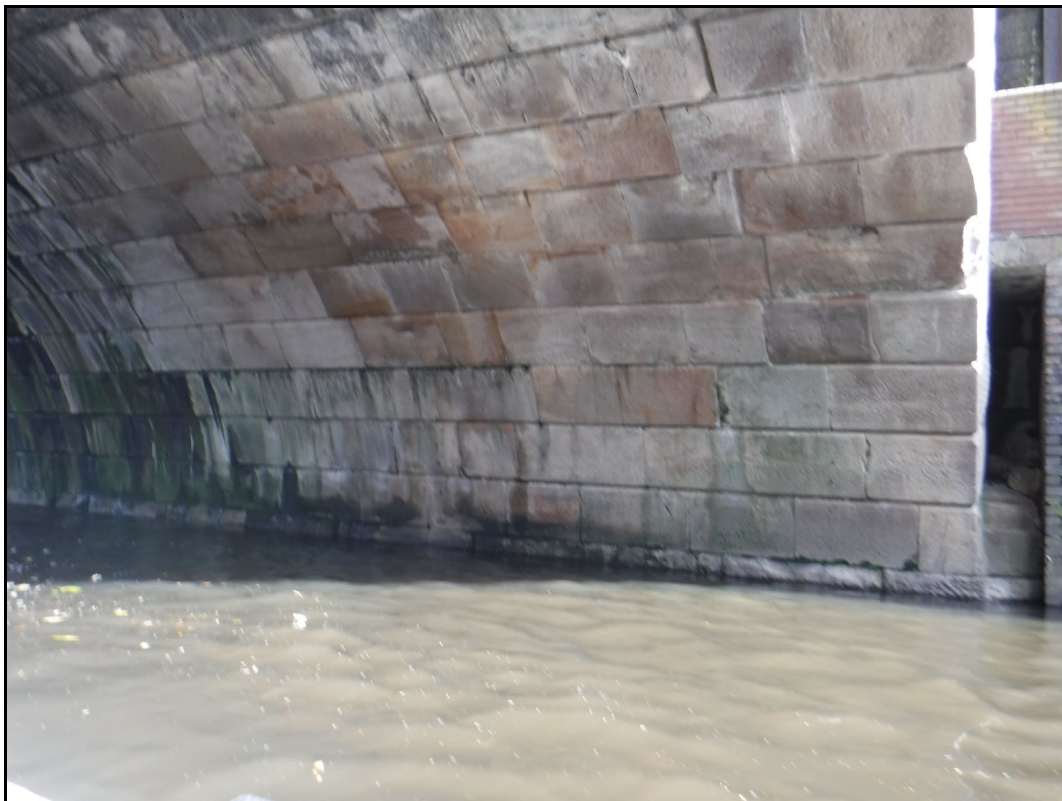
Above:- Ch 0m – 15m Blockwork to Victoria Bridge

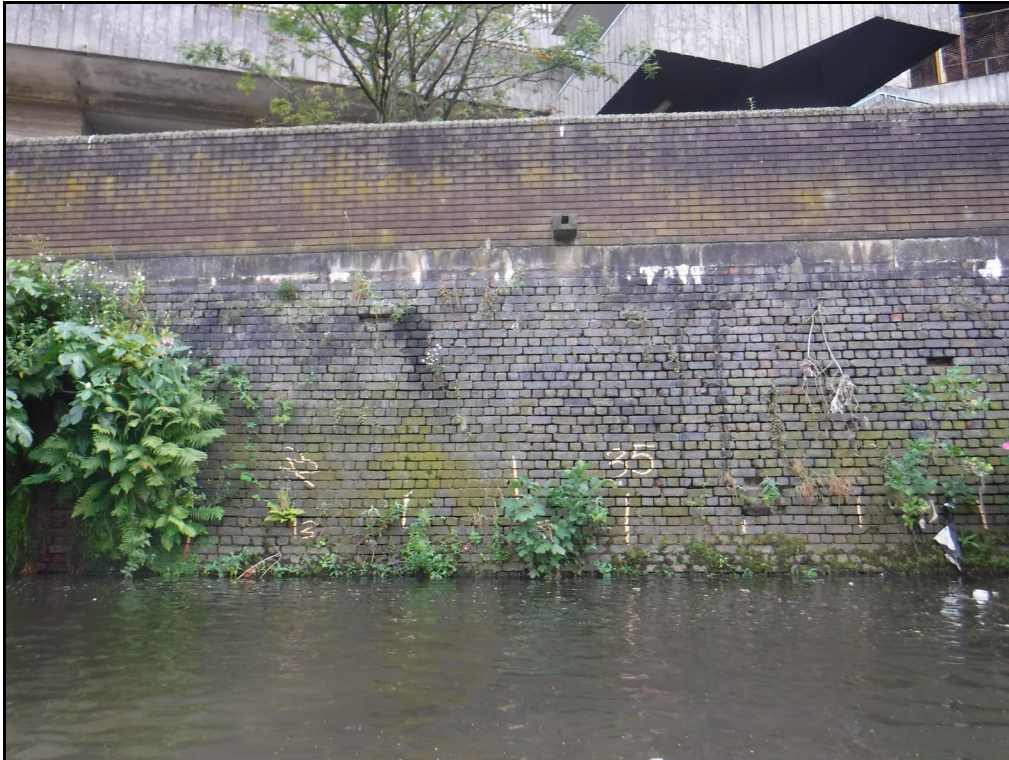
Above:- General view of wall at Ch 35m. Open joints and vegetation growth

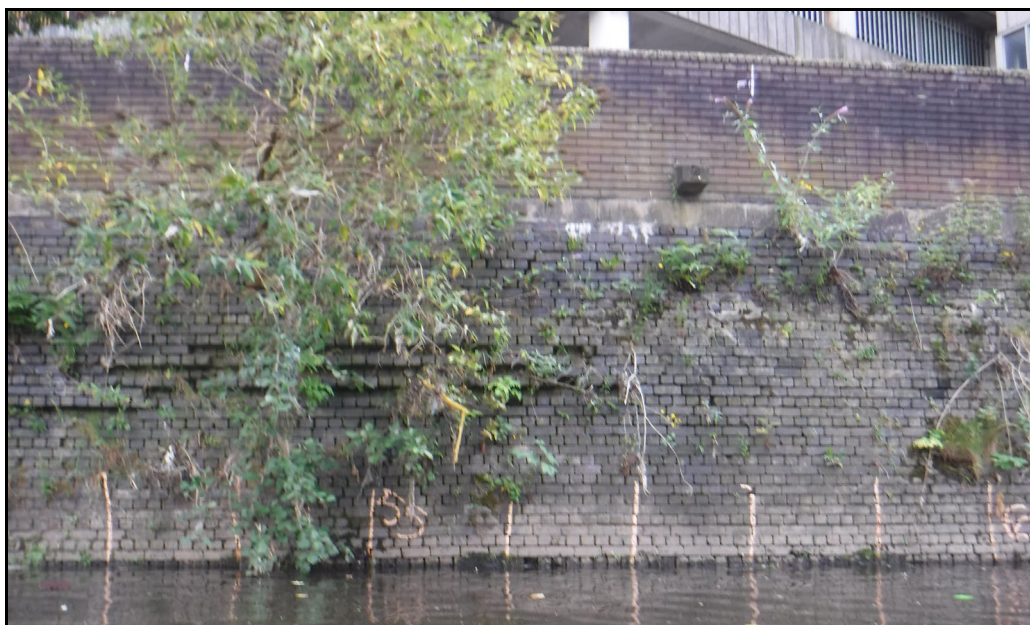
Above :- Ch 55m, displaying displacement of brick courses due to tree and vegetation growth.

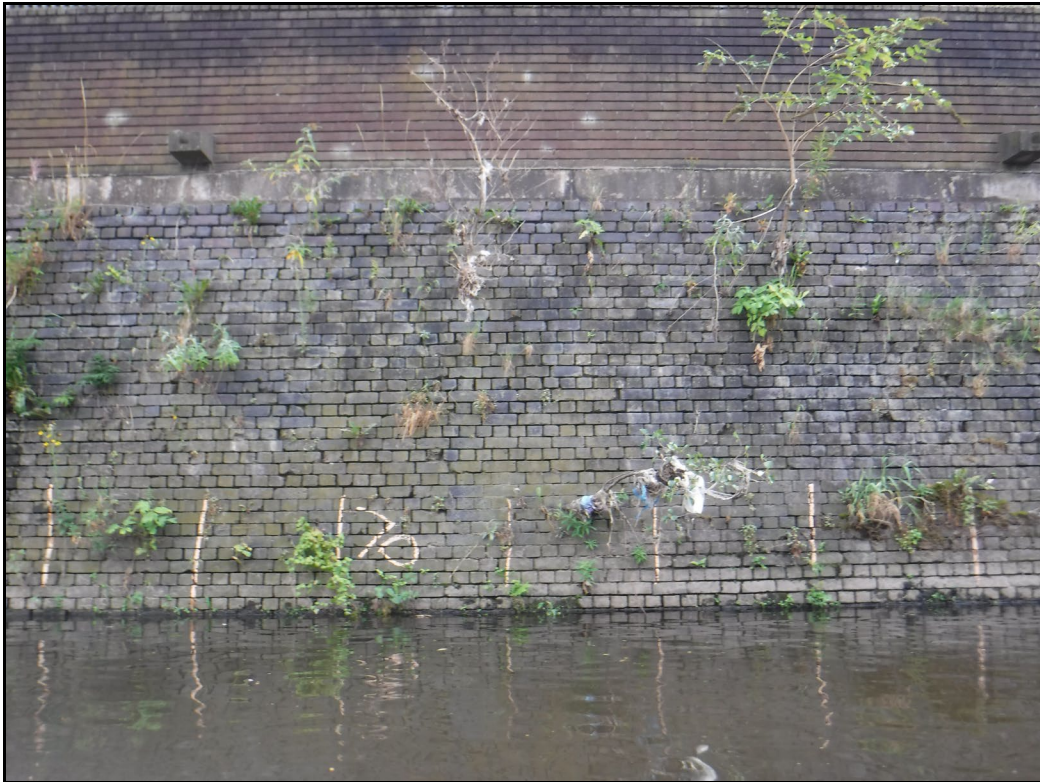
Above:- General view of wall at Ch 70m. Open joints and vegetation growth

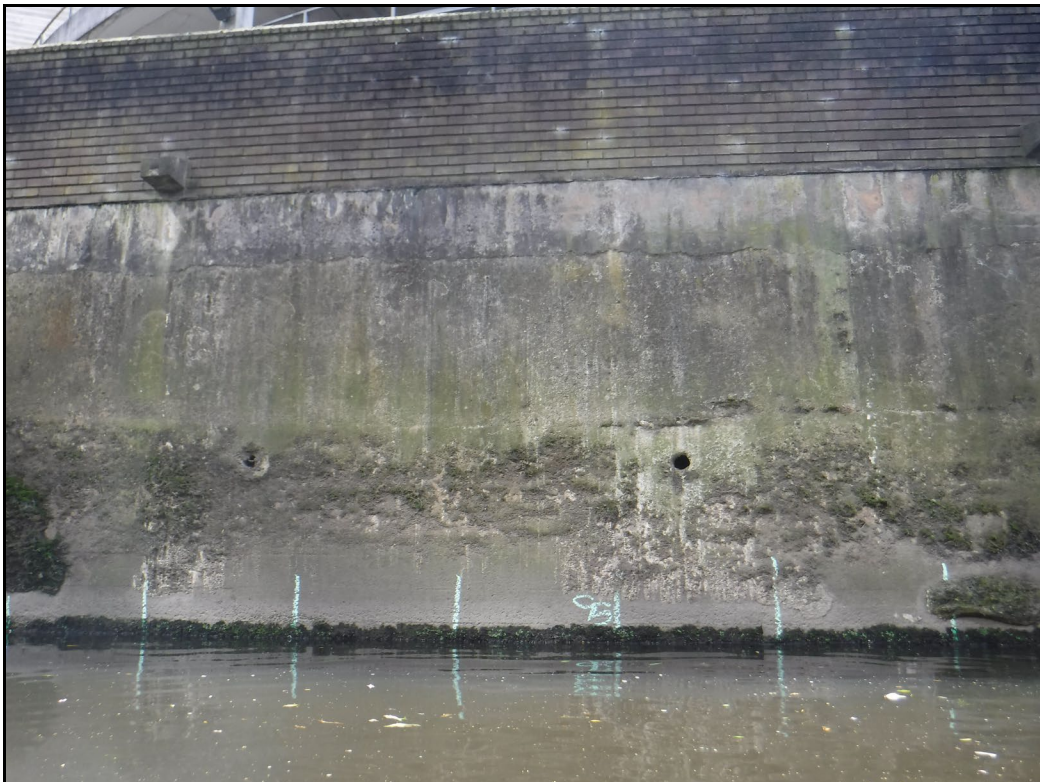
Above:- General view of Ch 95m, showing concrete wall condition.

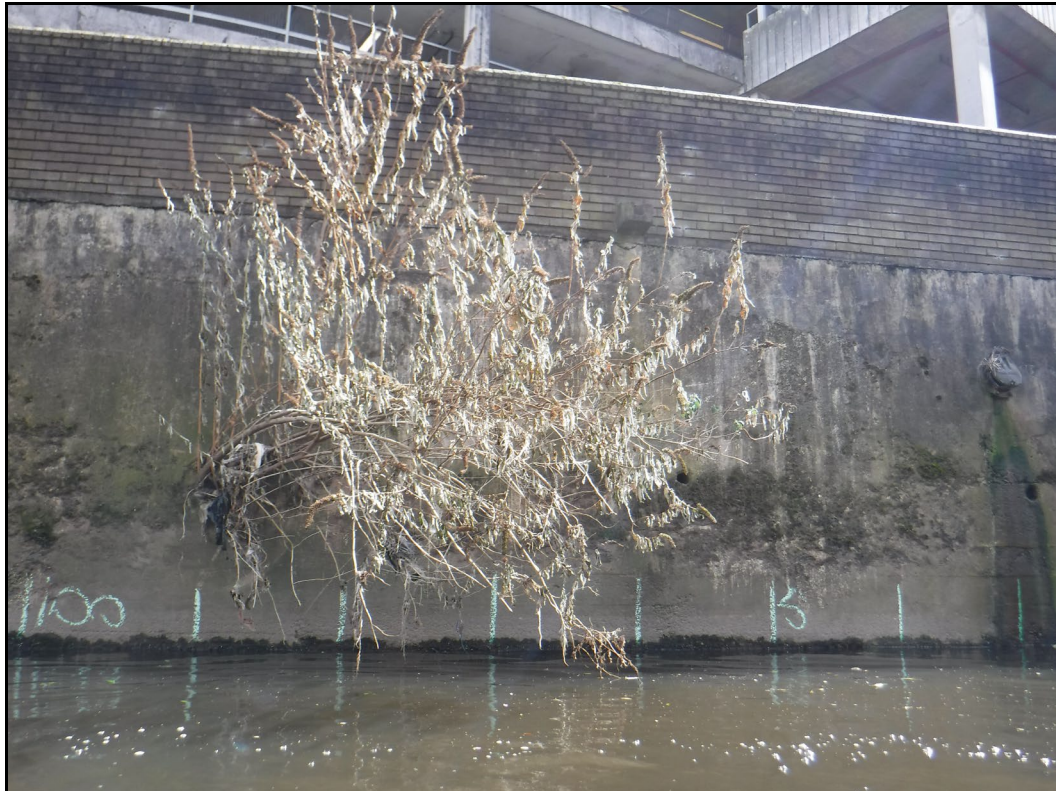
Above:- General view around Ch102m showing vegetation growth through concrete wall

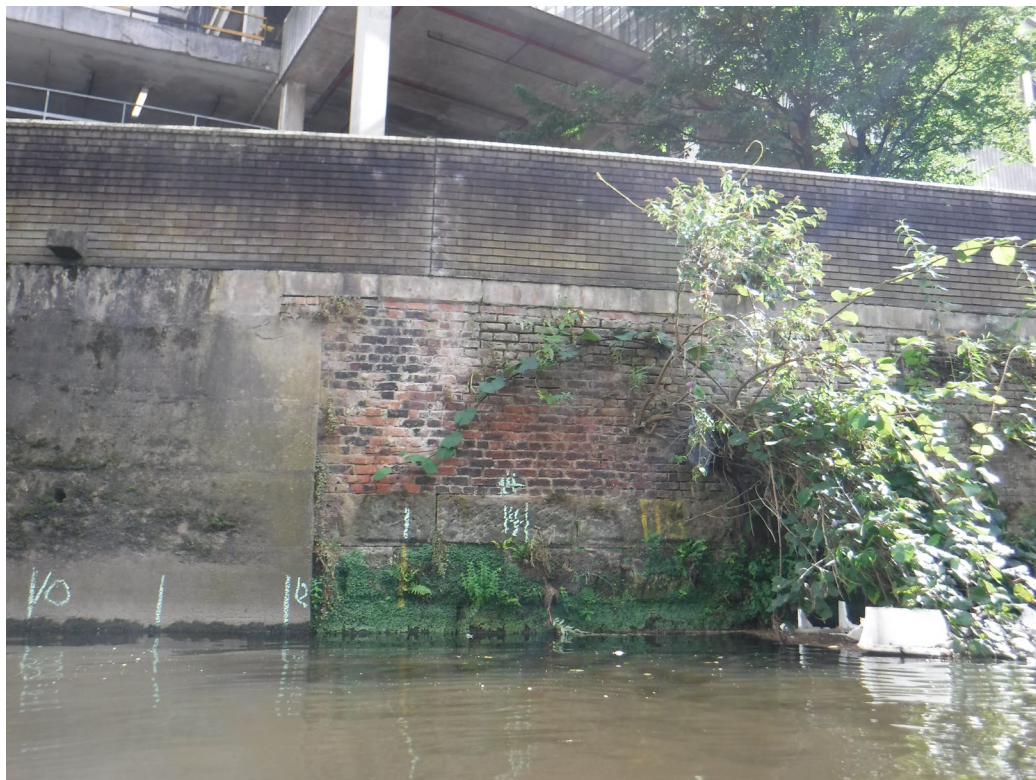
Above:- General of Ch115m showing change in construction detail

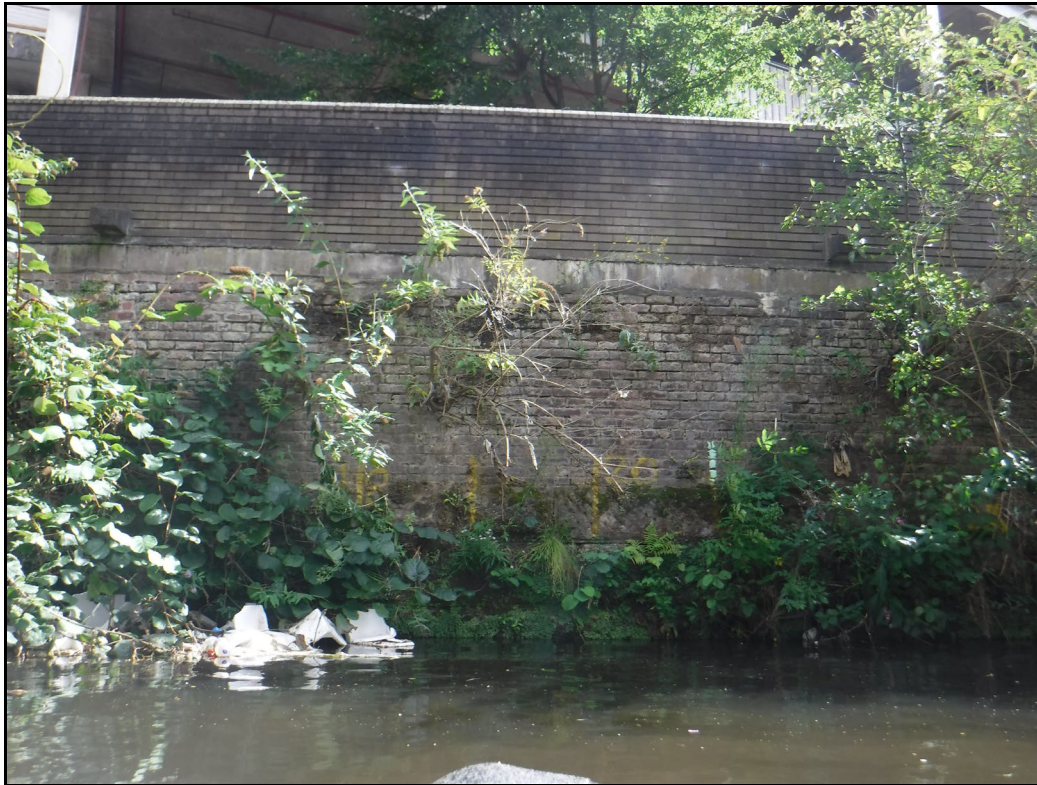
Above:- General view of Ch120m showing condition of wall

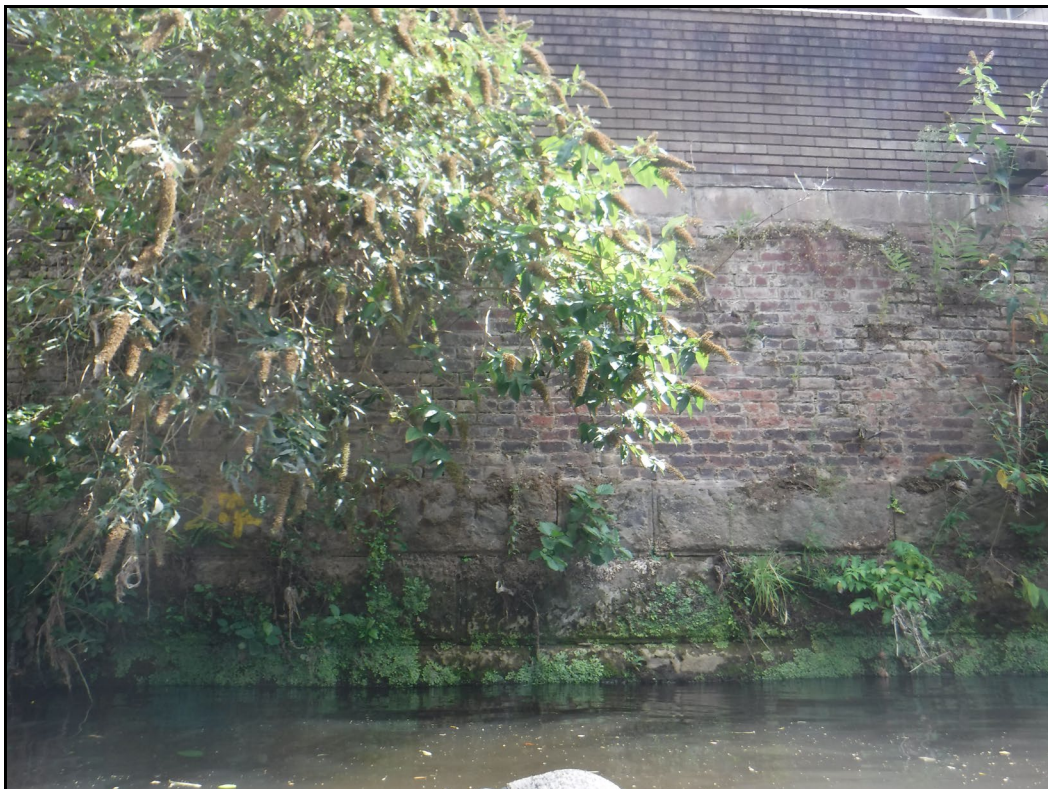
Above:- General view showing condition of wall and construction detail

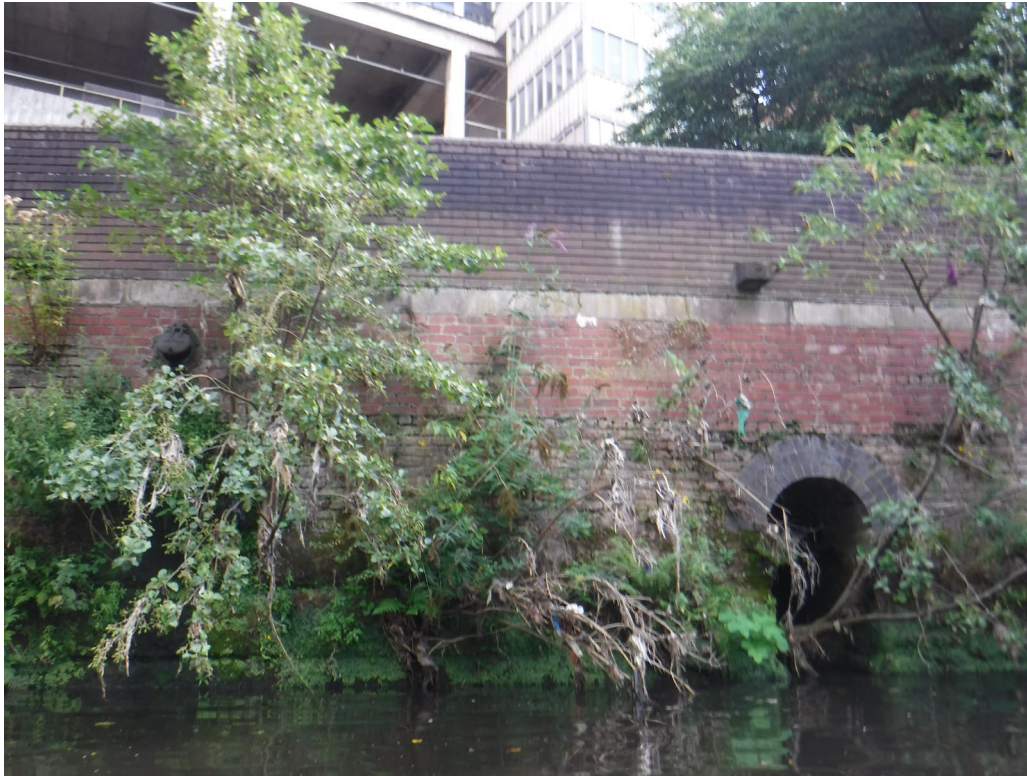
Above:- Ch145m, showing vegetation growth and culvert entrance

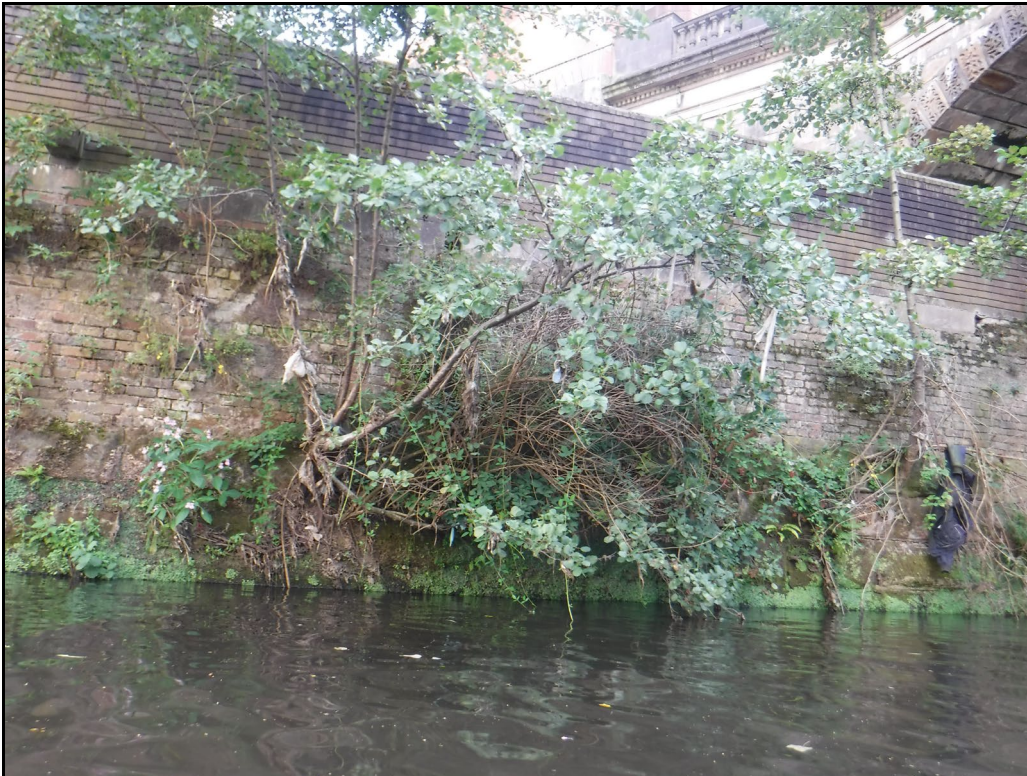
Above:- Ch 170m, showing vegetation growth

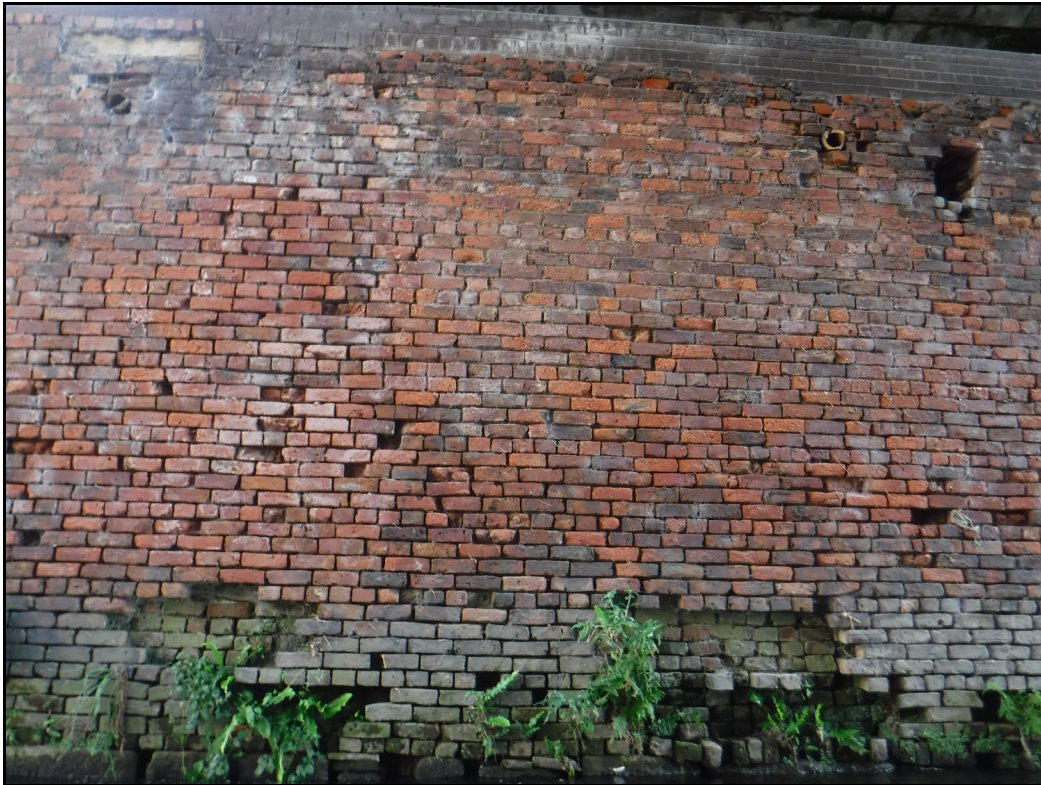
Above:- Ch 175m, showing condition of displaced brickwork

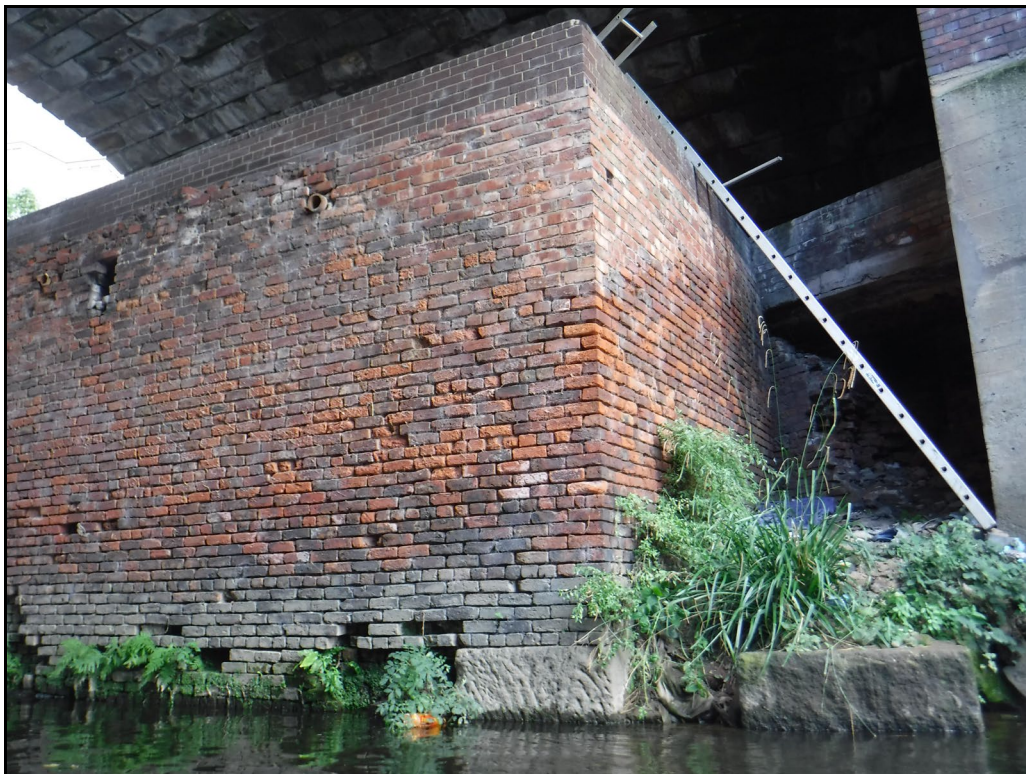
Above:- Ch 182m, showing condition of displaced brickwork. End of survey.
