## Neptune Mill, Manchester - Paint Analysis

### Report on Findings Report No HPMLNM01

ISSUE 01– 01/12/2023

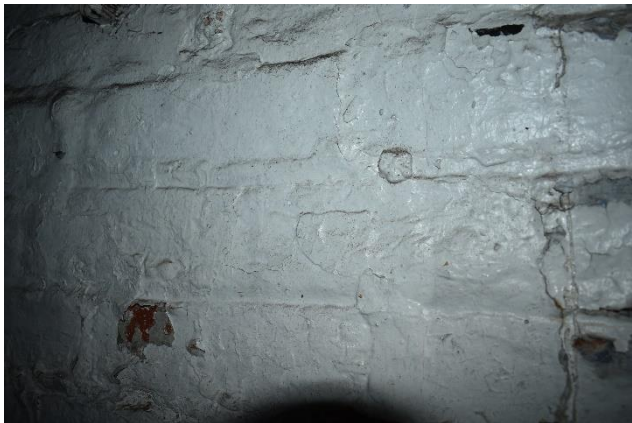
| Sample Ref: P01 – (Level 4 Wall) | | Location: Neptune Mill | |

| Sample Ref: P01 – (Level 4 Wall) | | Location: Neptune Mill | |
|---|--|---|--|
| Paint sample removed from:<br><br>Location: P01- Paint on brick wall to level 4. | | | |

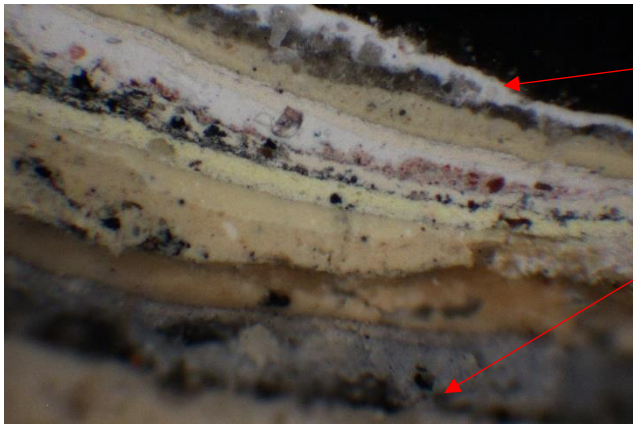
| Sample Ref: P01 – (Level 4 Wall) | | Location: Neptune Mill | |
|---|--|---|--|
| | | 100x Magnification.<br>Current visible paint layer<br><br>20 No. Total paint layers.<br><br>Earliest paint layer. | |

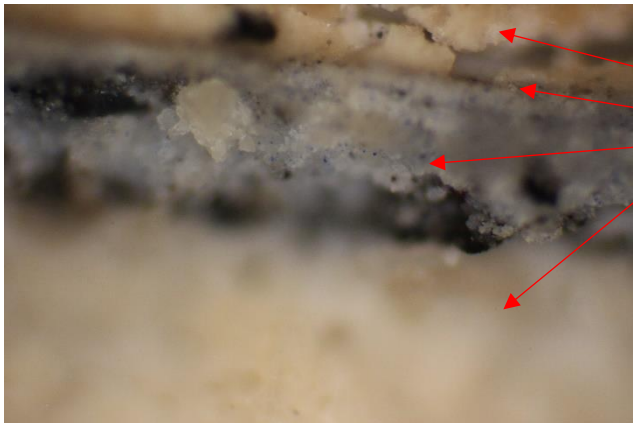
| Sample Ref: P01 – (Level 4 Wall) | | Location: Neptune Mill | |
|---|--|---|--|
| | | Earliest paint layers 400x Magnification.<br><br>Off White (Lime wash)<br>Off White (Lime wash)<br>X2 Blue (Lime wash)<br>X3 White (Lime wash) | |

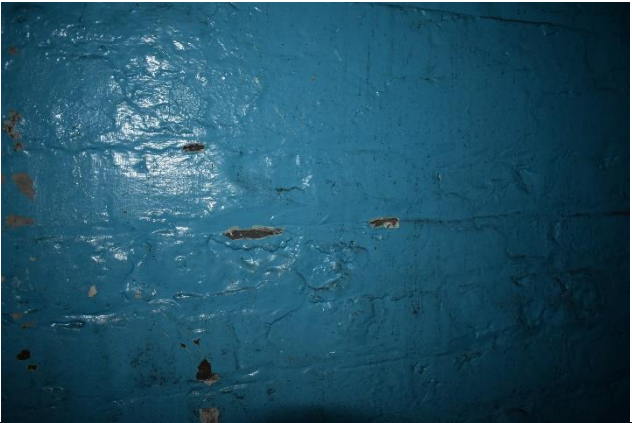
| Sample Ref: P02 – (Level 4 Wall) | Location: Neptune Mill |
|---|---|
| <p>Paint sample removed from:</p> <p>Location: P02- Paint on brick wall to level 4.<br/>(RN. Exterior of former toilet block)</p> | |

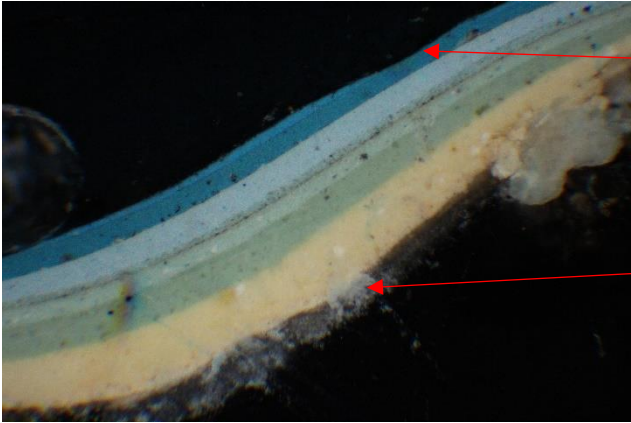
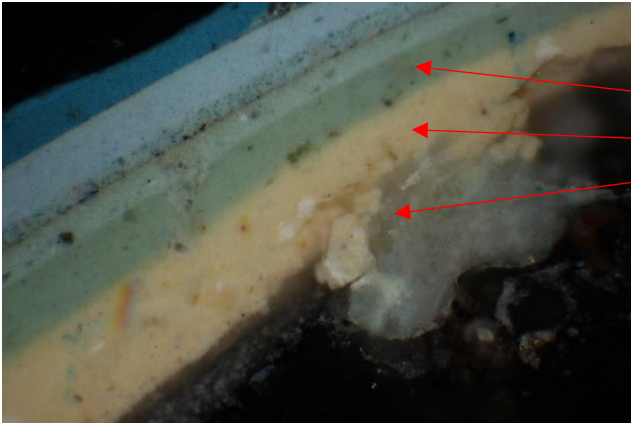
| Sample Ref: P02 – (Level 4 Wall) | Location: Neptune Mill |
|---|---|
| <br> | <p>100x Magnification.</p> <p>Current visible paint layer</p> <p>8 No. Total paint layers.</p> <p>Earliest paint layer.</p><br><p>Earliest paint layers 400x Magnification.</p> <p>Green</p> <p>Off white</p> <p>White (Lime wash)</p><br><p>Note: Wall may be a later construction as only 1 limewash paint layer was discovered.</p> |

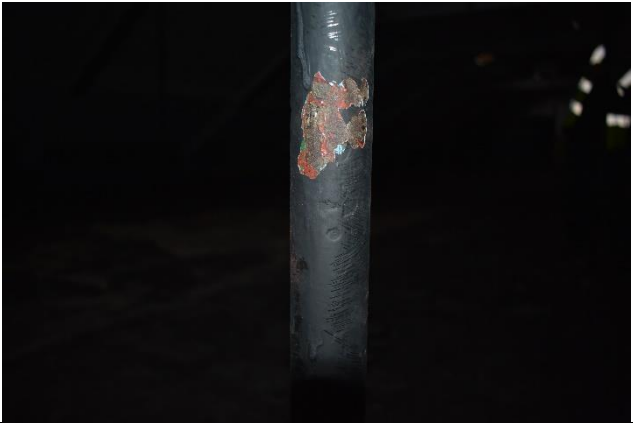
| Sample Ref: P03 – (Level 4 Tie Rod) | Location: Neptune Mill |
|---|---|
| <p>Paint sample removed from:</p> <p>Location: P03- Paint on tie rod from roof.</p> | |

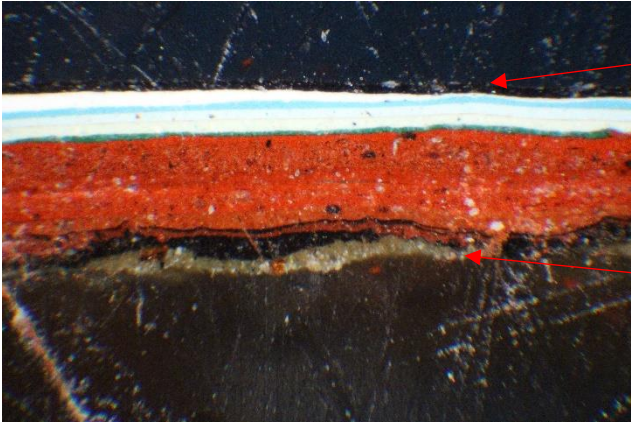
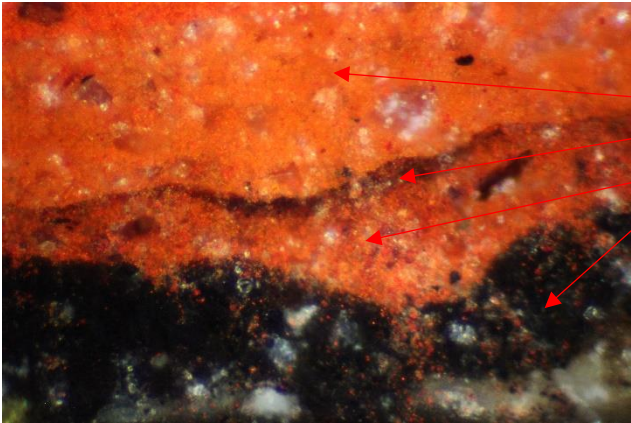
| Sample Ref: P03 – (Level 4 Tie Rod) | Location: Neptune Mill |
|---|---|
| <br> | <p>100x Magnification.</p> <p>Current visible paint layer</p> <p>15 No. Total paint layers.</p> <p>Earliest paint layer.</p><br><p>Earliest paint layers 400x Magnification.</p> <p>5x Iron Oxide Red oil paints.</p> <p>Trace of varnish oils to earliest paint coating</p> <p>Red Iron Oxide oil paint (earliest paint scheme).</p> <p>Carbon black oil paint – foundry paint.</p> |

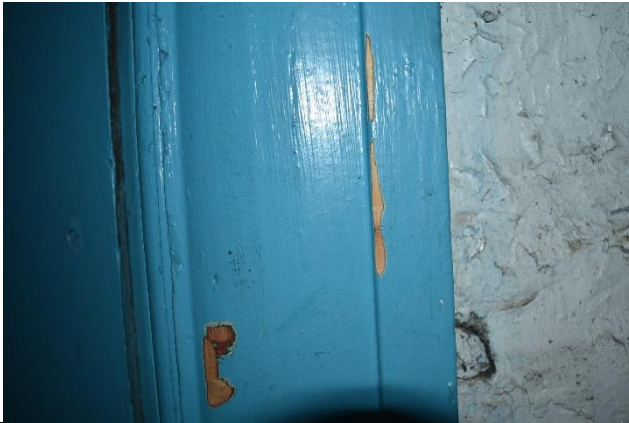
| Sample Ref: P04 – (Door Architrave) | Location: Neptune Mill |
|---|---|
| <p>Paint sample removed from:</p> <p>Location: P04- Timber Architrave to door to stairs.</p> | |

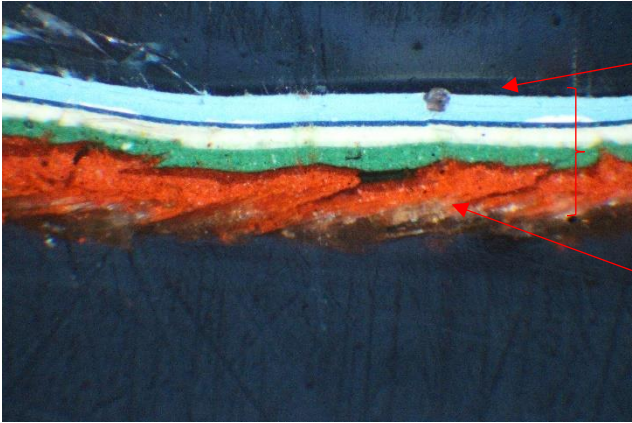
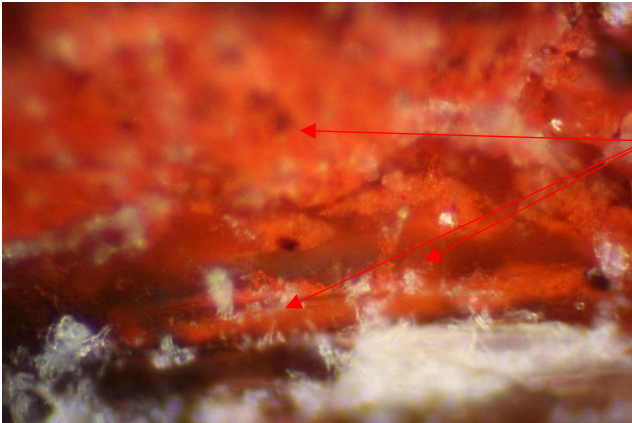
| Sample Ref: P04 – (Door Architrave) | Location: Neptune Mill |
|---|---|
| <br> | <p>100x Magnification.</p> <p>Current visible paint layer</p> <p>11 No. Total paint layers.</p> <p>Dirt on early paint layers.</p> <p>Earliest paint layer.</p><br><p>Earliest paint layers 400x Magnification.</p> <p>3x Red Iron Oxide oil paints (original decorative scheme)</p> <p>Note: Iron oxide paints have been abraded to key for other paint layers and some layers may be missing.</p> |

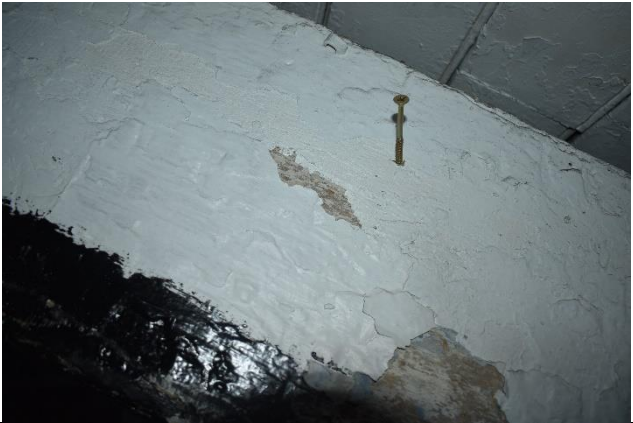
| Sample Ref: P05 – (Roof Beam) | Location: Neptune Mill |
|---|---|
| <p>Paint sample removed from:</p> <p>Location: P05- Painted Timber Beam to roof.</p> <p>20 No Paint layers visible in the sample.</p> | |

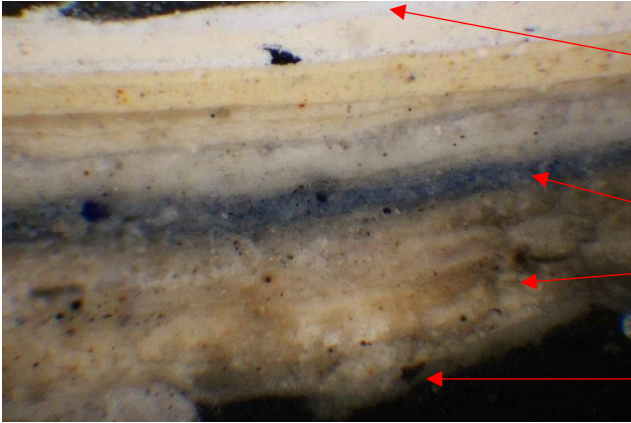
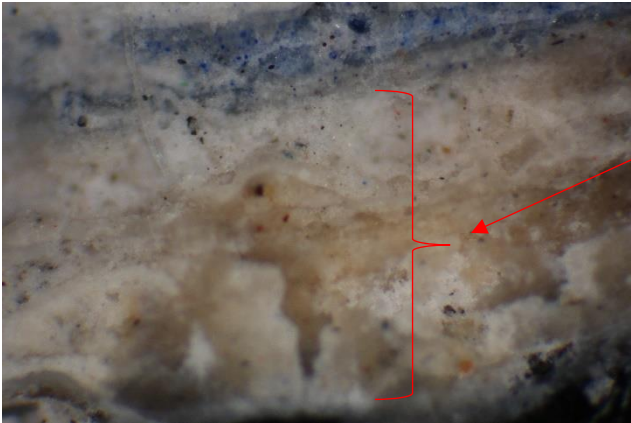
| Sample Ref: P05 – (Roof Beam) | Location: Neptune Mill |
|---|---|
| <br> | <p>100x Magnification.</p> <p>Current visible paint layer (modern Titanium White)</p> <p>3 Blue Limewash layers</p> <p>6 White Limewash layers</p> <p>Earliest paint layer.</p><br><p>Earliest paint layers 400x Magnification.</p> <p>6x Off white (Lime wash)</p> |

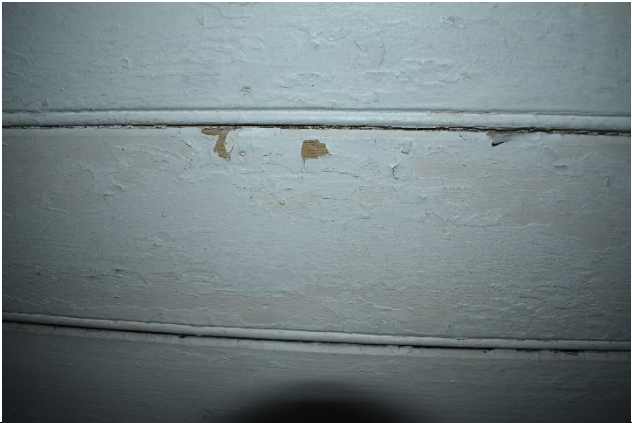
| Sample Ref: P06 – (Roof Ceiling Boarding) | Location: Neptune Mill |
|---|---|
| <p>Paint sample removed from:</p> <p>Location: P06- Painted timber boards to ceiling.</p> <p>8No total paint layers.</p> | |

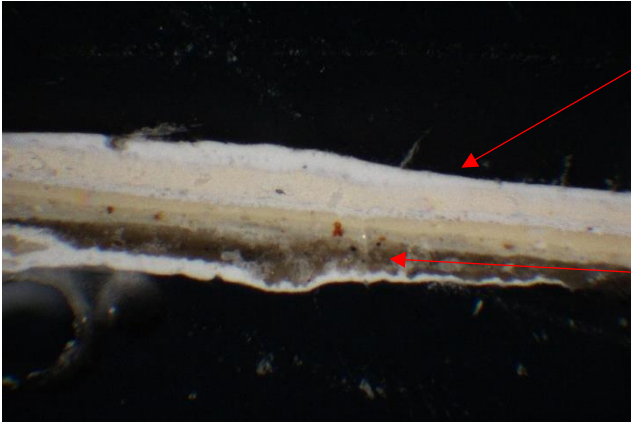
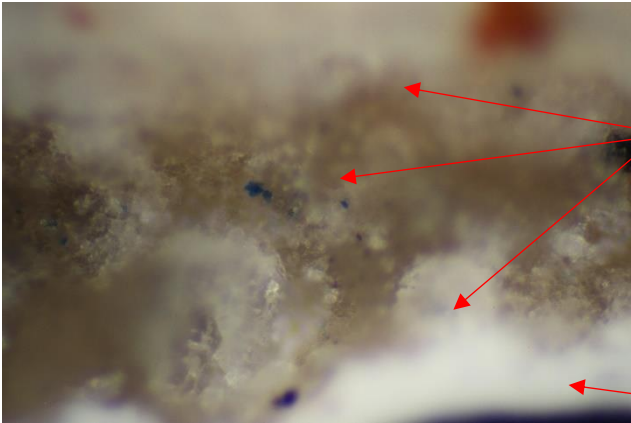
| Sample Ref: P06 – (Roof Ceiling Boarding) | Location: Neptune Mill |
|---|---|
| <br> | <p>100x Magnification.</p> <p>Current visible paint layer (modern Titanium white).</p> <p>Earliest paint layers.</p><br><p>Earliest paint layers 400x Magnification.</p> <p>3x White Lime Wash paint coatings.</p> <p>Note: The limewash has been slightly tinted with a small amount of Prussian Blue to make a bright white colour.</p> <p>Titanium white under creep from later paint layer.</p> |

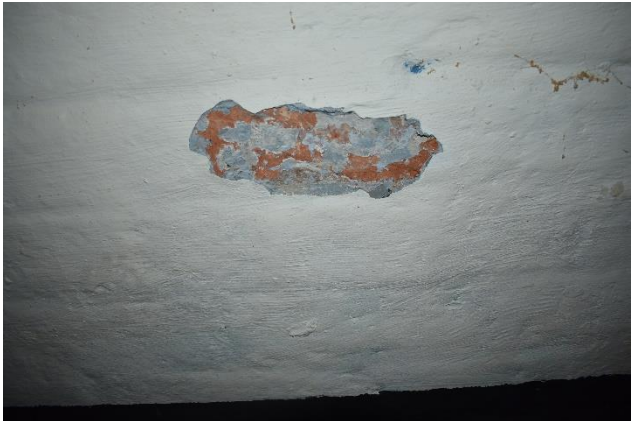
| Sample Ref: P07 – (Third Floor Wall) | Location: Neptune Mill |
|---|---|
| <p>Paint sample removed from:</p> <p>Location: P07- Paint wall to third floor brickwork wall (above dado height).</p> <p>14 No total paint layers identified.</p> | |

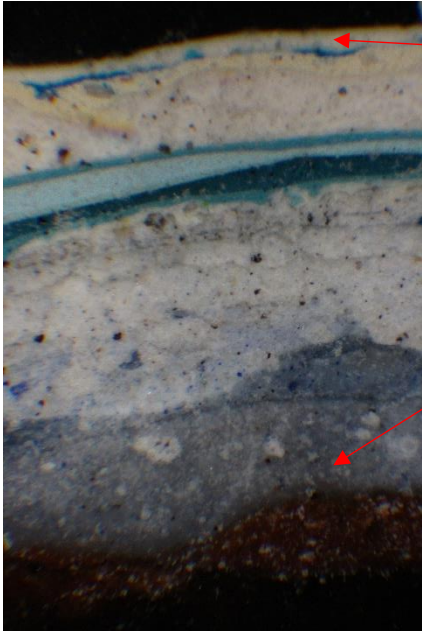
| Sample Ref: P07 – (Third Floor Wall) | Location: Neptune Mill |
|---|---|
| | <p>100x Magnification.<br/>Current visible paint layer (modern Titanium white).</p> <p>Earliest paint layer.</p> <p>Earliest paint layers 400x Magnification.</p> <p>3x White Lime Wash layers.<br/>3x Blue Lime Wash layers.</p> <p>Brick fragment</p> |

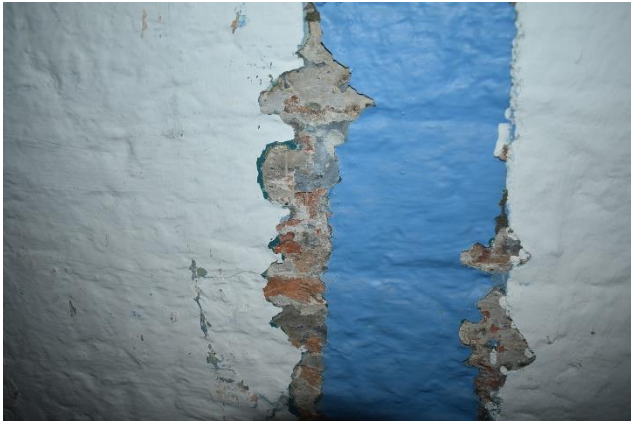
The wall areas were originally decorated in white lime wash with 7 separate early paint layers being identified in sample 08 before the introduction of a blue limewashes. Blue limewashes were often used where sanitary or clean conditions needed to be maintained, they were more expensive than standard white limewash and colours varied depending on the amount of pigment used.

| Sample Ref: P08 – (Third Floor Wall) | Location: Neptune Mill |
|---|---|
| <p>Paint sample removed from:</p> <p>Location: P08- Painted brick wall to third floor (below dado height).</p> <p>22 No paint layers identified.</p> | |

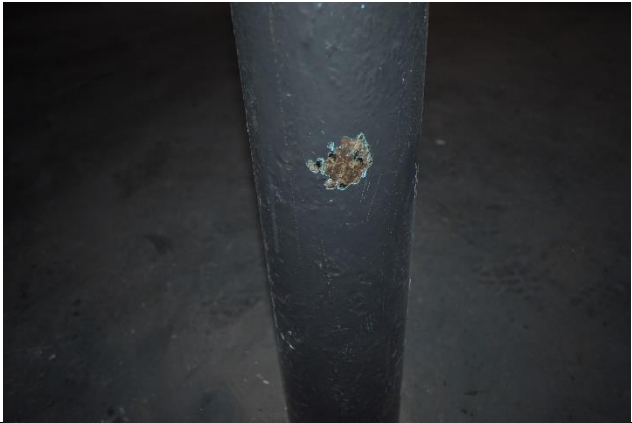
| Sample Ref: P09 – (Third Floor Column) | Location: Neptune Mill |
|---|---|
| <p>Paint sample removed from:</p> <p>Location: P09- Paint on cast iron column to third floor.</p> <p>16 No separate paint layers identified.</p> | |

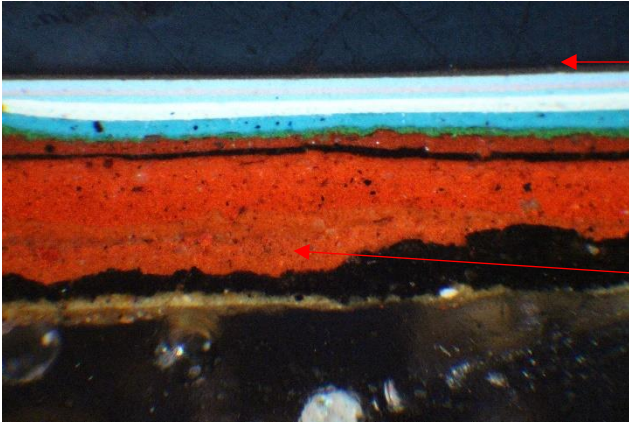
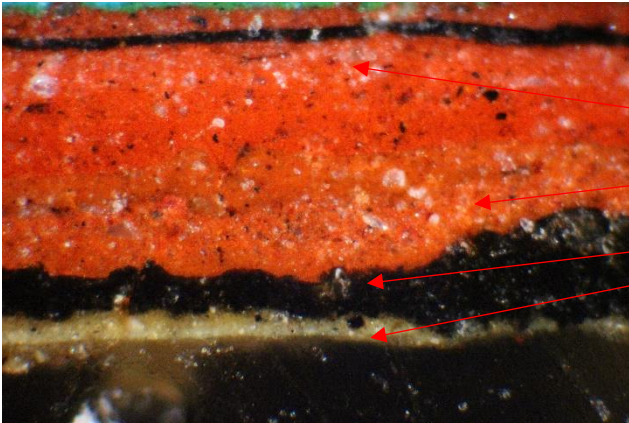
| Sample Ref: P09 – (Third Floor Column) | Location: Neptune Mill |
|---|---|
| <br> | <p>100x Magnification.</p> <p>Current visible paint layer (dark grey alkyd paint)</p><br><p>Earliest paint layers.</p><br><p>Earliest paint layers 400x Magnification.</p> <p>4x Red iron oxide oil paints.</p> <p>First decorative scheme.</p> <p>Carbon black oil paint (foundry paint).</p> <p>White Primer</p> <p>Note: Ironwork was typically delivered in a carbon black oil protection paint. The red iron oxide paint is the first decorative layer.</p> |
| Yes. | Primer layer is a lead-based paint. |

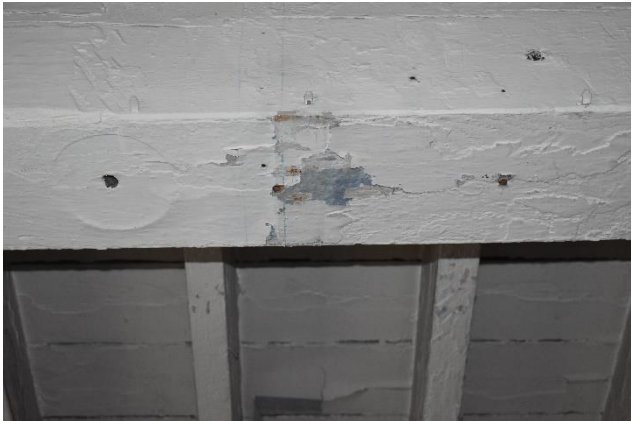
| Sample Ref: P10 – (Third Floor Beam) | Location: Neptune Mill |
|---|---|
| <p>Paint sample removed from:</p> <p>Location: P10- Paint on timber beam to third floor.</p> <p>22No separate paint layers identified.</p> | |

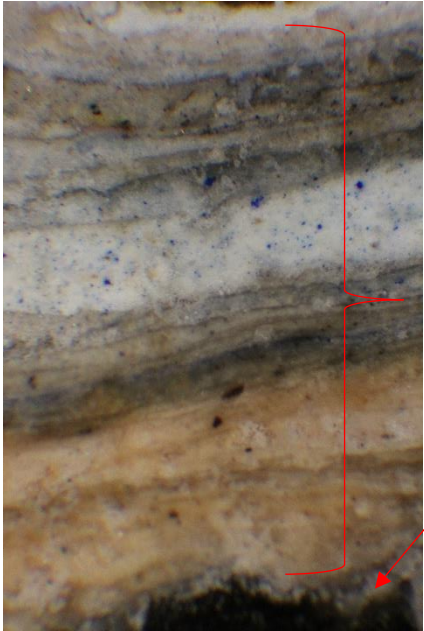
| Sample Ref: P10 – (Third Floor Beam) | Location: Neptune Mill |
|---|---|
| | <p>100x Magnification.</p> <p>Current visible paint layer (Modern Titanium white paint).</p> <p>21 layers of white and blue Lime Wash.</p> <p>Earliest paint layers.</p><br><p>Earliest paint layers 400x Magnification.</p> <p>5 No light blue Lime Wash layers.</p> <p>7 No white Lime Wash layers.</p> |

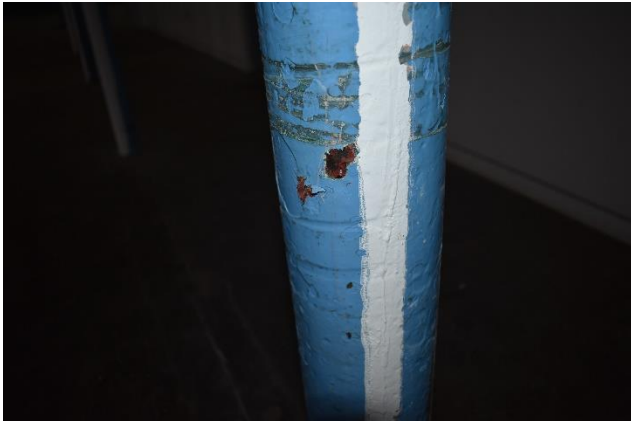
| Sample Ref: P11 – (Third Floor Blue Column) | Location: Neptune Mill |
|---|---|
| <p>Paint sample removed from:</p> <p>Location: P11- Painted cast iron column to third floor.</p> <p>16 No separate paint layers identified.</p> | |

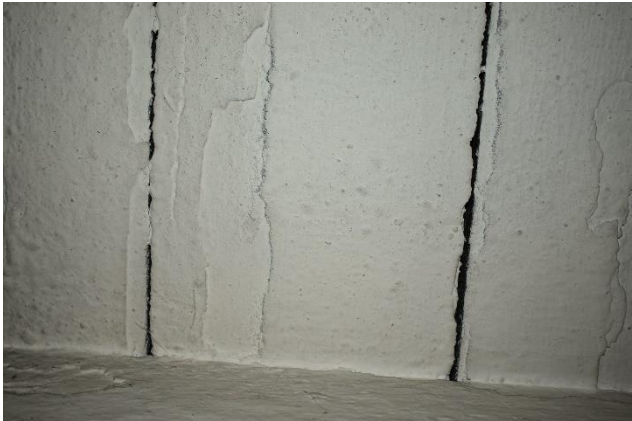
| Sample Ref: P12 – (Third Floor Ceiling Boards) | Location: Neptune Mill |
|---|---|
| <p>Paint sample removed from:</p> <p>Location: P12- Painted underside of timber floor boards.</p> <p>16No separately identified paint layers.</p> | |

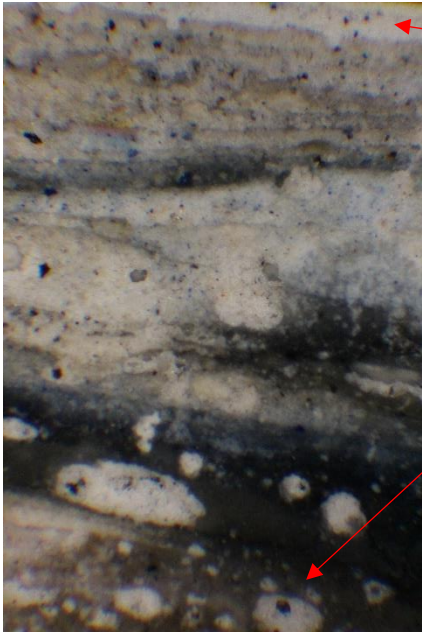
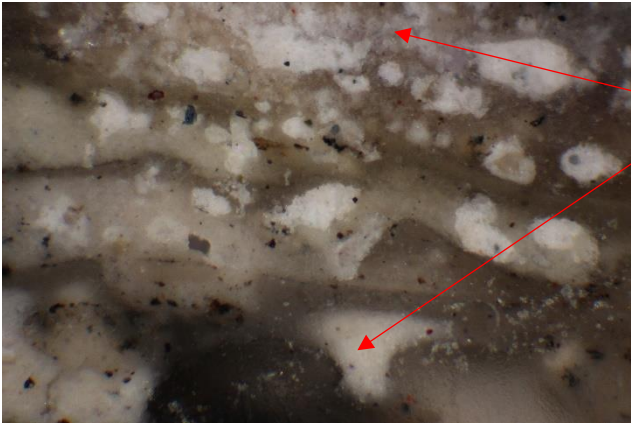
| Sample Ref: P12 – (Third Floor Ceiling Boards) | Location: Neptune Mill |
|---|---|
| <br> | <p>100x Magnification.</p> <p>Current visible paint layer (Modern Titanium white scheme).</p> <p>(14 separate white and blue Lime Wash layers).</p> <p>Earliest paint layers.</p><br><p>Earliest paint layers 400x Magnification.</p> <p>4No White Lime Wash layers (poor condition).</p> |

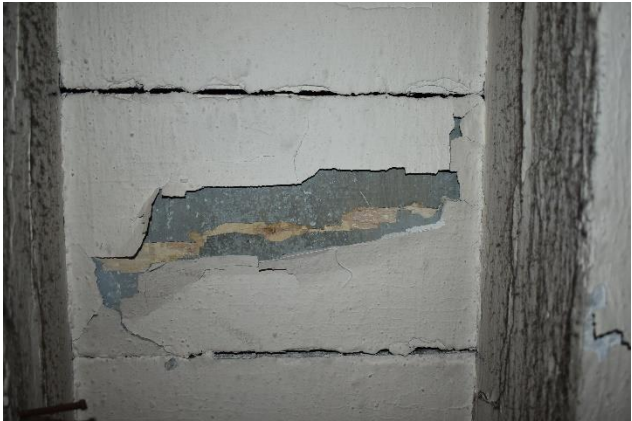
| Sample Ref: P13 – (Third Floor Ceiling Boarding) | Location: Neptune Mill |
|---|---|
| <p>Paint sample removed from:</p> <p>Location: P13- Paint on underside of floor boards to third floor.</p> <p>11 No separate paint layers identified.</p> | |

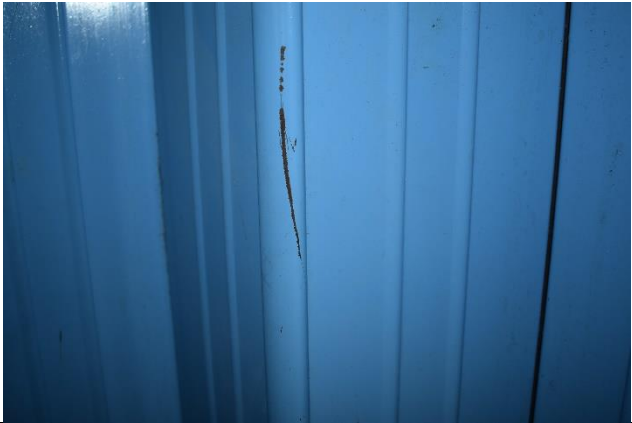
| Sample Ref: P14 – (Third Floor Lift Door) | Location: Neptune Mill |
|---|---|
| <p>Paint sample removed from:</p> <p>Location: P14- Paint on lift door to third floor.</p> <p>2No separate paint layers identified.</p> | |

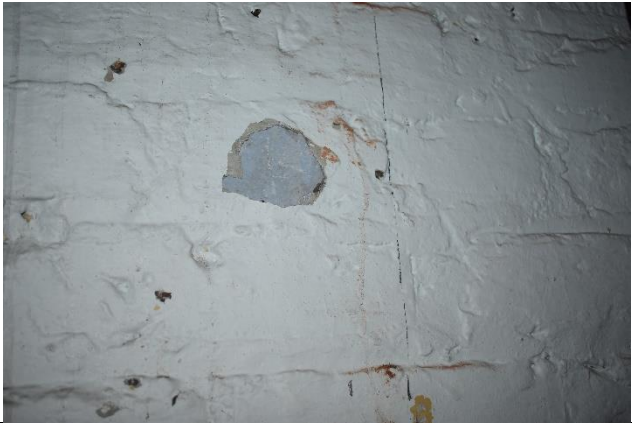
| Sample Ref: P15 – (Second Floor Wall) | Location: Neptune Mill |
|---|---|
| <p>Paint sample removed from:</p> <p>Location: P15- Paint on brick wall to second floor (above dado height).</p> <p>11No separate paint layers identified.</p> | |

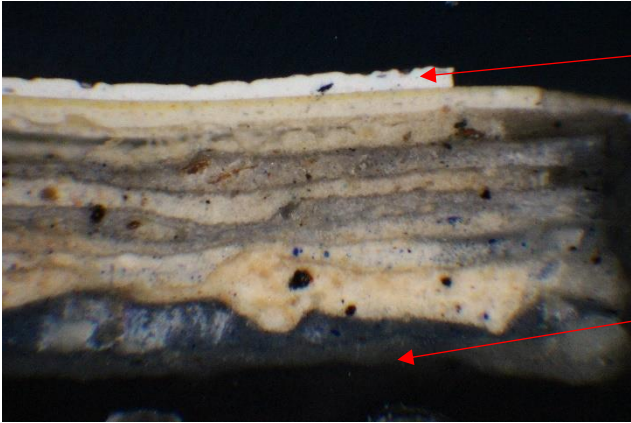
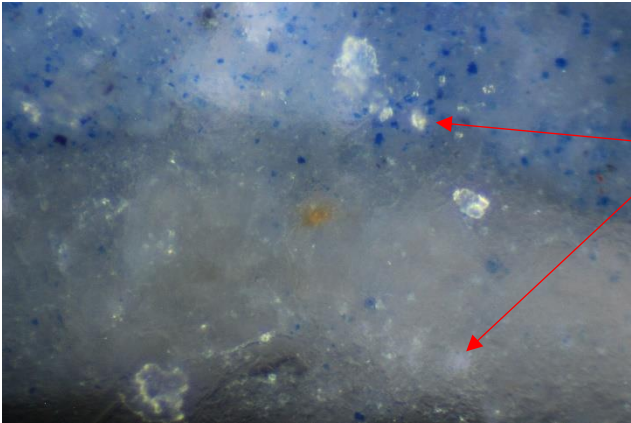
| Sample Ref: P15 – (Second Floor Wall) | Location: Neptune Mill |
|---|---|
| <br> | <p>100x Magnification.</p> <p>Current visible paint layer (Modern Titanium white scheme).</p><br><p>Earliest paint layers (Lime Washes).</p><br><p>Earliest paint layers 400x Magnification.</p> <p>Blue Lime Wash layer</p> <p>White Lime Wash paint layer. (First decorative scheme).</p> |

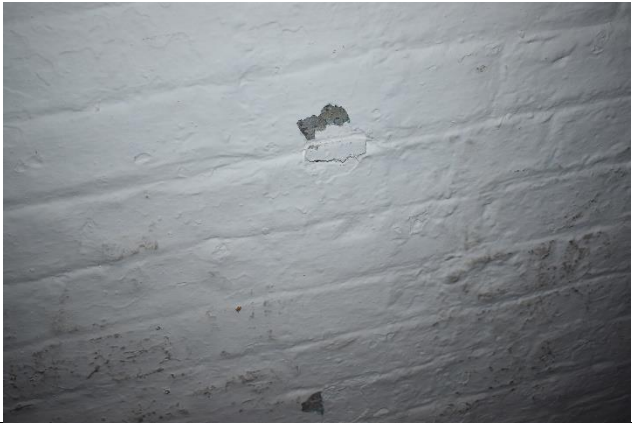
| Sample Ref: P16 – (Second Floor Wall) | Location: Neptune Mill |
|---|---|
| <p>Paint sample removed from:</p> <p>Location: P16- Paint on brick wall to second floor (below dado height).</p> <p>15No separate paint layers identified.</p> | |

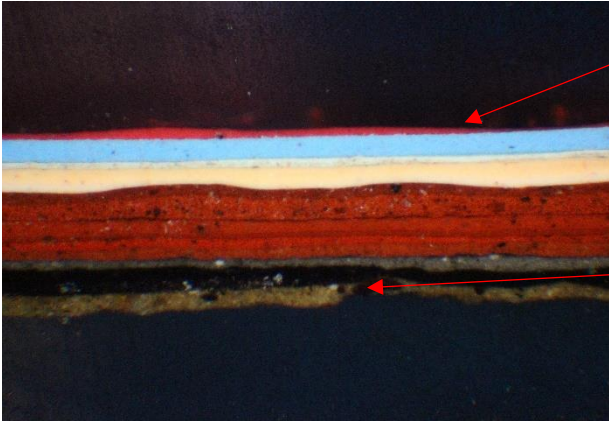
| Sample Ref: P17 – (Second Floor Column) | Location: Neptune Mill |
|---|---|
| | <p>100x Magnification.</p> <p>Current visible paint layer (red alkyd paint layer).</p> <p>Earliest paint layers.</p> |

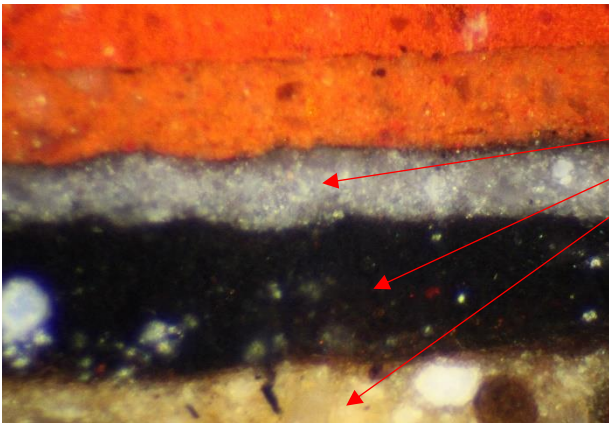
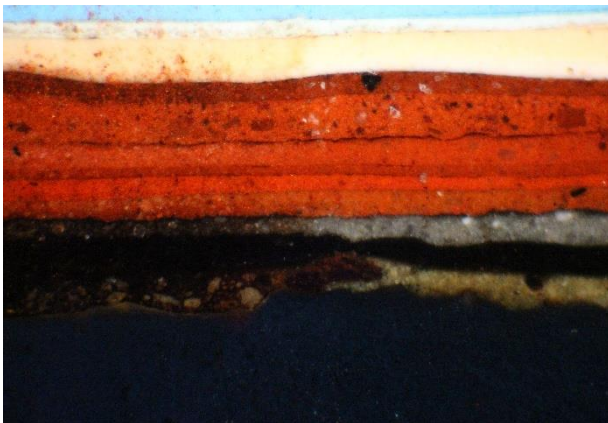
| Sample Ref: P17 – (Second Floor Column) | Location: Neptune Mill |
|---|---|
| <p>Note: - Dirt on the surface of the grey paint indicates that it was a visible paint layer ie the first decorative paint scheme. However repainted on 5 separate occasions with an Iron Oxide red.</p> | <p>Earliest paint layers 400x Magnification.</p> <p>Grey oil paint with dirt on surface of paint layer.</p> <p>Carbon Black oil paint (foundry paint).</p> <p>Primer</p> |
| Yes. | Positive identification for lead carbonate in primer and early grey paint layers (see above). |

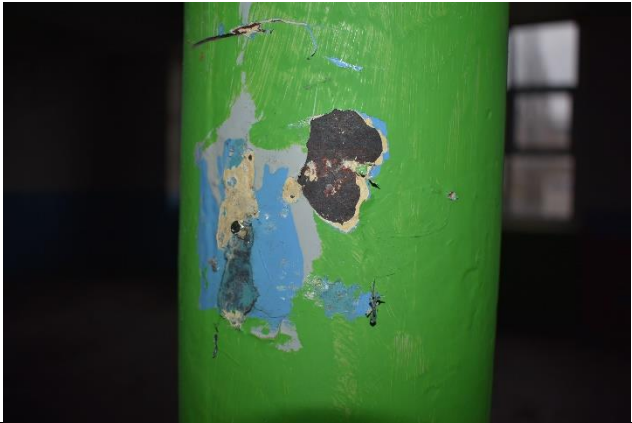
| Sample Ref: P18 – (Second Floor Column) | Location: Neptune Mill |
|---|---|
| <p>Paint sample removed from:</p> <p>Location: P18- Paint on green cast iron column to second floor.</p> <p>19 No separate paint layers identified.</p> | |

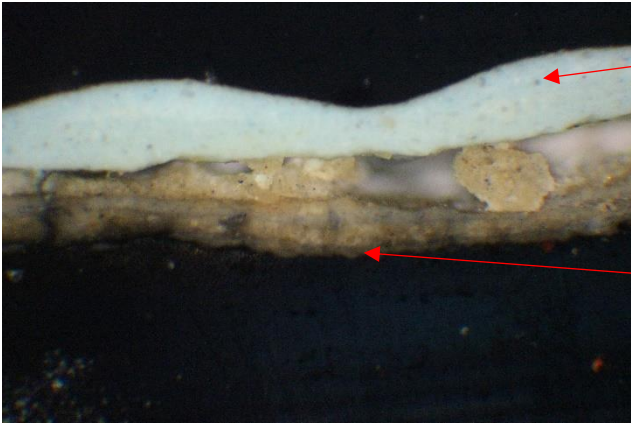
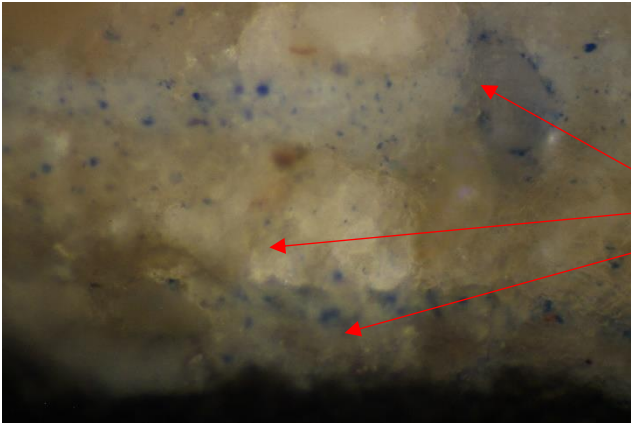
| Sample Ref: P19 – (Second Floor Ceiling Boards) | Location: Neptune Mill |
|---|---|
| <br> | <p>100x Magnification.</p> <p>Current visible paint layer (modern off-white decorative scheme).</p><br><p>Earliest paint layers.</p><br><p>Earliest paint layers 400x Magnification.</p> <p>Blue Lime Wash paint layer.</p> <p>White Lime Wash paint layer.</p> <p>Blue Lime Wash paint layer.</p> <p>Note: Boarding is likely to be a later fitment to the mill.</p> |

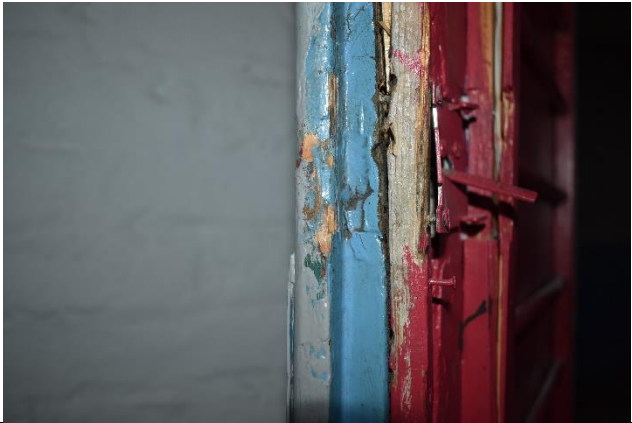
| Sample Ref: P21 – (Second Floor Door) | | Location: Neptune Mill | |

| Sample Ref: P21 – (Second Floor Door) | | Location: Neptune Mill | |
|---|--|---|--|
| Paint sample removed from:<br><br>Location: P21- Paint to door on second floor.<br><br>3No separate paint layers identified. | | | |

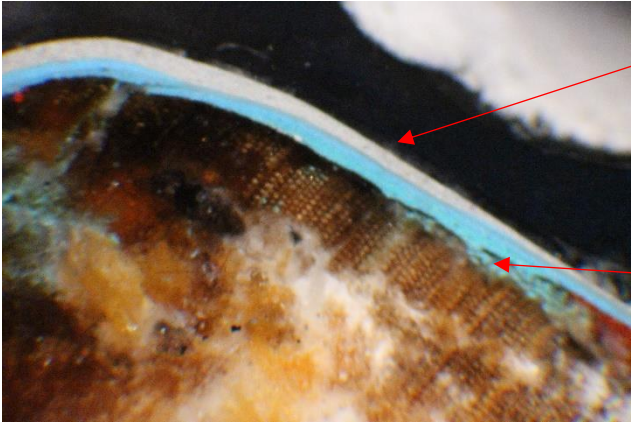
| Sample Ref: P21 – (Second Floor Door) | | Location: Neptune Mill | |
|---|--|---|--|
| | | 100x Magnification.<br>Current visible paint layer (Grey alkyd paint).<br><br>Earliest paint layer. | |

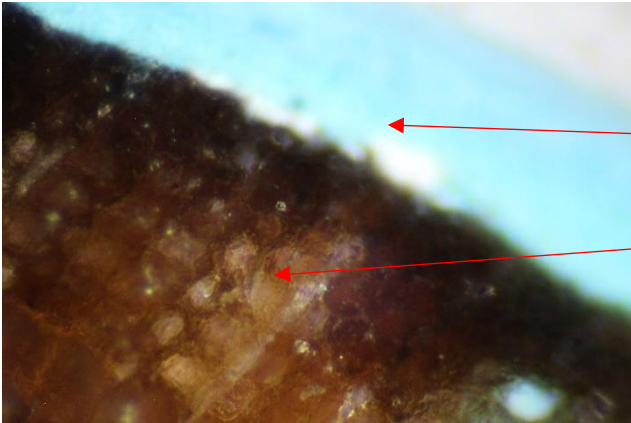
| Sample Ref: P21 – (Second Floor Door) | | Location: Neptune Mill | |
|---|--|---|--|
| | | Earliest paint layers 400x Magnification.<br>Blue alkyd paint over blue undercoat.<br>Timber of door. | |

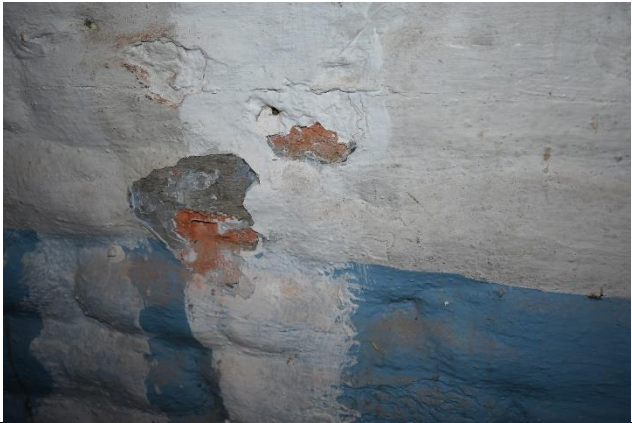
| Sample Ref: P22 – (Ground Floor Wall) | Location: Neptune Mill |
|---|---|
| <p>Paint sample removed from:</p> <p>Location: P22- Paint on brick wall to ground floor (above dado height).</p> <p>15 No paint layers identified.</p> | |

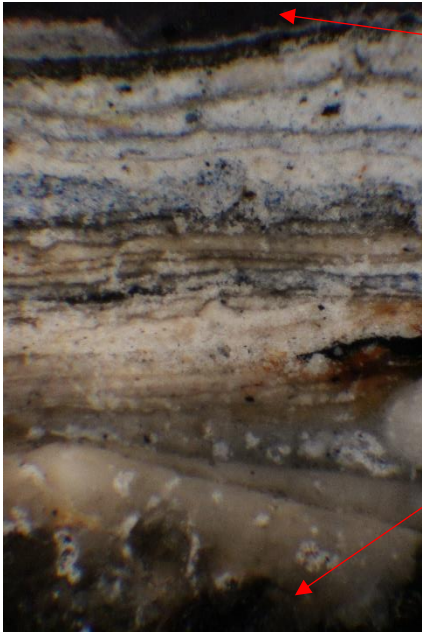
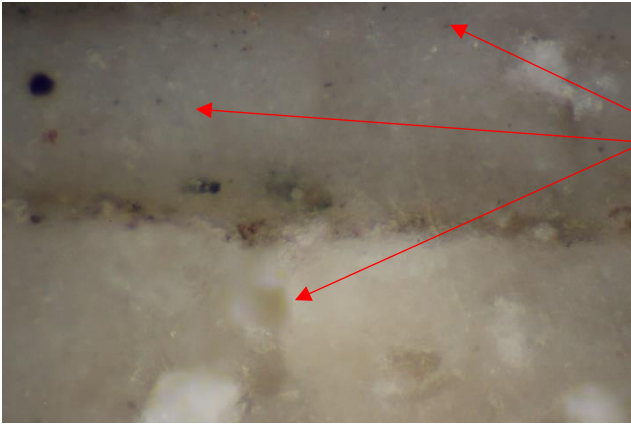
| Sample Ref: P23 – (Ground Floor External Wall) | Location: Neptune Mill |
|---|---|
| <br> | <p>100x Magnification.<br/>Current visible paint layer (Purple painted mural).</p> <p>(23 layers of white and blue lime wash and later similar paint layers).</p> <p>Earliest paint layers.</p><br><p>Earliest paint layers 400x Magnification.</p> <p>2No white Lime Wash paint layers.</p> |

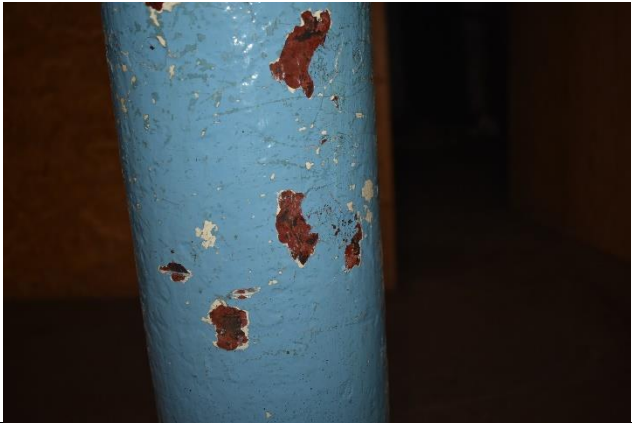
| Sample Ref: P24 – (Ground Floor Column) | Location: Neptune Mill |
|---|---|
| <p>Paint sample removed from:</p> <p>Location: P24- Paint on blue cast iron column to ground floor.</p> <p>10 No separate paint layers identified.</p> | |

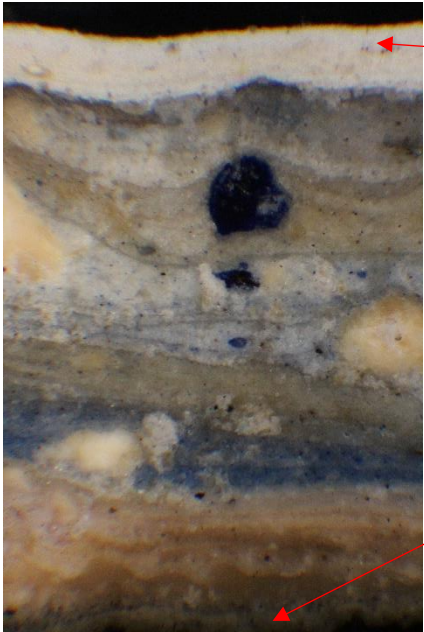
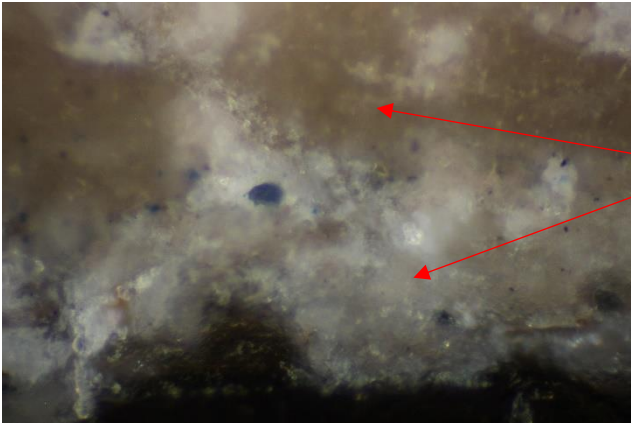
| Sample Ref: P26 – (Ground Floor Ceiling Beam) | Location: Neptune Mill |
|---|---|
| <br> | <p>100x Magnification.</p> <p>Current visible paint layer (Modern Titanium white scheme).</p> <p>(21 white and blue Lime Wash paint layers)</p><br><p>Earliest paint layer.</p><br><p>Earliest paint layers 400x Magnification.</p> <p>Later white Lime Wash paint layer.</p> <p>White Lime Wash paint layer – earliest decorative layer (tinted with a small amount of Prussian Blue pigment).</p> |

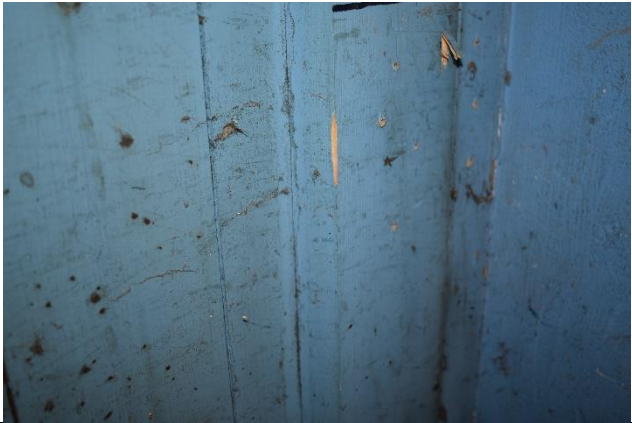
| Sample Ref: P28 – (Ground Floor Doors) | | Location: Neptune Mill | |
|---|--|---|--|
| <p>Paint sample removed from:</p> <p>Location: P28- Paint on timber doors to ground floor.</p> <p>2 No paint layers identified.</p> | | | |

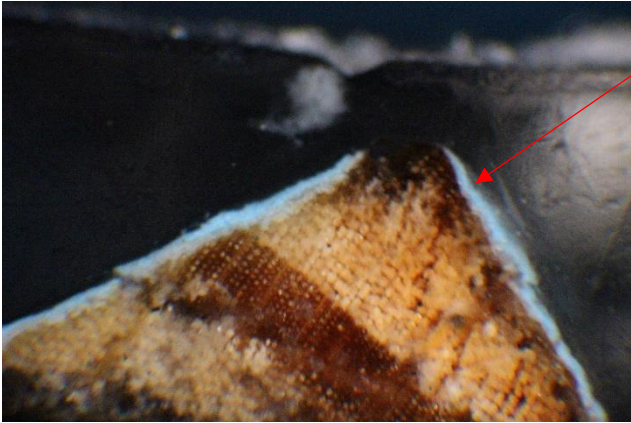
| Sample Ref: P28 – (Ground Floor Doors) | | Location: Neptune Mill | |
|---|--|---|--|
| | | <p>100x Magnification.<br/>Current visible paint layer (Modern blue alkyd paint).</p> | |

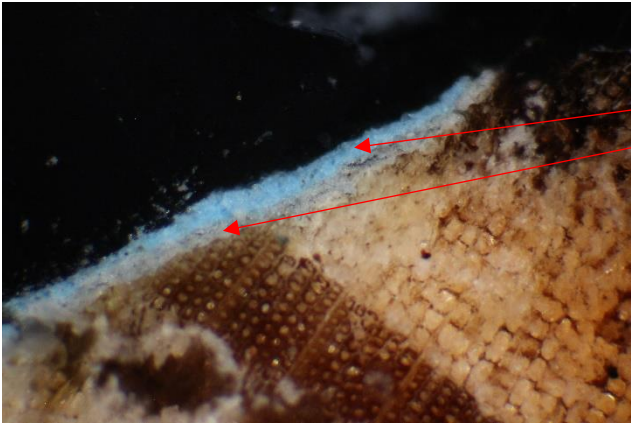
| Sample Ref: P28 – (Ground Floor Doors) | | Location: Neptune Mill | |
|---|--|---|--|
| | | <p>Earliest paint layers 400x Magnification.</p> <p>Blue alkyd paint (current visible decoration).<br/>Grey undercoat</p> <p>Note: Only 2No modern paint layers are present.</p> | |

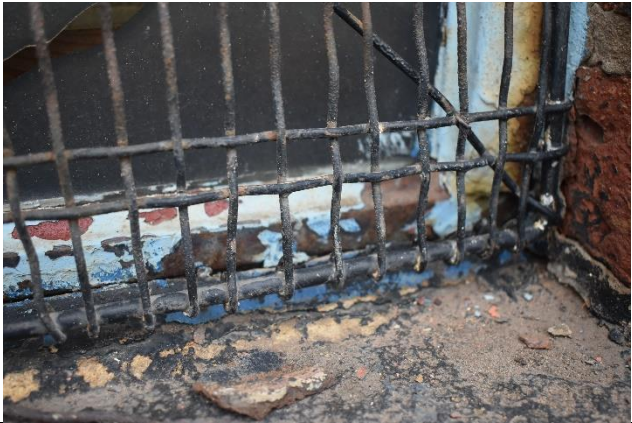
| Sample Ref: P29 – (Ground Floor Window) | Location: Neptune Mill |
|---|---|
| <p>Paint sample removed from:</p> <p>Location: P29- Iron window frame to ground floor.</p> <p>12No separate paint layers identified.</p> | |

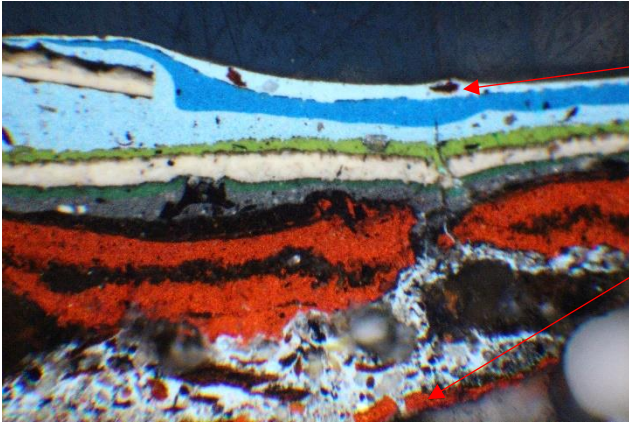
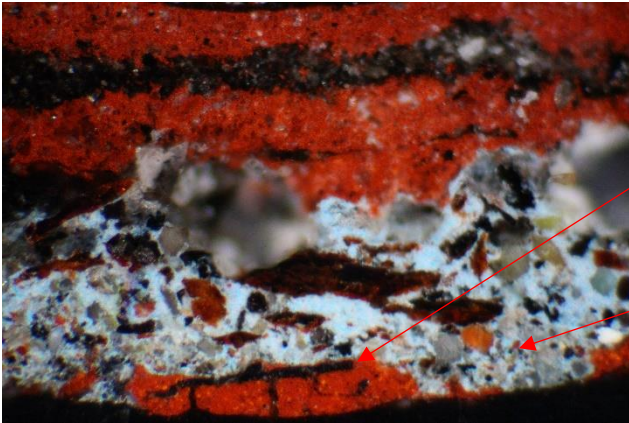
| Sample Ref: P29 – (Ground Floor Window) | Location: Neptune Mill |
|---|---|
| <br> | <p>100x Magnification.</p> <p>Current visible paint layer (modern blue alkyd paint).</p> <p>(2No green decorative schemes).</p> <p>(4 No red iron oxide paint layers).</p> <p>Earliest paint layer.</p><br><p>Earliest paint layers 400x Magnification.</p> <p>Red iron oxide oil paint (earliest decorative coating).</p> <p>Note: Area of modern white paint which has run into earlier layers with paint dust particles. (Paint generally in a poor condition).</p> |

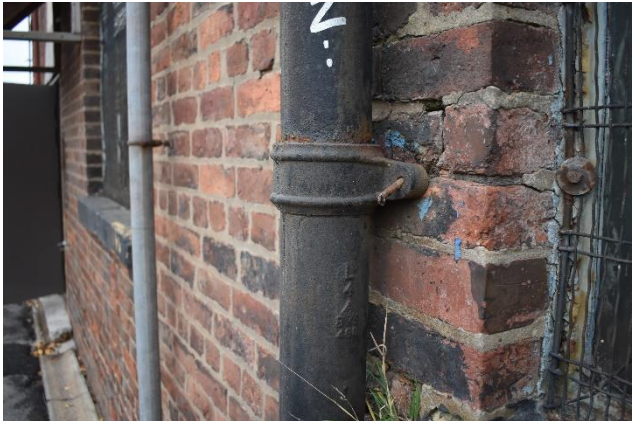
| Sample Ref: P30 – (Ground Floor Rainwater Pipe) | Location: Neptune Mill |
|---|---|
| <p>Paint sample removed from:</p> <p>Location: P30- Rainwater pipe fitted to brickwork.</p> <p>Only 1No paint layer identified.</p> | |

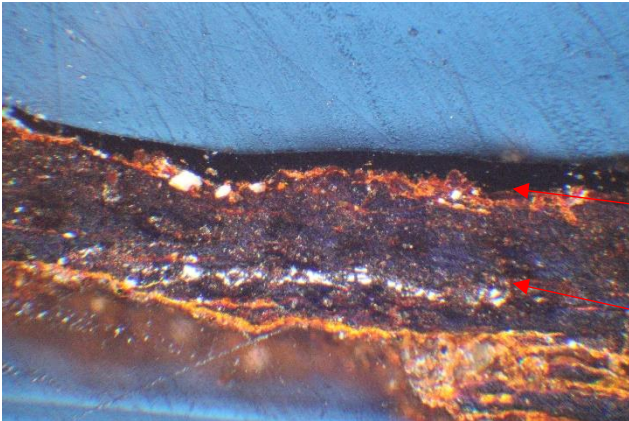
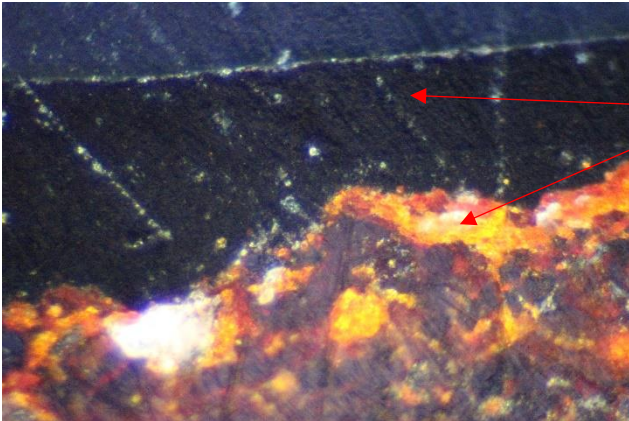
| Sample Ref: P30 – (Ground Floor Rainwater Pipe) | Location: Neptune Mill |
|---|---|
| <br> | <p>100x Magnification.<br/>Current visible paint layer (black alkyd paint).</p> <p>Earliest and only paint layer.</p> <p>Corrosion products.</p><br><p>Earliest paint layers 400x Magnification.</p> <p>Black alkyd paint.<br/>Iron oxide corrosion</p> |

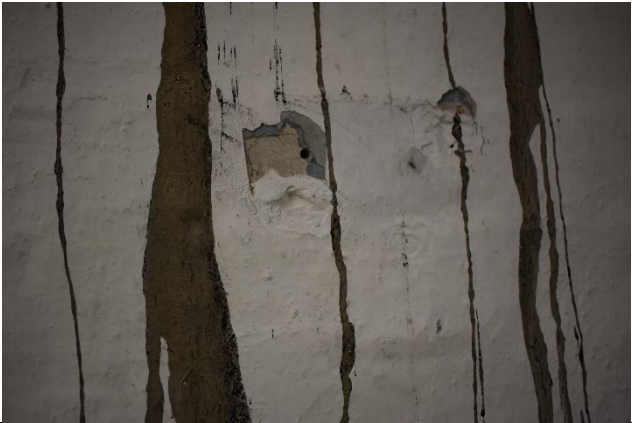
| Sample Ref: P32 – (First Floor Brick Wall) | Location: Neptune Mill |
|---|---|
| <p>Paint sample removed from:</p> <p>Location: P32- Paint on brickwork wall to first floor.</p> <p>30 No separate paint layers identified.</p> | |

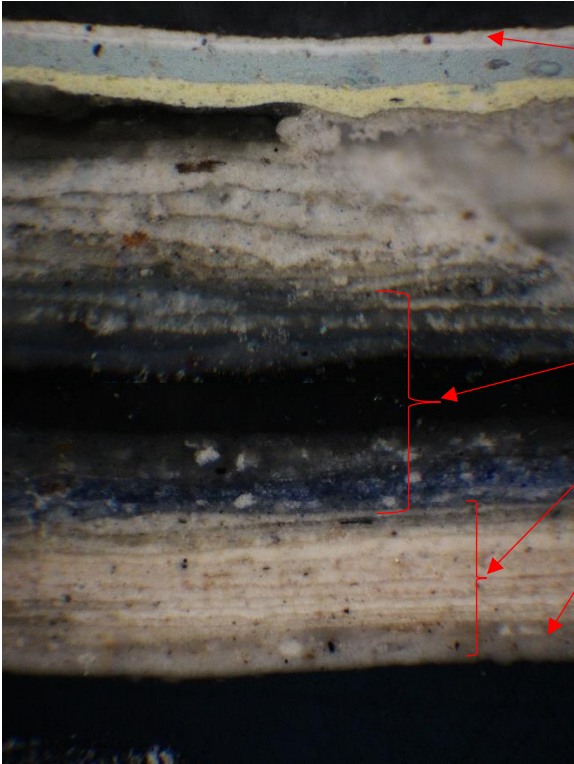
| Sample Ref: P32 – (First Floor Brick Wall) | Location: Neptune Mill |
|---|---|
| | <p>100x Magnification.</p> <p>Current visible paint layer (Modern Titanium white scheme).</p> <p>(3No modern schemes base don Titanium white).</p> <p>(7No white decorative schemes).</p> <p>(8No blue Lime Wash paint layers)</p> <p>(12No white Lime Wash paint layers)</p> <p>Earliest paint layer.</p> <p>Earliest paint layers 400x Magnification.</p> <p>White Lime Wash paint layer – earliest decorative scheme.</p> |

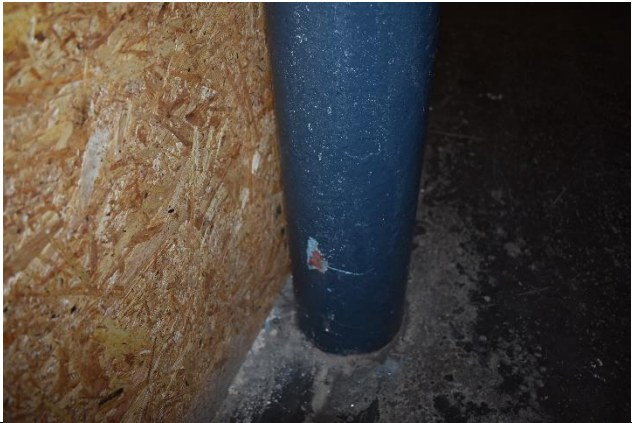
| Sample Ref: P34 – (First Floor Column) | Location: Neptune Mill |
|---|---|
| <p>Paint sample removed from:</p> <p>Location: P34- Paint to cast iron column to first floor.</p> <p>9No paint layers identified.</p> | |

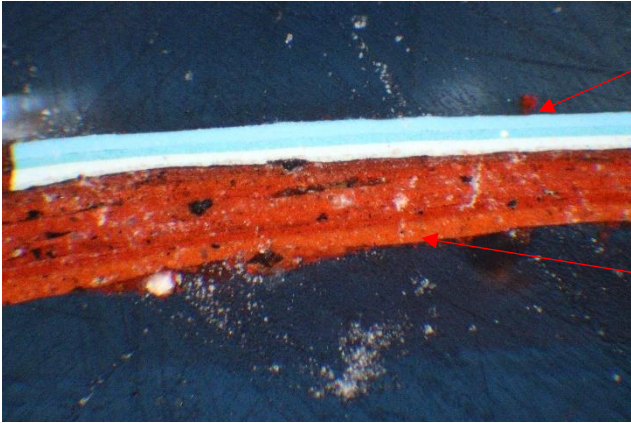
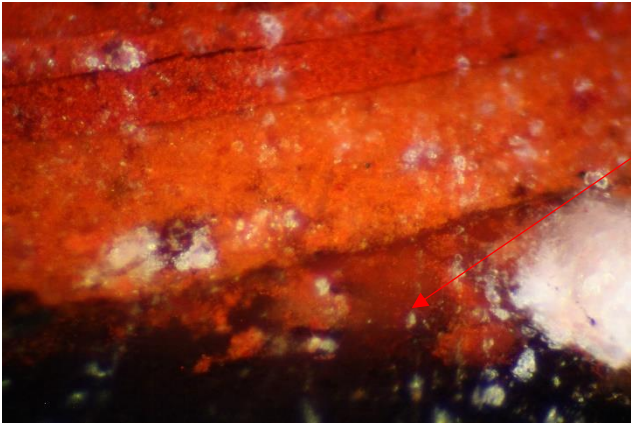
| Sample Ref: P34 – (First Floor Column) | Location: Neptune Mill |
|---|---|
| | <p>100x Magnification.</p> <p>Current visible paint layer (Modern blue alkyd paint).</p> <p>6No red iron oxide paint layers.</p> <p>Earliest paint layer.</p> <p>Earliest paint layers 400x Magnification.</p> <p>Red iron oxide oil paint. (earliest decorative scheme).</p> |
