# GORTON LANE

## PHASE 4 VALIDATION REPORT

**Curtins Ref:** 067694-CUR-00-XX-RP-GE-00007

Site Address: Gorton Lane Sites, Manchester, M12 5WF

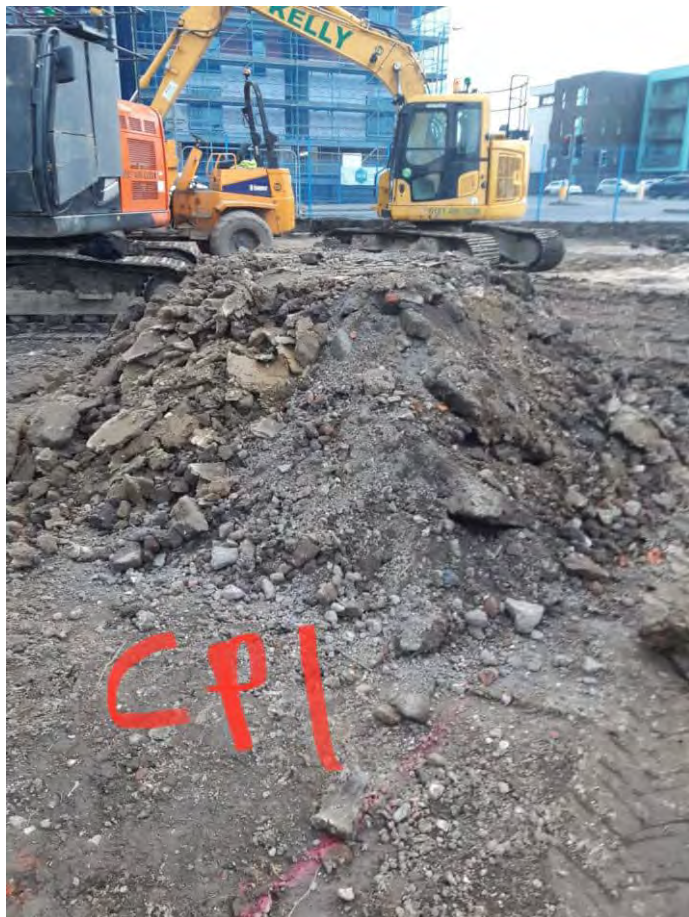
**Project:** Gorton Lane, Site 1 – CP1.  
**Sheet:** 1

## Photographic Record: Naphthalene Removal

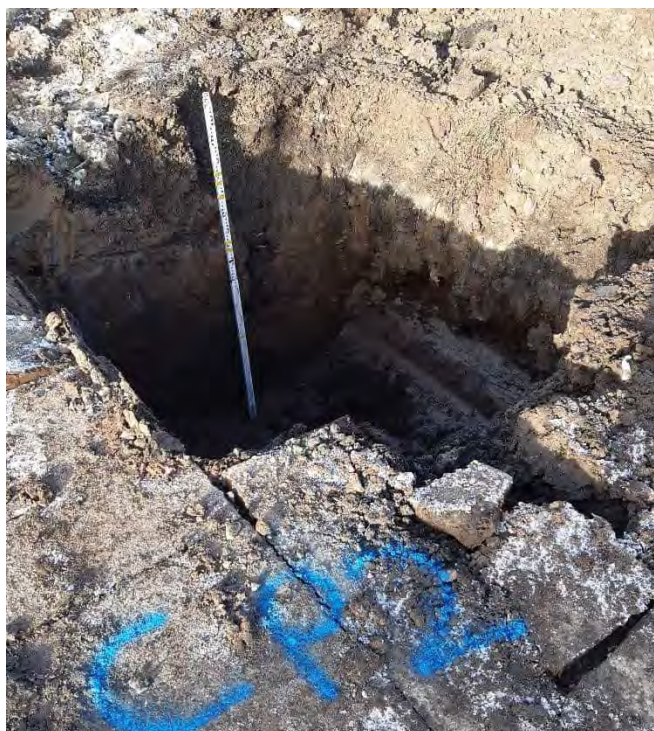
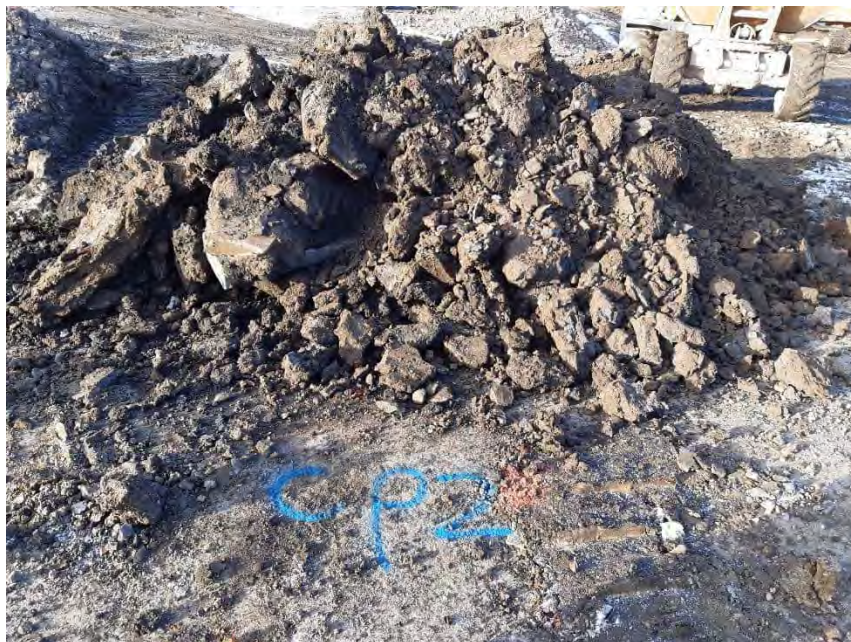
**Project:** Gorton Lane, Site 2 – CP2  
**Sheet:** 1

## Photographic Record: Naphthalene Removal

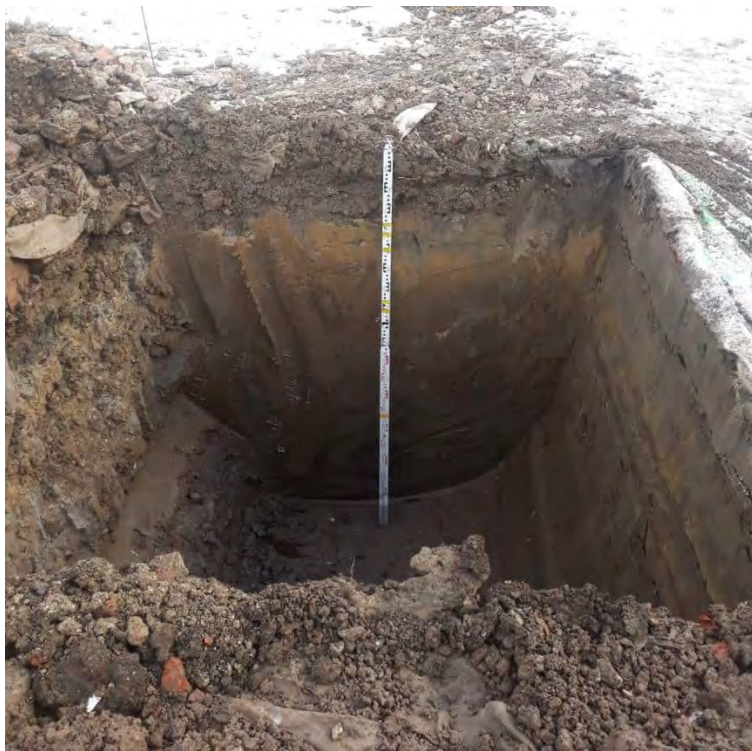
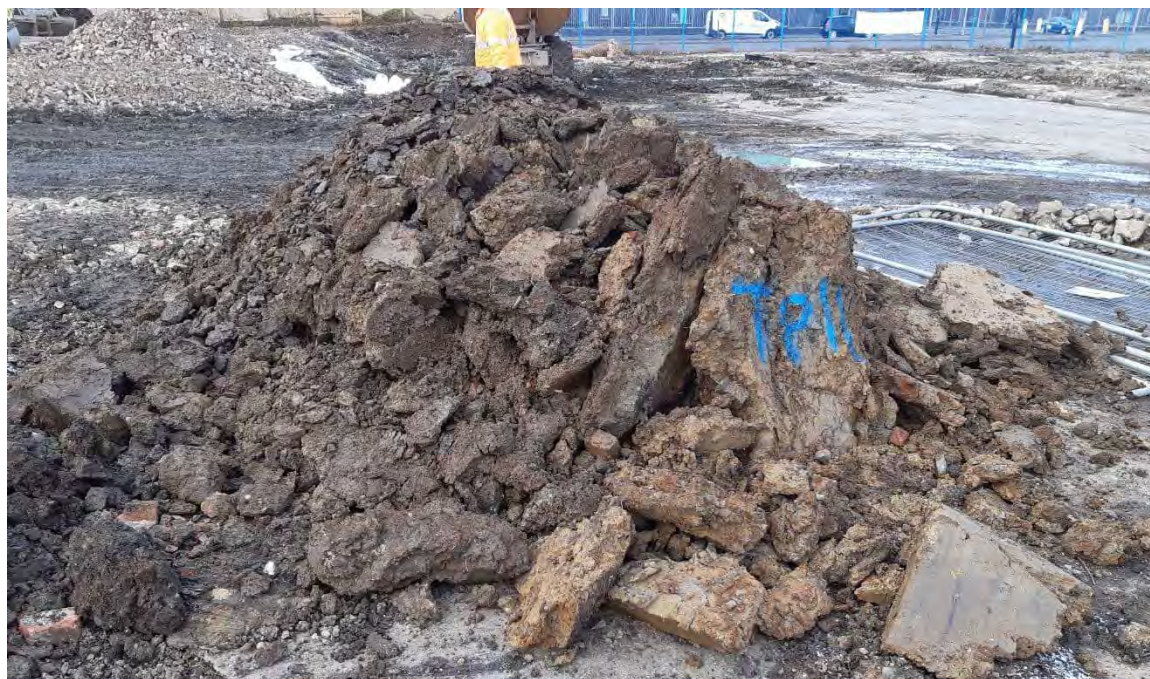
**Project:** Gorton Lane, Site 2 – TP11.  
**Sheet:** 1

## Photographic Record: Naphthalene Removal
