# Hutton + Rostron Environmental Investigations Limited

## Manchester Art Gallery, Mosley Street Entrance Foyer Lantern Timbers: Timber Condition Survey

Site note 1 for 21 & 23 November 2023, job no. 212-98

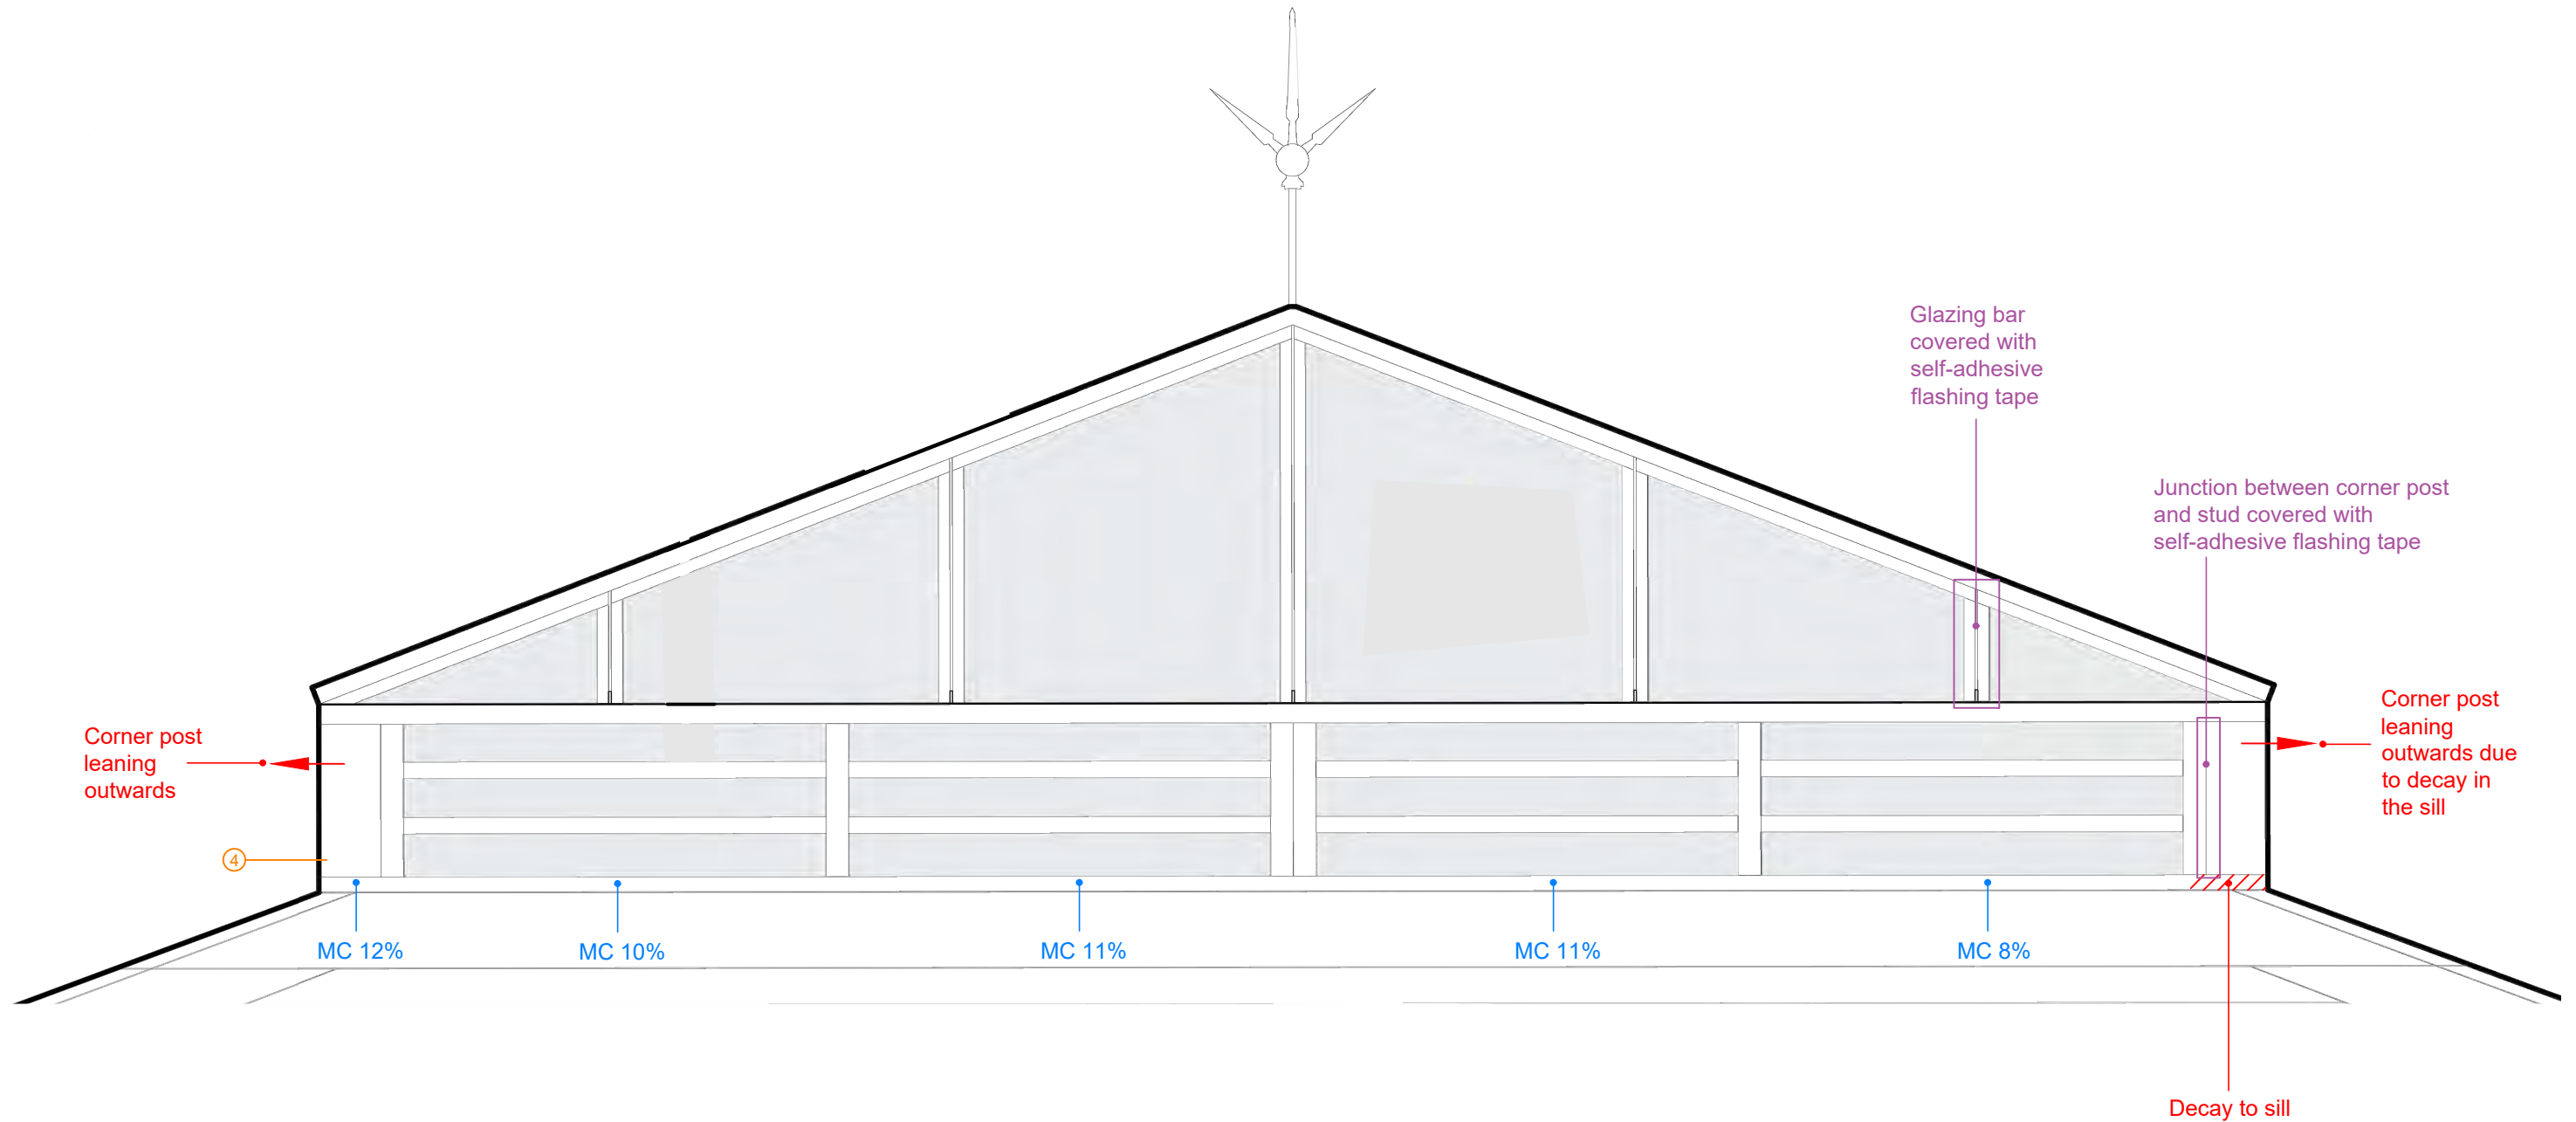
**Manchester Art Gallery, Mosley Street Entrance Foyer Lantern - North Elevation**  
**Timber Condition Survey**  
**21&23 November 2023**

- 1 North elevation: There was 1no. area of decay to the sill in the north-west corner. Both corner posts were leaning outwards causing the joints between the corner posts and studs to open. In the north-west corner this joint had been covered with self-adhesive flashing tape. The decorative finish to the timber frame was largely intact with some localised areas of missing/flaking paint. Timber moisture contents were measured at 8-12 per cent w/w which is below the threshold for structurally significant decay to occur

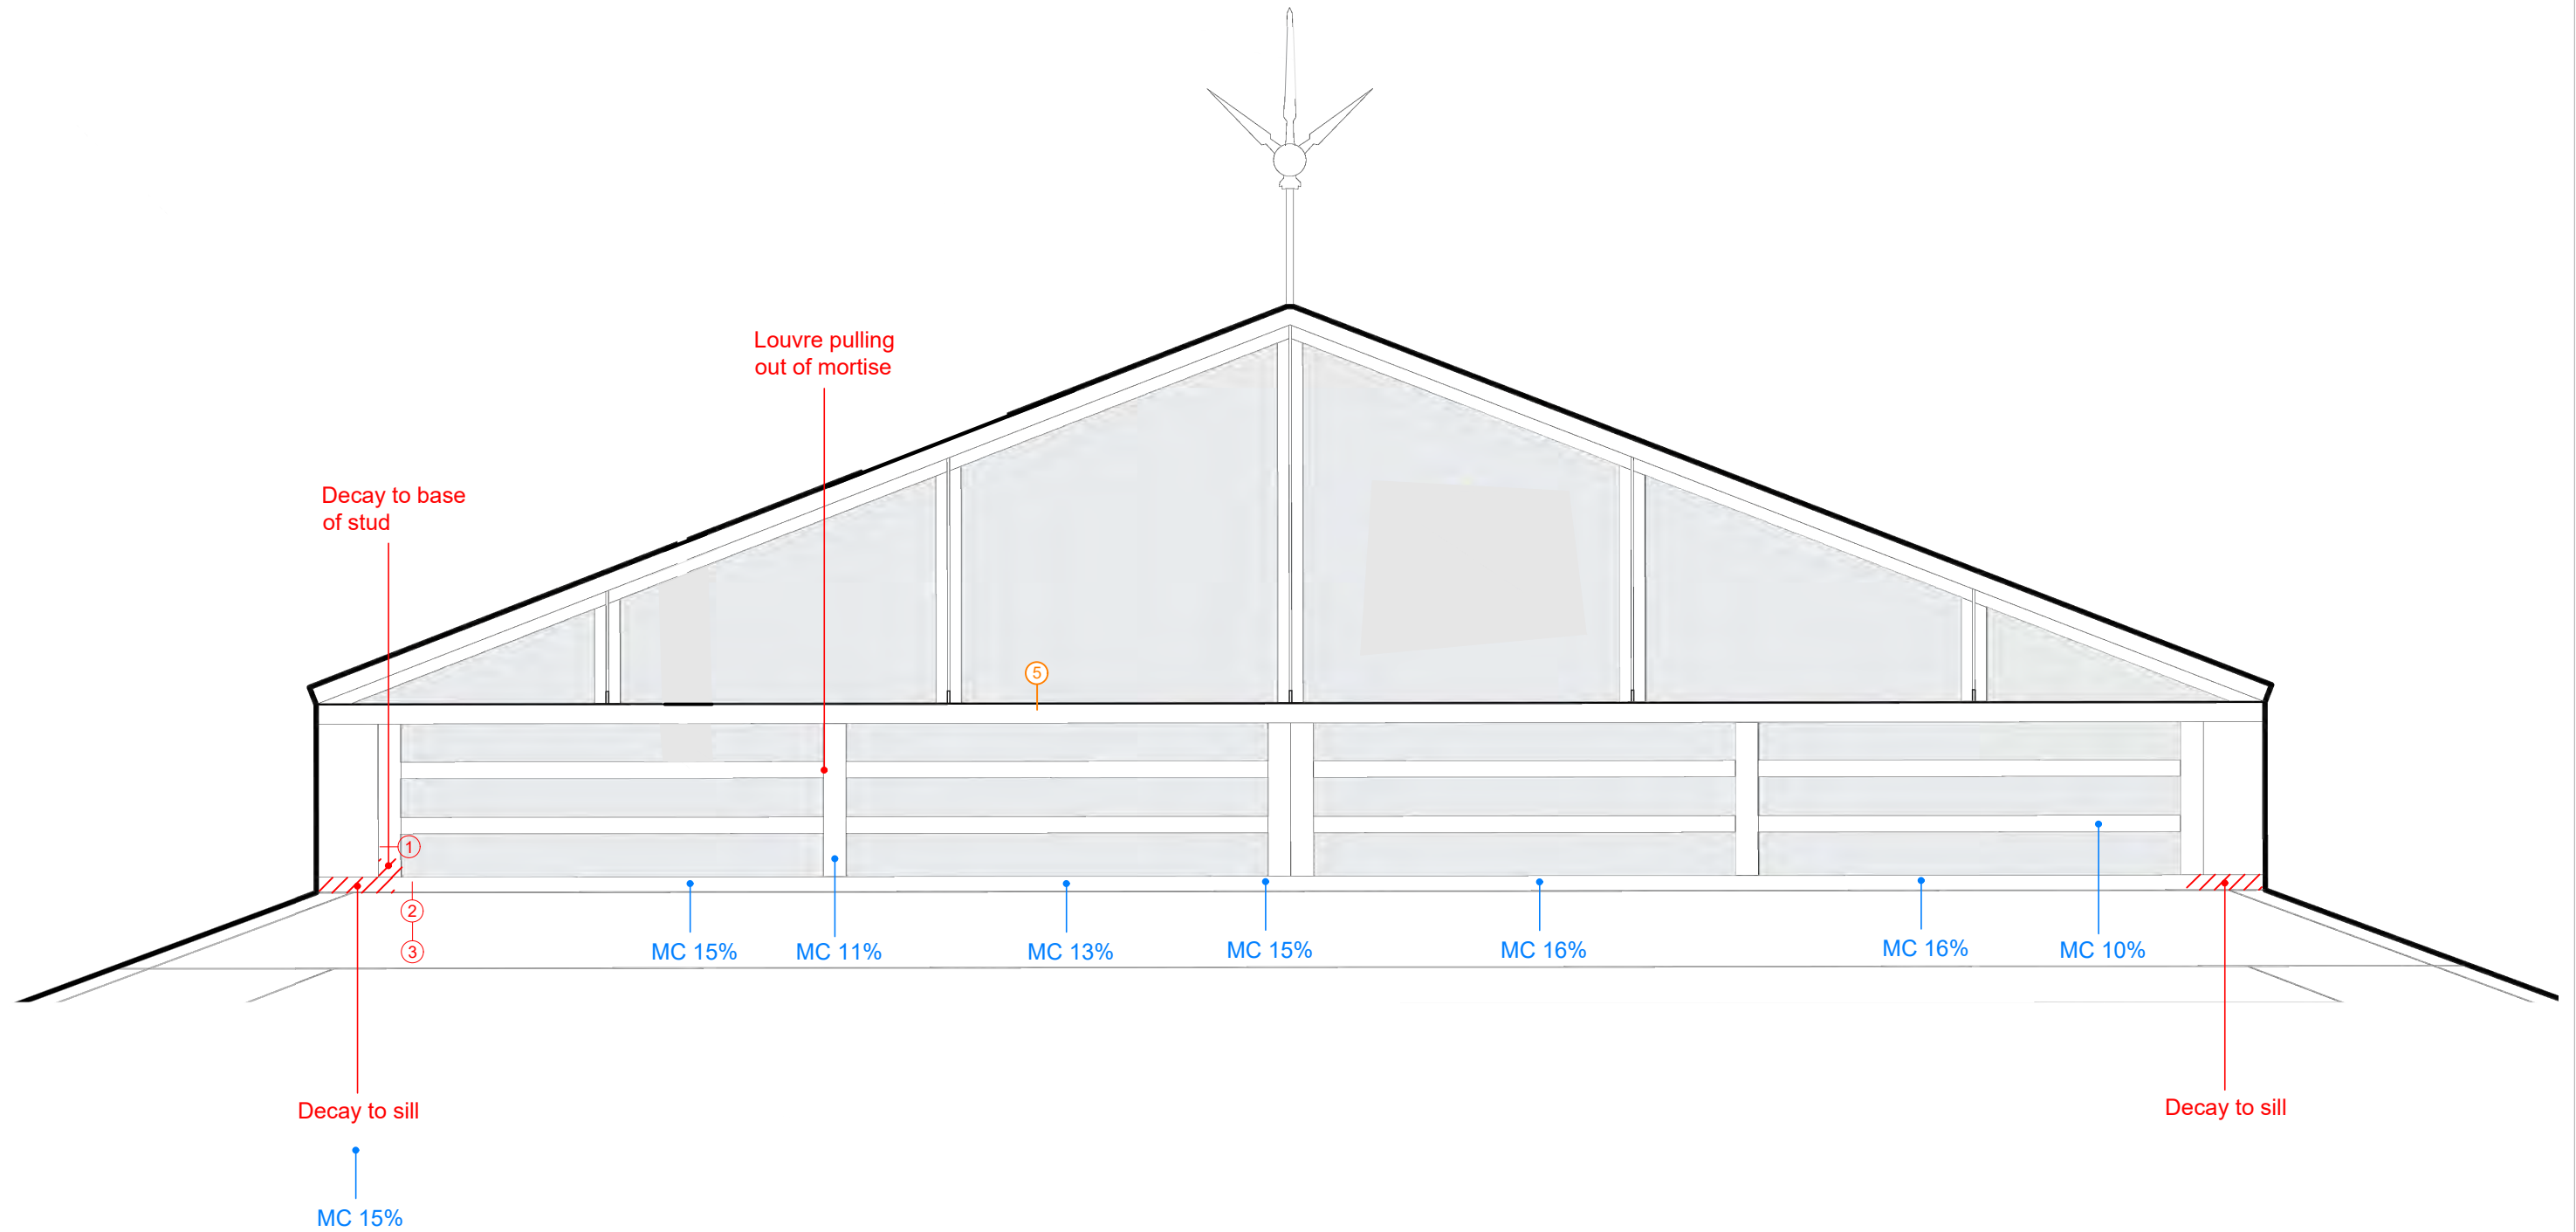
**Manchester Art Gallery, Mosley Street Entrance Foyer Lantern - East Elevation**  
**Timber Condition Survey**  
**21&23 November 2023**

- 2 East elevation: There were 2no. areas of decay to the sill in the north-east and south-east corners, and 1no. area of decay to the base of the stud in the south-east corner. 1no. louvre in the south-east corner was pulling out of its mortise. The decorative finish to the timber frame was in poor condition with areas of missing/flaking paint. Timber moisture contents were measured at 11-16 per cent w/w which is below the threshold for structurally significant decay to occur

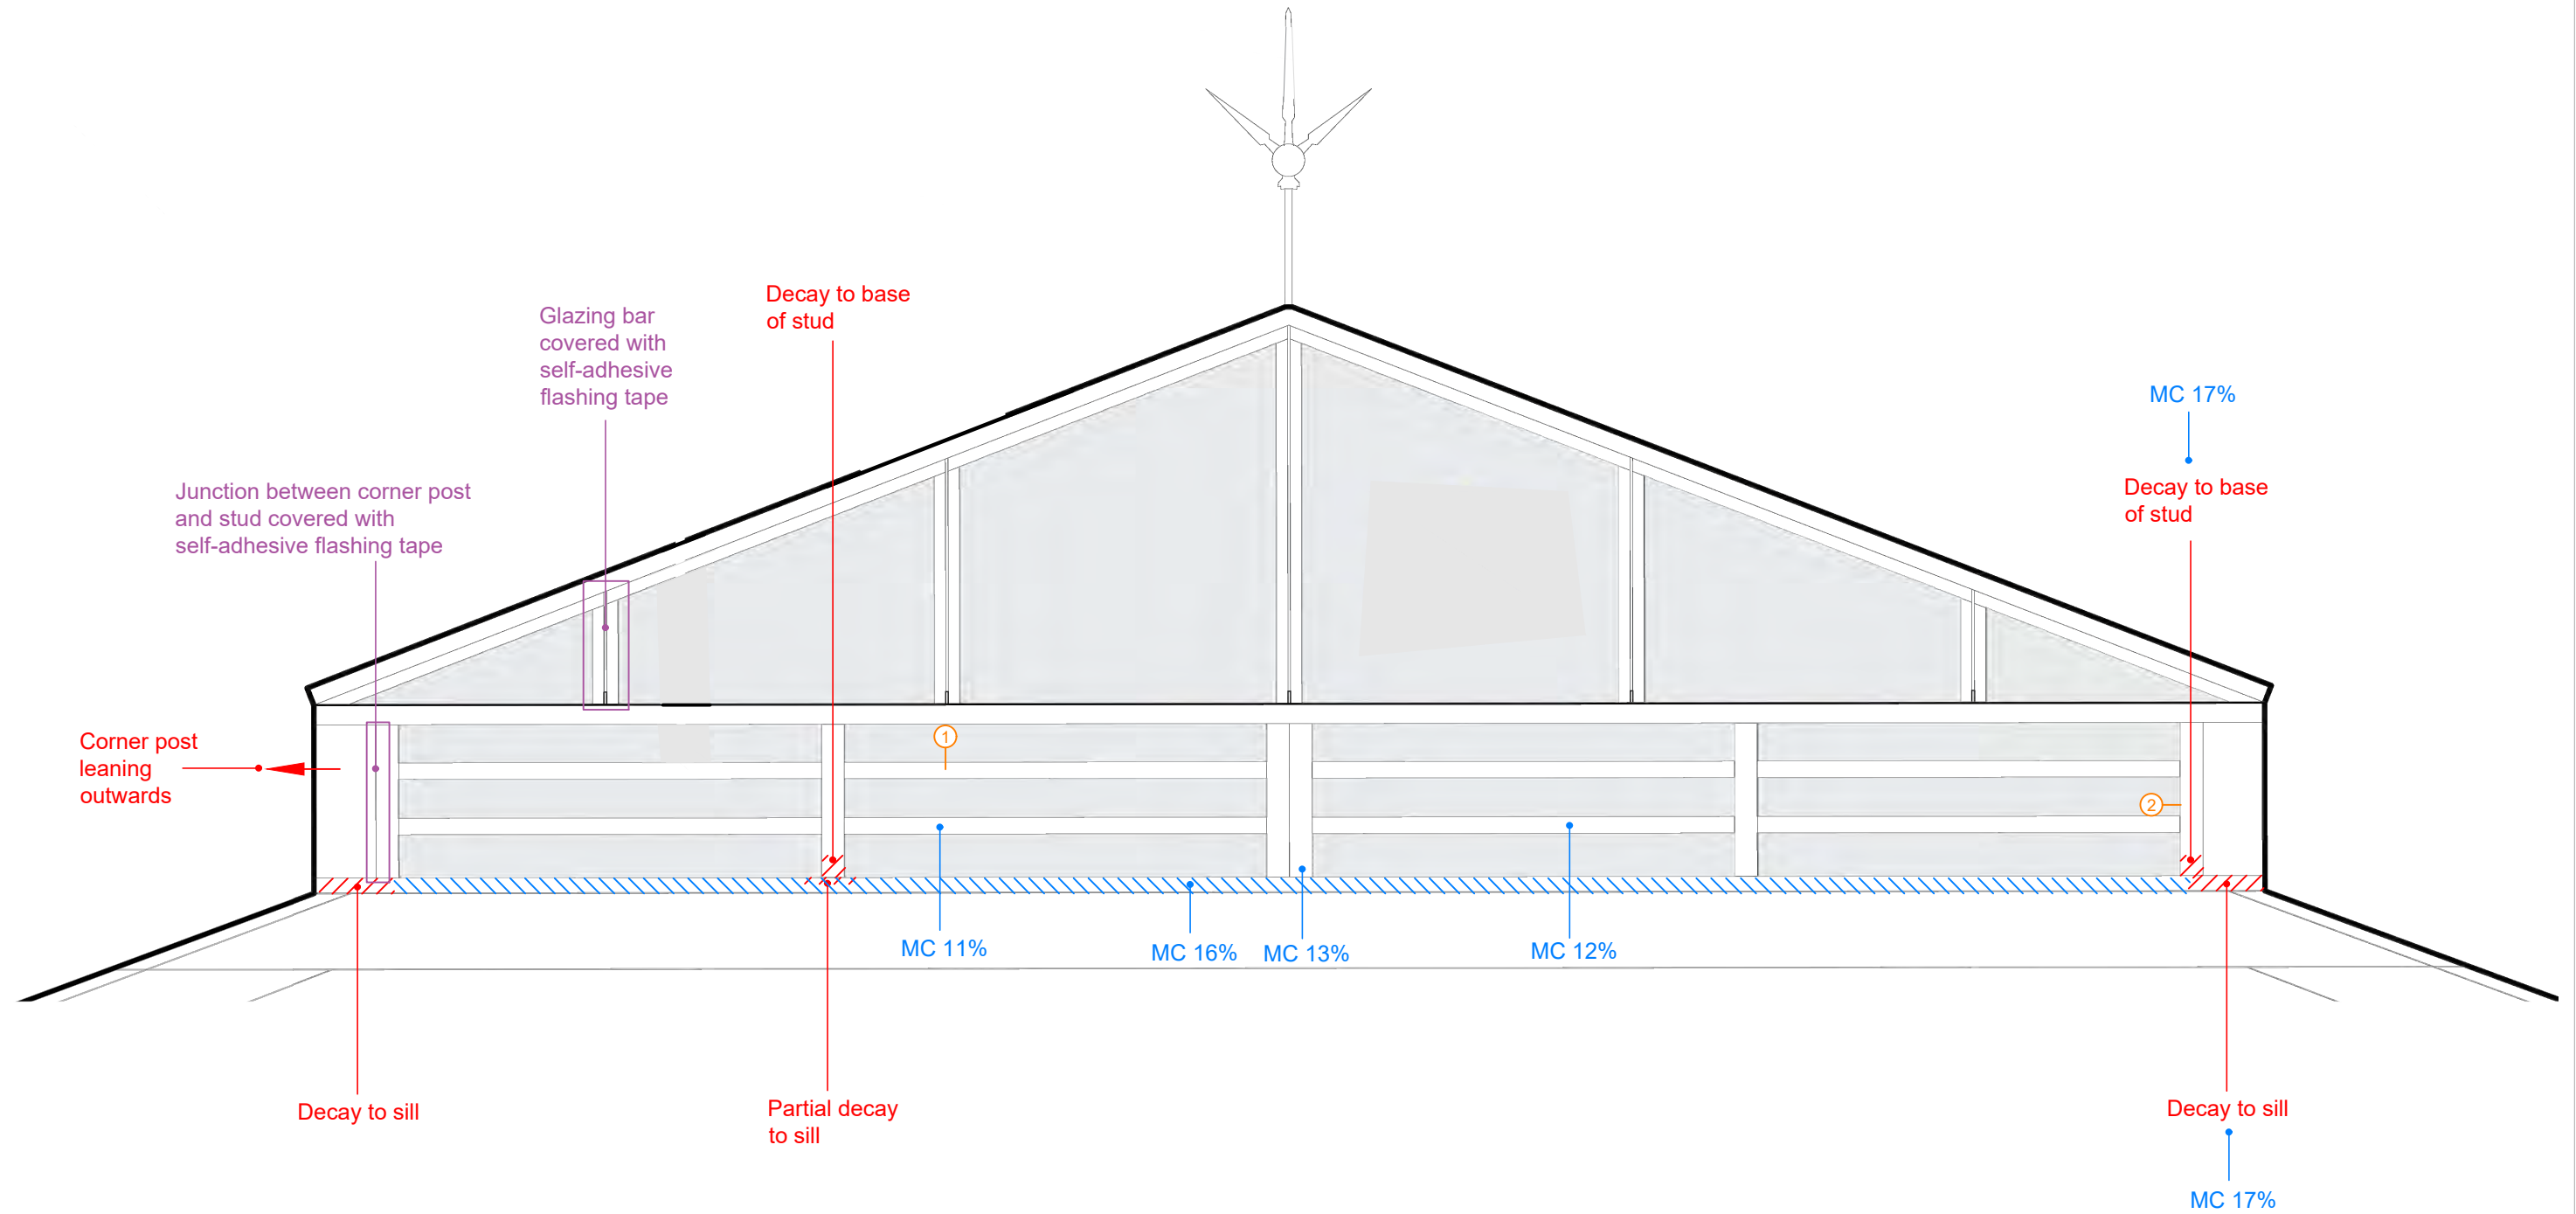
**Manchester Art Gallery, Mosley Street Entrance Foyer Lantern - South Elevation**  
**Timber Condition Survey**  
**21&23 November 2023**

- 3 South elevation: There were 3no. areas of decay to the sill and decay to the base of 2no studs. The south-west corner post was leaning outwards, likely as a result of decay in the sill beneath. The joint between the corner post and stud in the south-west corner had been previously covered with a temporary self-adhesive flashing tape. The decorative finish to the timber frame was in poor condition with areas of missing/flaking paint. Timber moisture contents were measured at 11-17 per cent, likely due to the increased exposure of the elevation to prevailing weather. There was superficial decay to the sill across the whole elevation

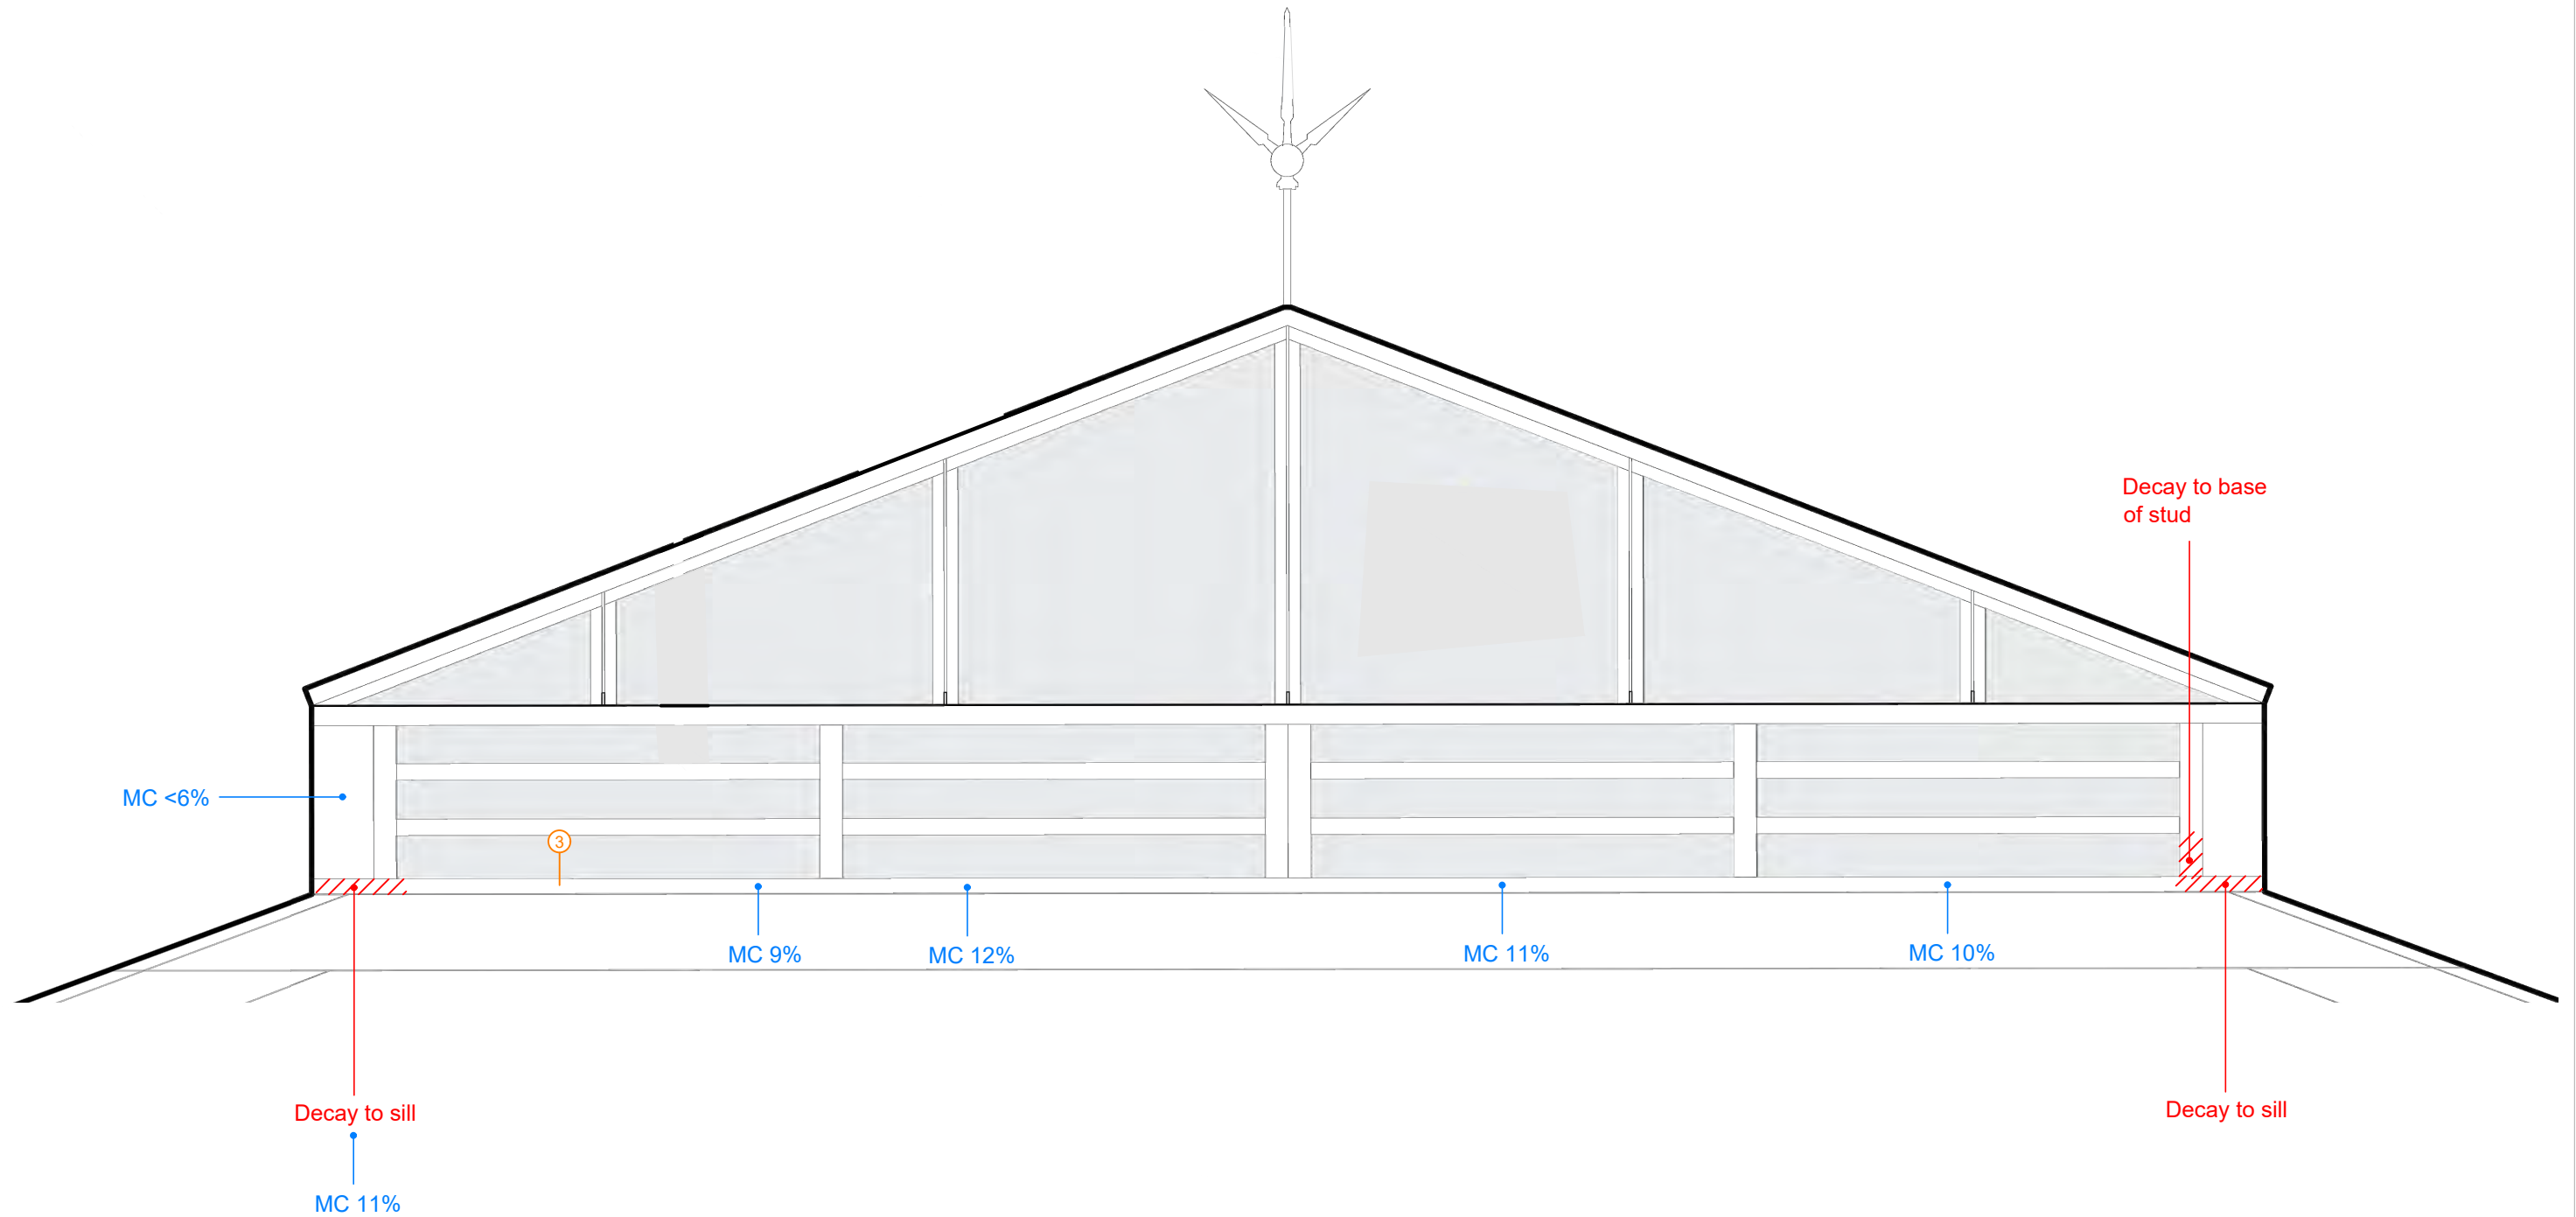
**Manchester Art Gallery, Mosley Street Entrance Foyer Lantern - West Elevation**  
**Timber Condition Survey**  
**21&23 November 2023**

- 4 West elevation: There were 2no. areas of decay to the sill in the north-west and south-west corners, and 1no. area of decay to the base of the stud in the south-west corner. The decorative finish to the timber frame was largely intact with some localised areas of missing/flaking paint. Timber moisture contents were measured at <6-12 per cent w/w which is below the threshold for structurally significant decay to occur

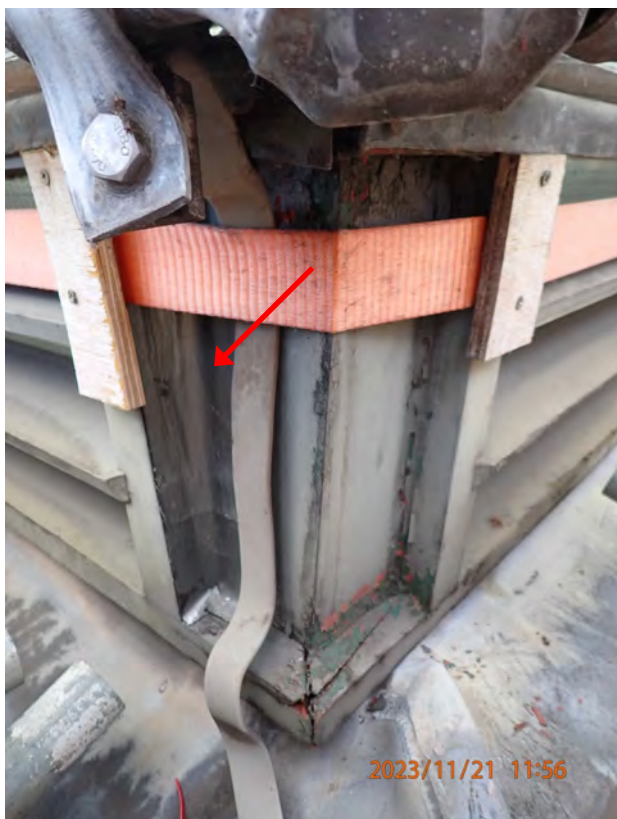
**Fig 2:**

North elevation; showing close-up view of north-west corner post. Decay to sill in this location. Note also temporary self-adhesive flashing (arrowed) covering joint between corner post and stud

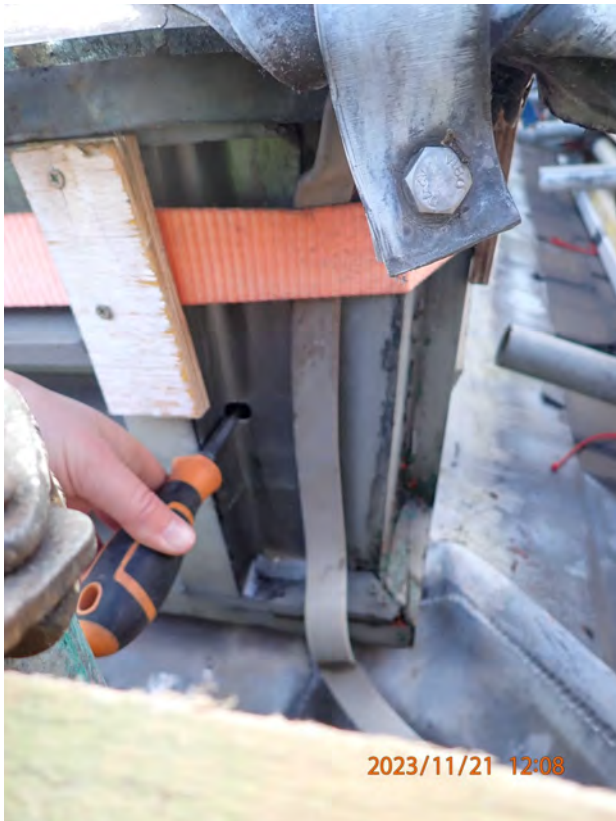
**Fig 3:**

North elevation; showing close-up view of temporary self-adhesive flashing, covering open joint between north-west corner post and stud

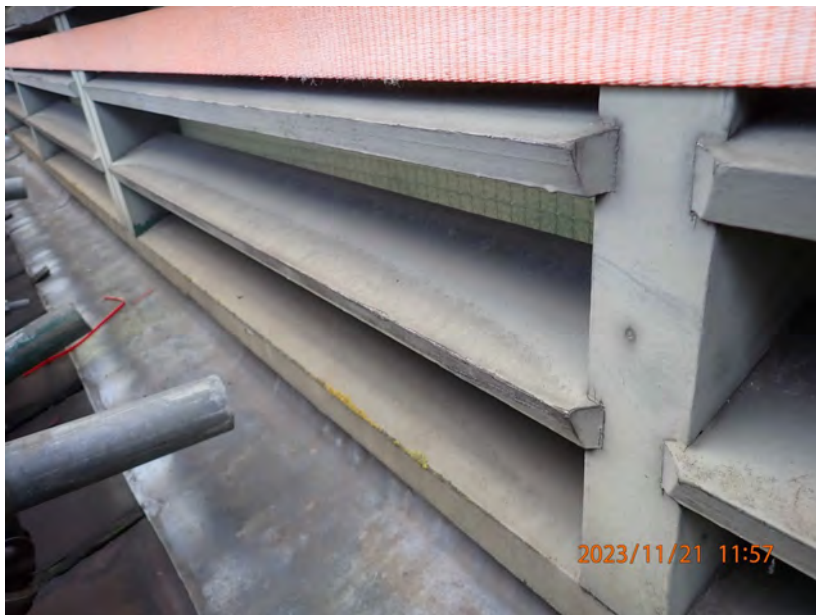
**Fig 4:**

North elevation; showing close-up view of decorative finish. Note wired glass panes installed behind louvres

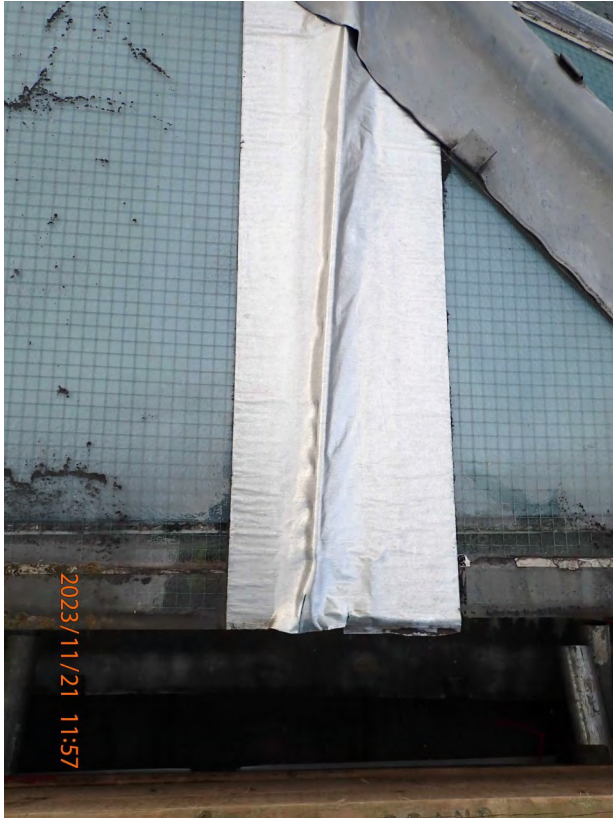
**Fig 5:**

North elevation; showing self-adhesive flashing tape over metal glazing bar in north-west corner. Note wired glass panes

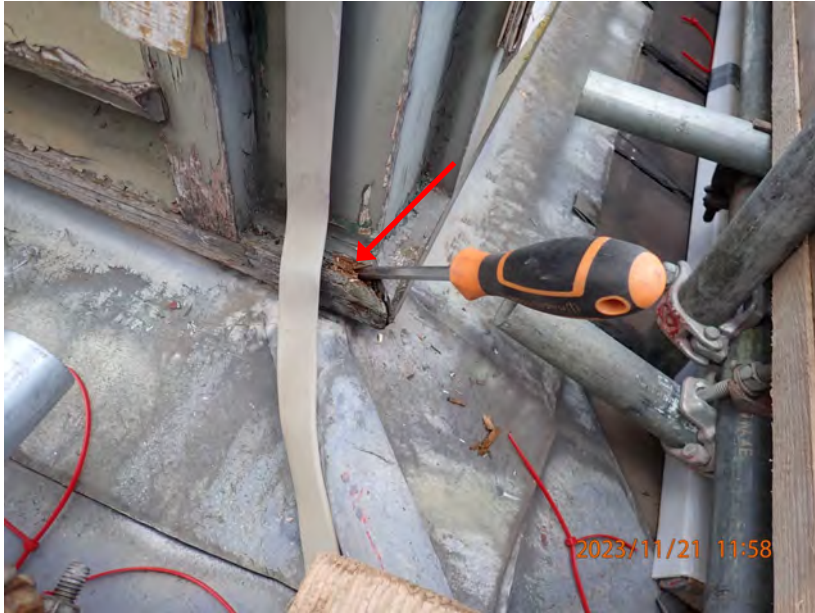
**Fig 7:**

East elevation; showing close-up view of north-east corner post. Note decay to sill in this location (arrowed)

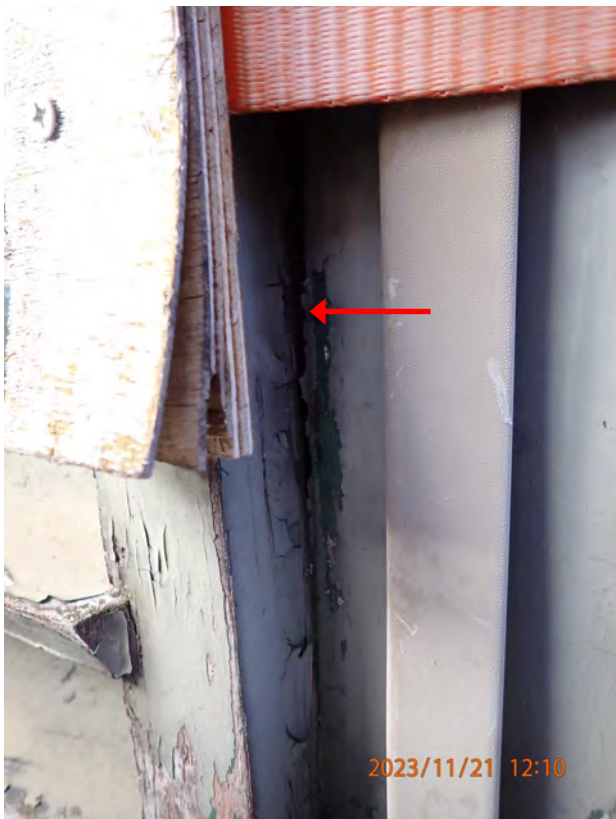
**Fig 8:**

East elevation; showing close-up view of open joint between north-east corner post and stud (arrowed)

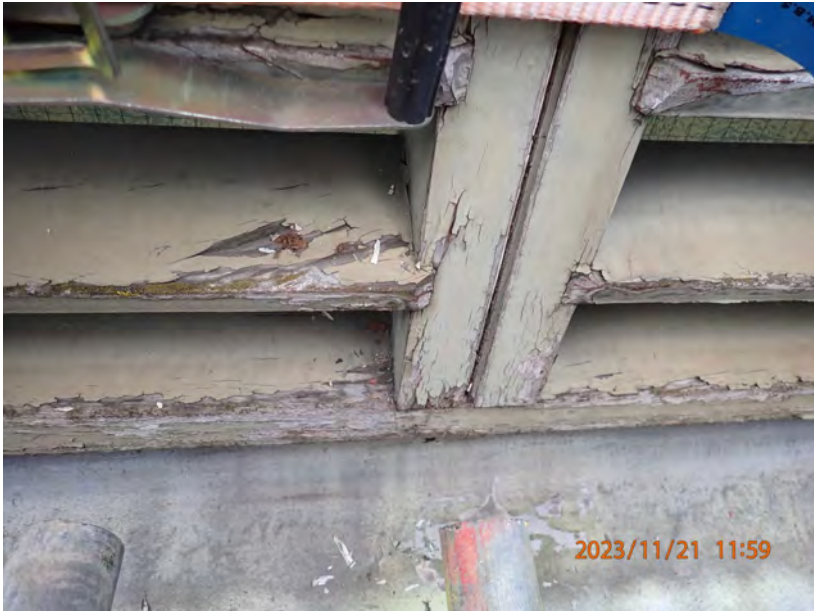
**Fig 9:**

East elevation; showing close-up view of poor condition decorative finish

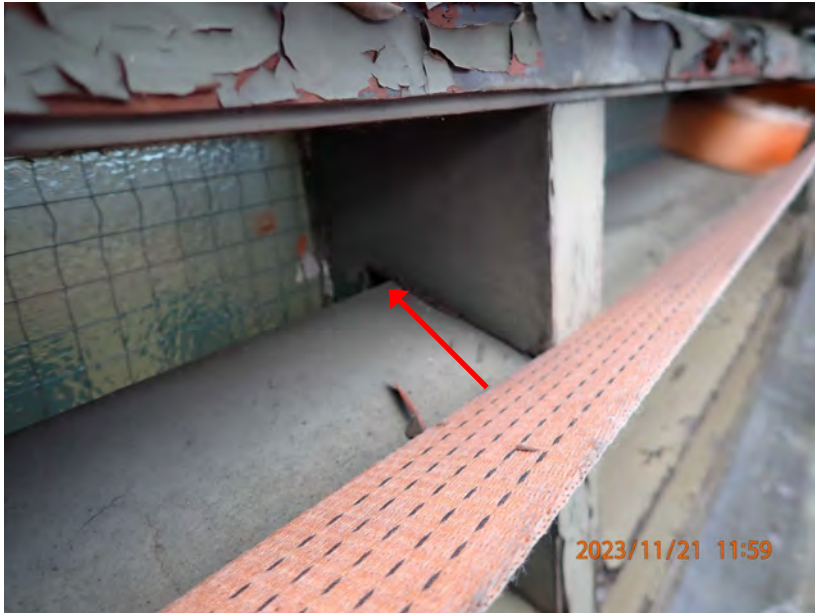
**Fig 11:**

East elevation; showing close-up view of louvre pulling out of its mortise (arrowed)

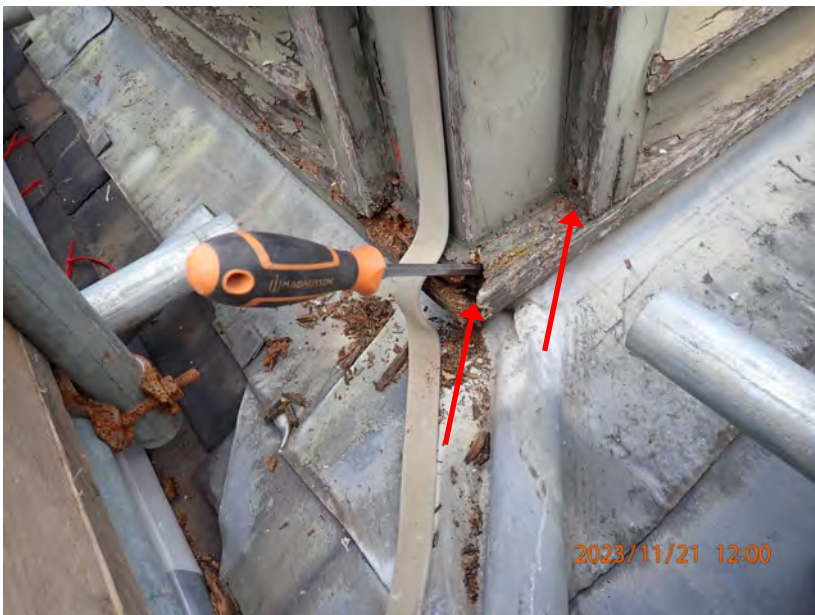
**Fig 12:**

East elevation; showing close-up view of south-east corner post. Note decay to sill and base of stud in this location (arrowed)

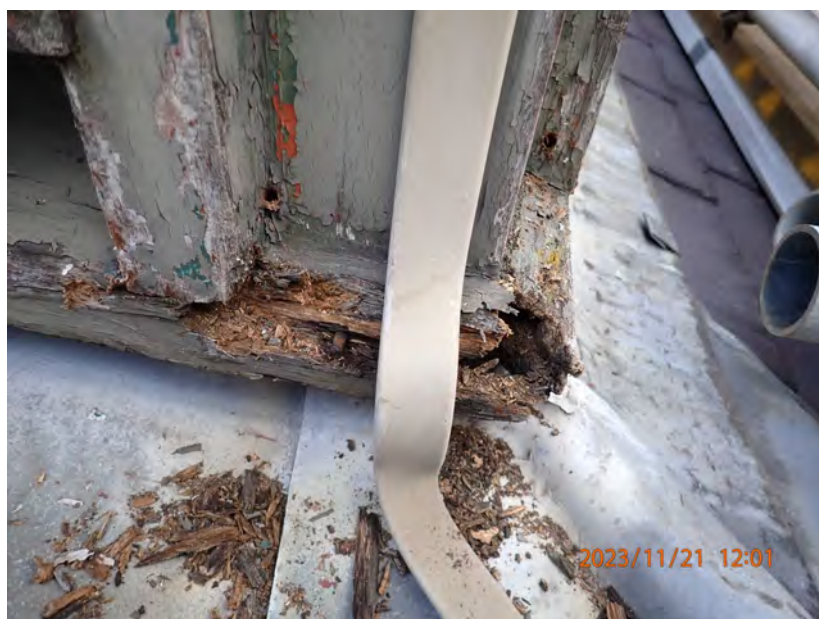
**Fig 14:**

South elevation; showing close-up view of decay to sill and base of stud in south-east corner

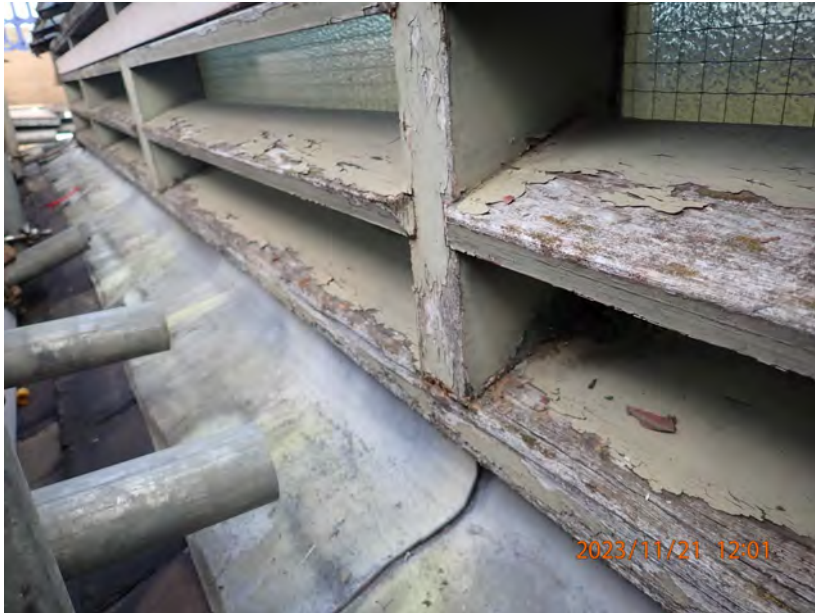
**Fig 15:**

South elevation; showing close-up view of poor condition of decorative finish

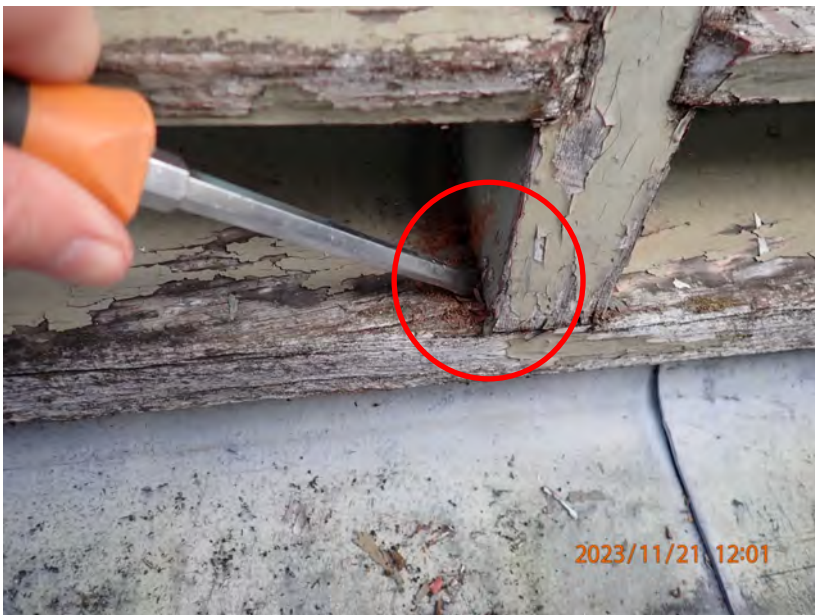
**Fig 16:**

South elevation; showing decay to base of vertical stud (circled)

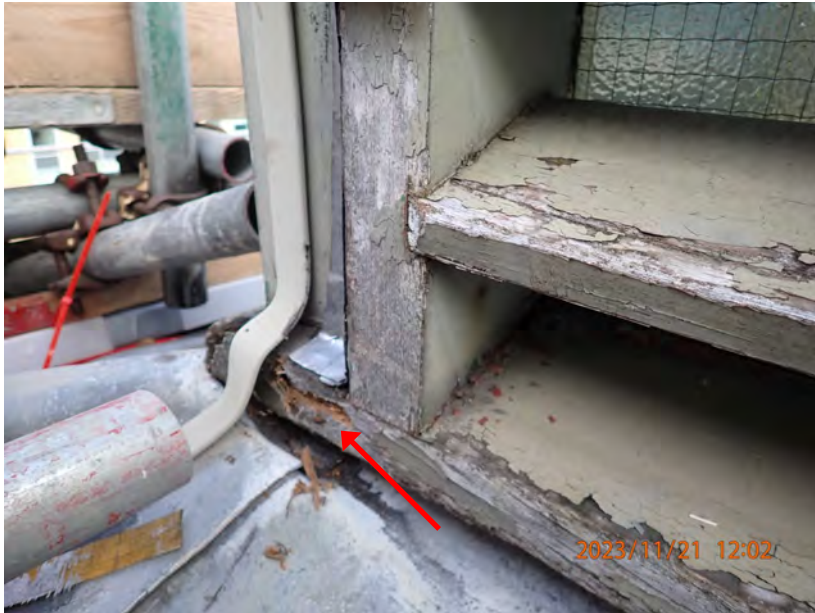
**Fig 17:**

South elevation; showing close-up view of decay to sill in south-west corner (arrowed)

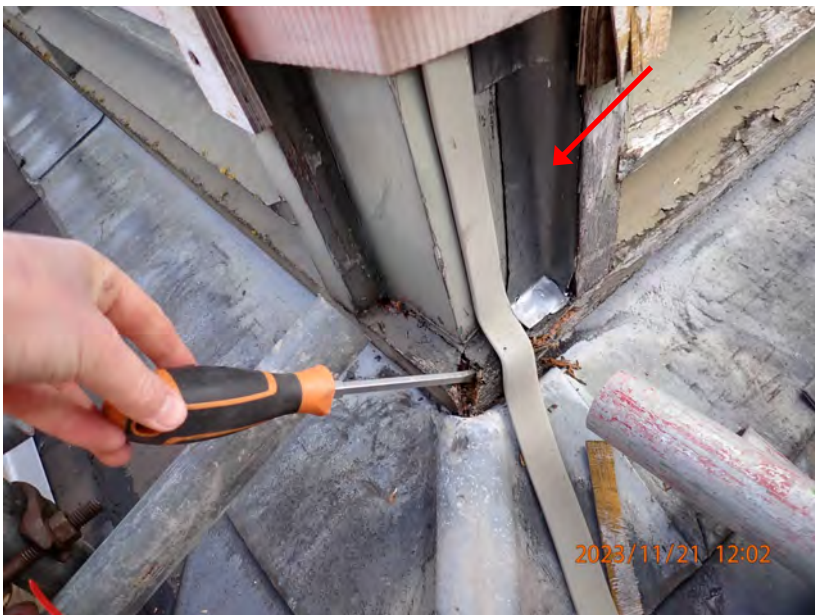
**Fig 18:**

South elevation; showing alternative view of decay to sill in south-west corner. Note self-adhesive flashing tape covering open joint between corner post and stud (arrowed)

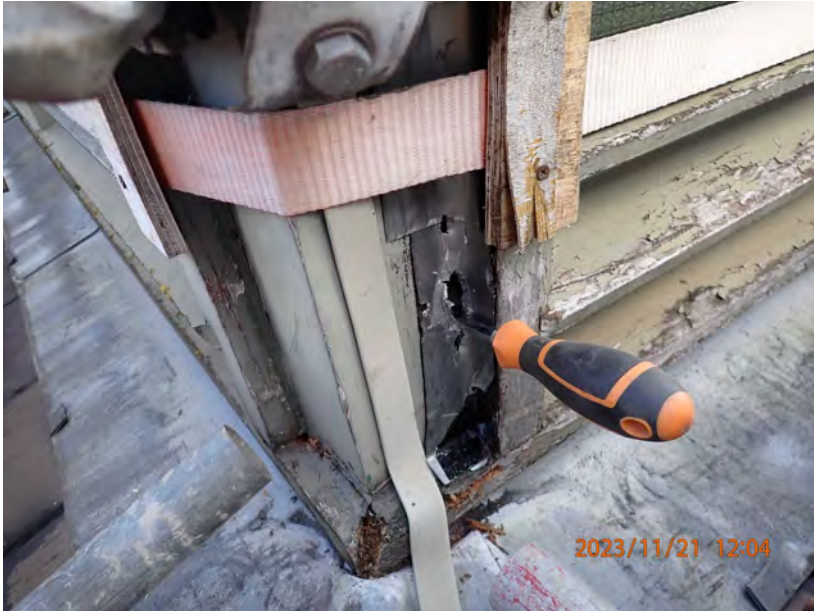
**Fig 19:**

South elevation; showing close-up view of self-adhesive flashing tape covering open joint between south-west corner post and stud

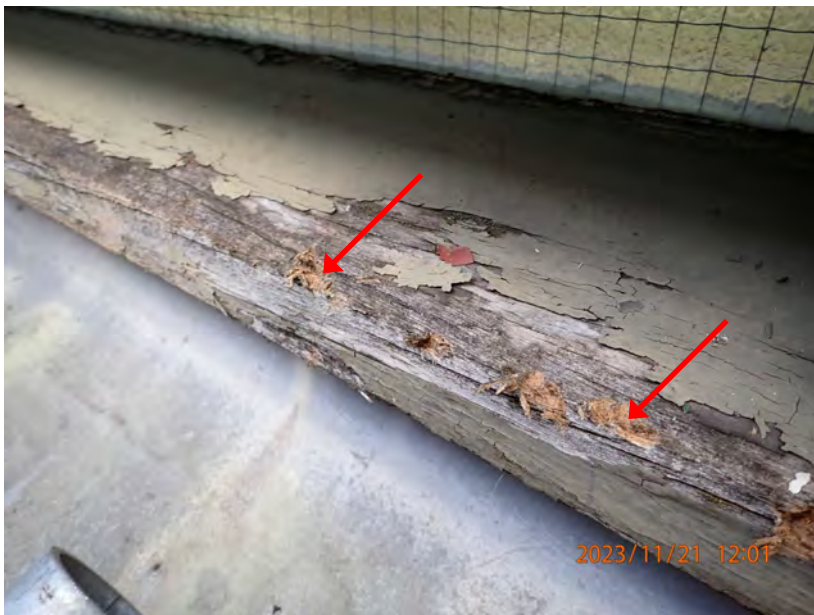
**Fig 20:**

South elevation; showing example of superficial decay to the sill along the elevation (arrowed)

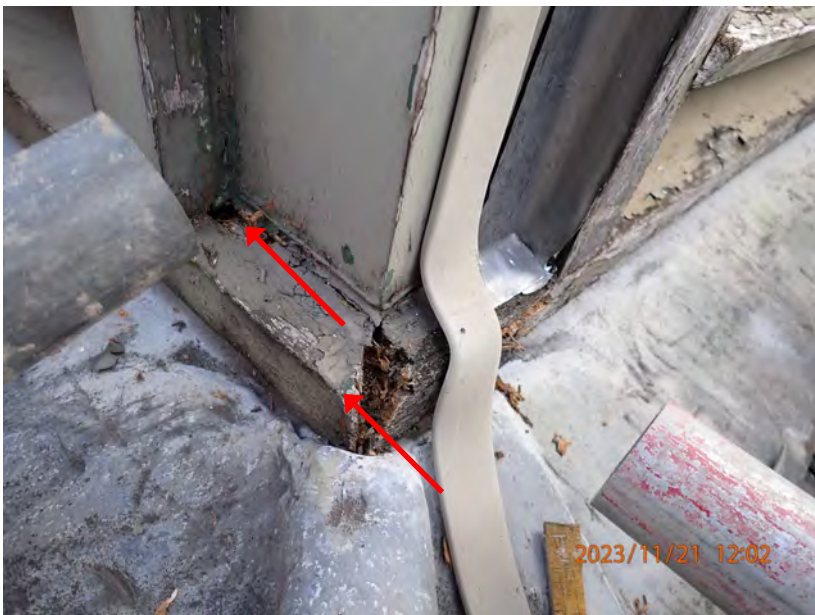
**Fig 22:**

West elevation; showing close-up view of decay to sill and stud in south-west corner (arrowed)

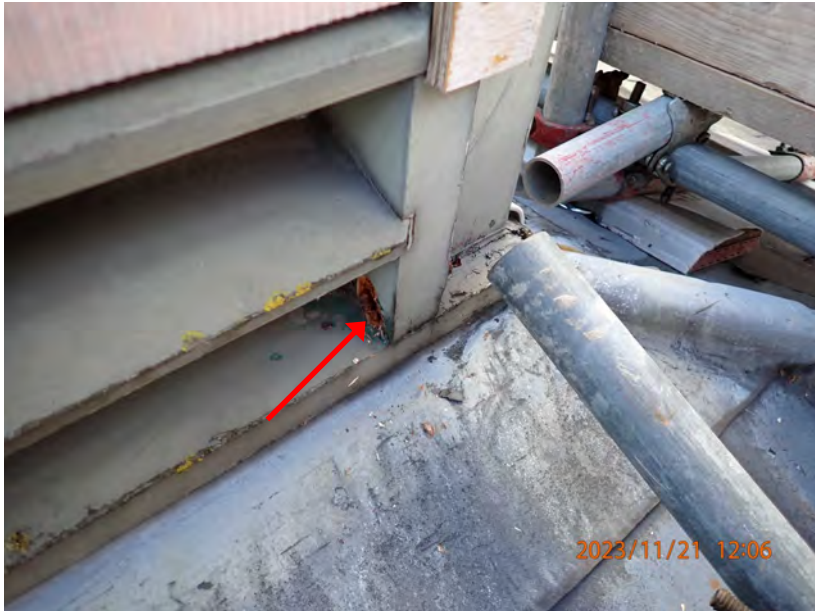
**Fig 23:**

West elevation; showing decay to base of stud in south-west corner (arrowed)

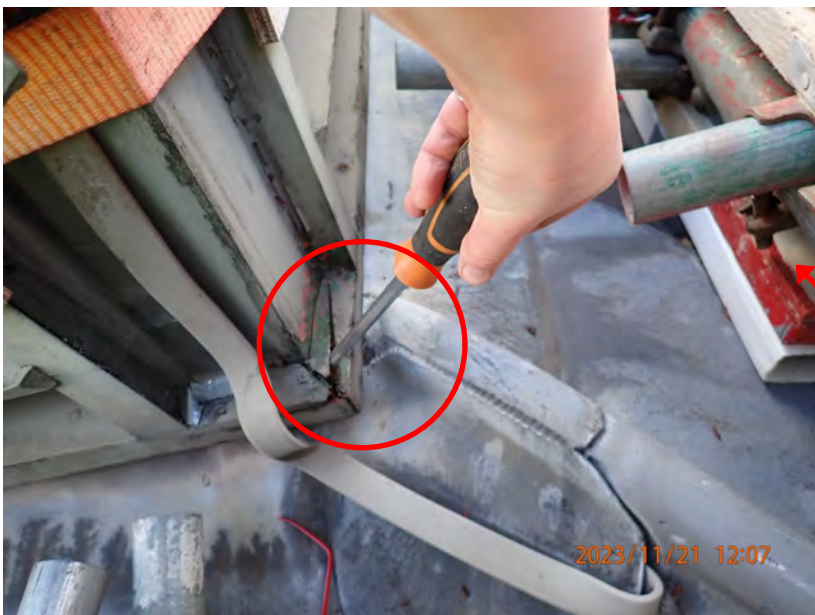
**Fig 24:**

West elevation; showing decay to sill in north-west corner (circled)
