# Hutton + Rostron Environmental Investigations Limited

## Manchester Art Gallery, Mosley Street Entrance Foyer Lantern Timbers: Timber Condition Survey

Site note 1 for 21 & 23 November 2023, job no. 212-98

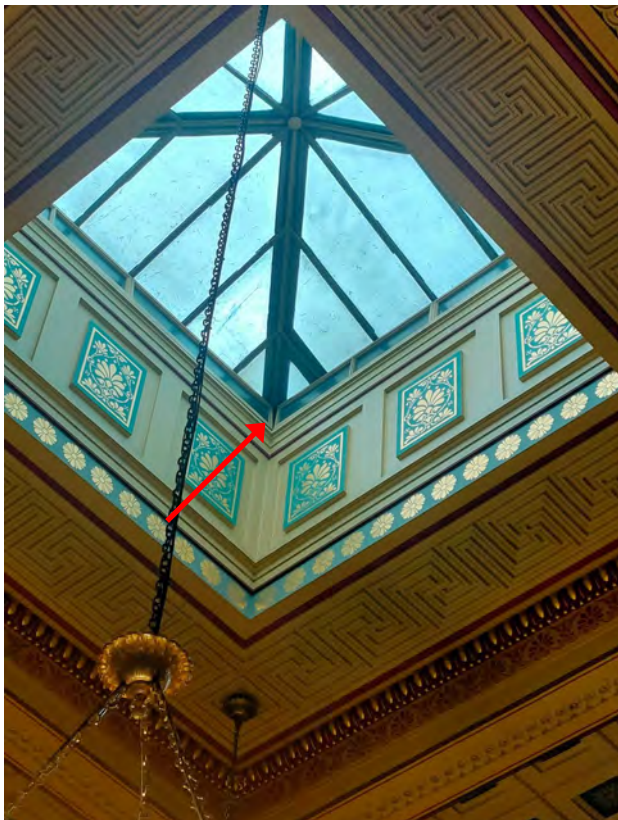
Fig 26:

Mosley Street entrance foyer; showing internal view of lantern. Note movement visible at corner (arrowed)

- 1 Further investigation is required to determine the works needed to address the apparent 'roof spread' and to determine the condition of the hip rafters

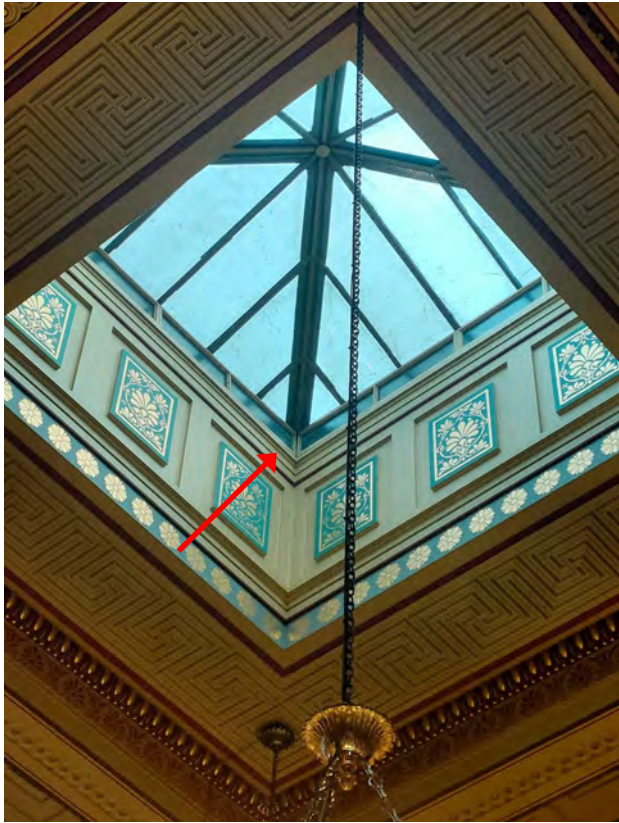
**Fig 27:**

Mosley Street entrance foyer; showing internal view of lantern. Note movement visible at corner (arrowed)

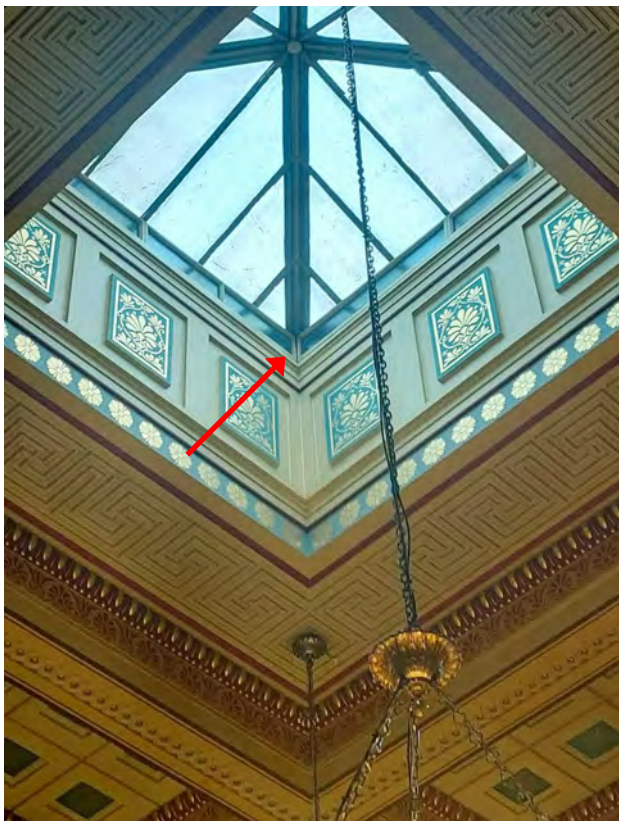
**Fig 28:**

Mosley Street entrance foyer; showing internal view of lantern. Note movement visible at corner (arrowed)

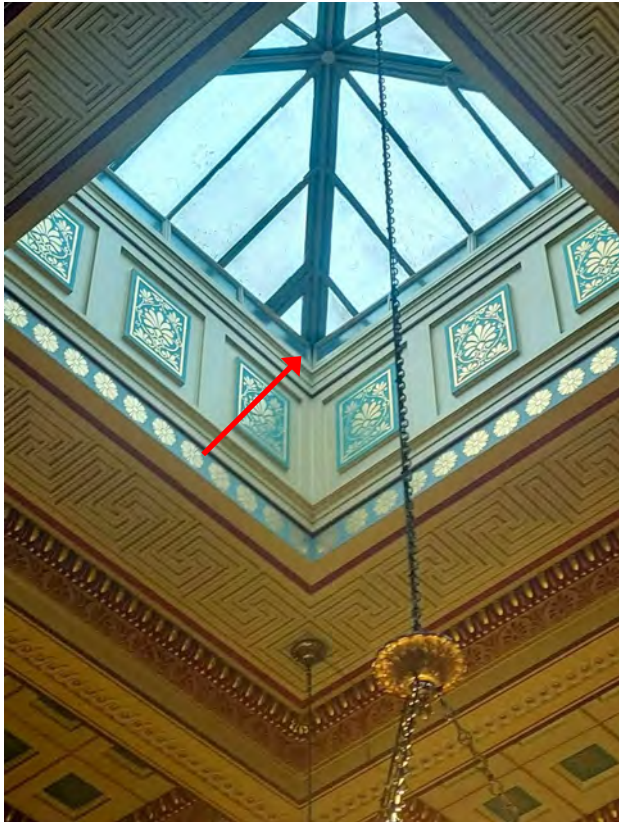
**Fig 29:**

Mosley Street entrance foyer; showing internal view of lantern. Note movement visible at corner (arrowed)
