# DRAINAGE SURVEY

Job Number  
**LAYERSERV0001859**

Brunswick Mill,  
Bradford Road,  
Manchester,  
M40 7EZ

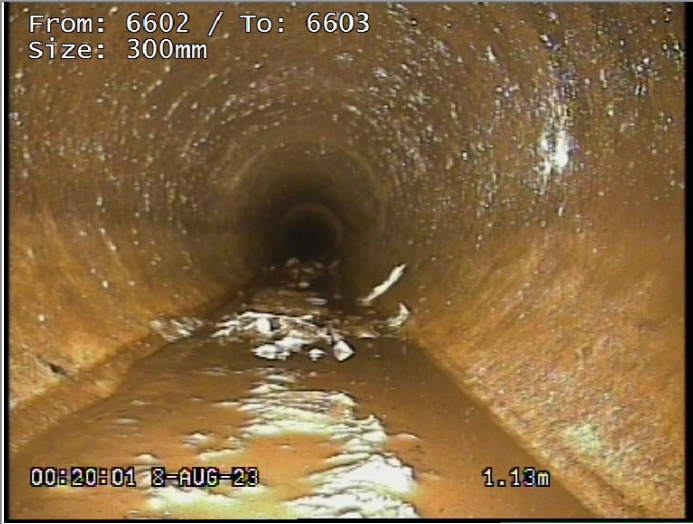
| Start Node Ref:6602 I/L :mm Depth: 3.80mm | | | | Photo | Type/Grade |
|---|---|---|--|---|---|
| 1.00 | DER (S01) | Settled deposits coarse 10% cross-sectional area loss, Start | | 8320928 | Service / 3 |

| Job Number<br>LAYERSERV0001859 | Surveyed by (Operator)<br>Joe COLLINS | Base Unit<br>DJVV56JNNH | Date<br>08/08/2023 |
|---|---|---|---|
| Settled deposits coarse 10% cross-sectional area loss, Start | | | |

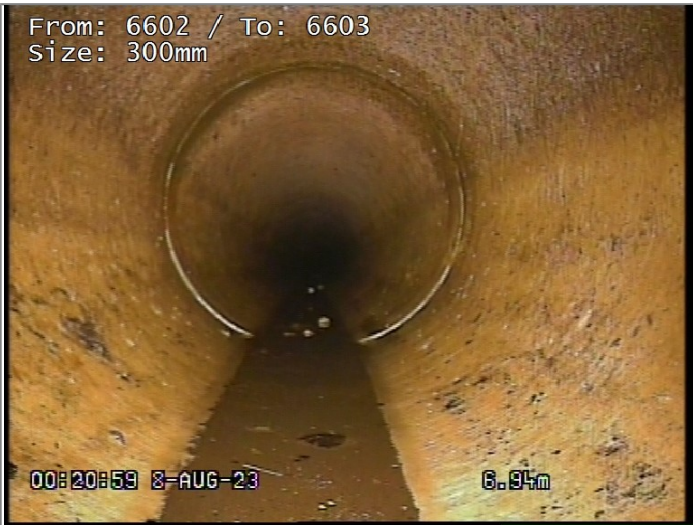
| Start Node Ref:6602 I/L :mm Depth: 3.80mm | | | | Photo | Type/Grade |
|---|---|---|--|---|---|
| 7.45 | DER (F01) | Settled deposits coarse 10% cross-sectional area loss, Finished | | 8320930 | Service / 3 |

| Job Number<br>LAYERSERV0001859 | Surveyed by (Operator)<br>Joe COLLINS | Base Unit<br>DJVV56JNNH | Date<br>08/08/2023 |
|---|---|---|---|
| Settled deposits coarse 10% cross-sectional area loss, Finished | | | |

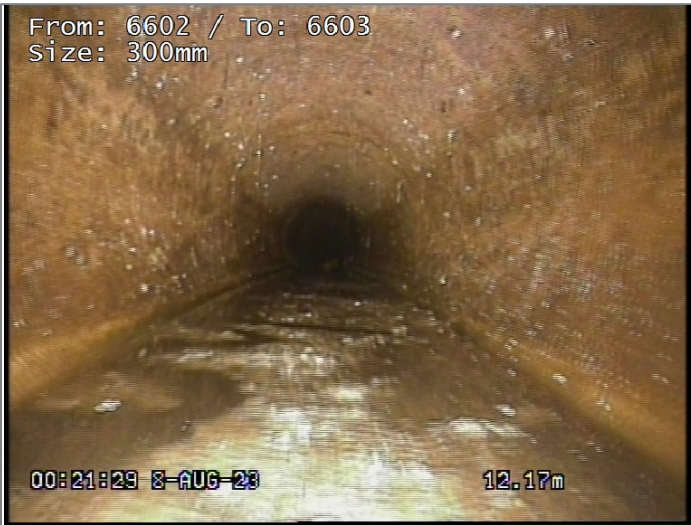
| Start Node Ref:6602 I/L :mm Depth: 3.80mm | | | | Photo | Type/Grade |
|---|---|---|--|---|---|
| 12.65 | DER (S02) | Settled deposits coarse 10% cross-sectional area loss, Start | | 8320931 | Service / 3 |

| Job Number<br>LAYERSERV0001859 | Surveyed by (Operator)<br>Joe COLLINS | Base Unit<br>DJVV56JNNH | Date<br>08/08/2023 |
|---|---|---|---|
| Settled deposits coarse 10% cross-sectional area loss, Start | | | |

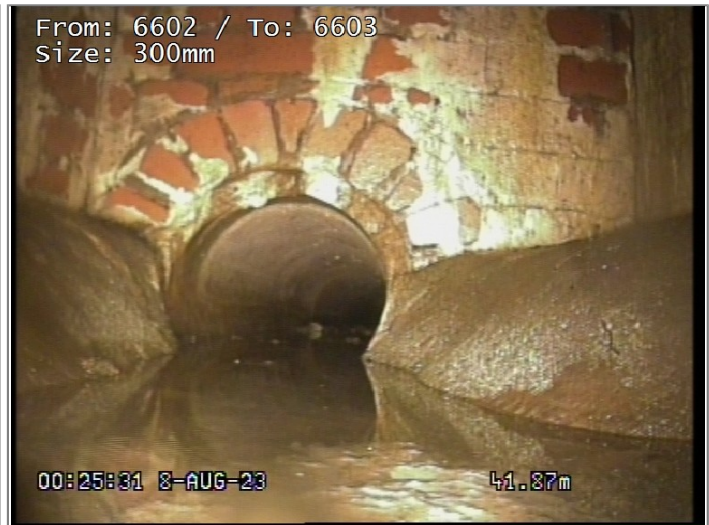
| Start Node Ref:6602 I/L :mm Depth: 3.80mm | | | | Photo | Type/Grade |
|---|---|---|--|---|---|
| 41.87 | DER (F02) | Settled deposits coarse 10% cross-sectional area loss, Finished | | 8320933 | Service / 3 |

Settled deposits coarse 10% cross-sectional area loss, Finished

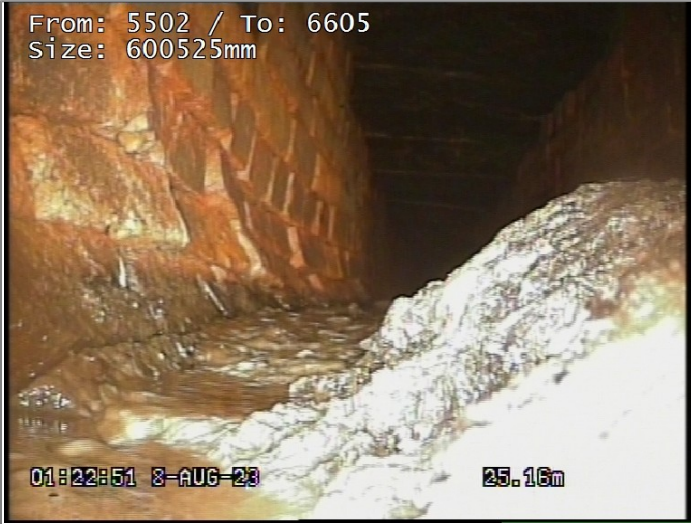
| Position | Code | Description | Photo | Type/Grade | |
|---|---|---|---|---|---|
| | 25.16 | SA | Survey abandoned - Remark: DUE TO 40% DER | 8320946 | Comment / 0 |

| Job Number<br>LAYERSERV0001859 | Surveyed by (Operator)<br>Joe COLLINS | Base Unit<br>DJVV56JNNH | Date<br>08/08/2023 |
|---|---|---|---|
| From: 5502 / To: 6605<br>Size: 600525mm<br>Survey abandoned - Remark: DUE TO 40% DER | | | |

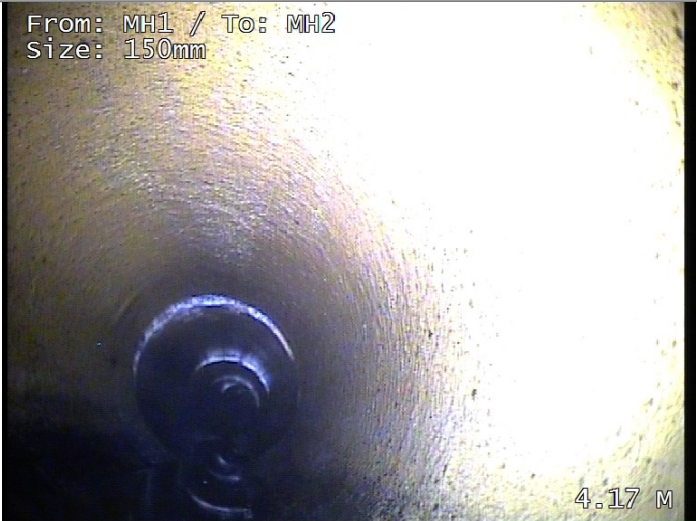
| Position | Code | Description | Photo | Type/Grade |
|---|---|---|---|---|
| 4.17 | DEE | Attached deposits, encrustation from 5 to 7 o'clock 5% cross-sectional area loss | 8336222 | Service / 2 |

| Job Number<br>LAYERSERV0001859 | Surveyed by (Operator)<br>Joe COLLINS | Base Unit<br>DJVV56JNNH | Date<br>11/08/2023 |
|---|---|---|---|
| <p>From: MH1 / To: MH2<br/>Size: 150mm</p> <p>4.17 M</p> <p>Attached deposits, encrustation from 5 to 7 o'clock 5% cross-sectional area loss</p> | | | |

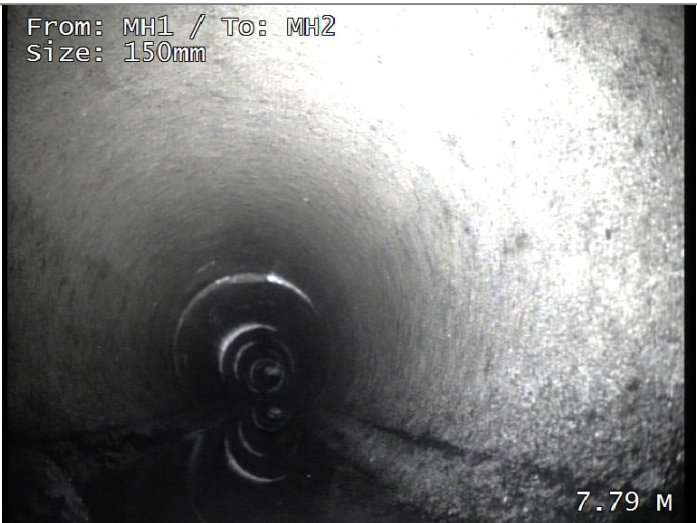
| Job Number<br>LAYERSERV0001859 | Surveyed by (Operator)<br>Joe COLLINS | Base Unit<br>DJVV56JNNH | Date<br>11/08/2023 |
|---|---|---|---|
| <p>From: MH1 / To: MH2<br/>Size: 150mm</p> <p>7.79 M</p> <p>Attached deposits, encrustation from 5 to 7 o'clock 5% cross-sectional area loss</p> | | | |

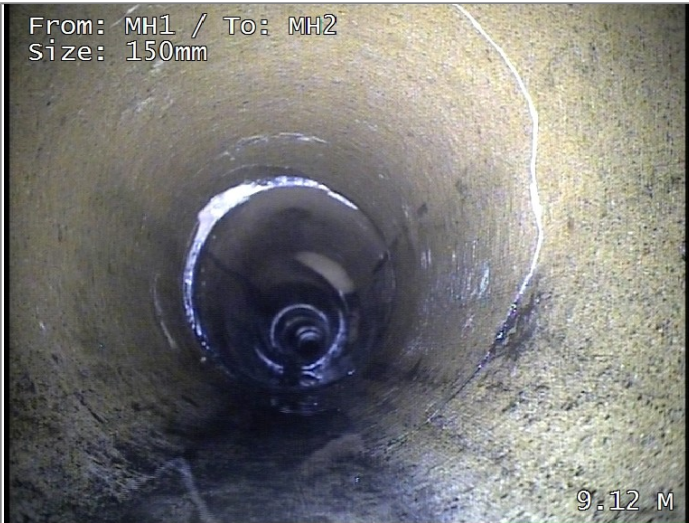
| Position | Code | Description | Photo | Type/Grade |
|---|---|---|---|---|
| 9.10 | FC | Fracture circumferential from 12 to 6 o'clock | 8336226 | Structural / 3 |

| Job Number<br>LAYERSERV0001859 | Surveyed by (Operator)<br>Joe COLLINS | Base Unit<br>DJVV56JNNH | Date<br>11/08/2023 |
|---|---|---|---|
| <div><div>From: MH1 / To: MH2<br/>Size: 150mm</div><div><div>9.12 M</div></div><div>Fracture circumferential from 12 to 6 o'clock</div></div> | <div><div>From: MH1 / To: MH2<br/>Size: 150mm</div><div><div>9.67 M</div></div><div>Junction at 2 o'clock, diameter 100mm</div></div> | | |

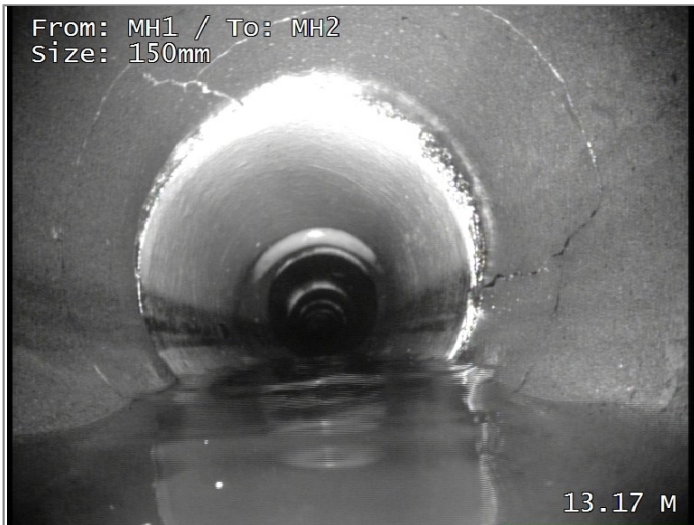
| Position | Code | Description | Photo | Type/Grade |
|---|---|---|---|---|
| 13.17 | FC | Fracture circumferential from 12 to 12 o'clock | 8336233 | Structural / 3 |

| Job Number<br>LAYERSERV0001859 | Surveyed by (Operator)<br>Joe COLLINS | Base Unit<br>DJVV56JNNH | Date<br>11/08/2023 |
|---|---|---|---|
| <div><div>From: MH1 / To: MH2<br/>Size: 150mm</div><div><div>13.17 M</div></div><div>Fracture circumferential from 12 to 12 o'clock</div></div> | <div><div>From: MH1 / To: MH2<br/>Size: 150mm</div><div><div>13.69 M</div></div><div>Junction at 12 o'clock, diameter 150mm</div></div> | | |

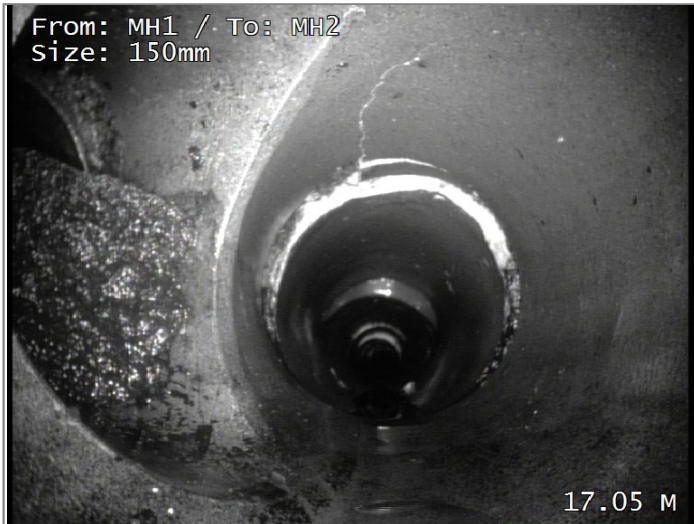
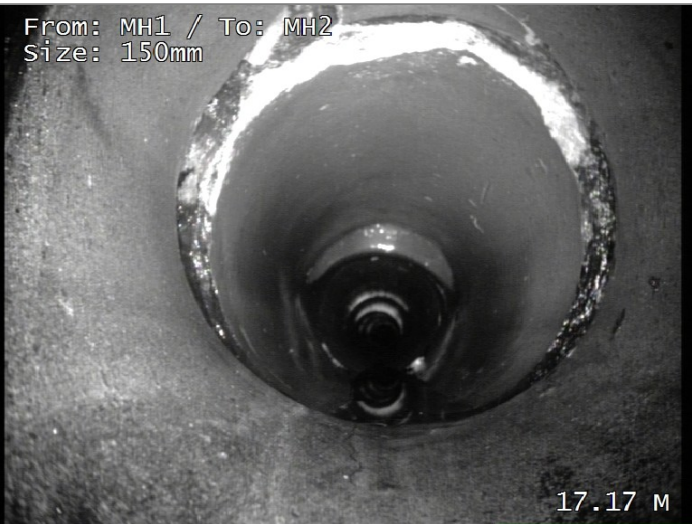
| Position | Code | Description | Photo | Type/Grade |
|---|---|---|---|---|
| 17.05 | JXB | Junction defective, connecting pipe is blocked at 9 o'clock, diameter 150mm | 8336235 | Comment / 0 |
| 17.17 | B | Broken pipe from 8 to 2 o'clock | 8336238 | Structural / 4 |

| Job Number<br>LAYERSERV0001859 | Surveyed by (Operator)<br>Joe COLLINS | Base Unit<br>DJVV56JNNH | Date<br>11/08/2023 |
|---|---|---|---|
| <div><div>From: MH1 / To: MH2<br/>Size: 150mm</div><div><div>17.05 M</div></div><div>Junction defective, connecting pipe is blocked at 9 o'clock, diameter 150mm</div></div> | <div><div>From: MH1 / To: MH2<br/>Size: 150mm</div><div><div>17.17 M</div></div><div>Broken pipe from 8 to 2 o'clock</div></div> | | |

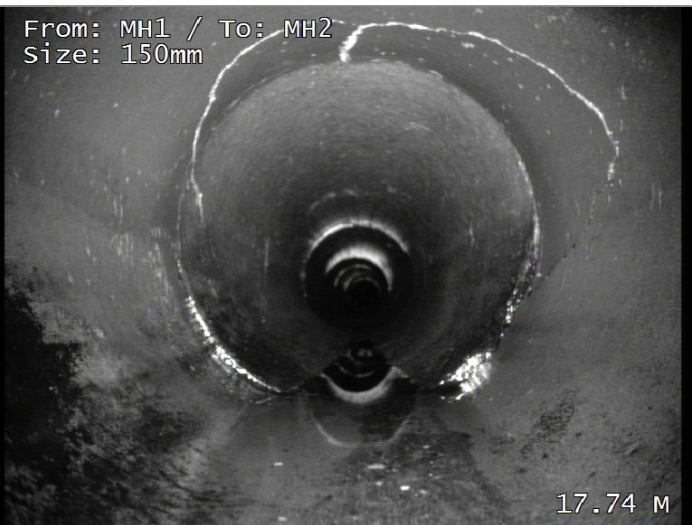
| Position | Code | Description | Photo | Type/Grade |
|---|---|---|---|---|
| 17.74 | FC | Fracture circumferential from 12 to 12 o'clock | 8336240 | Structural / 3 |

| Job Number<br>LAYERSERV0001859 | Surveyed by (Operator)<br>Joe COLLINS | Base Unit<br>DJVV56JNNH | Date<br>11/08/2023 |
|---|---|---|---|
| <div><div>From: MH1 / To: MH2<br/>Size: 150mm</div><div><div>17.64 M</div></div><div>Junction at 12 o'clock, diameter 150mm</div></div> | <div><div>From: MH1 / To: MH2<br/>Size: 150mm</div><div><div>17.74 M</div></div><div>Fracture circumferential from 12 to 12 o'clock</div></div> | | |

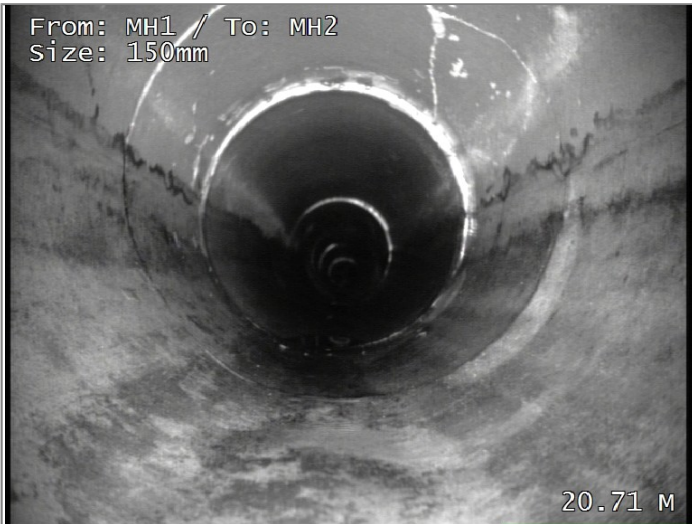
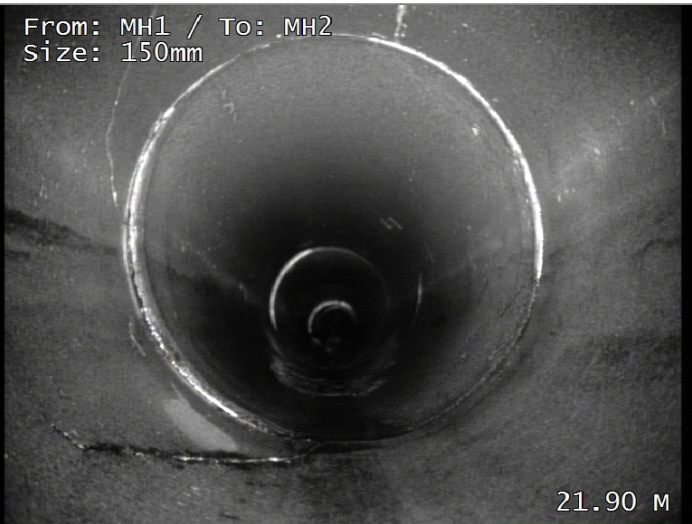
| Position | Code | Description | Photo | Type/Grade |
|---|---|---|---|---|
| 20.69 | FC | Fracture circumferential from 12 to 12 o'clock | 8336248 | Structural / 3 |
| 21.93 | FC | Fracture circumferential from 6 to 12 o'clock | 8336252 | Structural / 3 |

| Job Number<br>LAYERSERV0001859 | Surveyed by (Operator)<br>Joe COLLINS | Base Unit<br>DJVV56JNNH | Date<br>11/08/2023 |
|---|---|---|---|
| <div>From: MH1 / To: MH2<br/>Size: 150mm</div> <div></div> <div>20.71 M</div> <div>Fracture circumferential from 12 to 12 o'clock</div> | <div>From: MH1 / To: MH2<br/>Size: 150mm</div> <div></div> <div>21.90 M</div> <div>Fracture circumferential from 6 to 12 o'clock</div> | | |

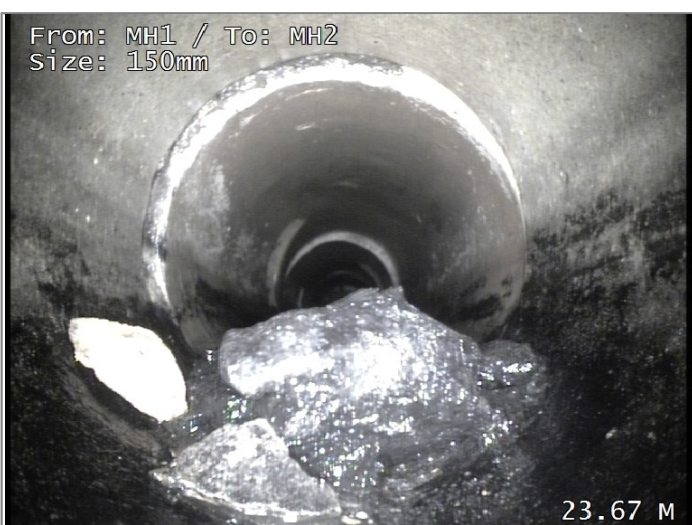
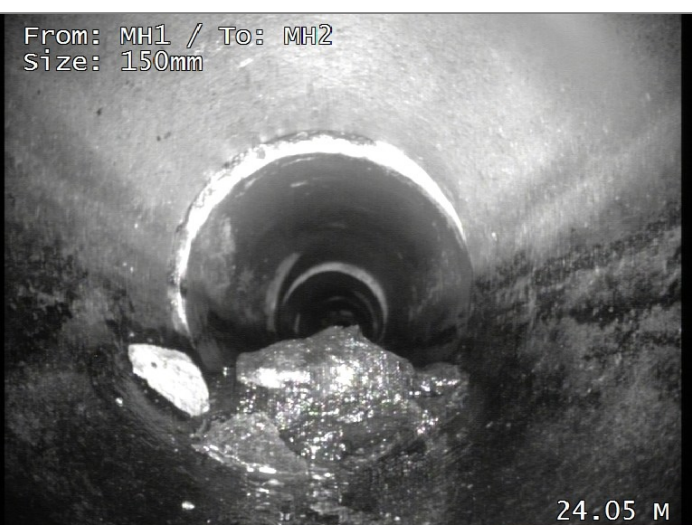
| Job Number<br>LAYERSERV0001859 | Surveyed by (Operator)<br>Joe COLLINS | Base Unit<br>DJVV56JNNH | Date<br>11/08/2023 |
|---|---|---|---|
| <div>From: MH1 / To: MH2<br/>Size: 150mm</div> <div></div> <div>23.67 M</div> <div>Settled deposits hard or compacted 25% cross-sectional area loss</div> | <div>From: MH1 / To: MH2<br/>Size: 150mm</div> <div></div> <div>24.05 M</div> <div>Survey abandoned - Remark: DUE TO HARD STANDING UNABLE TO REMOVE</div> | | |

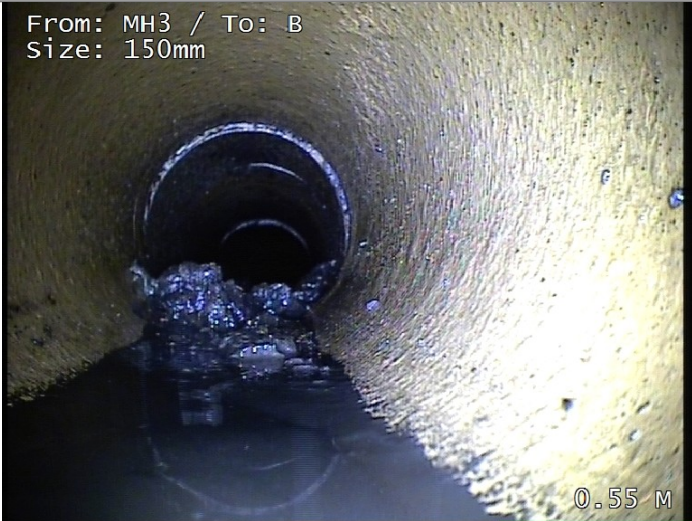
| Position | Code | Description | Photo | Type/Grade |
|---|---|---|---|---|
| 0.52 | FC | Fracture circumferential from 9 to 3 o'clock | 8336376 | Structural / 3 |

| Job Number<br>LAYERSERV0001859 | Surveyed by (Operator)<br>Joe COLLINS | Base Unit<br>DJVV56JNNH | Date<br>11/08/2023 |
|---|---|---|---|
| <div><div><p>From: MH3 / To: B<br/>Size: 150mm</p><p>0.55 M</p><p>Fracture circumferential from 9 to 3 o'clock</p></div><div><p>From: MH3 / To: B<br/>Size: 150mm</p><p>0.93 M</p><p>Settled deposits coarse 10% cross-sectional area loss</p></div></div> | | | |

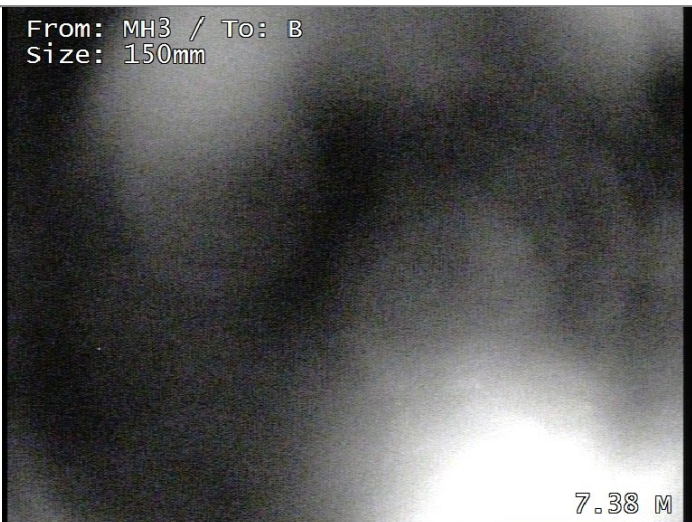
| Job Number<br>LAYERSERV0001859 | Surveyed by (Operator)<br>Joe COLLINS | Base Unit<br>DJVV56JNNH | Date<br>11/08/2023 |
|---|---|---|---|
| <div><p>From: MH3 / To: B<br/>Size: 150mm</p><p>7.38 M</p><p>Survey abandoned - Remark: OLD DOW SPOUT CAPPED</p></div> | | | |
