## Phase I GeoEnvironmental Desk Study

Bury Old Road

Cheetham Hill

**Report No. A5545/23/FDS**

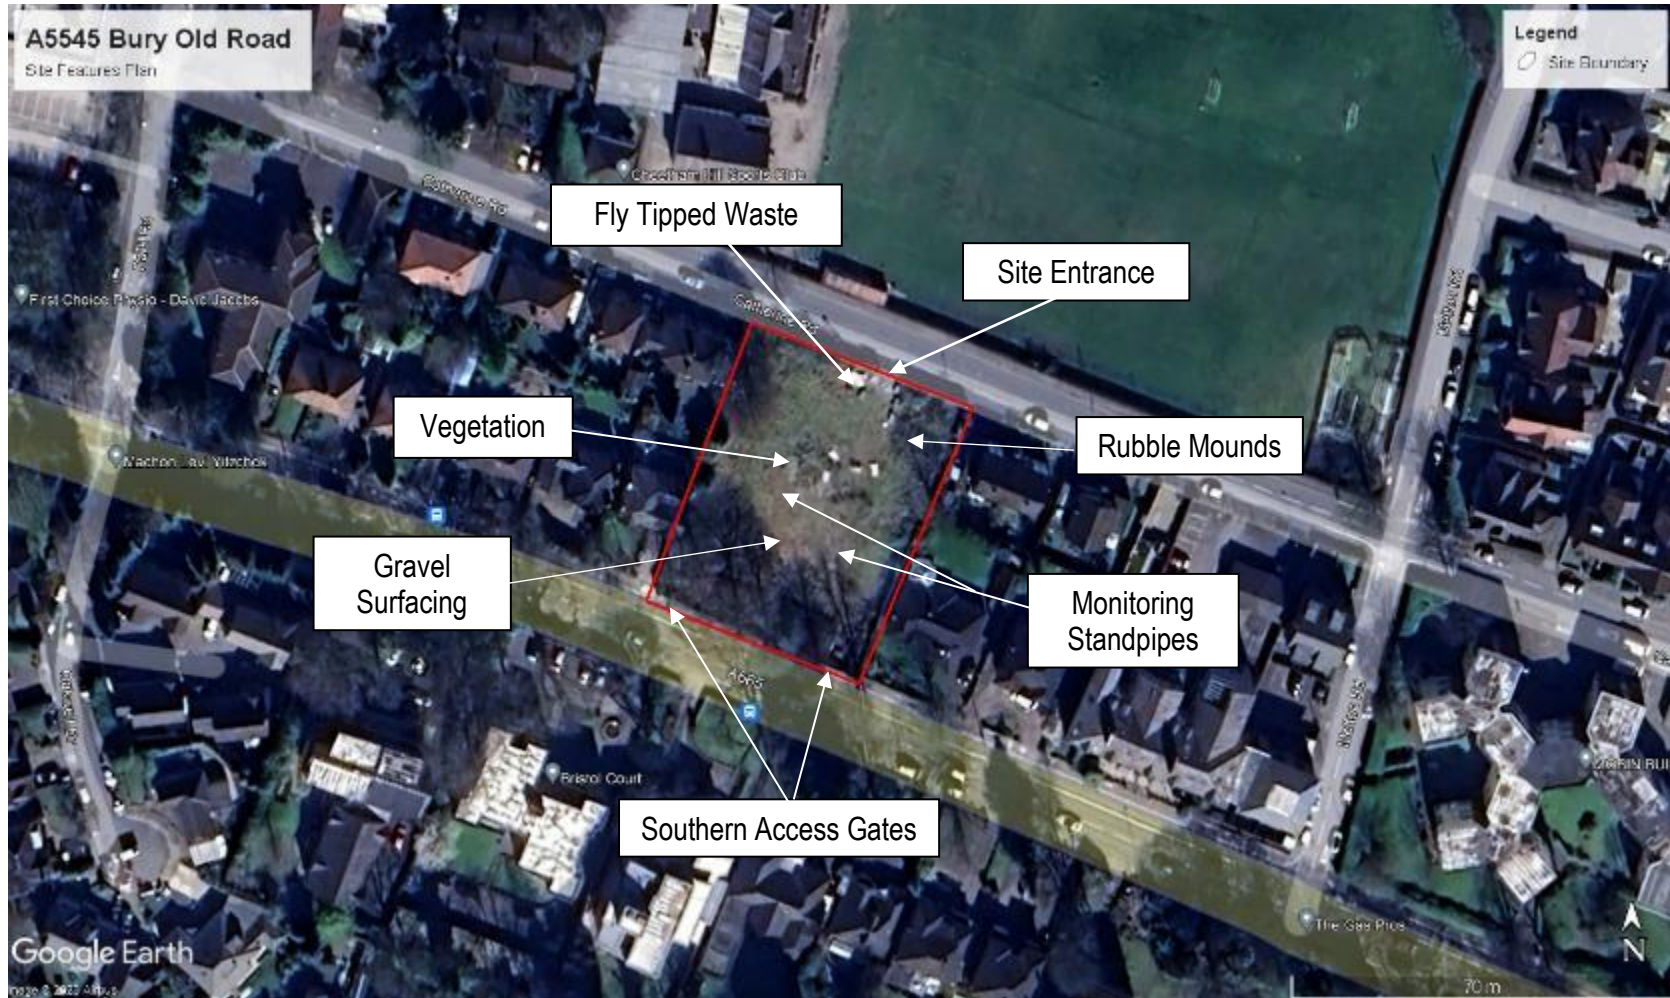
**Figure 8 Site Features Plan**

- 5.10 Canisters of gas were observed near the northern boundary, and an empty Trade Eggshell paint can was observed near the southeastern access gate.

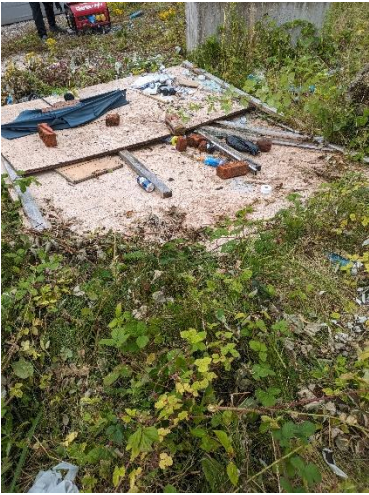
| <p><b>Plate 3 Overview of the site from the northern area.</b></p> | <p><b>Plate 4 Area of fly tipped material in the northern area of the site.</b></p> |

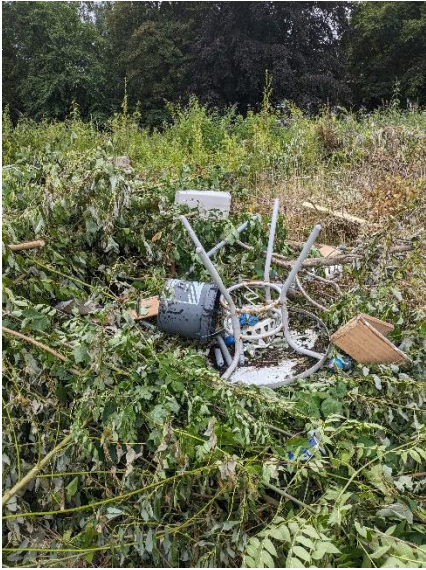
| <p><b>Plate 5 Fly tipped material and plant cuttings in the northern area of the site.</b></p> | <p><b>Plate 6 Overview of eastern area of the site from the northern access.</b></p> |

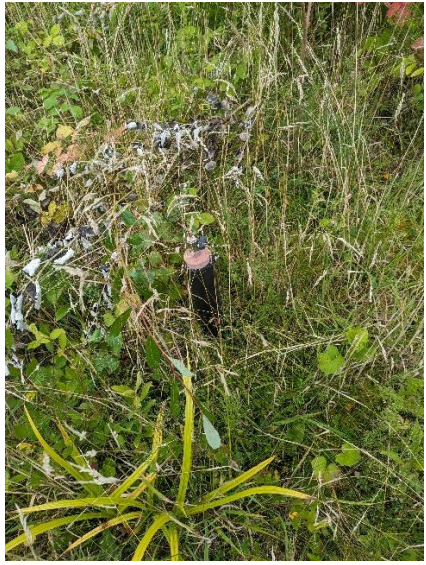
| <p><b>Plate 7 Monitoring standpipe located in the central region of the site.</b></p> | <p><b>Plate 8 Empty Trade Eggshell paint can located near south eastern access gate.</b></p> |
