# ASBESTOS DEMOLITION SURVEY

LOCATION: Cheetham Hill Site, Herbert Street, Manchester M8 0DG

SURVEYED ON: 3 Jan 2024

OUR REF: PR12298

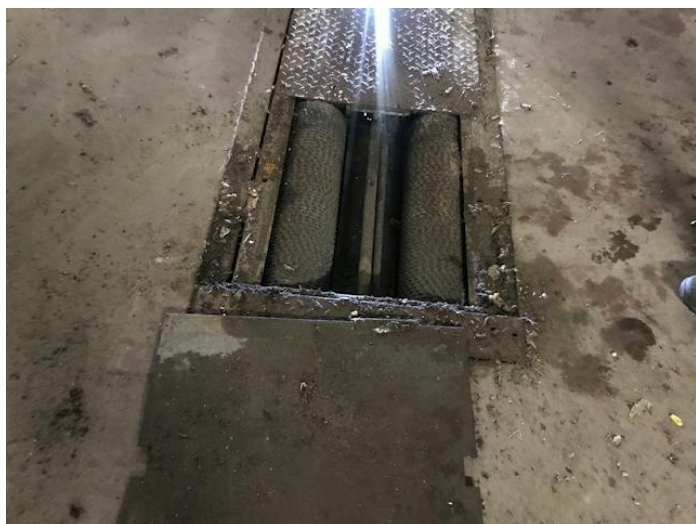
| Location | 001 - Unit 1 | Item | Floor recessed equipment |
| Access / Notes | No Access / No safe access to equipment or elements within floor pit | | |

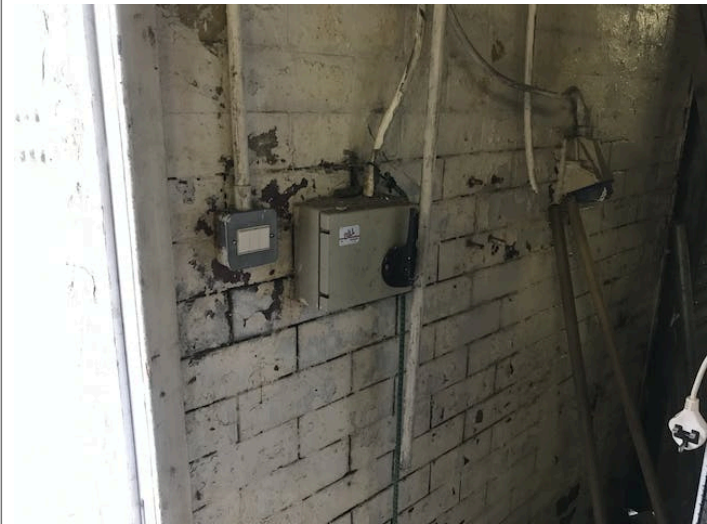
| <b>Material</b> | Presumed flash pads to fuse box | <b>Extent</b> | 0.5M <sup>2</sup> |
| <b>Strategy</b> | Presume | <b>Presumed Fibre Type</b> | Chrysotile |

| <b>Product Type (or Debris from Product)</b> | 1 | <b>Extent of Damage / Deterioration</b> | 0 |

| <b>Recommendation</b> | Remove | | |

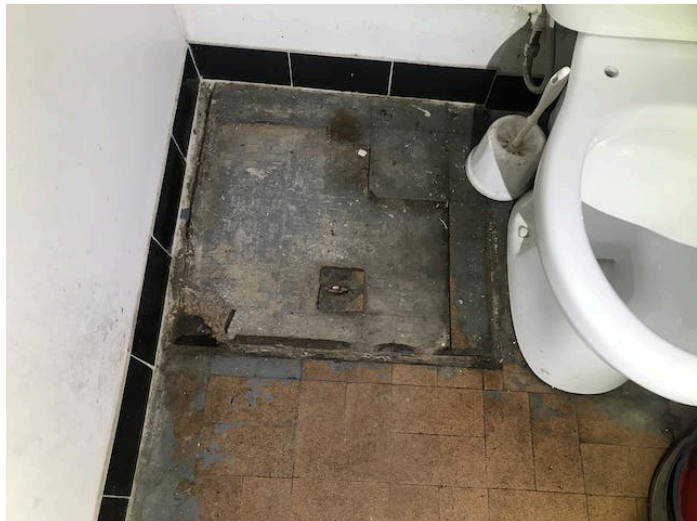
| Location | 001 - Unit 1 | Item | Sub-level elements beneath manhole cover |
| Access / Notes | No Access / Unable To Open | | |

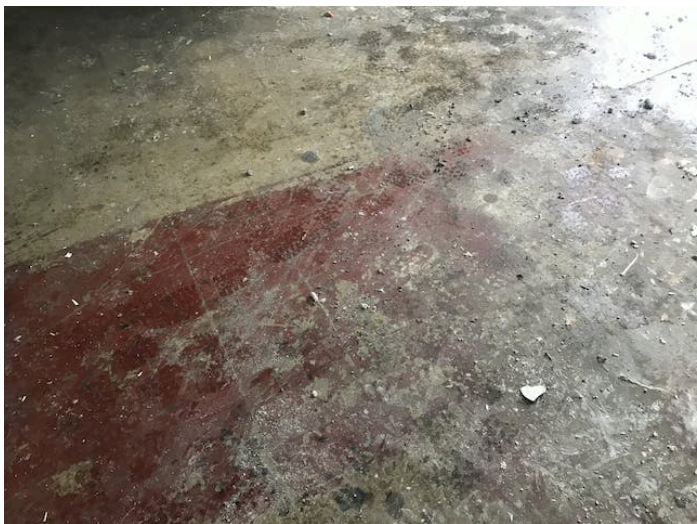
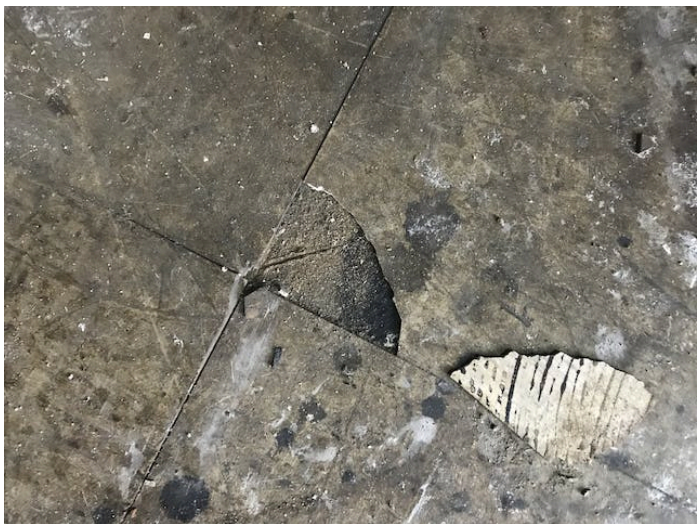
| Material | Floor tiles and bitumen | Extent | 84M <sup>2</sup> |
| Strategy / Sample Id | Sample / RS01 | Fibre Type | NAD |

| Recommendation | No further action required | | |

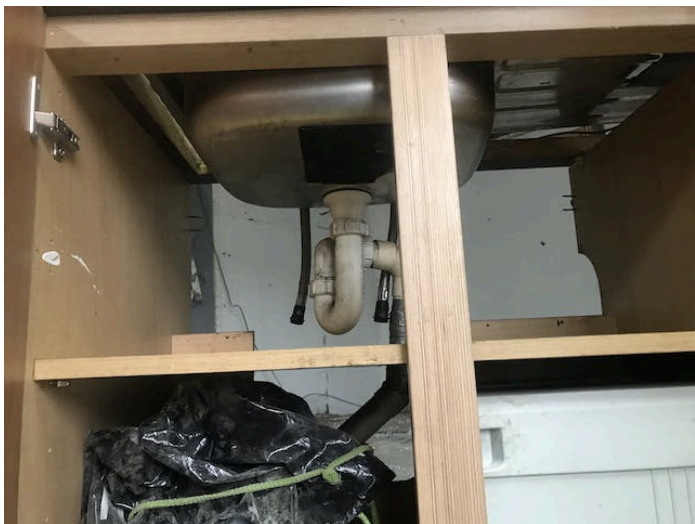
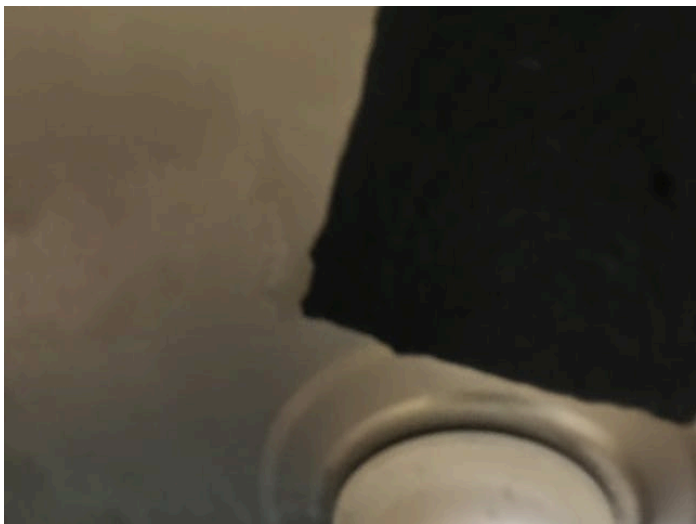
| Material | Sink pad | Extent | 0.5M <sup>2</sup> |
| Strategy / Sample Id | Sample / RS02 | Fibre Type | NAD |

| Recommendation | No further action required | | |

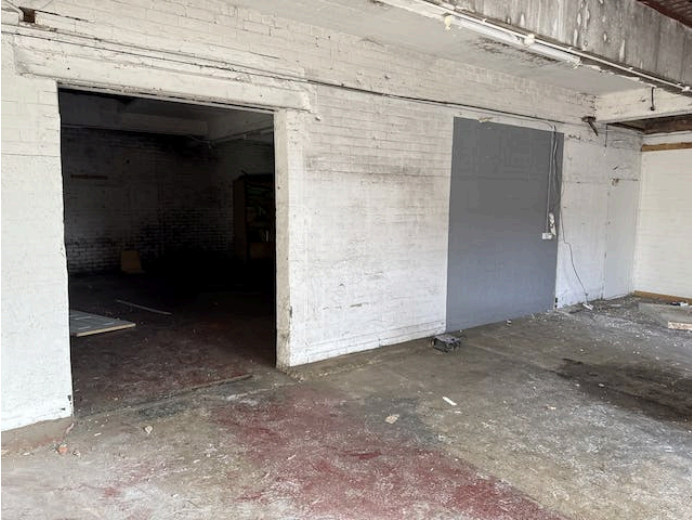
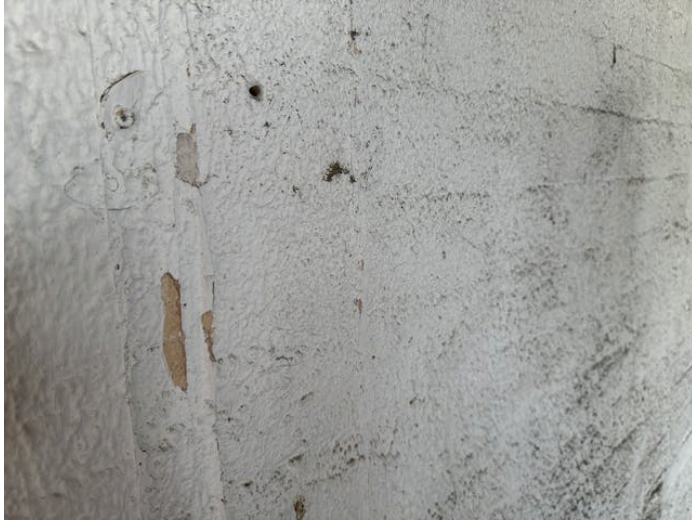
| Material | Coating to wall to unit 2 room 1 | Extent | 20M <sup>2</sup> |
| Strategy / Sample Id | Sample / RS03 | Fibre Type | NAD |

| Recommendation | No further action required | | |

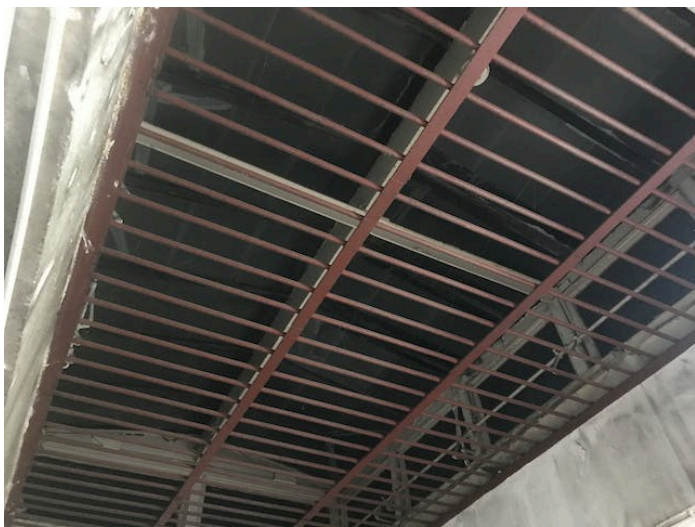
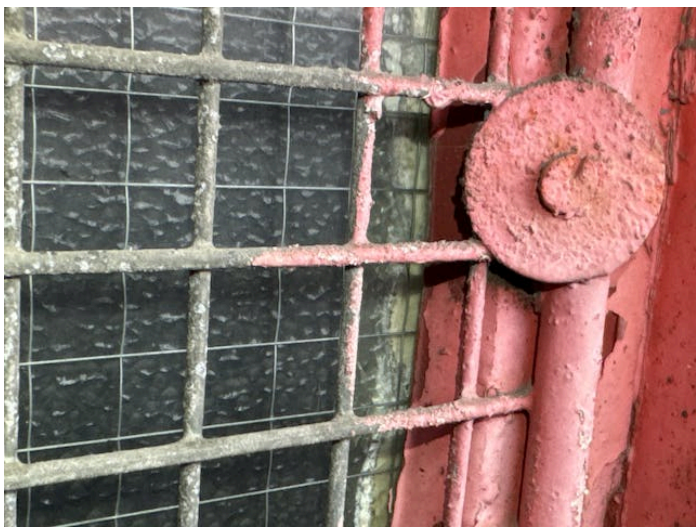
| Material | Putty to skylights, access made from roof | Extent | 16M <sup>2</sup> |
| Strategy / Sample Id | Sample / RS04 | Fibre Type | NAD |

| Recommendation | No further action required | | |

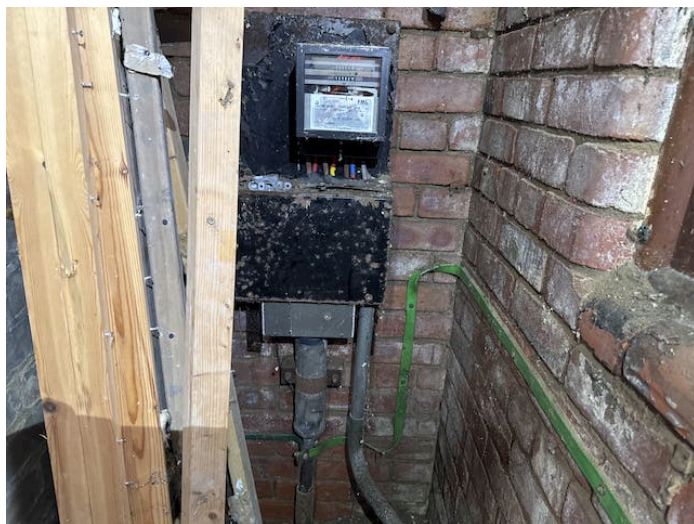
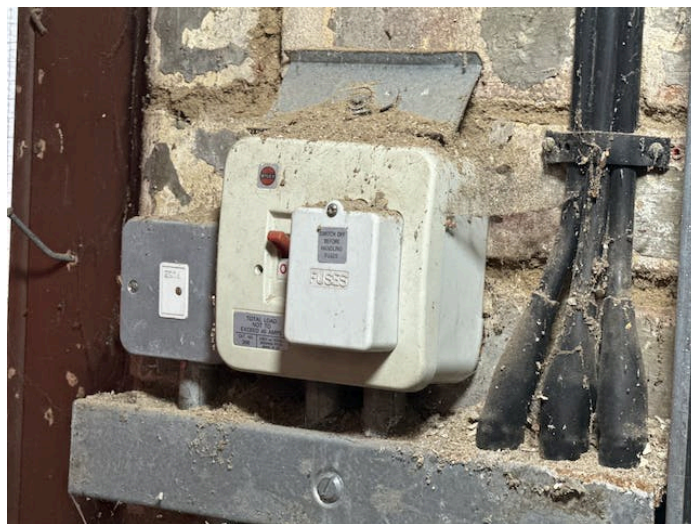
| <b>Material</b> | No access within old fuse boxes presume flash pads | <b>Extent</b> | 0.5M <sup>2</sup> |

| <b>Strategy</b> | Presume | <b>Presumed Fibre Type</b> | Chrysotile |

| <b>Product Type (or Debris from Product)</b> | 1 | <b>Extent of Damage / Deterioration</b> | 0 |

| <b>Recommendation</b> | Remove | | |

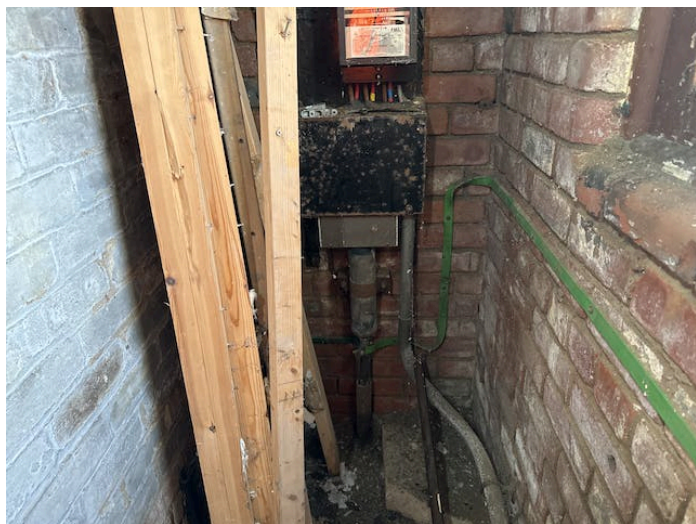
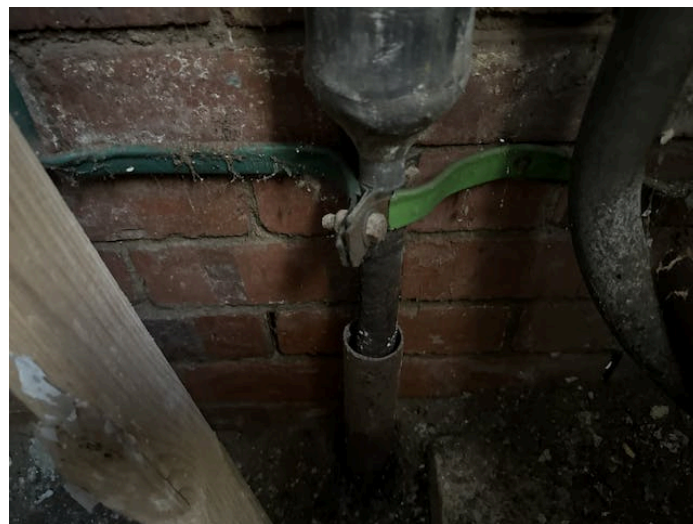
| <b>Material</b> | Presume bitumen wrap to electrics no access as live | <b>Extent</b> | 1Lm |

| <b>Strategy</b> | Strongly Presume | <b>Presumed Fibre Type</b> | Chrysotile |

| <b>Product Type (or Debris from Product)</b> | 1 | <b>Extent of Damage / Deterioration</b> | 0 |

| <b>Recommendation</b> | Remove | | |

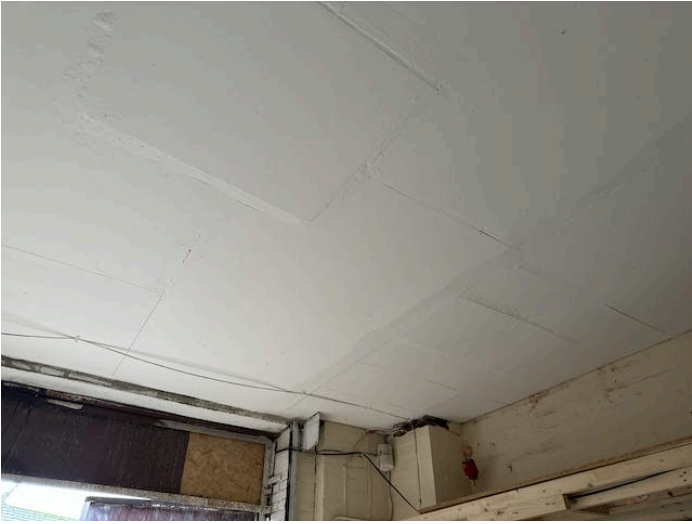
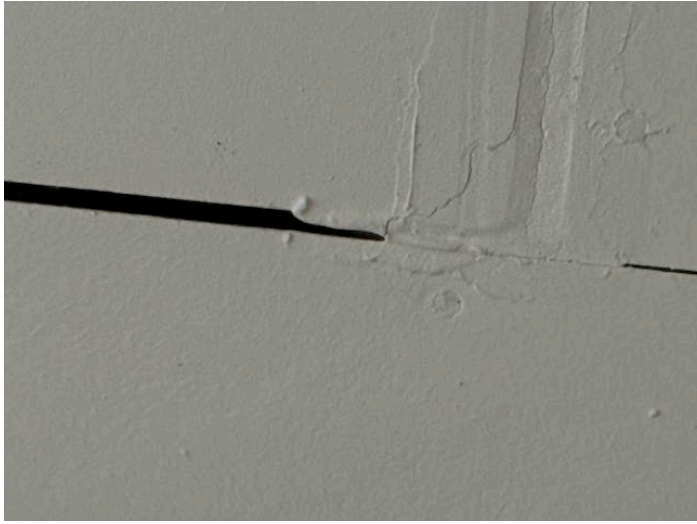
| Material | Panels to ceiling | Extent | 50M <sup>2</sup> |
| Strategy / Sample Id | Sample / RS05 | Fibre Type | NAD |

| Recommendation | No further action required | | |

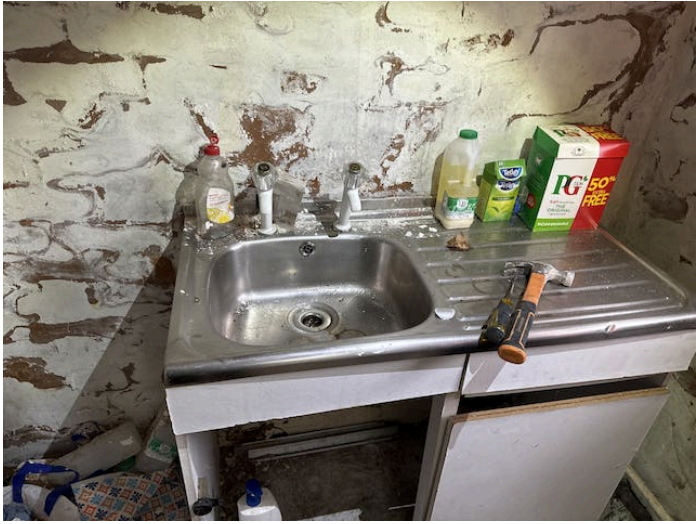
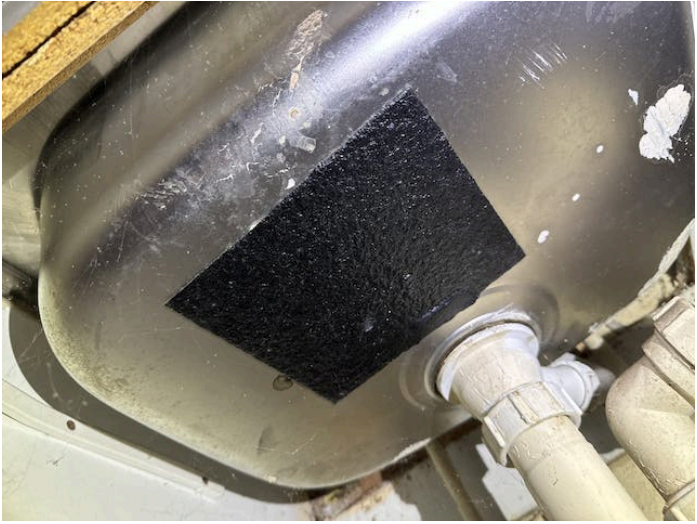
| Material | Sink pad | Extent | 1M <sup>2</sup> |
| Strategy / Sample Id | Sample / RS06 | Fibre Type | NAD |

| Recommendation | No further action required | | |

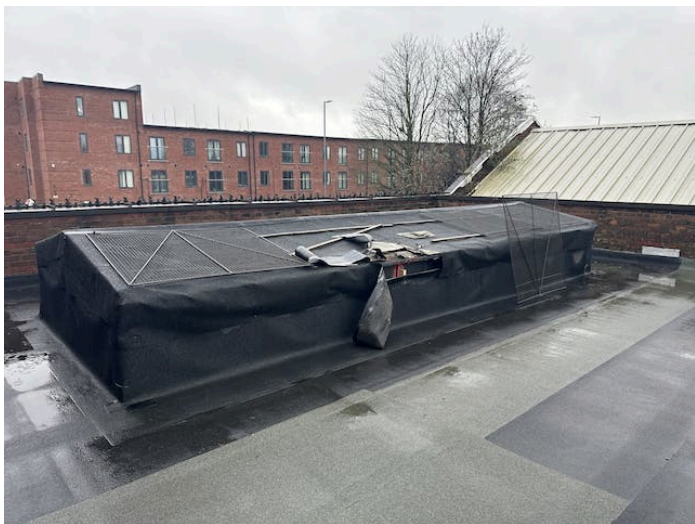
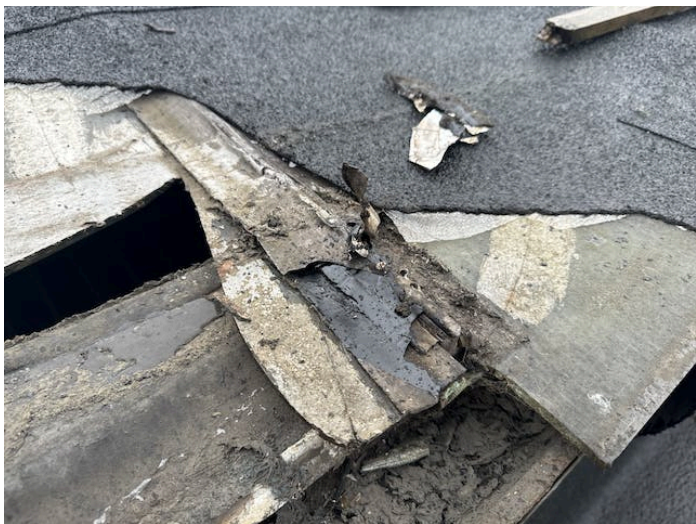
| Material | Old felt to skylights | Extent | 32M <sup>2</sup> |
| Strategy / Sample Id | Sample / RS07 | Fibre Type | NAD |

| Recommendation | No further action required | | |

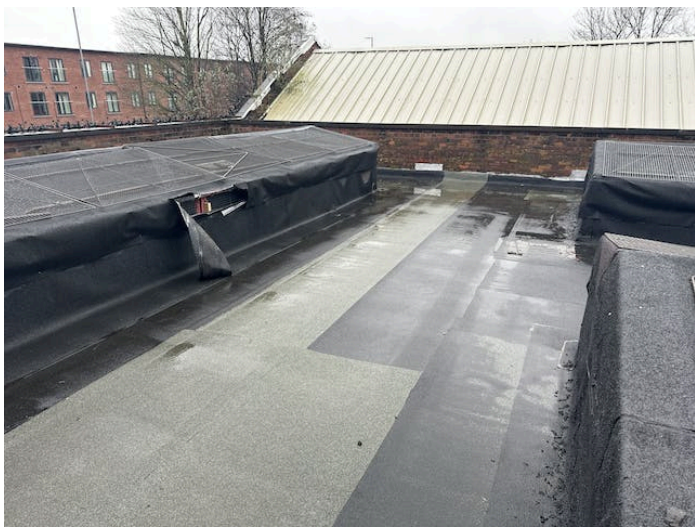
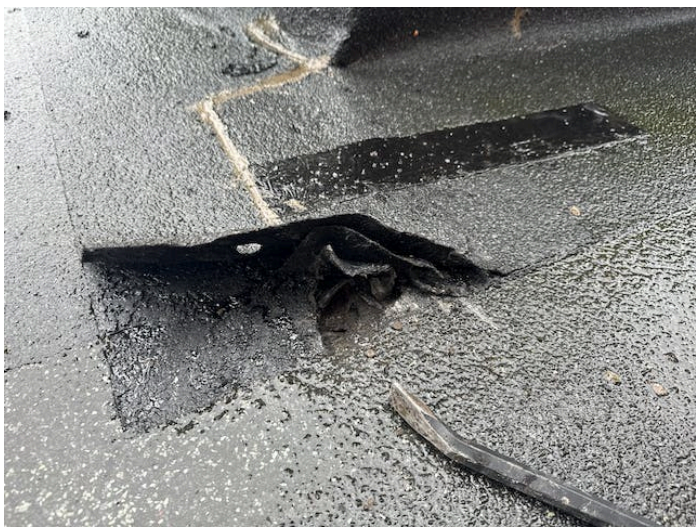
| Material | Roofing felt sample to concrete roof | Extent | 168M <sup>2</sup> |
| Strategy / Sample Id | Sample / RS08 | Fibre Type | NAD |

| Recommendation | No further action required | | |

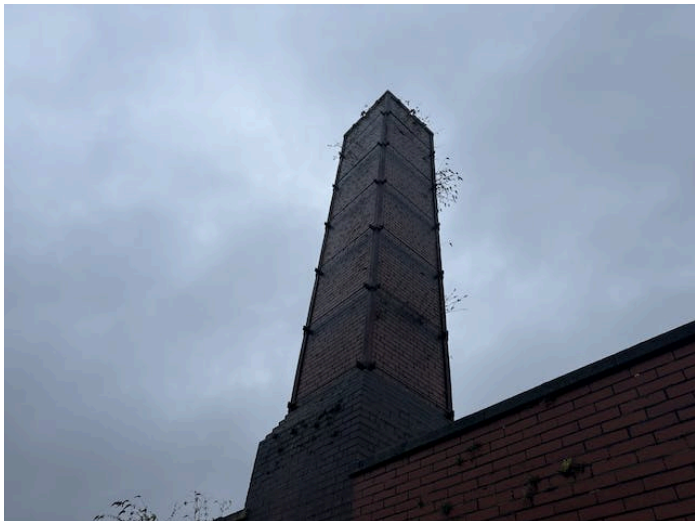
| Location | 017 - Level 2 Roof | Item | Internal and external elements to chimney |
| Access / Notes | No Access / No safe access available | | |

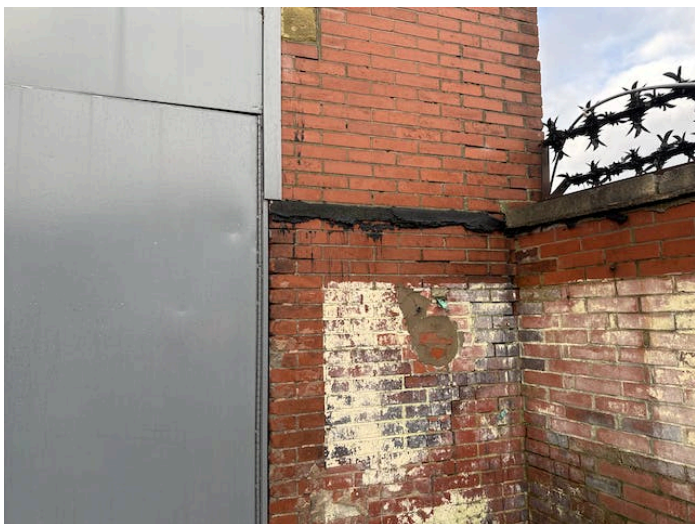
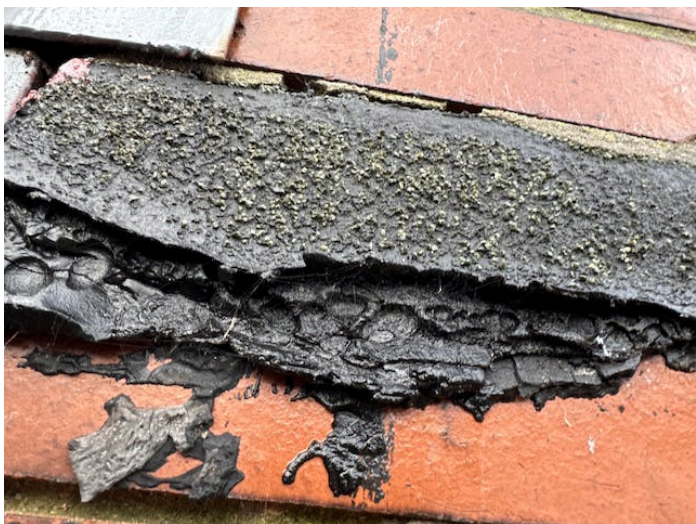
| Material | Felt/dpc to unit 4 external wall | Extent | 9Lm |
| Strategy / Sample Id | Strongly Presume / RS09 | Presumed Fibre Type | NAD |

| Recommendation | No further action required | | |
