Heaton Hall Orangery  
Manchester City Council  
Heaton Hall, Manchester

Existing Elevation with Repairs

Elevation 02 & 3

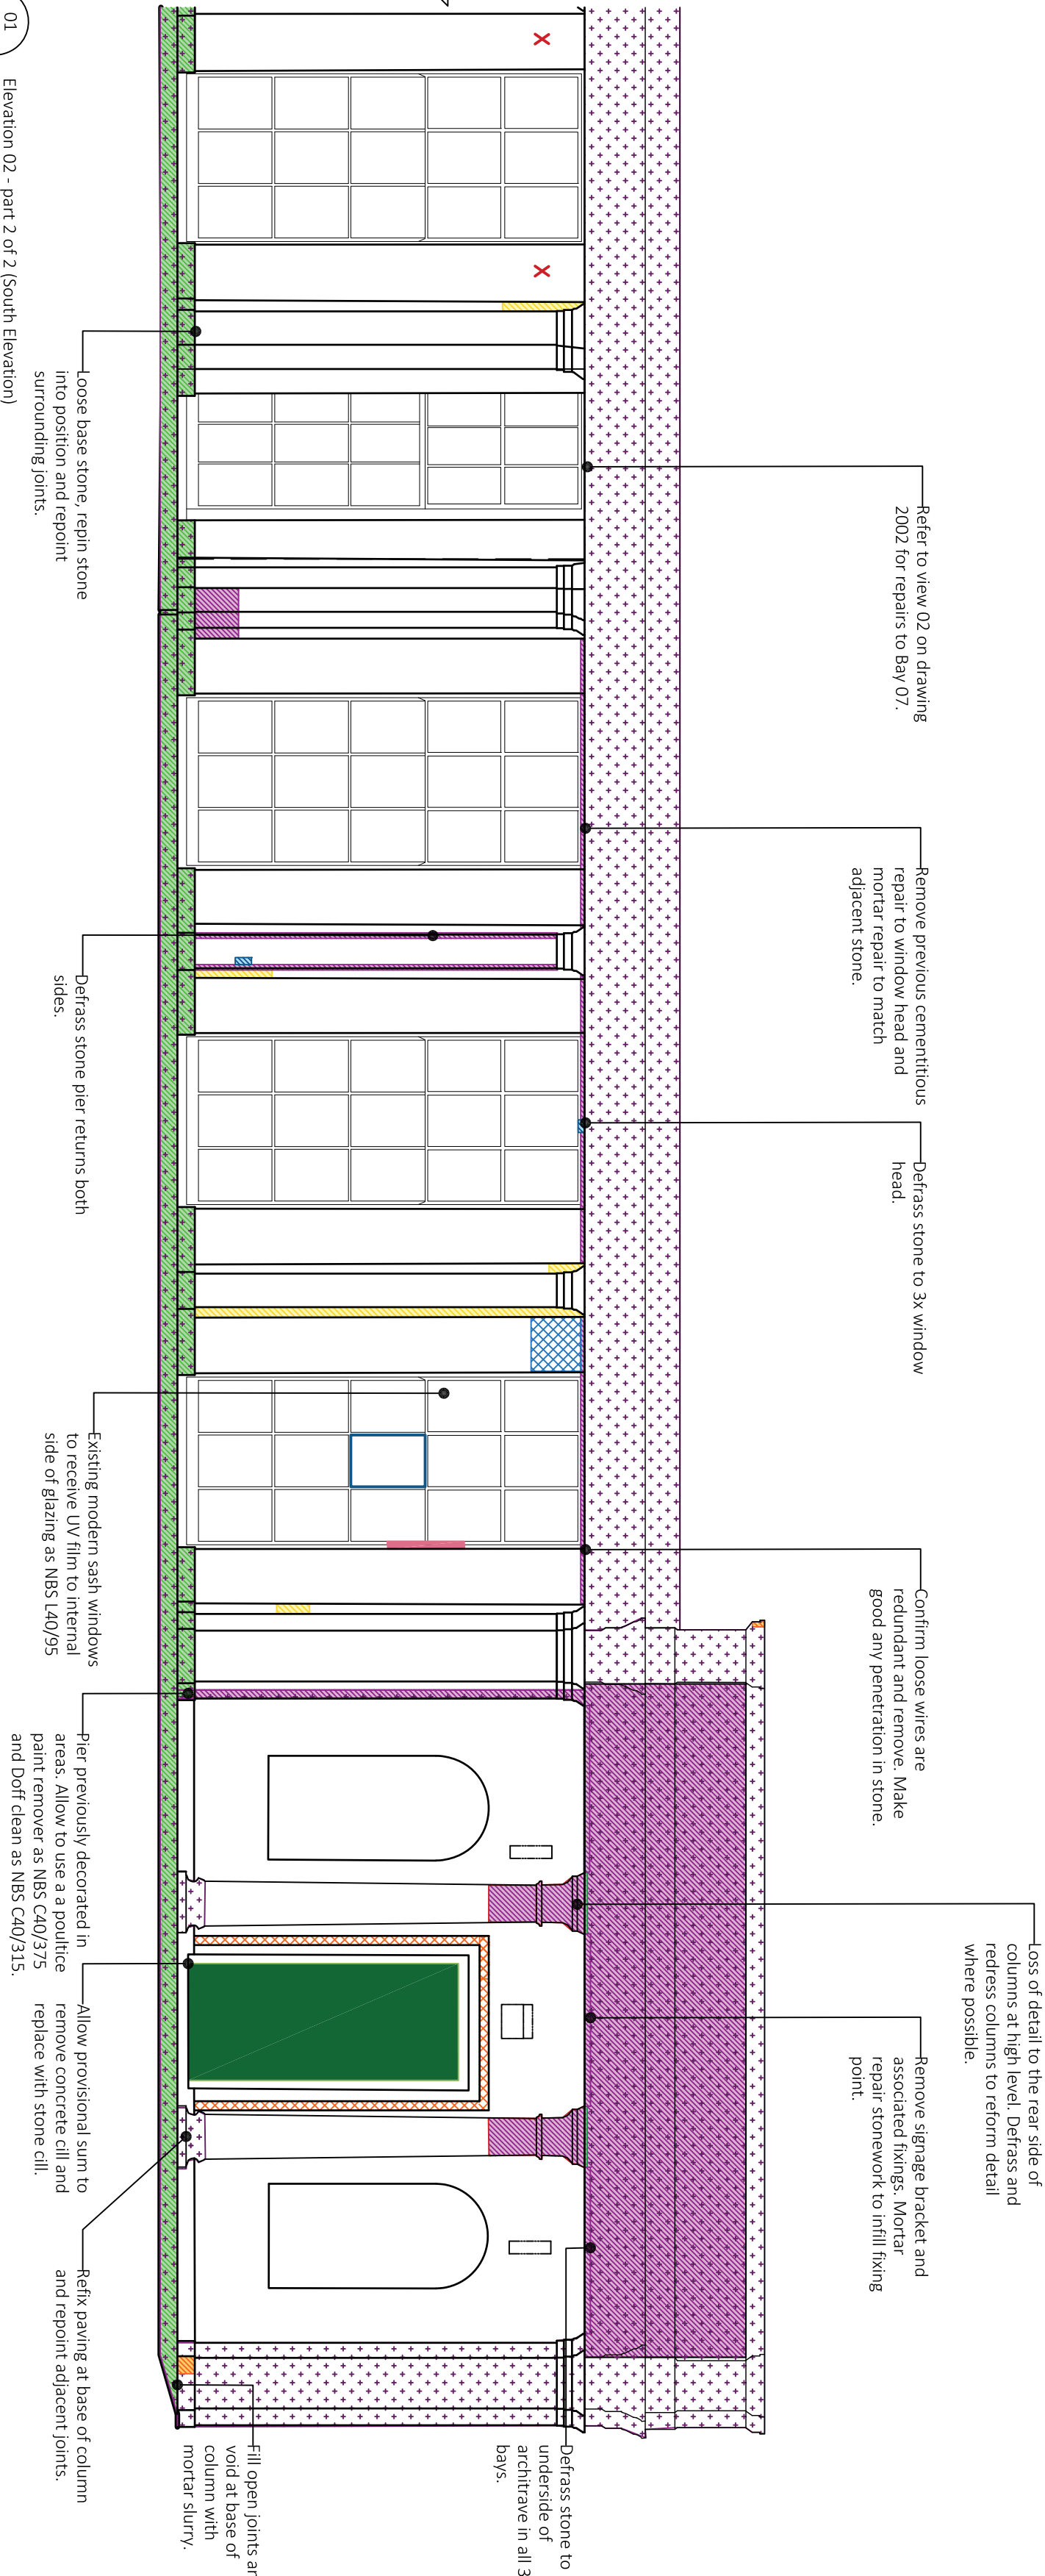
01  
9752  
Elevation 02 - part 2 of 2 (South Elevation)

Evidence of previous structural movement. Allow provisional sum for assessment by Structural Engineer. Allow for rake out of previous mortar repair, pin crack with stainless steel bar, and repoint joint.

Replace cracked render to door reveal at head and RHS jamb.

Remove existing flood light. Redress and consolidate stone to u/s architrave.

Window boarded up during inspection. Assumed non-original window inserted in the mid 20th century. Overhaul window, remove window bars and allow for 25% replacement timber repairs as BUT13. Replace glazing with 4mm clear glass. Add security rated secondary glazing internally.

Remove SVP if redundant and make good fixing points.

On return wall:  
- to parapet, architrave and copings, doff clean, rake out and repoint.

Replace cracked render on return wall.

Clear debris from gutter and downpipe. Check connection to below ground drainage. Allow for new grated gully.

Carefully remove commemorative plaque, undertake specialist restoration and reinstate.

Remove modern vent if redundant and infill wall with masonry. Render and decorate. Lift and re-bed coping stone. Repoint joints.

Remove existing render to wall. Rake out and repoint joints to all sides.

Remove cracked and damaged section of rendered plinth to LHS door jamb and remodel to match existing profile.

Allow provisional sum to lift paving slabs and bury existing lightning protection 500mm below ground level within protective conduit. Allow for relocation of existing earthing if required. Relay

Allow to replace cast iron grate cover to match pattern of original adjacent grate.
