## PRELIMINARY INVESTIGATION OF DAMP

HEATON HALL ORANGERY, HEATON PARK, MANCHESTER

JOB NO. 212.97

16 FEBRUARY & 15 MARCH 2022

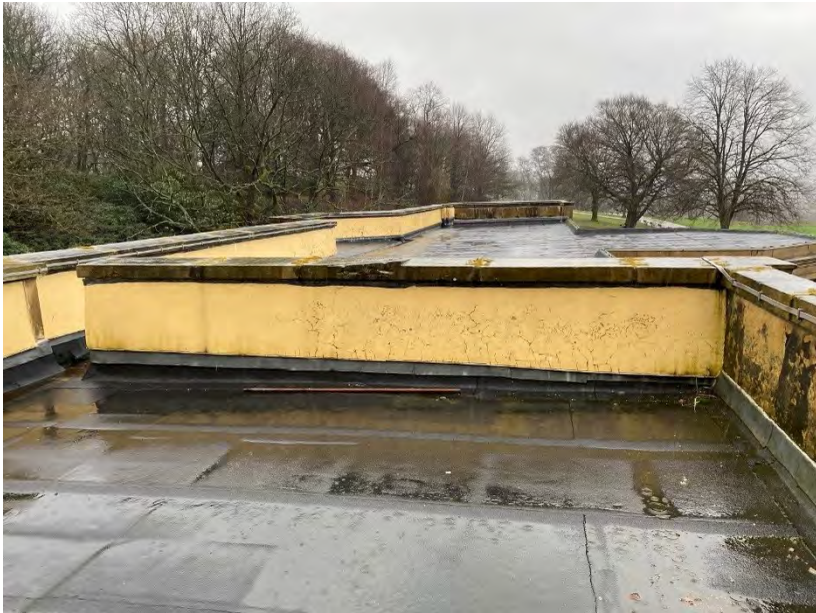
**Fig 9:**

RF-002; showing general view of the main flat roof looking east. The roof was covered with torch-on felt and generally fell to the north. Some minor pooling water was occurring in undulations in the flat roof but this was not a significant problem

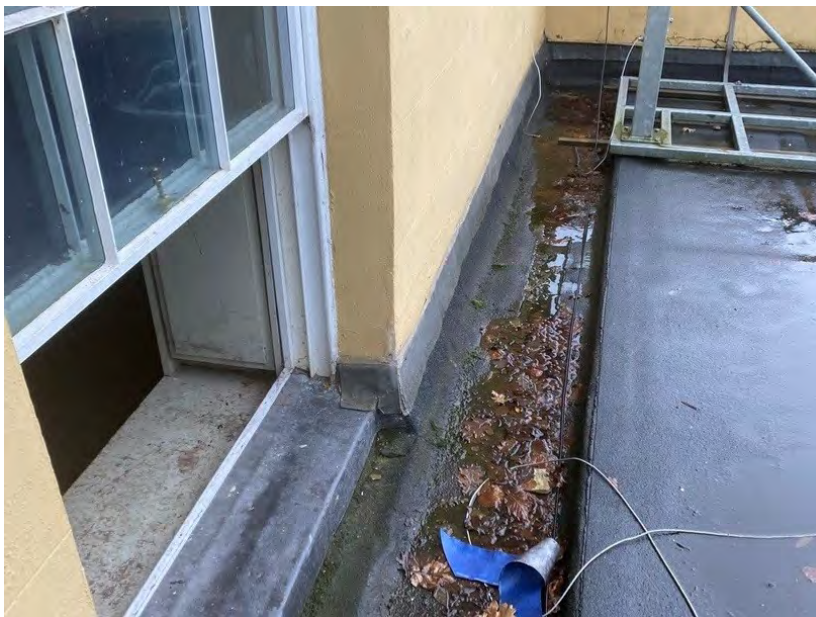
**Fig 10:**

RF-002; showing vegetation and debris caught in the drainage gully

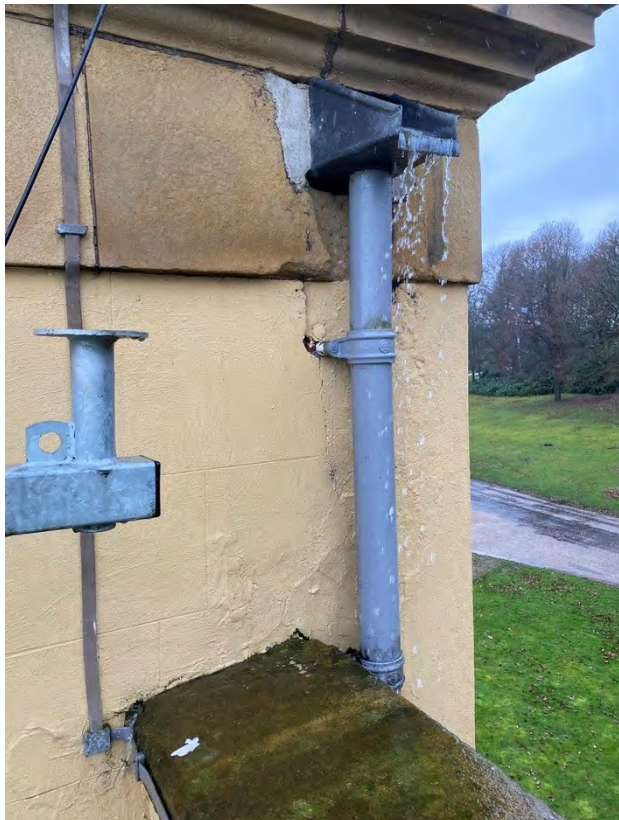
**Fig 11:**

RF-002; showing the rainwater downpipe to the north-east corner of Heaton Hall. The downpipe was blocked and rainwater was discharging via the lead overflow, wetting the masonry below

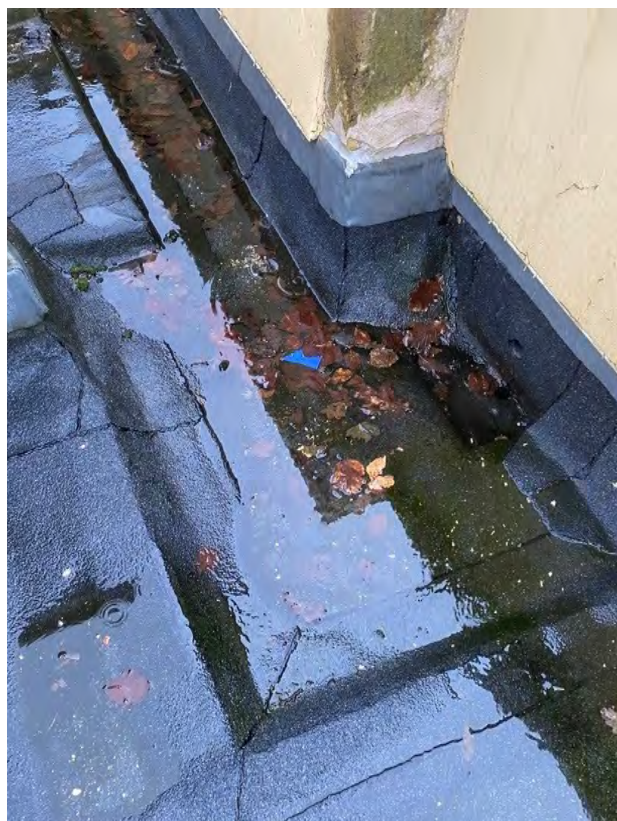
**Fig 14:**

RF-002; showing debris collecting in the drainage gulley and in the catchpit of outlet 1

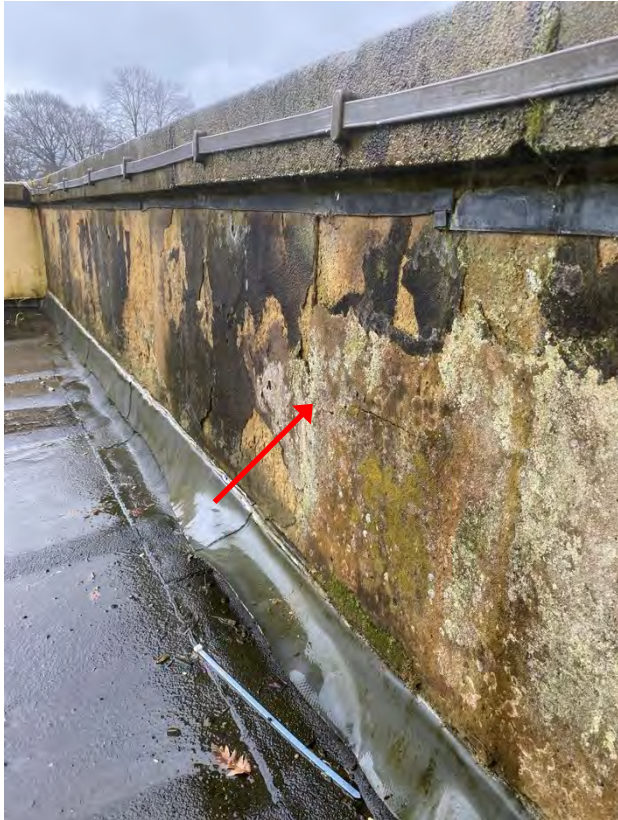
**Fig 15:**

RF-002; showing deterioration of the stone parapet and previous mortar repairs to the stone. The damage appeared to largely predate the re-bedding of the coping stones

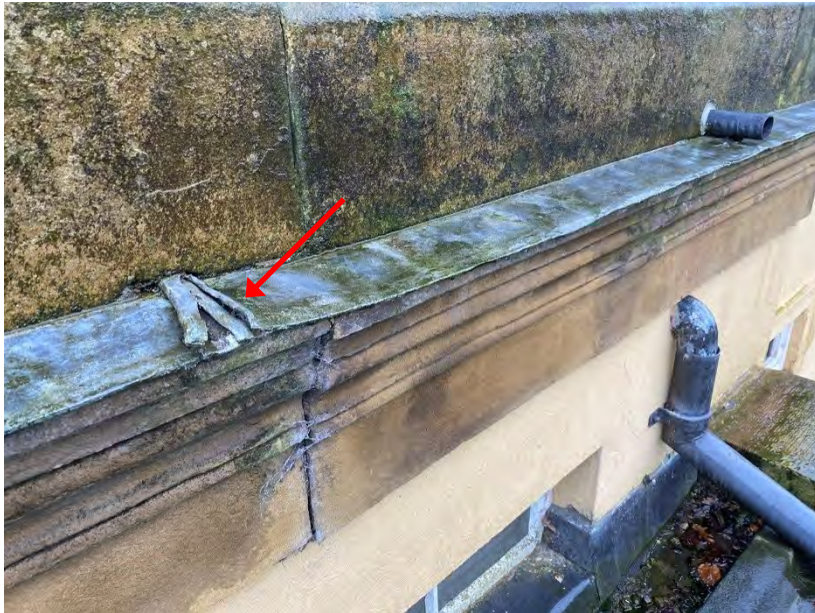
**Fig 27:**

North elevation; showing splitting of the older thicker gauge leadwork capping to the base of the parapet. This increased the risk of water penetration via the mortar joints between abutting string course units

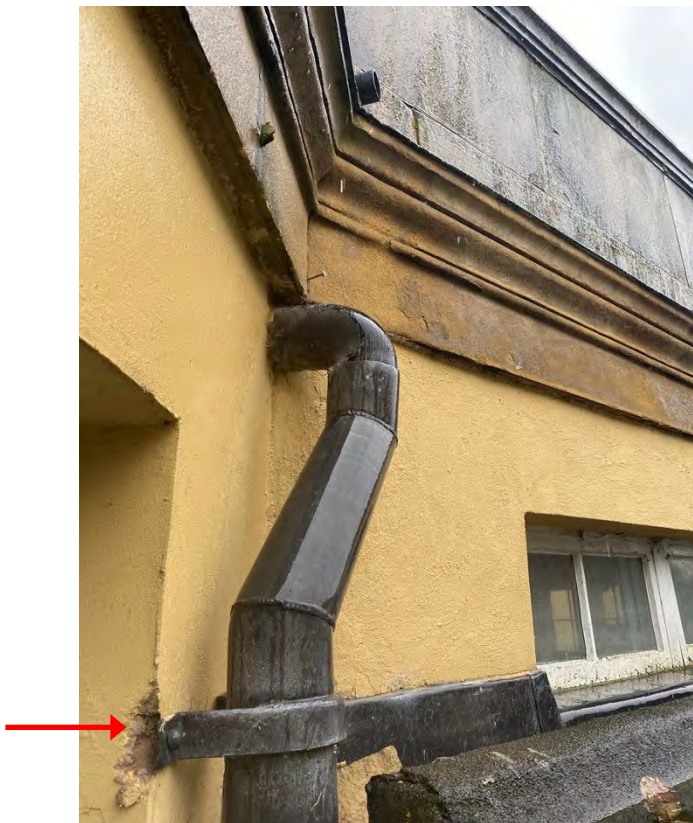
**Fig 31:**

RF-003; showing the downpipe serving outlet 2. The downpipe clip was screwed into the render rather than the masonry, making its connection tenuous

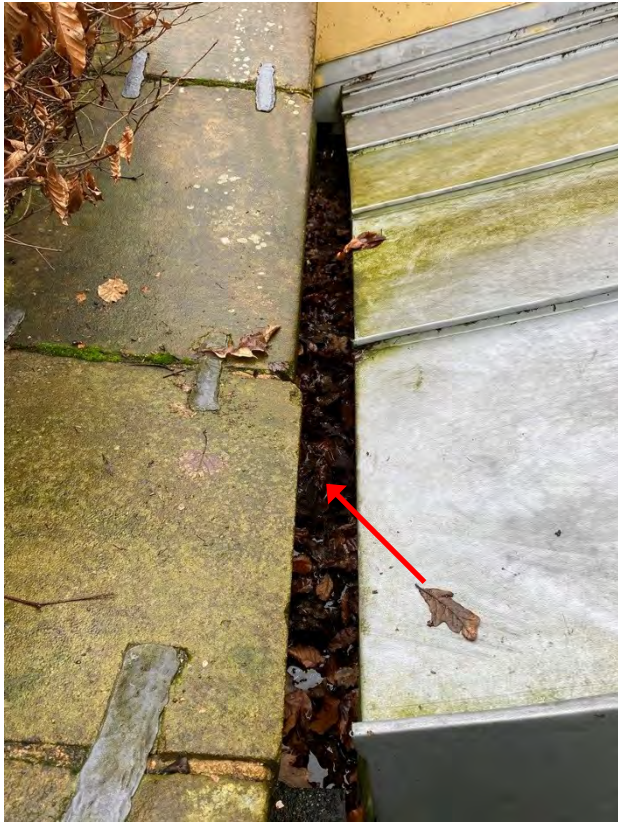
**Fig 35:**

RF-004; showing a build-up of debris within the gutter

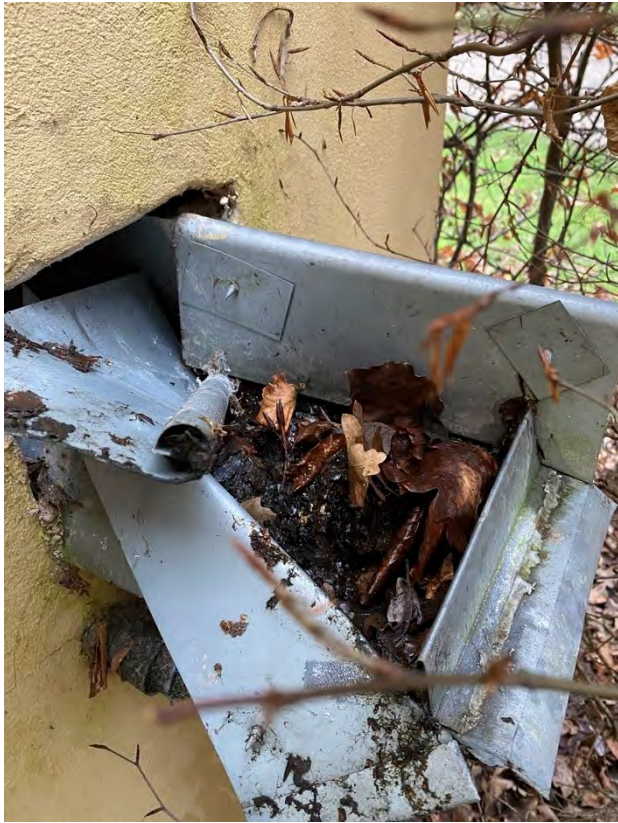
**Fig 37:**

East elevation; showing the damaged hopper and debris build-up

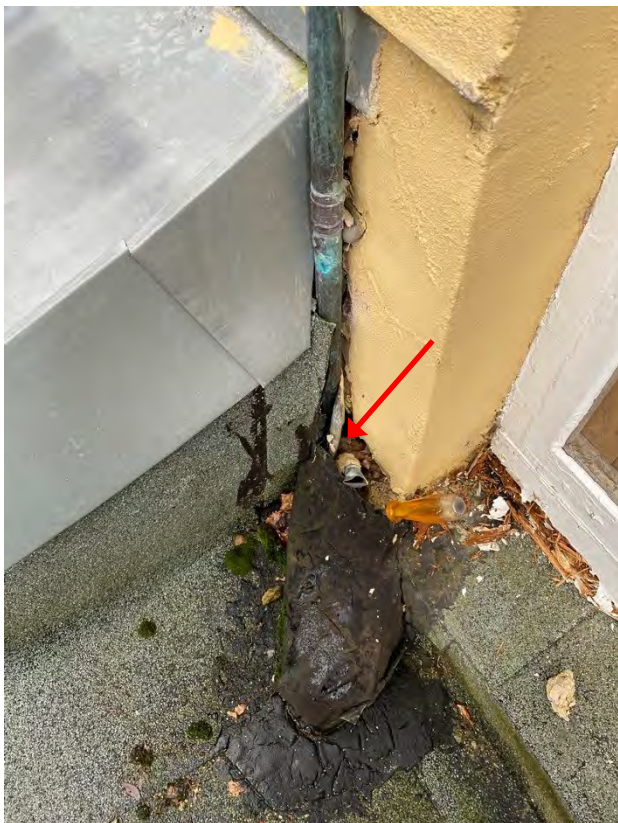
**Fig 39:**

- 1 Roof coverings: The roof covering was of torch-on bitumen felt
- 2 Coverings condition: The re-roofing works had not accounted for an opening for a service pipe penetration in the southeast corner of the flat roof. As a result, there were numerous attempts at waterproofing, using liquid bitumen waterproofing compound and torch-on bitumen patches. There was also splitting in the east felt upstand beneath the verge capping to RF-004. Both of these defects were allowing water penetration
- 3 Roof drainage: Roof was drained by a plastic eaves gutter to the west, served by plastic downpipe 5, discharging directly onto the ground
- 4 Drainage condition: No evidence of significant issue

RF-005; showing a copper water pipe penetration through the flat roof. The recent re-roofing had not accounted for this detail and liquid asphalt had been applied for waterproofing. This was ineffective and water penetration was ongoing

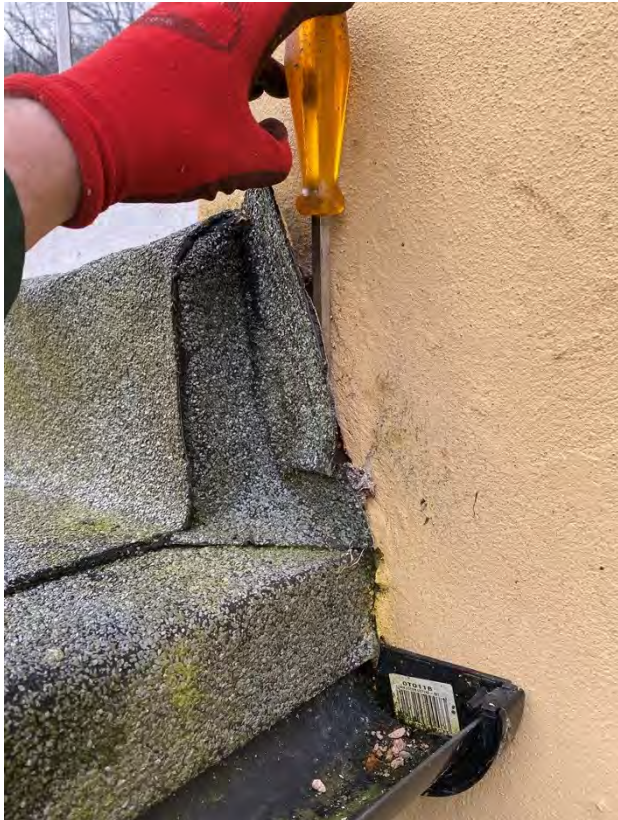
**Fig 41:**

RF-005; showing poor detailing of the felt upstand at the abutment to the north elevation of the main building. This was vulnerable to water penetration

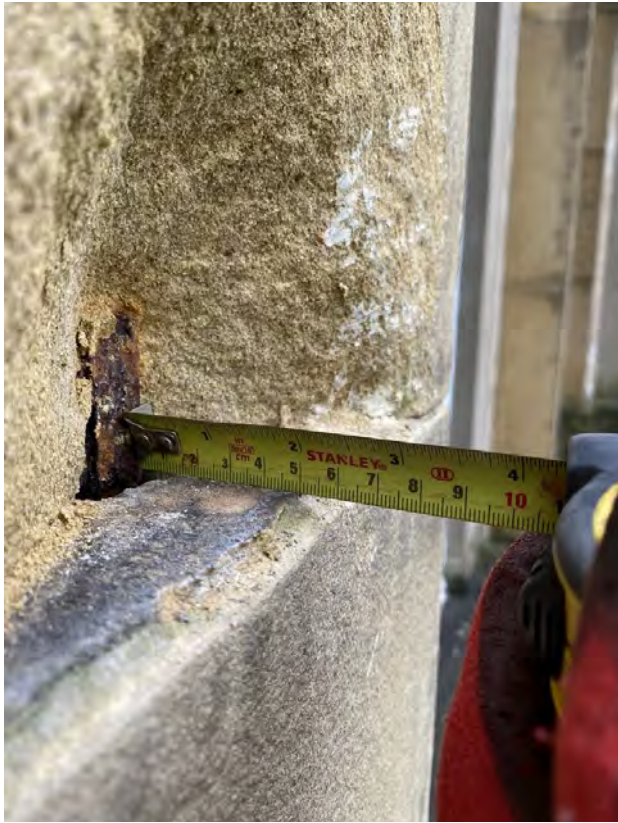
**Fig 59:**

South elevation; showing approximately 60mm stone cover to the dowel

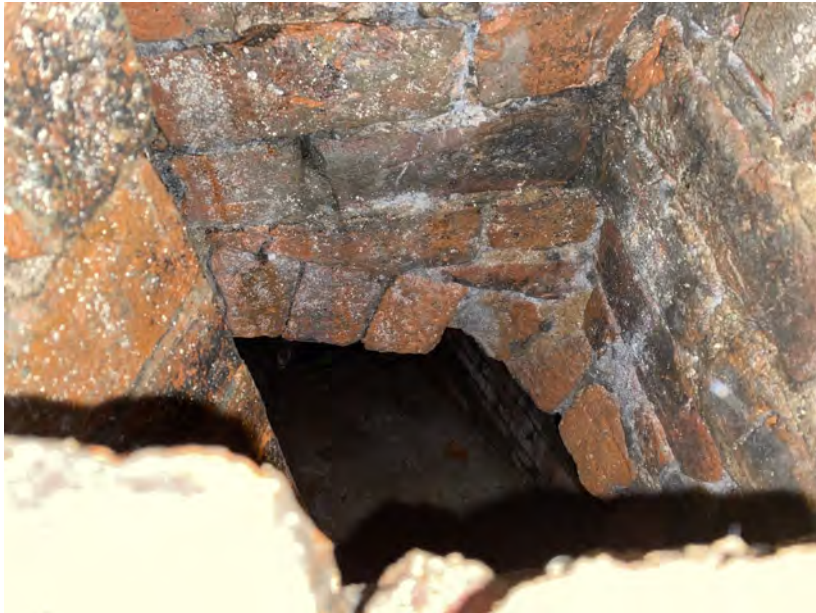
**Fig 65:**

South elevation; showing a view of the brick culvert system. Detailed construction, condition and extents are unknown

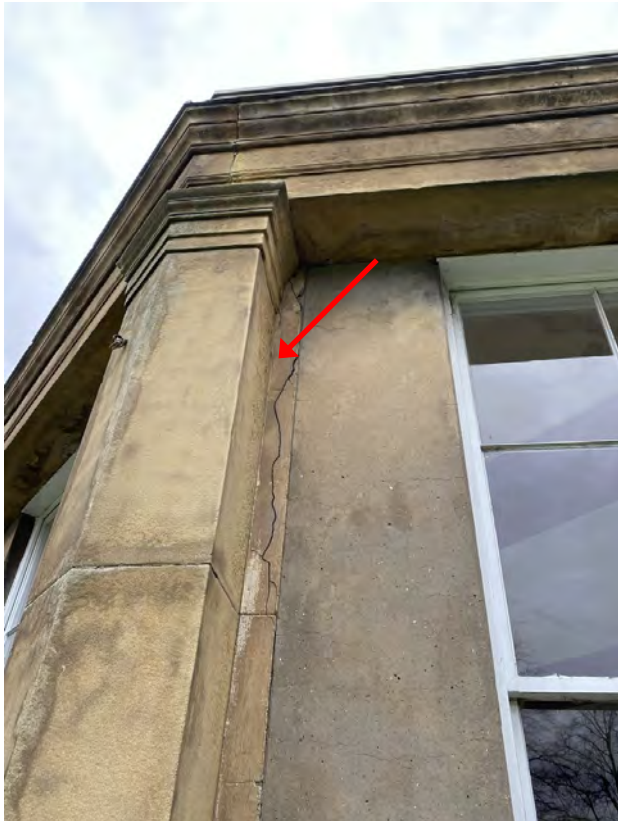
**Fig 67:**

South elevation; showing cracking and debonding of the render

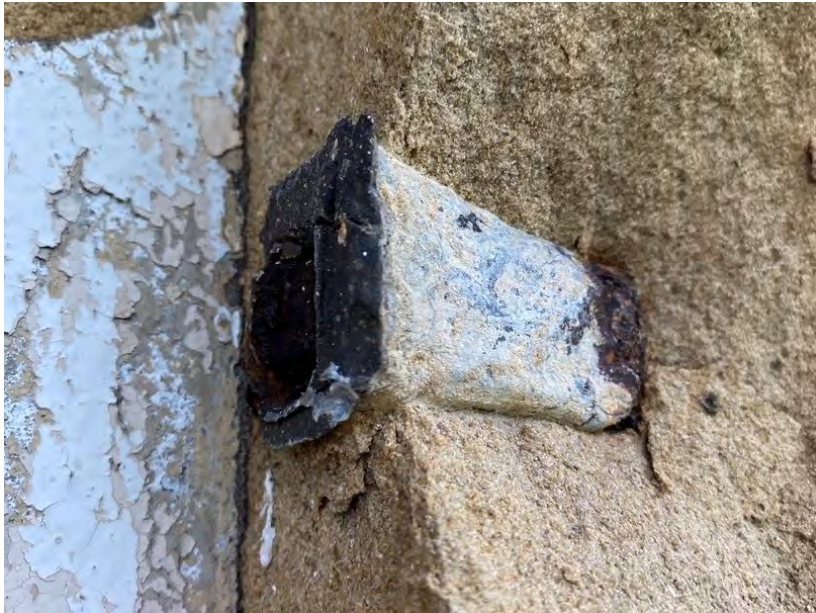
**Fig 71:**

East colonnade; showing corroded, disused door fixing. Sandstone surrounding is degraded

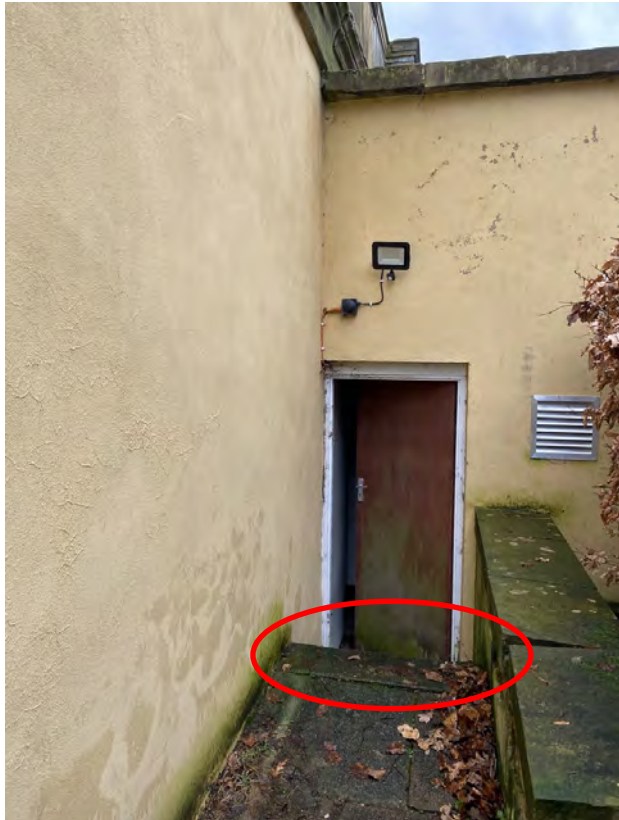
**Fig 75:**

East elevation of Northeast extension; showing rear entrance. This door was decayed at the base of its casing, due to collected debris and inadequate drainage

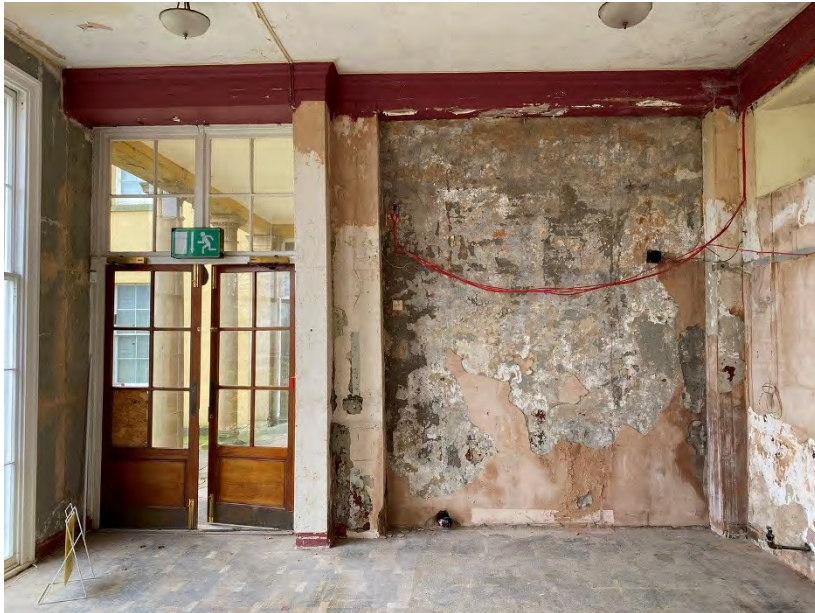
**Fig 79:**

Main gallery; showing previous phases of replastering using gypsum. The gypsum and earlier lime plaster was debonding

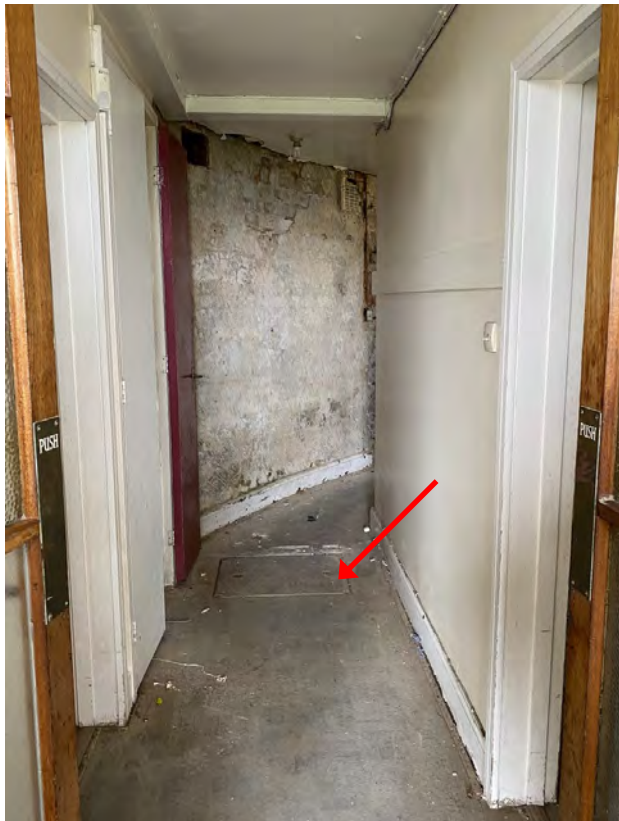
**Fig 81:**

Northwest extension; showing an internal manhole cover that could not be raised during the survey. Ceramic floor coverings had suffered mechanical damage in this area

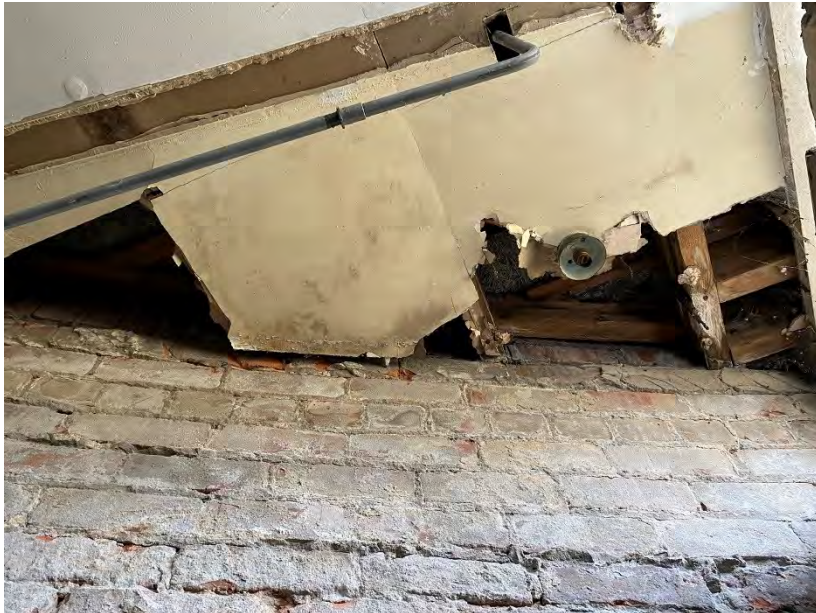
**Fig 85:**

Northwest extension; showing timber roofs joists and wood wool boards. The roof was largely concealed by the plasterboard ceiling but there was a significant risk of timber decay in the bearing ends of the joists

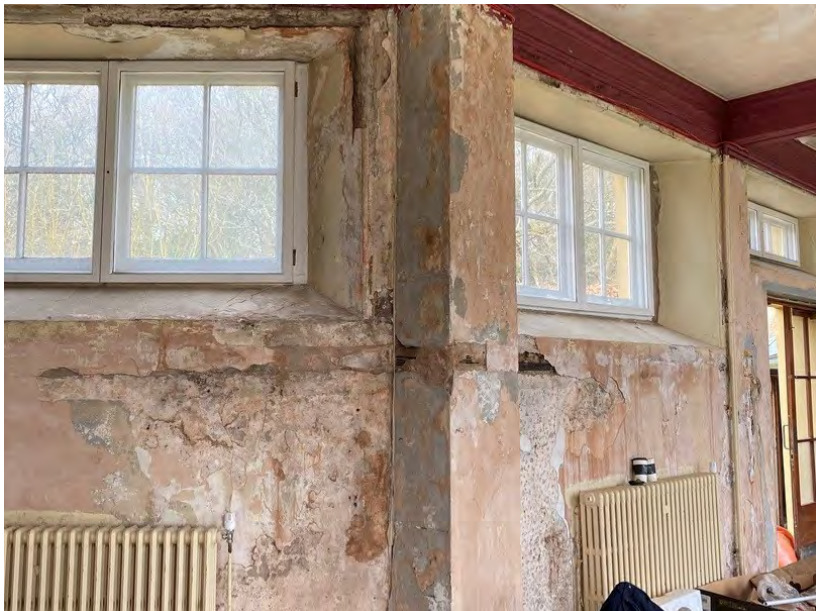
**Fig 89:**

Main gallery; showing poor decorative finishes directly beneath the overloaded rainwater outlet 4. Park staff confirmed this area had recently been subject to water penetration due to blockage in the outlet. Replastering in this area also indicates a history of failure. Masonry moisture contents in this area were high

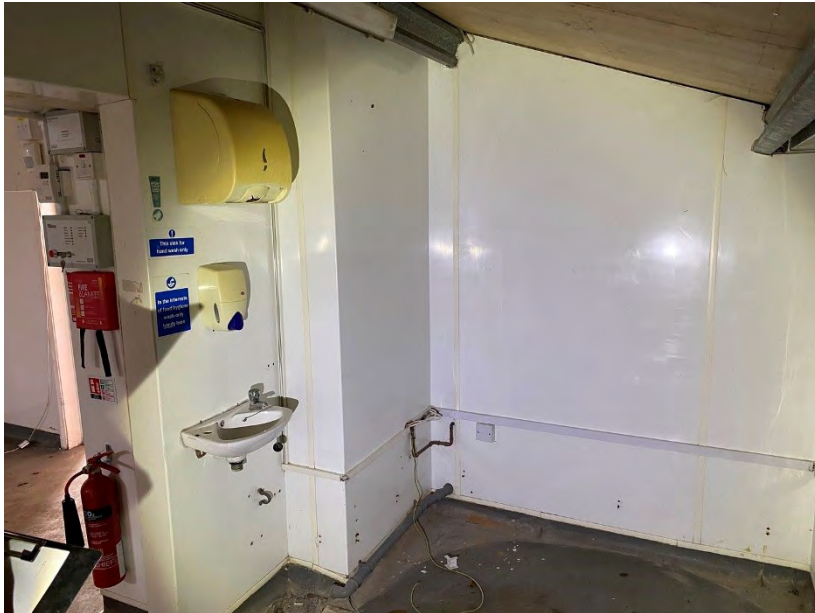
**Fig 93:**

Northeast extension; showing plastic wall coverings which prevented access for masonry moisture profiling. The lower portion of these walls were earth-retaining and should be assumed to be wet
