**SIM - Sitewide Capital Works**

**Stage 3 Structural Report – Viaduct Repair Planning Submission**

**SIM-BHE-XX-XX-RP-S-0101**

Revision P02

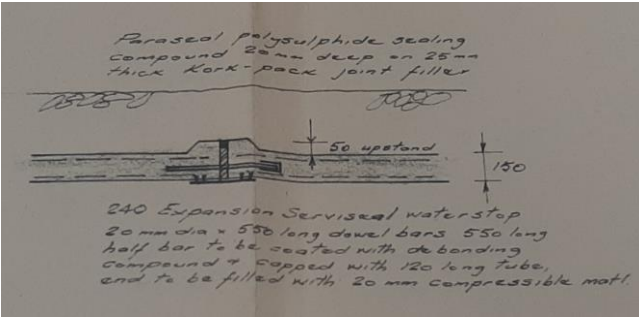
Figure 2-4 Section through expansion joint

At track level, the original build-up has been capped with a new concrete slab and drainage channels to the north and south, which were constructed in the 1980s. This slab includes extensive expansive and construction joints, the failure of which may be a cause of water ingress. The details for slab and channels appear to be well-documented, and a selection of details are included below.

- Reinstating expansion and construction joint mastic. All joints to be cleaned out to full depth and new waterproof structural mastic to be injected. Expansion joints are assumed to be full slab depth (150mm) and construction joints 30mm deep. Extent is to be confirmed at later design stages but archive drawings indicate 3 no. expansion joints which run N-S across track area, and a series of construction joints (which also require shallow mastic) at c. 10x10m centres. Based on this a suggested allowance of 450m of mastic should be allowed for.

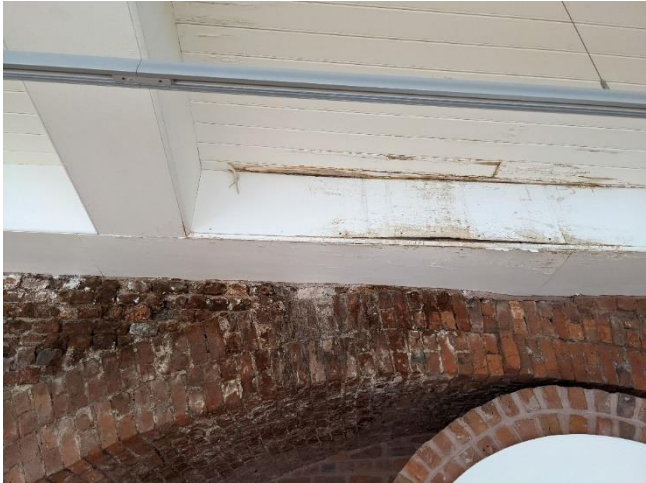
- It is apparent that the crown of arch 4A at the southern face has dropped by a small amount. As there is no evidence of cracking or progressive movement it is likely that this movement occurred in the past, likely due to mortar loss as this area appears to have suffered from significant historic water ingress. This is not judged to pose a structural concern at present. See Figure 2-6.

Figure 2-6 Flattening of crown of arch 4A

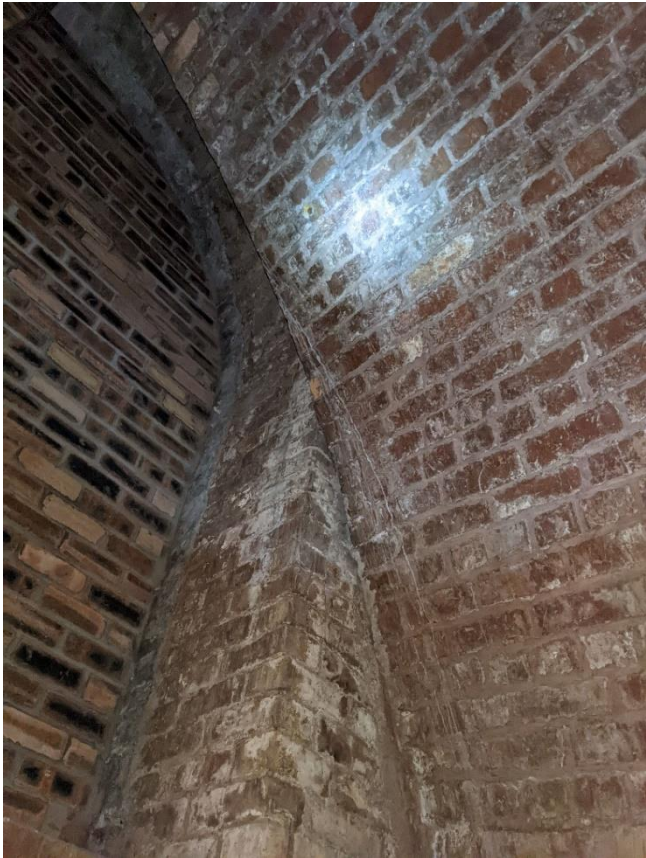
Figure 2-7 Typical condition of viaduct arches

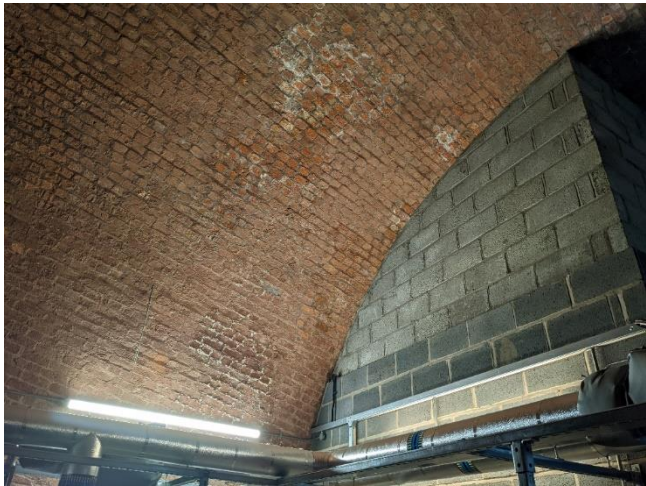
Figure 2-8 Typical condition of viaduct arches

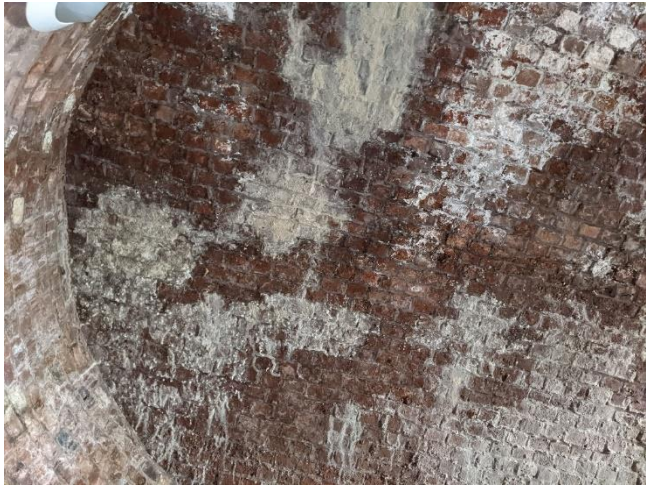
Figure 2-9 Staining due to extensive water ingress – arch 3A

- Minor re-pointing to be carried out to all arches where not previously carried out. This primarily applies to arches 1A, 2B, 3A.
- Several elements of work are required at track level to improve drainage and waterproofing. Reference should be made to the architectural proposals for these works to avoid duplication, but structural aspects are addressed below:

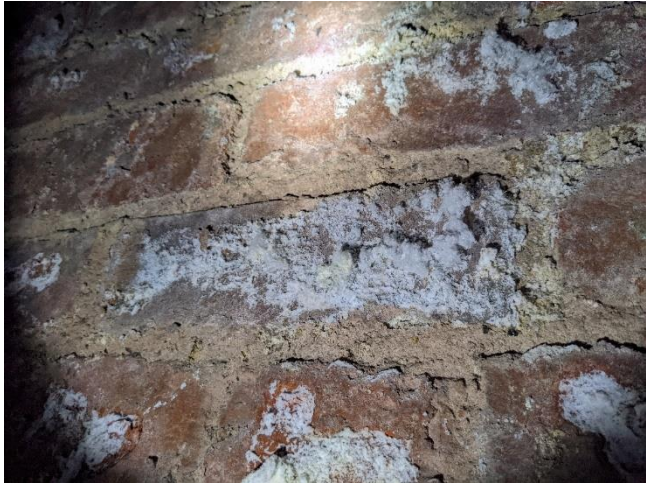
Figure 2-10 Efflorescence to face of masonry – arch 5B

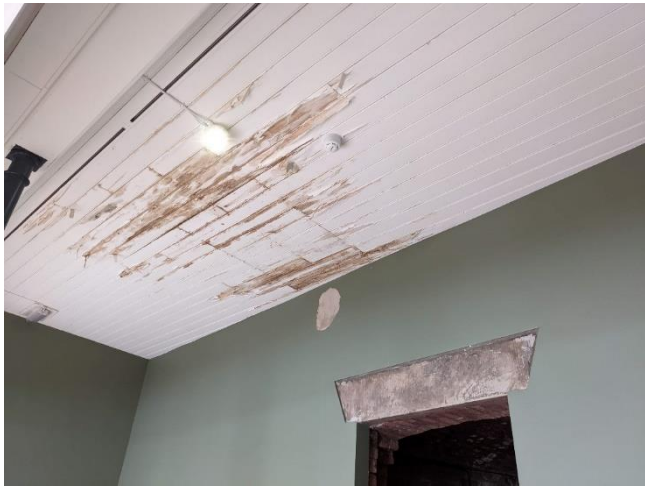
Figure 2-11 Water damage to ceilings in Station Building

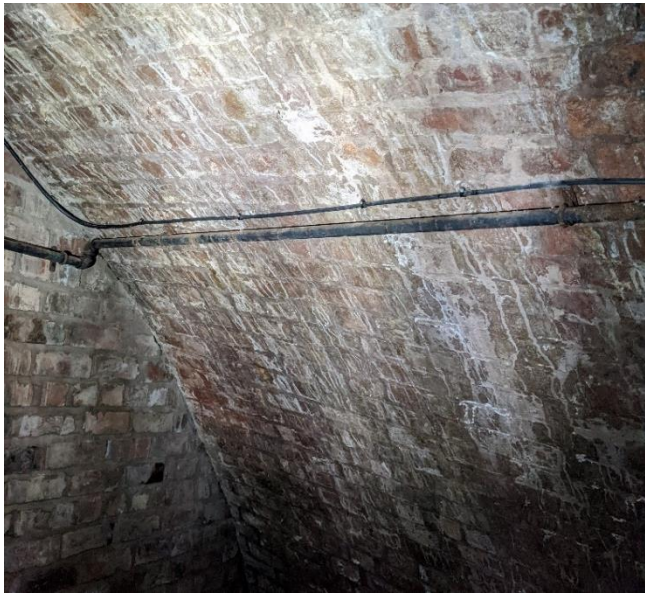
Figure 2-12 Staining due to water ingress – arch 5B

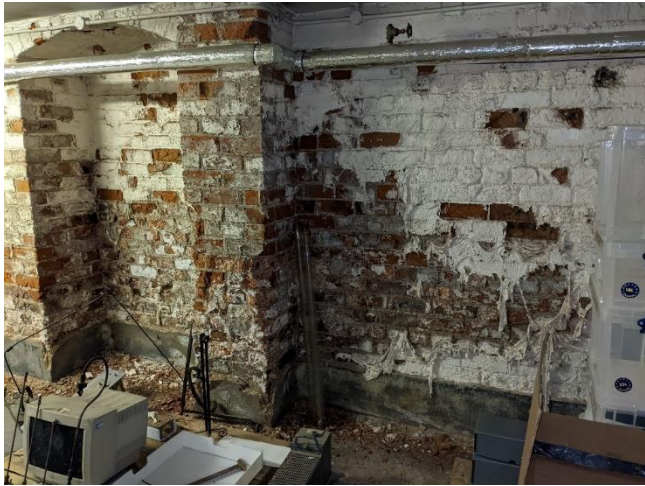
condensation, with fairly severe degradation of masonry noted in several areas. However, this appears to be due to penetrating low level damp rather than from water ingress through the arches, and as such is unlikely to be remedied by the works proposed as part of this scheme at present. This should be addressed in further design stages. See Figure 2-13 and Figure 2-14.

Figure 2-13 Station Bldg basement – masonry degradation due to moisture ingress

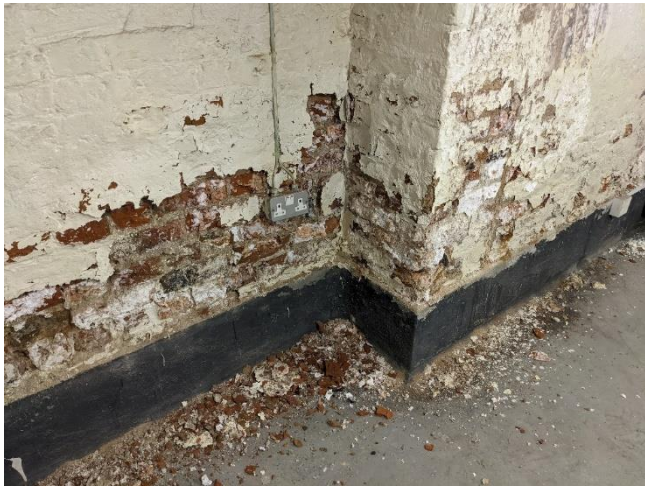
Figure 2-14 Station Bldg basement – masonry degradation due to moisture ingress
