# Bennett Street Manchester

## Road Safety Audit Stage 1/2 Report

| <b>Document reference and revision:</b> | BSMS38S278/KH/1-2/0 |

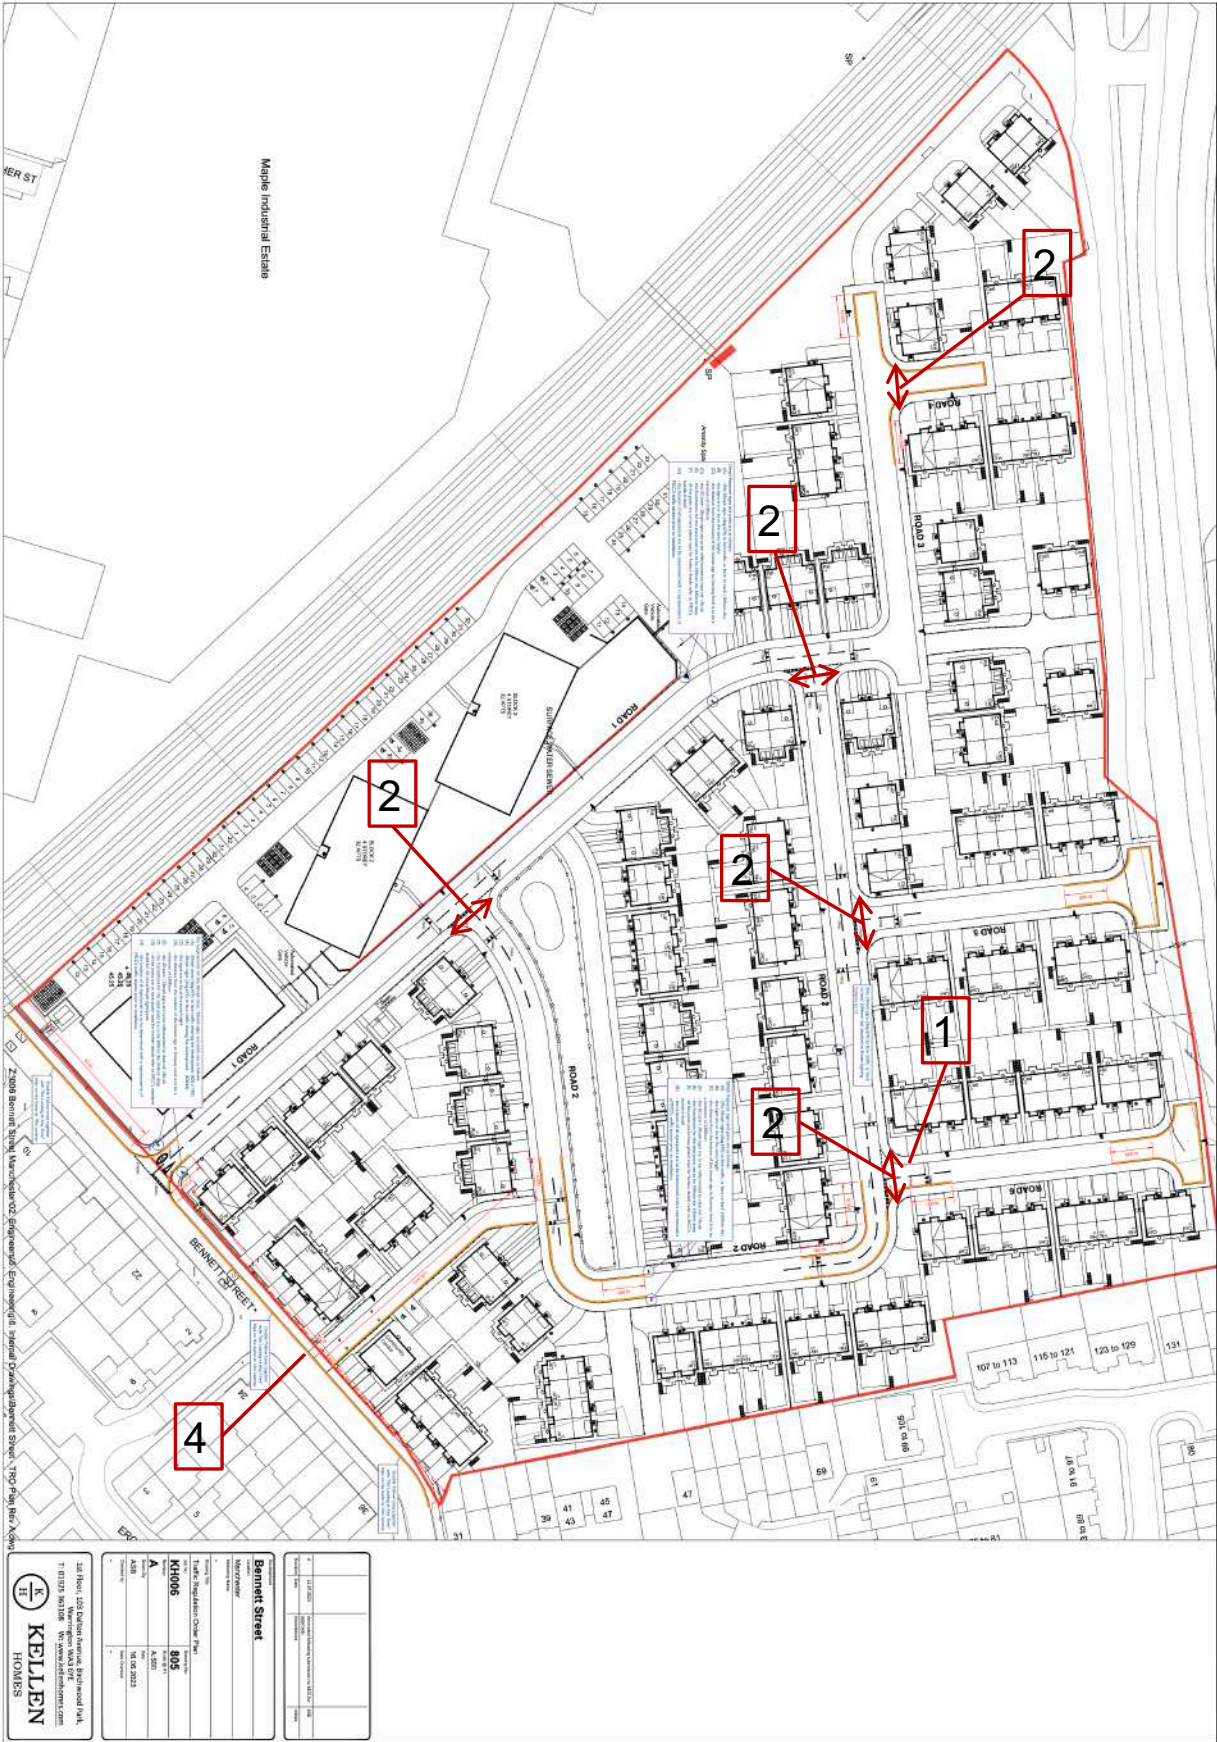
7.0 Problem location plan (problem no.3 not shown)

**Summary:** Lack of waiting restrictions could encourage obstructive parking

Waiting restrictions are proposed on the eastern side of the junction between Road 2 and Road 6. However, waiting restrictions aren't proposed for the western side of the junction. Providing restrictions on one side of the junction could increase the likelihood of vehicles, parking on the unrestricted side of the junction. This could restrict visibility for vehicles emerging from the junction and pedestrians crossing the junction increasing the risk of collisions.

**Summary:** Lack of pedestrian crossing points

Most of the priority junctions within the development incorporate raised tables. None of the junctions appear to incorporate pedestrian crossing points. There is a risk that pedestrians, particularly those with pushchairs or wheelchairs could have difficulty negotiating kerbs that aren't flush which increases exposure to passing traffic and likelihood of collisions.

**Summary:** Dropped kerb could be a hazard to visually impaired pedestrians

There is a footway that runs parallel to the emergency access. The development footway links with the footway on Bennett Street at a point where the kerb, on Bennett Street is dropped. There is a risk that visually impaired pedestrians walking along the development footway could unknowingly step out into the carriageway on Bennett Street due to the low kerb height, increasing the likelihood of collisions with passing traffic.

Waiting restrictions should be provided on the eastern side of the junction on both Road 2 and Road 6 with similar extents to those proposed for the eastern side of the junction.

Pedestrian crossing points should be provided at all junctions including dropped kerbs and appropriate tactile paving.

### RECOMMENDATION

The kerb on Bennett St directly opposite the end of the footway should be raised. As the access is for emergency use only there could be benefit in installing a battered kerb rather than a dropped kerb across the access.
