| <b>Project Name</b> | 37 Cross Street Fire Remedial Works | <b>Notes:</b><br><i>The items below are based on the following documents:</i><br><i>Fire Compartmentation Risk Assessment report, Apartments 201-404 undertaken by 4Site Consulting Limited dated 22.06.21.</i><br><i>Fire Compartmentation Risk Assessment report, Apartments 201-404 undertaken by 4Site Consulting Limited dated 19.08.22.</i><br><u>JBH Property Consulting accept no responsibility in terms of identifying the breaches of fire compartmentation.</u> |
| <b>Address</b> | 37 Cross Street, Manchester, M2 4JE | |
| <b>Client</b> | 37 Cross Street Management Company | |

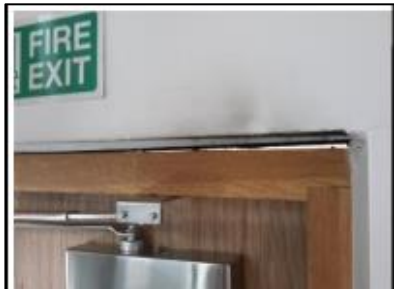
| Item Number | Location | Risk Type | Description | Photo | Works Required |
|---|---|---|---|---|---|
| 1 | 2nd floor stairwell / fire lobby fire doors | FBS03a | Breach in horizontal compartmentation around door frame with insufficient fire stopping installed.<br><br>Potential for fire, heat and smoke to bypass fire door and spread through the property. | | Replace door and frame with fire door and compliant ironmongery |

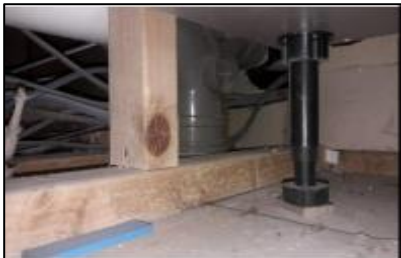
| Item Number | Location | Risk Type | Description | Photo | Works Required |
|---|---|---|---|---|---|
| 2 | Flat 403 | FBS03a | Breach in vertical compartmentation with no fire stopping collar installed around plastic pipework.<br><br>Potential for fire, heat and smoke to spread through the property | | Install new fire collar to soil stack and waste pipe |

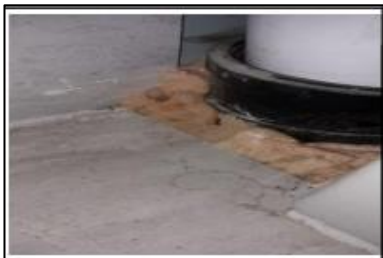
| Item Number | Location | Risk Type | Description | Photo | Works Required |
|---|---|---|---|---|---|
| 3 | Flat 302 Toilet | FBS03a | Breach in compartmentation with insufficient fire stopping installed around soil stack.<br><br>Potential for fire, heat and smoke to spread through the property. | | Remove rockwool and install fire batt and fire collar |

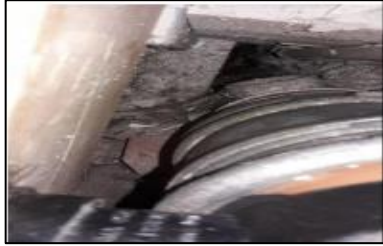
| 6 | Internal stairwell soil stacks leading into brick column from units 202, 203, 302, 303, 402 & 403 | FBS03a | <p>Breach in compartmentation with no fire stopping collars installed.</p> <p>Potential for fire, heat and smoke to spread through the property</p> | | Supply and install fire batt, intumescent caulk and install 110mm fire collars |

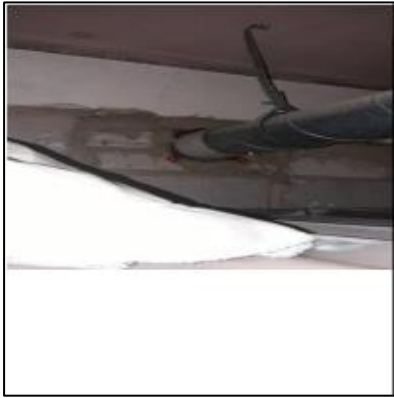
| 7 | Air extract systems | FBS03a | <p>Breach in compartmentation with insufficient fire stopping installed around fire collars. Given the evidence of smoke spread to many of the flats, its likely that the sealant installed around air extract systems is not suitable. The temperature of the smoke was not sufficient to activate the fire collars and so its likely that smoke spread around the collars themselves.</p> <p>Potential for fire, heat and smoke to spread through the property.</p> | | Remove old fire stopping materials, install new 300mm x 300mm fire batt. Intumescent caulk and install 110mm fire collars (allowance for 5nr) |

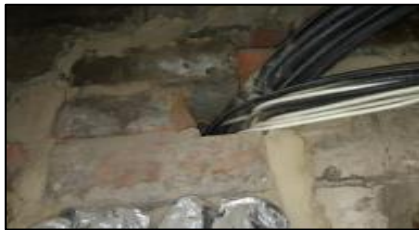
| 10 | 3rd - 4th floor stairwell riser cupboard | FBS03a | <p>Breach in horizontal compartmentation with no, or insufficient fire stopping installed.</p> <p>Potential for fire, heat and smoke to spread through the property.</p> | | Infill with fire batt and intumescent caulk 2nr 300mm x 300mm |

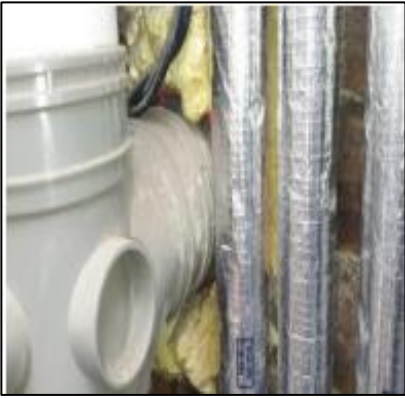
| 11 | 3rd - 4th floor stairwell riser cupboard | FBS03a | <p>Breach in horizontal compartmentation with insufficient fire stopping installed. Fire collar wont work as intended as not suitable fixed to the wall. Non fire rated yellow expansion insulation foam has been used rather than a more suitable fire stopping material.</p> <p>Potential for fire, heat and smoke to spread through the property.</p> | | Remove yellow foam, replace with fire foam and pasted with intumescent caulk. Box in pipework floor to ceiling with two layers of fire boards taped and jointed. Install fire collars to the base ad top of walls. (assumed 2500mm high) |

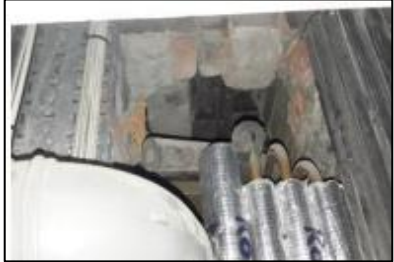
| 12 | 1st - 2nd floor stairwell riser | FBS03a | <p>Breach in horizontal compartmentation with no fire stopping installed.</p> <p>Potential for fire, heat and smoke to spread through the property.</p> | | Supply and install fire batt, intumescent caulk and install 110mm fire collars. |

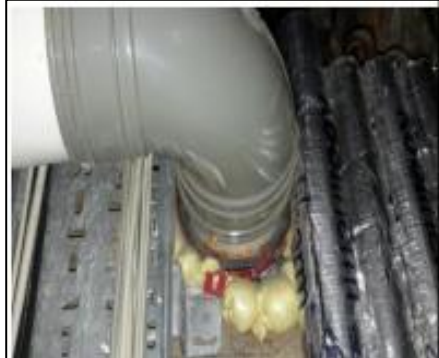
| 13 | Hazard Location 1st - 2nd floor stairwell riser | FBS03a | <p>Breach in horizontal compartmentation with insufficient fire stopping installed. Fire collar wont work as intended as not suitable fixed to the wall. Non fire rated yellow expansion insulation foam has been used rather than a more suitable fire stopping material.</p> <p>Potential for fire, heat and smoke to spread through the property.</p> | | Supply and install fire batt and intumescent caulk and fit collar. Full Remedy TBC. P.S. |

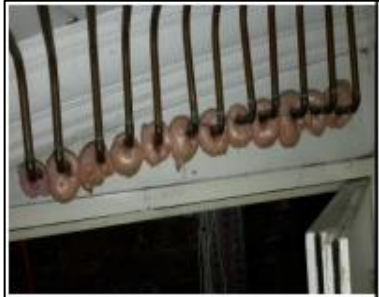
| 14 | Basement | FBS03a | <p>Breach in horizontal and vertical compartmentation with insufficient fire stopping installed.</p> <p>Potential for fire, heat and smoke to spread through the property.</p> | | Remove fire foam and install fire batt, all areas pasted and caulked. |

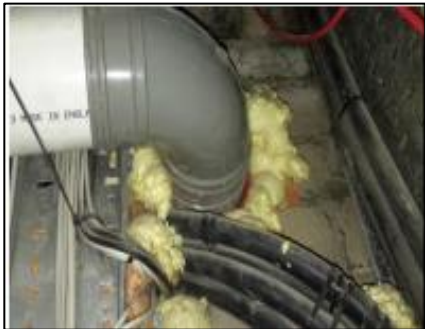
| 15 | 2nd - 3rd floor stairwell riser | FBS03a | <p>Breach in horizontal compartmentation with insufficient fire stopping installed. Fire collar wont work as intended as not suitable fixed to the wall. Non fire rated yellow expansion insulation foam has been used rather than a more suitable fire stopping material.</p> <p>Potential for fire, heat and smoke to spread through the property.</p> | | Sufficiently fire stop area. Full Remedy TBC. P.S. |

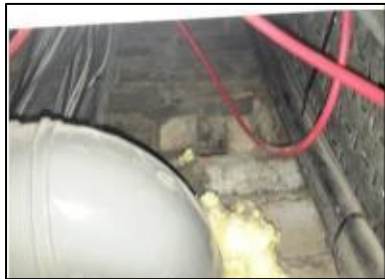
| 16 | 2nd - 3rd floor stairwell riser | FBS03a | <p>Breach in horizontal compartmentation with no fire stopping installed.</p> <p>Potential for fire, heat and smoke to spread through the property</p> | | Sufficiently fire stop area. Full Remedy TBC. P.S. |

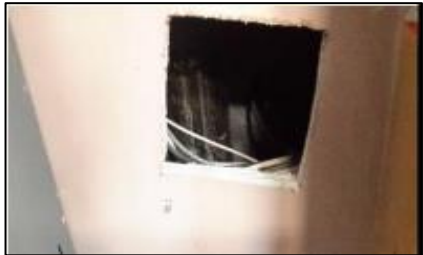
| 17 | Grnd floor electrical cupboard | FBS03a | <p>Breach in horizontal compartmentation with no fire stopping installed and damaged plasterboard.</p> <p>Potential for fire, heat and smoke to spread through the property.</p> | | Infill plasterboard and clad over with fire board complete with tape and joint |

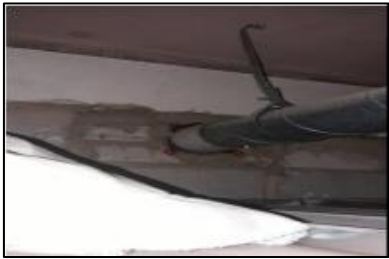
| 18 | Flat 302, air extract system in bathroom ceiling void | FBS03a | <p>Future breach in horizontal compartmentation as a result of the poorly installed fire collar.</p> <p>Potential for fire, heat and smoke to spread through the property</p> | | Remove fire collar, install fire batt and intumescent caulk, refix exiting fire collar |

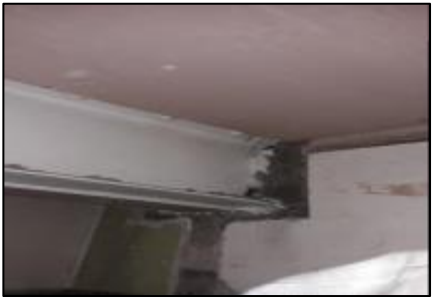
| 19 | Flat 302 above bathroom ceiling void | FBS03a | <p>Breach in compartmentation around steel frame no fire stopping installed.</p> <p>Potential for fire, heat and smoke to spread through the property.</p> | | Infill void with fire batt, clad steel beam with two layers of plaster board, all joint to be taped |

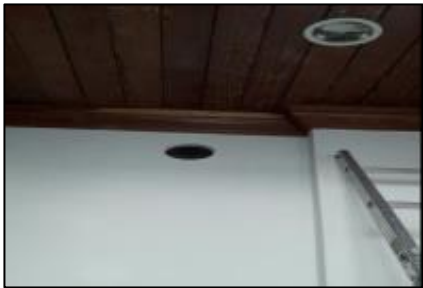
| 20 | 3rd floor stairwell | FBS03a | <p>Inconsistent levels of fire plasterboard.</p> <p>Potential for fire, heat and smoke to spread through the property.</p> | | Remove plasterboards and install new to give a FD30 fire rating. P.S. |

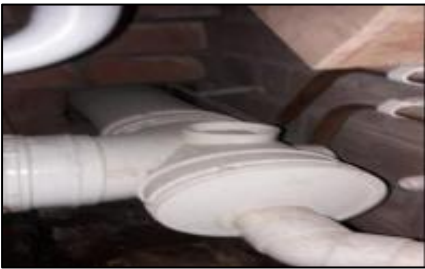
| 21 | Flat 301, waste pipes within bathroom suite | FBS03a | <p>Breach in compartmentation where waste pipes enter through compartmentation wall with no fire stopping installed.</p> <p>Potential for fire, heat and smoke to spread through the property.</p> | | Infill void with fire batt, and intumescent caulk 300mm x 300mm and install a new 110mm fire collar. |

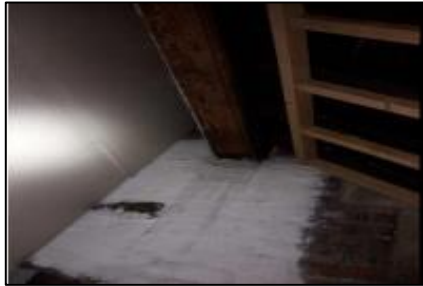
| 22 | Ceiling void above unit 402 | FBS03a | <p>Breach in compartmentation with no fire stopping installed.</p> <p>Potential for fire, heat and smoke to spread through the property.</p> | | Clad over existing timbers with two layers of Fireline plaster boards, intumescent caulk joints and perimeter of wall |

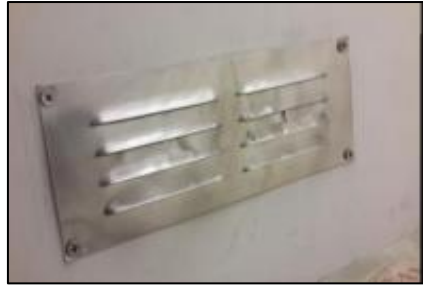
| 23 | Lift motor room | FD02b | <p>Fire door has a vent installed that does not include an intumescent air transfer grille.</p> <p>Potential for fire and smoke to spread through property</p> | | Replace vent with an intumescent block and door vents |

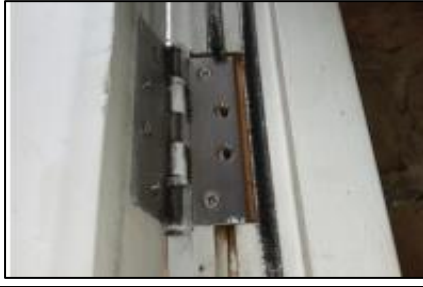
| 24 | 3rd - 4th floor stairwell riser cupboard | FD04 | <p>Fire door will not perform correctly in the event of a fire as a result of missing screws from hinges.</p> <p>Potential for fire and smoke to spread through property</p> | | Remove and replace 2no. fire doors with compliant ironmongery, decorated on completion |

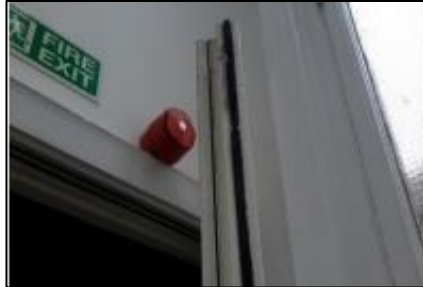
| 25 | 3rd - 4th floor riser cupboard | FD06 | <p>Cold smoke seal/intumescent strip damaged.</p> <p>Potential for fire &amp; smoke to spread through property.</p> | | Remove and replace intumescent fire strips |

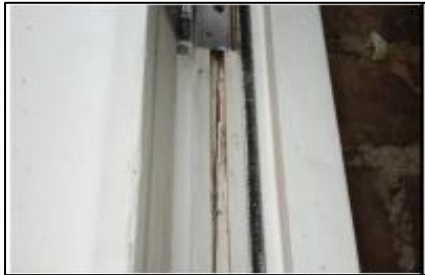
| 26 | 3rd - 4th floor stairwell riser cupboard | FD06 | <p>Cold smoke seal/intumescent strip missing.</p> <p>Potential for fire &amp; smoke to spread through property.</p> | | Remove and replace intumescent fire strips |

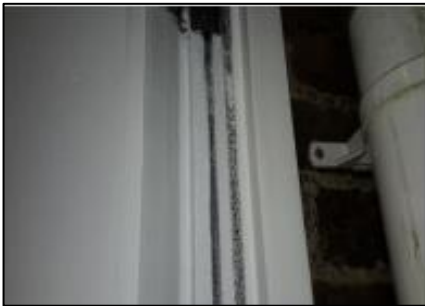
| 27 | 1st - 2nd, 2nd - 3rd floor stairwell riser cupboard | FD06 | <p>Cold smoke seal damaged as a result of it being painted over.</p> <p>Potential for fire &amp; smoke to spread through property</p> | | Remove and replace intumescent fire strips |

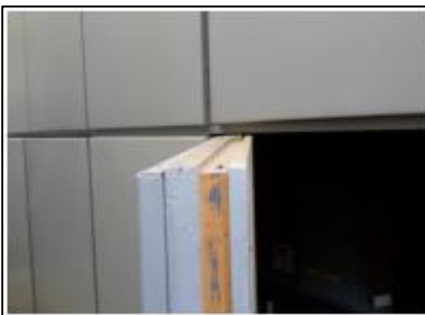
| 28 | Grnd floor electrical cupboard | FD06 | <p>Cold smoke seal/intumescent strip missing.</p> <p>Potential for fire &amp; smoke to spread through property.</p> | | Remove and replace intumescent fire strips |

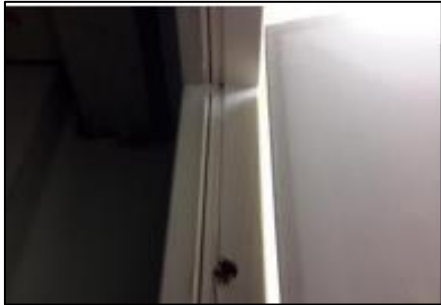
| 29 | Lift motor room | FD06 | <p>No cold smoke seal/intumescent strip installed.</p> <p>Potential for fire &amp; smoke to spread through property.</p> | | Remove and replace intumescent fire strips |

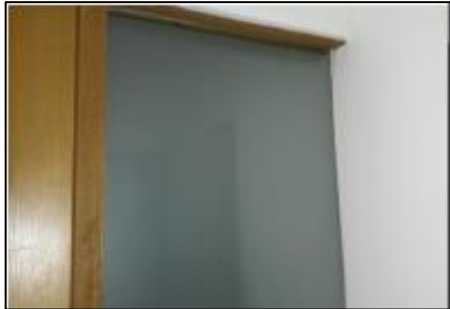
| 30 | Glazing adjacent to tenants demise main entry door - Flat 401 | FD17a | <p>The glazing in and adjacent to the tenant's demise main entry door does not appear to meet the required half hour standard of fire resistance. The glazing offers no safety markings affixed to the glass.</p> <p>Potential for fire and smoke to spread onto the open-air landing, preventing the safe escape of persons from neighbouring flats due to there being only one escape route.</p> | | Remove glazing and supply and install Pyro Door glass ( FD30 ) (assumed 2M2) |

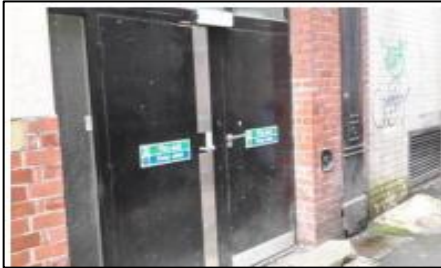
| 31 | Side access door | No Access | <p>The advisor was unable to gain access to this area.</p> <p>Potential for hazards to exist undetected, remain unmanaged and subsequently, cause injury and/or present a fire hazard.</p> | | P.S. for items found inside. |

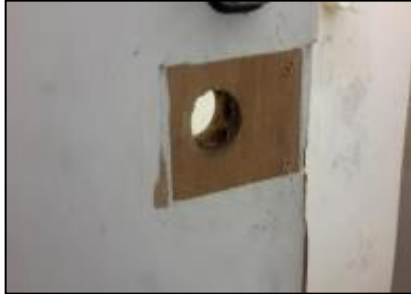
| 32 | Lift motor room | FD02 | <p>Door is not to the minimum half hour standard of fire resistance.</p> <p>Potential for fire to spread throughout premises.</p> | | Remove and replace the FD30 fire door, decorated on completion |

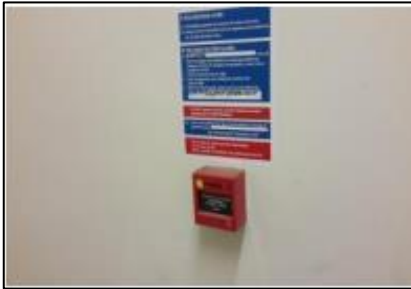
| 33 | Basement | FMCP06 | <p>No protective covers fitted over the manual call points.</p> <p>Potential for accidental/malicious actuation of the fire alarm system, leading to an increase in false alarm calls to the local fire authority</p> | | TBC on how to proceed with this item. P.S. |

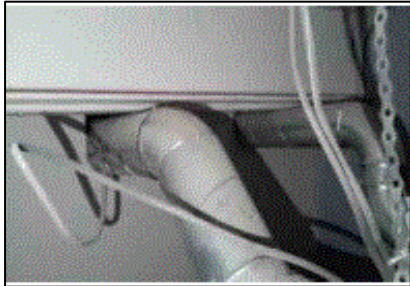
| 34 | Above false ceiling & toilet in flat 201 | FBS03a | <p>Breach in compartmentation with insufficient fire stopping installed. (Flat 201 is currently undergoing a refurbishment, so current breaches should be undertaking as the works progress).</p> <p>Potential for fire, heat and smoke to spread through the property.</p> | | Install fire batt and fire collar |

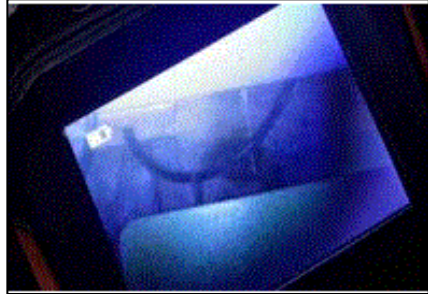
| 35 | Rear of kitchen in flat 401 | FBS03a (1) | <p>Breach in compartmentation with insufficient fire stopping installed behind kitchen units.</p> <p>Potential for fire, heat and smoke to spread through the property.</p> | | Install fire batt |

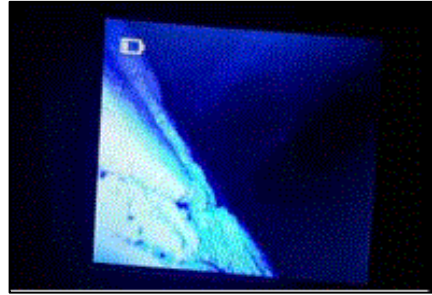
| 36 | Flat 401 | FBS03a (2) | <p>Breach in compartmentation with insufficient fire stopping installed. Boiler cupboard</p> <p>Potential for fire, heat and smoke to spread through the property.</p> | | Install fire batt |

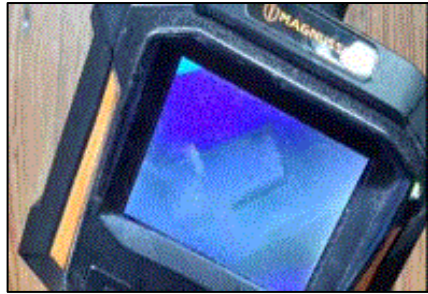
| 37 | Flat 204 | FBS03a (3) | <p>Breach in compartmentation with insufficient fire stopping installed, pipework leading from kitchen.</p> <p>Potential for fire, heat and smoke to spread through the property.</p> | | Install fire batt and fire collar |

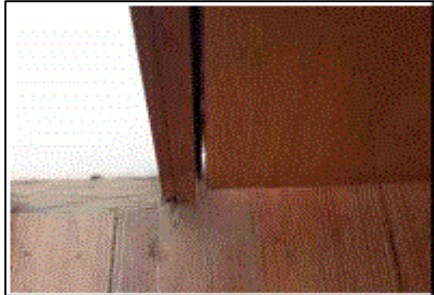
| 38 | Flat 404 main door | FD02c | <p>The gap between the fire door leaf and the frame is excessive.</p> <p>Potential for fire and smoke to spread through property.</p> | | Replace door and frame with compliant ironmongery |

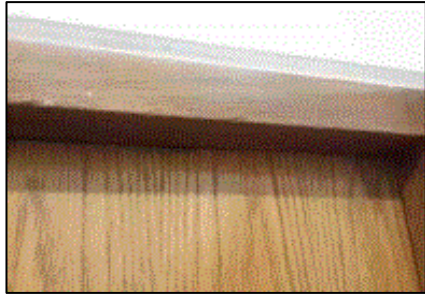
| 39 | Flat 204 main door | FD02c (1) | <p>The gap between the fire door leaf and the frame is excessive.</p> <p>Potential for fire and smoke to spread through property.</p> | | Replace door and frame with compliant ironmongery |

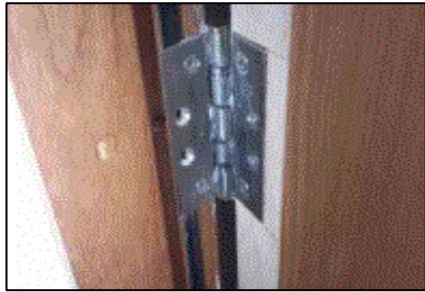
| 40 | Flat 201 main door | FD04 | <p>Fire door may not perform correctly, missing screws from hinges.</p> <p>Potential for fire and smoke to spread through the property.</p> | | Install screws to all hinges |

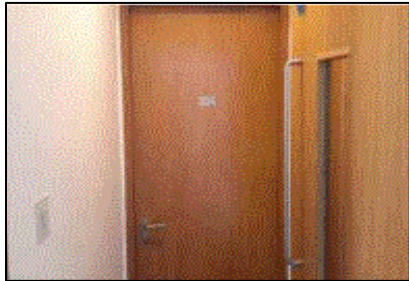
| 41 | Flat 304 | FD16 | <p>Unable to determine if the entry door to the tenant demise meets the minimum half hour standard of fire resistance.</p> <p>Potential for fire, heat and smoke to spread into the communal area and compromise the escape route.</p> | | Replace door and frame with compliant ironmongery if determined that the door does not meet the minimum half hour standard upon gaining access |

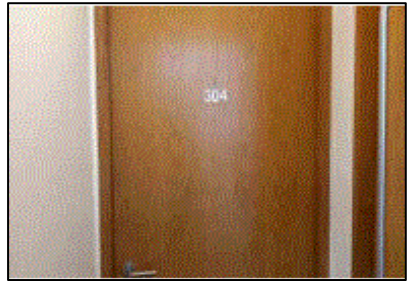
| 42 | Flat 304 | No Access | <p>The advisor was unable to gain access to this area.</p> <p>Potential for hazards to exist undetected, remain unmanaged and subsequently, cause injury and/or present a fire hazard.</p> | | Provisional sum for any items identified within flat 304 upon access |
