# Site 2 at Gorton Lane, Manchester

## Verification and Drainage maintenance report

Curtins Ref: 8790-CUR-00-XX-RE-C-003

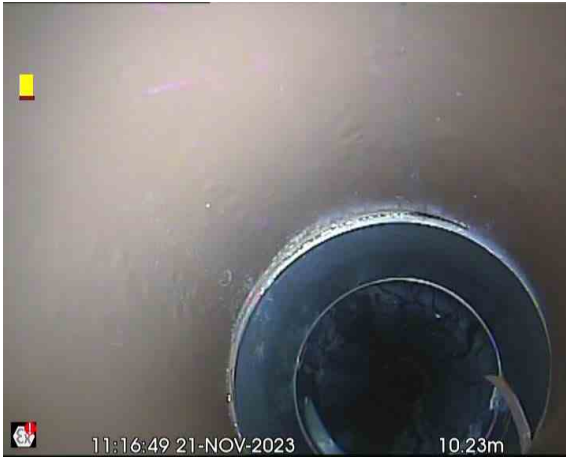
| Item No. | Inspection Direction | PLR | Client's Job Ref | Contractor's Job Ref |
|---|---|---|---|---|
| 9 | Upstream | SVPBX | | |

| Section | PLR | Grade | Description |
|---|---|---|---|
| 9 | SVPBX | 4 | Broken pipe at joint from 4 o'clock to 5 o'clock |

9\_SVPB\_FW10B.jpg, 00:01:04, 10.23 m  
Broken pipe at joint from 4 o'clock to 5 o'clock, SMALL PEACE  
OF PLASTIC STICKING OUT AT JOINT

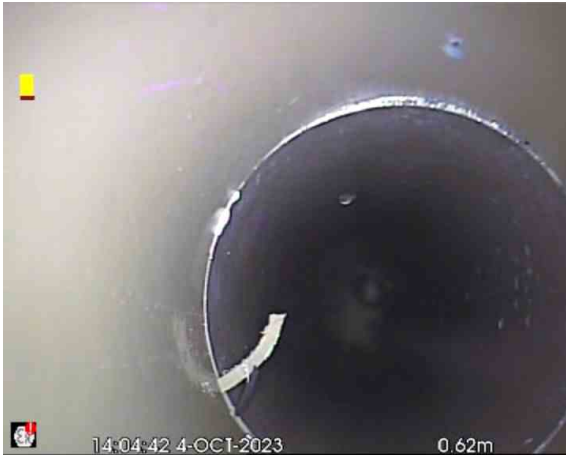
| Item No. | Inspection Direction | PLR | Client's Job Ref | Contractor's Job Ref |
|---|---|---|---|---|
| 89 | Downstream | SW 3AX | | |

89\_SW 3A\_MAIN.jpg, 00:00:09, 0.62 m  
General remark, PLASTIC WEDGED IN JOINT
