## Bituminous Interim Inspection

| <b>PROJECT NUMBER</b> | B190846/1 | <b>AREA MANAGER</b> | John Wilkinson |
| <b>PROJECT NAME</b> | Paterson Building - Christie Hospital | | |

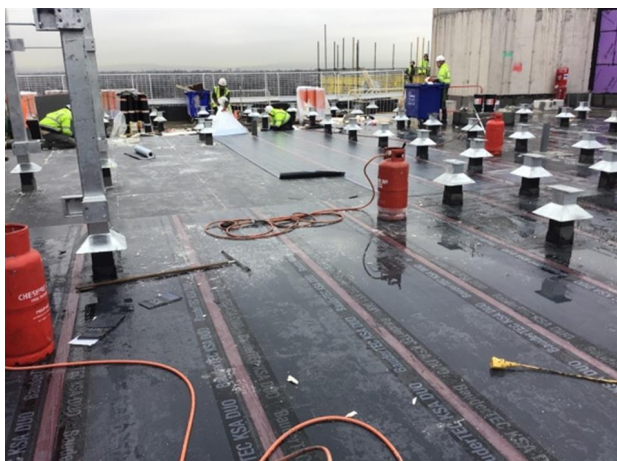
Photo 1 - View of level 9 section 1

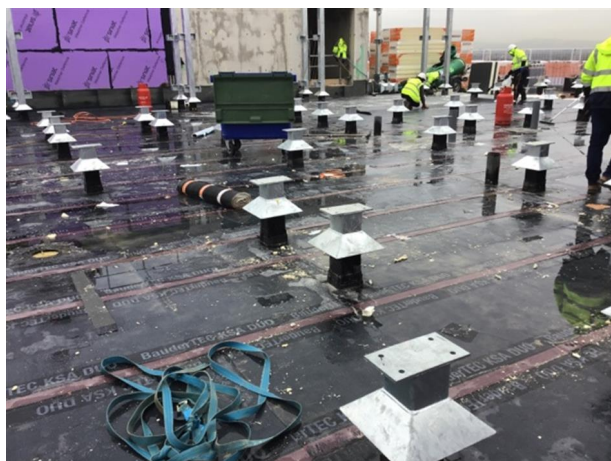
Photo 2 - Overview of progress

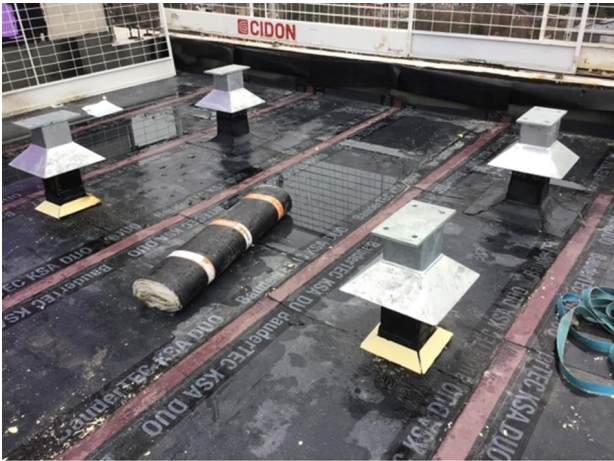
**Photo 3 - View of steel section details**

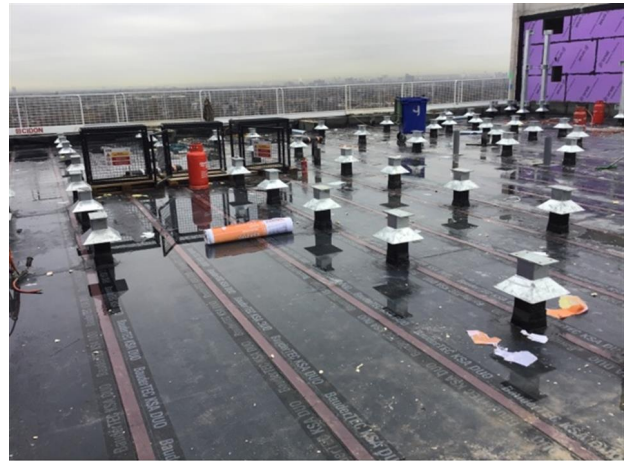
**Photo 4 - View of level 9 section 1**

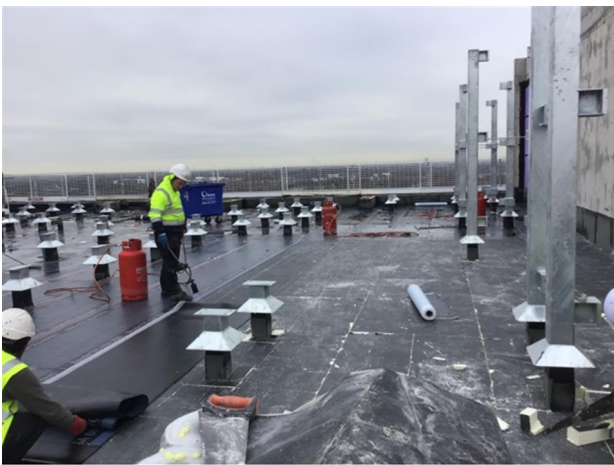
**Photo 5 - View of progress to date**

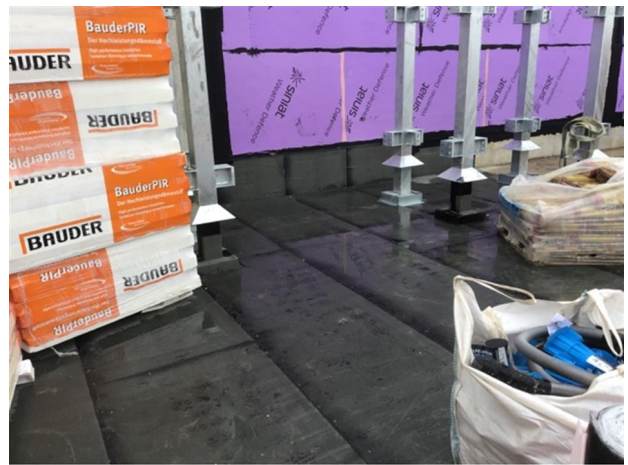
**Photo 6 - View of AVCL to level 9 section 1**

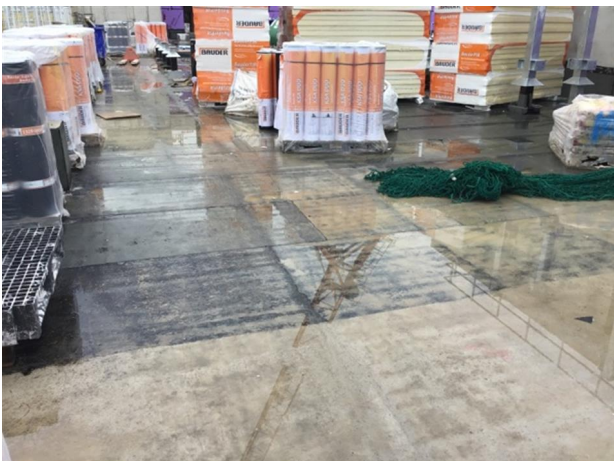
**Photo 7 - View of AVCL**

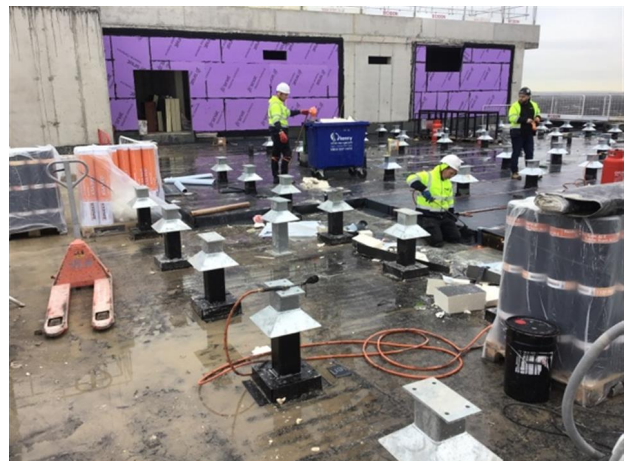
**Photo 8 - Overview of level 9 section 1**
