**Job Title**  
Hotspur Press, Cambridge Street,  
Manchester

**Report Type**  
Structural Appraisal, Condition  
and Proposals Report

**Date**  
Sept 2023

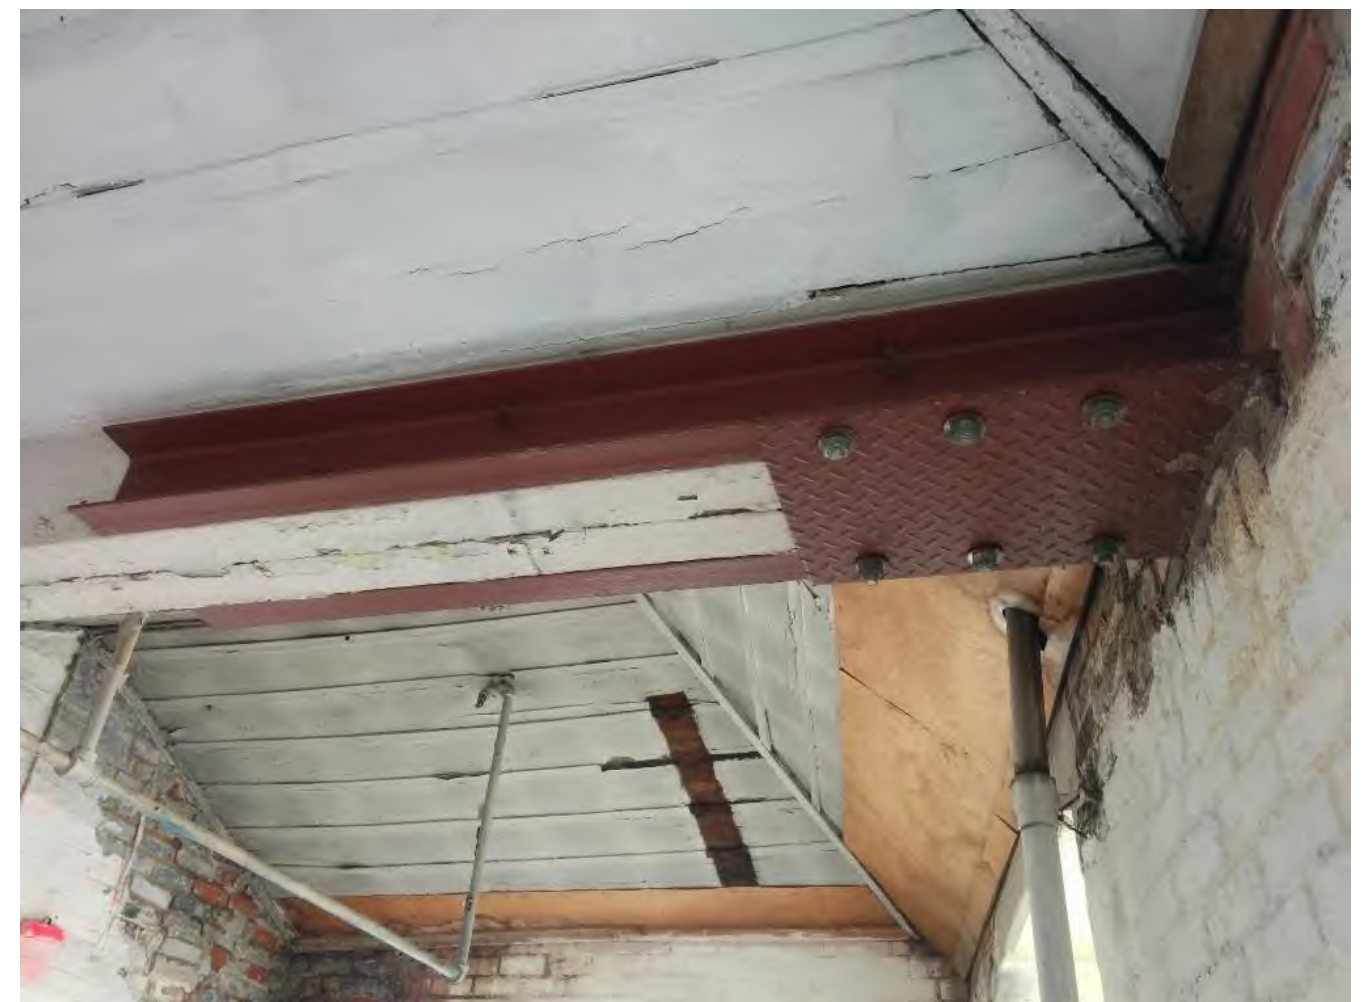
*Figure 12 - Previous strengthening of timber beams (taken 2018)*

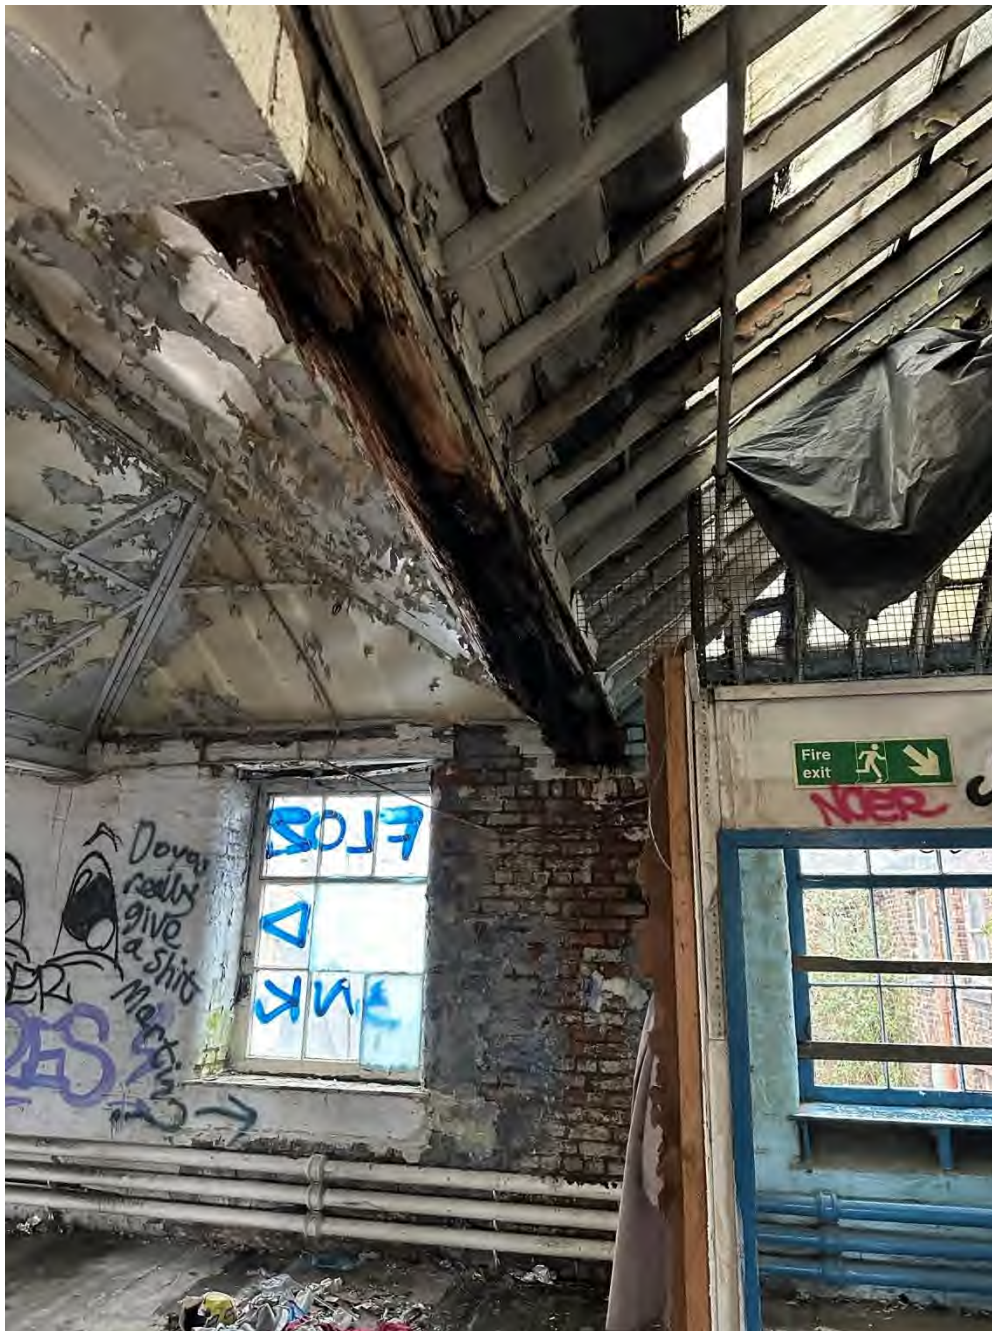
During the most recent site visits in 2023, it was evident that water ingress at this level had continued since the original observations were made. Water staining and flaking paint finishes were more pronounced across the majority of roof members, with evidence of timber members having deteriorated further resulting in section loss in some instances (refer to figure 13).

Figure 13 – Timber structural member decay and section loss (taken 2023)

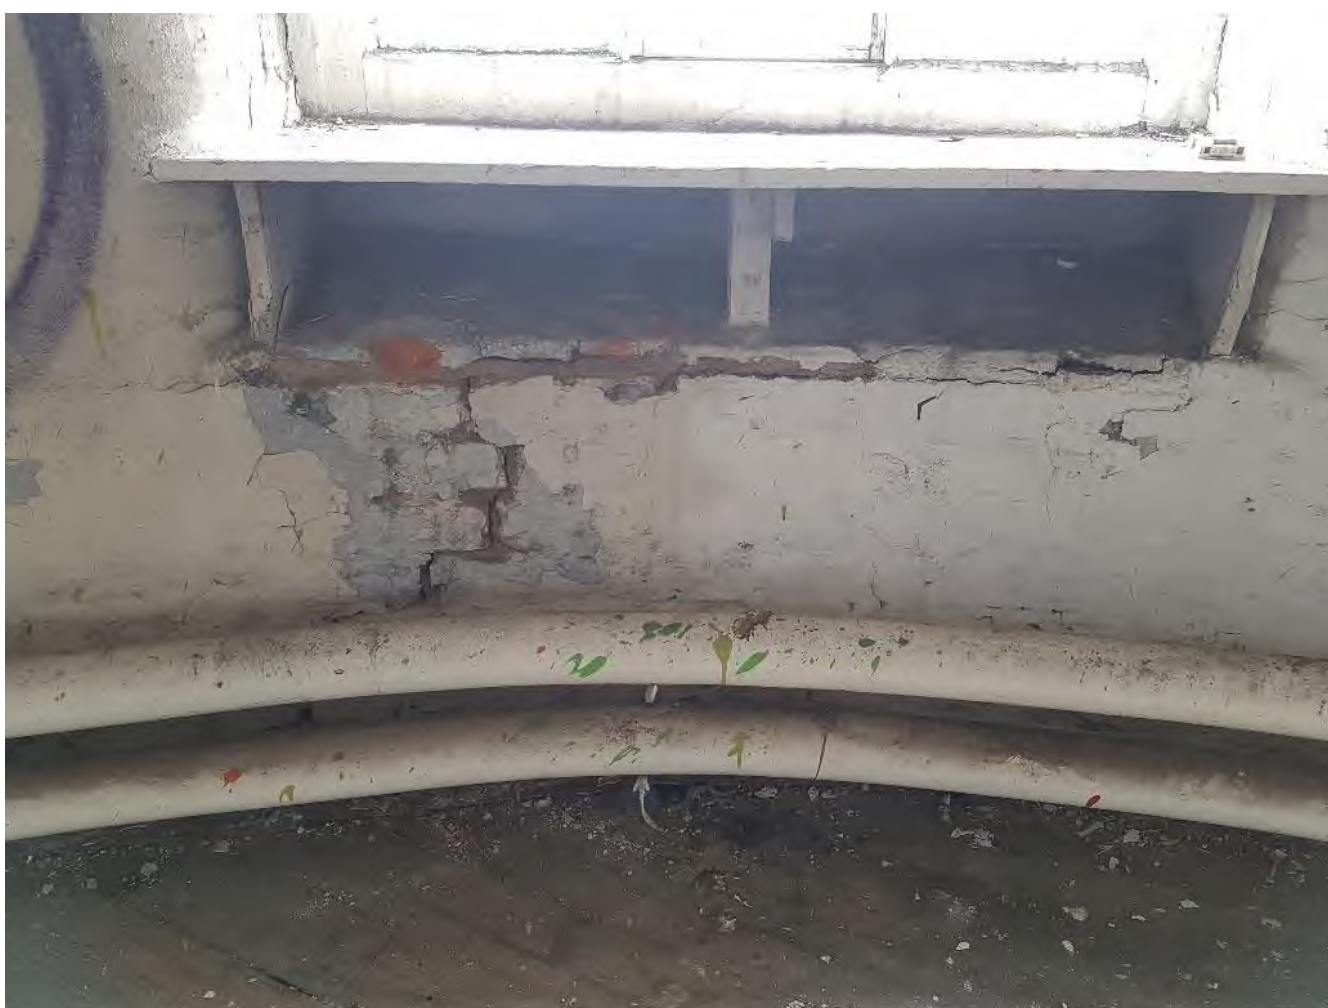
*Figure 17 - Cracks below sill at third floor level (taken 2018)*

There are numerous visible cracks below window sills, which is likely attributed to the failure of timber lintels above windows at second floor level, as shown in Figure 17. The failure of the lintels has allowed the sill to deflect with the possible rotten timber. Crack patterns are consistent with failed lintels; diagonal cracks emanating from the support where the timber lintel has been allowed to deflect. Tension develops to the underside of the brickwork resulting in the cracking.

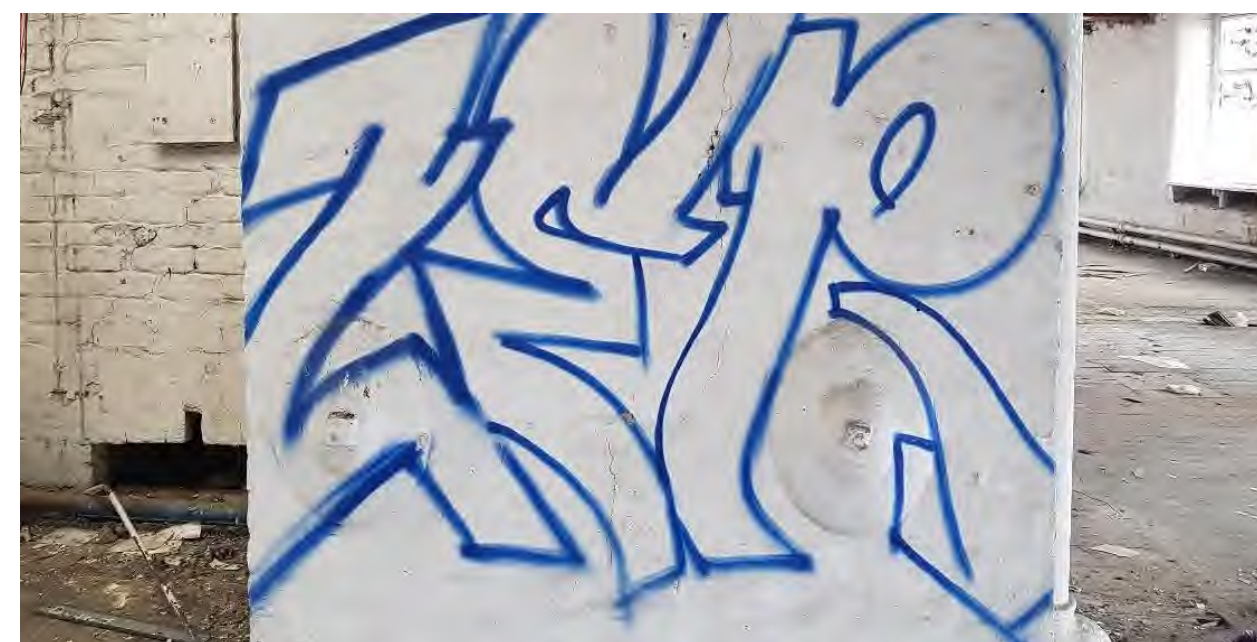
Pattress plates are found in the large brickwork pier adjacent to the lift shaft, as shown in Figure 18. The pattress plates may be an indication that the brickwork pier is hollow. A large tension rod was found that ties the external elevation with Cambridge St to the pier, which is likely to be attributed to the cracking evident in the pier that extends vertically from roof level. It is not known when the tension rod was installed during the lifetime of the warehouse.

*Figure 18 - Brickwork pier adjacent to the lift shaft (taken 2018)*

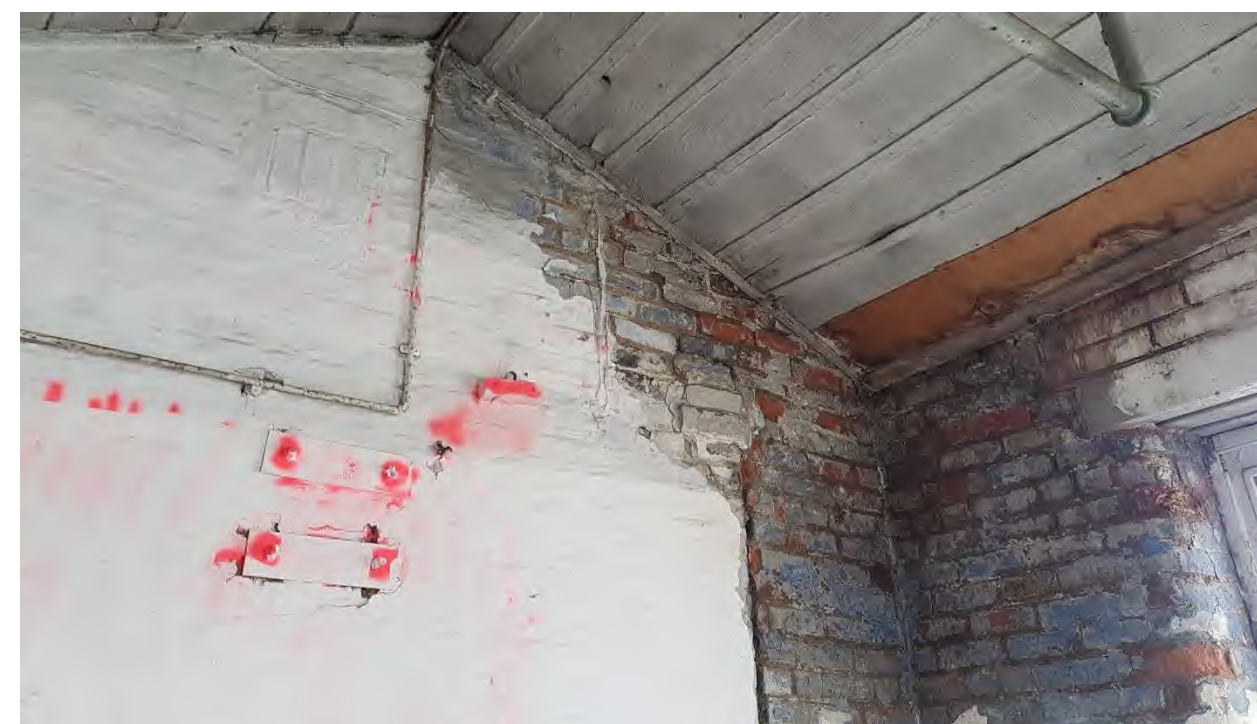
*Figure 19 - Cracking to external wall on Cambridge Street, corresponding to return wall (taken 2018)*

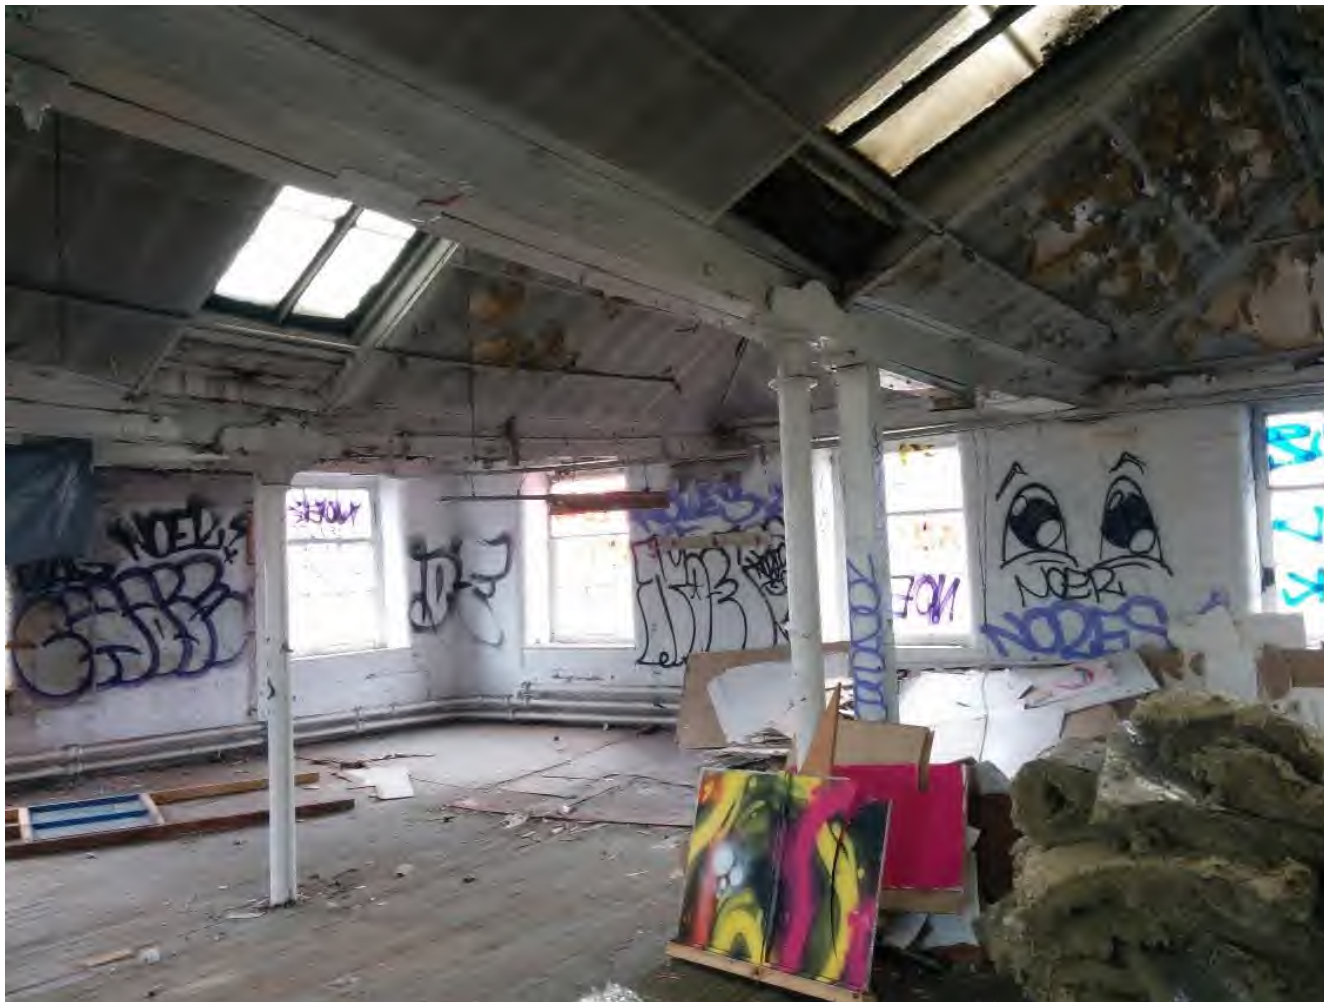
*Figure 20 – Significant dish to the third floor (left column) (taken 2018)*

Significant dish is evident to the floor plate where there has been movement of the column supporting the roof, as per Figure 20. The floor is sloping down towards the position of the left column delineated in Figure 20. The magnitude of the slope was not recorded, however the dishing is clearly visible to the eye. Further investigations are recommended to better understand the cause of the dishing. Opening-up works are proposed to be carried out here to investigate the restraint of the column base.

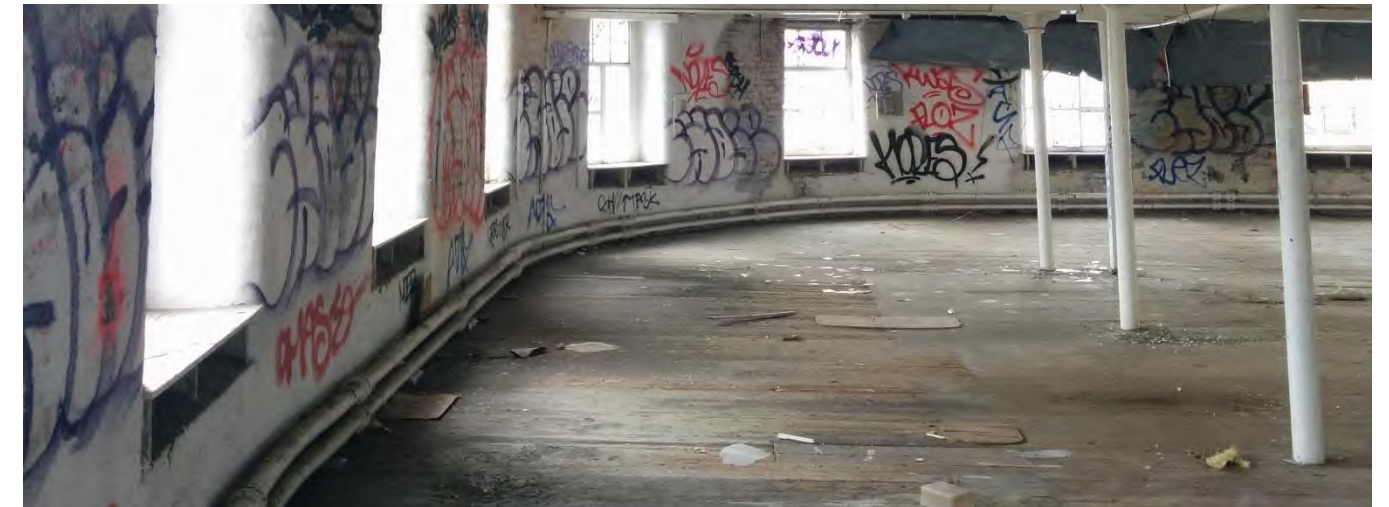
Some areas of the timber floor at third floor level are displaying obvious signs of damp and deterioration from previous water ingress, as is evident in Figure 21. Water ingress is prevalent through the external walls.

*Figure 21 - Deterioration of the timber floor at third floor level (taken 2018)*

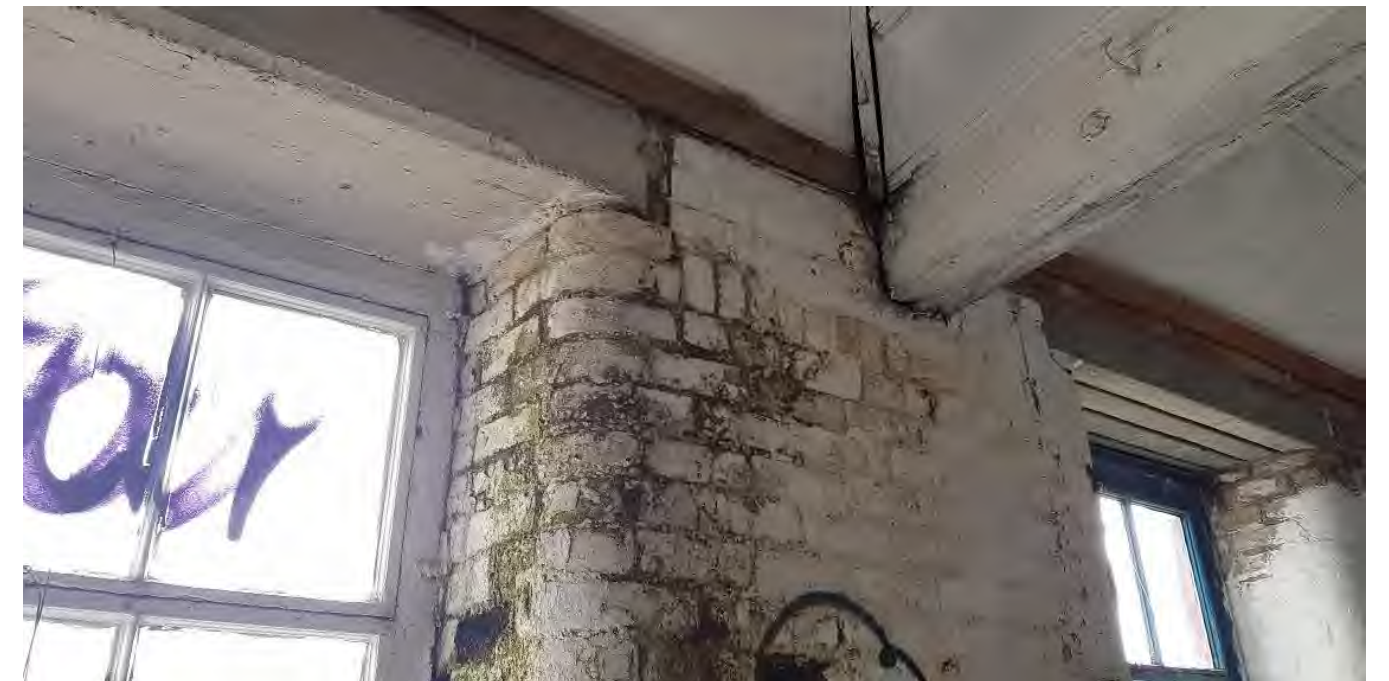
*Figure 22 - Internal vegetation growth on southern masonry wall (taken 2018)*

Vegetation growth is evident along all elevations at third floor level, see Figure 22 as example. Missing rainwater goods may have facilitated the vegetation growth as water may be running down the elevation rather than flowing in to roof gutters and down pipes.

Open joints and missing mortar between the masonry units is further facilitating the vegetation growth within the elevation walls.

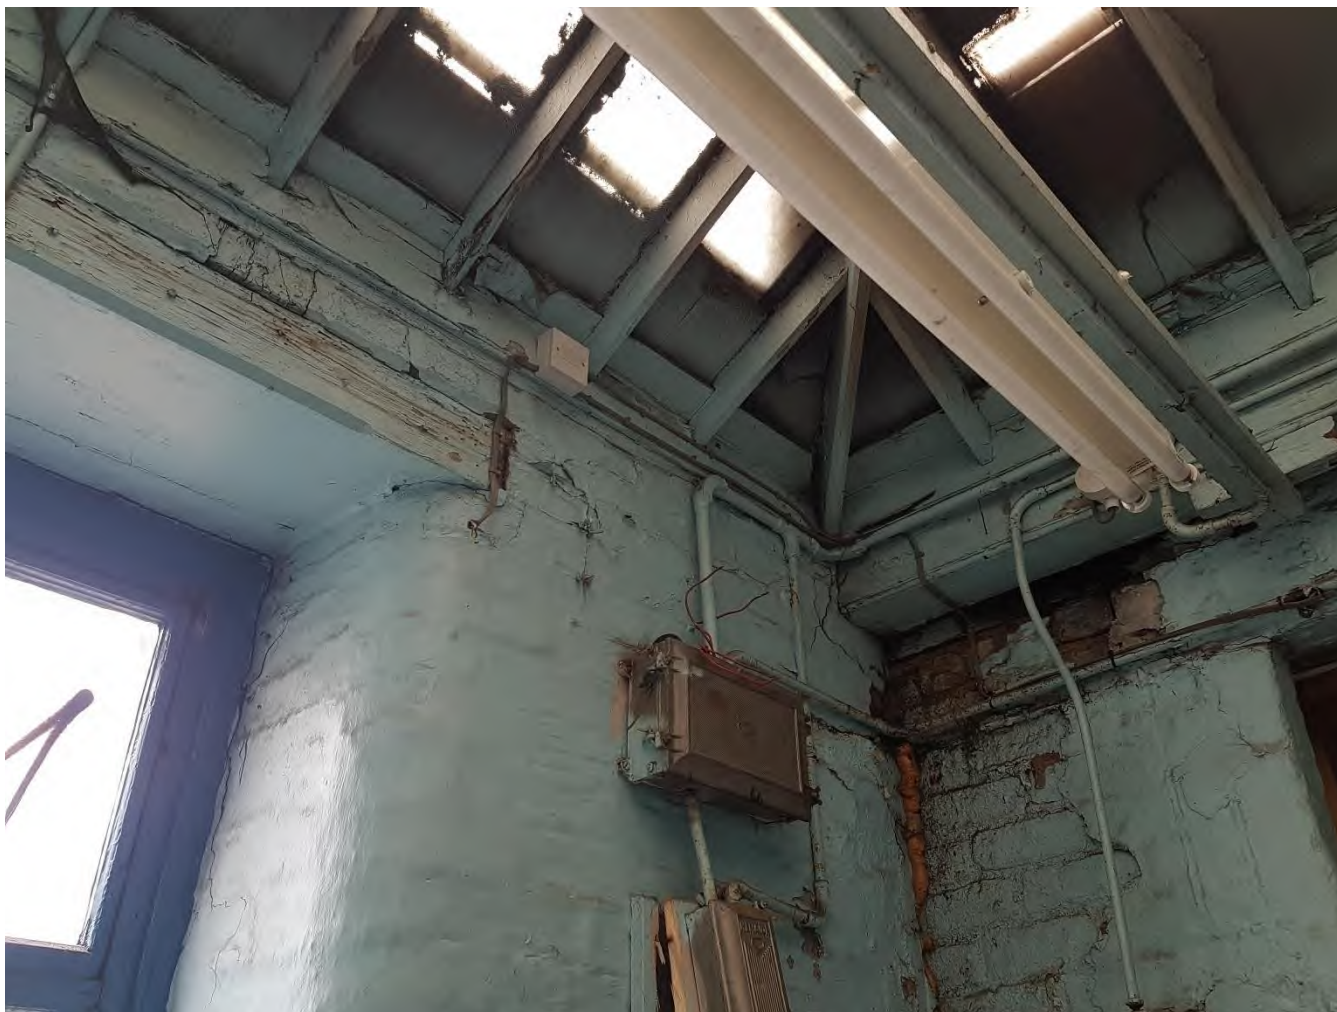
Debonding of perpendicular walls is evident between the 1801 mill (shown bottom right) and the 1882 warehouse (shown bottom left). This is shown in Figure 23 below, in which expandable foam can be seen between the two wall interfaces. The expanding foam is a later addition to the original construction.

Figure 23: Debonding of walls between 1882 warehouse and 1801 mill (taken 2018)

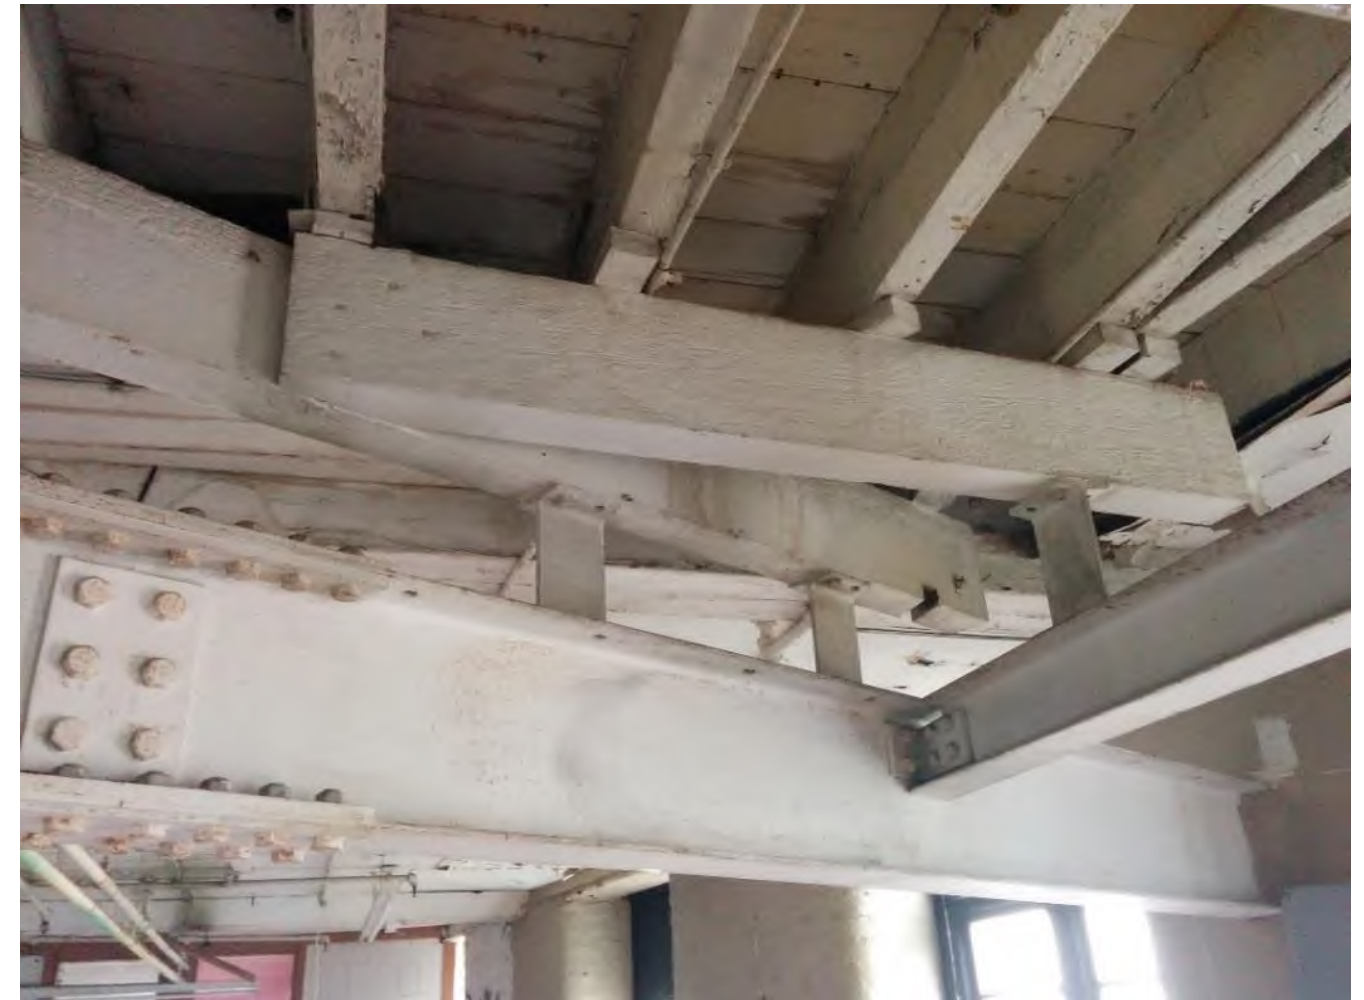
Located near the lift shaft there is a complex steel beam structure in a V-form arrangement with several stacked layers of steel beams and timber beams, as delineated in Figure 27. The steel beam structure most probably provided support for a heavy lifting hoist. Splice connections are located at approximately mid-span of the steel beams.

Figure 27 - Complex steel and timber beam structure (taken 2018)

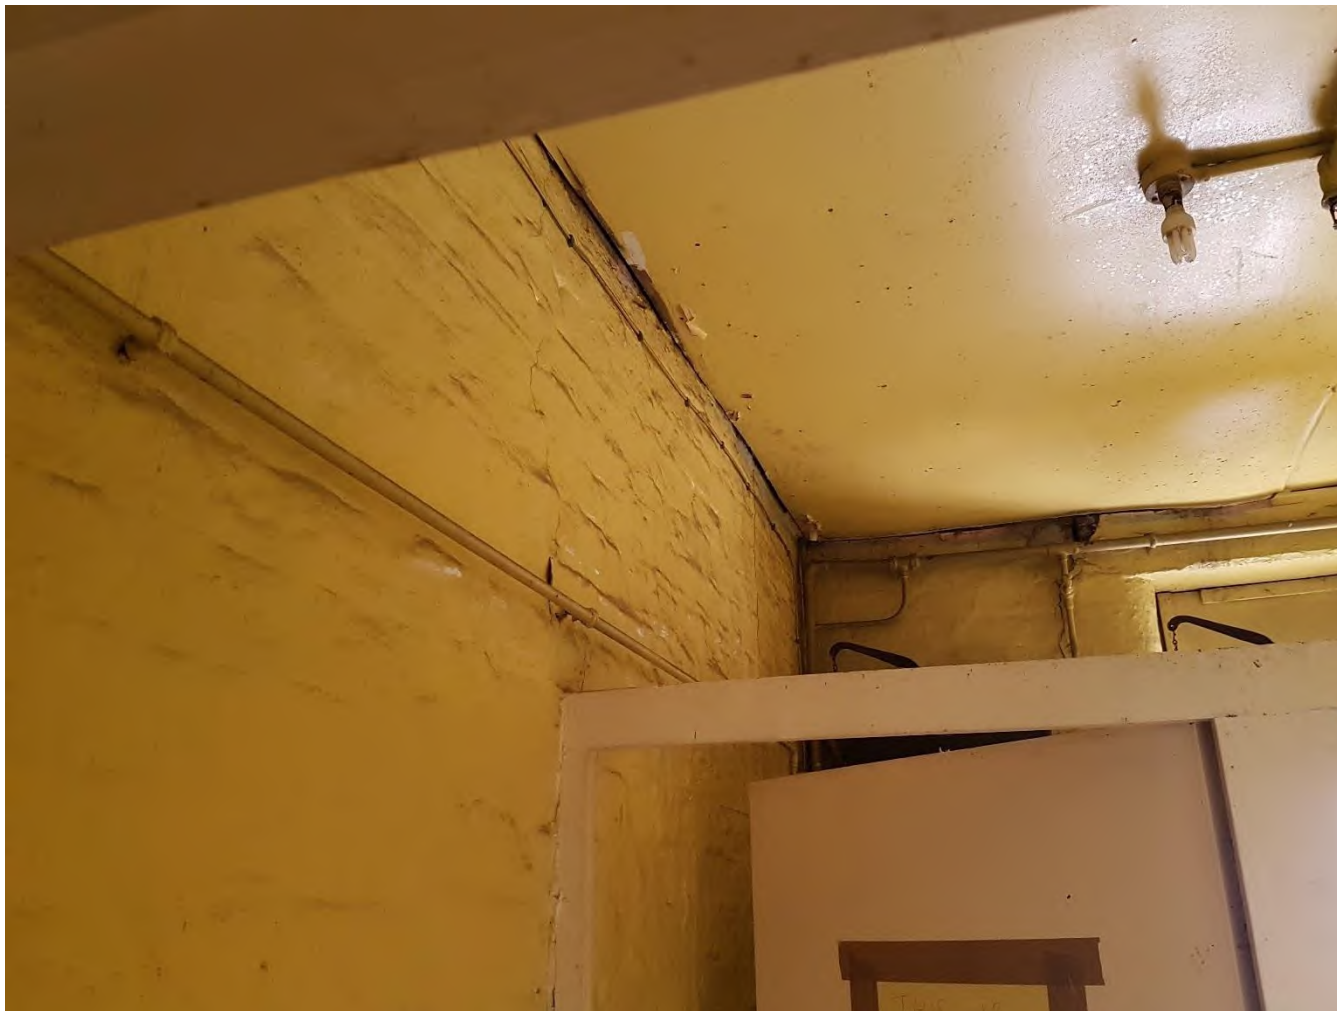
Further cracking is evident through the large masonry pier adjacent to the lift. It appears this cracking is at approximately the same location as the crack in the large pier at upper levels. There is further cracking to the masonry wall on Cambridge St elevation which seems to be a continuation from above. The joint in the masonry wall is wide open. This is shown below with cracking evident through the paintwork in the WC that extends from ceiling to floor level, see Figure 28

Figure 28 - Further cracking through external wall (taken 2018)

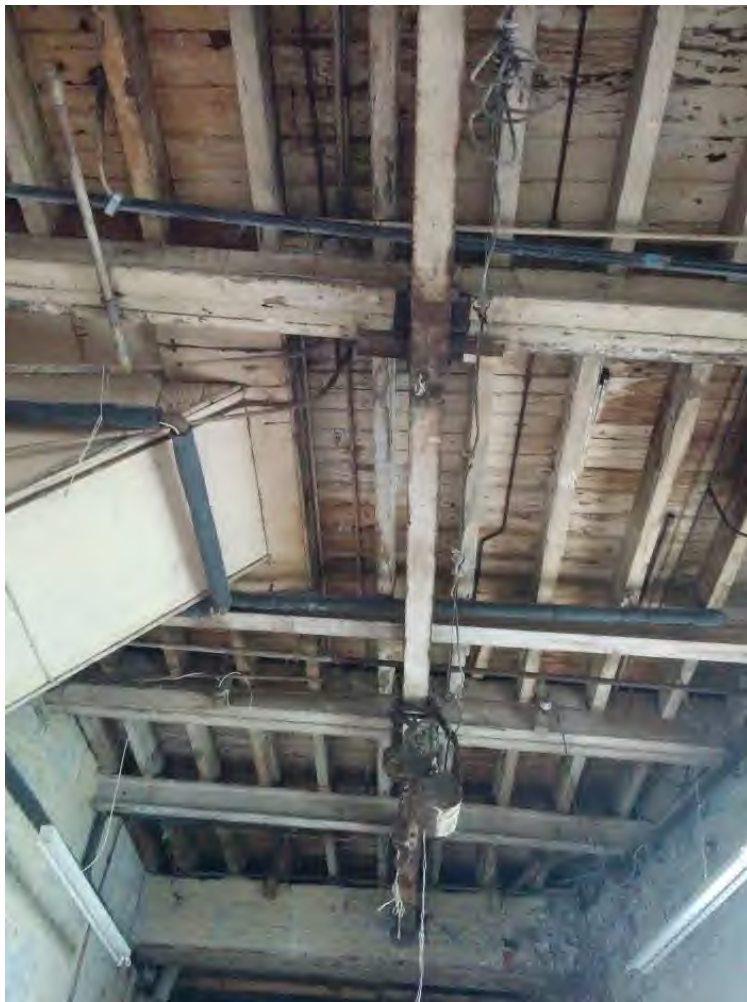
Located in the eastern section of the Warehouse there is a heavily corroded steel beam infilled with brickwork, as per Figure 30 (far end). It appears the steel beam is offering support to the upper eastern elevation. The underside of the timber floor at first floor level is showing significant signs of decay, as delineated in Figure 30. Steel beams are spanning between the southern elevation masonry wall and internal masonry wall. These steel beams have obvious signs of corrosion as illustrated by Figure 30.

*Figure 30 - Corroded steel beams infilled with brickwork (far end) (taken 2018)*

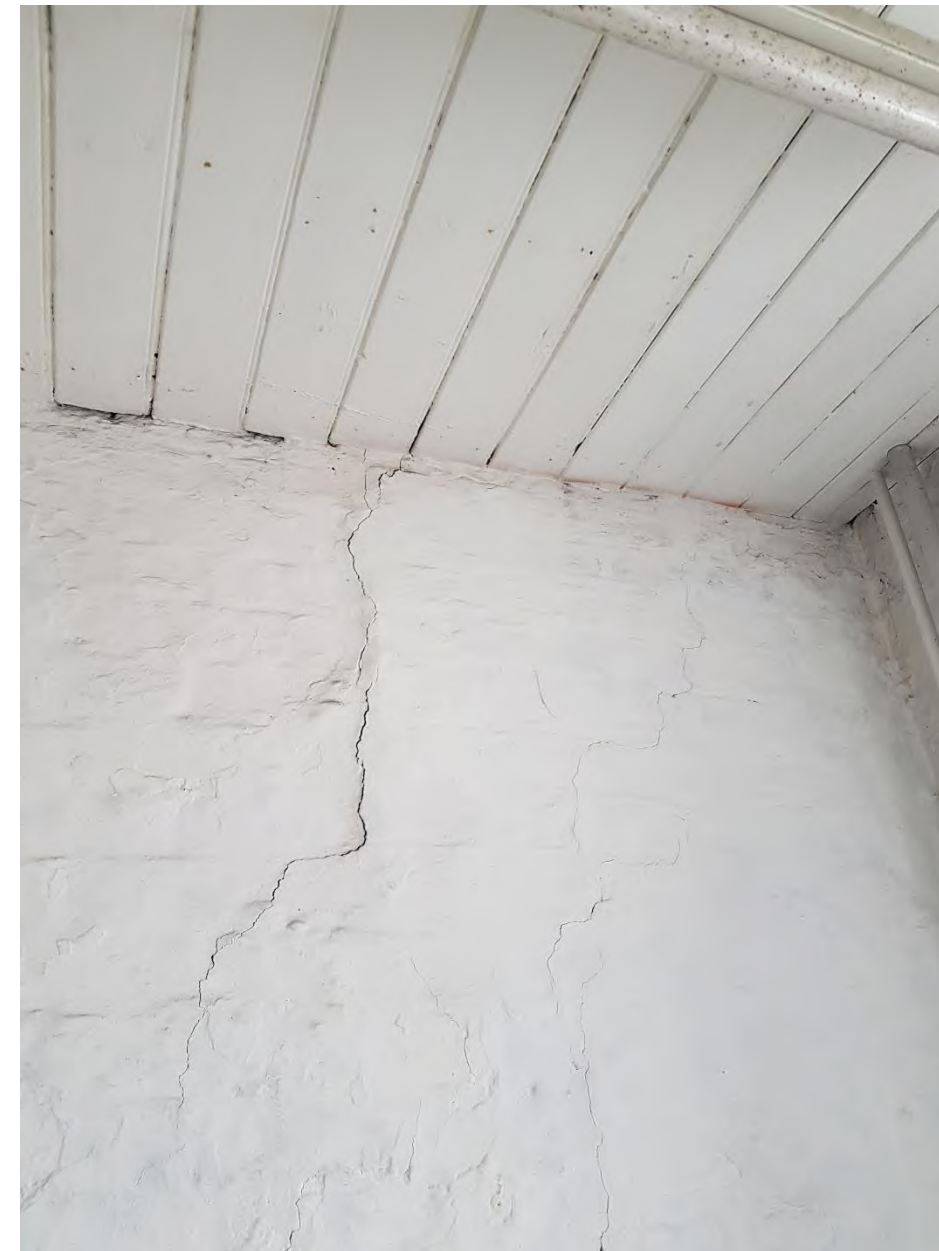
Further cracking to the wall on Cambridge St elevation, a continuation from above. Two cracks have developed at the lower level, which continue from ceiling level down to ground floor, as illustrated in Figure 31.

*Figure 31 - Cracking to wall elevation on Cambridge Street (taken 2018)*

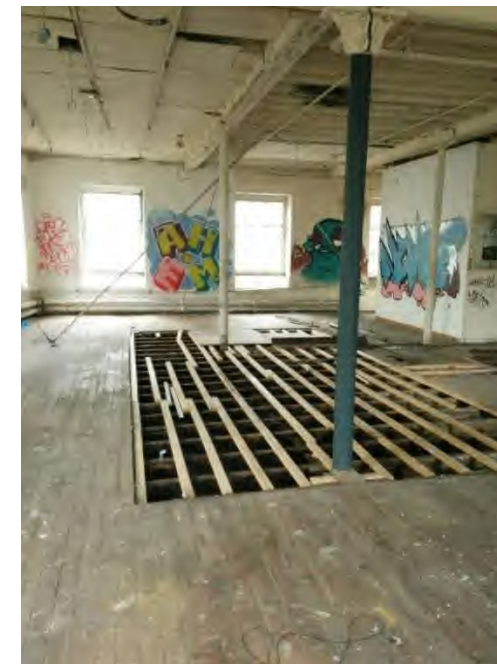
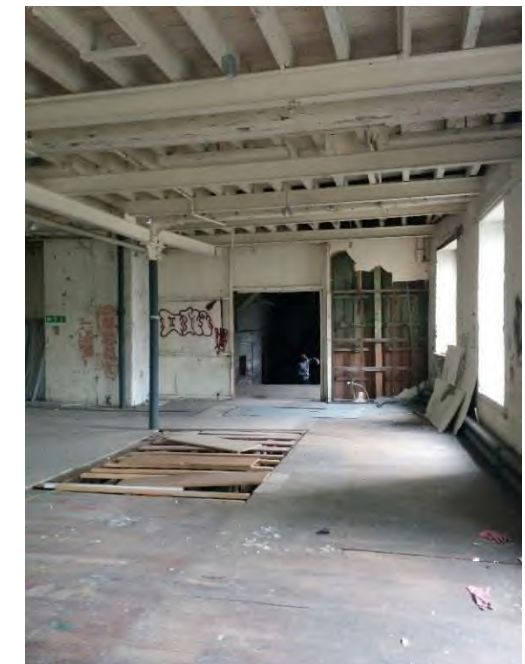
Several areas at ground floor have missing floor boards, as delineated in Figure 33. This may be attributed to reparation of fire damaged timber.

Figure 33 - Missing floor boards at ground floor level (taken 2018)

Evidence of replacement joists where previous fire has caused damage as indicated in Figure 33.

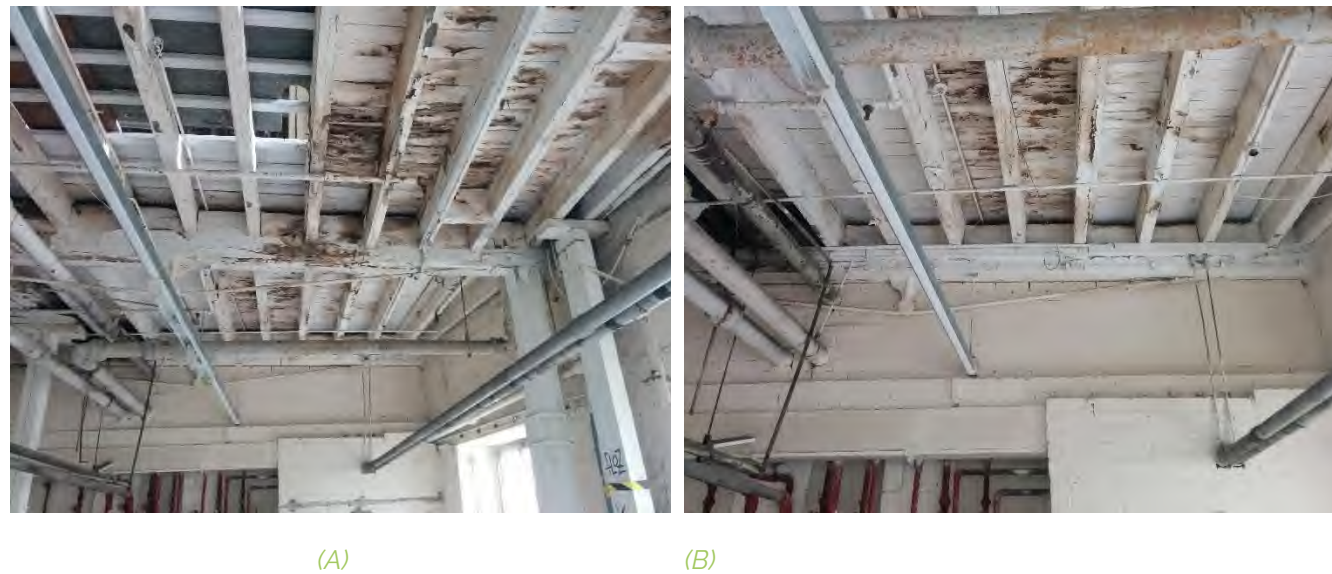
Water ingress is present along the western and southern brickwork elevation and staining is typical throughout the floor plate at ground floor level, as delineated in Figure 35.

Figure 35 – Decayed timber joisted floor at ground floor level (taken 2018)

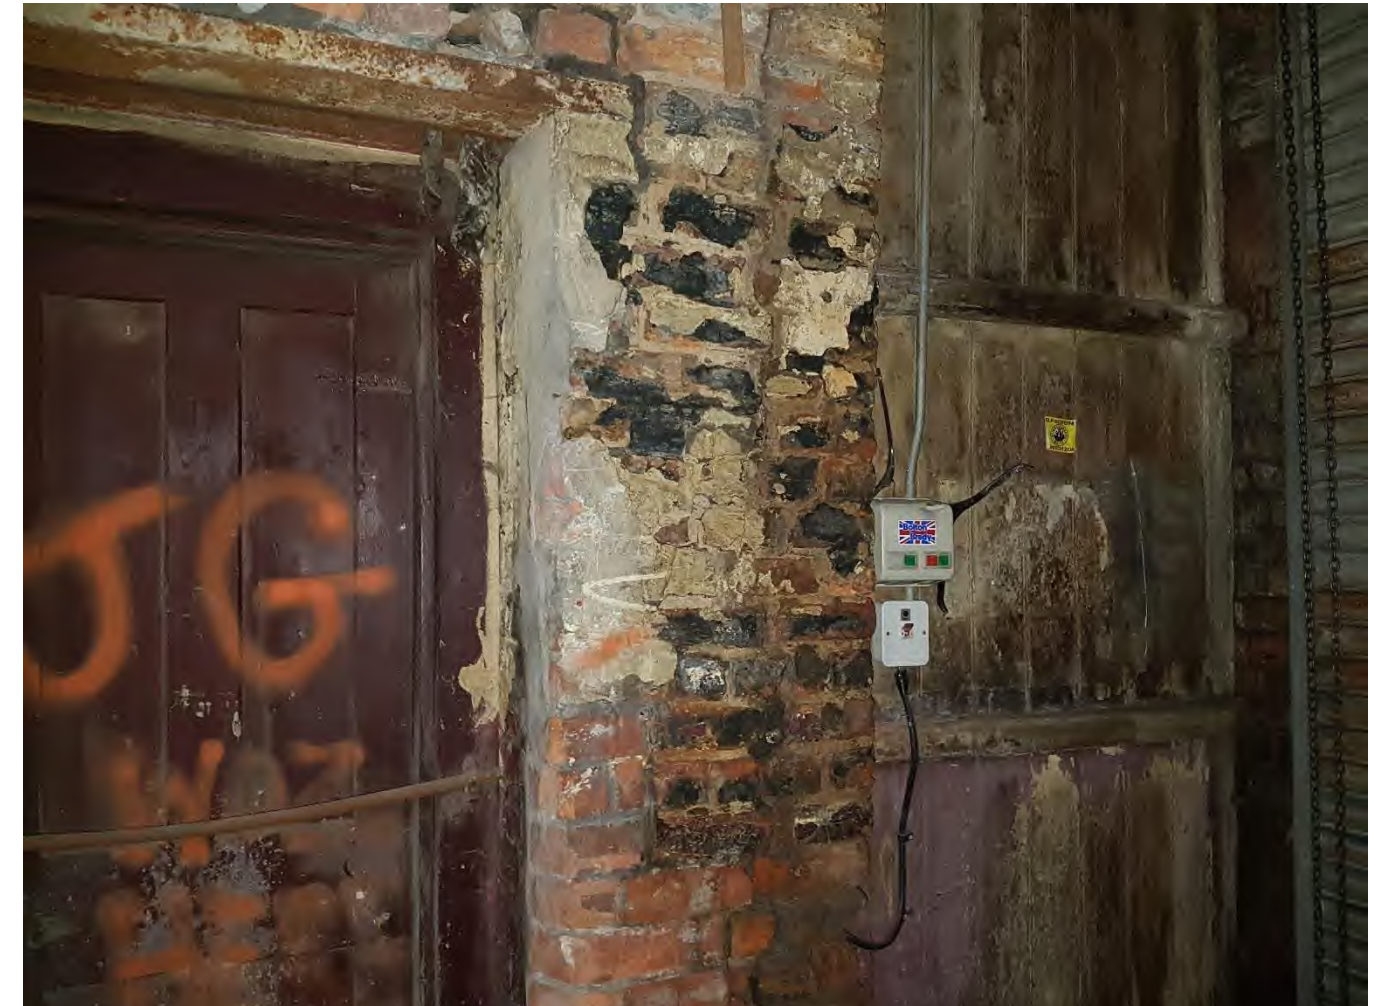
Further cracking is evident to the wall on Cambridge St elevation. The crack at ground floor level seems to be a continuation of the crack found at upper levels. The cracking has opened at the lower level, which is found to be in excess of 10mm. The cracking appears

to be historic as there is water staining inside the crack, in the pier and mortar. This is shown in Figure 36 below.

Figure 36 - Extensive cracking through pier at ground floor level (taken 2018)

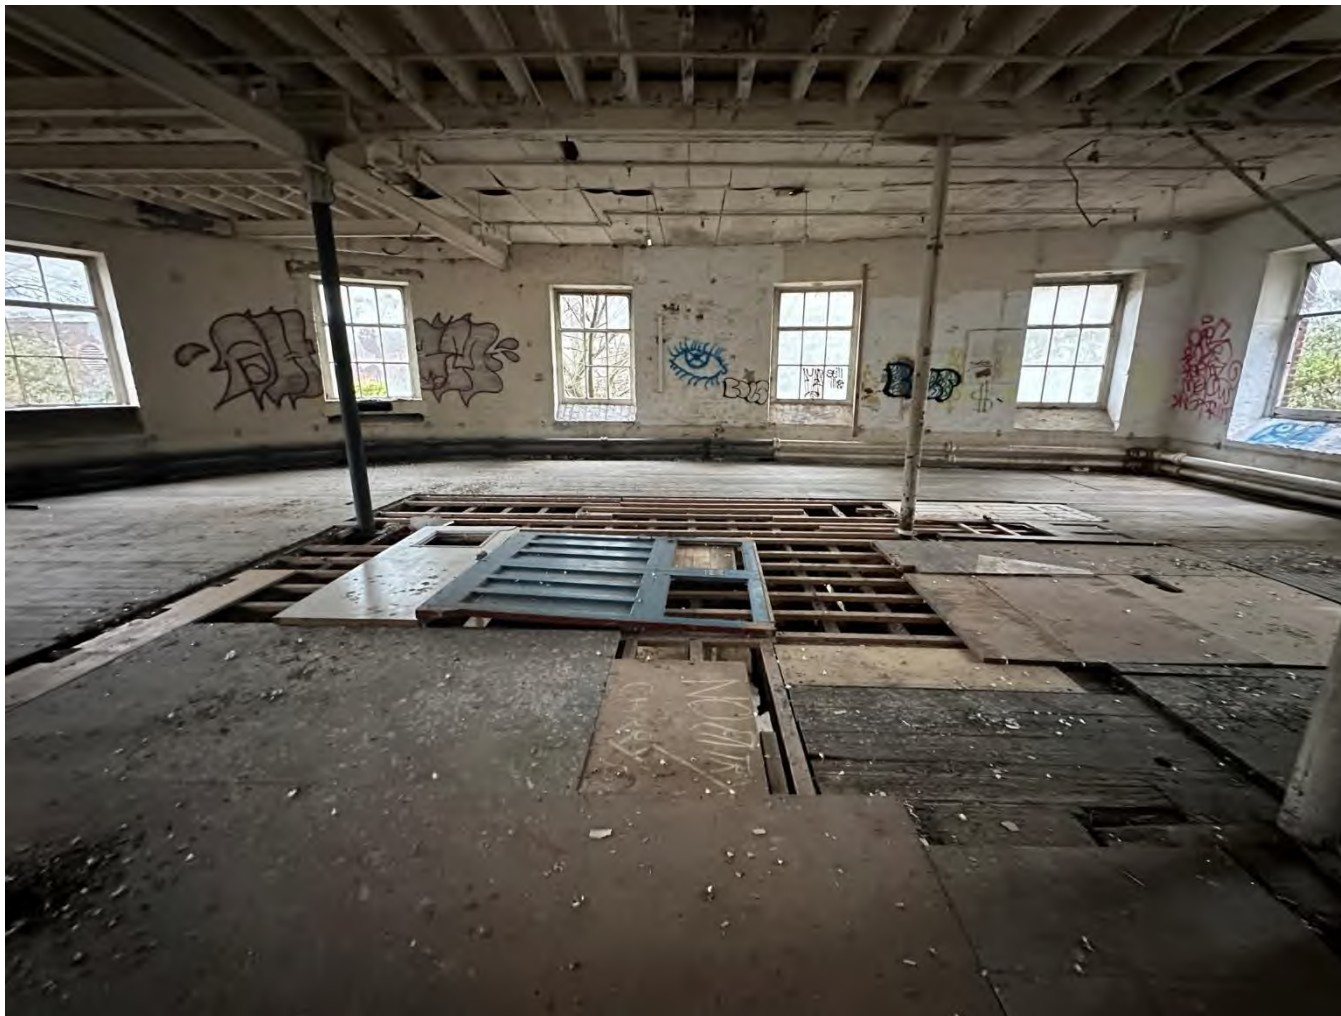
Figure 37 – Photo of missing floor boards and general floor condition at ground floor level (taken 2023)

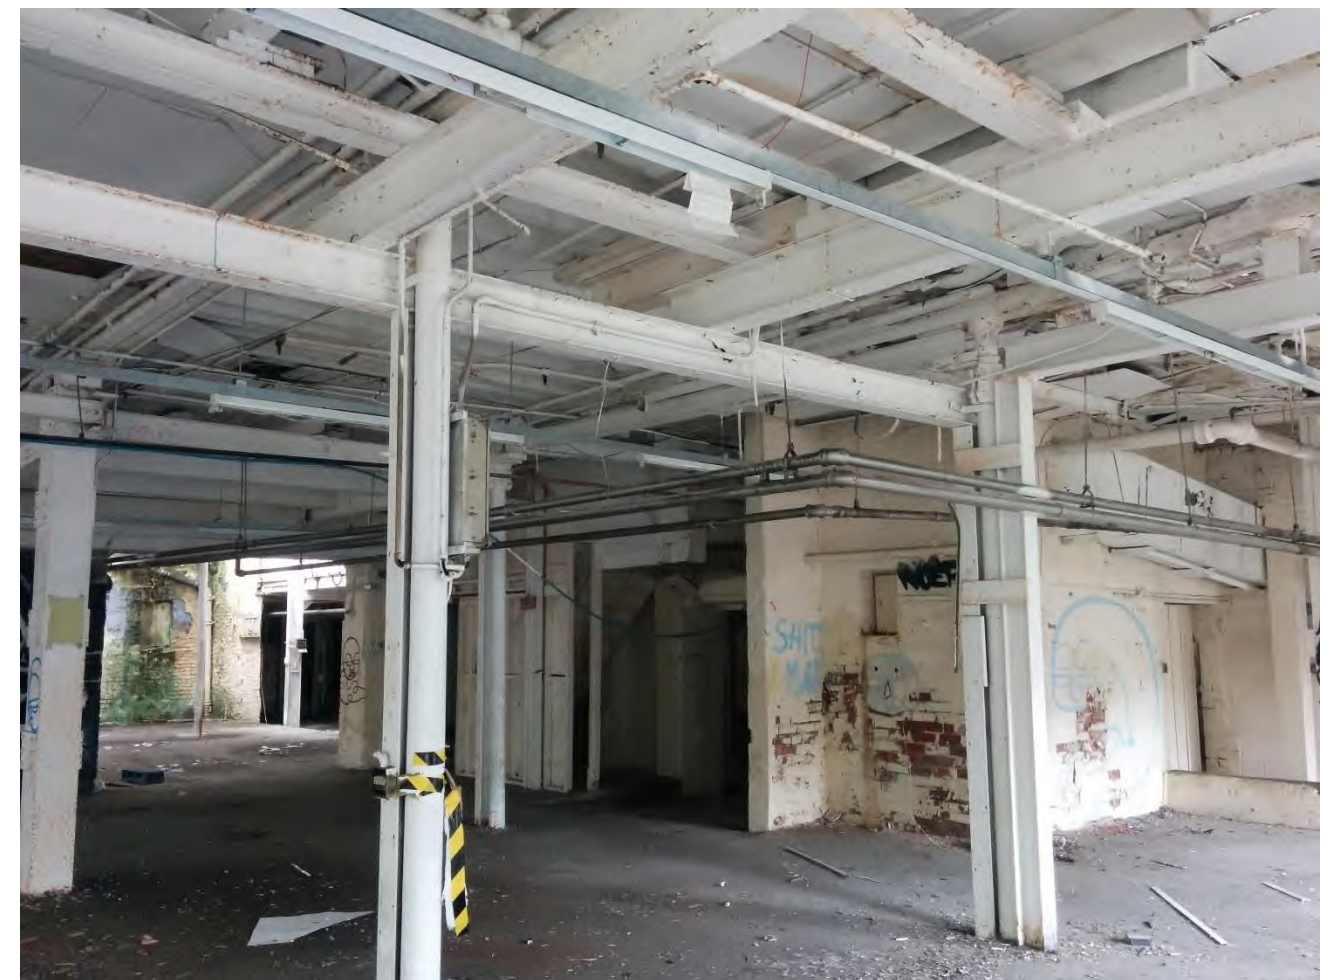
Several more recent steel columns appear to have been previously introduced at basement level in close proximity to the original cast iron columns, as illustrated in Figure 38 and Civic Engineers drawing S-EX-100 found in Appendix A of this report. The steel columns support the supplementary steel beams at the floor levels above. The additional steel columns appear to have been introduced on an ad hoc basis, compromising of parallel flange channels (PFC) or universal beams (UB) sections alongside the existing cast iron columns, and the newer columns are bolted together using plates between adjacent flanges. The new steel columns bear on to the same footings as the existing cast iron columns. It is likely these more recent additions were to provide additional support to machinery throughout the life of the building.

Figure 38 – Ad hoc additional steel columns in basement (taken 2018)
