**Job Title**  
Hotspur Press, Cambridge Street,  
Manchester

**Report Type**  
Structural Appraisal, Condition  
and Proposals Report

**Date**  
Sept 2023

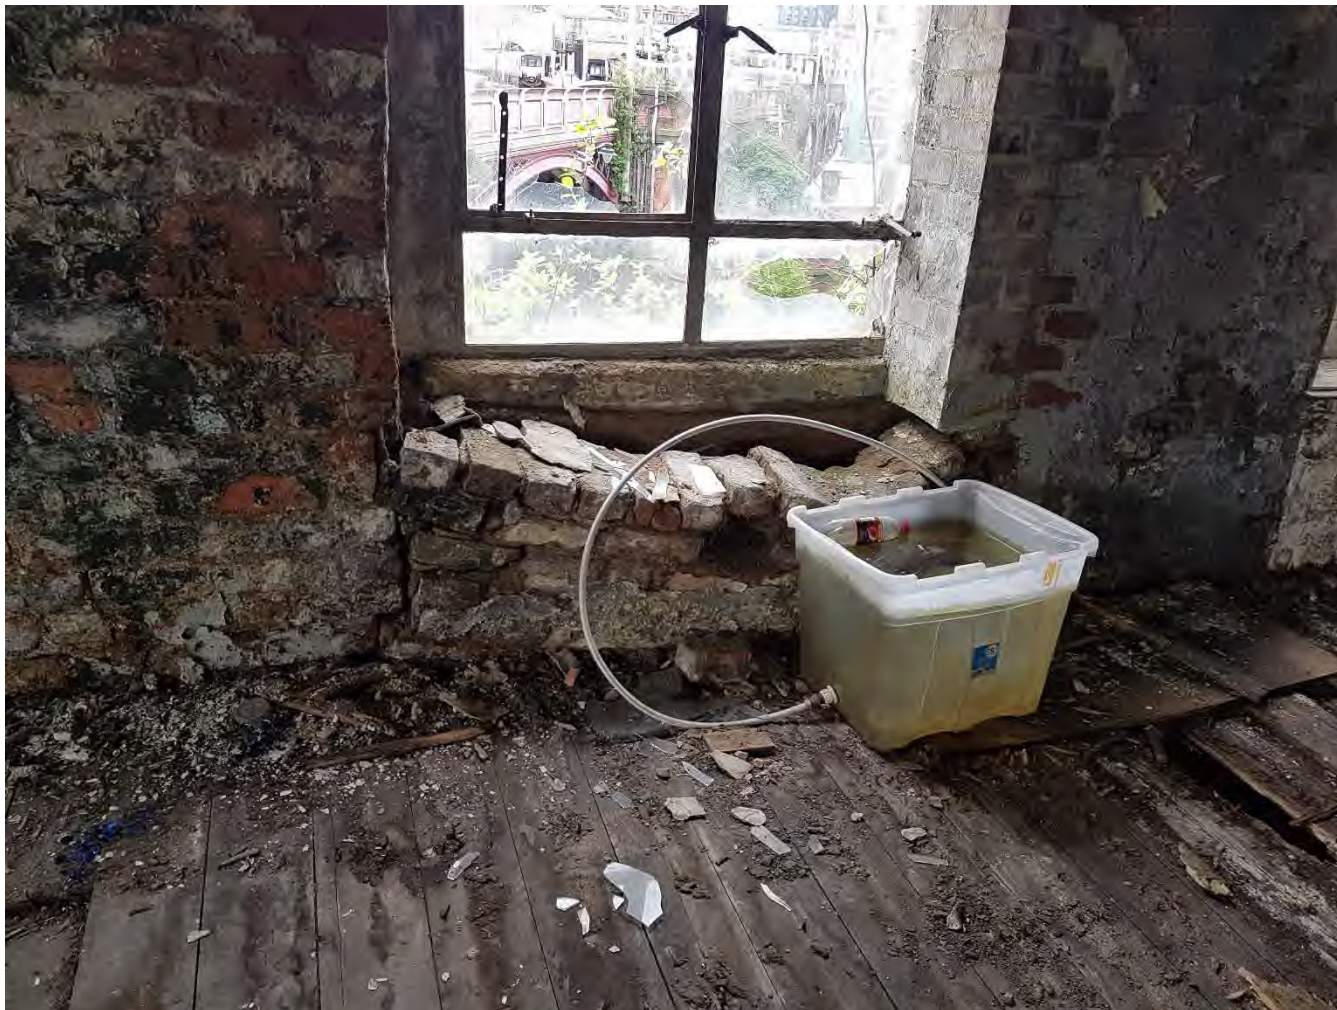
*Figure 45 - Significant movement of sill at third floor level. Also shows water ingress (taken 2018)*

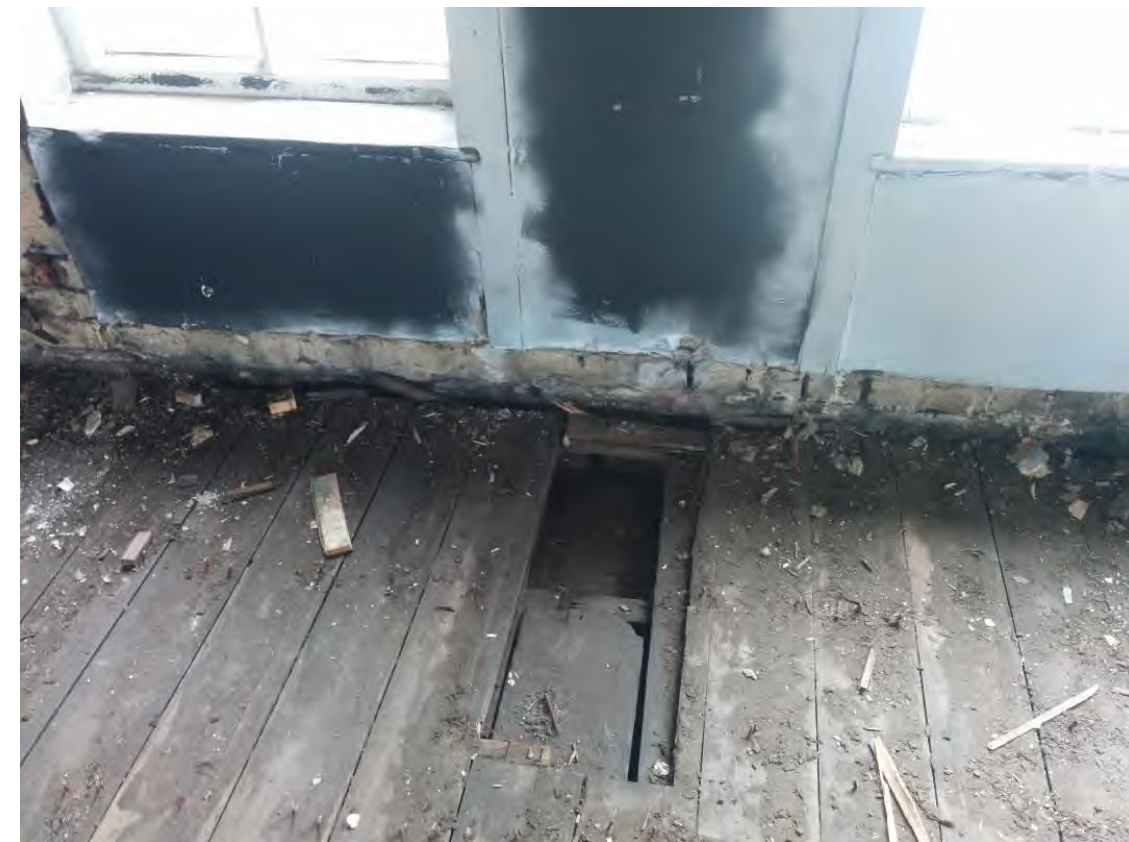
*Figure 46 - Missing timber floorboards at third floor level (taken 2018)*

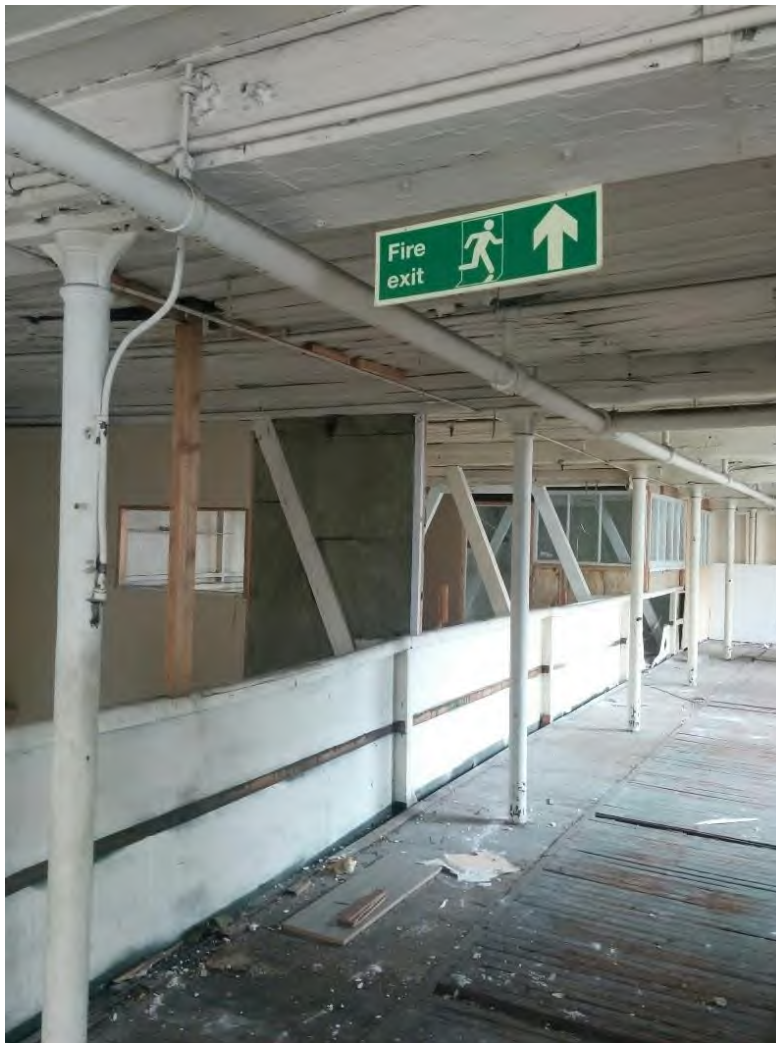
Figure 49 - Damp timber floor with missing floorboards at second floor level (taken 2018)

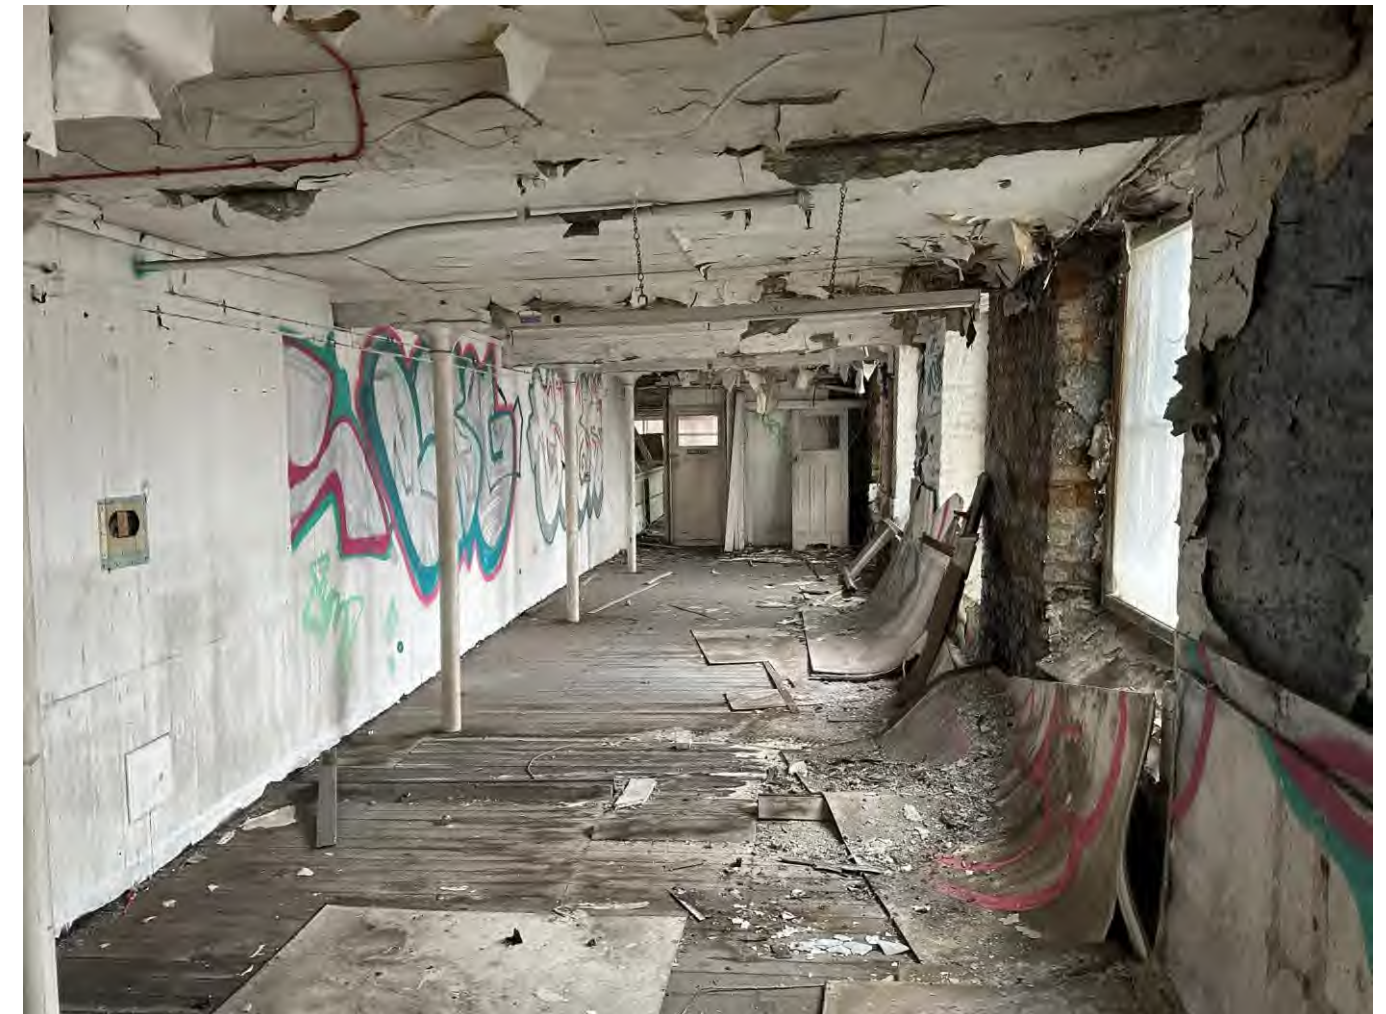
Figure 50 – General view of second floor showing deterioration due to continued water ingress (taken 2023)

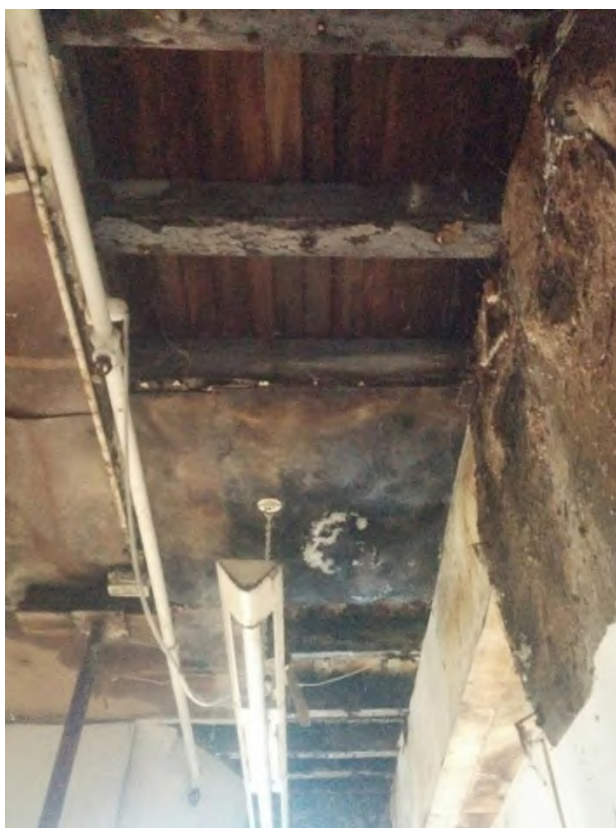
*Figure 54 - Very damp timber floor areas (possible rot) at first floor level (taken 2018)*

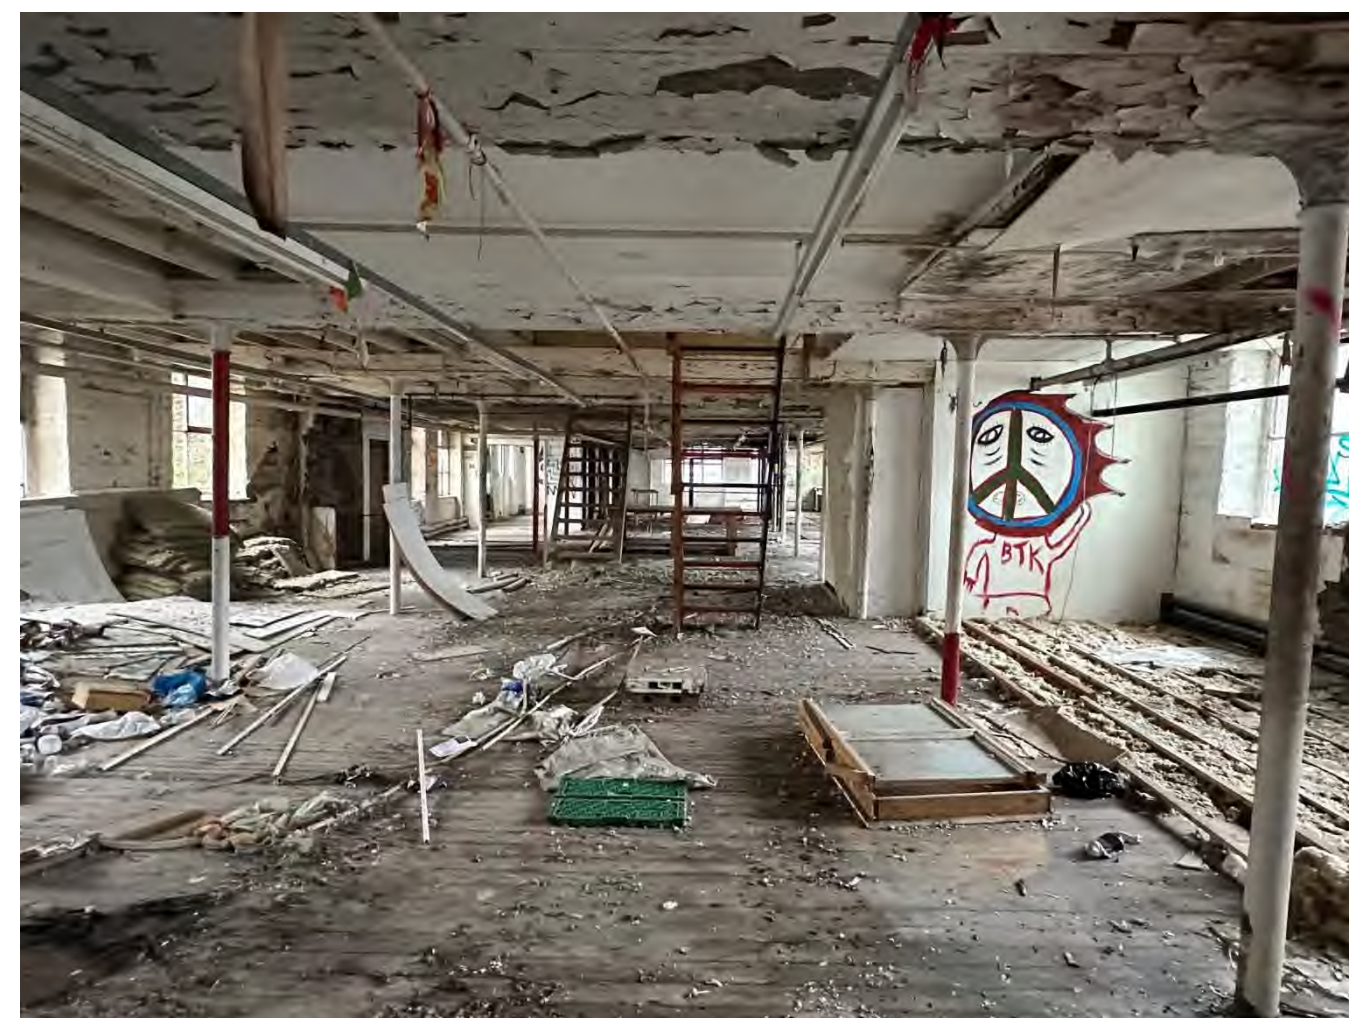
*Figure 55 - General view of first floor indicating continued deterioration due to water ingress and damp (taken 2023)*

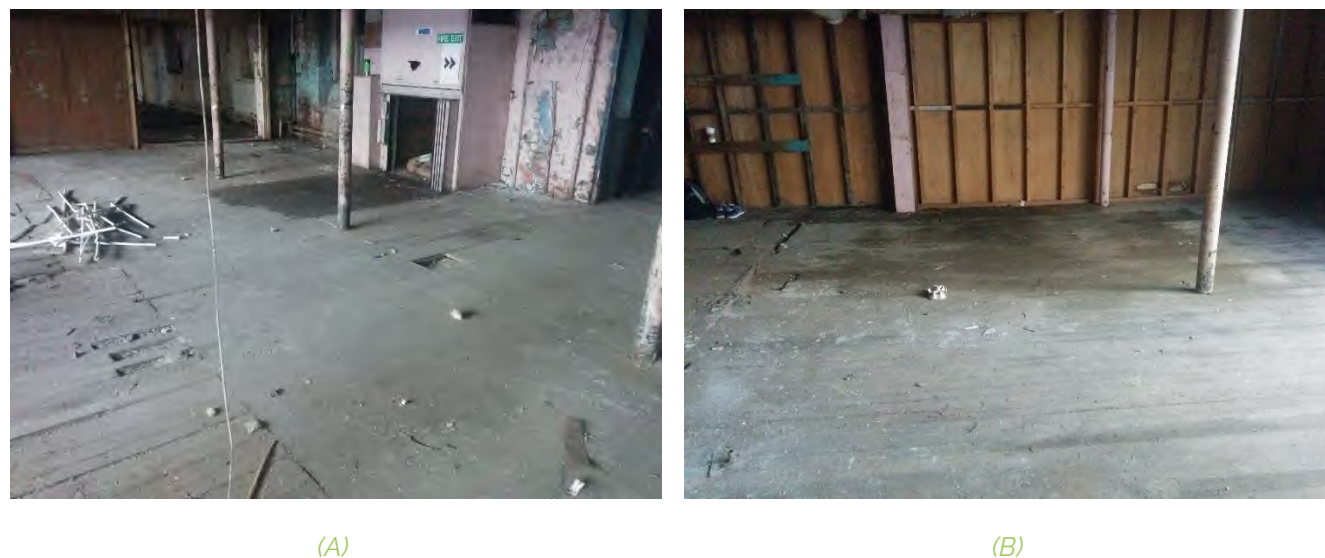
Water ingress evident at ground floor level is facilitating the further decay of the timber floor as per Figure 58 (A) and (B). Several timber floorboards are missing at ground floor level, as per Figure 58 (A).

Figure 58 - Water ingress at ground floor and missing timber floorboards (taken 2018)

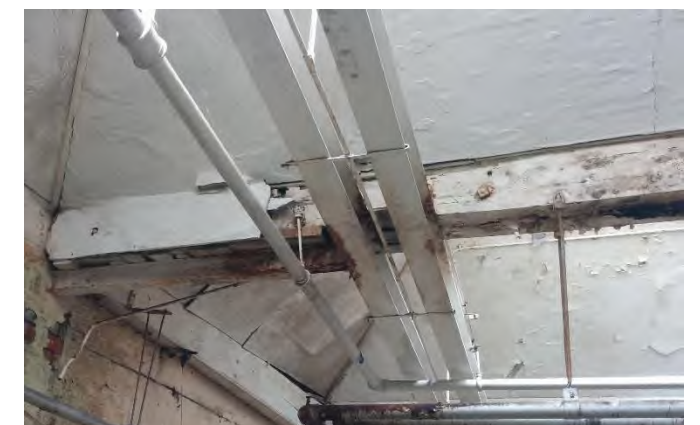
(B)

Figure 66 - Decayed roof valley timber beams (taken 2018)

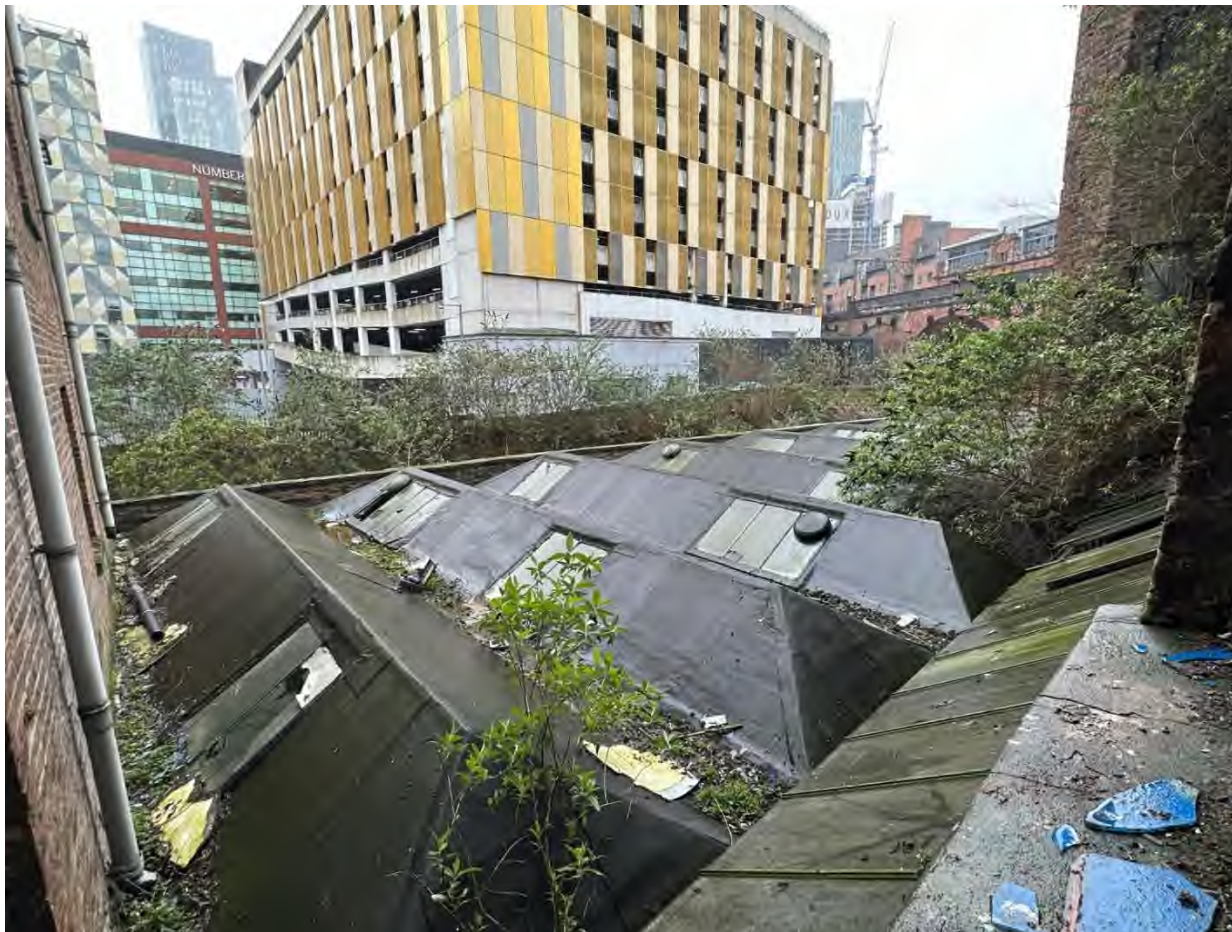
*Figure 67 – Roof and continued vegetation growth in gutters (taken 2023)*

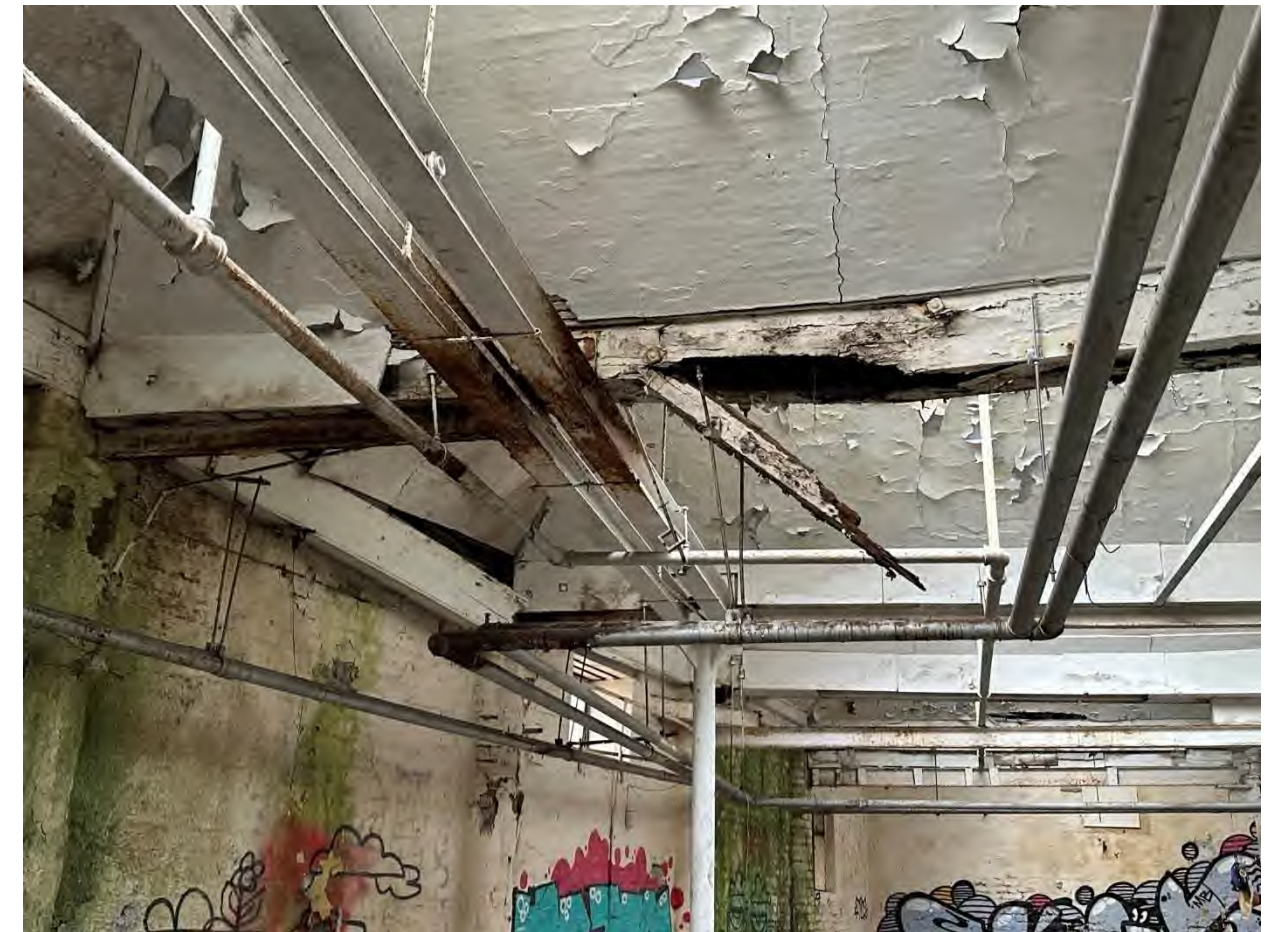
*Figure 68 – Evidence of continued water ingress and staining (taken 2023)*

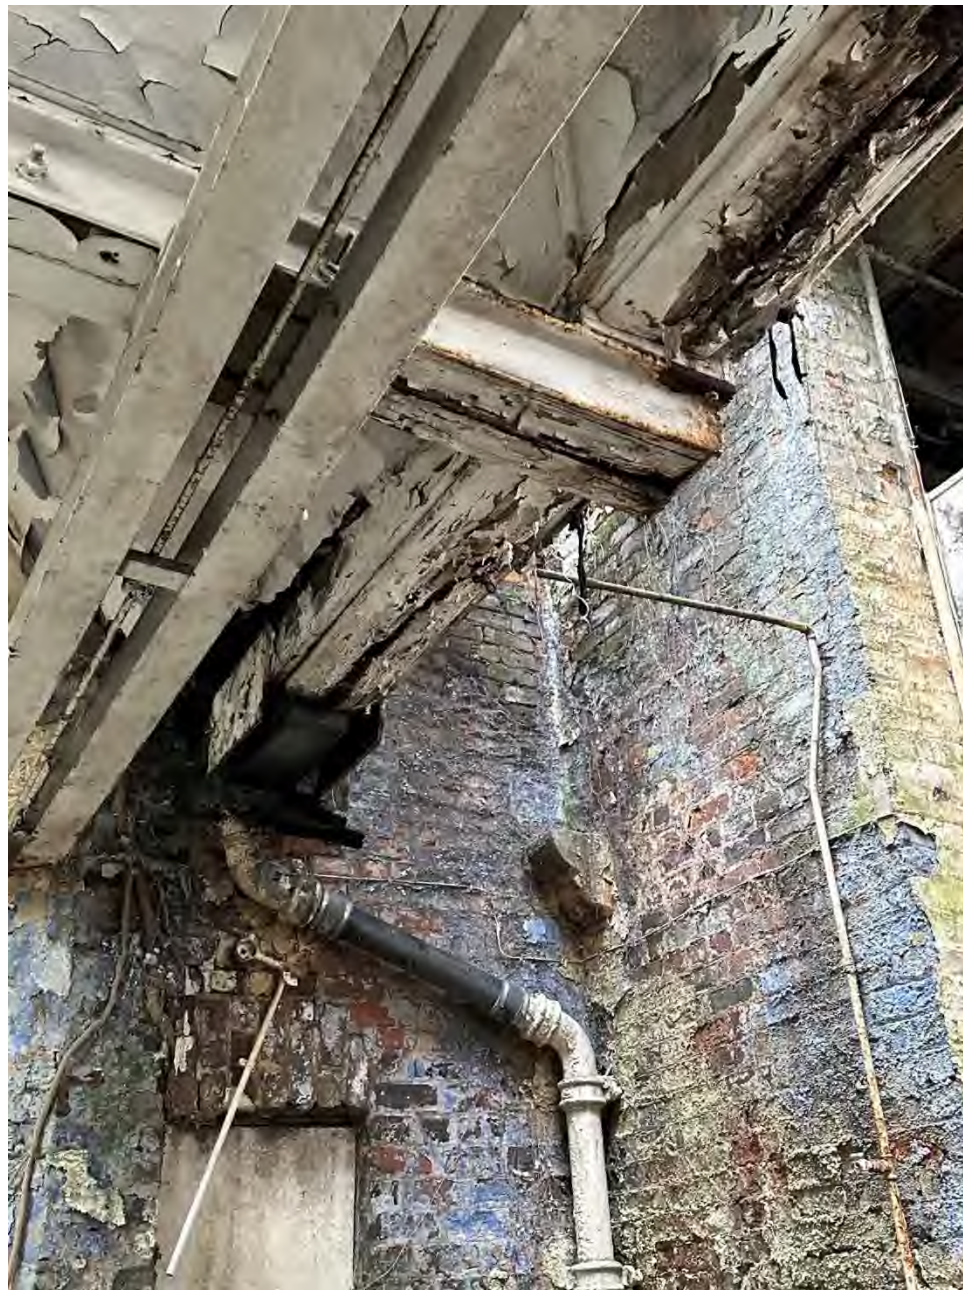
During the most recent site visits in 2023, it was evident that the vegetation to the lower level roof had continued to grow and intrude into the building roof covering and structure. The result of this is visible from below whereby evidence of continued water ingress and subsequent failure of timber structural elements was observed.

Figure 69 – Continued water ingress leading to timber decay and failure (taken 2023)

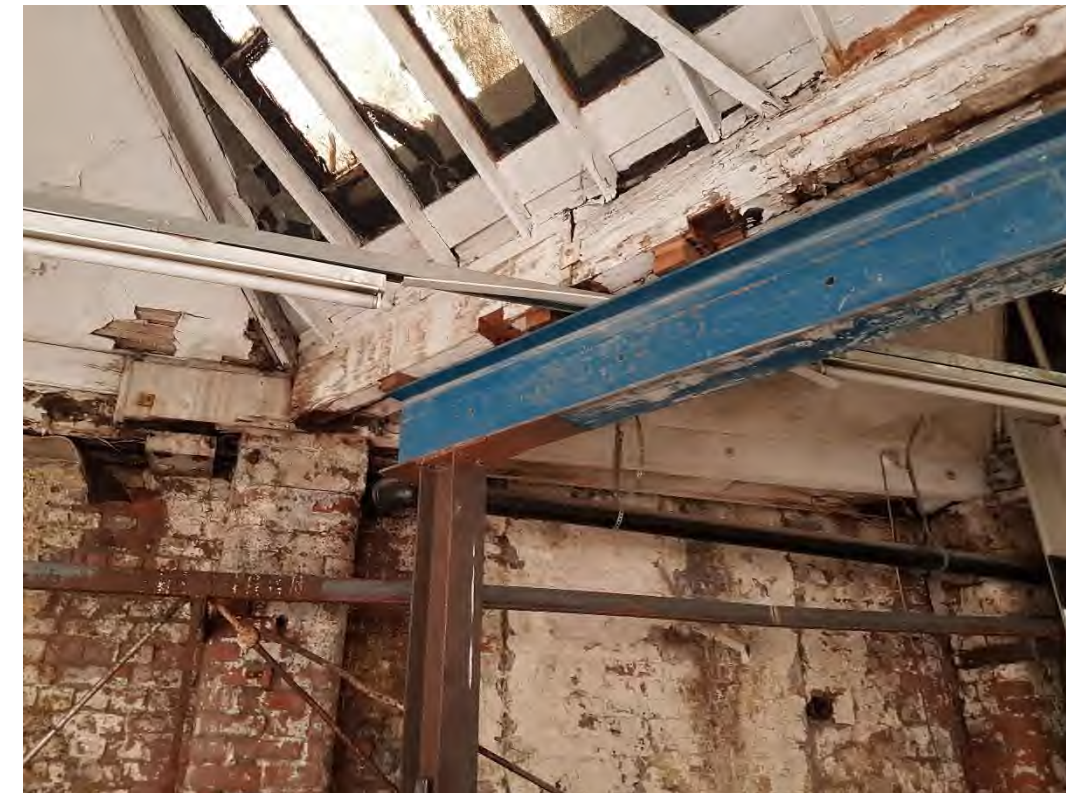
Several steelwork portal frames have been previously added in the eastern section of the shed assumed to offer additional support to the decayed roof timber beams, as shown in Figure 72. It appears that two of the steelwork portal frames might have been introduced to substitute the cast iron columns which were previously removed.

*Figure 72 - Steelwork portal frames supporting decayed timber roof beams (taken 2018)*

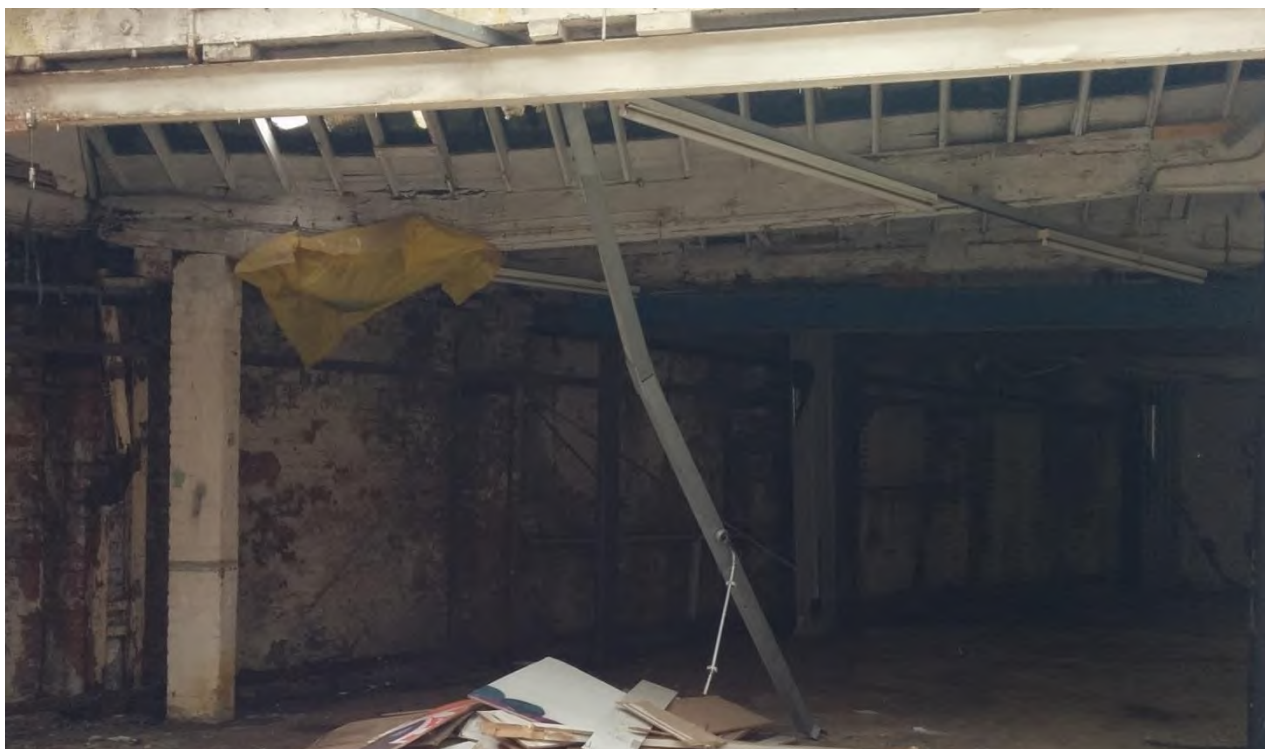
Figure 74 - Failed timber beam end (taken 2018)

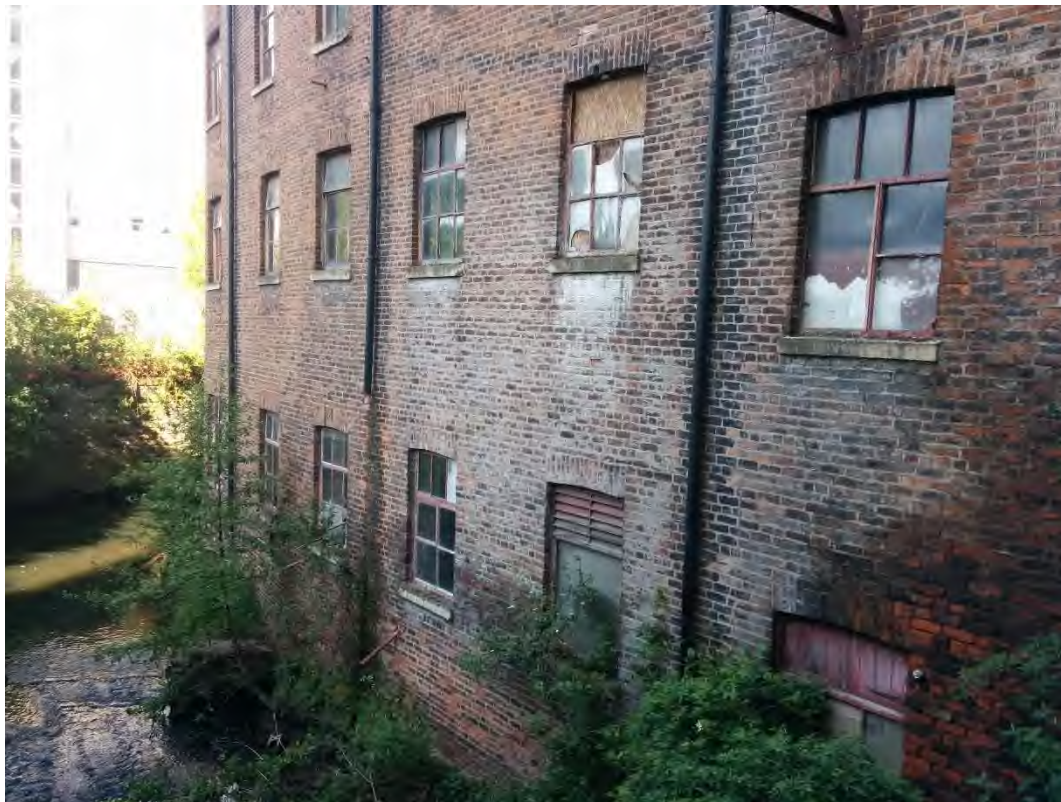
*Figure 77 - Heavy vegetation growth on south elevation (taken 2018)*

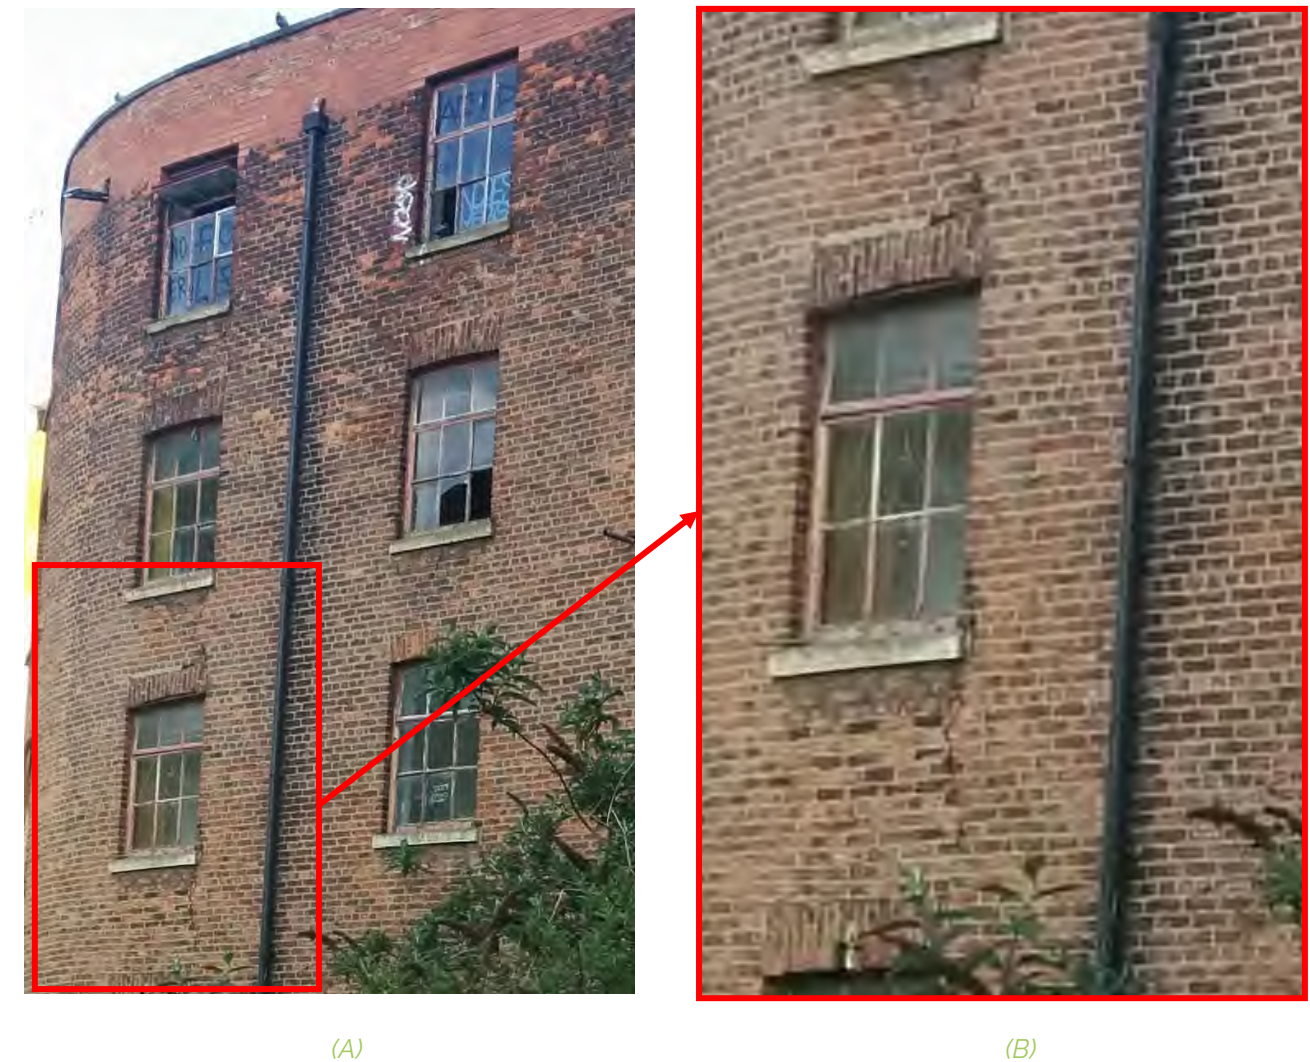
*Figure 78 - Significant cracking on southern elevation (taken 2018)*

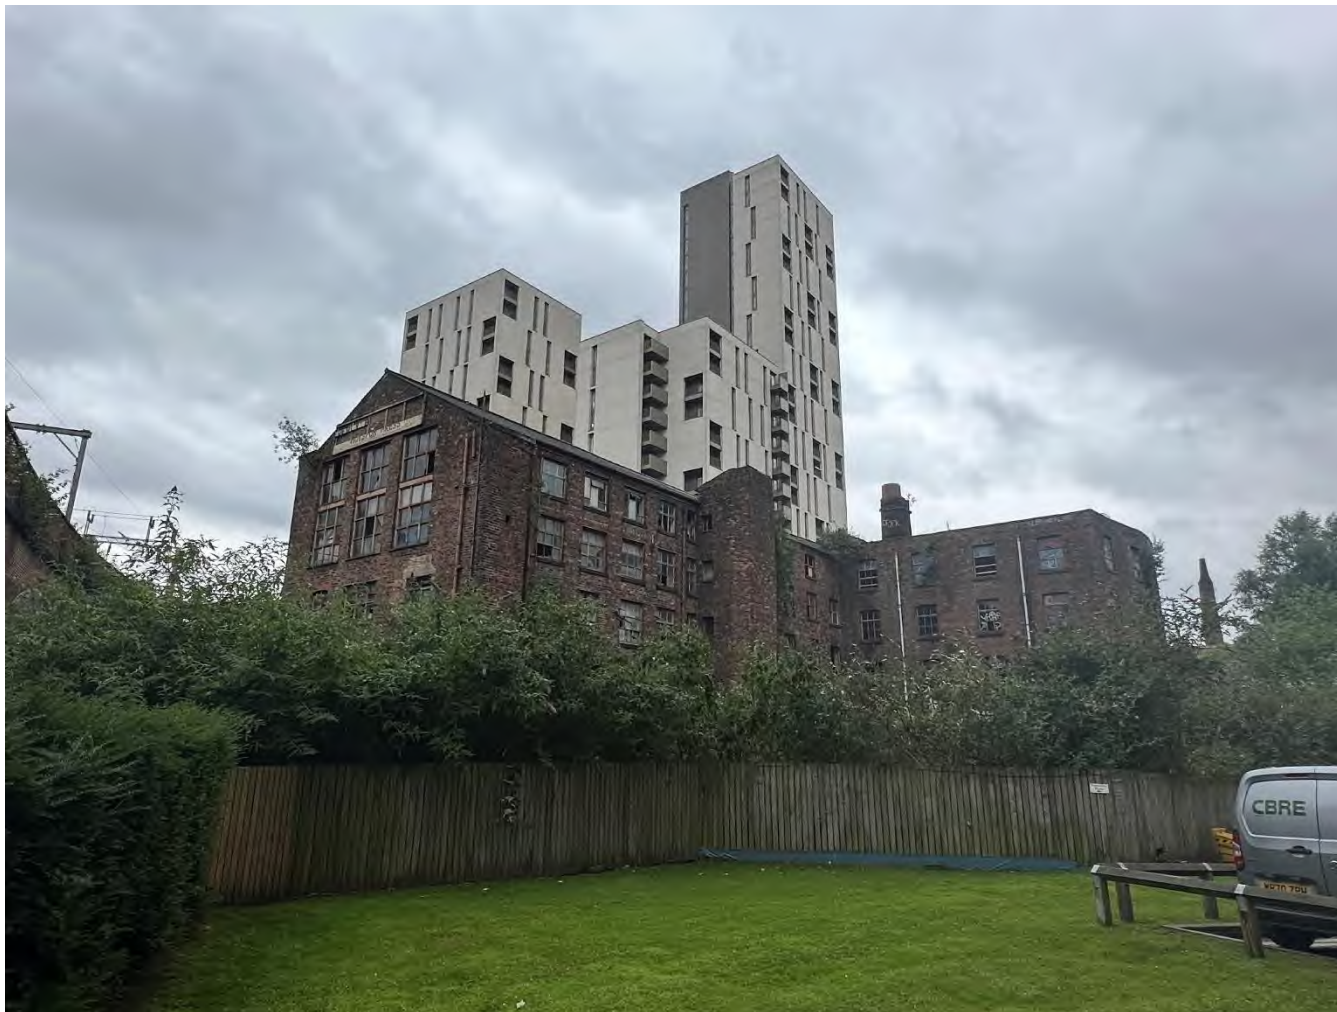
Figure 81 - Western elevation (adjacent to River Medlock) showing continued vegetation growth (taken 2023)
