Phase II Geoenvironmental Site Assessment  
Vine Street, Gorton

Reference: 14-944-R1-3  
Date: October 2023

## **PHASE II GEOENVIRONMENTAL SITE ASSESSMENT**

Land off Vine Street  
Gorton  
Manchester  
M18 8SR

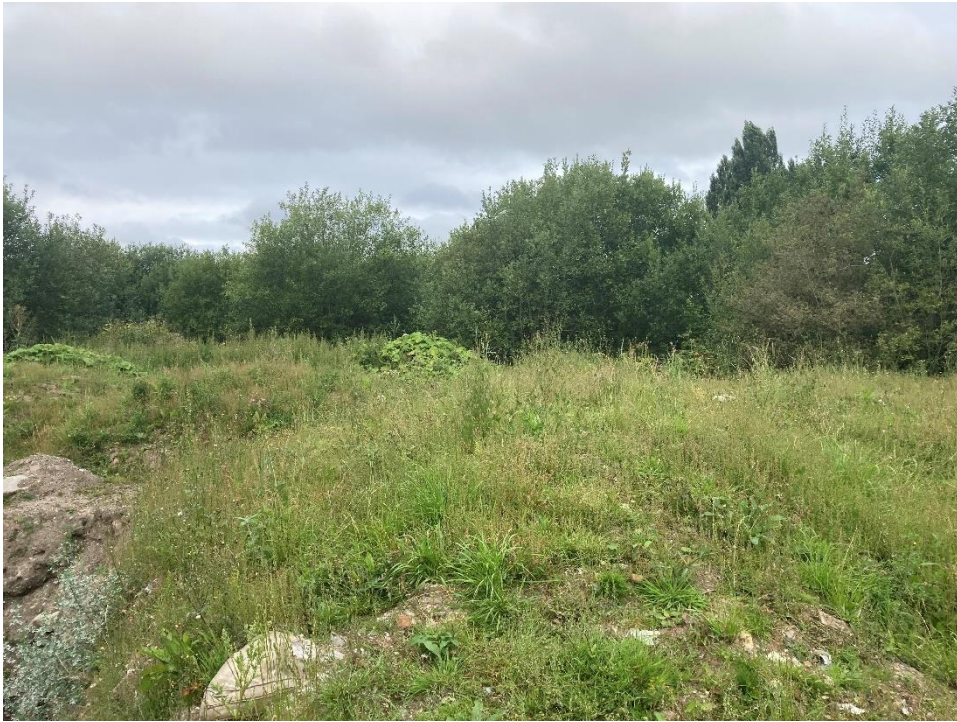
PLATE 3      VIEW OF WASTE STOCKPILES IN THE WESTERN SECTOR

Based on these results, the material within the stockpiles can be removed as non-hazardous.

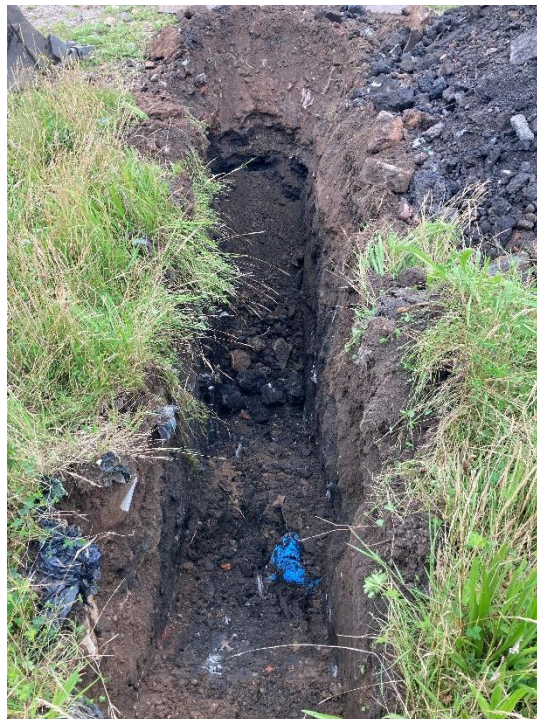
PLATE 6      EXAMPLE OF SHALLOW GRANULAR MADE GROUND (TP106)

The sides of the exploratory trial pit excavations appeared to be generally stable during excavation with the exception of TP106, where sidewall collapse was observed and the excavation terminated on a concrete obstruction.
