**SIM - Sitewide Capital Works**

**Stage 3 Structural Report – Gantry Planning Submission**

**SIM-BHE-XX-XX-RP-S-0102**

14 September 2023

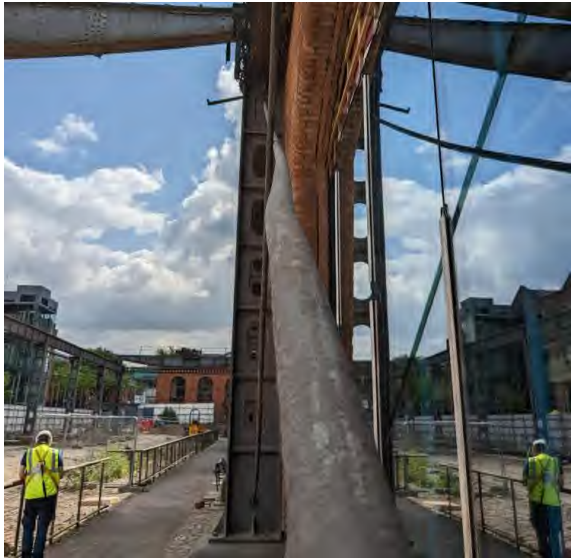
- Bracing to the southern columns shows signs of historic surface pitting but appears to be generally free from current corrosion. Braces are distorted along their length suggesting that they are no longer functional in resisting lateral loads, without first allowing significant movement. Figure 2-18.
- Bracing to the northern columns appears to be in good condition, with little sign of corrosion.

Figure 2-18 South cross bracing showing pitting & deformation

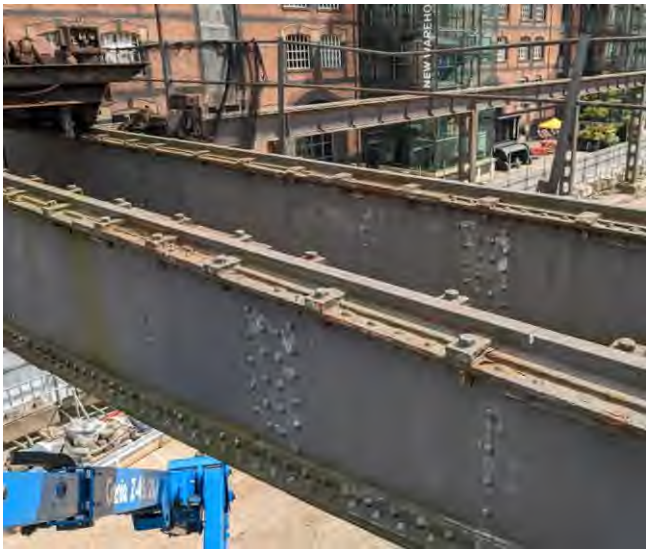
- As with the Gantry beams, the crane beams show widespread corrosion, ranging from minor to localised severe cases. Figure 2-22 to Figure 2-27
- 3 main types of corrosion are present on the crane beams:
  - Moderate/severe corrosion to the lower section of the beams along their full length. Similar to the Gantry beams this typically affects the angle which connects the web to the bottom flange, but also includes corrosion of the web and flange themselves.
  - Minor/moderate corrosion to the beam webs – particularly affecting the outside faces of beams 2 and 3.
  - Moderate severe corrosion to the top face of beams, with details as per the Gantry beams.
- Crane beams are understood to be hollow and the lack of drain holes means that they are likely to trap water, leading to internal corrosion. This is likely exacerbated by internal stiffeners which will trap water at various

Figure 2-22 Corrosion to top face crane beam

locations along the length of the beam. It is suggested that the conservation works address this by adding drainage points, and the works should include allowance for these areas to be inspected via borescope of similar.

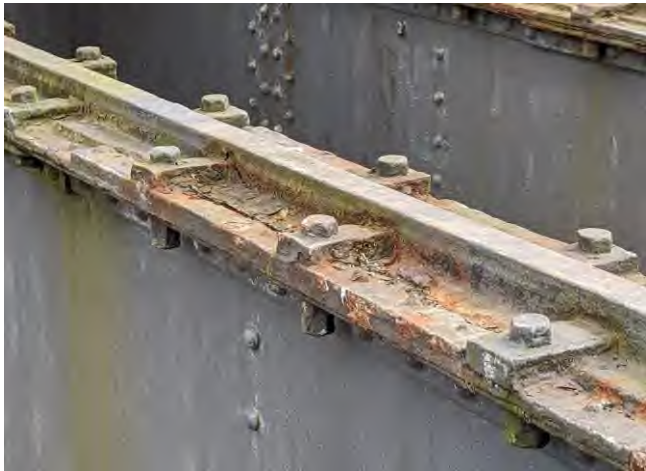
Figure 2-23 Corrosion top face crane beam

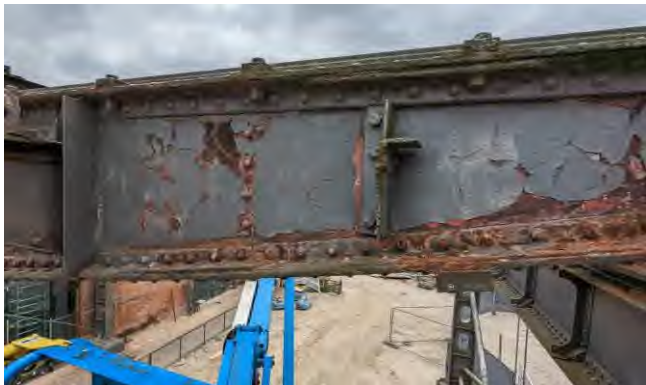
Figure 2-24 Corrosion to side face crane beam (western)

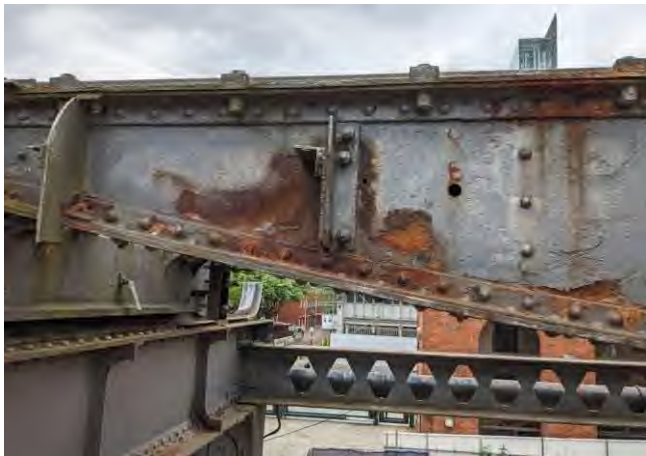
Figure 2-25 Corrosion to side face crane beam (eastern)

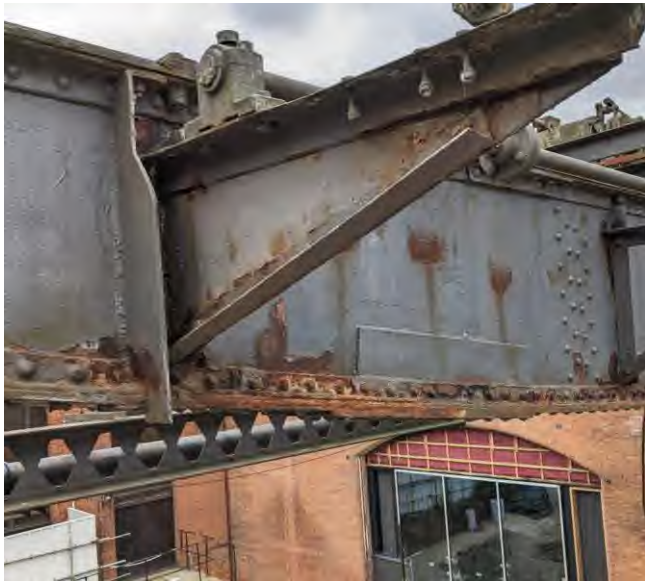
Figure 2-26 Corrosion to bottom of crane beam

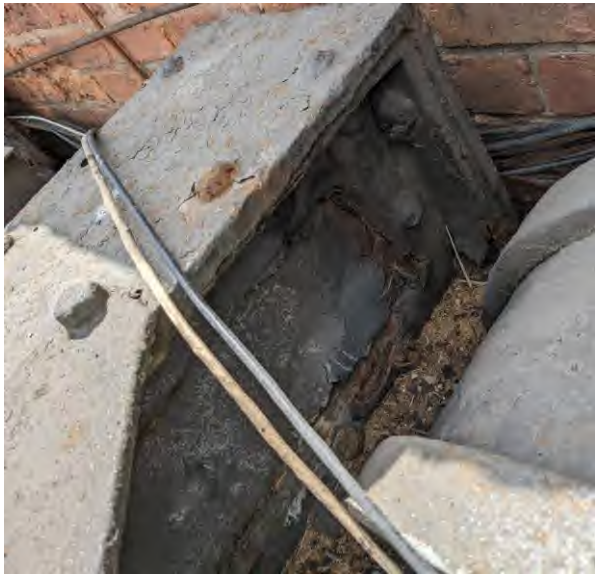
Figure 2-27 Crane beam end corrosion

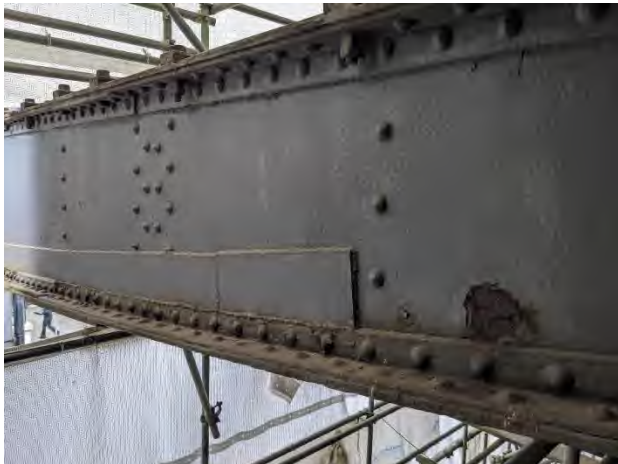
- Many of the crane beams show evidence of previous repairs. There typically include welded plates to replace lost sections of metalwork. It is worth noting that most of these repairs would not be considered to be appropriate for conservation work due to their appearance.

Figure 2-28 – Previous repair to crane beam

- Crane beams have been subject to previous repair works which are not deemed to be of conservation standard. Whether or not these are replaced with more appropriate repairs should be considered.

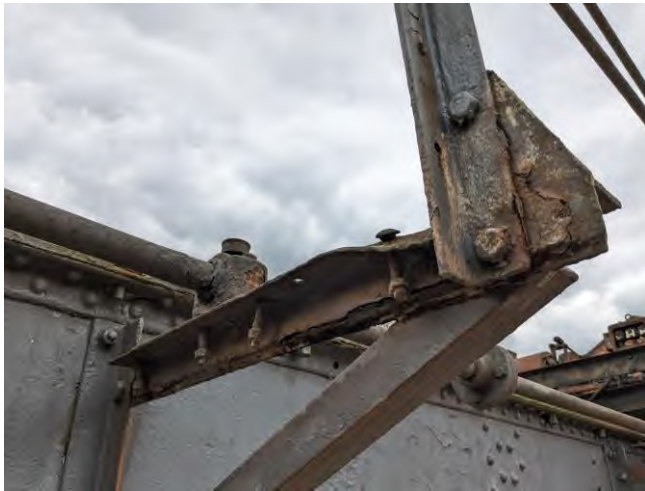
- The crane beams include several secondary structures including balustrades and lifting gear. Figure 2-29 & Figure 2-30.
  - Balustrades are typically in poor condition due to deformation and corrosion and can no longer considered to be functional. However, it is assumed that they no longer need to fulfil this function. Assuming they are retained as part of the exhibit they will require remedial measures to address corrosion.

Figure 2-29 Crane beam balustrade – corrosion & deformation

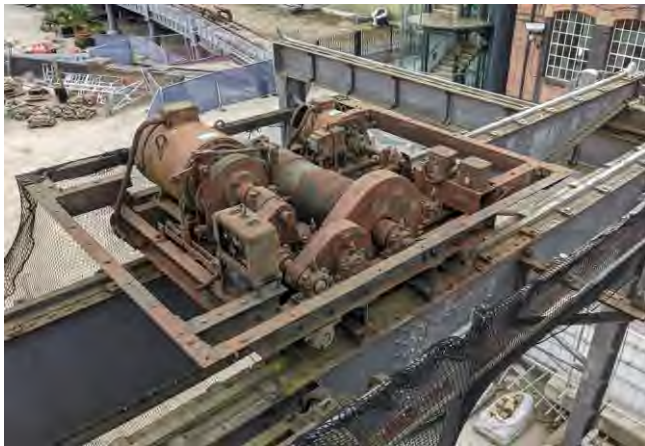
- The lifting gear appears to be sound, but with widespread minor corrosion. As the gear supports cabled hooks etc, it is suggested that this apparatus is inspected by a craneage specialist subcontractor who can advise on how best to preserve and make safe the gear.

Figure 2-30 Lifting gear to western crane beam

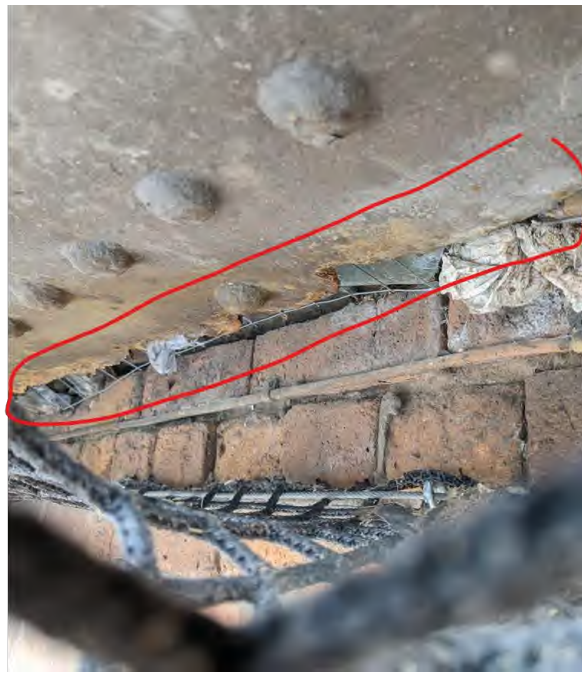
- There are 3 main areas of corrosion to the Gantry beams:
    - Southern face of south beams. Severe corrosion of the top and bottom flanges has reduced the section

width by up to 50mm. This is more prevalent at the western end of the Gantry, but is present across the whole length. Figure 2-31 to Figure 2-33.

Figure 2-31 Severe corrosion & loss of section width – southern face of south Gantry beam, bottom flange

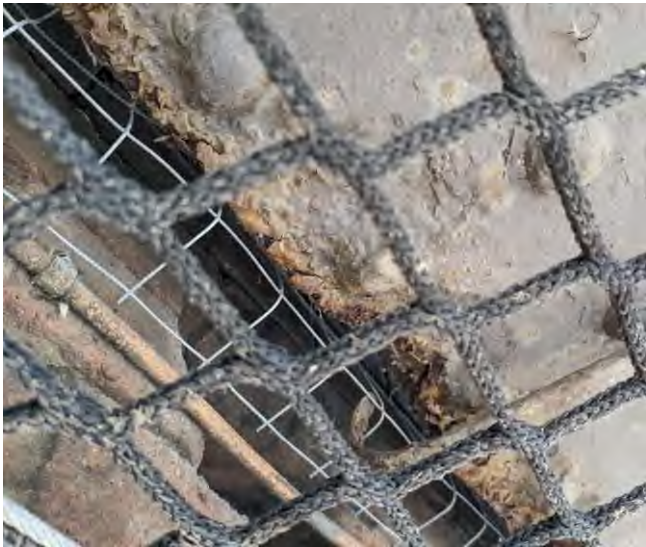
Figure 2-32 Severe corrosion & loss of section width – southern face of south Gantry beam, bottom flange

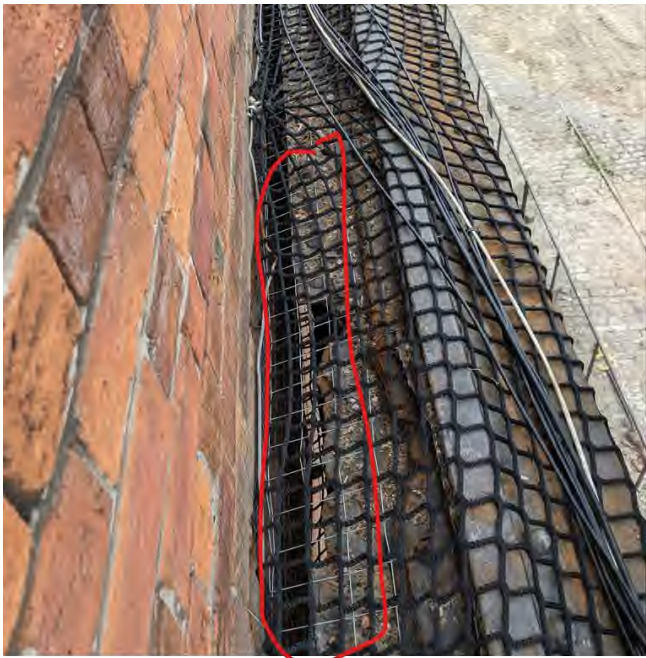
Figure 2-33 Severe corrosion & loss of section width – southern face of south Gantry beam, top flange

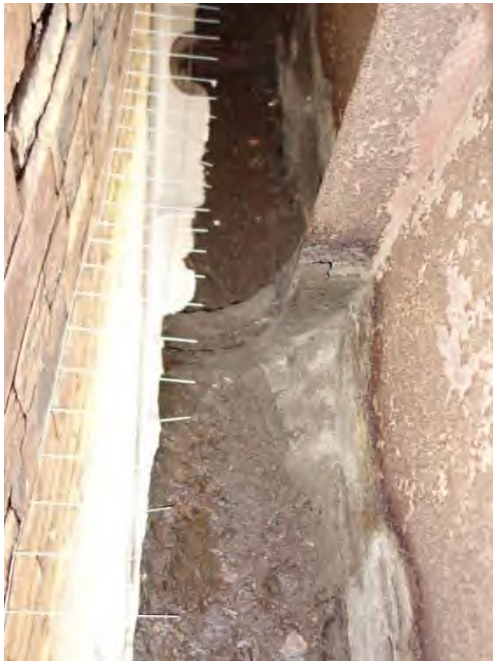
Figure 2-34 Corrosion and lack of protection to southern face of south Gantry beam

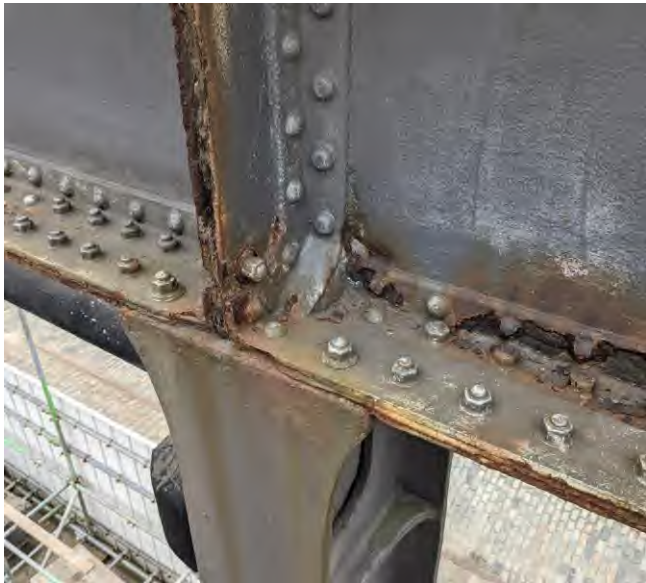
- #### Longitudinal Gantry Beams
- Gantry beams show widespread evidence of corrosion, ranging from minor surface corrosion to localised severe corrosion and loss of structural capacity. Figure 2-35 to Figure 2-40.

- Lower part of beam web, at stiffener/column head locations – south and north. These areas appear to have trapped water leading to moderate/severe corrosion in most instances along the length of the beams. This typically affects the angle which connects the web to the bottom flange, but also includes corrosion of the web and flange themselves.

Figure 2-35 Typical corrosion to Gantry beam at column head

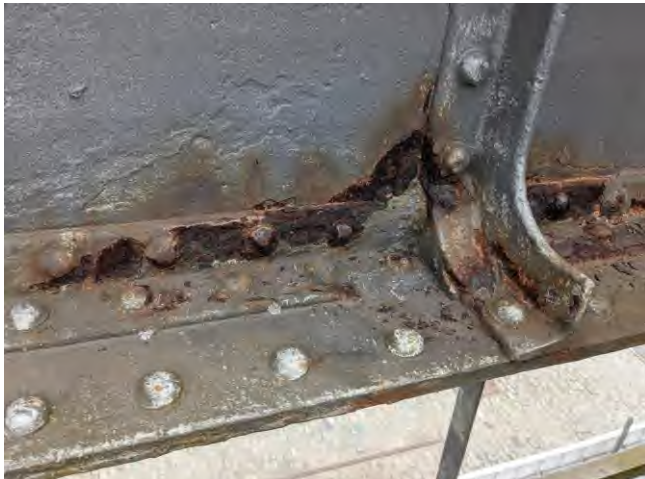
Figure 2-36 Typical corrosion to Gantry beam at stiffener

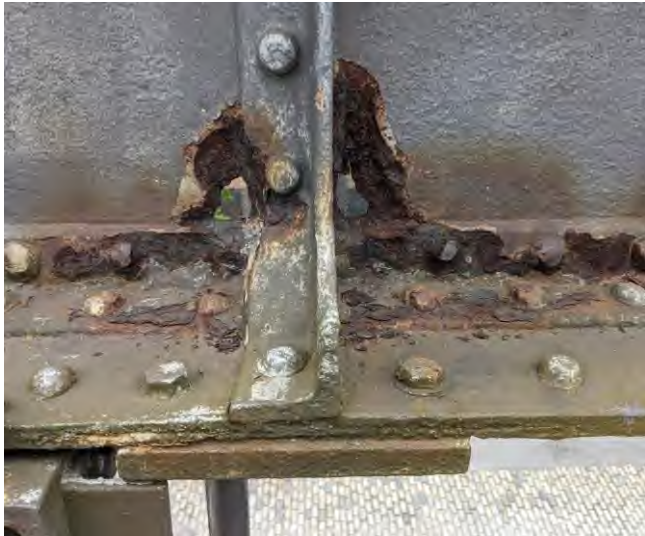
Figure 2-37 Severe corrosion to Gantry beam at stiffener

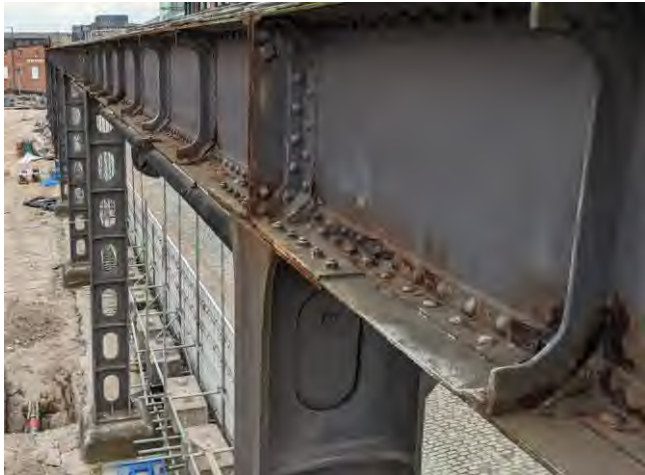
Figure 2-38 Typical corrosion to Gantry beam

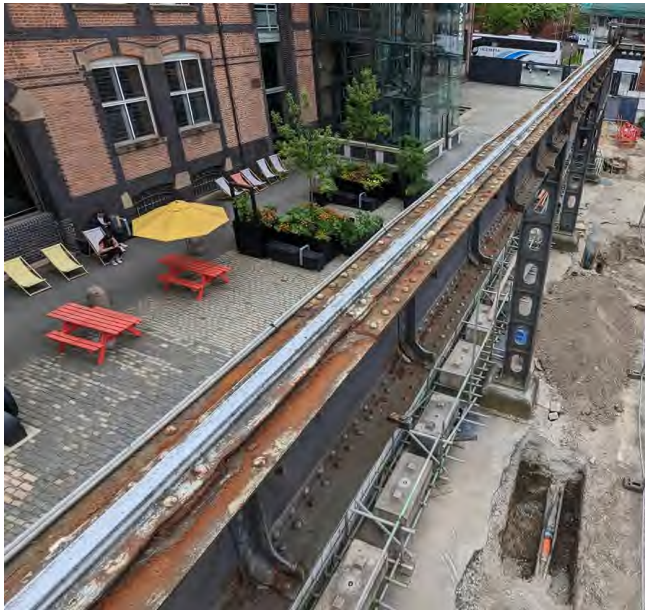
- Top face of the beams – south and north. Moderate/severe corrosion is present across the Gantry in these locations, particularly affecting the rail section which allows movement of the crane beams.

Figure 2-39 Typical corrosion to top face Gantry beam

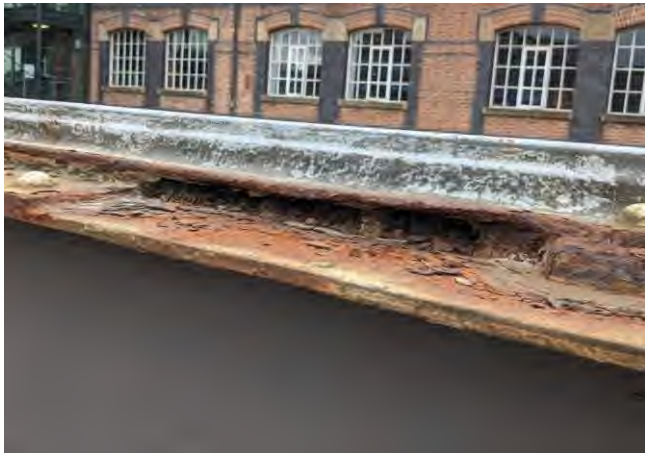
Figure 2-40 Moderate corrosion to top face Gantry beam
