## **Structural Statement for the proposed alterations to the former anti-chambers alongside the Rochdale Canal at Victoria Mill, Manchester.**

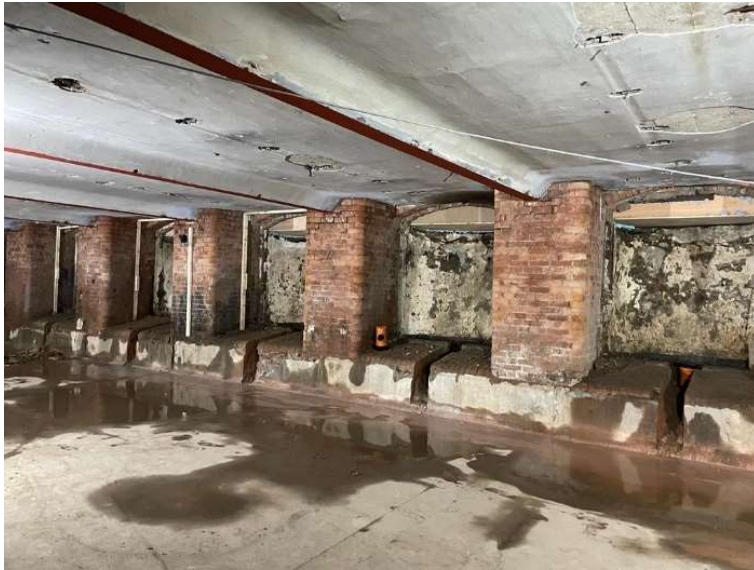
**Photo 2:** Internal view on the south wall of the warehouse, south block. The chambers can be seen between the pillars forming the external wall at that level.

- Floor beams span across the warehouse onto the external wall alongside the canal. The wall at the canal level is punctured by a series of openings leaving a series of pillars typically 5 bricks wide and deep at 3-4m apart.
- A curved wall (on plan) extends outside the line of the external wall to create the chamber. I understand that the wall is inclined to the vertical: This is a typical construction technique for buildings of this warehouse's age. The curved wall will be structural in that it resists the pressure of the canal water across the opening. The wall has been rendered. The render appears to be in a poor condition. I presume that the main body of the wall behind is masonry construction.

- The base of each of the chambers occur above the lower ground floor level, leaving a band of brickwork on the external wall line. I estimate that the lower ground floor level is approximately 2.5 - 3m below the canal walkway. A narrow chase has been formed in each bay in the lower wall section. Originally this may have accommodated a drainage outlet.

- From the above photographs it is not possible to tell the condition of the external wall of the chamber masonry. There is evidence of slight movement of the masonry below the floor beam bearings but elsewhere in the visible section of the wall, the masonry appears satisfactory. I presume that ADS will undertake their own detailed inspection of each chamber and the external wall.

- I note that there is a one brick wide arch over the opening to the chamber at canal water level. The external wall above must rely for its support on this arch acting in conjunction with the ground floor structure.

- The lower ground floor appears wet alongside the chambers but elsewhere the floors are relatively dry. This is probably rainwater entering the open roof space of the chamber. Typically canals relied on either puddled clay or asphalt applied to the external face of masonry buildings to act as a waterproofing membrane. Neither are visible in the photographs. The render is unlikely to be capable of preventing water ingress.

- a. Checks are made to establish the type of render that exist on the chamber walls. Originally it is likely that this wall either had no render or a lime based render was applied. This type of render is relatively easy to remove and will allow for checks to be made on the type of mortar used within the presumed chamber brickwork. If the render has been more recently applied then it is probably a cement based render: Such renders are difficult to remove and often bring the face of the brick with it. This will reduce the structural capacity of the wall.

- b. A sample of the existing mortar should be removed from the inside face of the chamber wall and be sent to a laboratory for constituents part analysis.

- c. Each of the chamber walls need careful examination.
  - The junction of the chamber wall with the warehouse external wall should be checked for integrity of bond. If found to be unbonded then install stainless steel stitch dowels across the joint and repoint the face.

- Any horizontal cracking should be checked to establish the cause. There may be embedded ironwork that is corroding.
  - Any local rebuilding of the wall should use brickwork of a similar strength and water absorption to the base brickwork. The masonry should be set in a mortar compatible with the findings of item b) above.

- d. The introduction of a reinforced concrete capping beam to the perimeter of the chamber, as shown on the sketch, will help to restrain the head of the wall and allow for fixing of handrailing. The level of this beam needs discussing further with the architect. Consideration should be given to dowelling the capping beam into the warehouse external wall as well as to the top of the chamber wall. All such dowels should be stainless steel bars fixed into site drilled holes and secured using an appropriate resin to suit the moisture content of the brickwork.

- e. The detail shows a new external concrete slab in the base of the chamber. I would suggest that trial holes should be excavated to check the level of the base of the inclined wall. The base of the existing inclined wall or the warehouse, external wall should not be undermined by any part of the new construction.

- f. The substrate at the formation level of the slab's sub-base needs checking in each location. if the substrate is solid brickwork, then the slab should bear onto a concrete blinding. If the substate is a filled ground, then the slab should bear onto visqueen onto a sand blinded granular hardcore compacted in place.

- g. The top face of the new lightwell slab should be laid to a fall towards the new drainage gulley.

- h. Depending on the integrity of the waterproofing to the existing construction and or the canal, this base slab may be subject to an upward pressure. Consideration should be given to dowelling this slab into the chamber's wall and the slab / reinforcement be designed to resist an assumed head of water pressure. This may require an engineering judgement to be made.
- i. The type of waterproofing membrane needs to be discussed further with a specialist supplier based on the findings of item a) above and the required level of waterproofing.

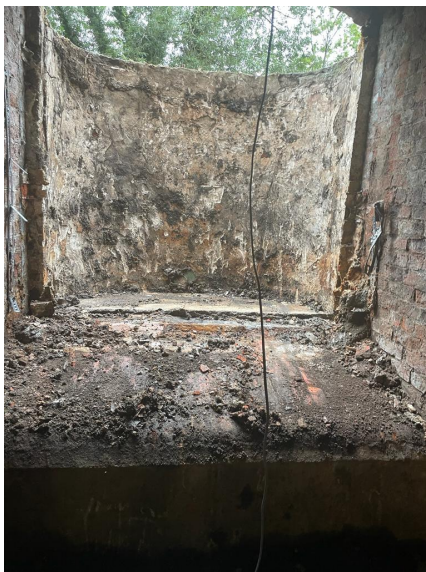
**Photo 3 Left:** Close up view of the chambers.

Note that the base of the external chamber terminates above the lower ground floor level and that the wall below has a sloping surface. The chamber wall is both curved on plan and has a vertical inclination.
