# Science & Industry Museum Viaduct

Viaduct  
Design and Access Statement  
September 2023

Project name: Viaduct  
Project number: 9488  
Client: Science & Industry Museum, Manchester

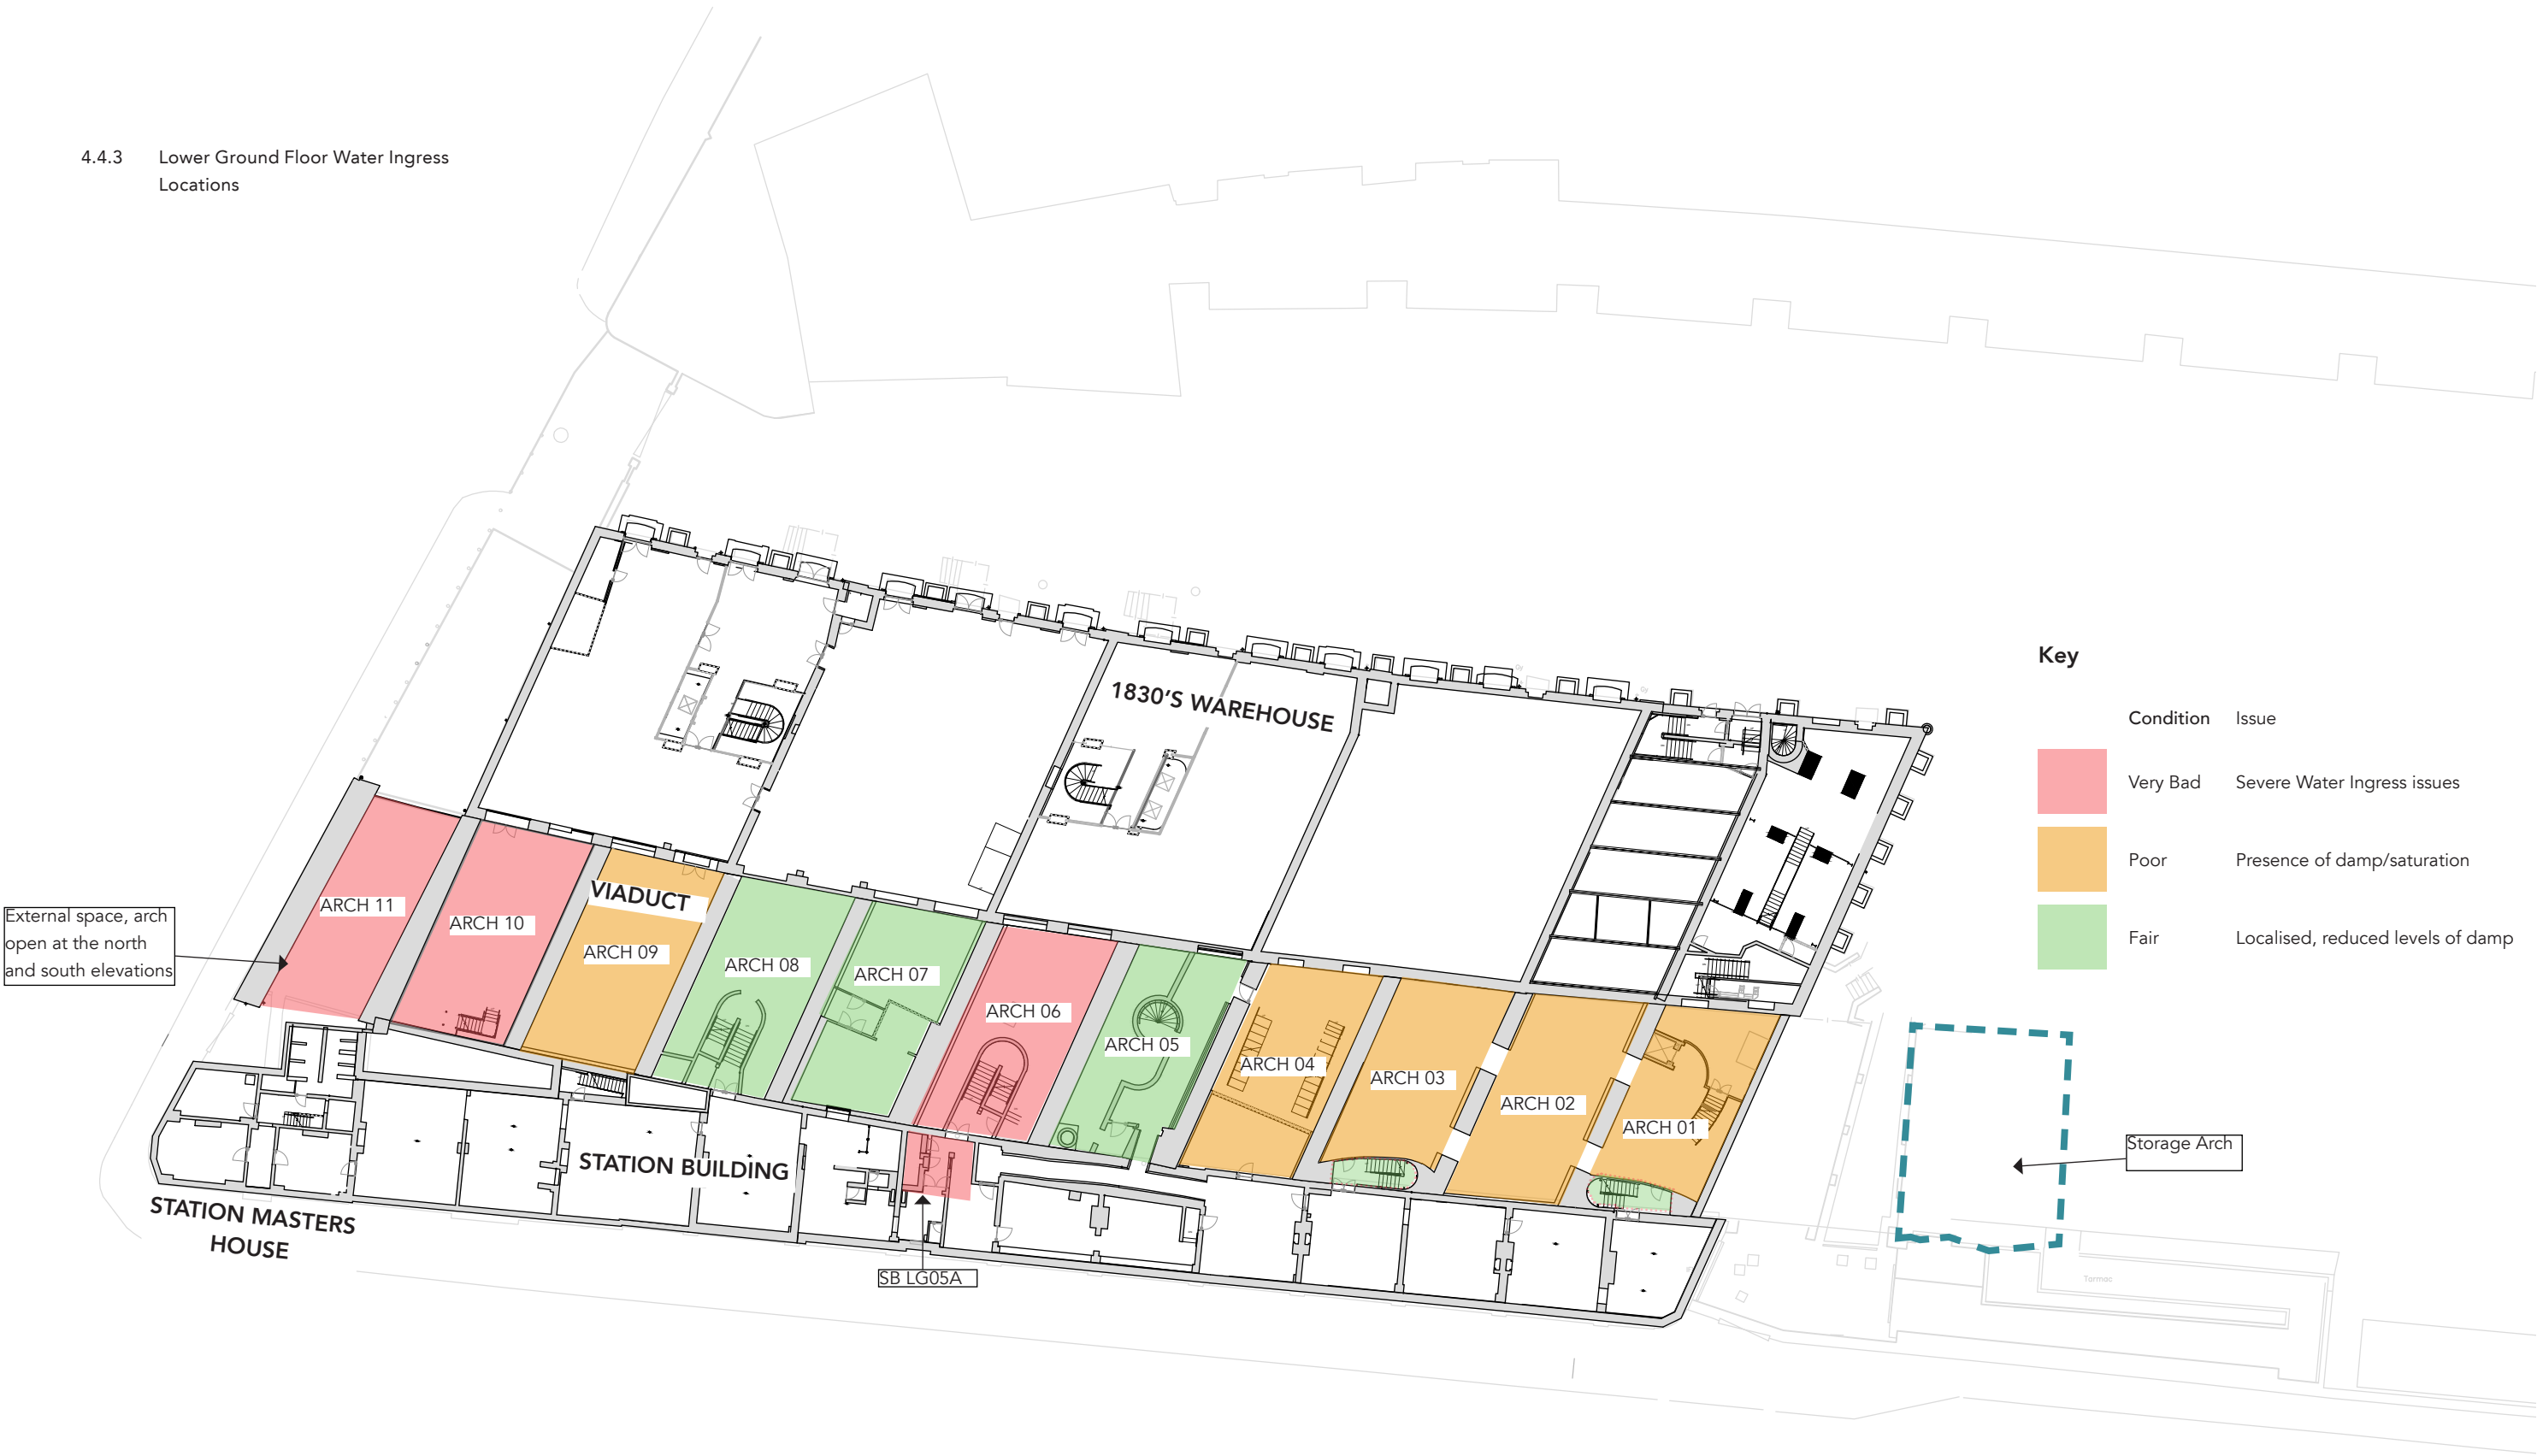
4.4.3 Lower Ground Floor Water Ingress Locations

The plan diagrams provided across the following pages illustrate the areas observed internally where there are high moisture levels and evidence of ongoing water ingress.
- 4.4.2

For the purposes of this report a Red, Amber, Green (RAG) system has been adopted as a means to graphically represent the condition and level of moisture/saturation observed internally.

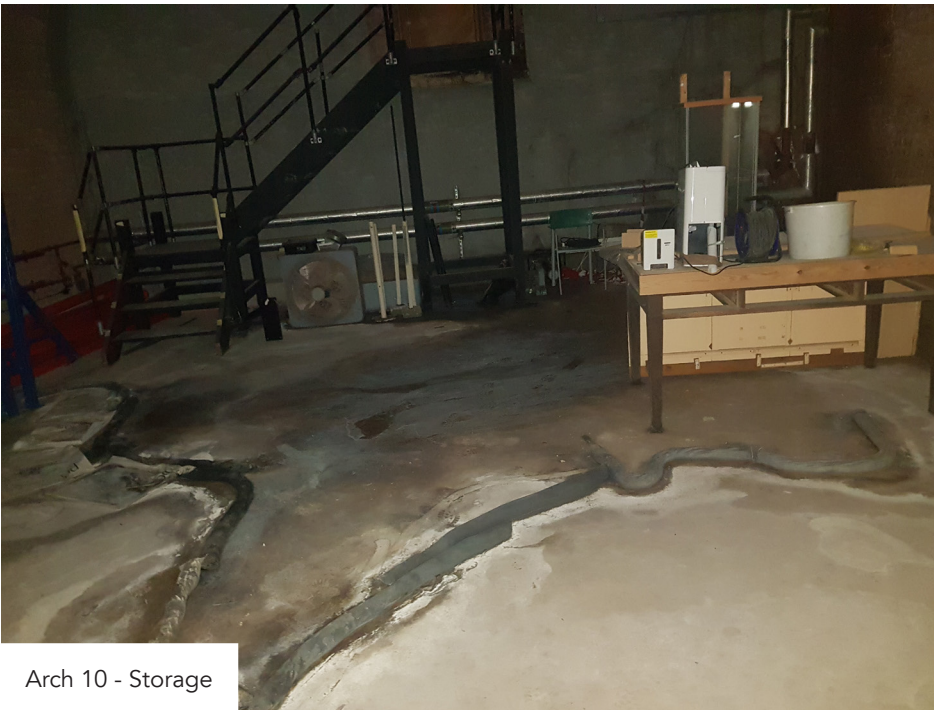
Arch 10 - Storage

4.5.6.3 There were signs of ongoing water ingress issues found, which appeared to be isolated towards the south western corner of the arch.

4.5.6.4 The masonry was visibly saturated, spalled, friable with open mortar joints.

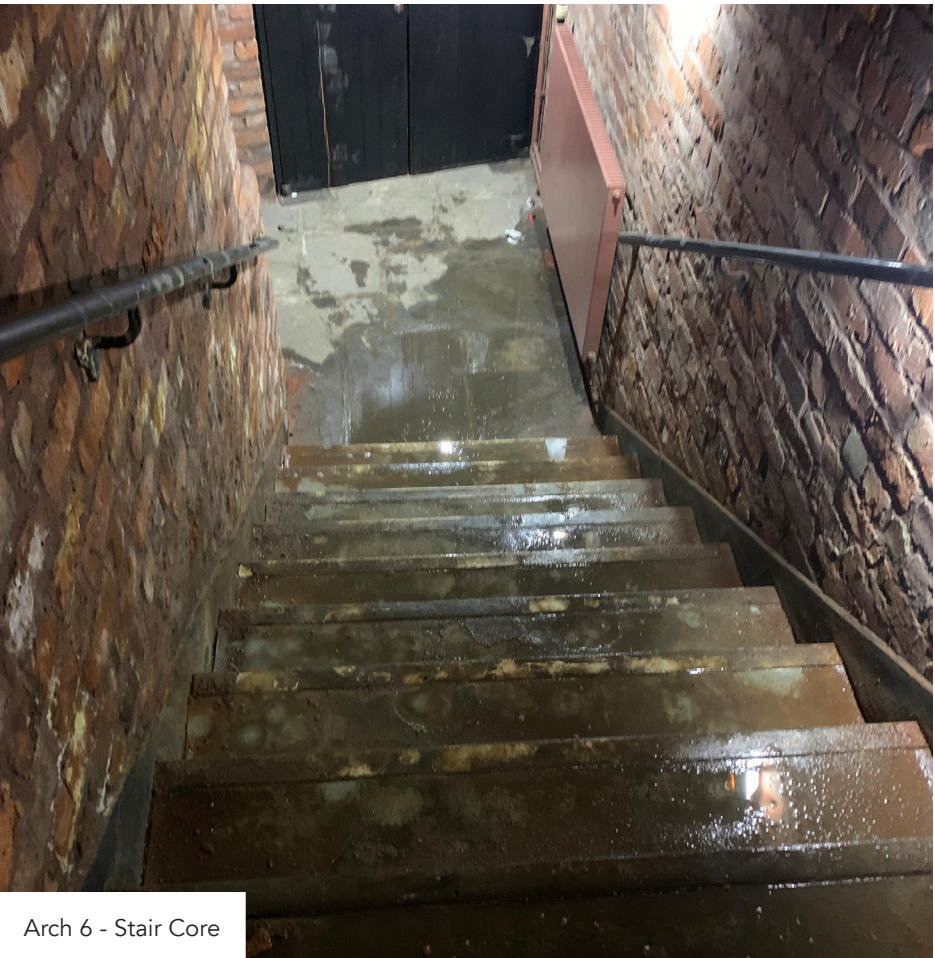
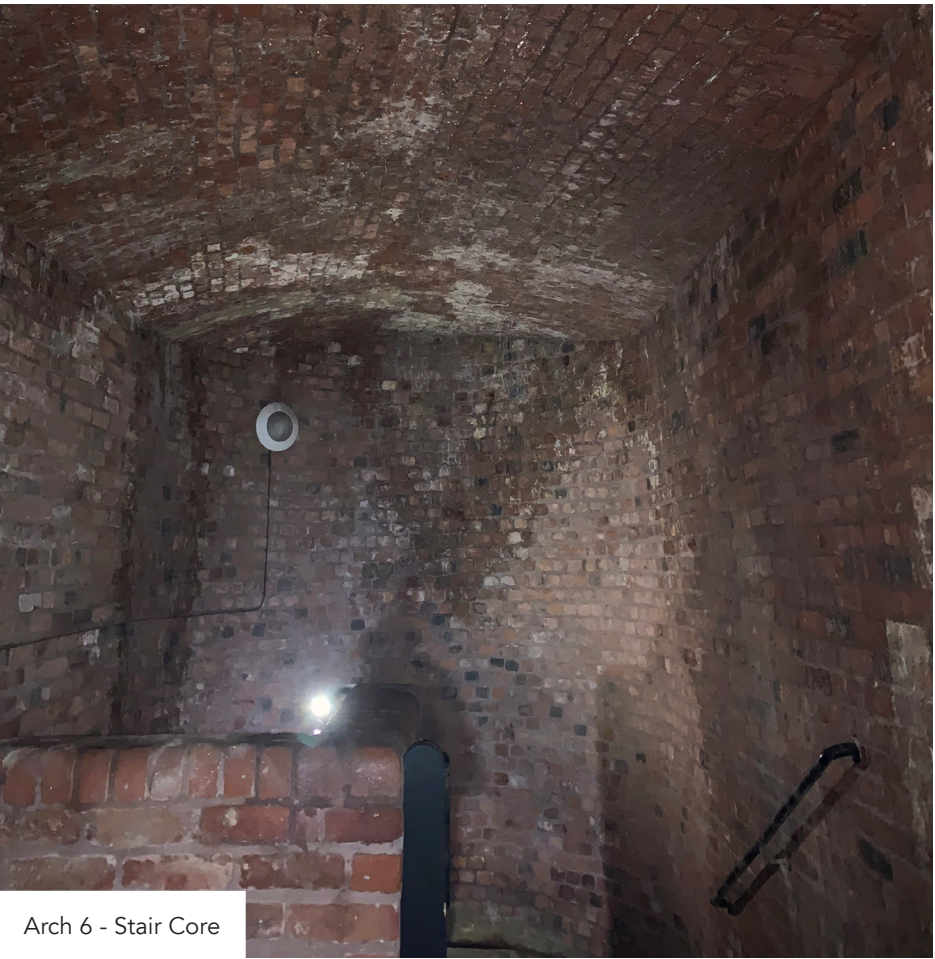
Arch 6 - Stair Core

4.5.6.15 The masonry walls are heavily soiled, with spalled bricks, open mortar joints and efflorescence.

4.5.6.16 This not only has a massive impact on the degradation of the structure, but also poses a health and safety risk, given that this stair core forms part of the means of escape strategy.

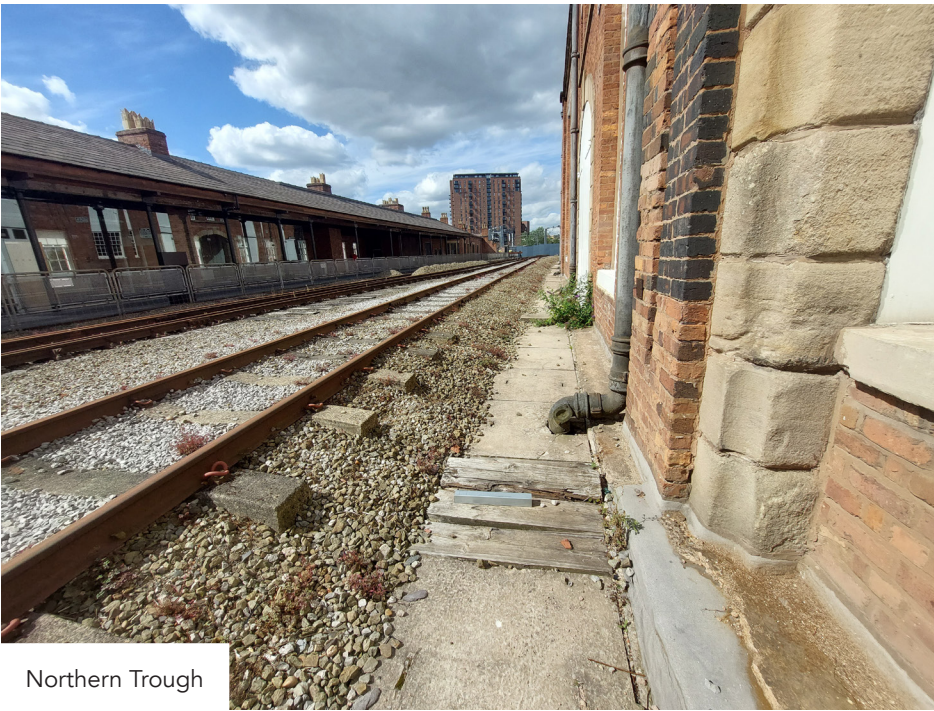
Northern Trough

4.5.7.2 The northern concrete trough runs the full length of the 1830s Warehouse to the south elevation and appears to take ground water from circa 50% of the viaduct slab, whilst also taking water from the rainwater pipes to the south elevation. It is likely that the downpipes take circa 50% of the roofscape across the warehouse. It is unknown what area of the warehouse roofscape the downpipes take. It is likely that there are a series of land drain connections from the viaduct slab, which discharge into the trough, though none were observed at the time of the survey. The flashing upstand was brittle, defective in areas.

4.5.7.5 Upon closer inspection, the hopper and downpipe appeared to be blocked with silt, vegetation growths. Given the extent of well establish vegetation, it is reasonable to suggest that there is a high moisture content within this location. Suggesting potentially defective below ground drainage pipework.

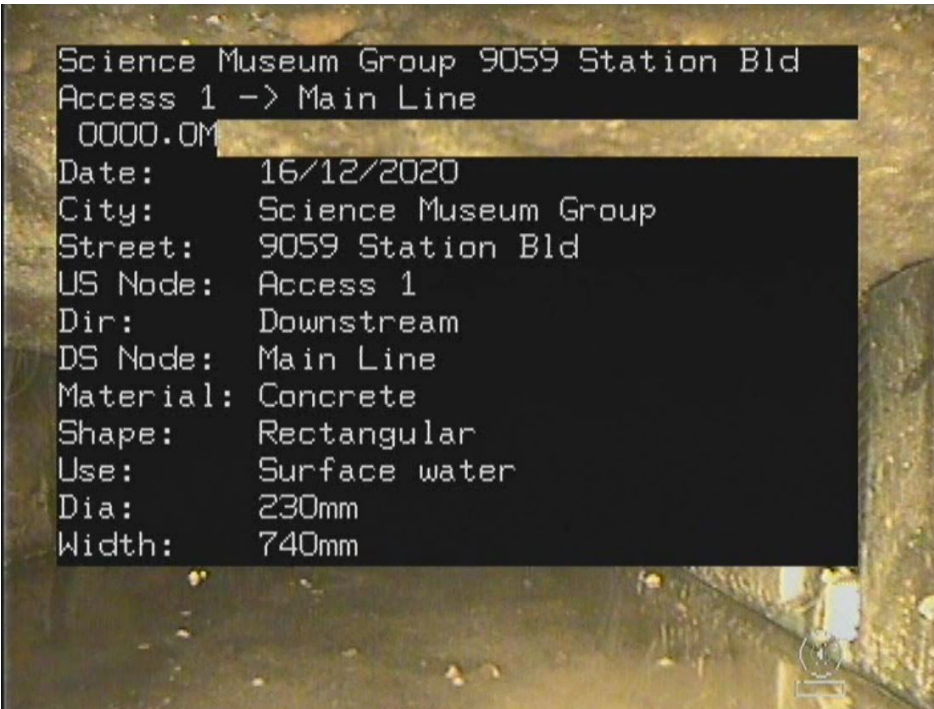
Image from CCTV inspection.

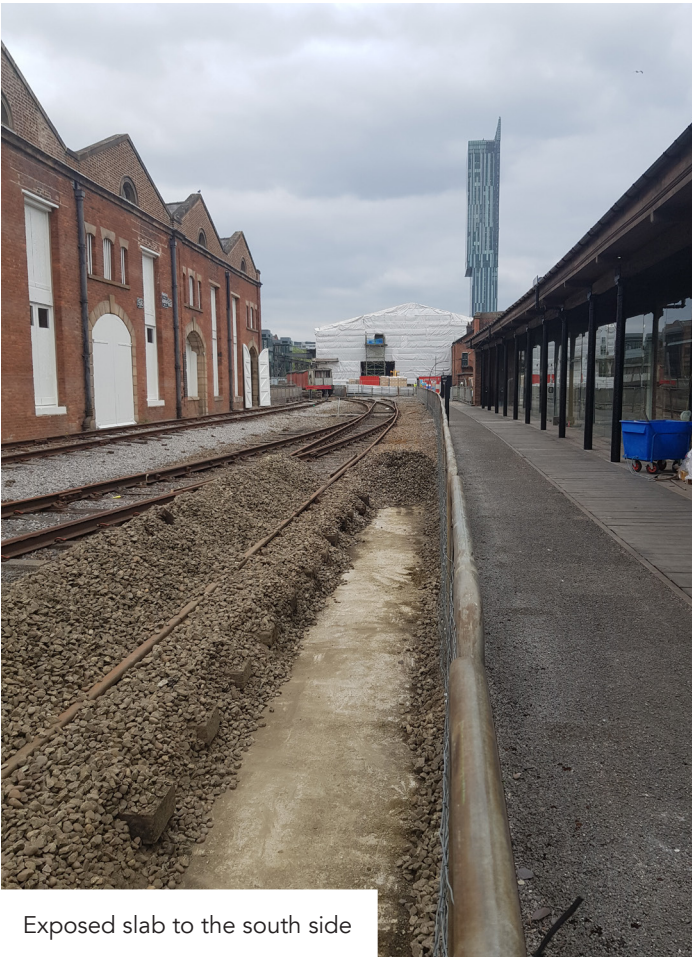
- Ground water is migrating between the original viaduct capping and the concrete slab.
- There is defective, broken below ground drainage.
- The slab and outlets cannot cope with the capacity imposed.

Exposed slab to the south side

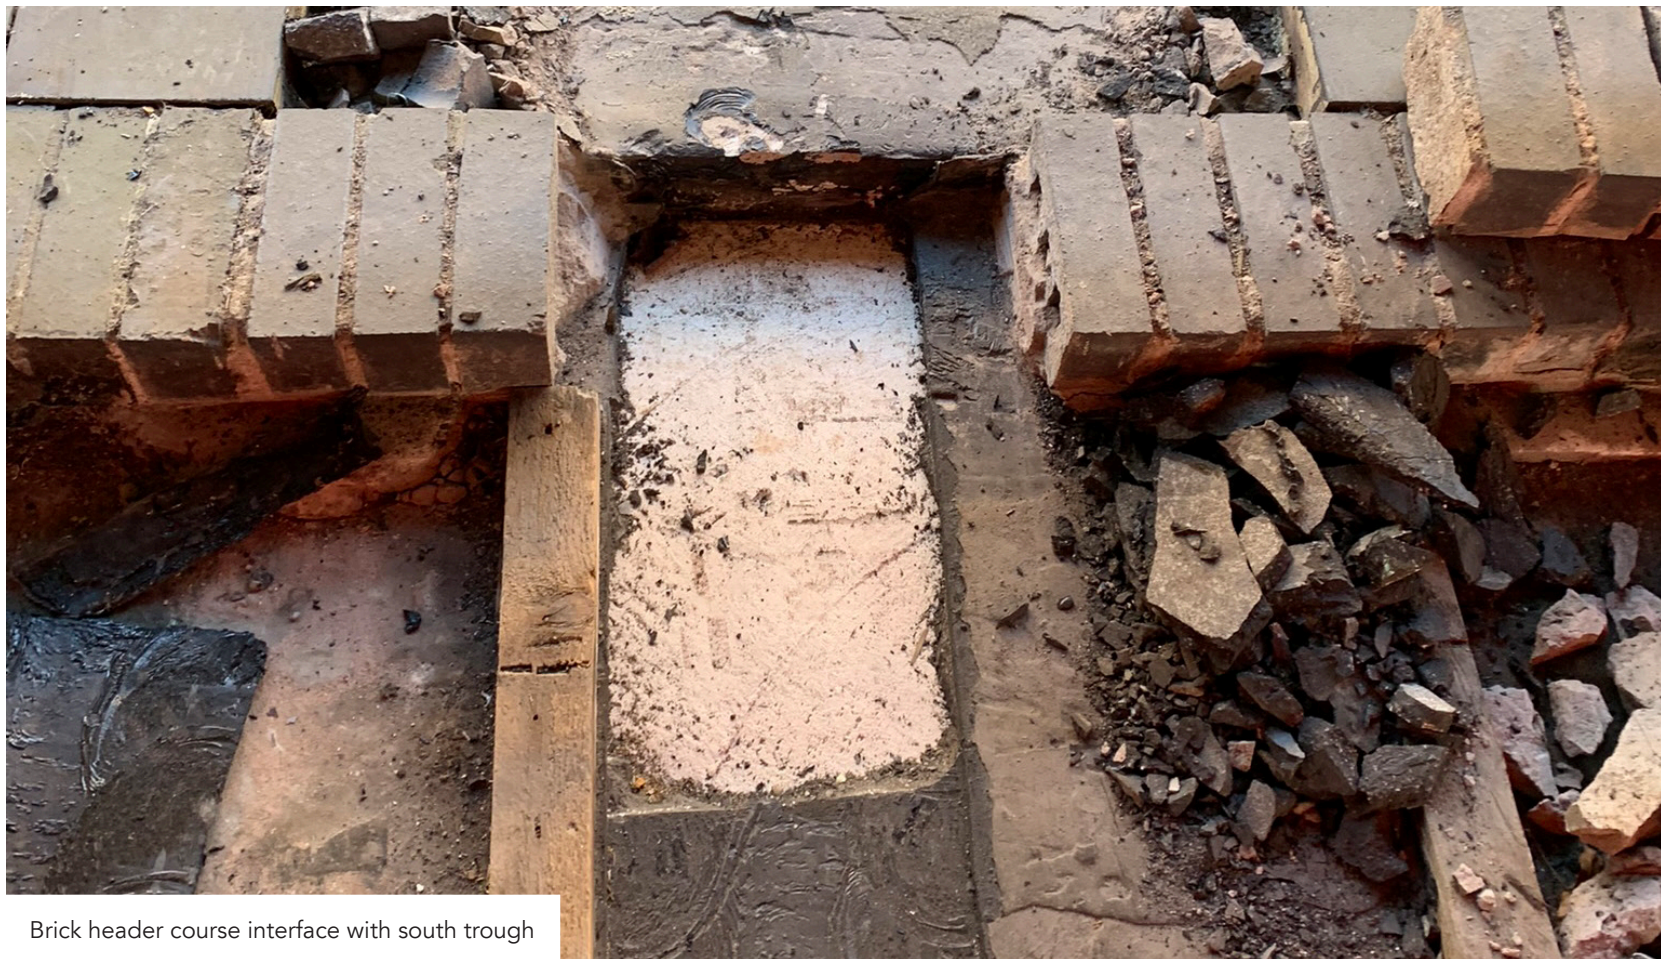
Brick header course interface with south trough

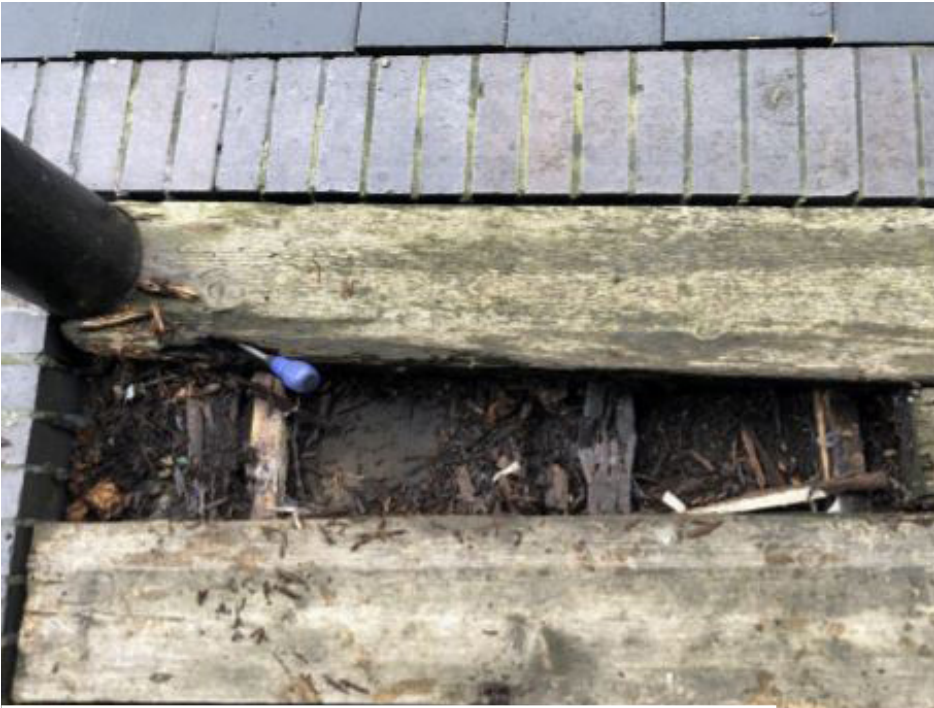
Wet rot decay to timber battens and boarding to platform boarding

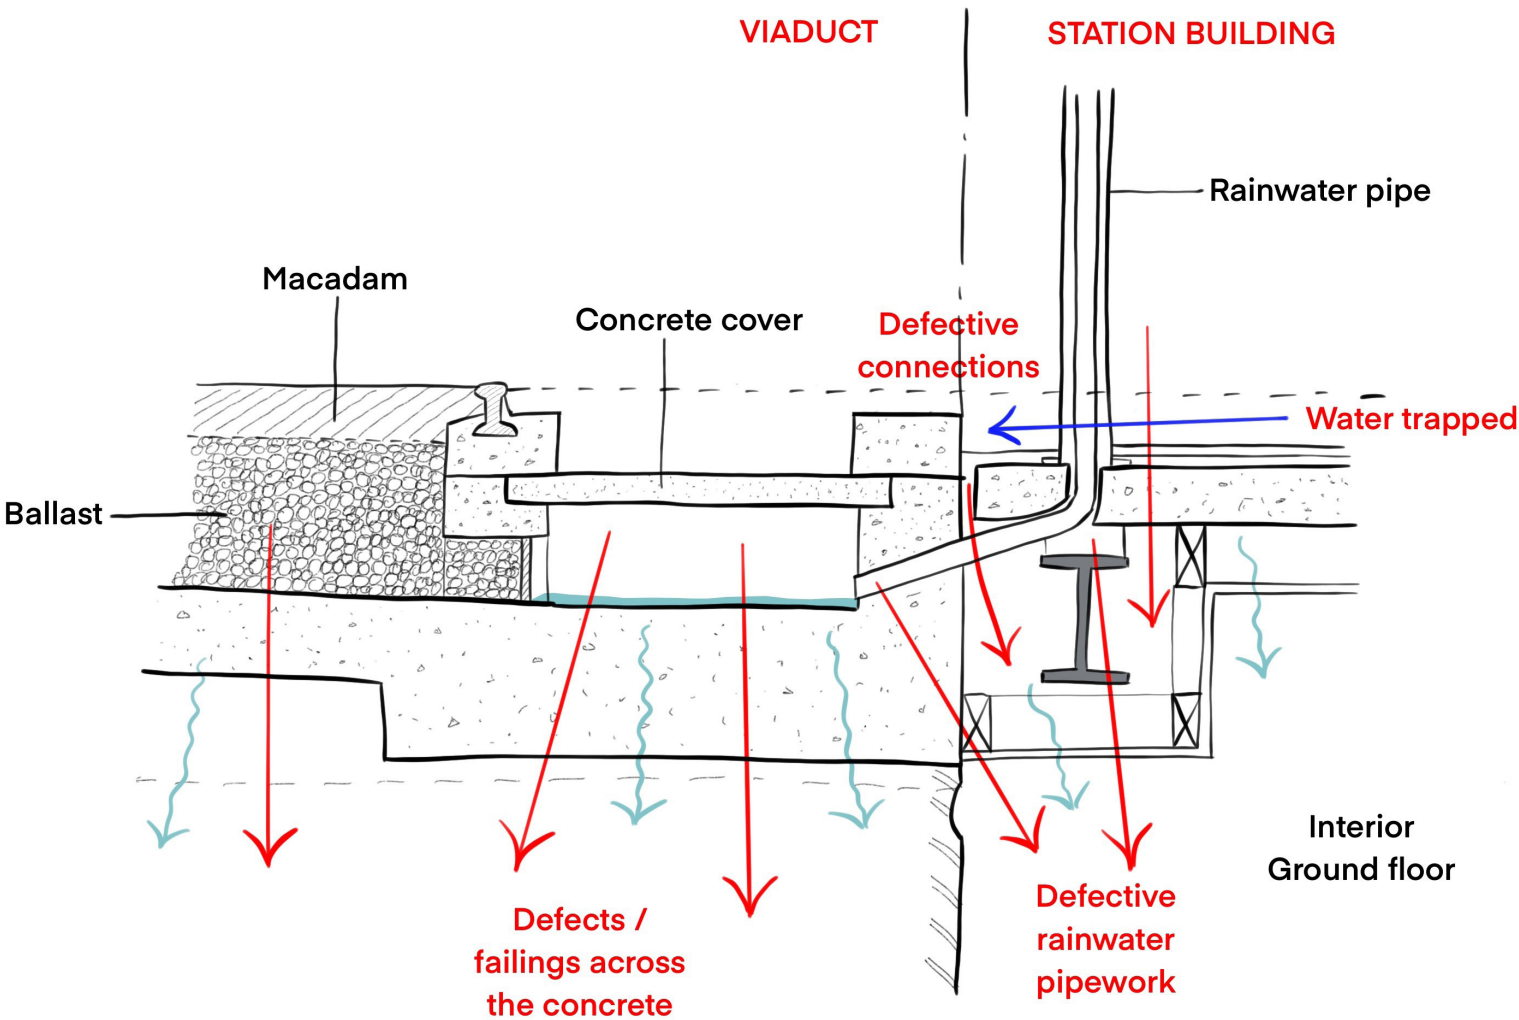
- 7.5.3 The adjacent diagram illustrates an interpretation of the likely interfacing conflicts and highlights potential areas of water ingress. This detail is at the junction between the Viaduct, southern trough and the Station Building. The arrangement is purely indicative with timber planks hidden for graphical purposes.
