## Schedule of Condition For

Wellington House,  
39 — 41 Piccadilly,  
Manchester  
M1 4AJ

JPM Real Estate Management Limited  
Northspring,  
70 Spring Gardens,  
Manchester,  
M2 2BQ

Dated: 22<sup>nd</sup> March 2022

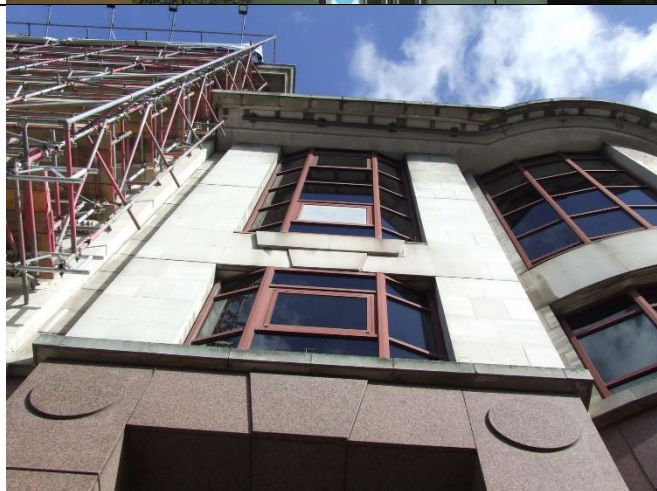
Aluminium double glazed rainscreen claddings and curtain walling windows systems.

Soiled frame and leaking rubber sealed to the windows generally.

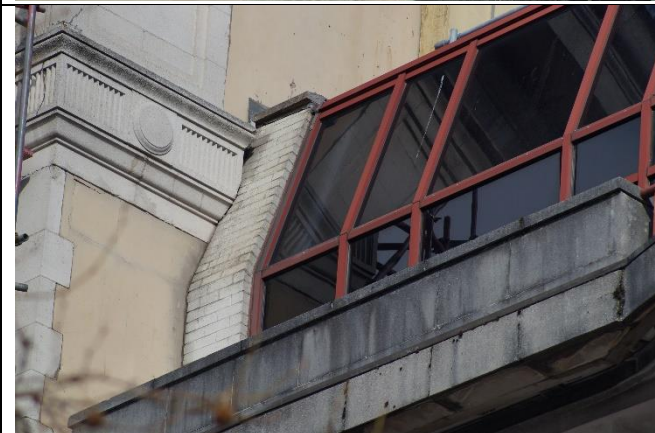
Aluminium double glazed rainscreen claddings and curtain walling windows systems.

Soiled frame and leaking rubber sealed to the windows generally.

Concrete stone block infills soiled with washed out and eroded jointing.

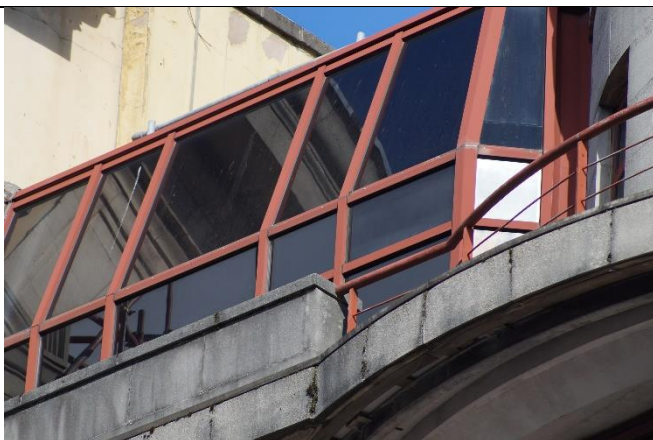
Aluminium double glazed rainscreen claddings and curtain walling windows systems.

Soiled frame and leaking rubber sealed to the windows generally.

Concrete stone block infills soiled with washed out and eroded jointing.

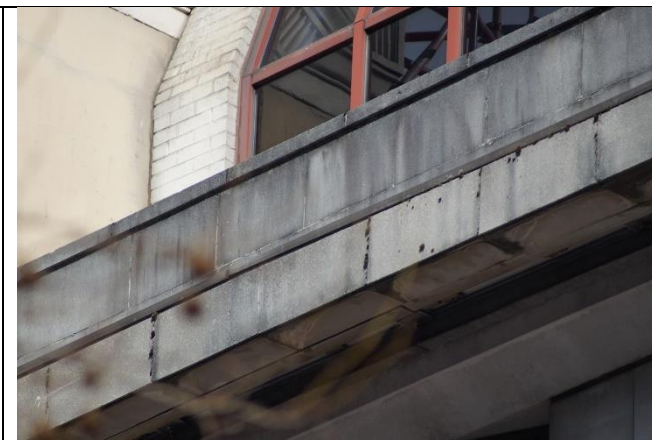
Concrete stone block infills soiled with washed out and eroded jointing.

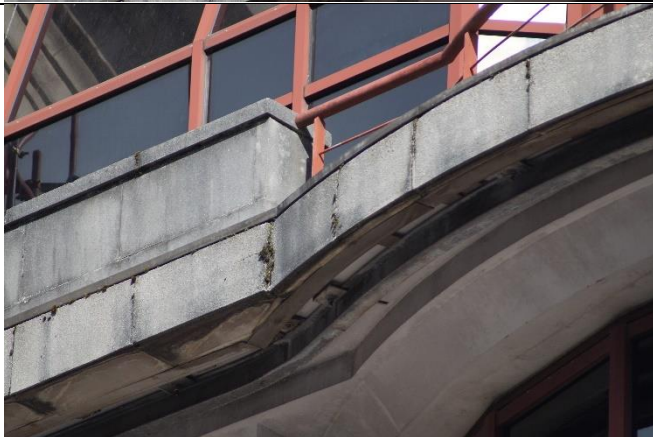
Aluminium double glazed rainscreen claddings and curtain walling windows systems.

Soiled frame and leaking rubber sealed to the windows generally.

Concrete stone block infills soiled with washed out and eroded jointing.

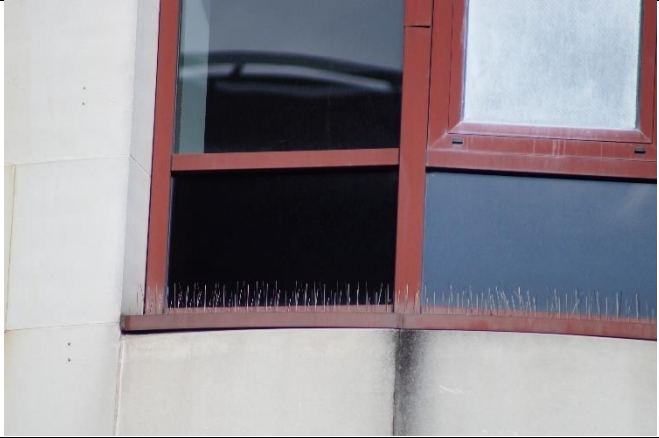
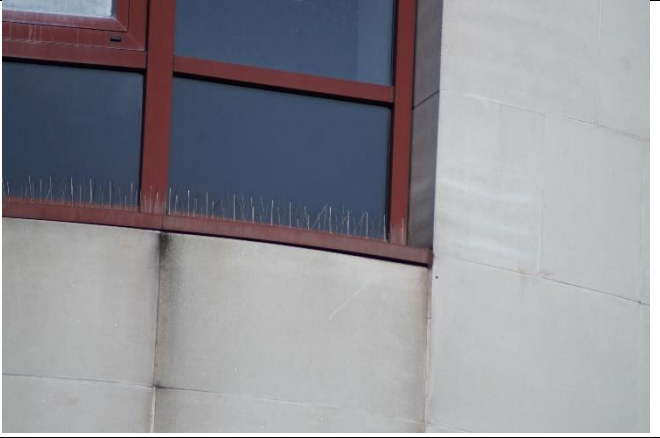
| <p>Aluminium double glazed rainscreen claddings and curtain walling windows systems.</p> <p>Soiled frame and leaking rubber sealed to the windows generally.</p> <p>Concrete stone block infills soiled with washed out and eroded jointing.</p> | | <p>Aluminium double glazed rainscreen claddings and curtain walling windows systems.</p> <p>Soiled frame and leaking rubber sealed to the windows generally.</p> <p>Concrete stone block infills soiled with washed out and eroded jointing.</p> | |

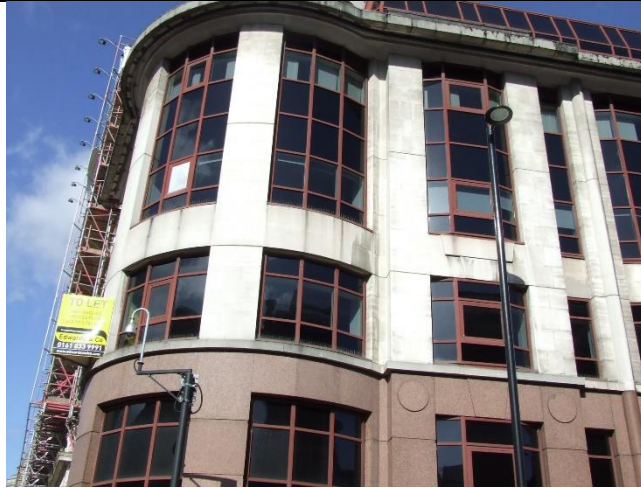
| <p>Side elevation.</p> <p>Steel frame building with stone or concrete block façade infills to curtain wall and rainscreen aluminium cladding systems.</p> | | <p>Aluminium double glazed rainscreen claddings and curtain walling windows systems.</p> <p>Soiled frame and leaking rubber sealed to the windows generally.</p> <p>Concrete stone block infills soiled with washed out and eroded jointing.</p> | |

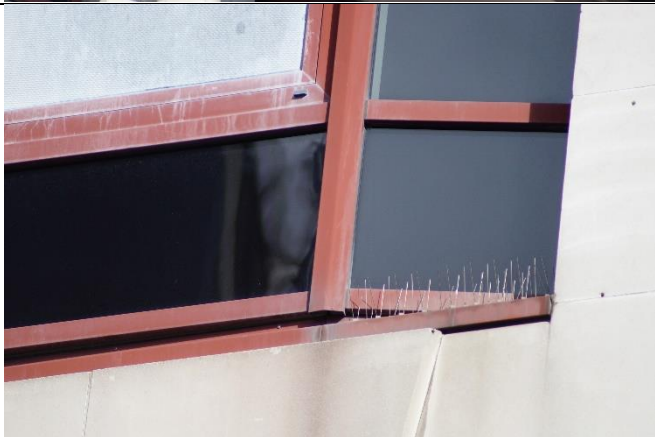
Aluminium double glazed rainscreen claddings and curtain walling windows systems.

Soiled frame and leaking rubber sealed to the windows generally.

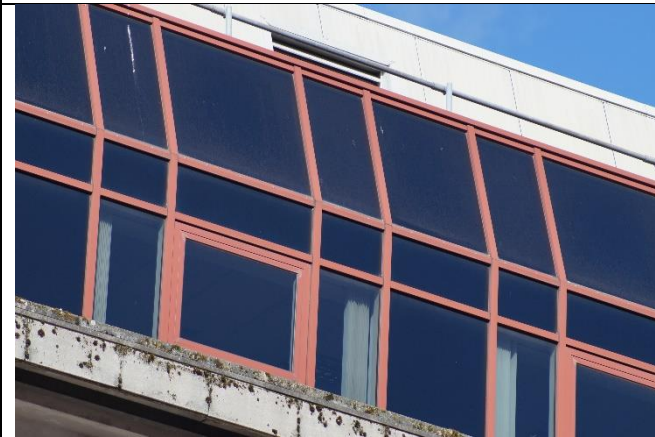
Aluminium double glazed rainscreen claddings and curtain walling windows systems.

Soiled frame and leaking rubber sealed to the windows generally.

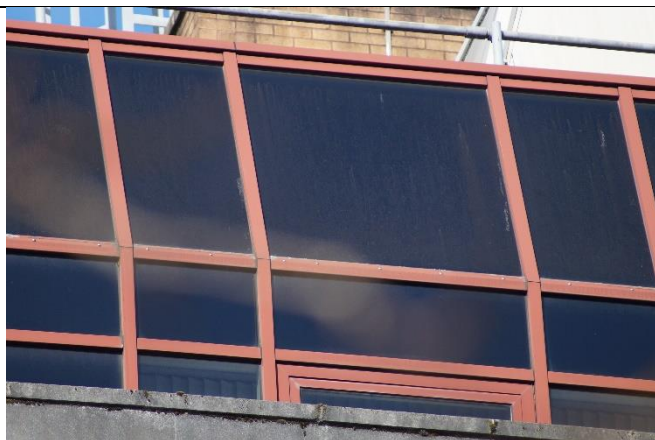
Aluminium double glazed rainscreen claddings and curtain walling windows systems.

Soiled frame and leaking rubber sealed to the windows generally.

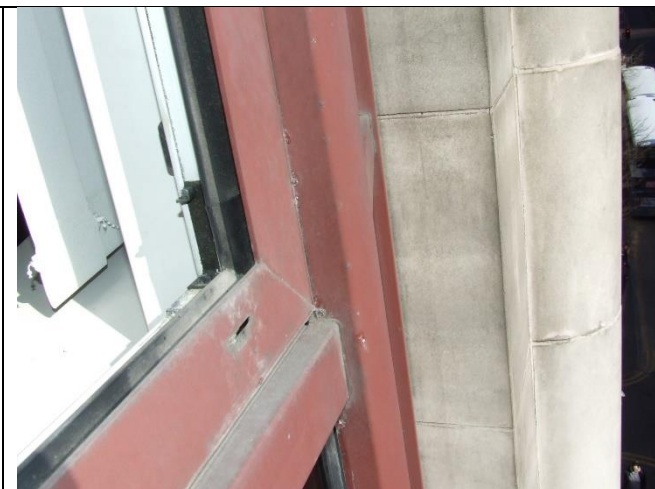
Aluminium double glazed rainscreen claddings and curtain walling windows systems.

Soiled frame and leaking rubber sealed to the windows generally.

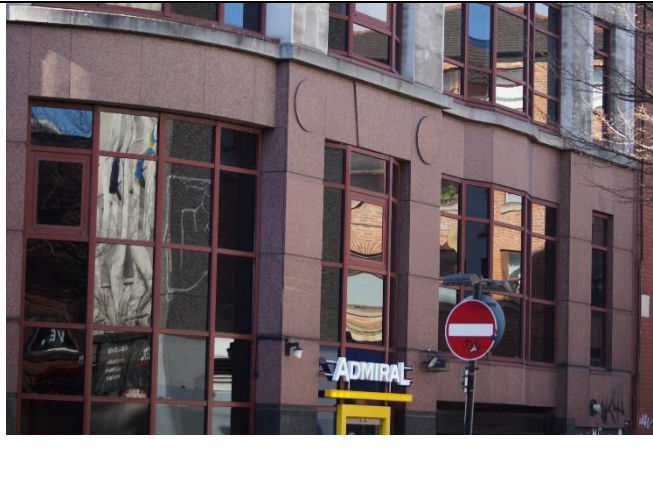
| <p>Rear elevation.</p> <p>Steel frame building with stone or concrete block façade infills to curtain wall and rainscreen aluminium cladding systems.</p> | | <p>Aluminium double glazed rainscreen claddings and curtain walling windows systems.</p> <p>Soiled frame and leaking rubber sealed to the windows generally.</p> | |

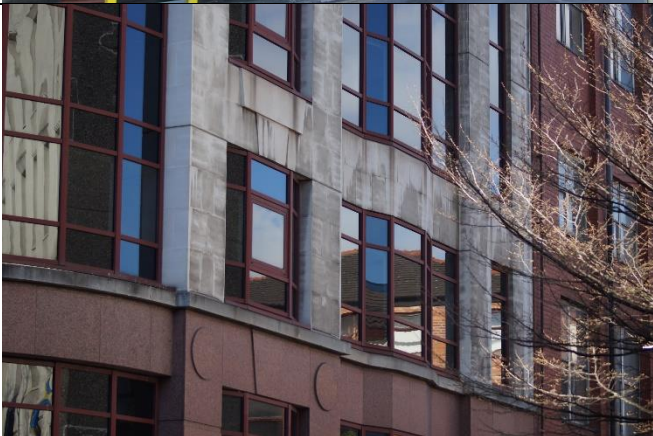
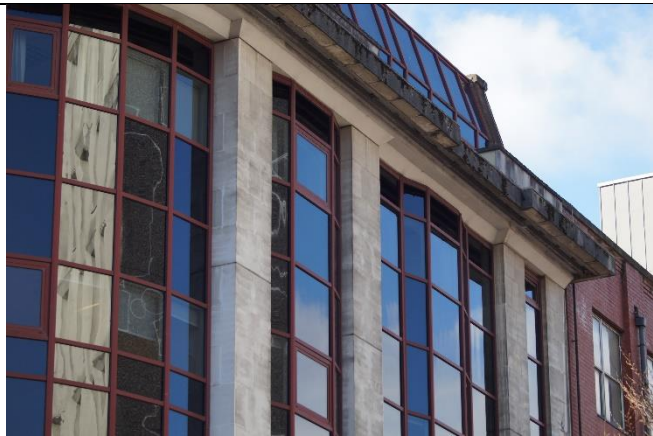
| <p>Concrete stone block infills soiled with washed out and eroded jointing.</p> | | <p>Concrete stone block infills soiled with washed out and eroded jointing.</p> | |

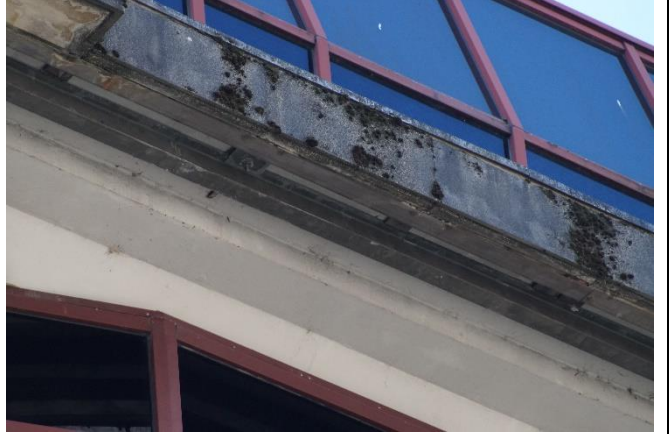
| <p>Generally.</p> | | <p>Concrete stone block infills soiled with washed out and eroded jointing.</p> | |

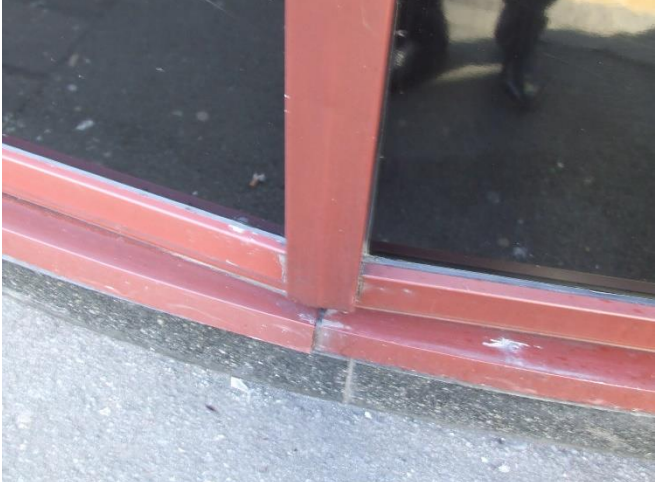
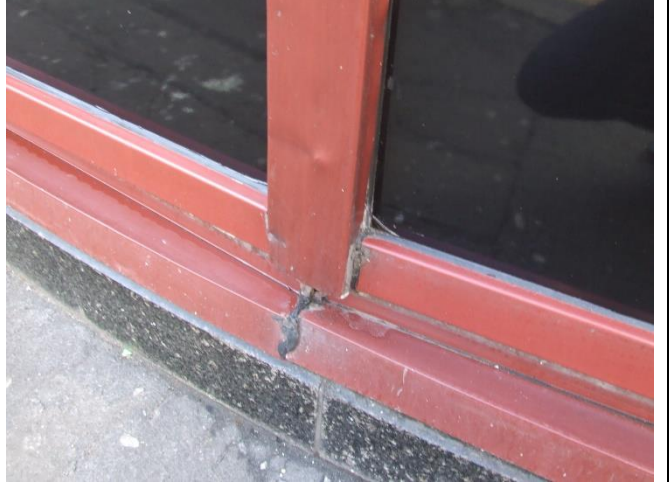
| <p>Aluminium double glazed rainscreen claddings and curtain walling windows systems.</p> <p>Soiled frame and leaking rubber sealed to the windows generally.</p> | | <p>Aluminium double glazed rainscreen claddings and curtain walling windows systems.</p> <p>Soiled frame and leaking rubber sealed to the windows generally.</p> | |

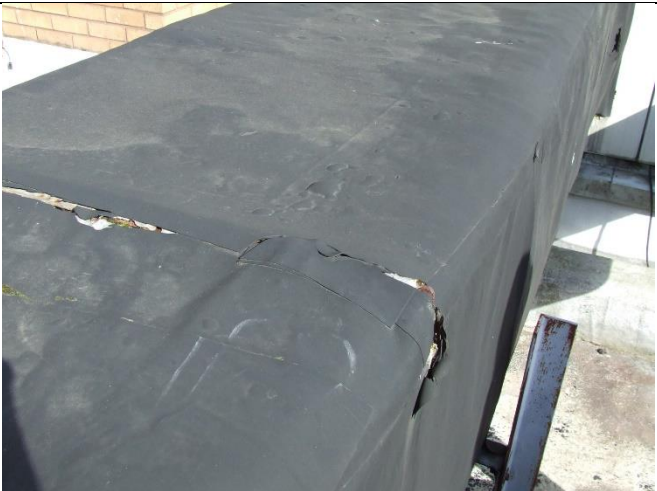
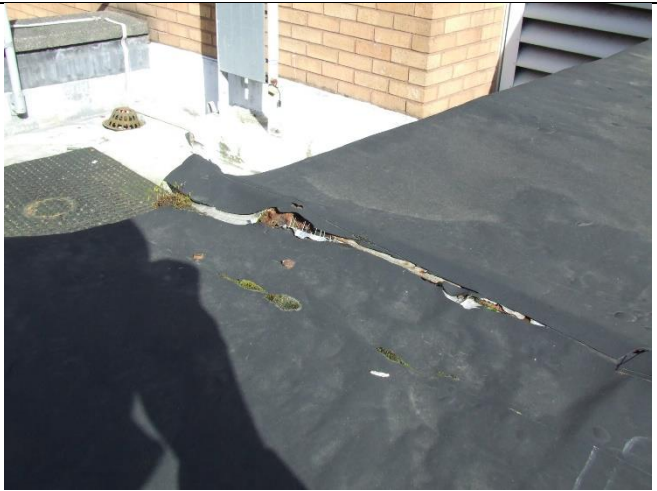
| Single ply rubber weathering to the air handling ducts is perished. | | Single ply rubber weathering to the air handling ducts is perished. | |

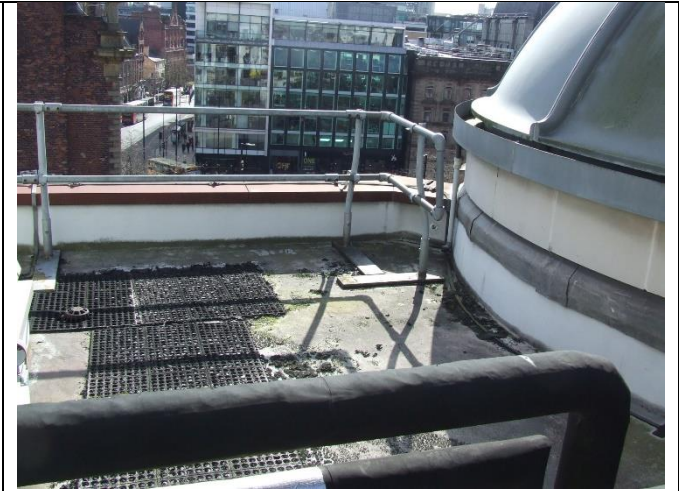
Asphalt roof deck coated with solar reflective treatments.

Some distress in the finish with crazed surfaces and peeling back of solar reflective treatments.

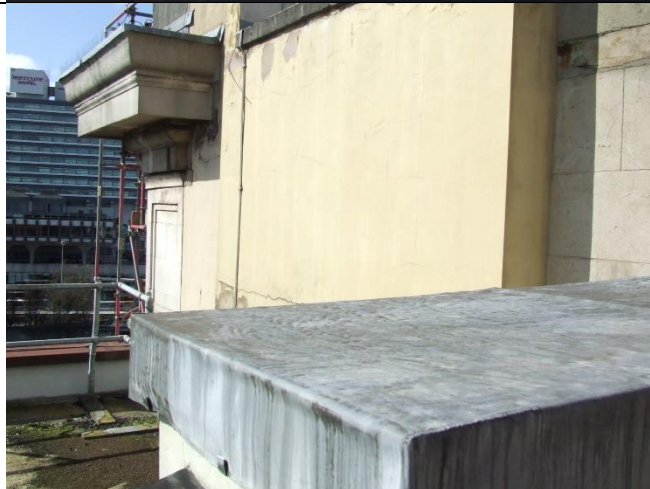
There are some loose and ill fitted lead flashings and the lead lined parapet claddings are stressed. There are leaks internally below these.

Distressed render to the party walls and loose and ill fitting lead abutment flashings.

- We understand that you intend to complete masonry block repairs;
- We understand that you intent to renew defective capping's and parapet tops;
- We understand that you plan to repoint the property including all the main facades together with the parapets.
- We understand that you intend to repair lead flashing leaks;
- We understand you wish to consider some repairs or recovery of the asphalt to the roofs;
- The masonry infill facades are in need of a cleaning, repointing and redecoration;
- We understand there is a need to decorate external elements, including the, security grilles, metal work, window systems and all joinery. As part of your normal cyclical maintenance.

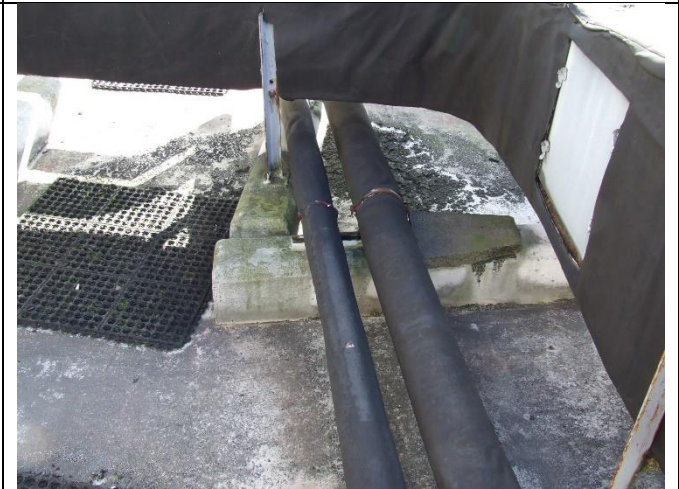
Asphalt roof deck coated with solar reflective treatments.

Some distress in the finish with crazed surfaces and peeling back of solar reflective treatments.

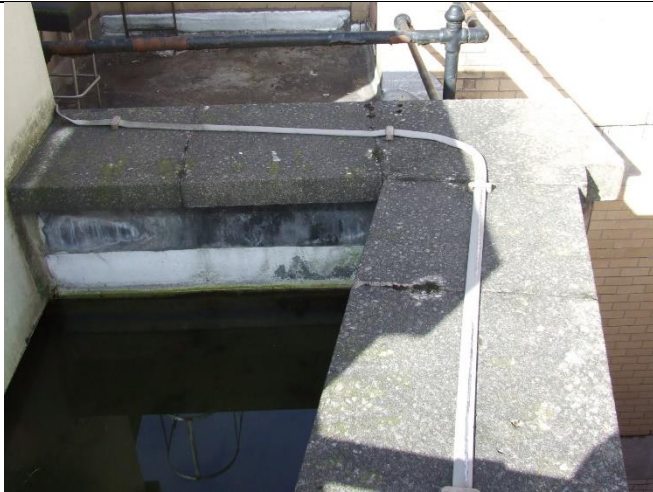
Eroded and washed out pointing to the concrete coping joints.

Lightening protection plastic coating is split and conductor exposed to the weather.

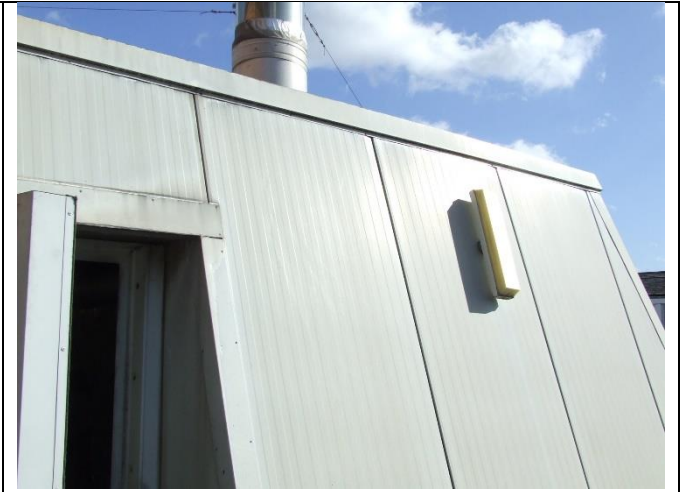
Light corrosion to the plant room colour coated cladding panels.

Heavy soiling.

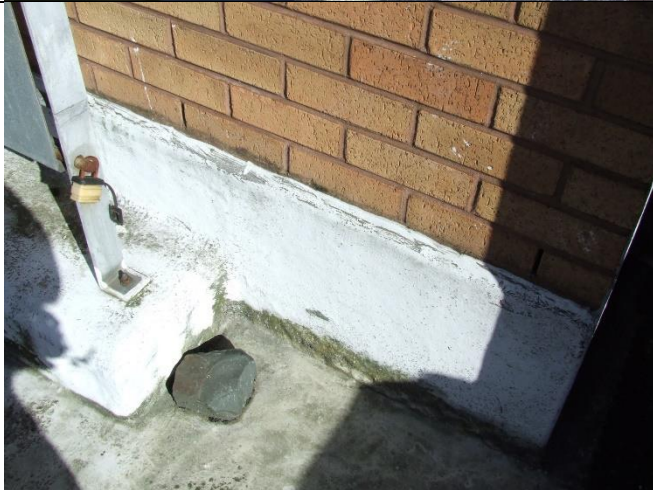
Asphalt roof deck coated with solar reflective treatments.

Some distress in the finish with crazed surfaces and peeling back of solar reflective treatments.

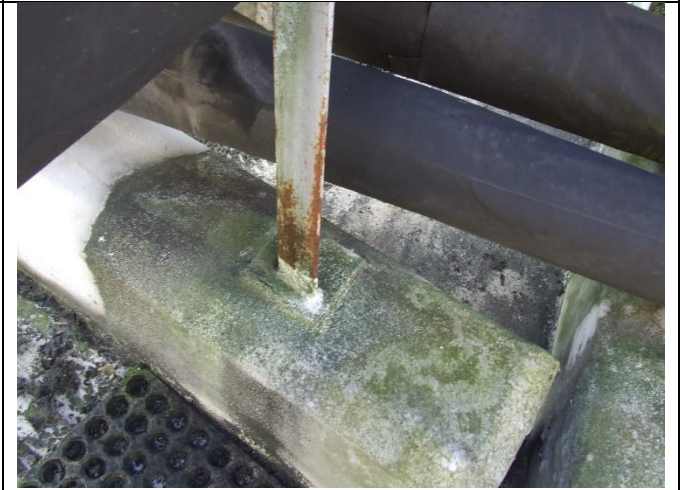
Corrosion to the legs of the air handling ducts.

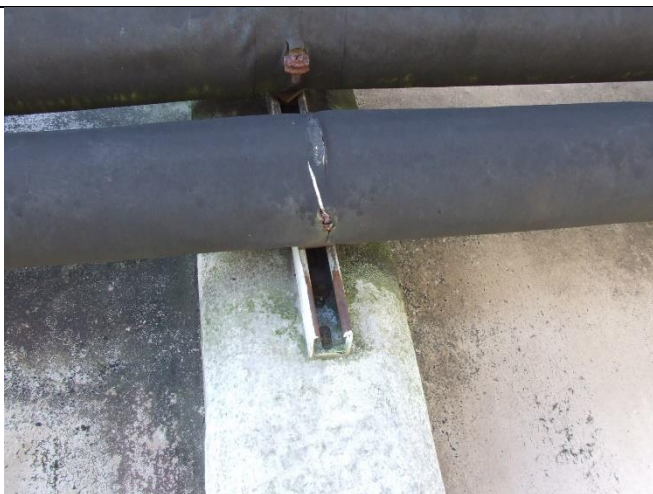
Penetrations through asphalt deck for air handling plant possibly leaking into the structure.

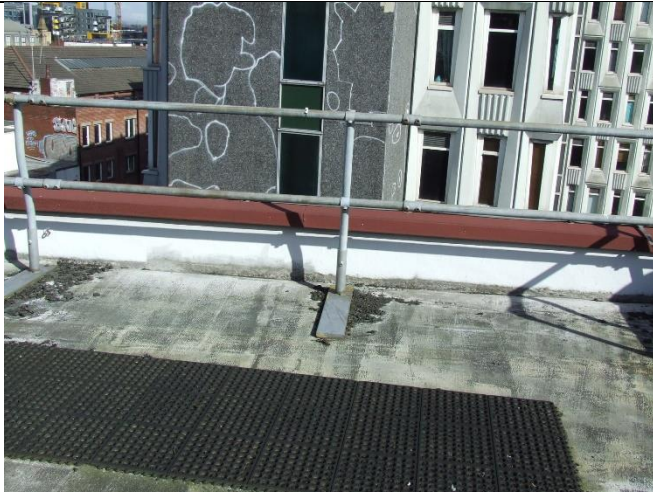
Asphalt roof deck coated with solar reflective treatments.

Some distress in the finish with crazed surfaces and peeling back of solar reflective treatments.

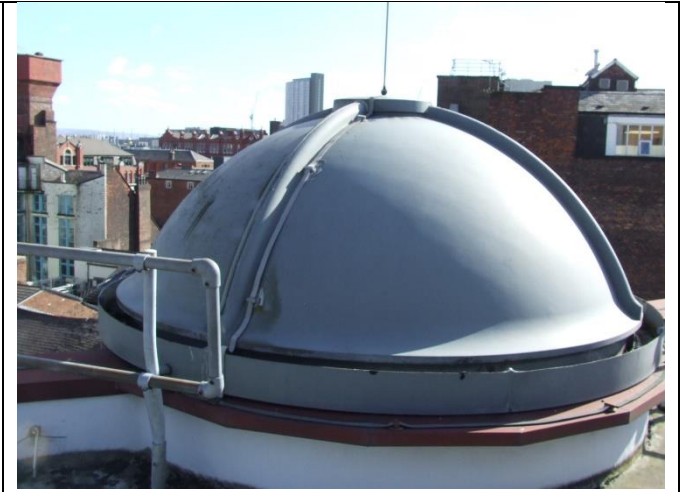
Open joints leaking to the capping's to the cupola.

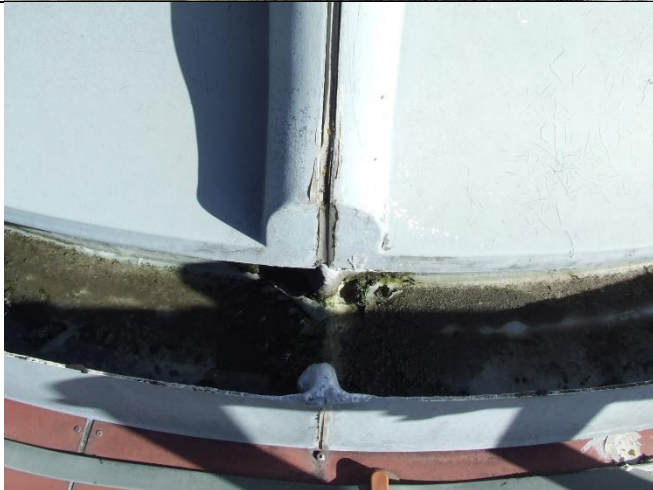
Open joints leaking to the capping's to the cupola.

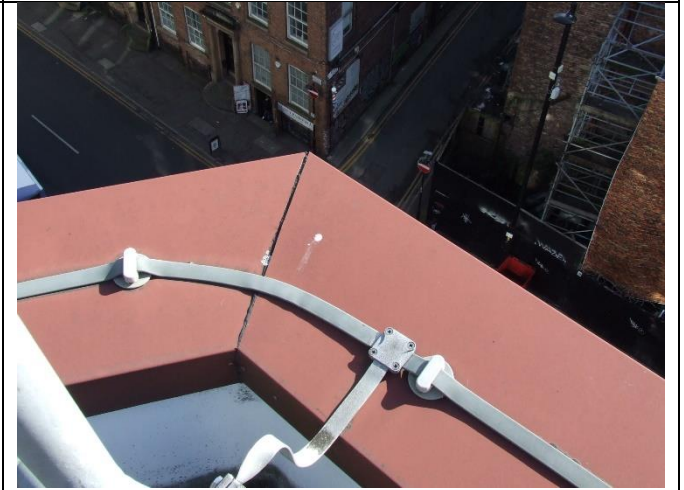
Open joints leaking to the capping's to the parapets.

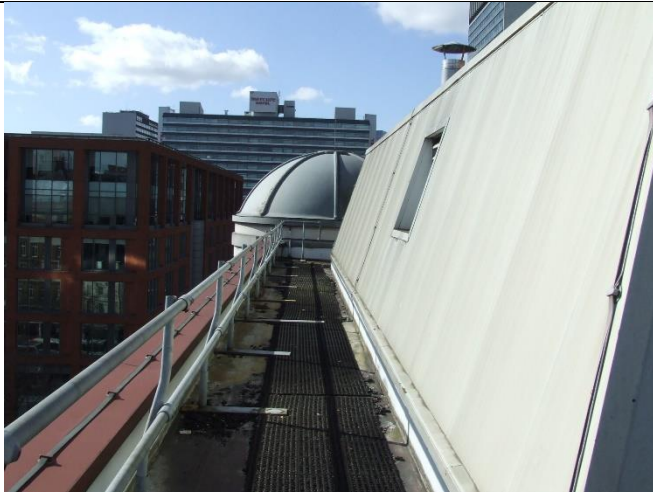
Light corrosion to the plant room colour coated cladding panels.

Heavy soiling.

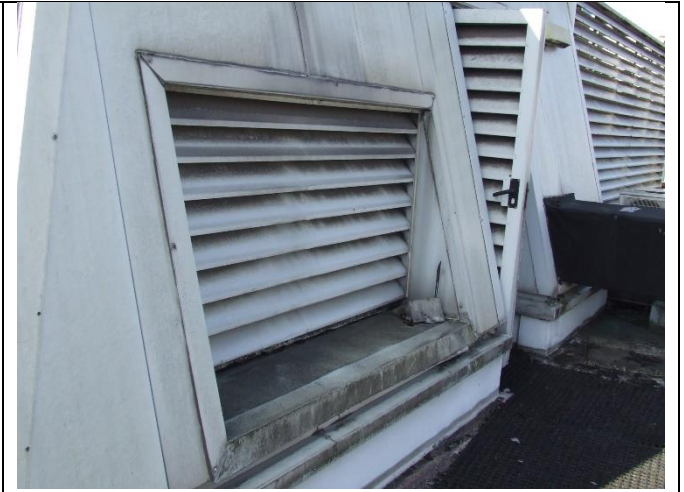
Light corrosion to the plant room colour coated cladding panels.

Heavy soiling.

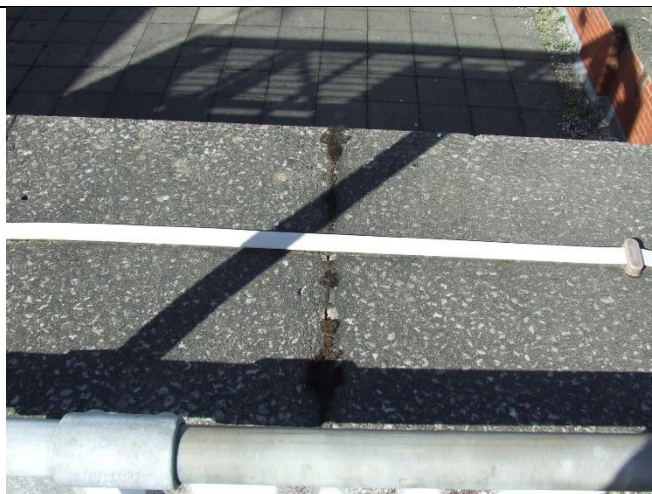
Eroded and washed out pointing to the concrete coping joints.

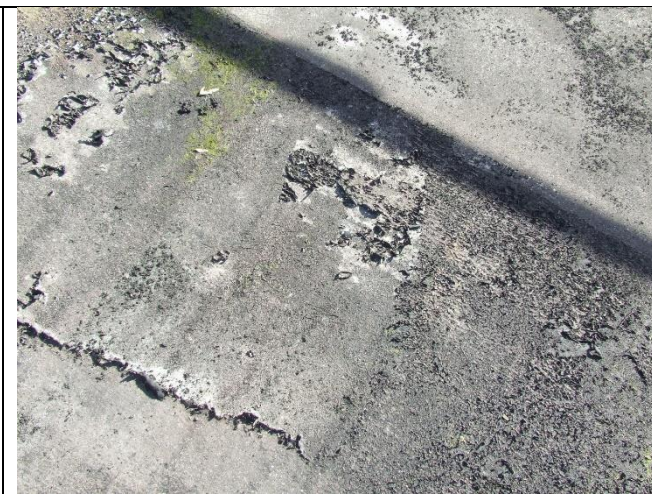
Asphalt roof deck coated with solar reflective treatments.

Some distress in the finish with crazed surfaces and peeling back of solar reflective treatments.

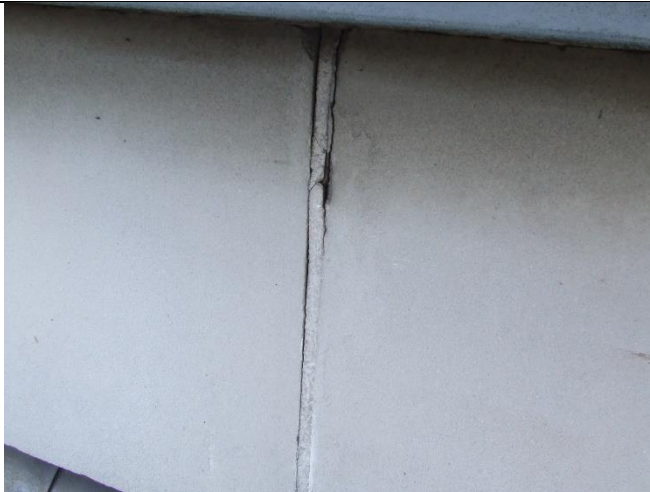
Eroded and washed out pointing to the masonry joints.

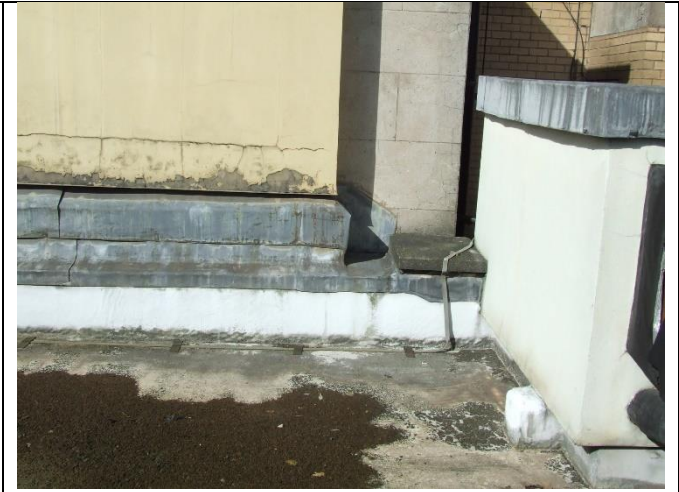
Distressed render to the party walls and loose and ill fitting lead abutment flashings.

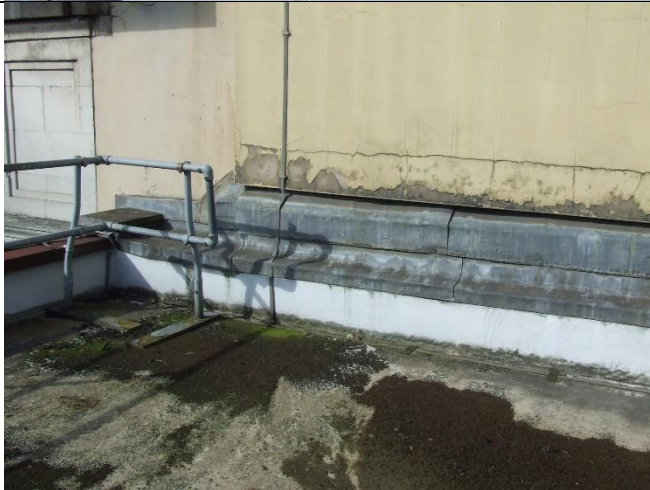
Distressed render to the party walls and loose and ill fitting lead abutment flashings.

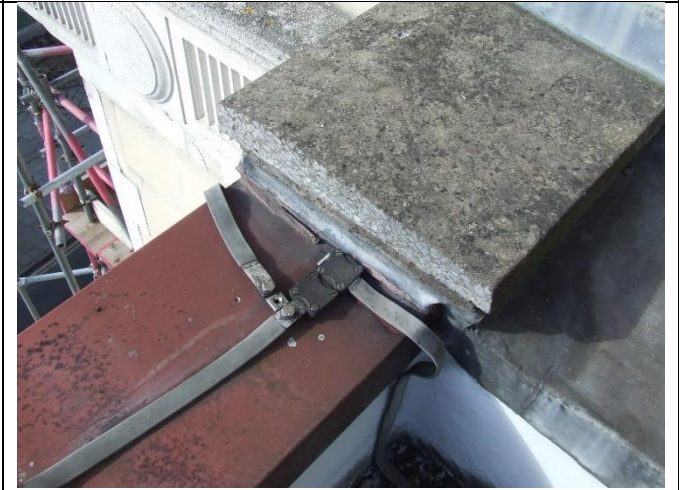
Eroded and washed out pointing to the concrete coping joints.

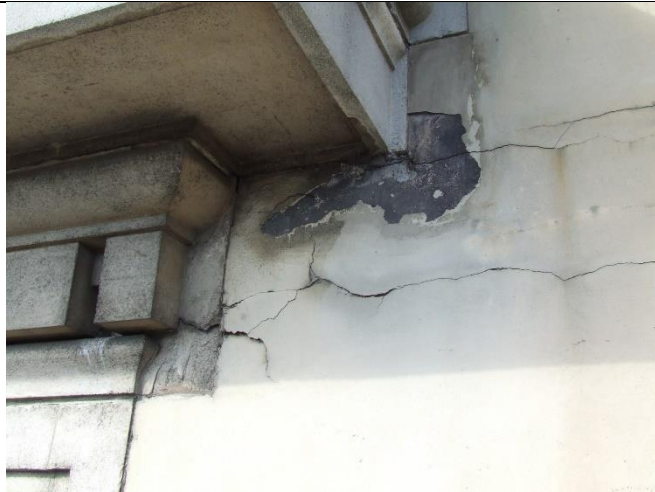
Distressed render to the party walls and loose and ill fitting lead abutment flashings.

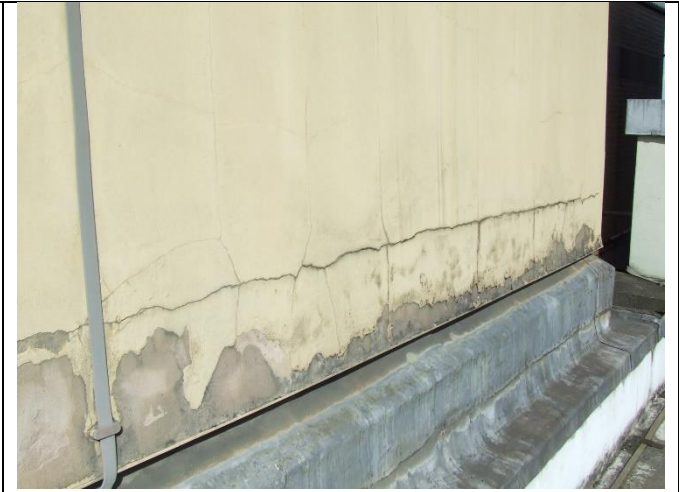
Distressed render to the party walls and loose and ill fitting lead abutment flashings.

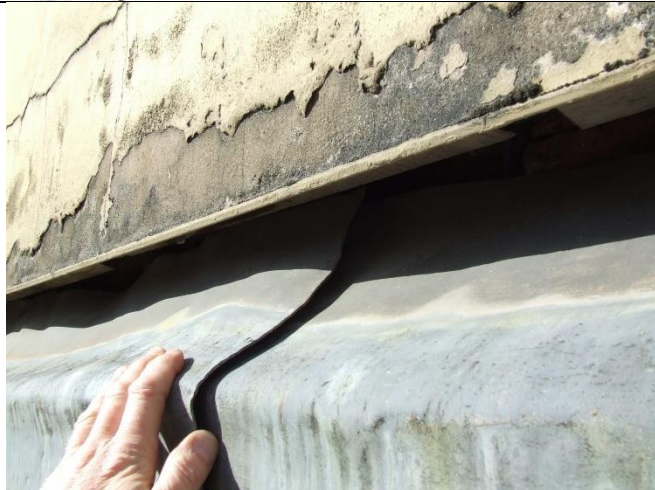
Distressed render to the party walls and loose and ill fitting lead abutment flashings.

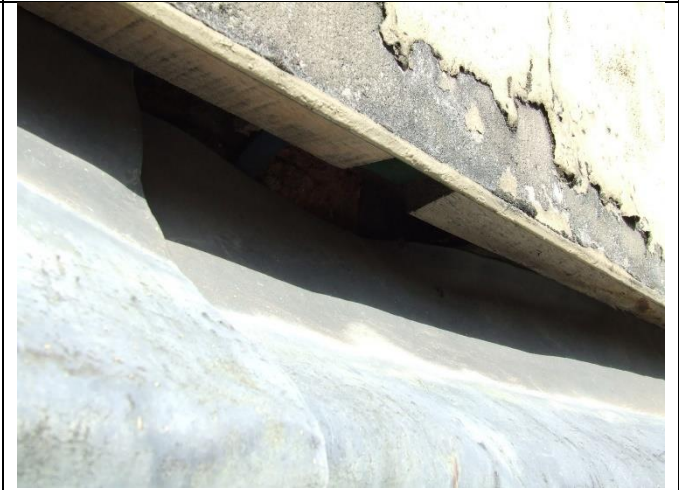
Distressed render to the party walls and loose and ill fitting lead abutment flashings.
