# Drainage Report

**27 Dale Street**  
**Manchester**  
**Manchester**

## Dale Street Manchester - CCTV Survey Report : 27/01/22

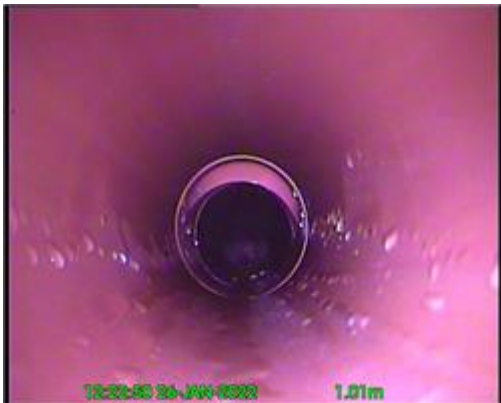
| Pos | Video Ref | Code | Description | Image |
|---|---|---|---|---|
| 01.01m | 0:00:06 | JN | Junction at 12 o'clock: 100mm<br>Diameter | Image Provided - Ref: 9_2<br> |

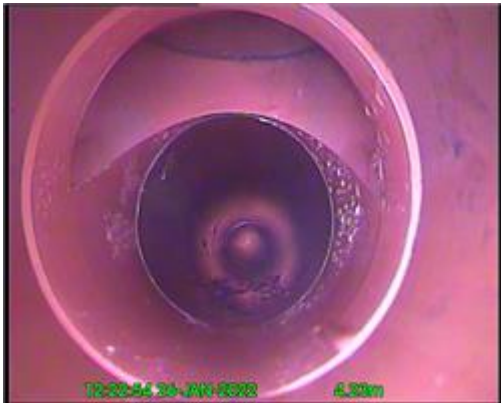
| Pos | Video Ref | Code | Description | Image |
|---|---|---|---|---|
| 04.23m | 0:00:10 | JN | Junction at 12 o'clock: 100mm<br>Diameter | Image Provided - Ref: 9_3<br> |
