SEG - EXISTING STRUCTURE KEY.

| Client | SCIENCE MUSEUM GROUP | | |
| Project | SIM SITE WIDE CAPITAL WORKS | | |
| Org Title | SEG<br>STRUCTURAL GENERAL ARRANGEMENT | | |

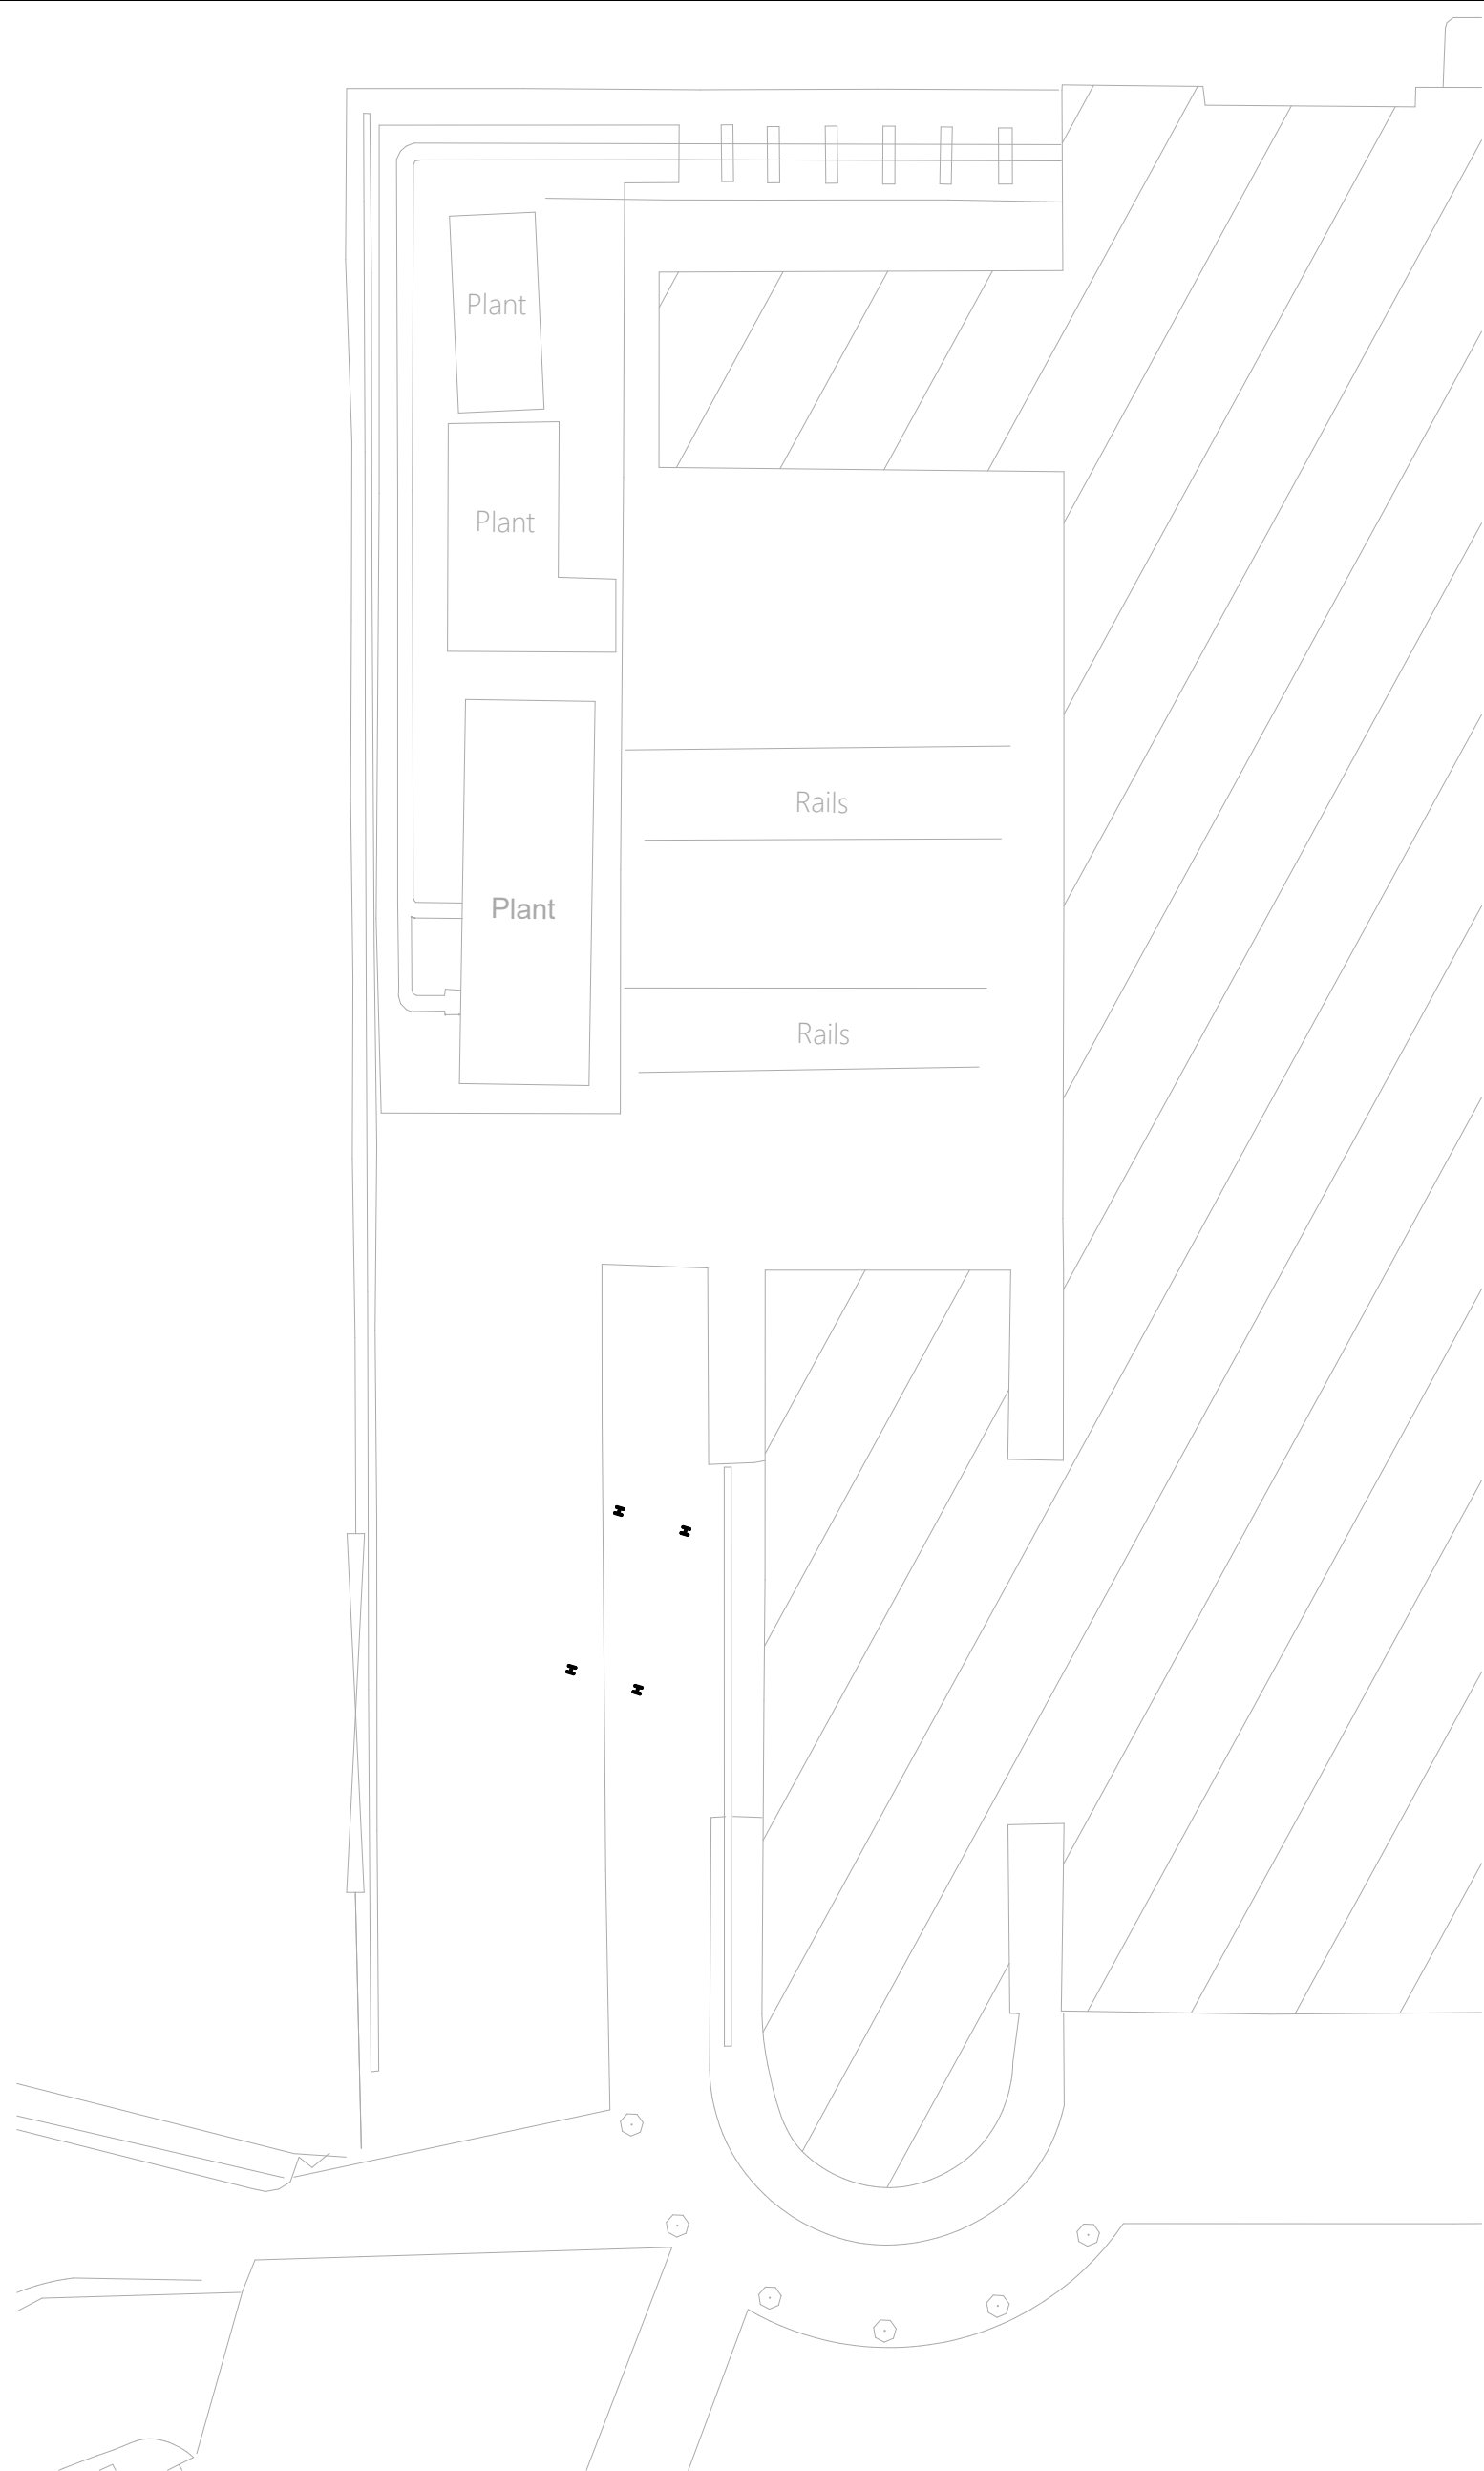
STRUCTURAL WORKS KEY PLAN  
SCALE 1 : 125

| PHOTO REF. | PHOTO | DESCRIPTION | COMMENTS | PHOTO REF. | PHOTO | DESCRIPTION | COMMENTS | PHOTO REF. | PHOTO | DESCRIPTION | COMMENTS | PHOTO REF. | PHOTO | DESCRIPTION | COMMENTS |
|---|---|---|---|---|---|---|---|---|---|---|---|---|---|---|---|
| SEG01 | | OTHER SIDE OF WEST WALL ADJACENT TO NEIGHBOURING BUILDING SHOWING SIGNIFICANT WATER DAMAGE AND CORROSION. | | SEG05 | | SALT BRICK DETECTED ON THE EAST WALL. | | SEG09 | | BEAMS EAST SUPPORT ARE IN GOOD CONDITION. | | SEG13 | | JACK ARCH BEAM FLANGE THICKNESS INCREASES AS MOVES TOWARDS MIDSPAN. | |
| SEG02 | | CORROSION AND POOR CONDITION OF JACK ARCHES INTERFACES WITH WALL. | | SEG06 | | CORRODED PIPE OBSERVED WITHIN JACK ARCH BAY. | | SEG10 | | SECONDARY STEEL ADDED LATER TO PICK UP THE LOAD FROM THE LINTELS. | | | | | |
| SEG03 | | EVIDENCE OF CONTINUOUS WATER INGRESS RESULTING IN A DAMP WALL AND ADDITION OF A DRAIN WHERE WATER HEADS DRAINS FROM THE WALL. | | SEG07 | | CORROSIONS SEEN AT AREAS ON THE CAST IRON FLANGES. | | SEG11 | | BEAMS GENERALLY IN GOOD CONDITION WITH CORROSION POINTS. SALT BRICK IDENTIFIED IN AREAS OF JACK ARCHES. | | | | | |
| SEG04 | | SALTBRICK MINERAL DEPOSITS OBSERVED AS A RESULT OF WATER INGRESS. WALL SURFACE DRY. | | SEG08 | | MISSING MATERIALS AT THE CENTRE WEB OF CAST IRON BEAM LINTEL. | | SEG12 | | CORROSION OF CAST IRON PLATES LEAVING THIN FLANGE THICKNESS. | | | | | |

- SPAN DIRECTION OF JACK ARCH BEAMS.
- INDICATES EXTENT OF NOTABLE EFFLORESCENCE & POSSIBLE LOSS OF MORTAR TO MASONRY WALL.
- INDICATES EXTENT OF NOTABLE EFFLORESCENCE & POSSIBLE LOSS OF MORTAR TO CEILING MASONRY.
