## **TECHNICAL REPORT ON A SUBSIDENCE CLAIM**

**Crawford Reference: SU2300734**

**18 Delaunays Road  
Manchester  
Lancashire  
M8 4QS**

**SUBSIDENCE CLAIM**

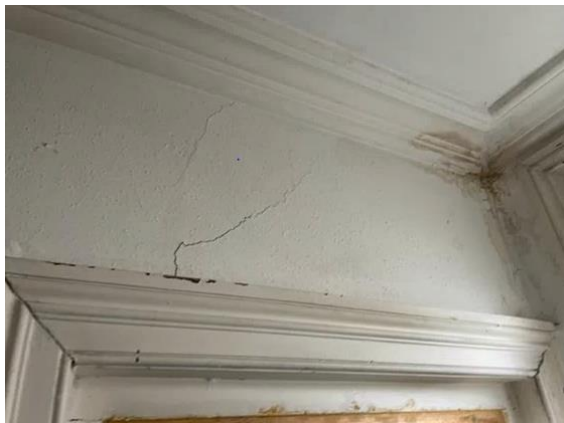
**Crack in hallway**

- To the front dividing wall, slight diagonal cracking was noted above the lounge and porch doors. The porch door head slopes to the left by 23mm.
- To the rear dividing wall, slight diagonal cracking extends up to towards the left hand external wall.

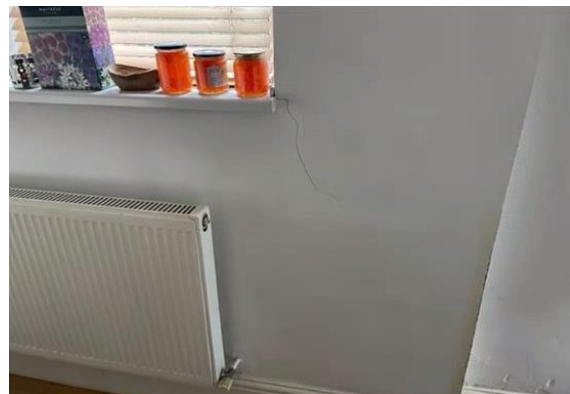
**Crack in rear dining room**

- The left wall, slight diagonal cracking was noted to the bottom rear corner of the window. Further cracking was noted above the window which then extends along the ceiling junction.

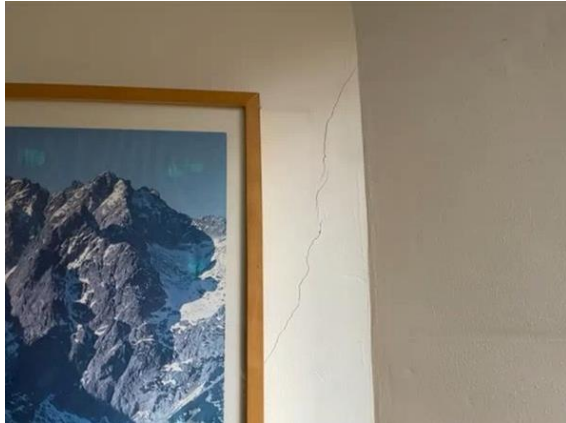
**Crack in rear dining room**

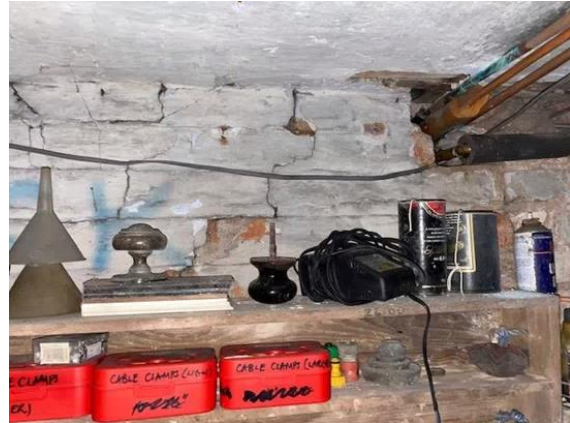
- Slight cracking was noted centrally to the front wall of the cellar.

**Crack in cellar wall.**
