The northern elevation was also constructed in a three-course English Garden Wall bond consisting of two central recessed windows with a steel ladder to the eastern end (Plate 52; Fig 5). The ladder had been fixed to the outer face and afforded access to the roof. As with the windows to the eastern elevation, the windows were set within a cast-iron housing with a pointed arch head. The cast-iron doors had been removed and exposed a four-light cast-iron window with modern wired obscured glass panes (Plate 53).

Hammerstone Road Depot, Gorton, Manchester

Hammerstone Road Depot, Gorton, Manchester  
Figure 5: Ambulance bay plan & elevations

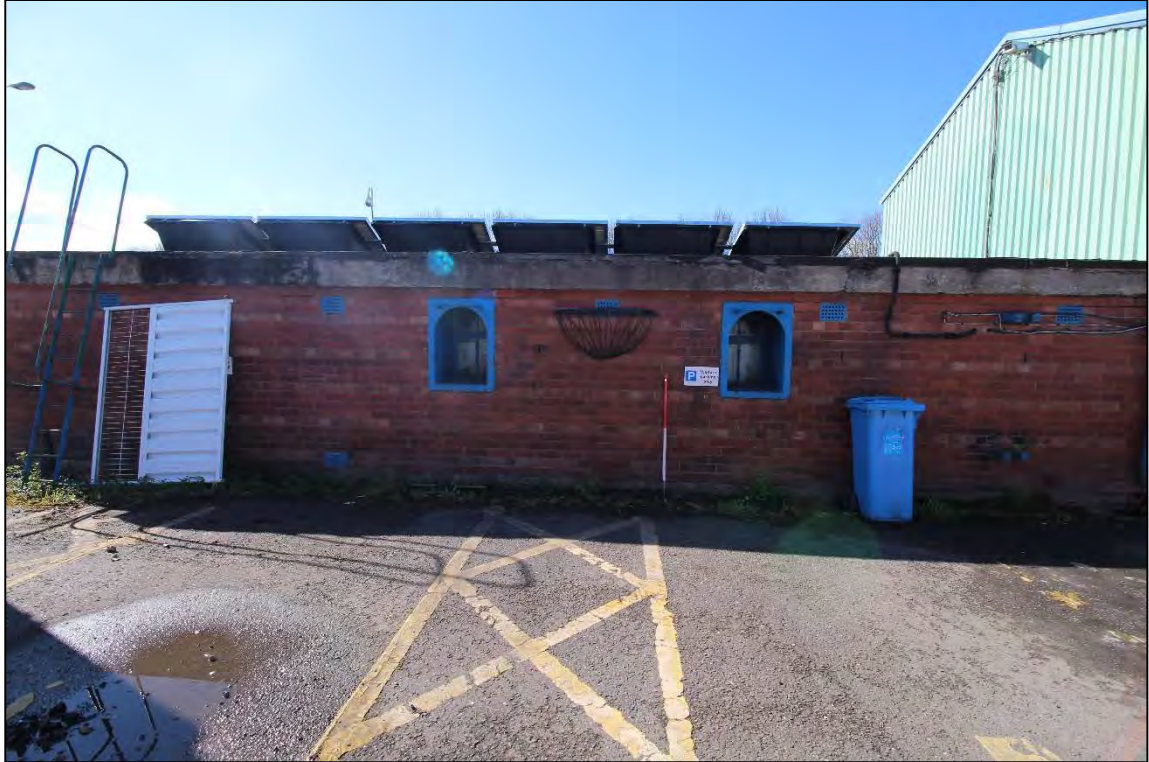
*Plate 52: General view of the northern elevation, facing south*

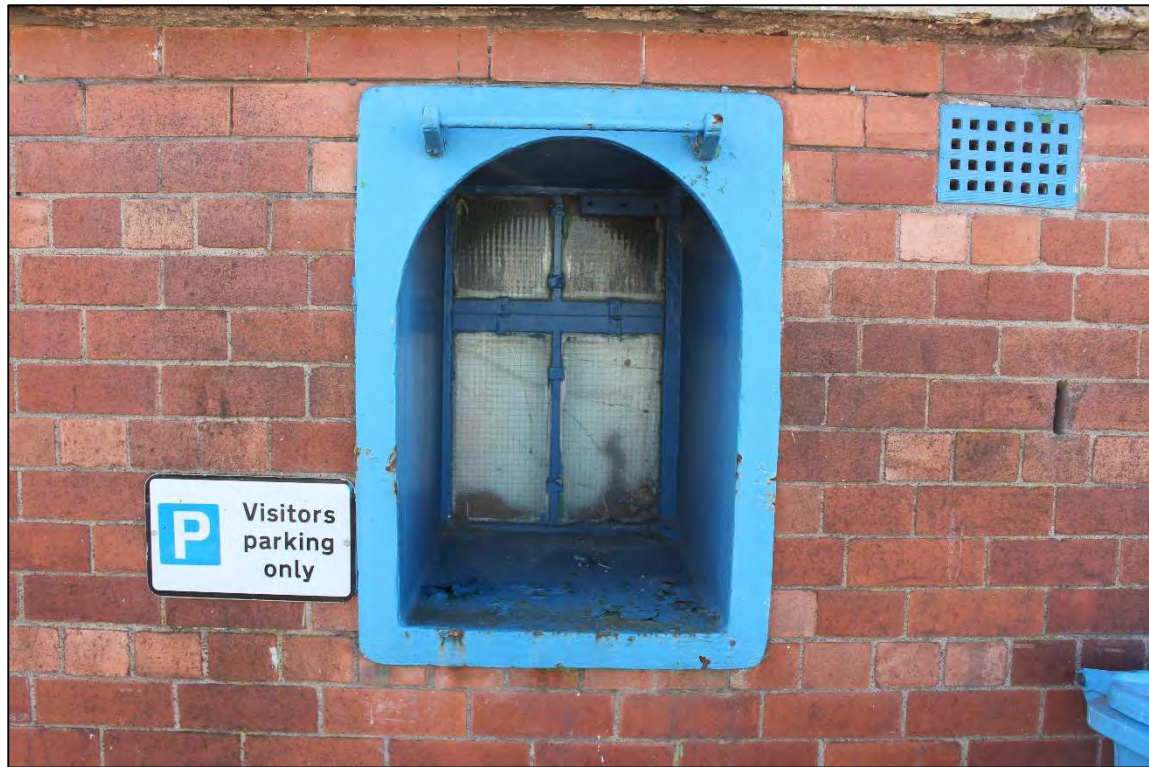
*Plate 53: Detail of the cast-iron surround window to the northern elevation, looking south*

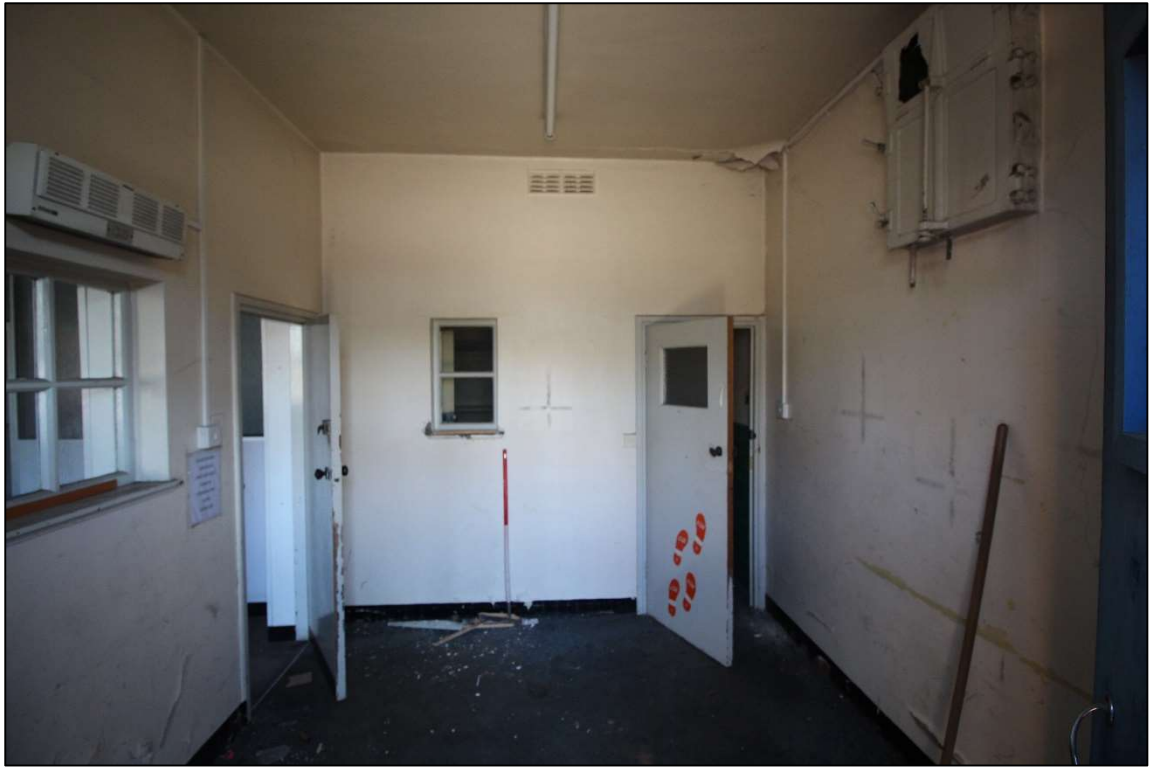
*Plate 54: General view of Room 1, facing north*

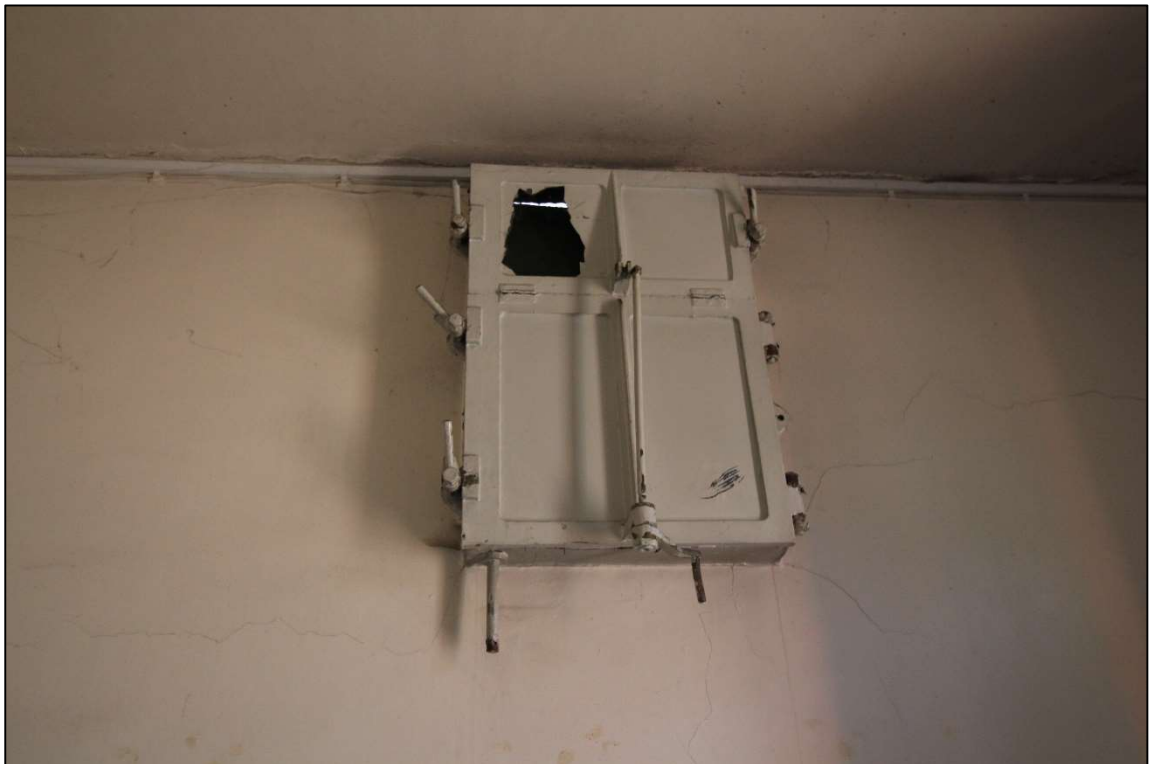
The centre of the eastern wall contained a hatch at a height of 2m from the floor level. This consisted of a cast-iron box that extended into the room and had two doors that was opened by a handle located directly below the hatch (Plate 55).

*Plate 55: Detail of the cast-iron hatch within the eastern wall*

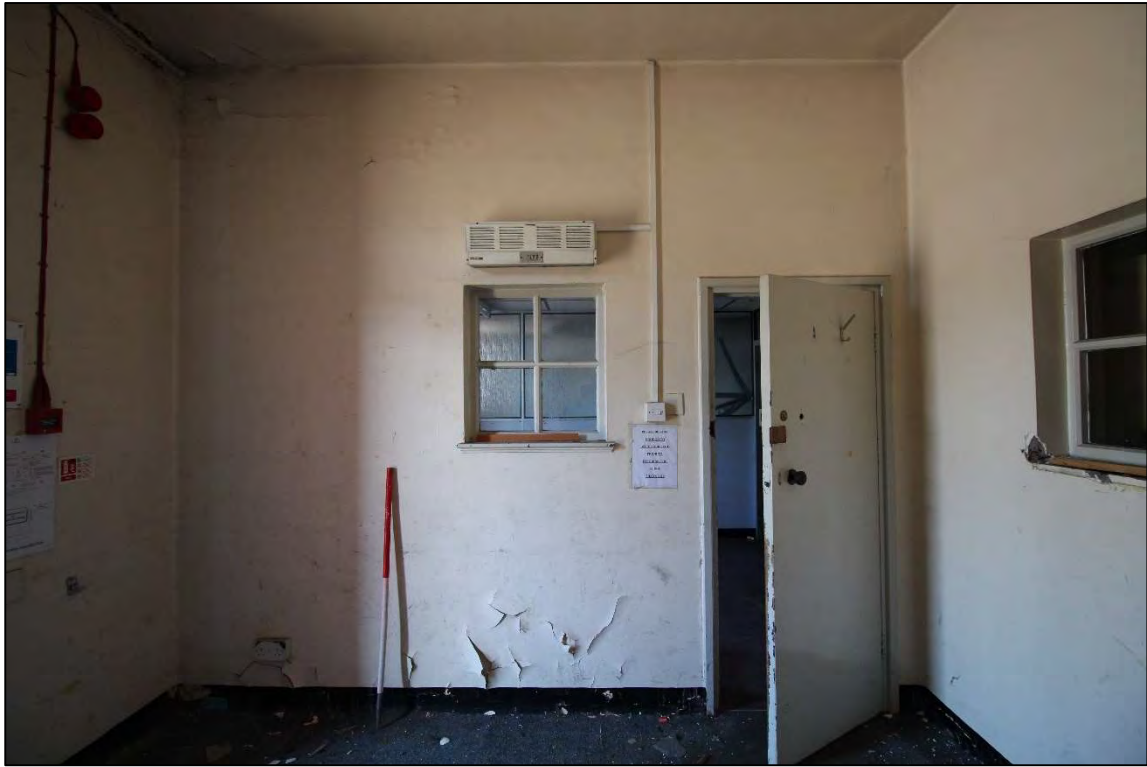
*Plate 56: The western wall of Room 1, detailing the central window and doorway affording access to Room 3, looking west*

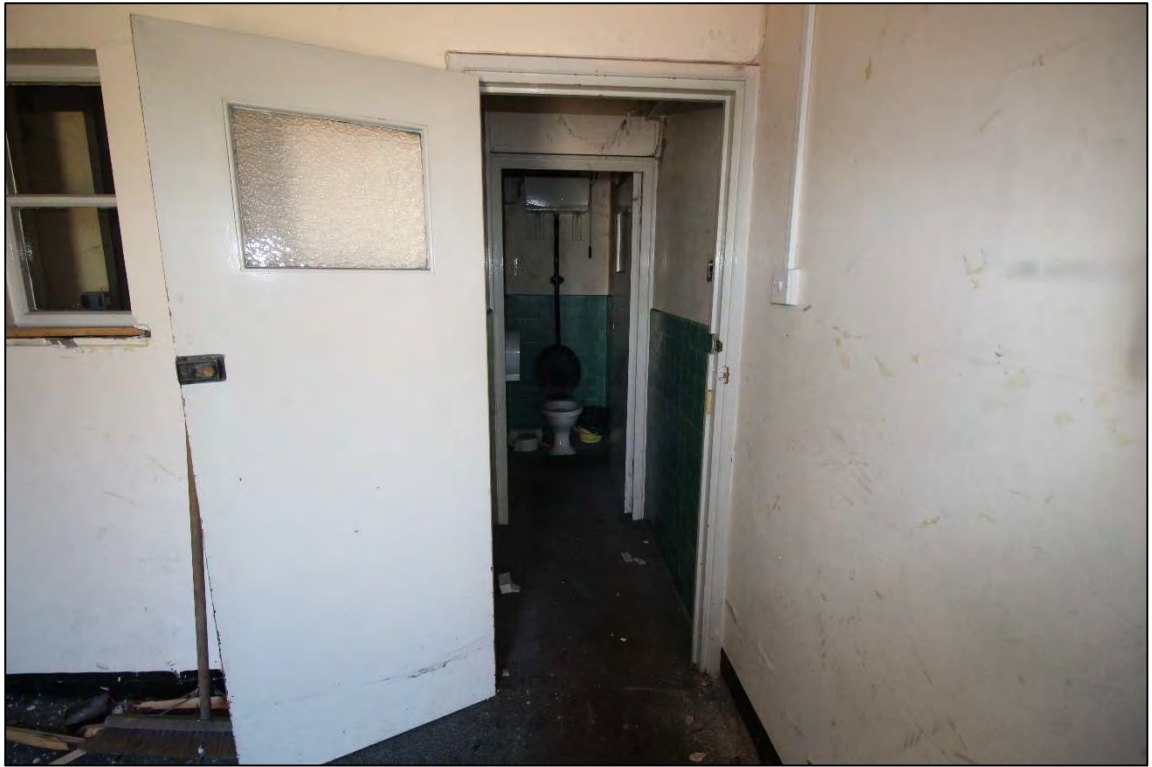
Room 2 measured 9'8½" (2.96m) by 2'11" (0.88m) and consisted of glazed tile walls, a flat ceiling and a linoleum covered floor (Plate 57). The room was used as a privy with all sanitaryware of mid-20<sup>th</sup>-century.

*Plate 57: General view of Room 2, looking north*

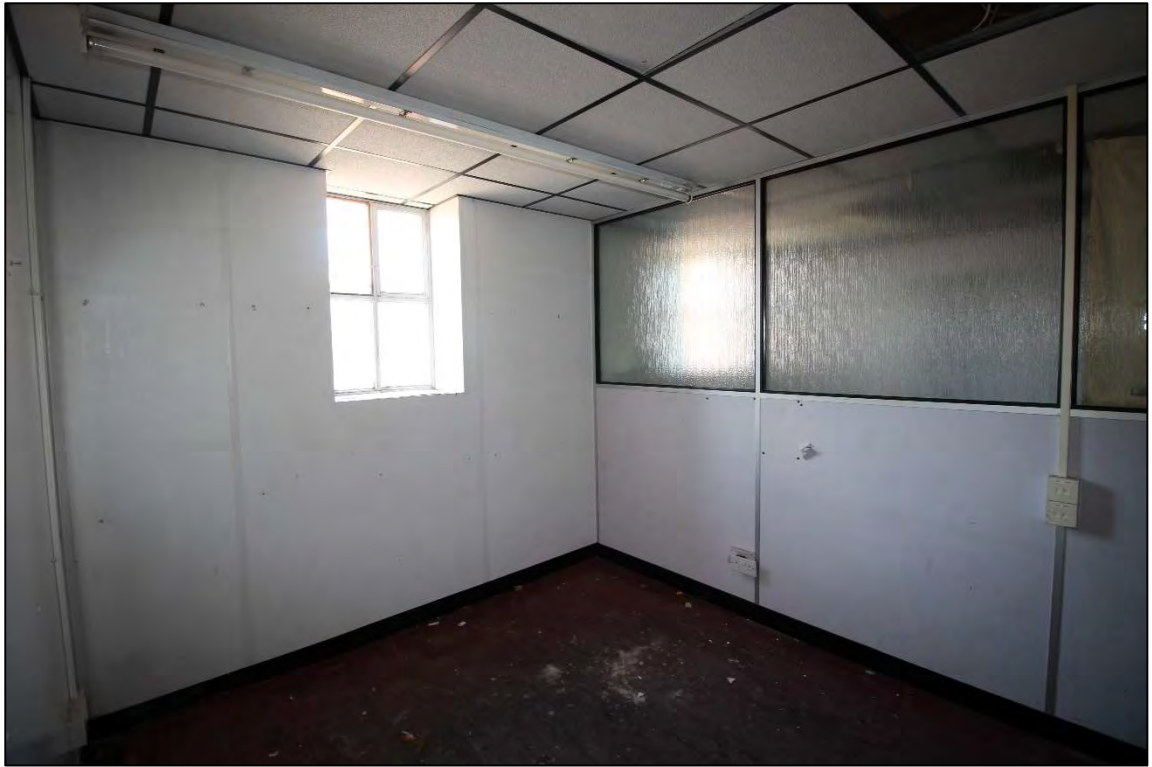
*Plate 58: General view of Room 3, facing south-west*

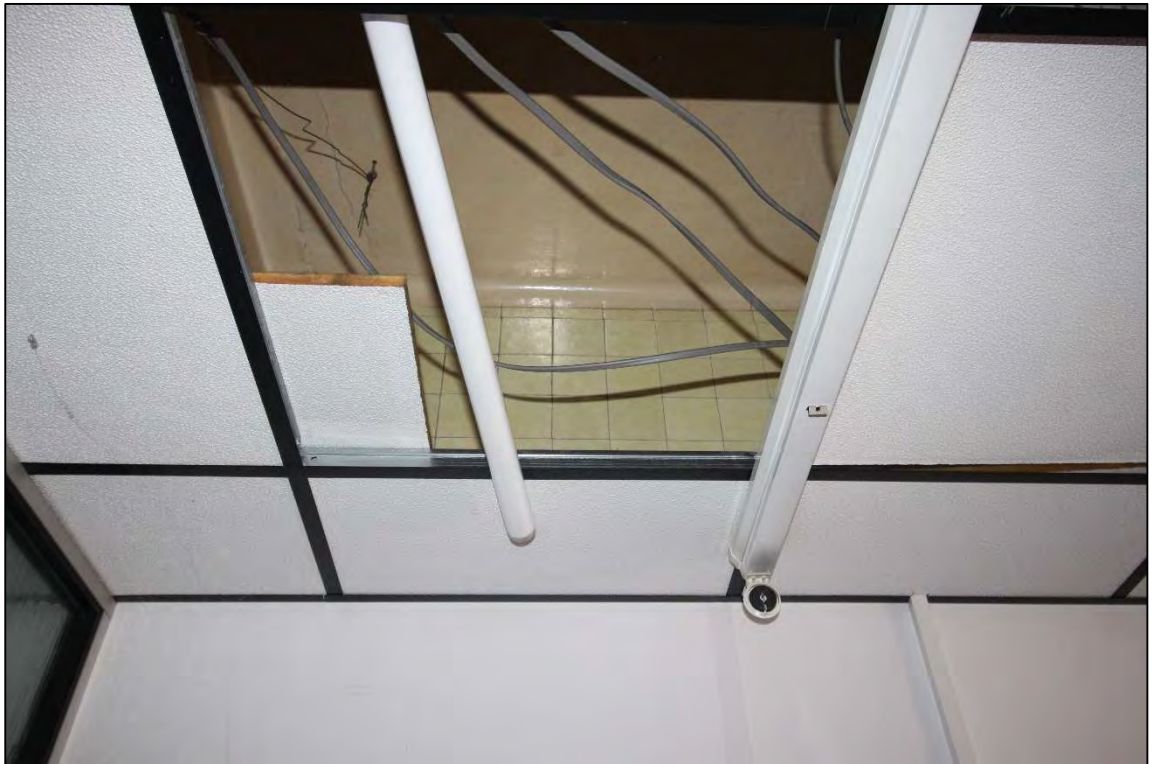
*Plate 59: Detail of the original tiled eastern wall*

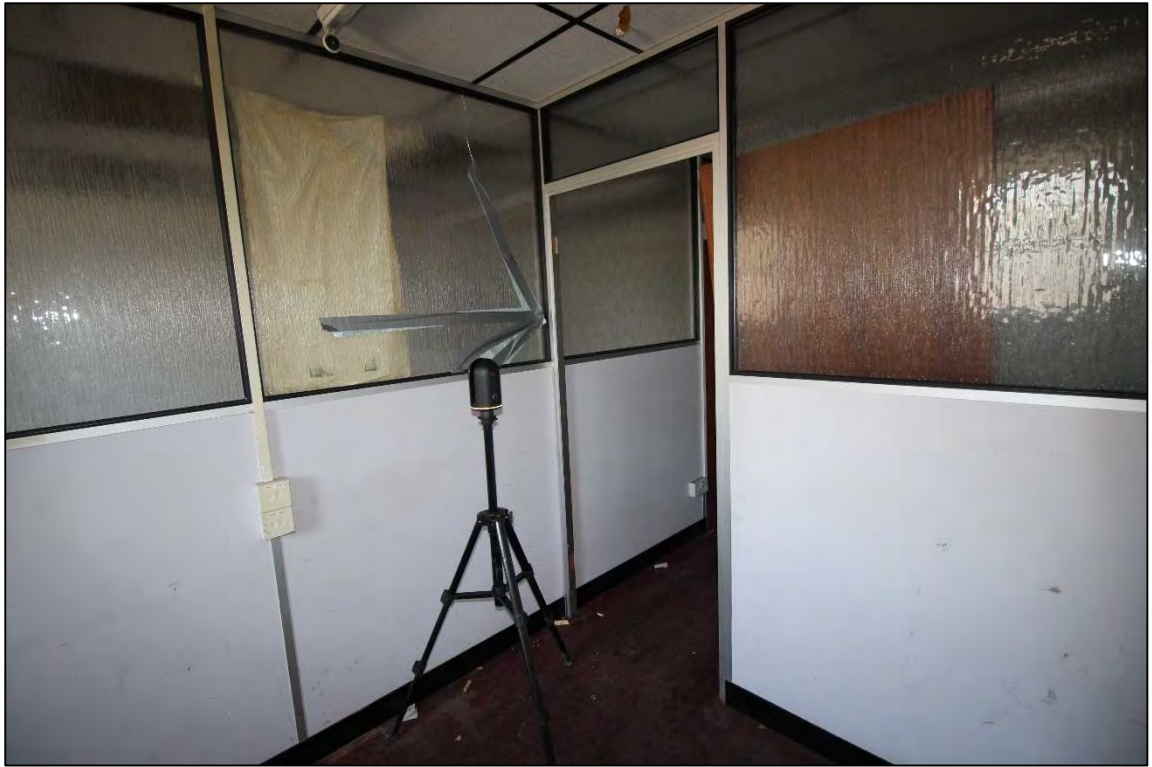
*Plate 60: The north and west partition walls of Room 3*

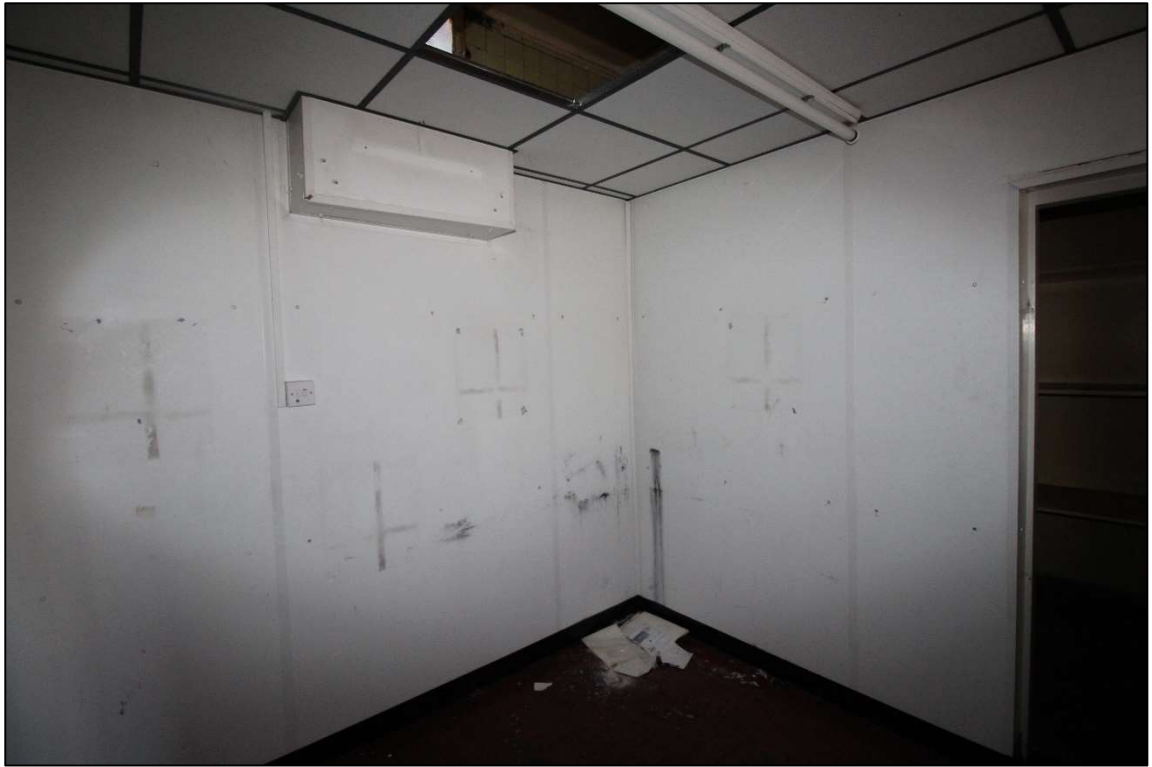
*Plate 61: General view of Room 4*

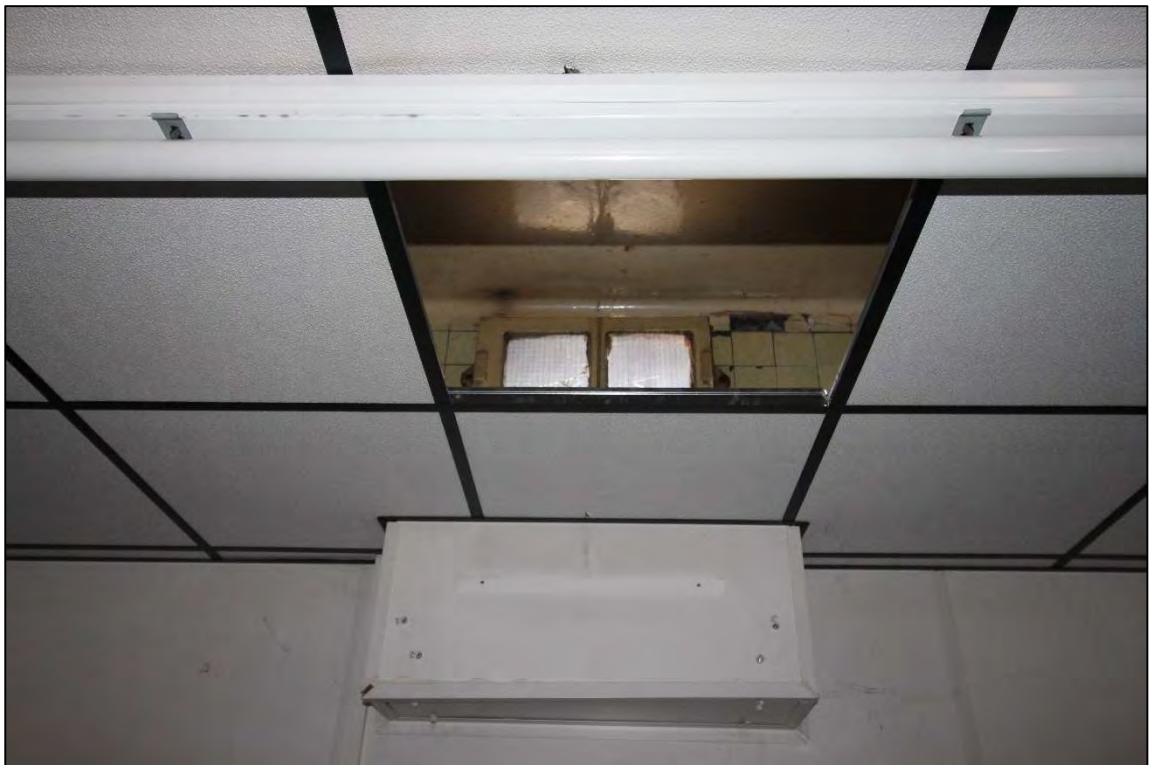
*Plate 62: Detail of the obscured window within the northern wall of Room 4*

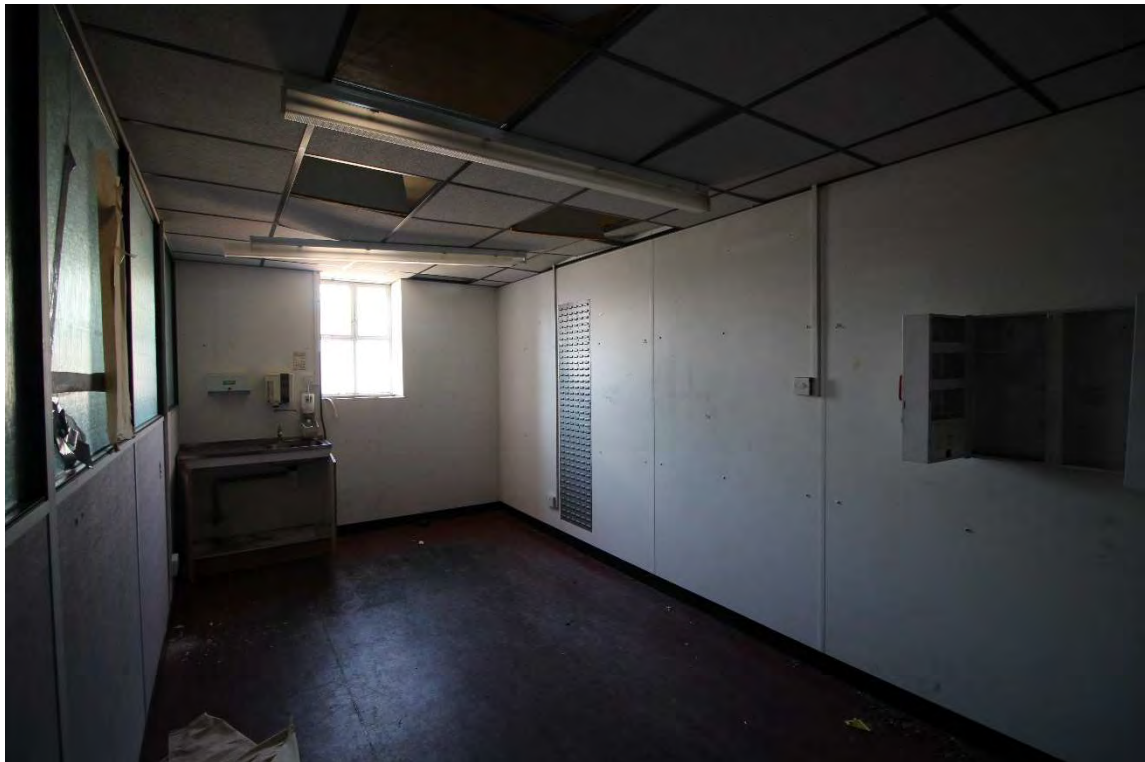
*Plate 63: General view of Room 6*

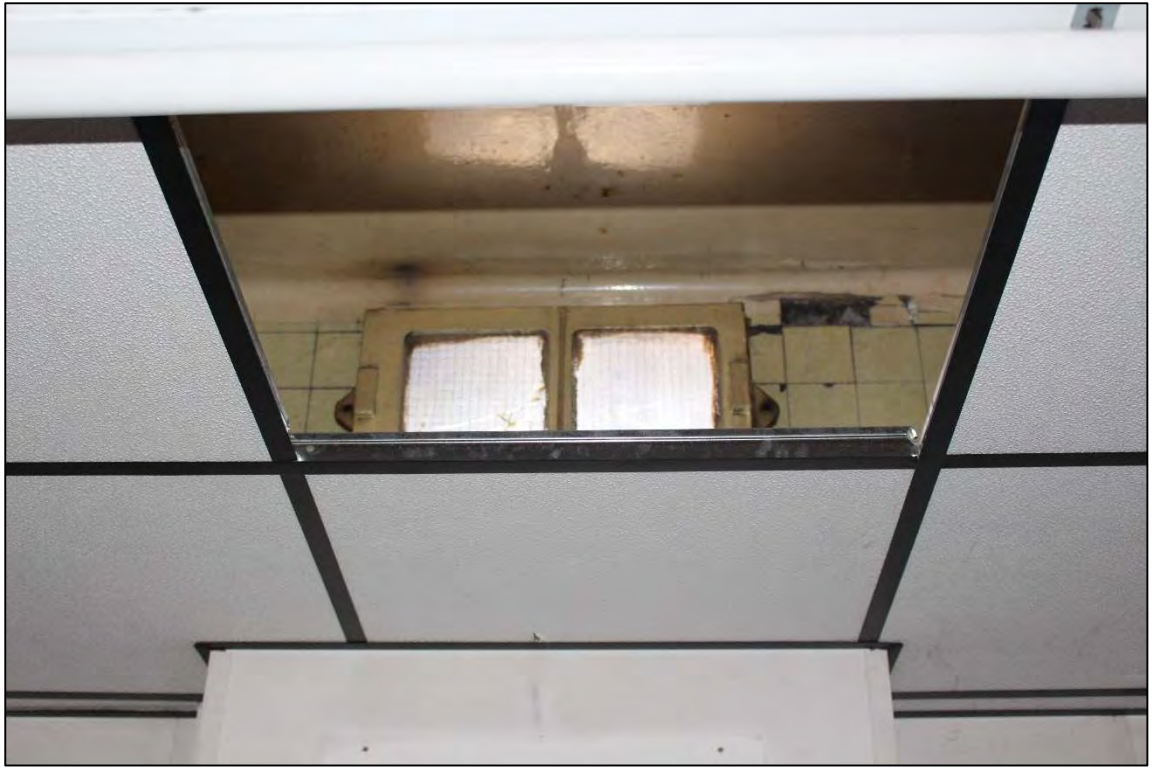
*Plate 64: Detail of the obscured window within the northern wall of Room 6*

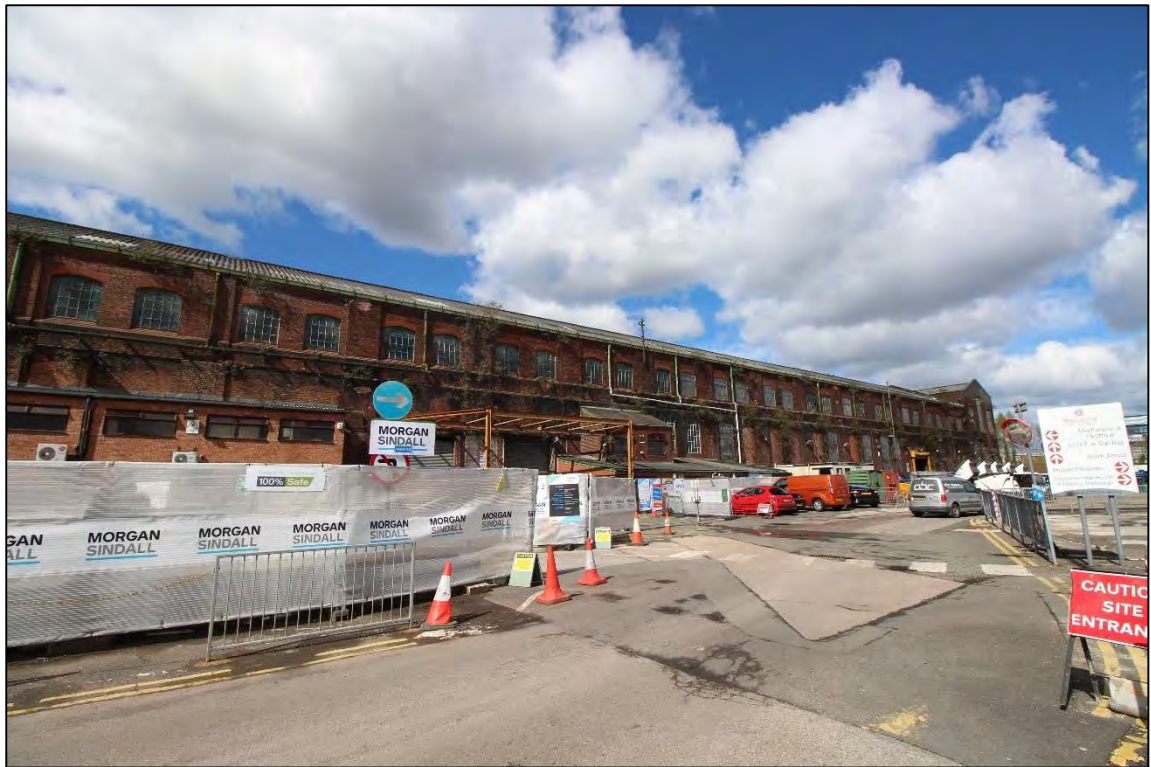
*Plate 65: General view of eastern elevation of the boiler shop, facing north-west*

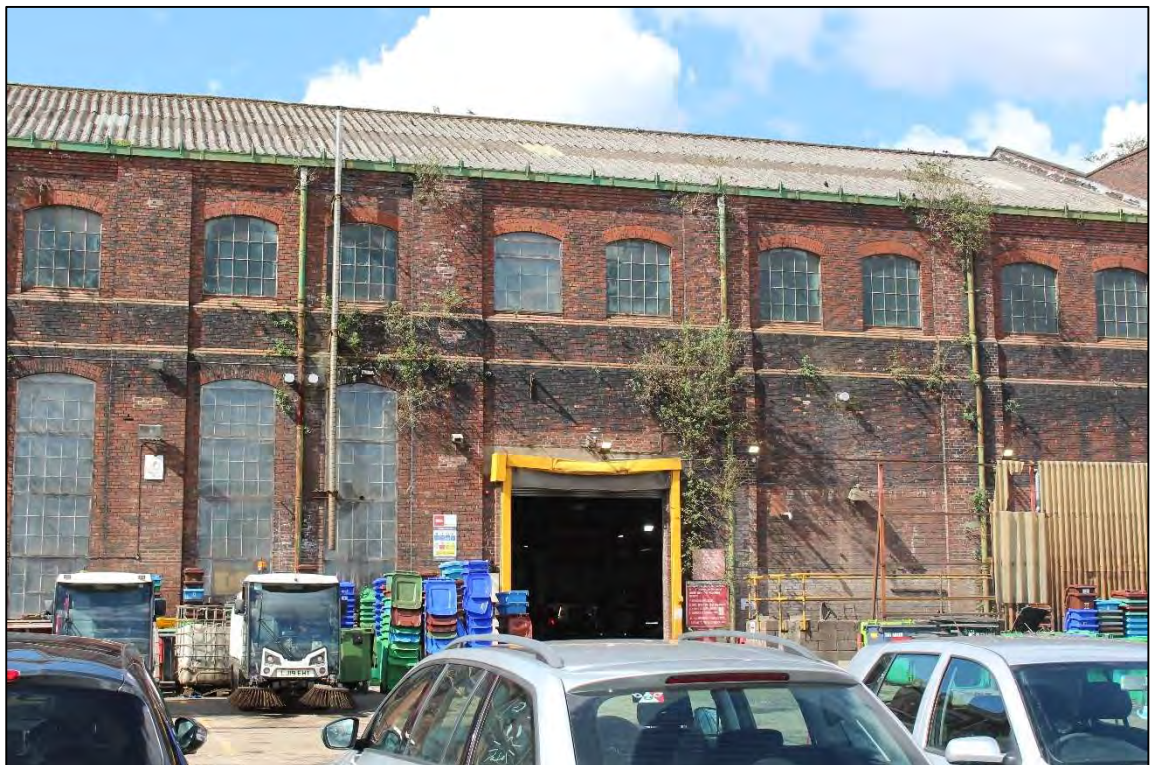
*Plate 66: The northern doorway within the eastern elevation*

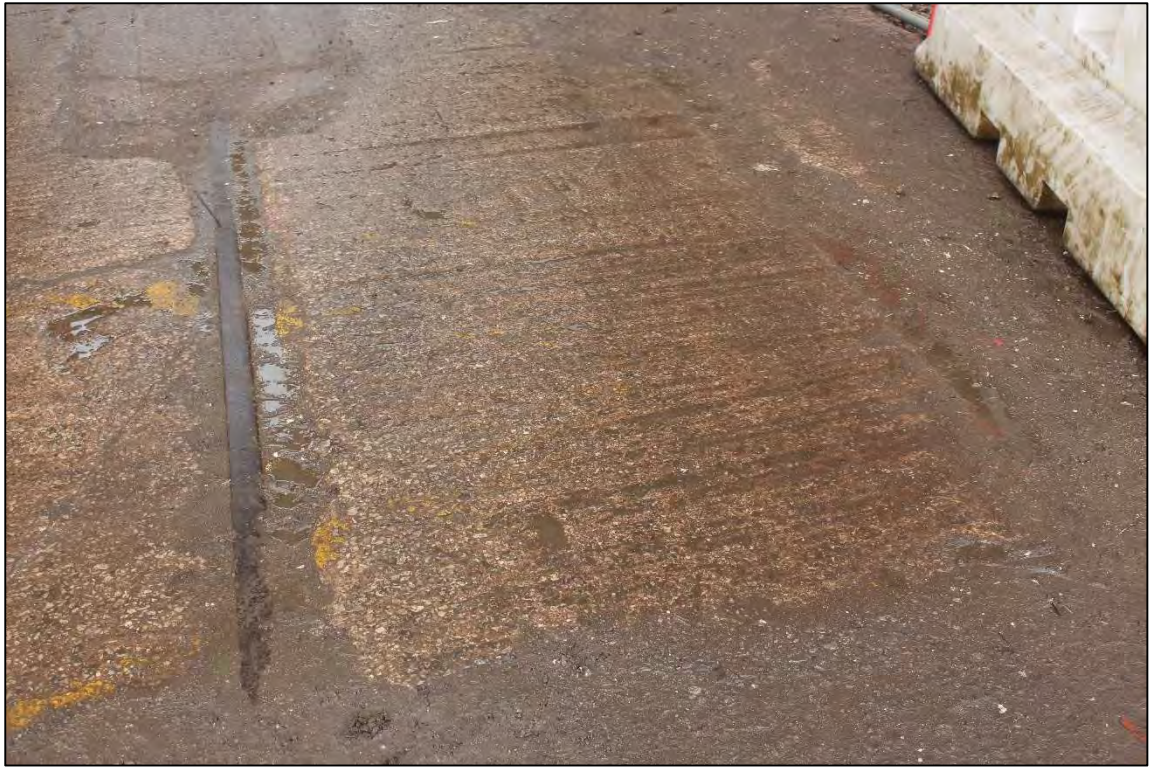
*Plate 67: The retained rail tracks within the opening of the northern doorway*

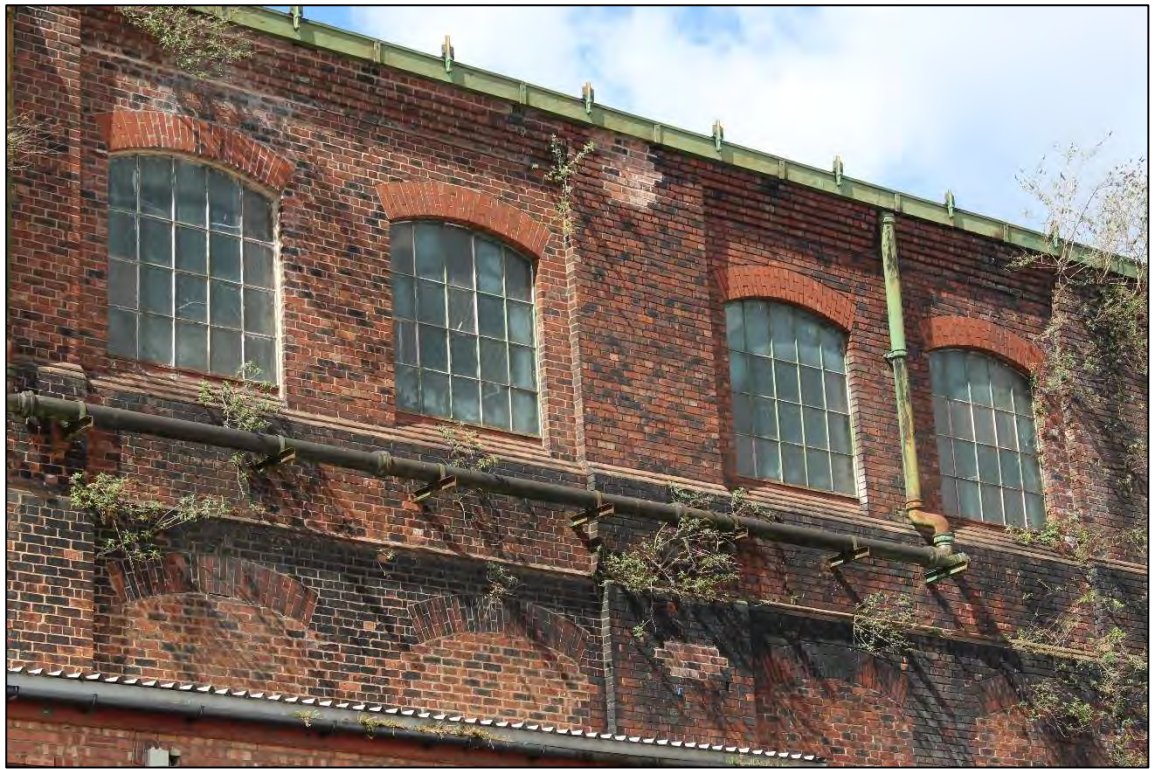
The upper section of the elevation contained a second row of 6'1 $\frac{3}{4}$ " (1.88m) wide window apertures. These were set within a recessed panel and comprised gauged brick segmental arched heads with sloping terracotta sills. Housed within the openings was a 20-light iron framed window with obscured glass panes (Plate 68).

*Plate 68: Detail to the upper windows on the eastern elevation of the boiler shop*

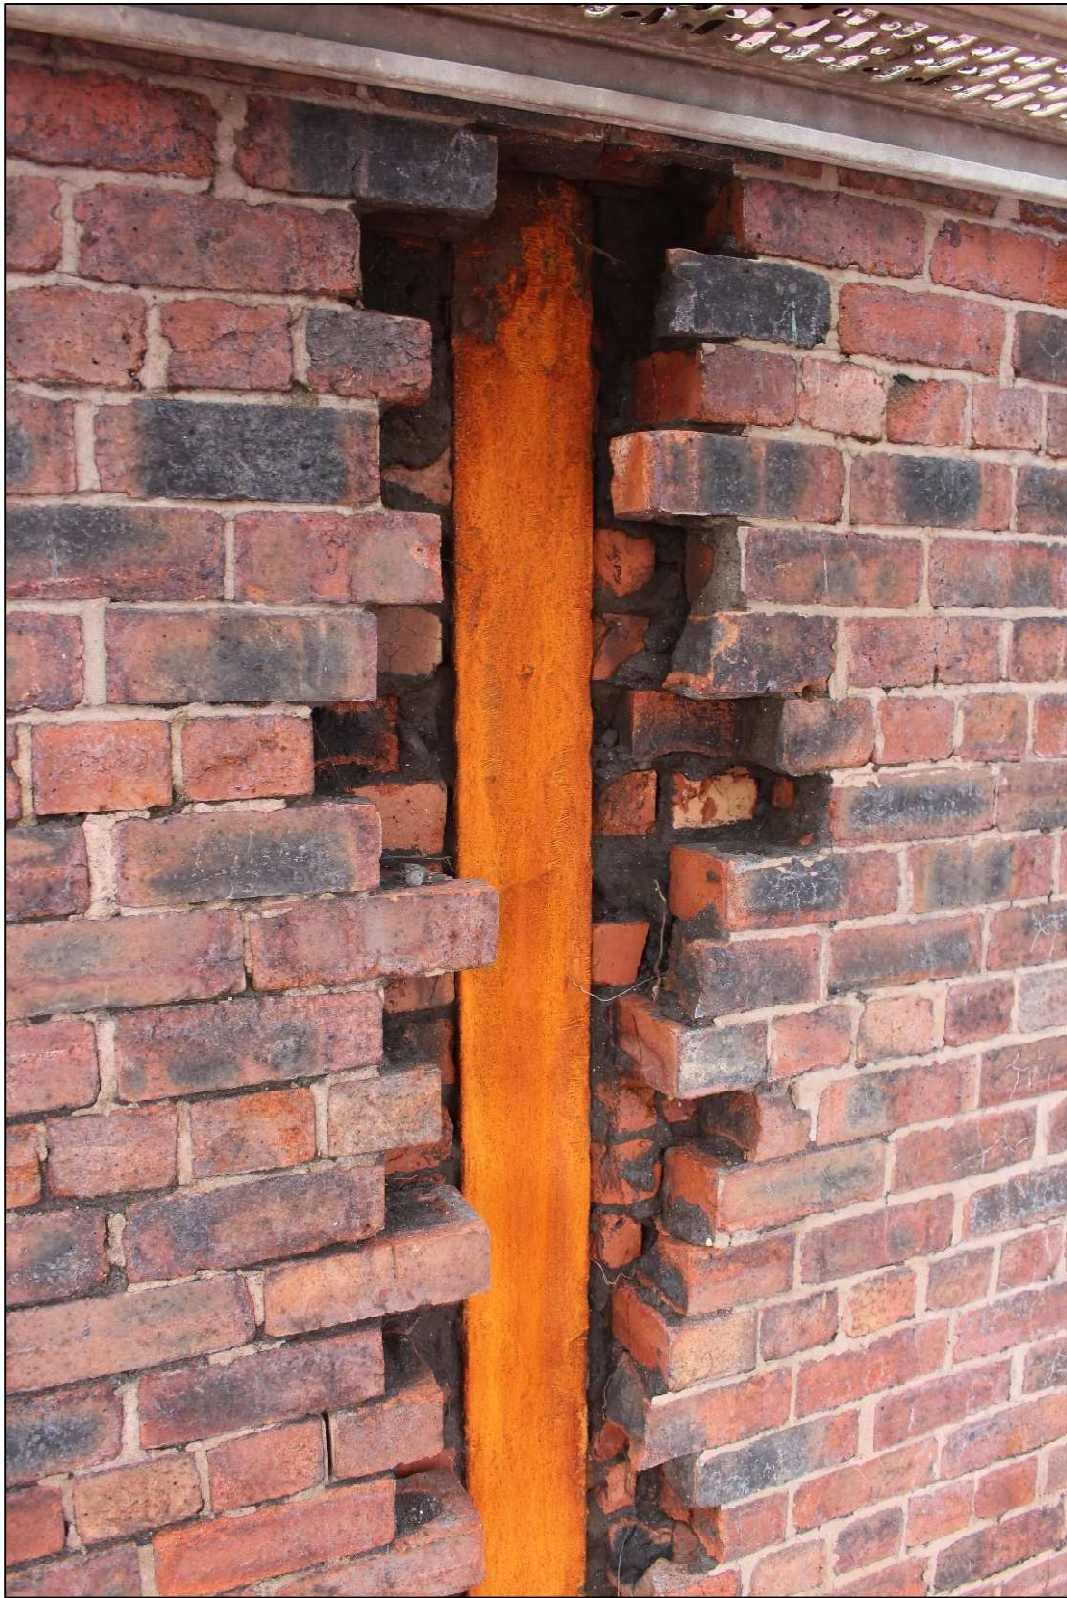
During the watching brief phase of the redevelopment the elevation had undergone several repairs which enabled the survey to record the construction process of the building. The brick piers between each of the windows had been constructed with a 6" wide I-section steel core (Plate 69).

*Plate 69: The steel I-section beam core within the piers to the eastern elevation*

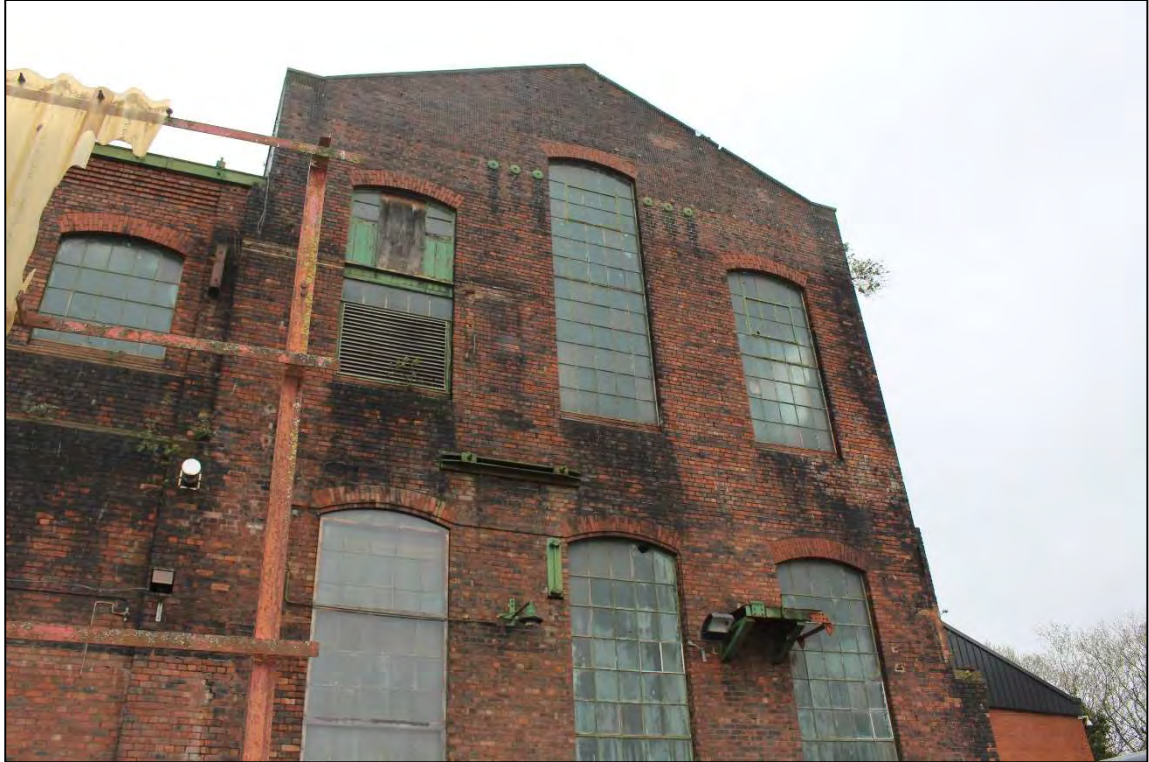
*Plate 70: The eastern gable wall of the riveting bay at the northern end of the boiler shop*

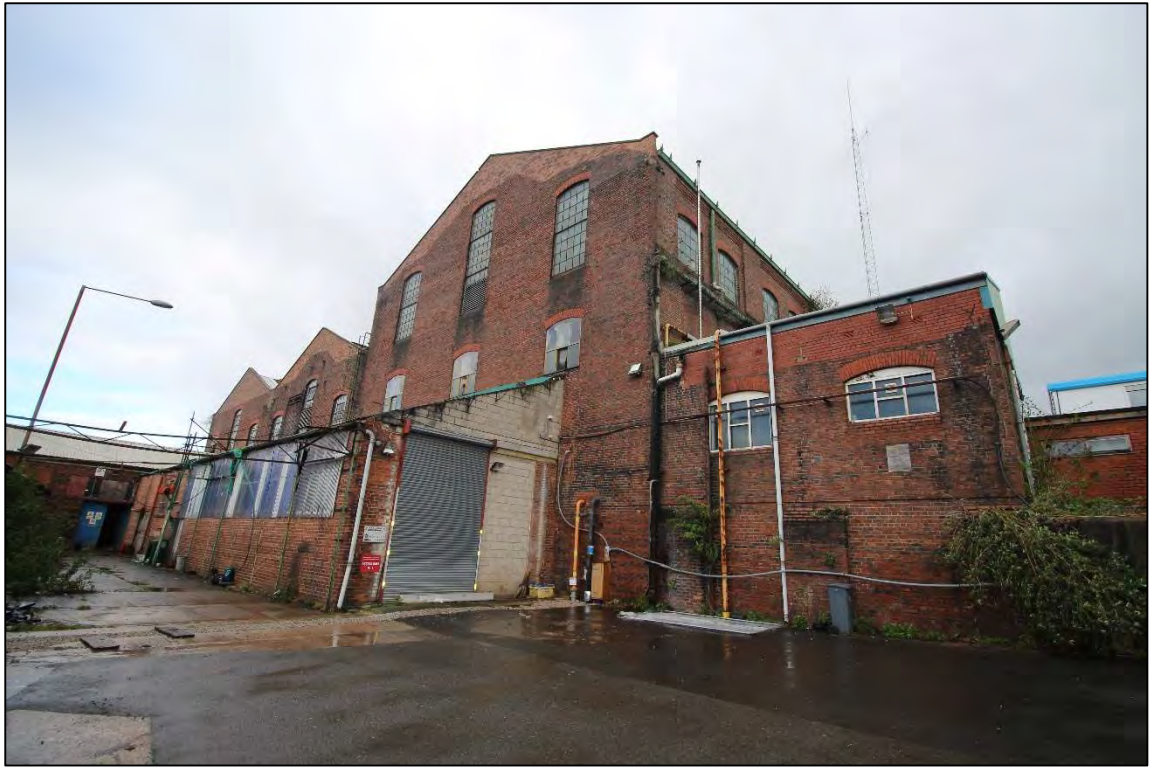
*Plate 71: The southern elevation of the boiler shop, looking north-west*

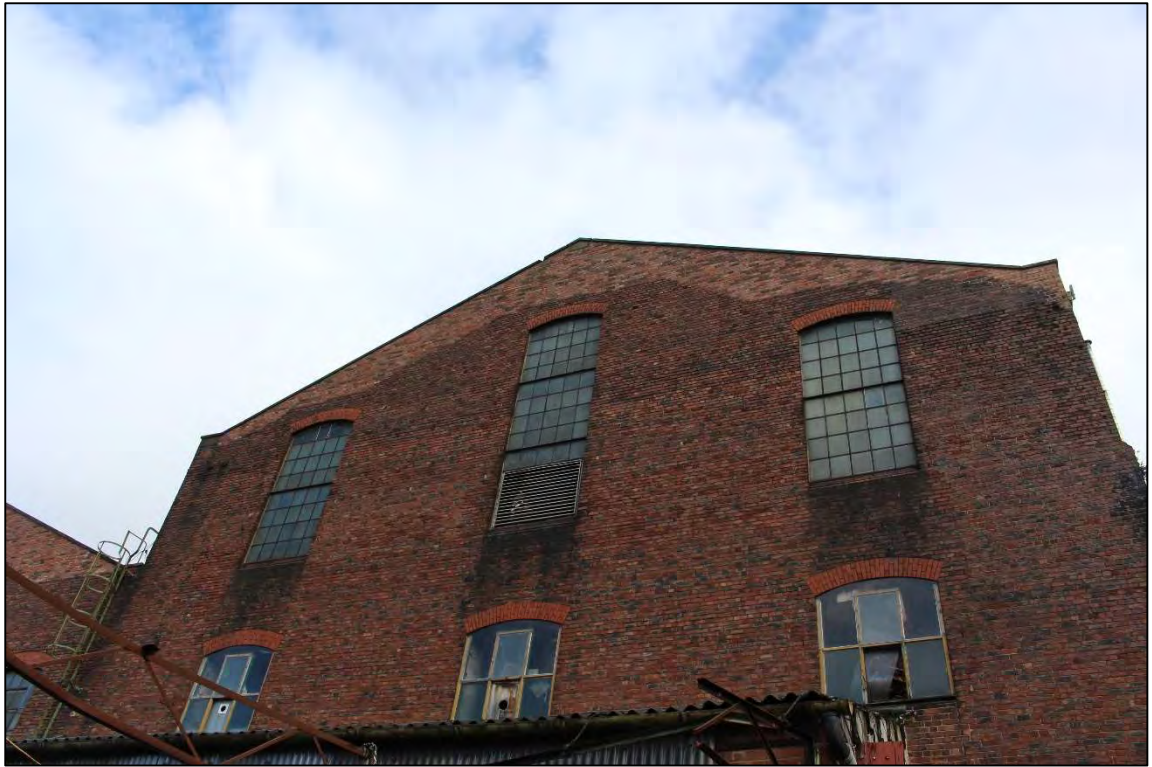
*Plate 72: The southern gable wall of the eastern bay of the boiler shop*

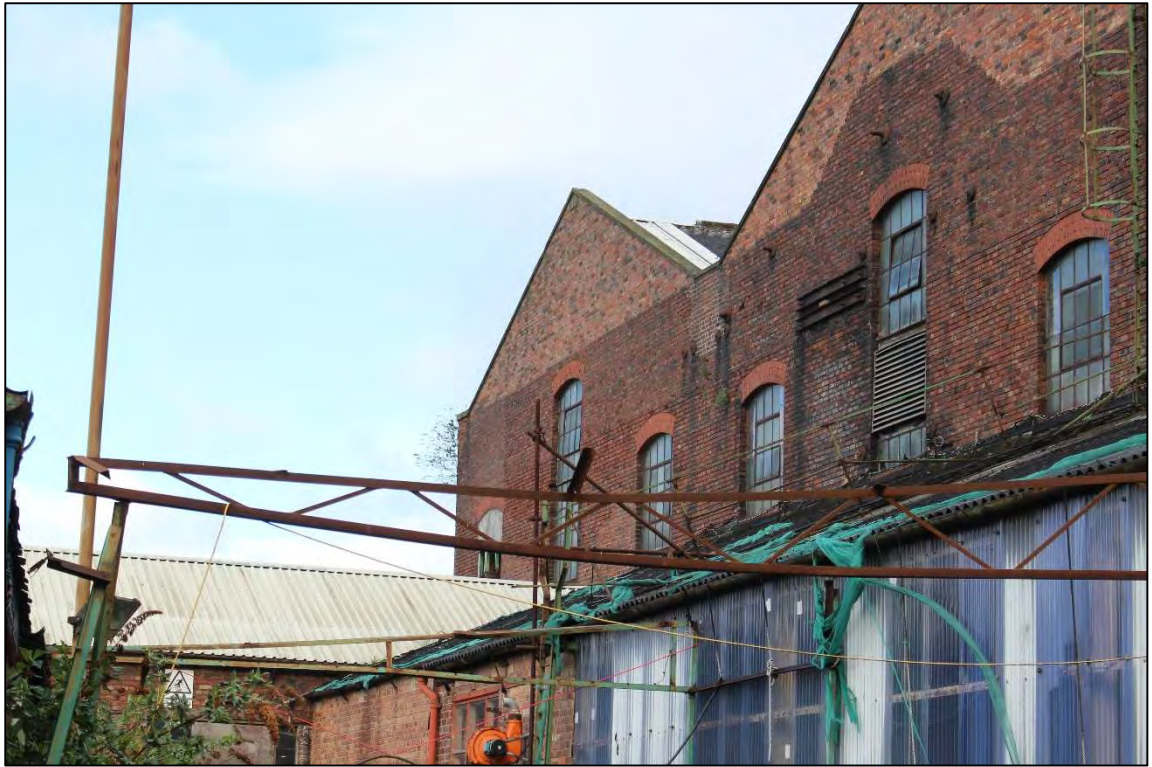
*Plate 73: The southern gable wall of the central and western bays of the boiler shop*

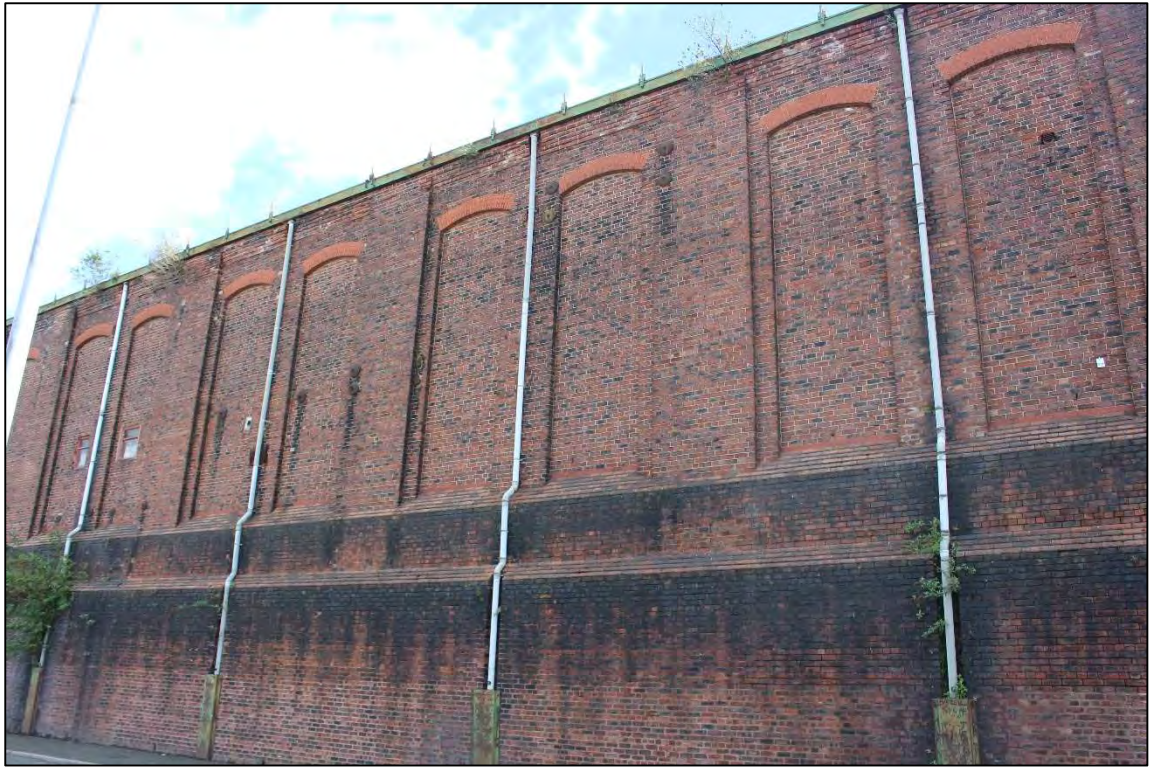
*Plate 74: The western elevation of the boiler shop*

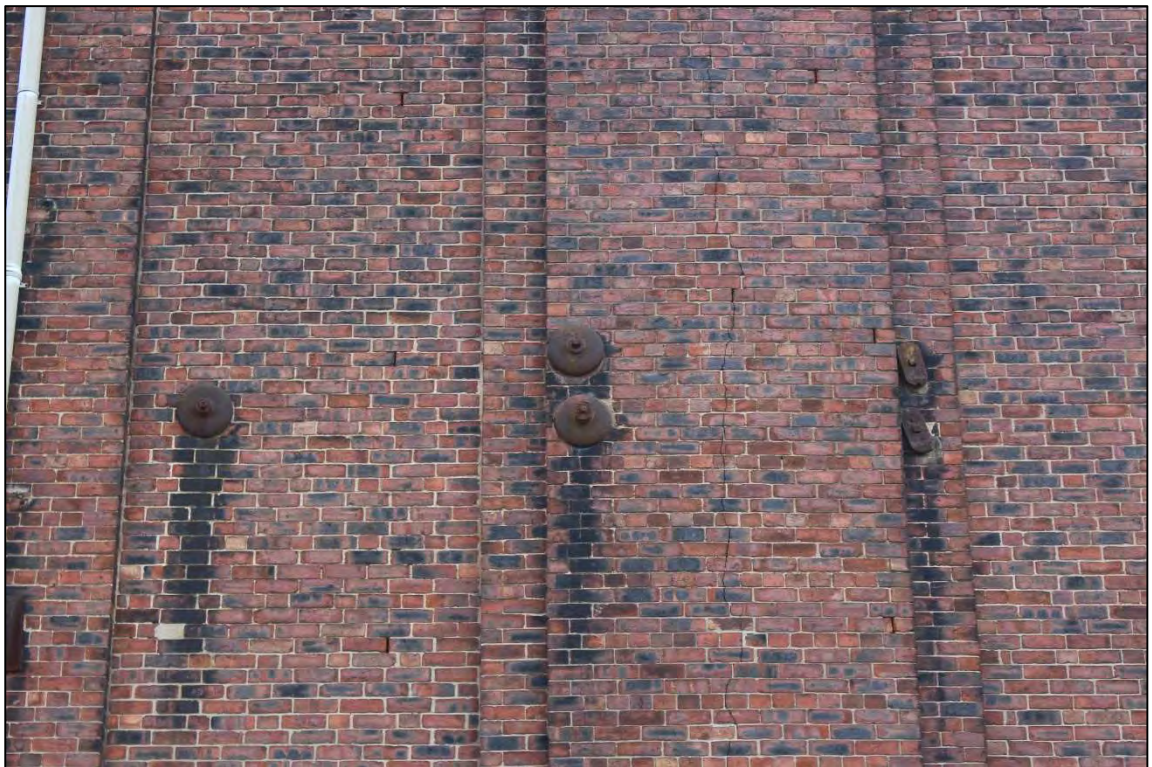
*Plate 75: Detail of the tie rod plates within the western elevation, facing east*
