The northern elevation was also constructed in a three-course English Garden Wall bond consisting of two central recessed windows with a steel ladder to the eastern end (Plate 52; Fig 5). The ladder had been fixed to the outer face and afforded access to the roof. As with the windows to the eastern elevation, the windows were set within a cast-iron housing with a pointed arch head. The cast-iron doors had been removed and exposed a four-light cast-iron window with modern wired obscured glass panes (Plate 53).

Hammerstone Road Depot, Gorton, Manchester

Hammerstone Road Depot, Gorton, Manchester  
Figure 5: Ambulance bay plan & elevations

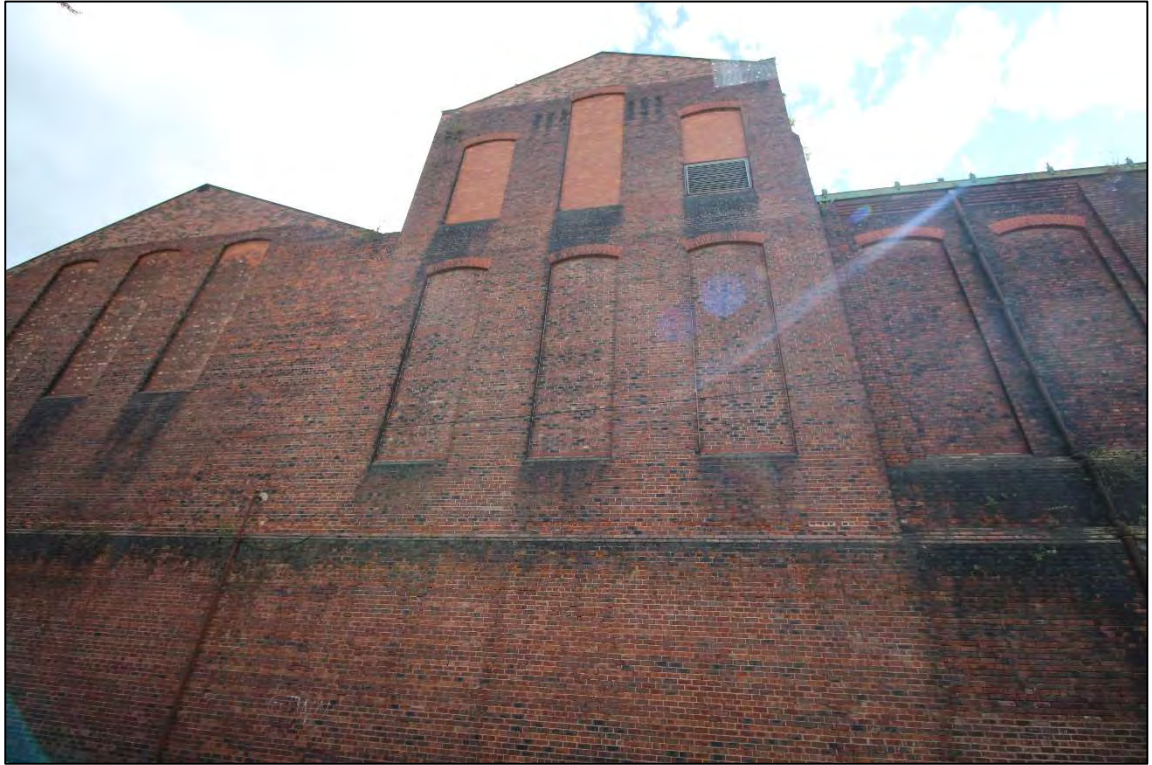
*Plate 76: The western gable wall of the riveting bay, facing east*

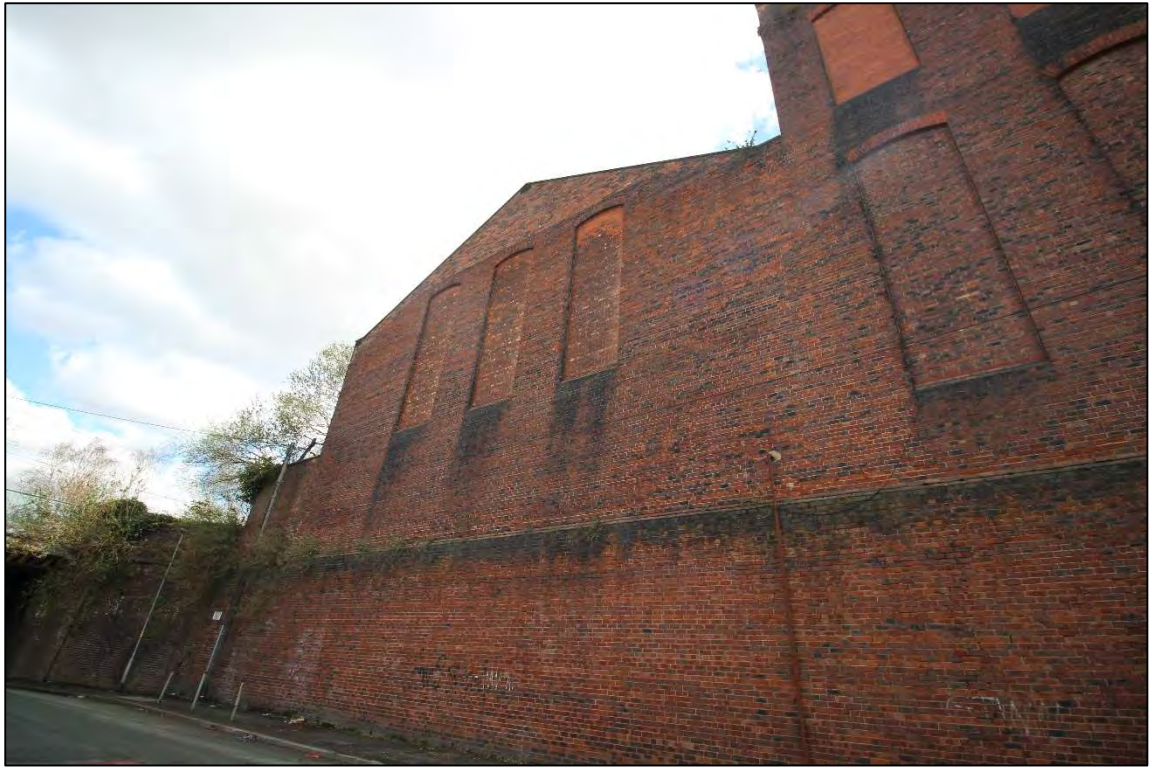
*Plate 77: The eastern gable of the northern shed*

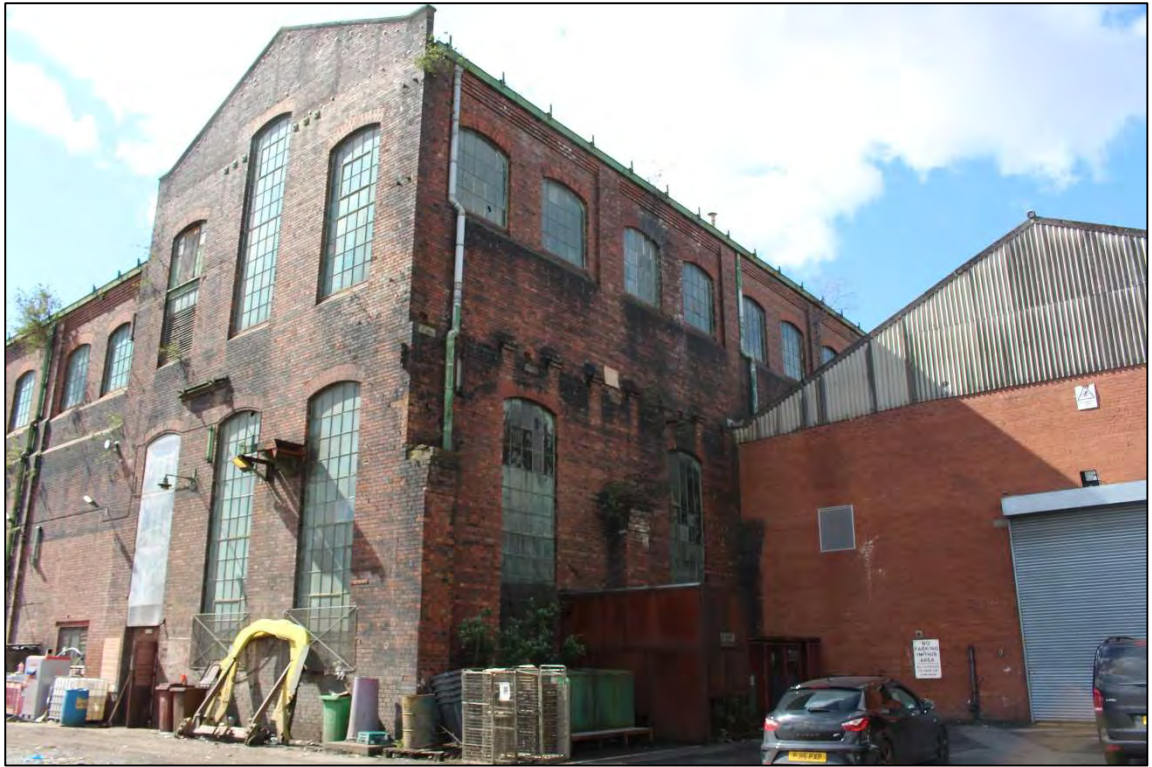
*Plate 78: The northern elevation of the riveting bay, facing south-west*

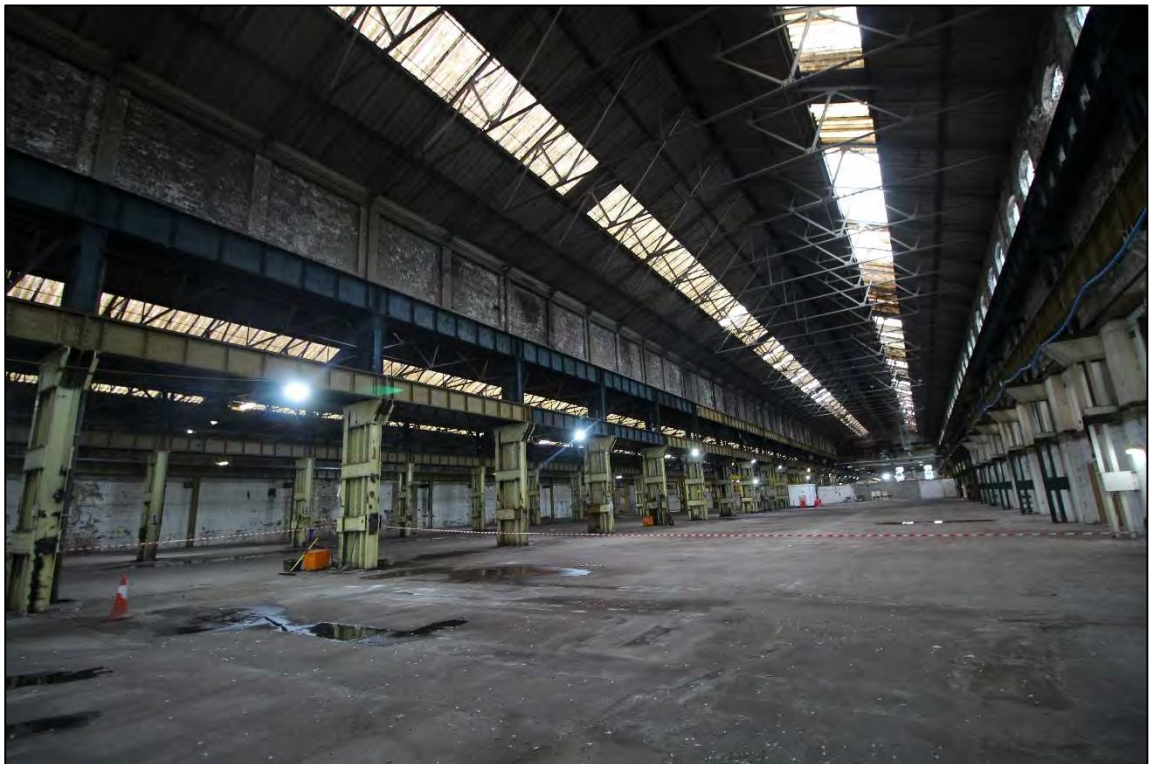
*Plate 79: Internal view of the boiler shop, looking north-west*

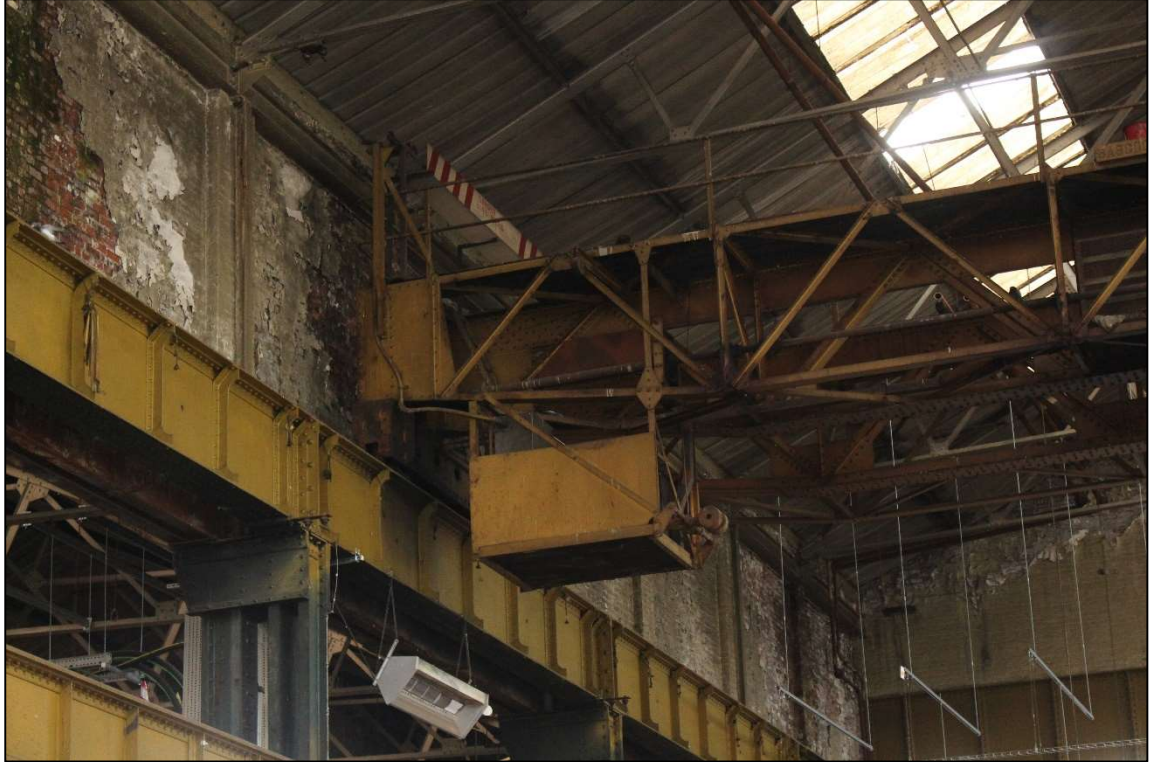
*Plate 80: Detail of the retained travelling crane within the eastern bay of the boiler shop*

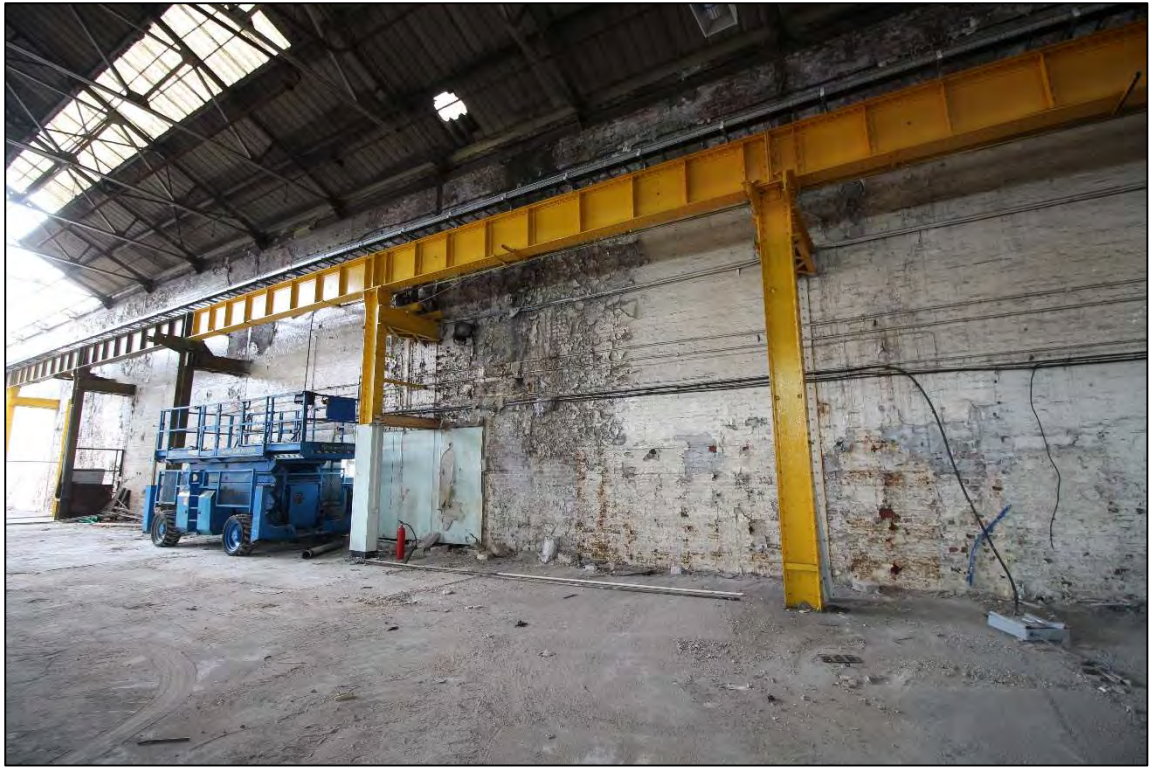
*Plate 81: The western riveted steel beam and supporting stanchions to the western bay*

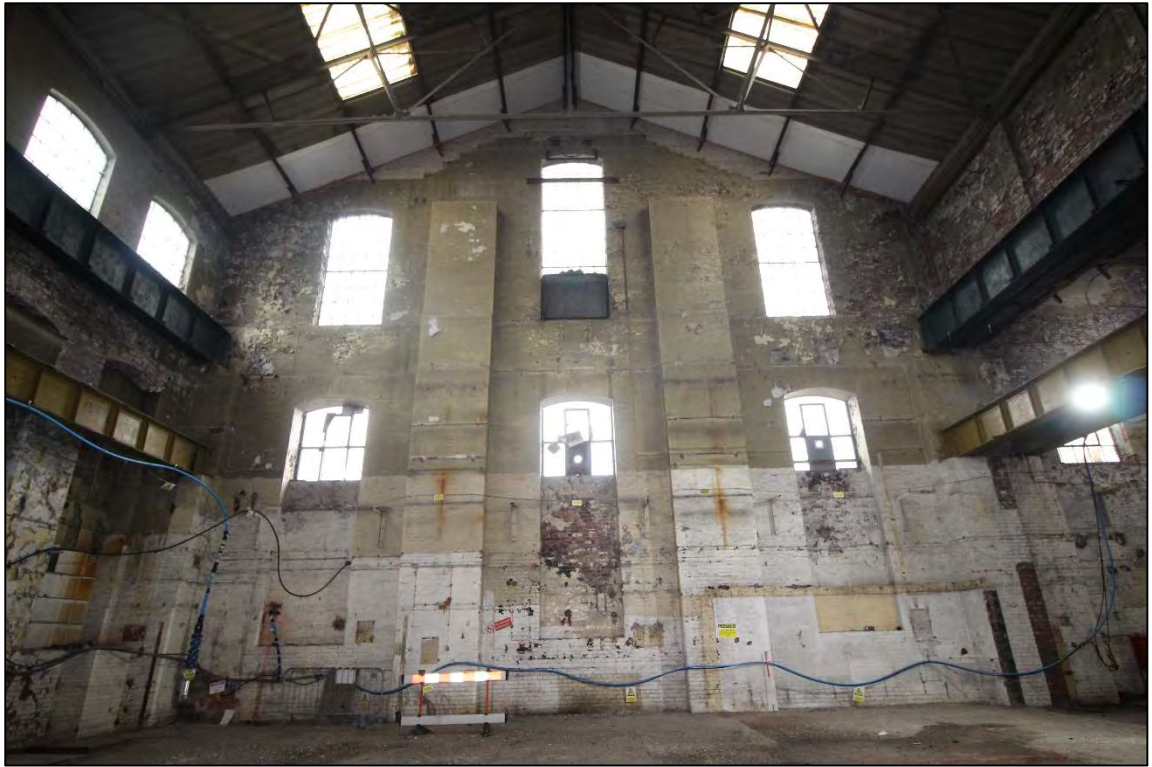
*Plate 82: The southern wall of the eastern bay*

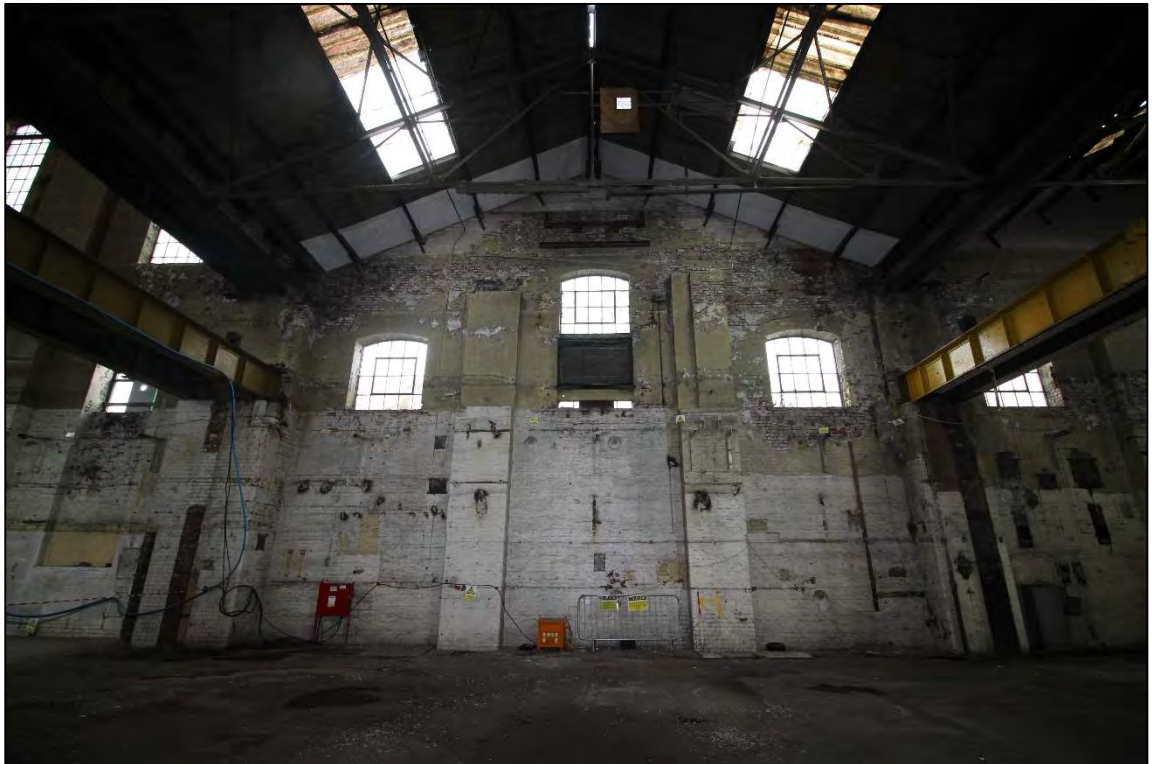
*Plate 83: The southern wall of the central bay*

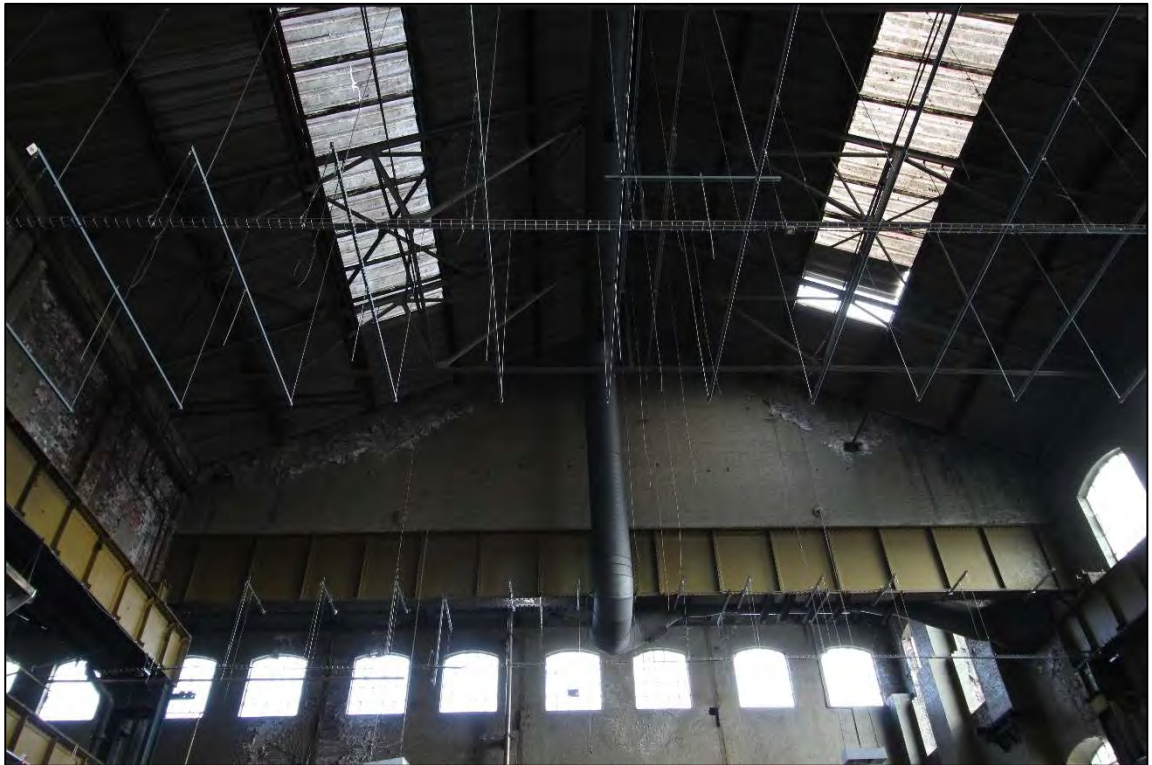
The northern wall to each of the bays was largely open with the brick wall above tie beam height that was supported by riveted steel beams (Plate 84). This suggests that there was unrestricted access between the boiler shop and the riveting bay.

*Plate 84: The northern wall of the eastern bay*

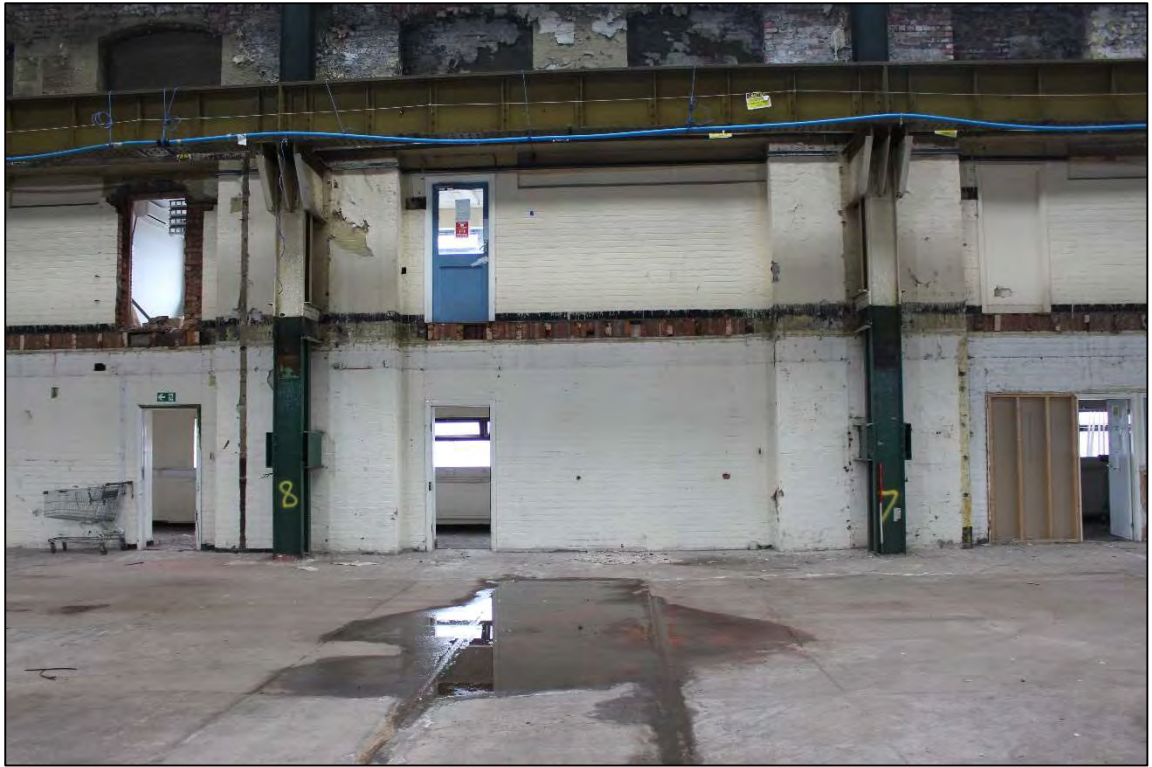
The eastern wall of the eastern bay had originally contained nine wagon doorways to the southern end. These comprised concrete lintels with the jambs projecting into the shop by 8". The openings were infilled with brick and a later doorway affording access into the ground and first floor of the late-20<sup>th</sup>-century extension (Plate 85). The concrete floor around each of the doorways had retained a set of standard gauge rails measuring 4'8½" (1.43m) apart (Plate 85).

*Plate 85: The infilled wagon doorway to the eastern wall of the eastern bay*

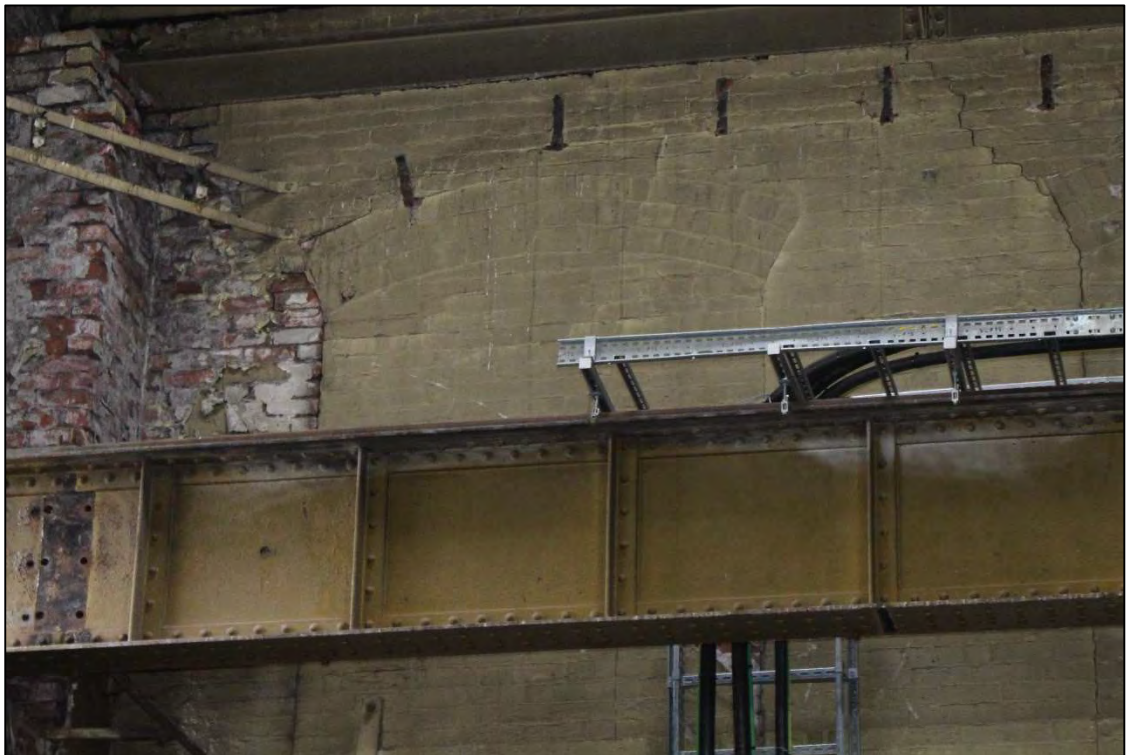
The western wall had recently been painted which obscured any historical features. However, the three-course segmental arched heads of the blind recesses within the western elevation were observed. The recesses were infilled flush with brick (Plate 86).

*Plate 86: The infilled recesses within the western wall of the western bay*

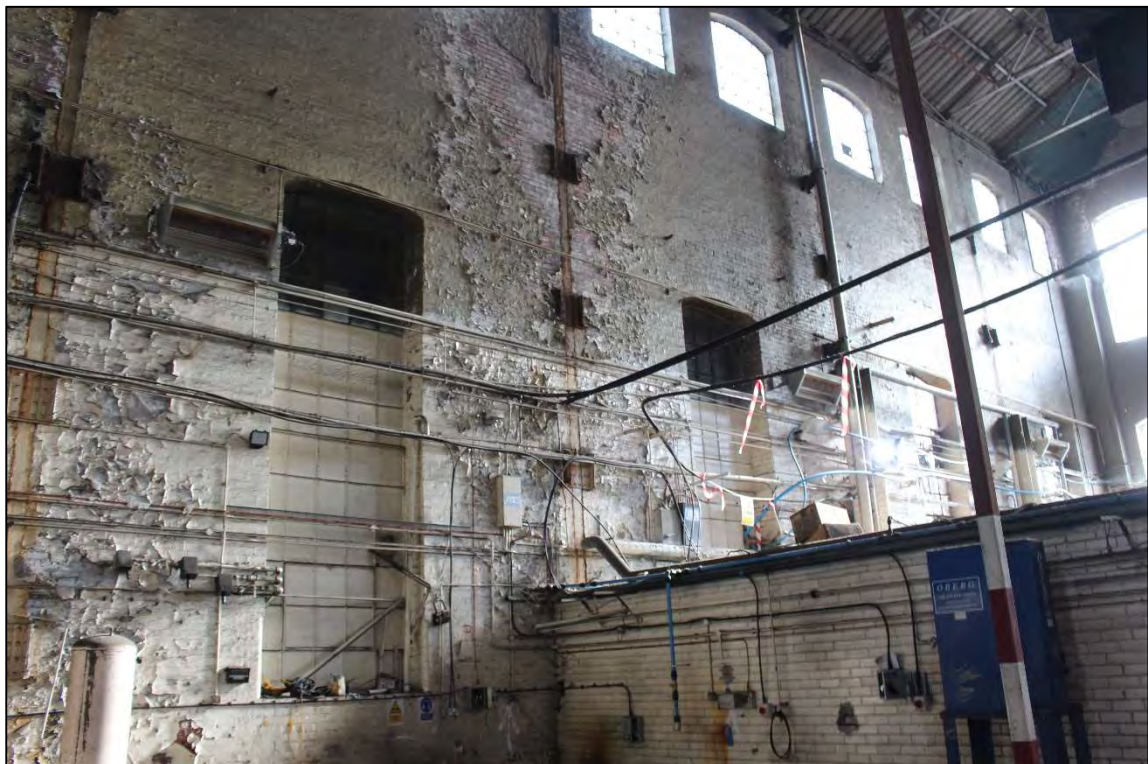
*Plate 87: The infilled windows within the northern wall of the riveting bay*

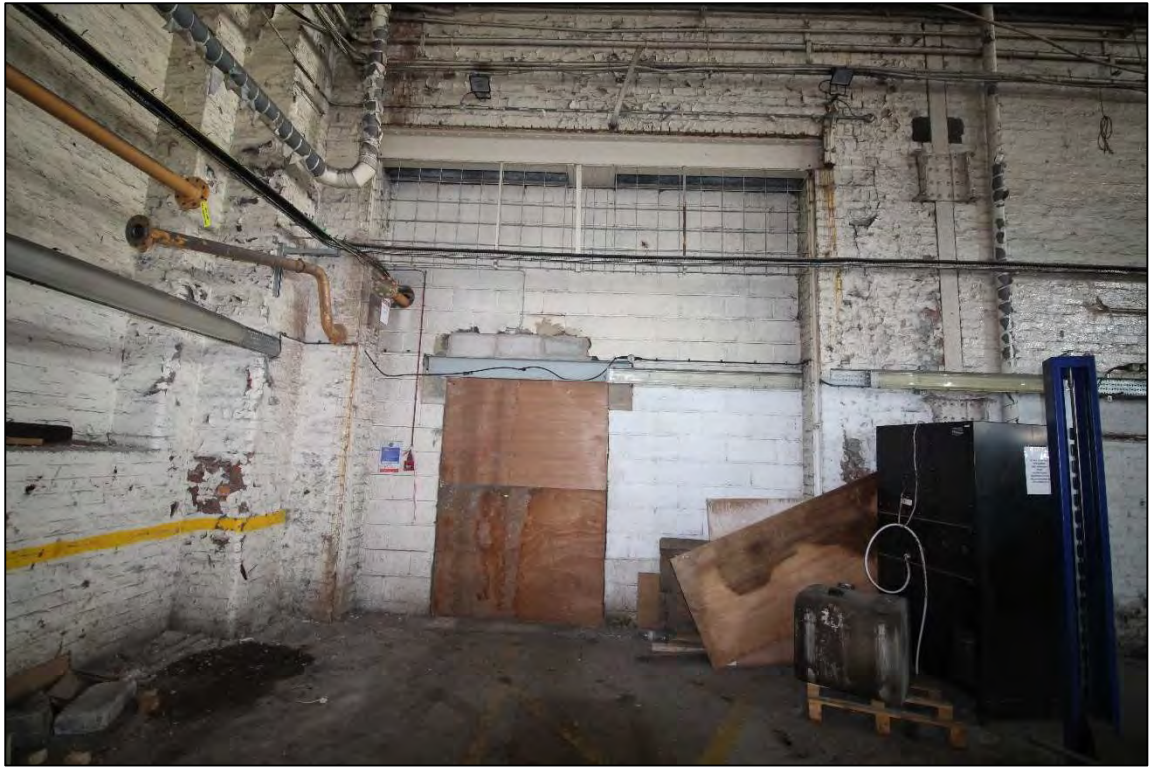
*Plate 88: The wagon doorway at the western end of the northern wall*

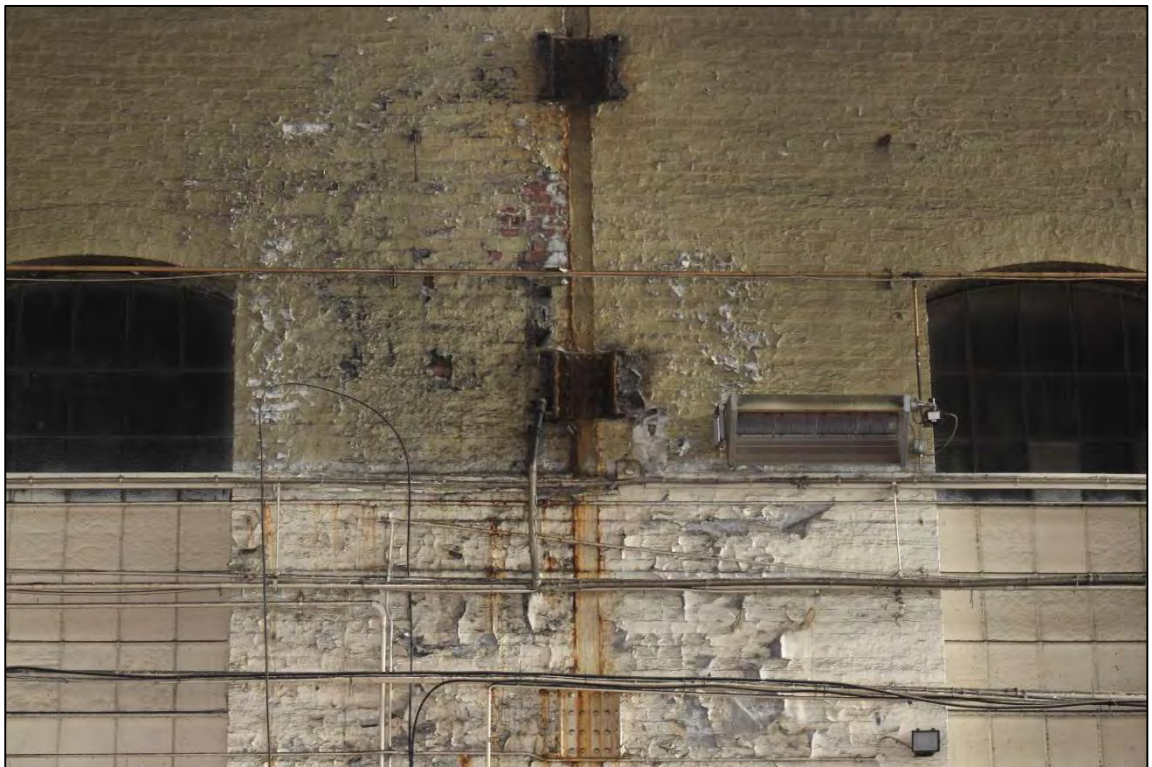
A series of riveted steel beams was bolted to the northern wall. These had been recently removed however they are evidence of a steel structure possibly another travelling crane (Plate 89).

*Plate 89: The remains of riveted steel beams within the northern wall of the riveting bay*

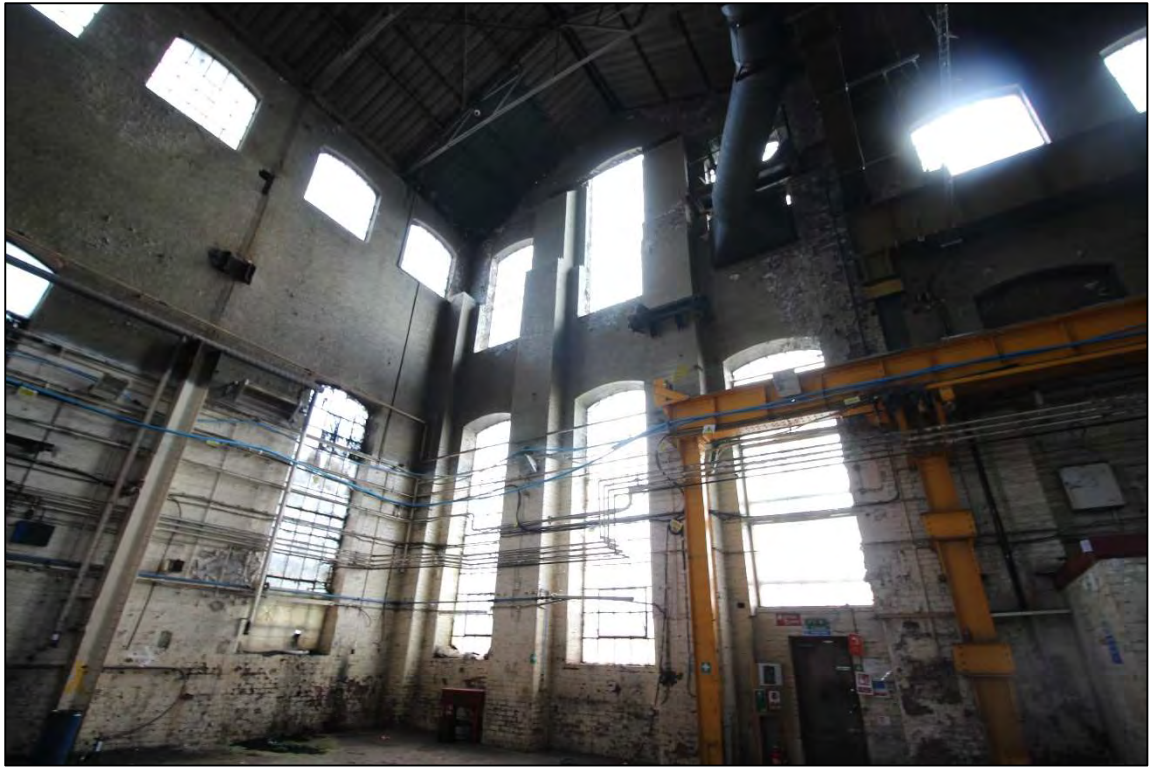
*Plate 90: The eastern wall of the riveting bay*

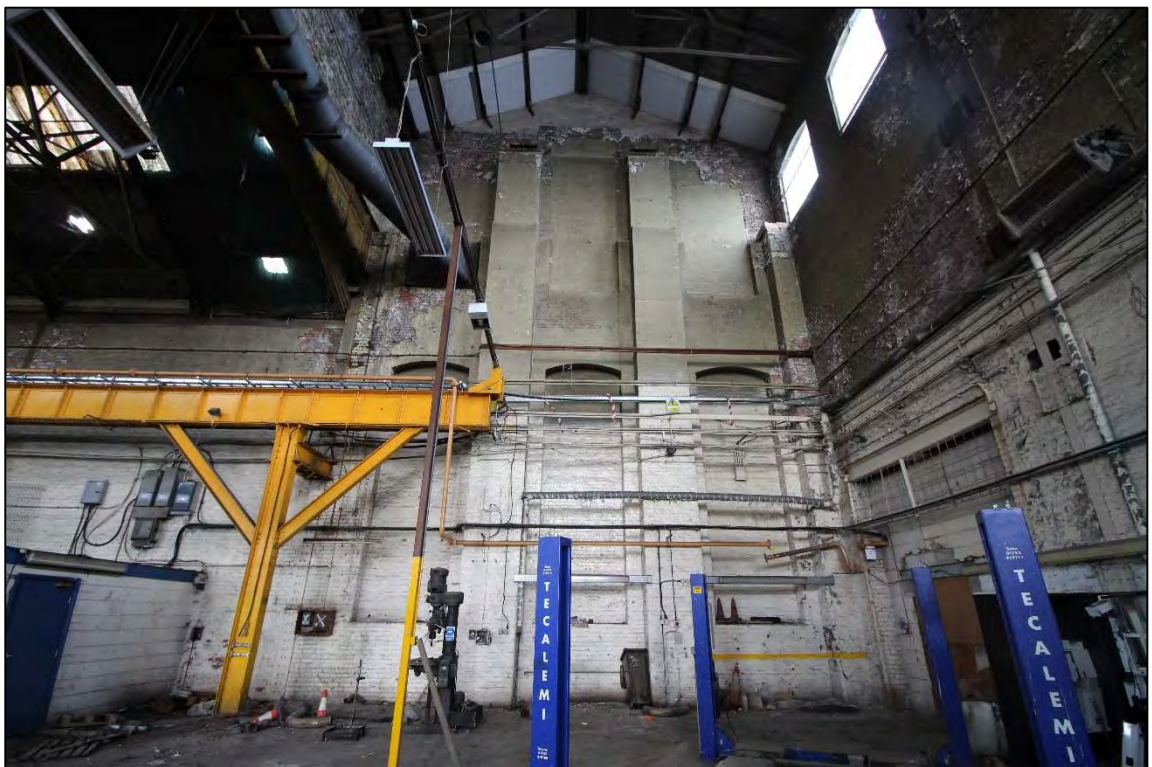
*Plate 91: The western wall of the riveting bay*

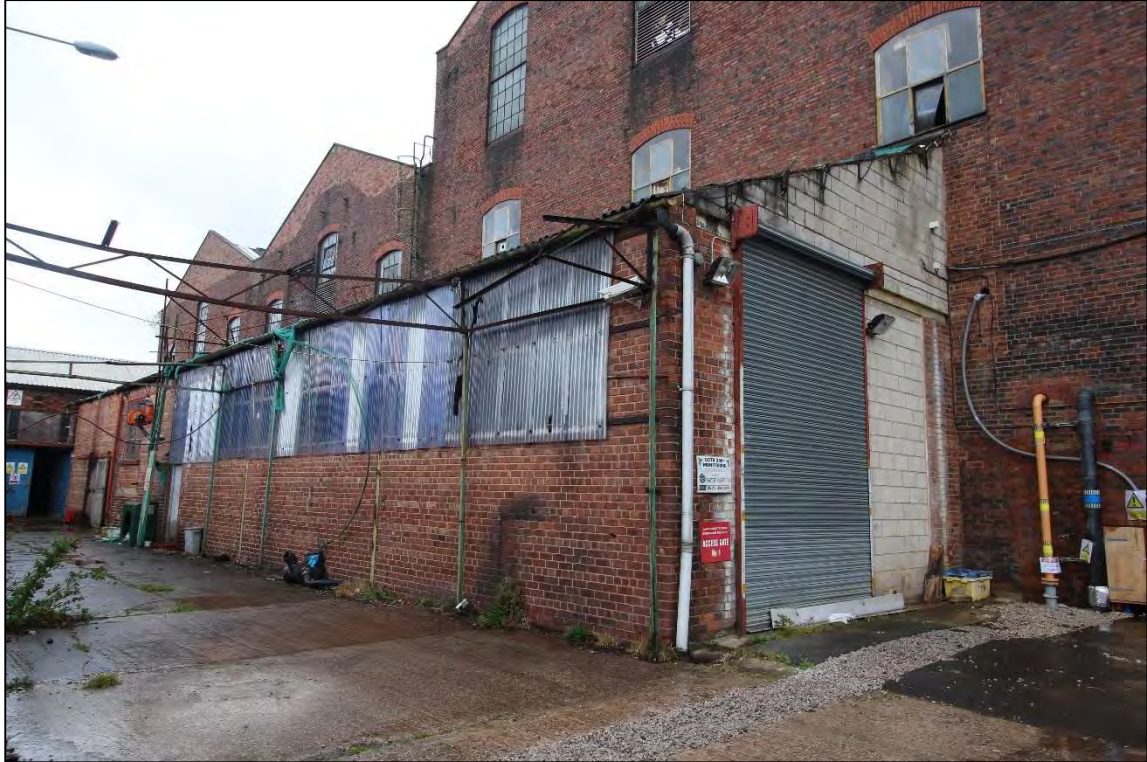
*Plate 92: General view of Shed 3, facing north-west*

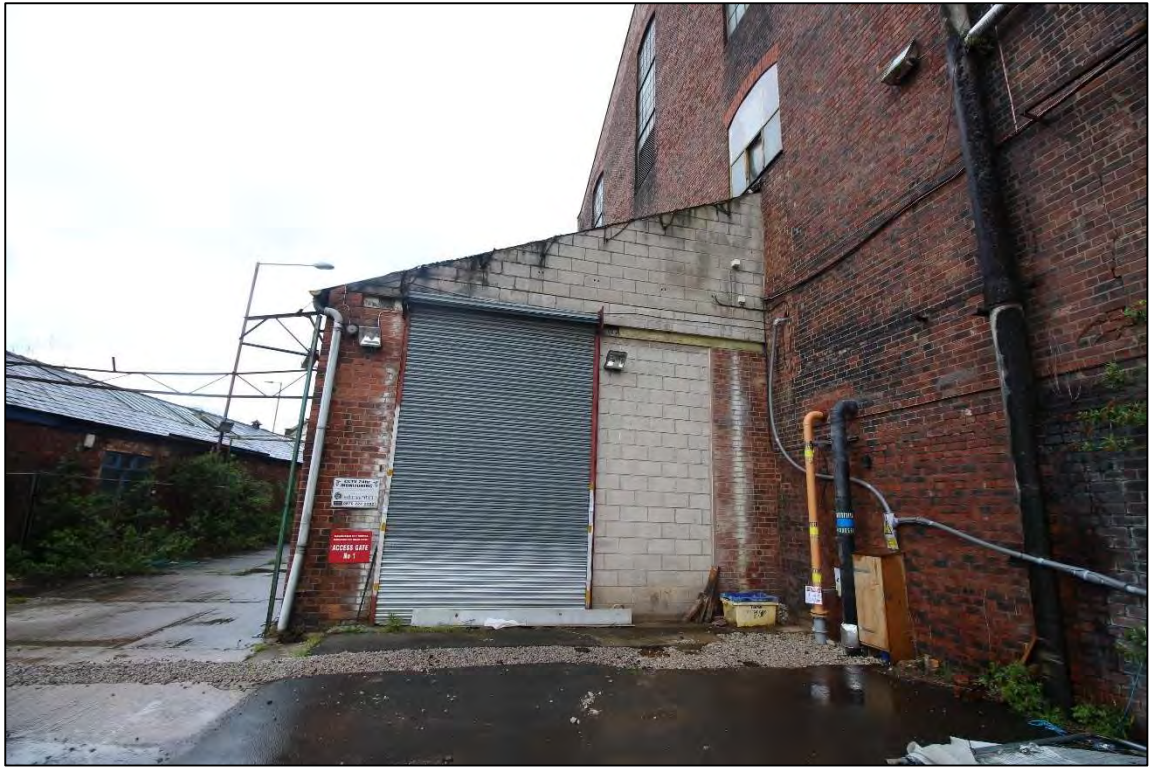
*Plate 93: The eastern elevation of Shed 3*

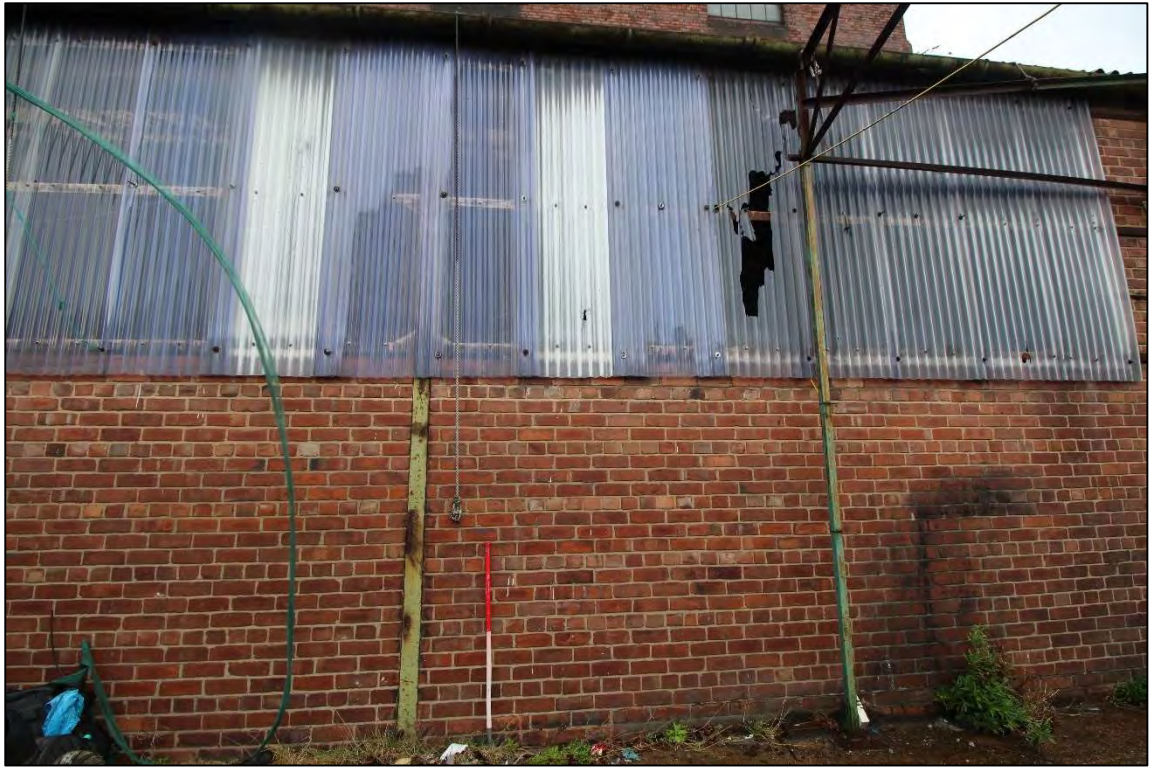
*Plate 94: Detail of the modern inserted horizontal window within the southern elevation, looking north*

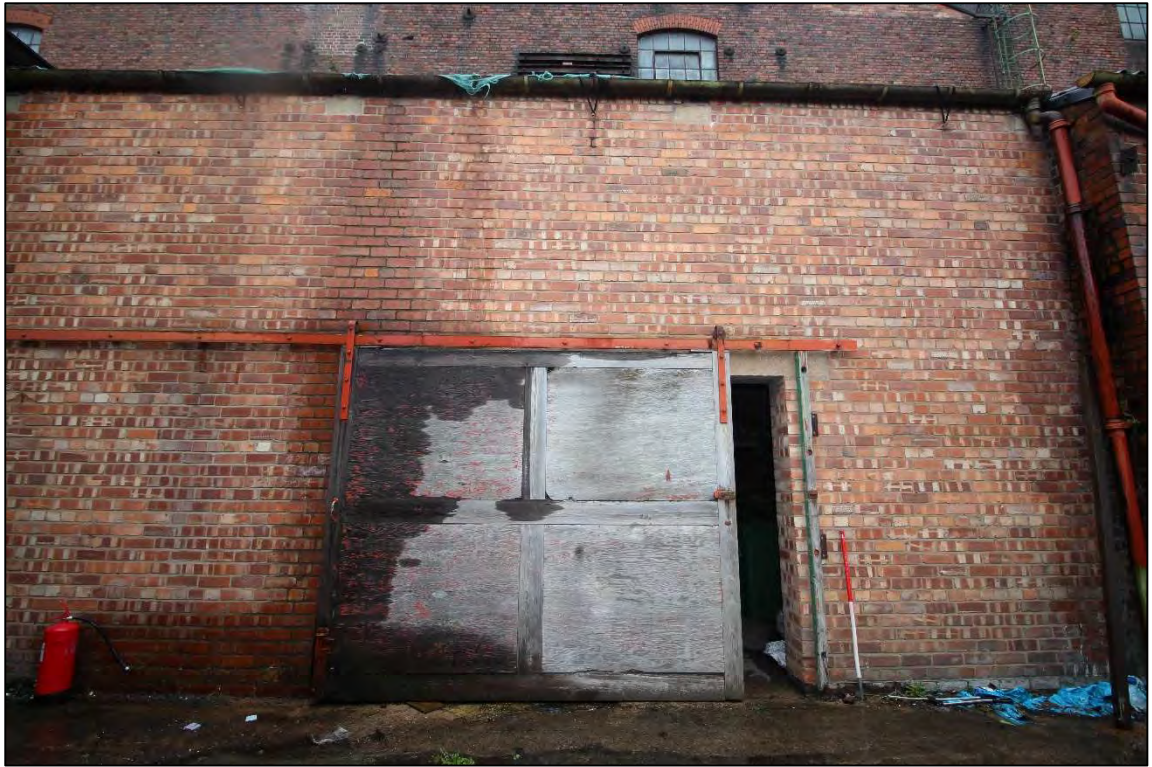
*Plate 95: The western doorway within the southern elevation*

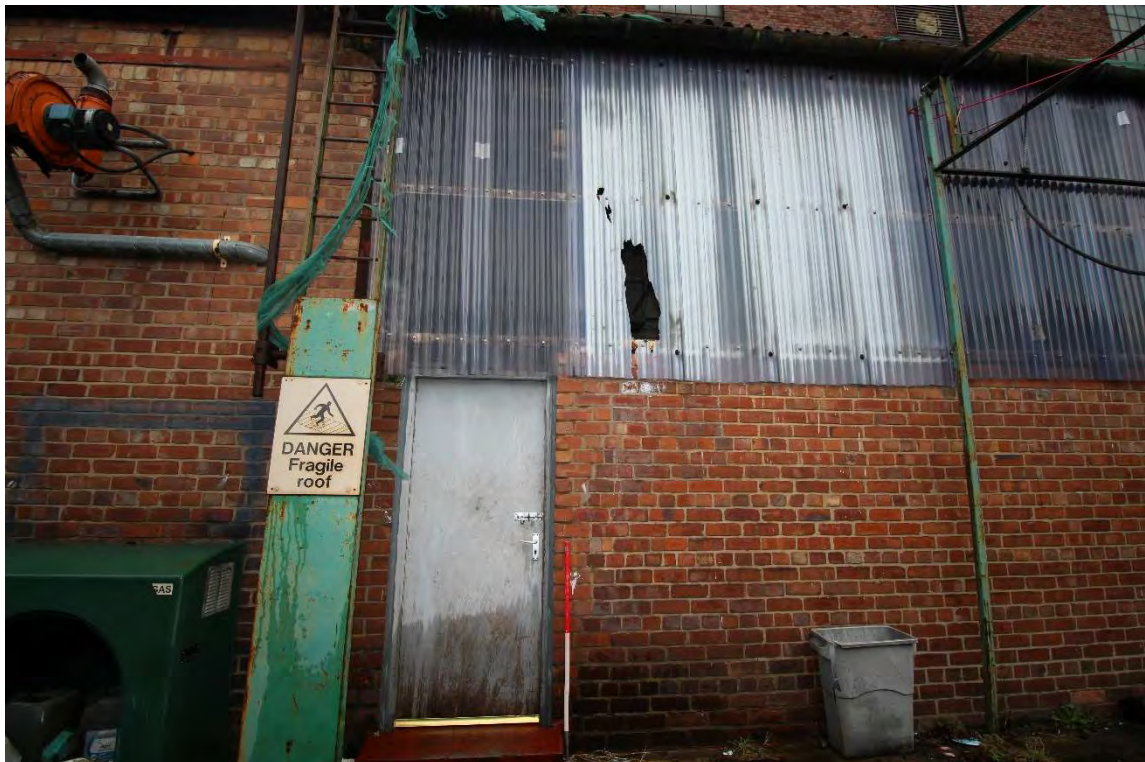
*Plate 96: The eastern doorway within the southern elevation*

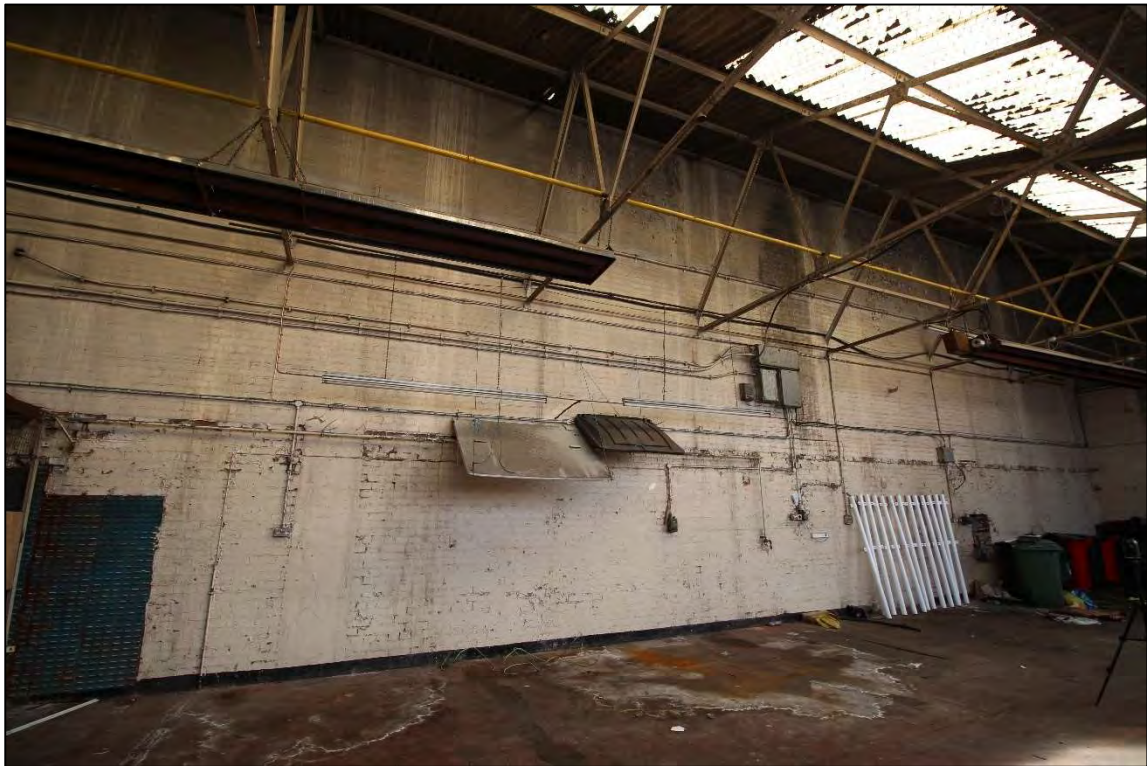
*Plate 97: General view of Room 1, looking north-east*

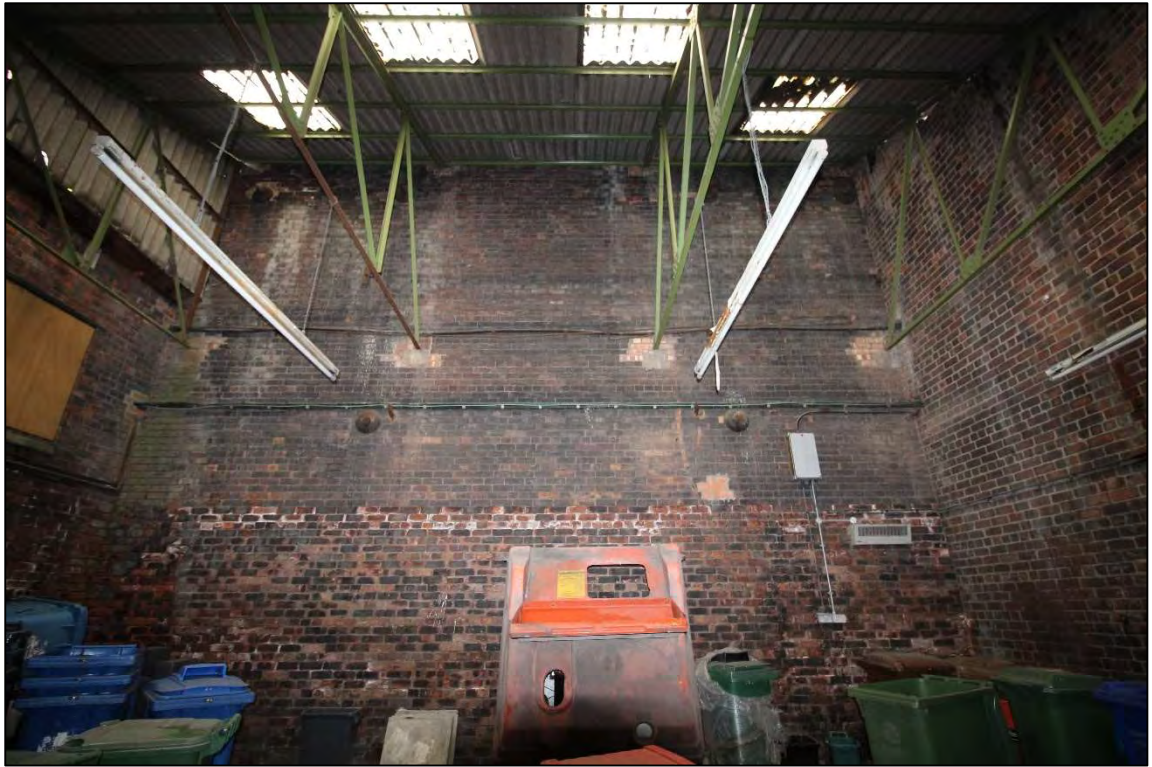
*Plate 98: General view of Room 2 within the lean-to, facing north*

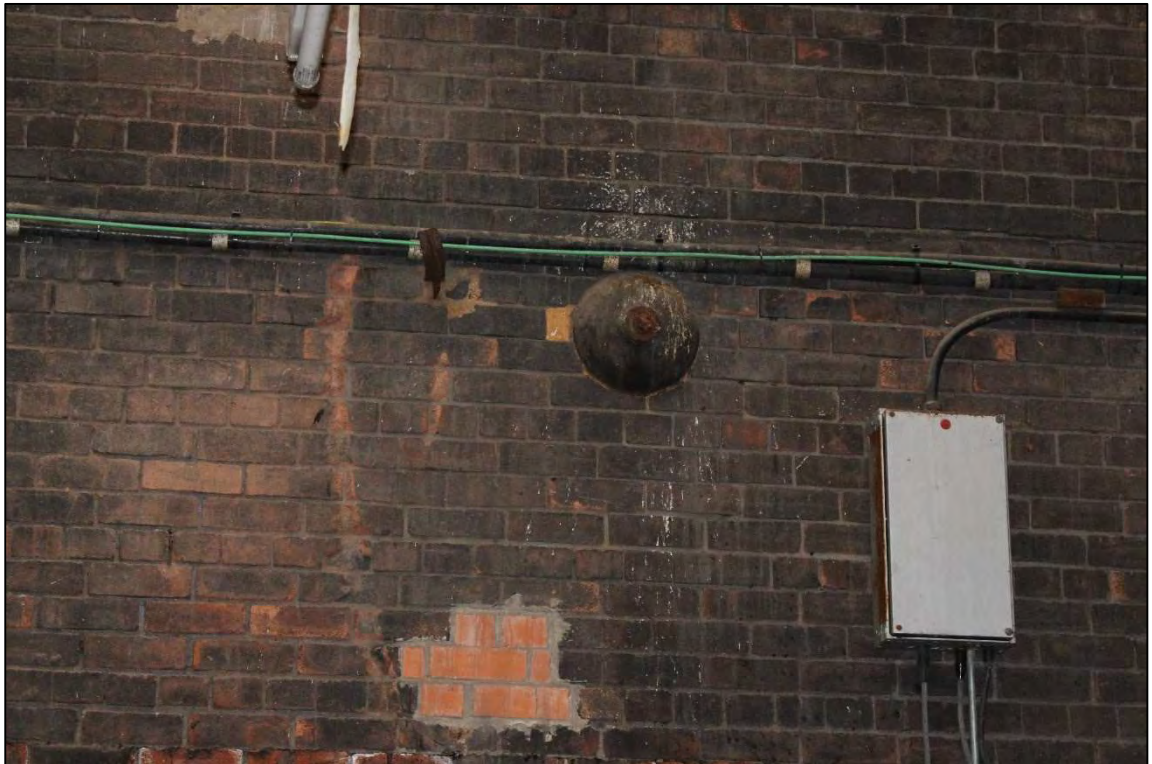
*Plate 99: Detail of the tie rod plates within the northern wall of the shed*

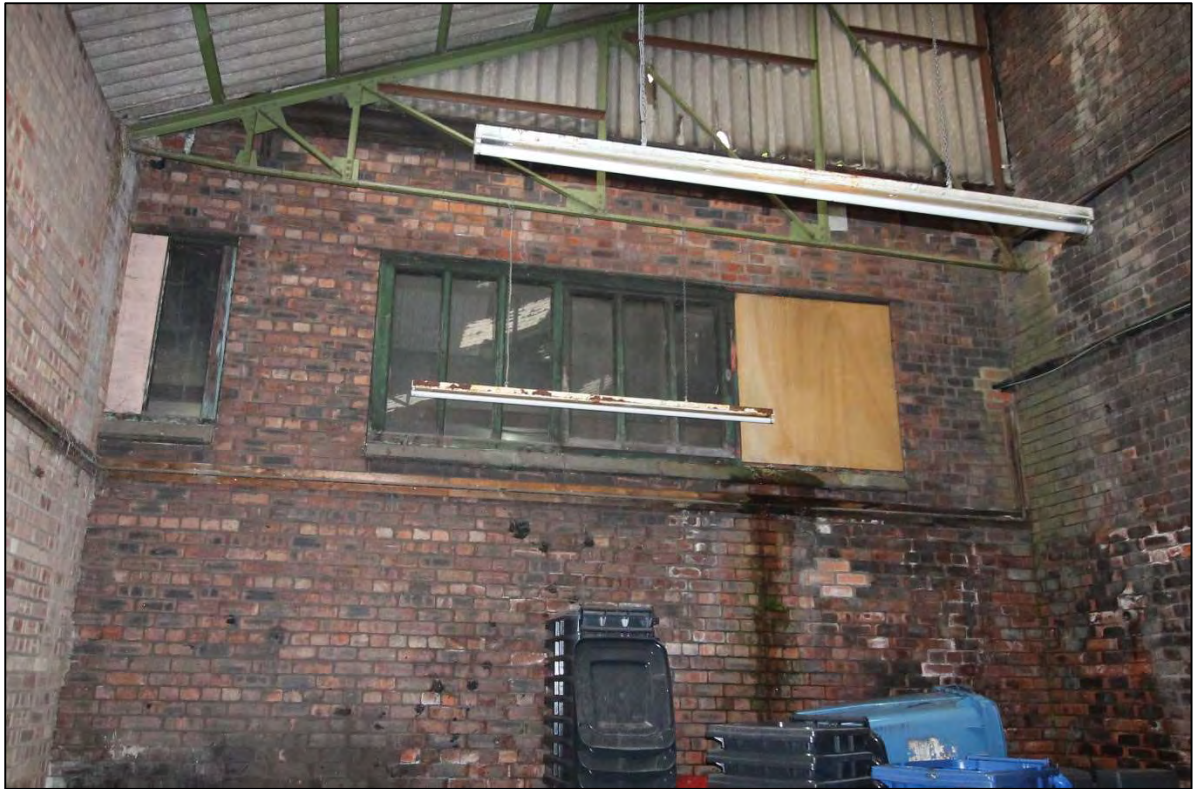
*Plate 100: The eastern elevation of the substation that formed the western wall of the lean-to*
