The northern elevation was also constructed in a three-course English Garden Wall bond consisting of two central recessed windows with a steel ladder to the eastern end (Plate 52; Fig 5). The ladder had been fixed to the outer face and afforded access to the roof. As with the windows to the eastern elevation, the windows were set within a cast-iron housing with a pointed arch head. The cast-iron doors had been removed and exposed a four-light cast-iron window with modern wired obscured glass panes (Plate 53).

Hammerstone Road Depot, Gorton, Manchester

Hammerstone Road Depot, Gorton, Manchester  
Figure 5: Ambulance bay plan & elevations

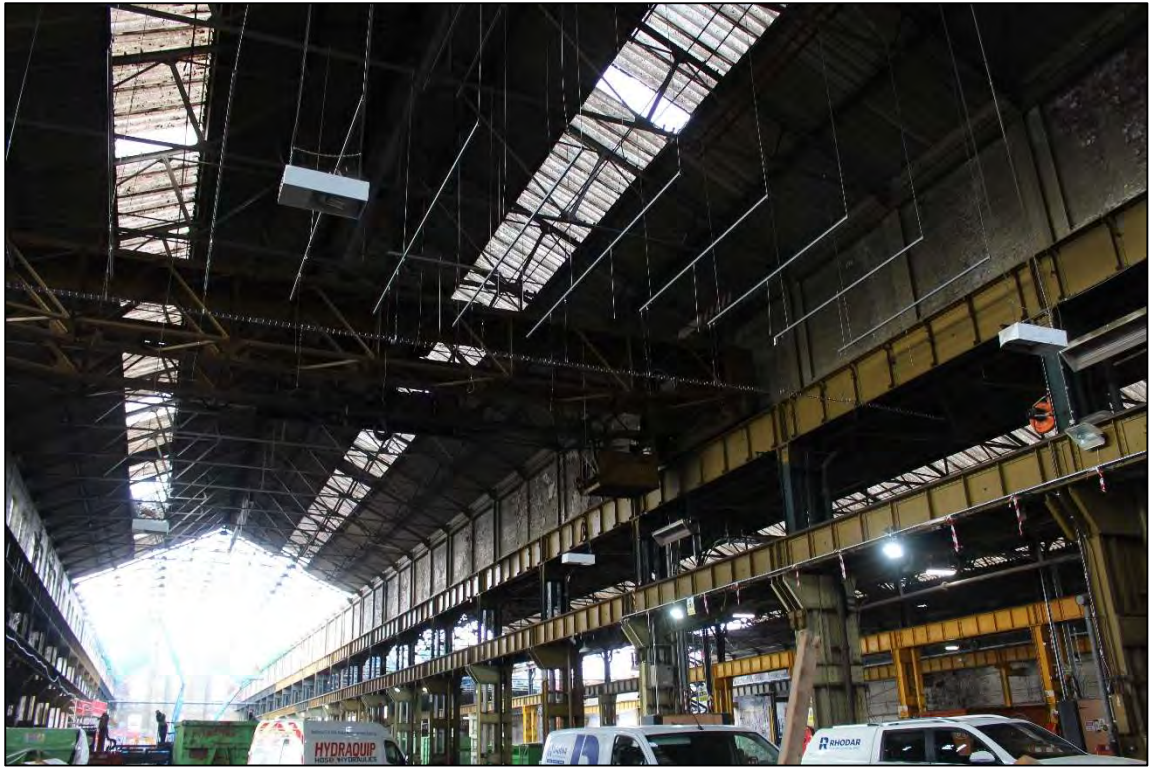
The three bays had retained the original travelling cranes that spanned the full length of the shop. The cranes travelled on rails that were fixed to the upper flange of riveted steel beams that spanned the boiler shop. The beams had been supported by riveted steel stanchions 7.25m apart, with the eastern and western stanchions fixed to the inner face of the brick walls with steel ties (Plate 102).

*Plate 102: The retained traveling crane within the eastern bay*

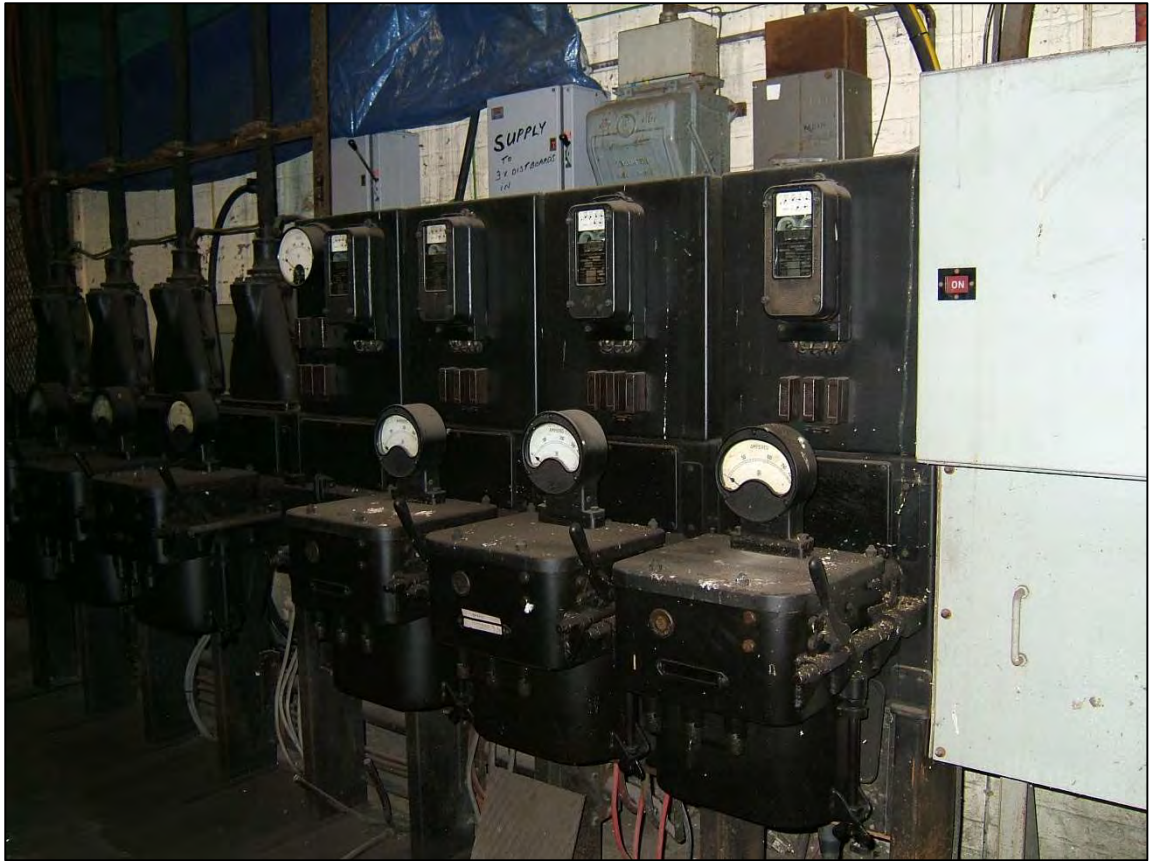
The new boiler shop was powered by an attached 'Power Room' to the south-western corner of the site. The western room (Room 3) of the building had contained several large fuse boards and banks situated to the north and west of the room (Plate 103). During the later-half of the 20<sup>th</sup> century these had been replaced with smaller modern fused boards and were housed within Room 4.

*Plate 103: The original electrical equipment to the northern end of Room 3*
