# Geotechnical Survey Report

FSI Ref: 26463  
Issue Date: May 2023

Risk Address: 18 Delaunays Road  
Manchester  
Lancashire  
M8 4QS

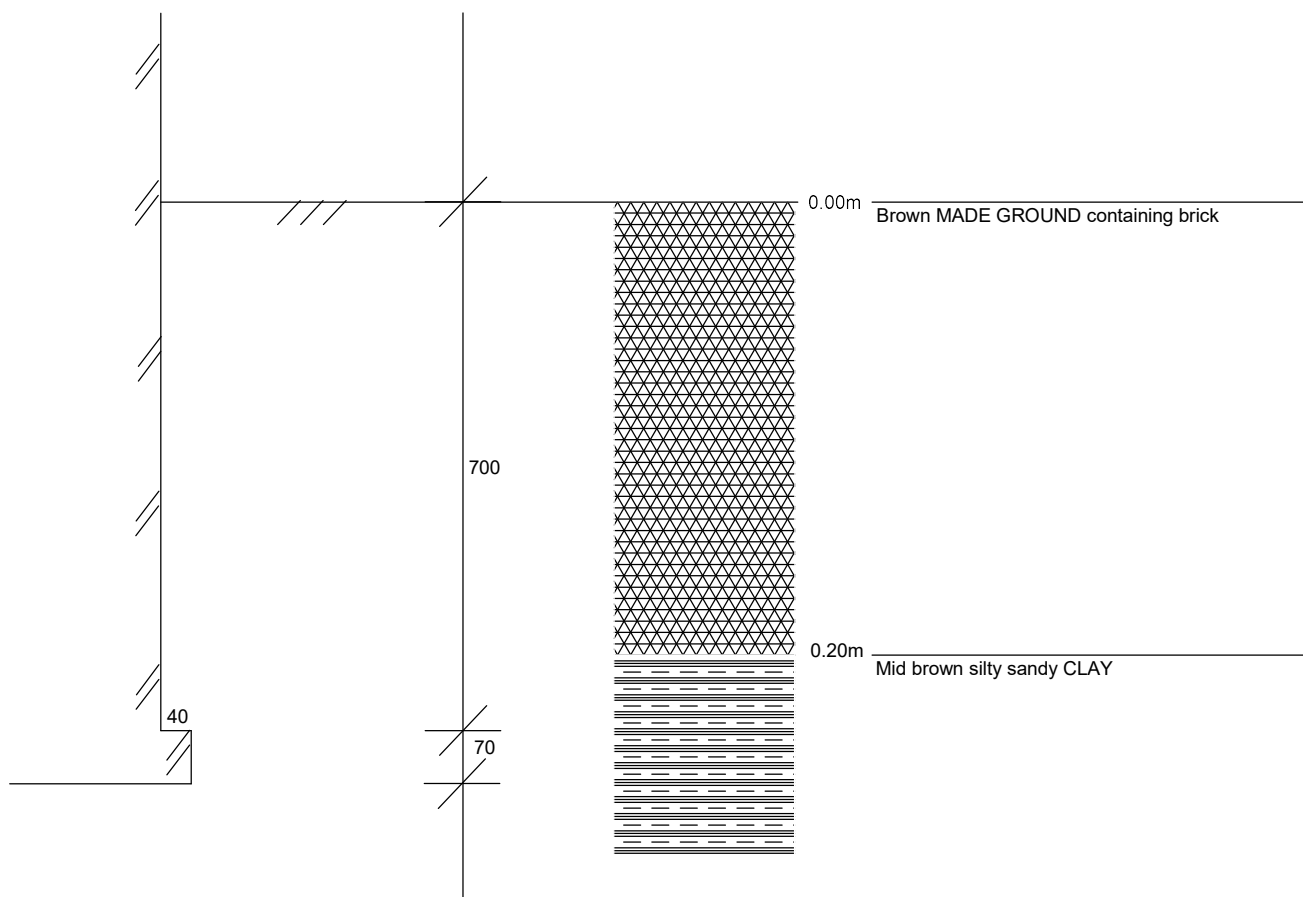
## TRIAL PIT 2

D1 @ F.L. (0.77m)

V = 70-80kPa

Founding strata: Mid brown silty sandy CLAY

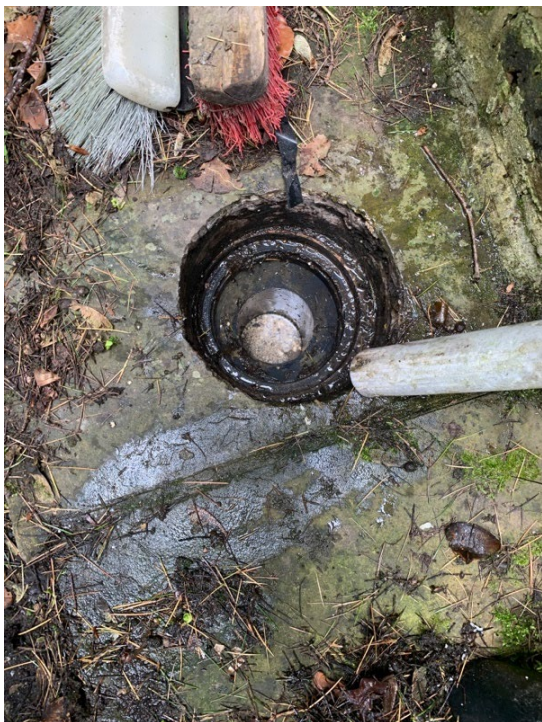
Water mains test passed. Unable to remove trap to survey FWG1.

Photo 1 (Unable to remove FWG1 trap without breaking it to survey)

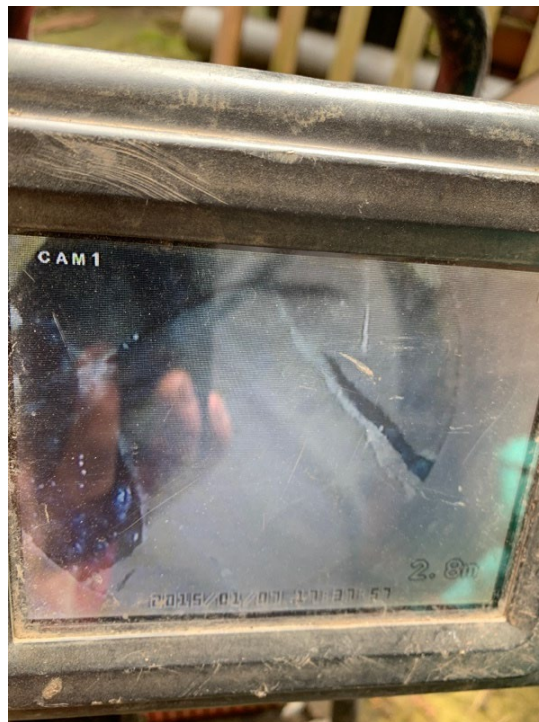
Photo 2 (SVP downstream large break in pipe at 2.90m)

| Run | Grade | Recommended action |
|---|---|---|
| 2 | C | Excavate & replace damaged section |

1. Run 2 Excavate & replace damaged section
2. Run 3 Jet to clear & re-survey

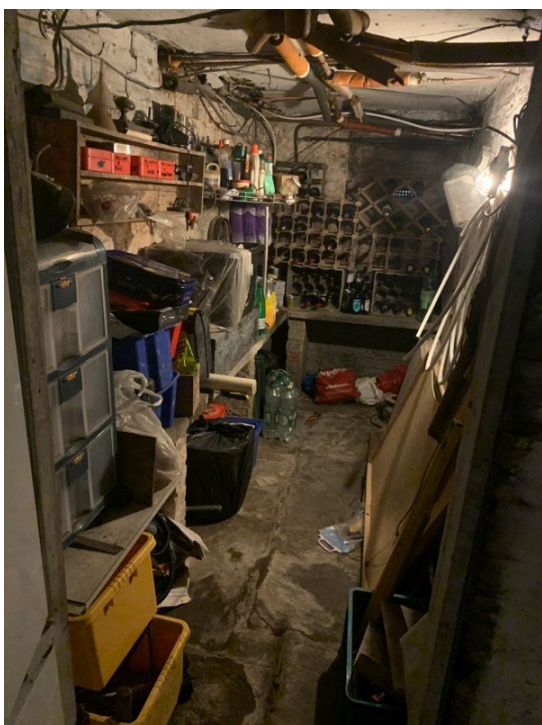
Photo 3 (Unable to complete TP1 due to obstruction-  
BH1 carried out close to proposed location)

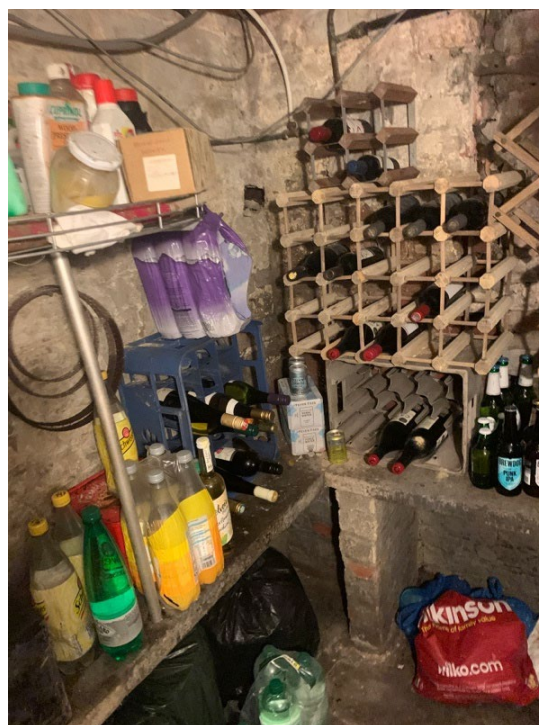
Photo 4 (Unable to complete TP1 due to obstruction-  
BH1 carried out close to proposed location)
