## Schedule of Condition

27-29 Church Street  
Manchester  
M4 1PE

Dated: 23<sup>rd</sup> October 2023

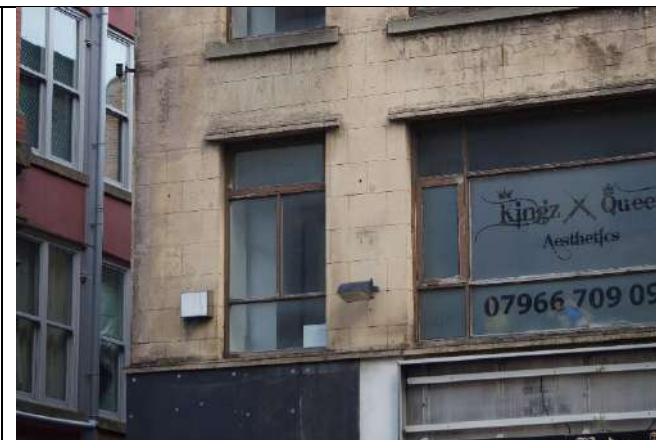
Timber style windows are distressed with ill fitting casement, draughty generally and rotting to the frames.

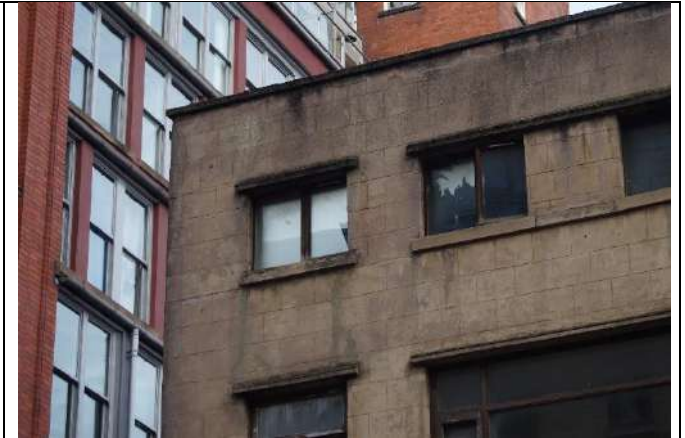
Crittall style windows are distressed with ill fitting casement, draughty generally and rotting to the frames.

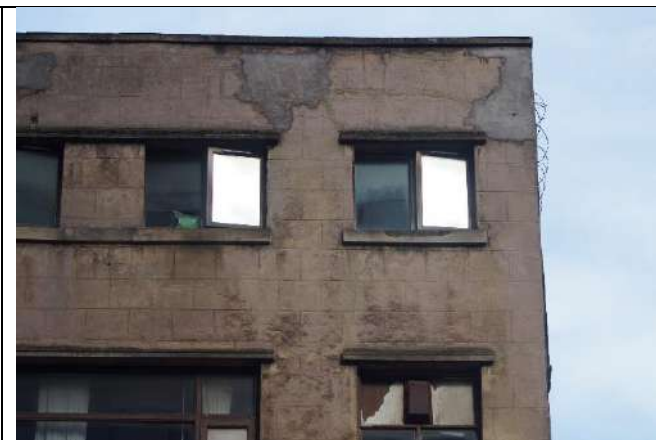
Rendered art décor façade is distressed with delaminated renders and broken and cracked masonry below. Possibly some bond loss in the brickwork below.

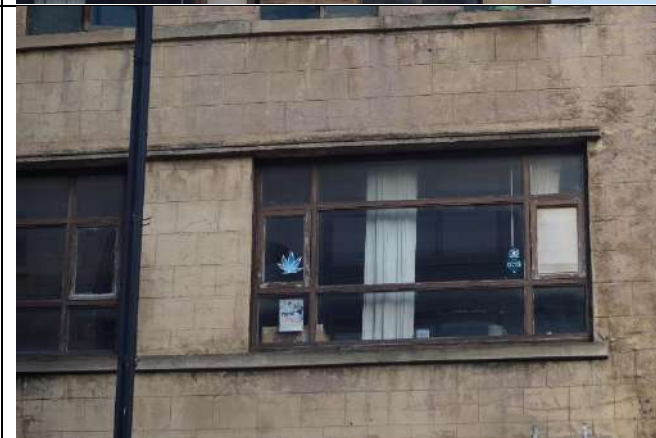
Timber style windows are distressed with ill fitting casement, draughty generally and rotting to the frames.

Some windows are timber and there is rot in the timber frames.

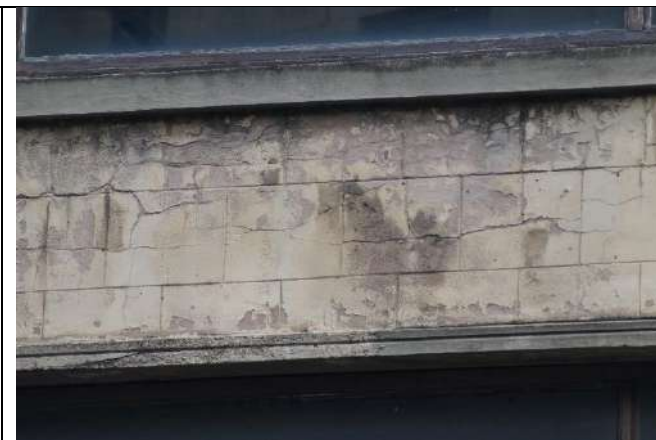
Render is added, delaminated and there is evidence of cracked brickwork below the render which is an indication of bond loss.

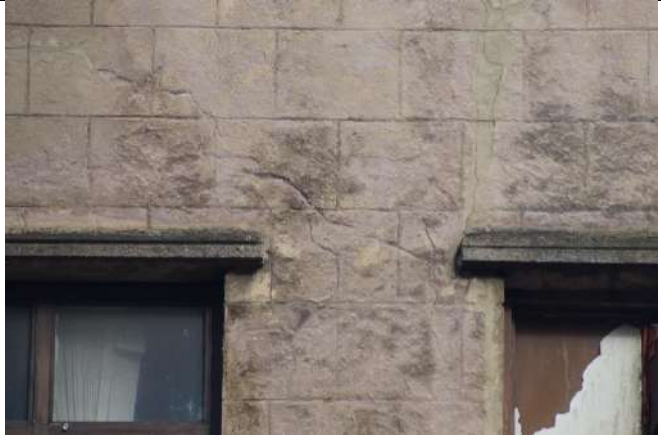
| <p>Render is addled, delaminated and there is evidence of cracked brickwork below the render which is an indication of bond loss.</p> | | <p>Render is addled, delaminated and there is evidence of cracked brickwork below the render which is an indication of bond loss.</p> | |

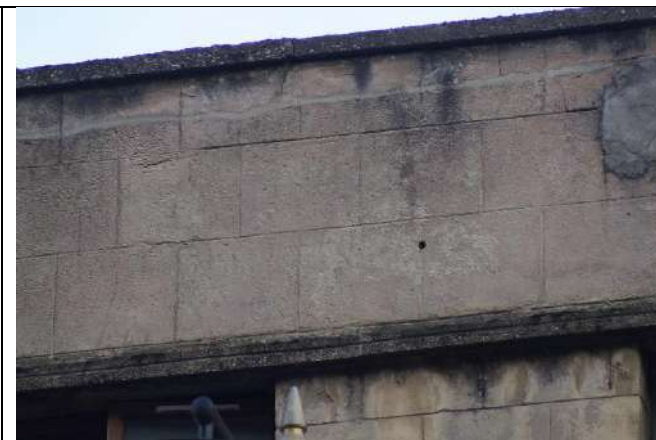
Render is addled, delaminated and there is evidence of cracked brickwork below the render which is an indication of bond loss.

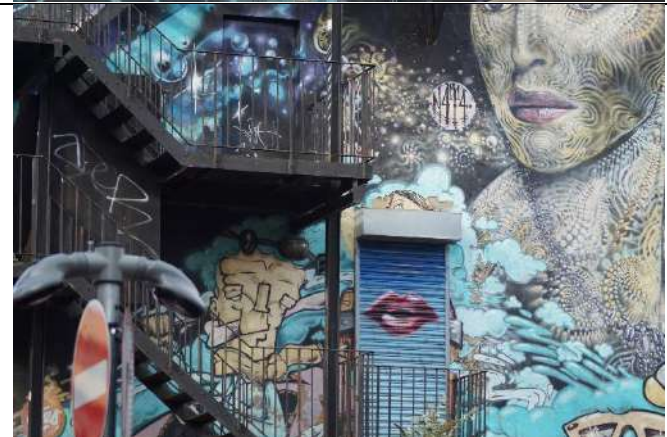
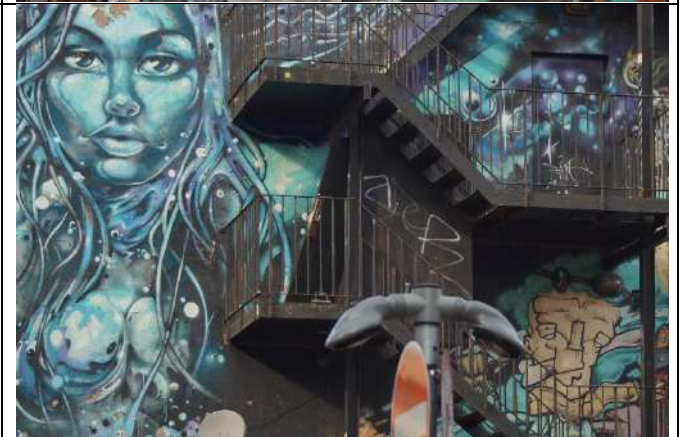
| <p>Steel fire escape stair is rusting and is decoratively distressed.</p> | | <p>Render is added, delaminated and there is evidence of cracked brickwork below the render which is an indication of bond loss.</p> | |

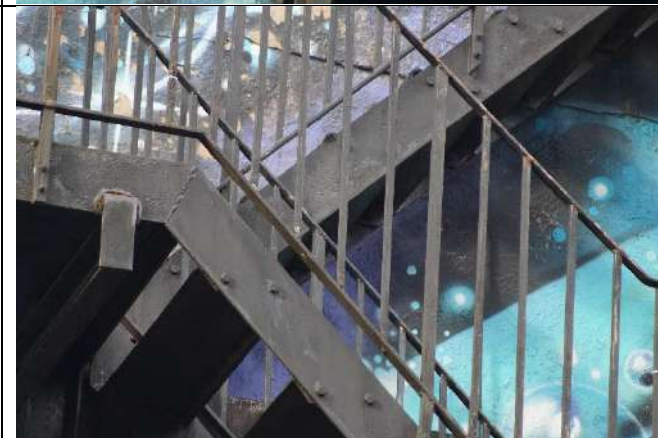
Steel fire escape stair is rusting and is decoratively distressed.

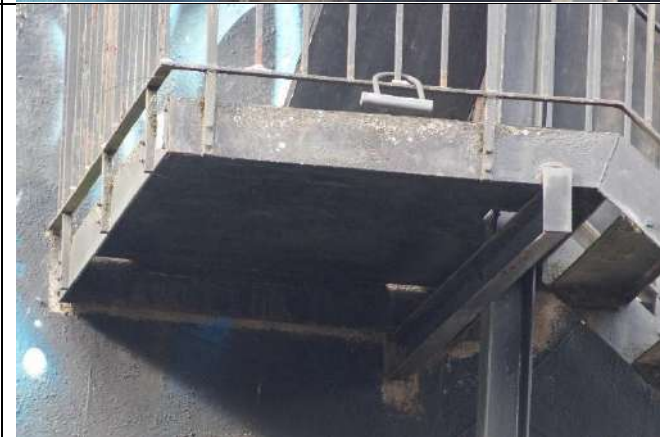
Steel fire escape stair is rusting and is decoratively distressed.

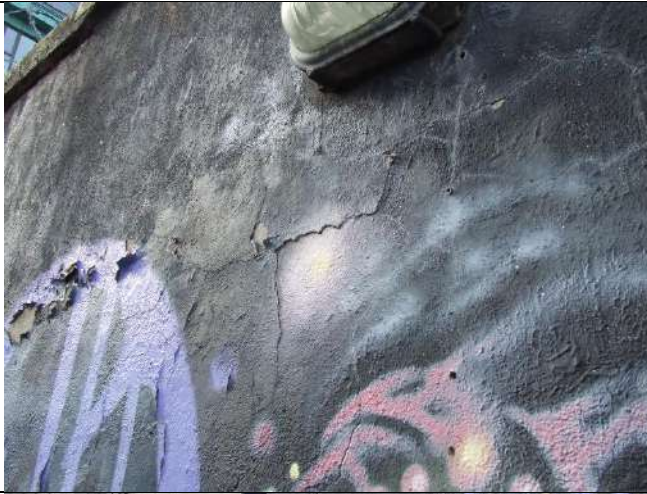
Render is added, delaminated and there is evidence of cracked brickwork below the render which is an indication of bond loss.

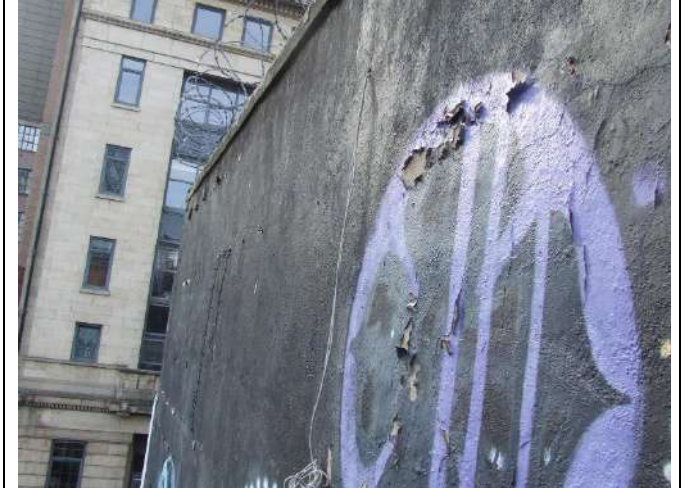
Render is added, delaminated and there is evidence of cracked brickwork below the render which is an indication of bond loss.

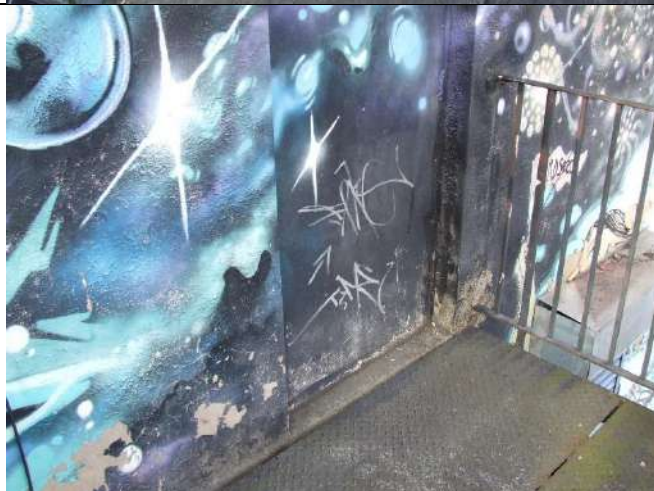
Distressed pedestrian door.

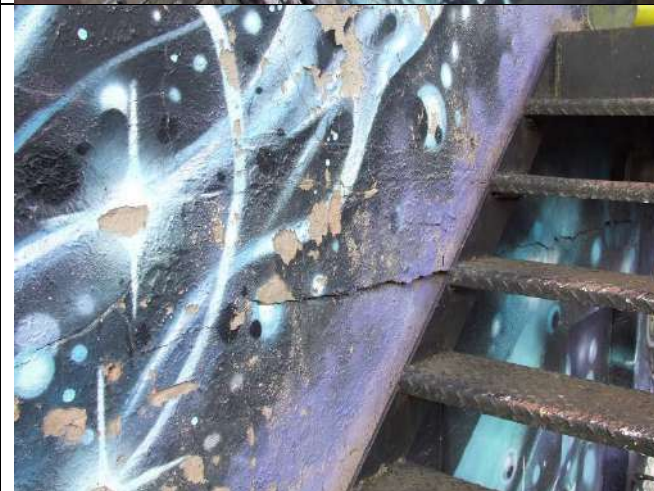
Render is added, delaminated and there is evidence of cracked brickwork below the render which is an indication of bond loss.

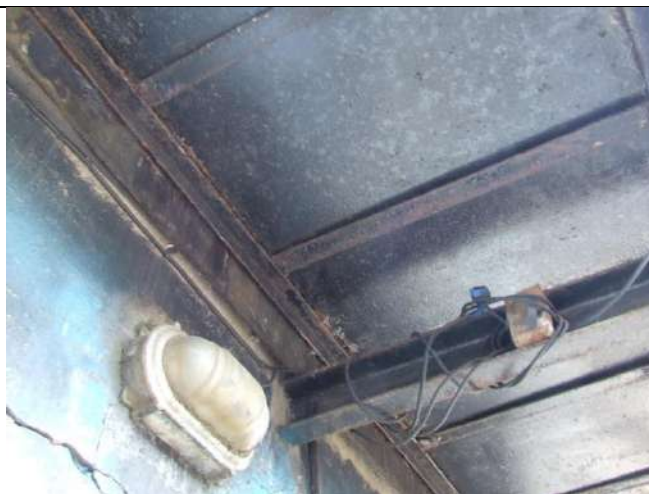
Steel fire escape stair is rusting and is decoratively distressed.

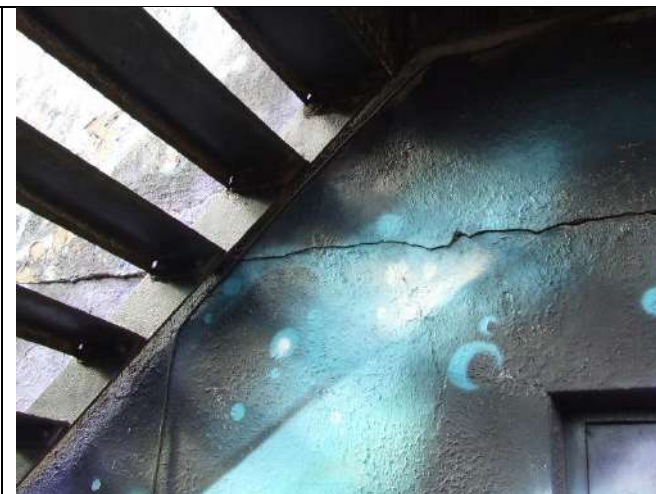
Render is addled, delaminated and there is evidence of cracked brickwork below the render which is an indication of bond loss.

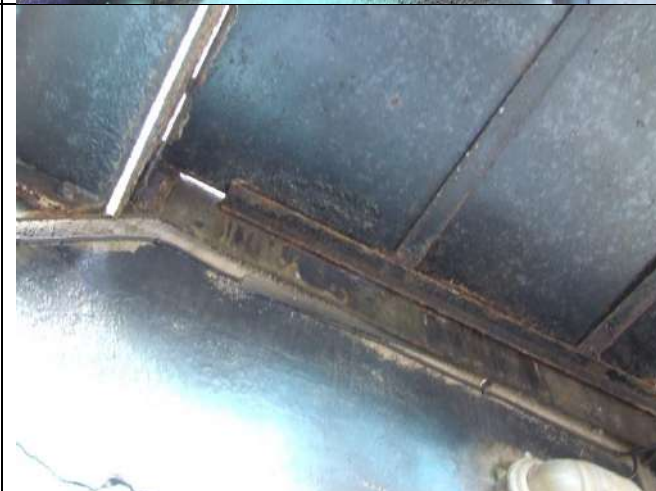
Steel fire escape stair is rusting and is decoratively distressed.

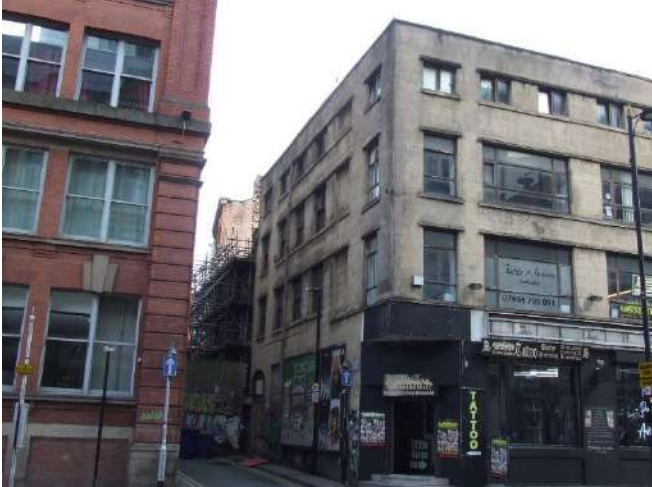
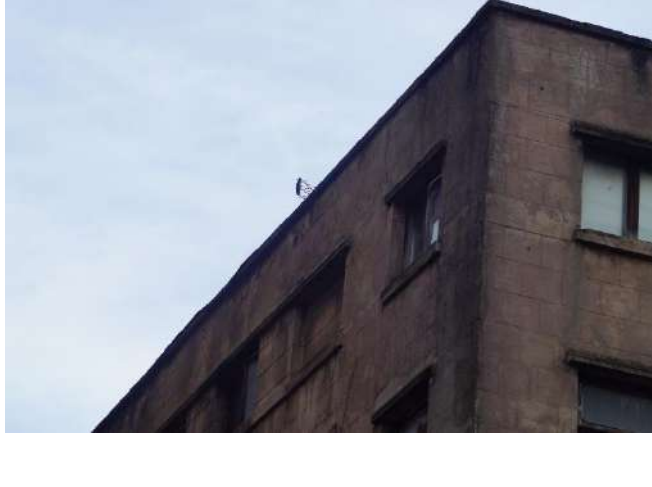
| <p>Side elevation generally.</p> | | <p>Timber style windows are distressed with ill fitting casement, draughty generally and rotting to the frames.</p> | |

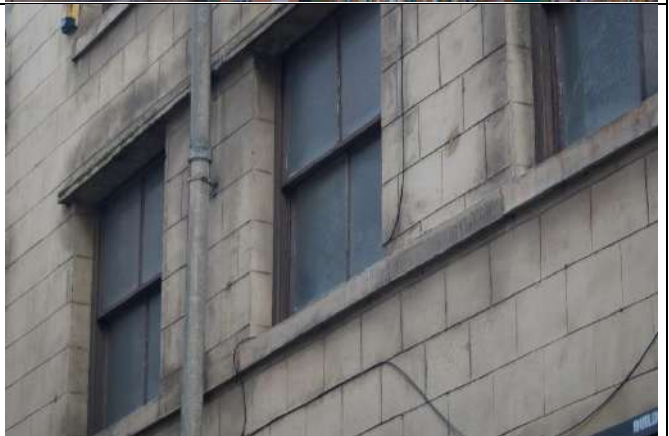
| <p>Timber style windows are distressed with ill fitting casement, draughty generally and rotting to the frames.</p> | | <p>Render is added, delaminated and there is evidence of cracked brickwork below the render which is an indication of bond loss.</p> | |

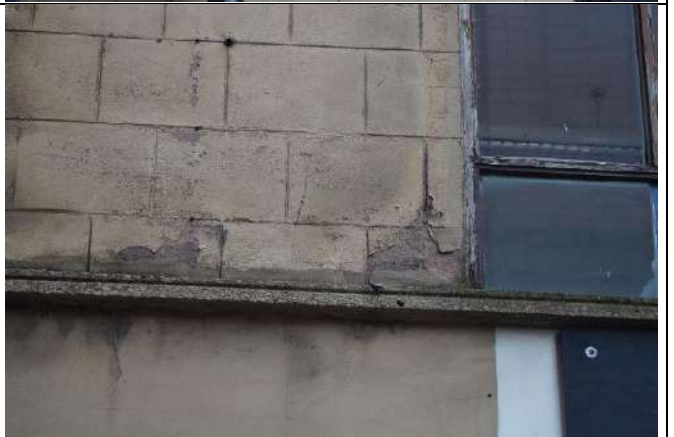
| <p>Timber style windows are distressed with ill fitting casement, draughty generally and rotting to the frames.</p> | | <p>Render is added, delaminated and there is evidence of cracked brickwork below the render which is an indication of bond loss.</p> | |

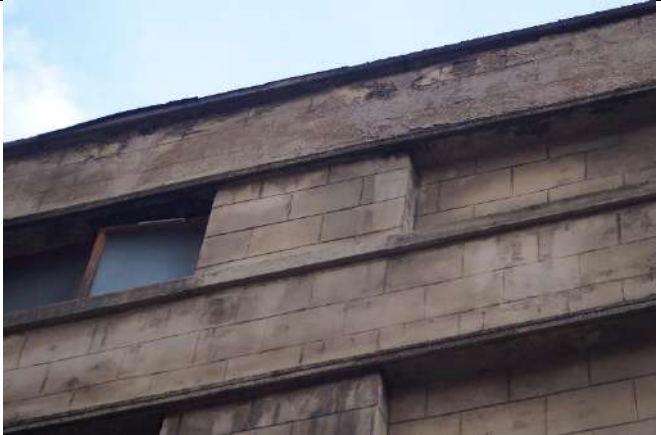
| Generally. | | Render is added, delaminated and there is evidence of cracked brickwork below the render which is an indication of bond loss. | |

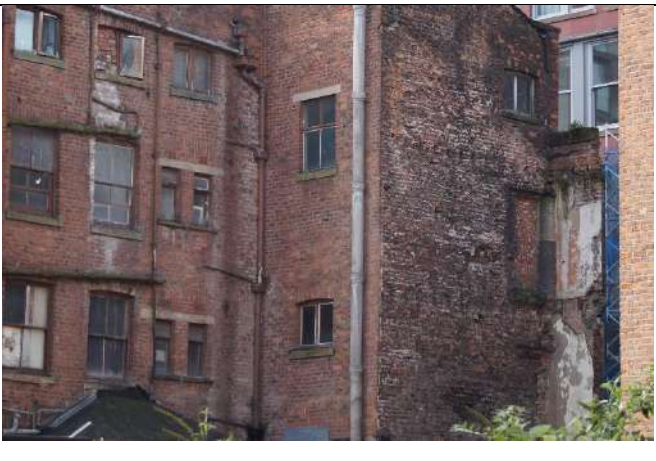
| <p>Rear elevation brickwork is generally distressed and in need of overhauling and repointing generally.</p> <p>Where the adjacent building has not been rebuilt after demolition the face of brick is at risk of weather penetration and needs to be repointed and made good to keep the property wind and water tight.</p> | | <p>Timber windows distressed as above with rot and a lack of good and regular decoration.</p> | |

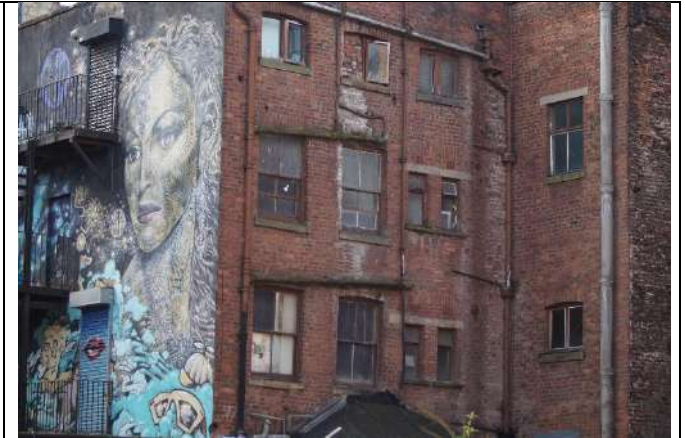
Timber windows distressed as above with rot and a lack of good and regular decoration.

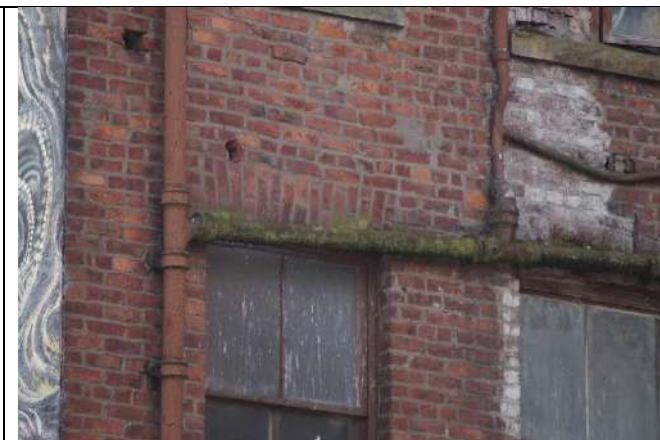
Timber windows distressed as above with rot and a lack of good and regular decoration.

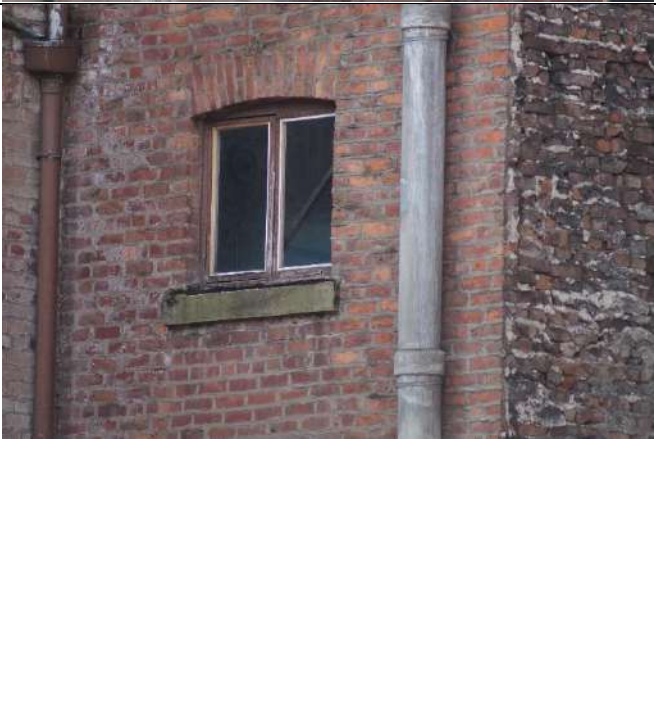
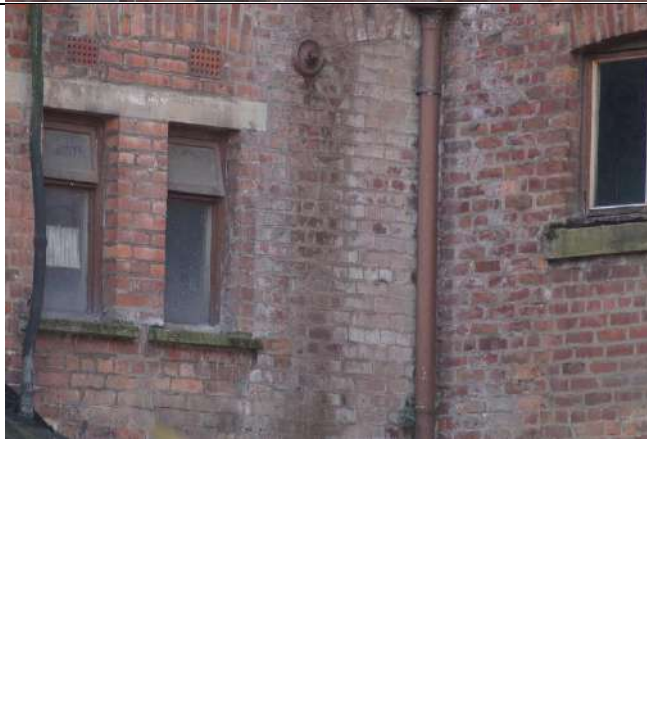
| <p>Rear elevation brickwork is generally distressed and in need of overhauling and repointing generally.</p> | | <p>Timber windows distressed as above with rot and a lack of good and regular decoration.</p> | |

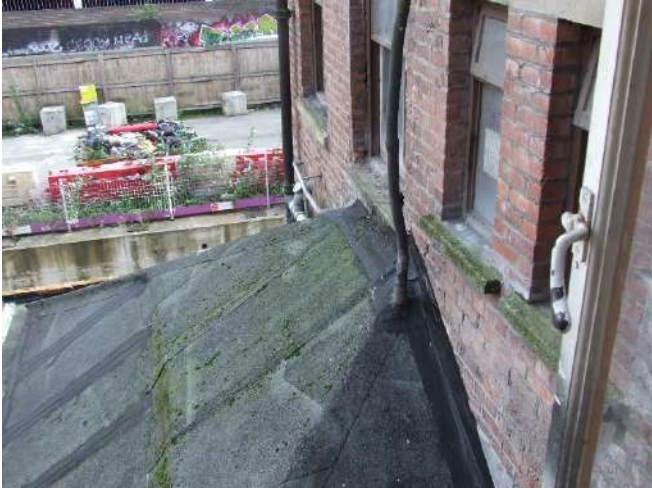
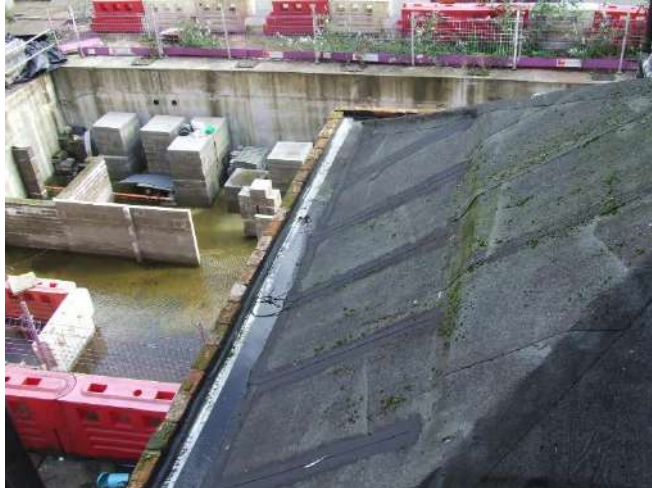
The low level retail roof this is covered in roofing felt over the original slate as a sort of poor over layer repair. This is very distressed and this roof needs to be stripped completely and relay with a new tile or slate covering.

| <p>Rear low level roof over felted on slate where it has been leaking. This is a poor repair and this roof needs to be stripped and recovered.</p> | | <p>Rear low level roof over felted on slate where it has been leaking. This is a poor repair and this roof needs to be stripped and recovered.</p> | |

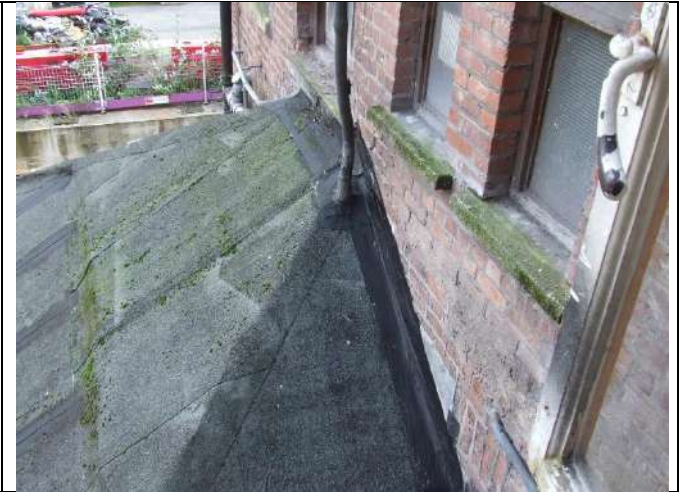
Rear low level roof over felted on slate where it has been leaking. This is a poor repair and this roof needs to be stripped and recovered.

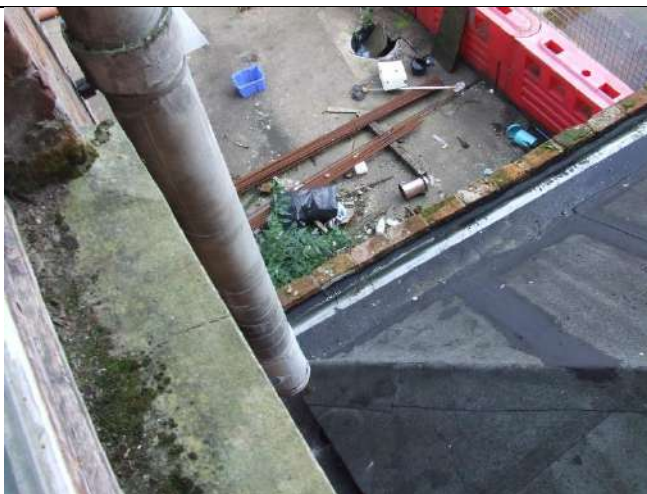
Rear low level roof over felted on slate where it has been leaking. This is a poor repair and this roof needs to be stripped and recovered.

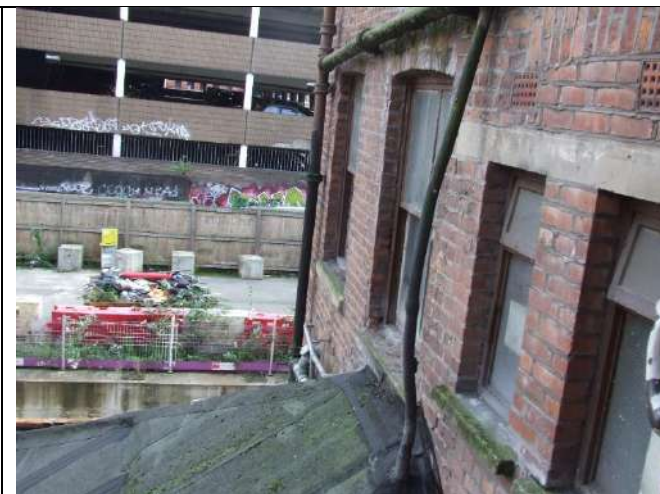
Rear low level roof over felted on slate where it has been leaking. This is a poor repair and this roof needs to be stripped and recovered.

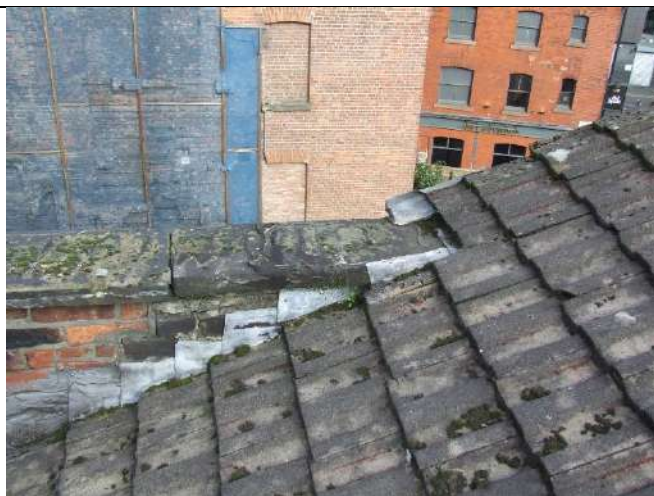
Flashing missing or split and leaking.

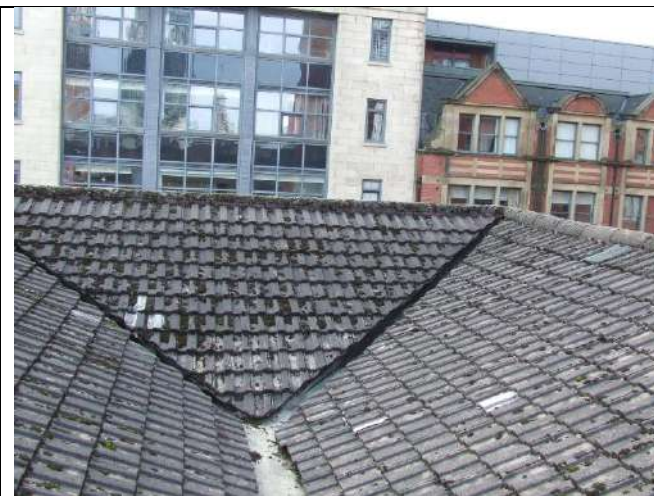
To the main roof the tiles are old concrete interlocking, and these are showing significant signs of being porous, aging and wear. The older tiles are heavily pitted, the patina of the surface of the tile is degraded and moss is building up on the surface. The aging process causes the otherwise smooth surface of the tile to breakdown and become pitted which results initially in moss being able to bind with the surface and then later the tiles can become porous, which ultimately allows water into the roof structure.

Main roof of aged concrete interlocking tiles.

The tiles are heavily moss pitted and are becoming porous.

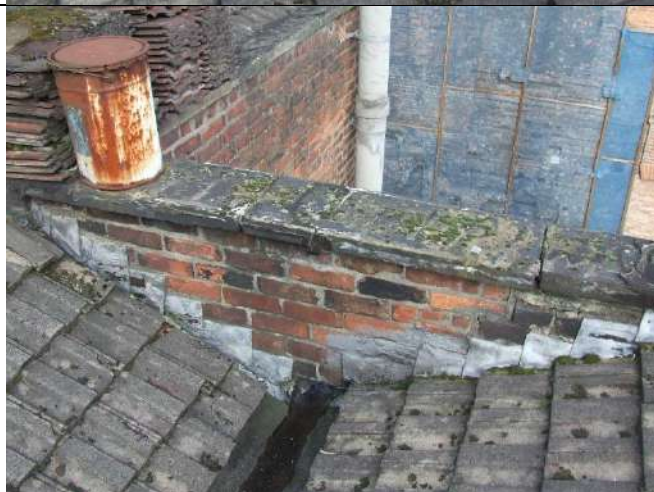
Flashing missing or split and leaking.

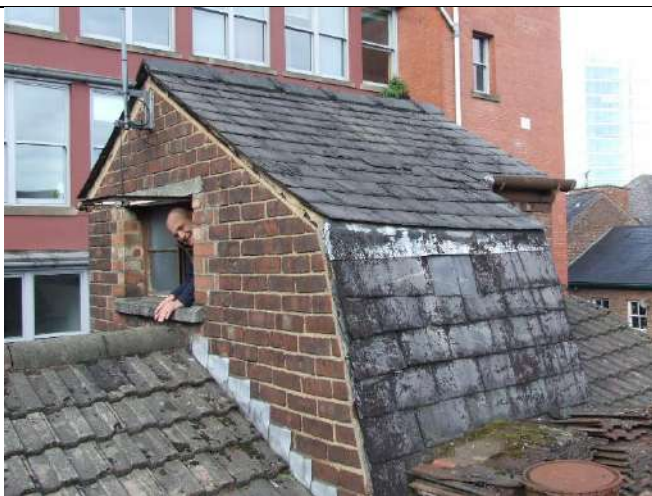
Slates to the plant room are distressed.

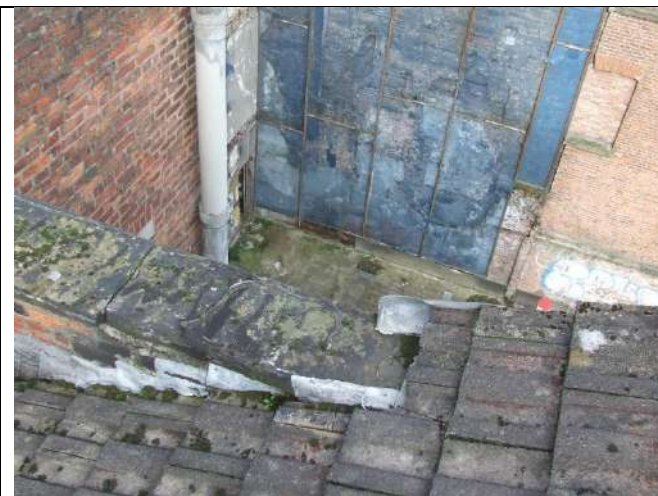
Flashing missing or split and leaking.

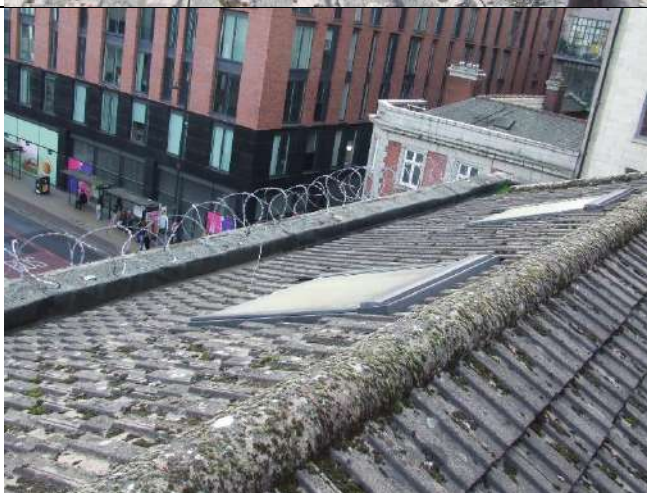
Patched roofing generally.

Valley and parapet gutters have been overlaid with felts to stop leaks.

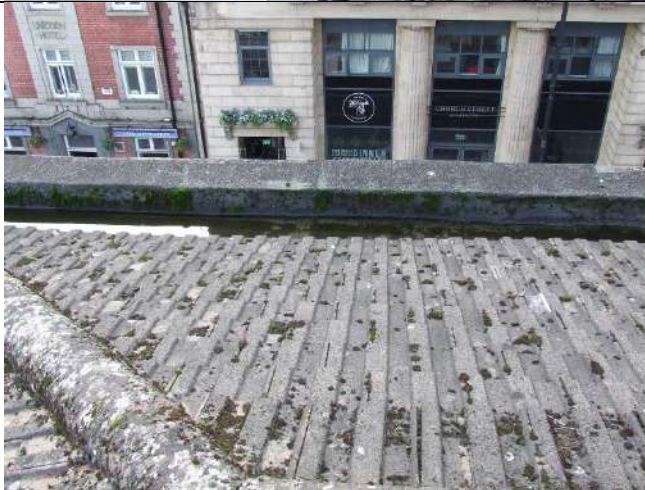
Main roof of aged concrete interlocking tiles.

The tiles are heavily moss pitted and are becoming porous.

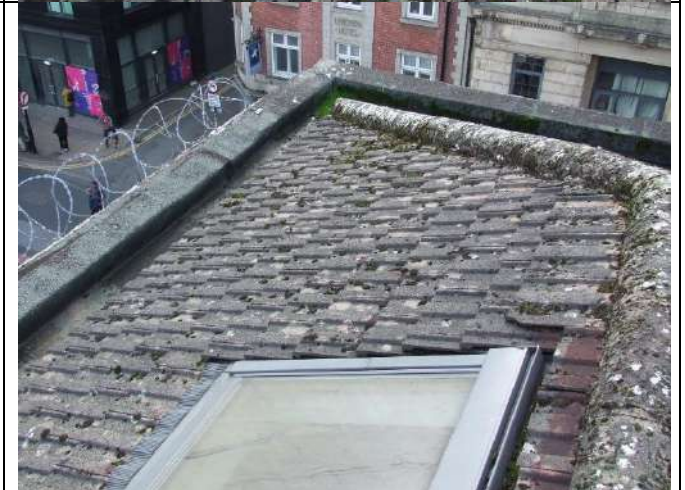
Patched roofing generally.

Valley and parapet gutters have been over laid with felts to stop leaks.

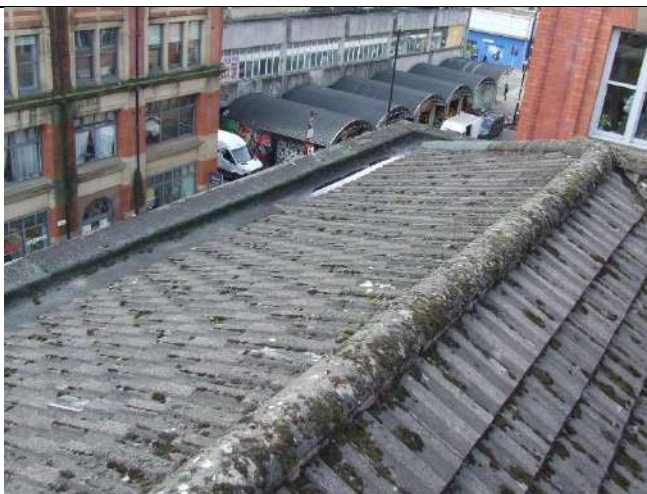
Valley and parapet gutters have been overlaid with felts to stop leaks.

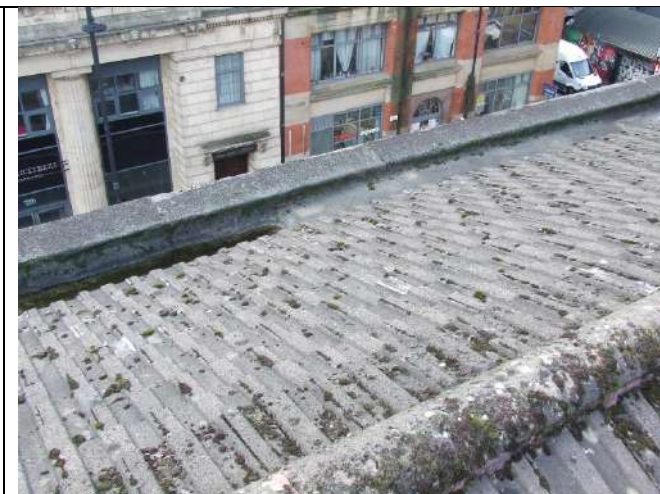
Patched roofing generally.

Valley and parapet gutters have been overlaid with felts to stop leaks.

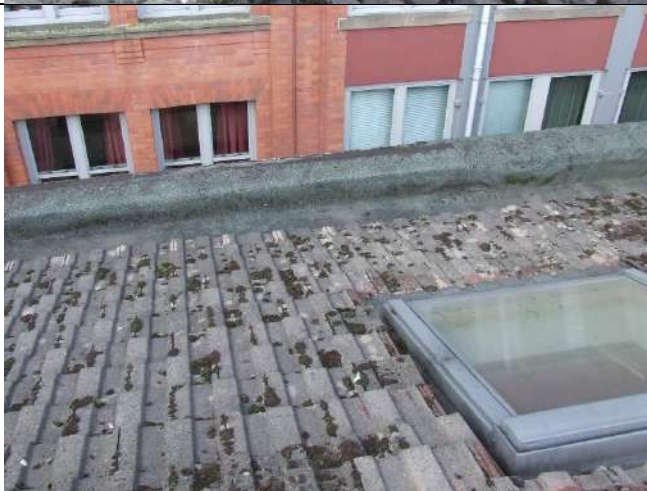
Valley and parapet gutters have been overlaid with felts to stop leaks.

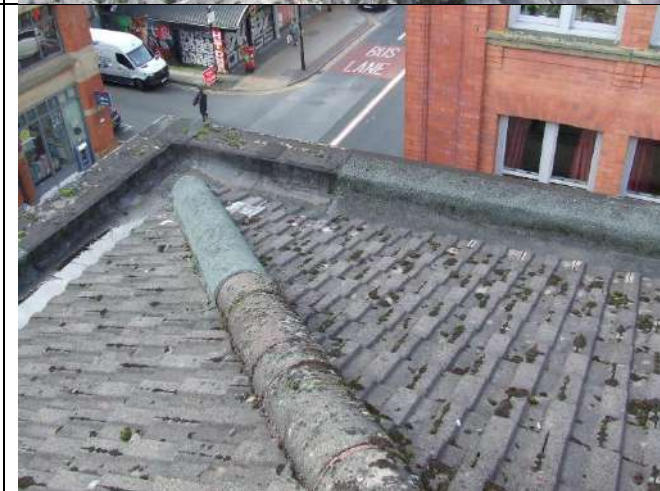
Patched roofing generally.

Valley and parapet gutters have been overlaid with felts to stop leaks.

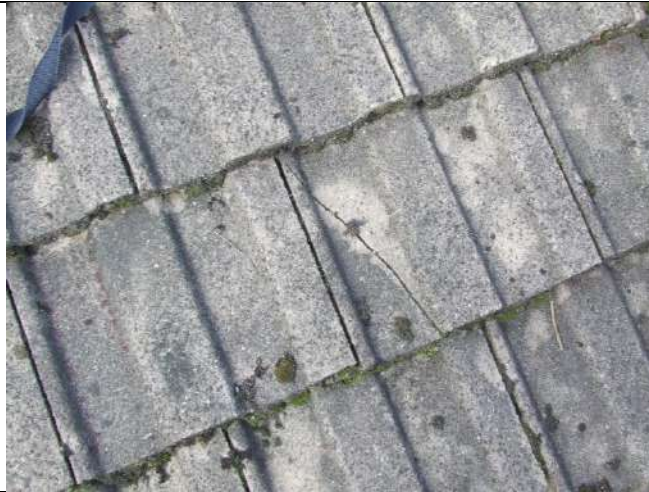
Example of broken tiles.

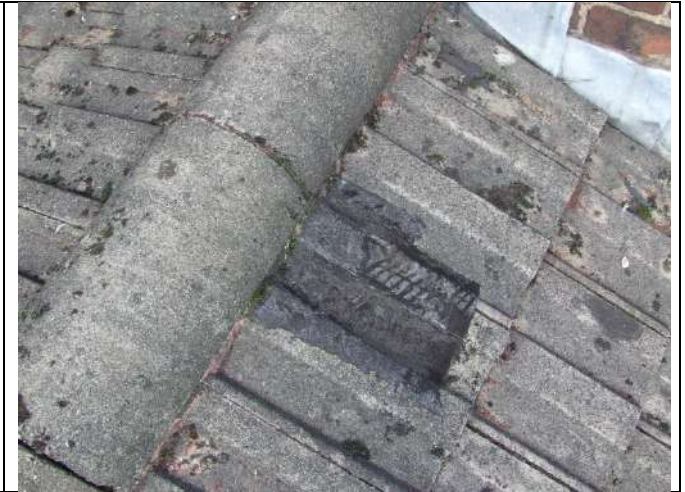
Patches to broken tiles.
